30 March 2021

RE: PRELIMINARY SITE INVESTIGATION ADDENDUM LETTER: 100 EXPLORERS WAY, ST CLAIR, NSW

Report Type: Preliminary Site Investigation
Site Address: 94 – 100 Explorers Way, St Clair, NSW
Report Number: 1842/ER-1-1
Report Date: 28th April 2015

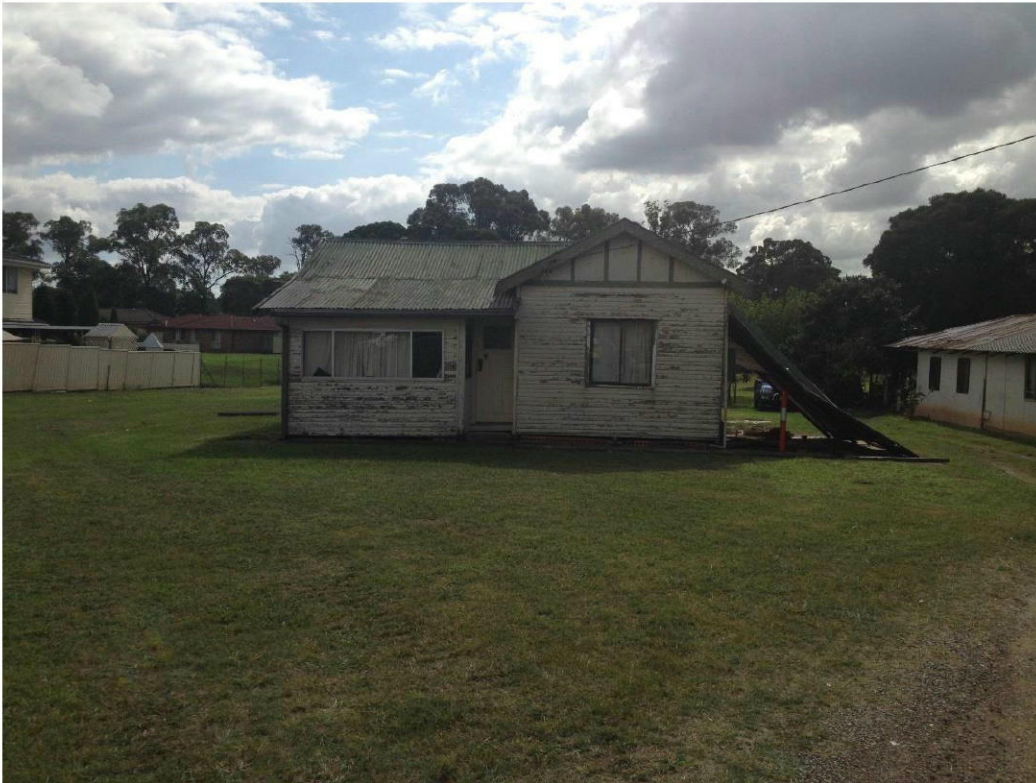
Photo 1: Front of small, wooden dwelling, looking north.

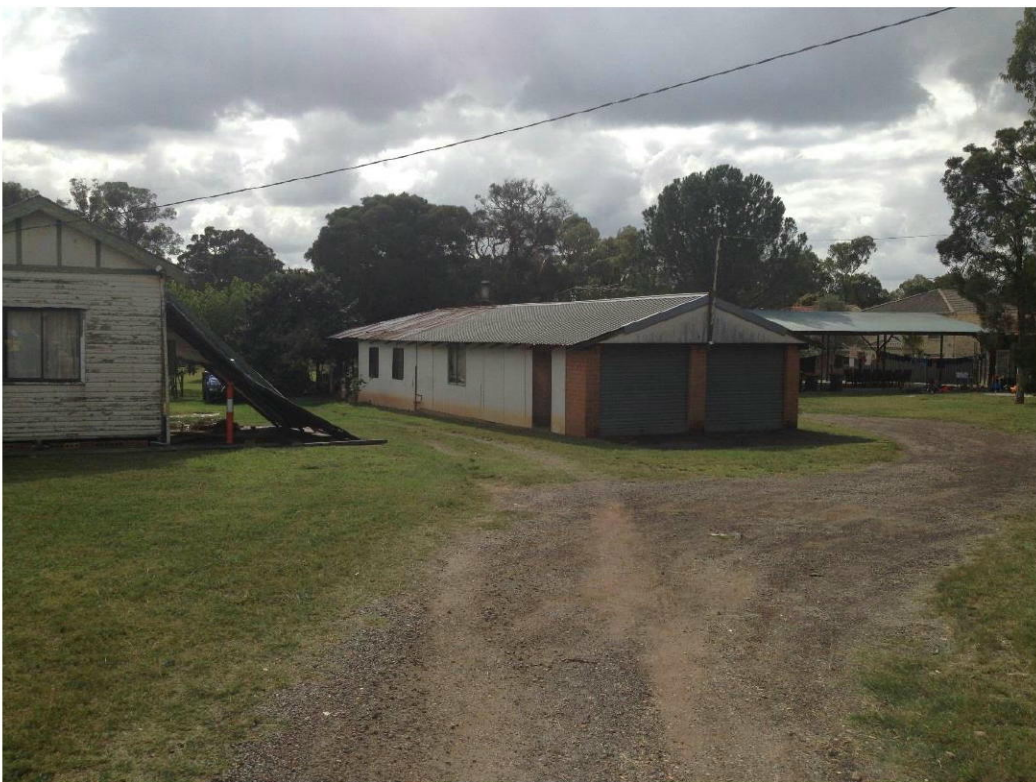
Photo 2: Front of garage with wooden dwelling to the left and the gazebo in the background to the right. Looking north-east.

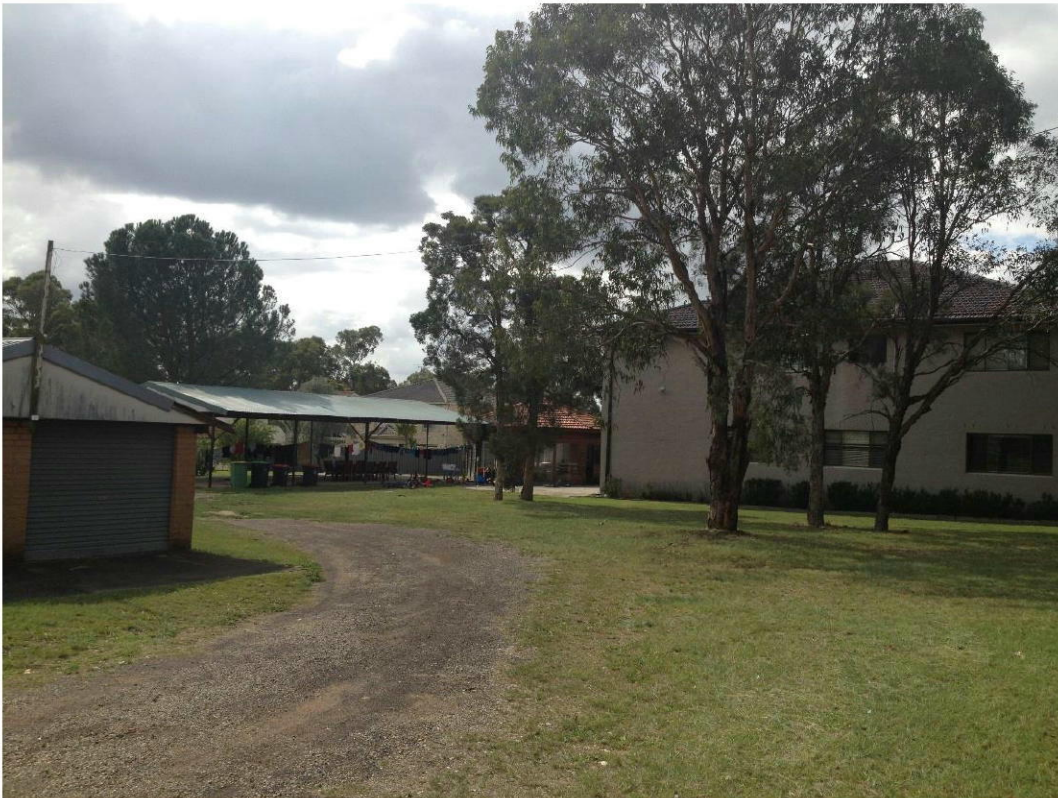
Photo 3: Gazebo, wooden hut and large two-storey dwelling with driveway in foreground. Looking east.

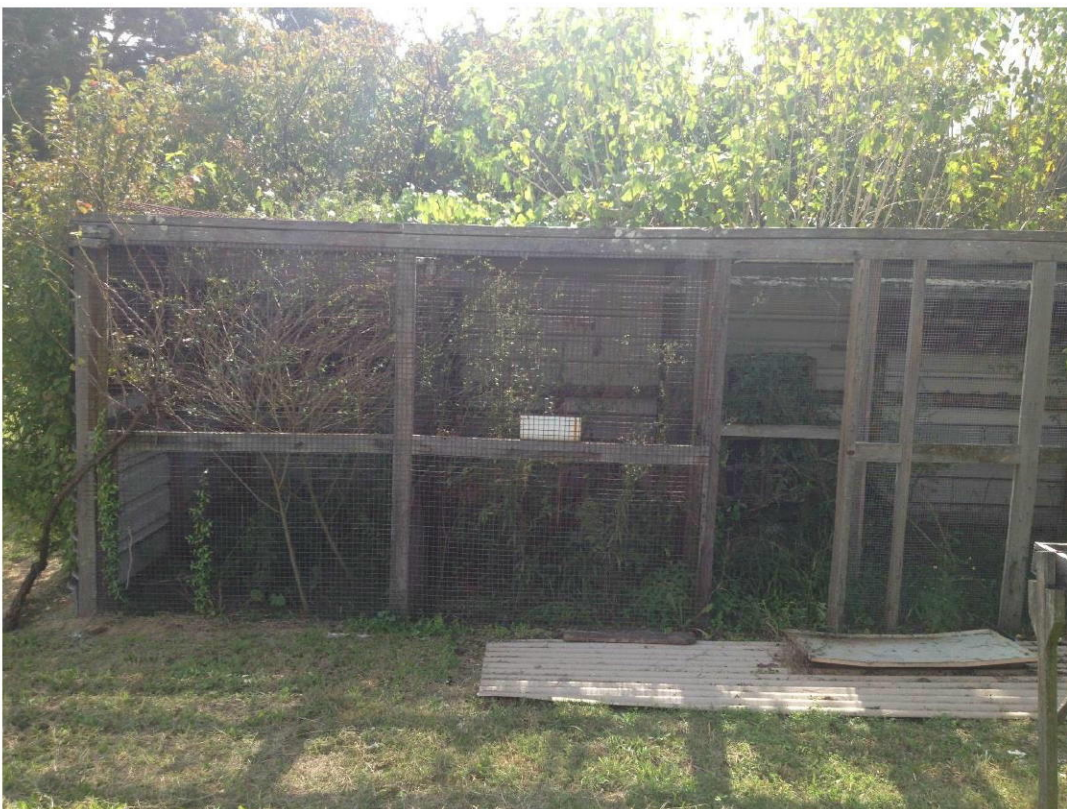
Photo 4: Chicken coop, looking north.

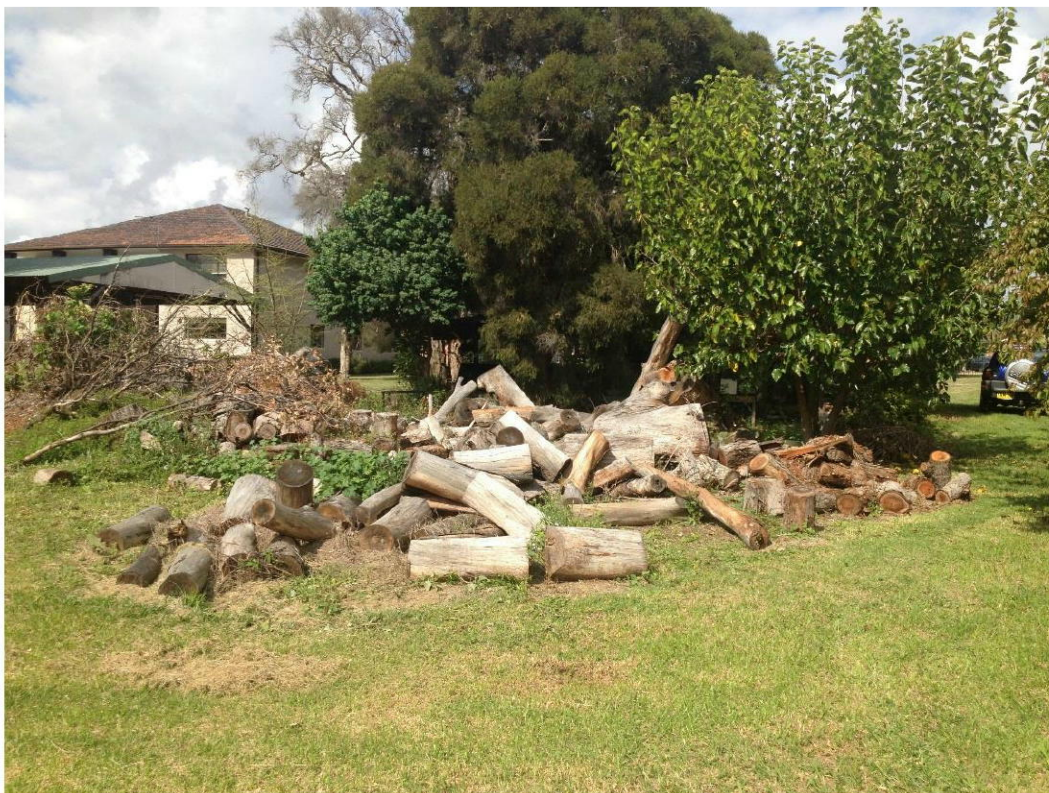
Photo 5: Wood stockpiles and rear of site dwellings, looking south.

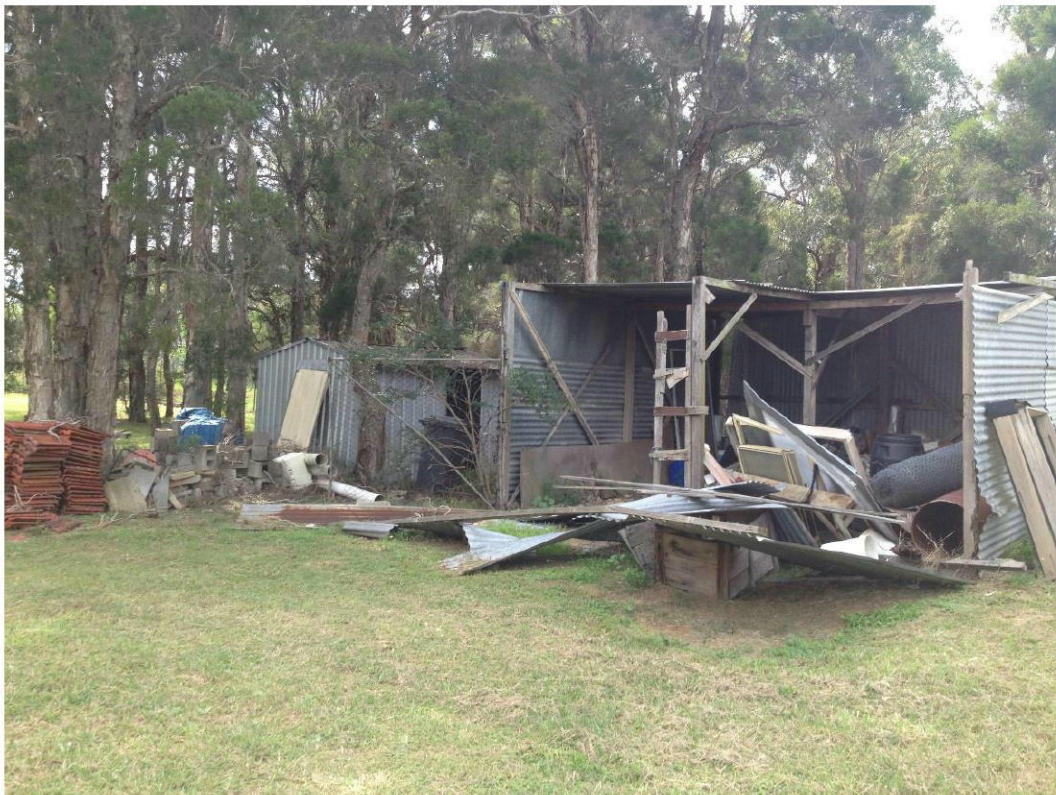
- Two small sheds, located on the eastern boundary of the site, constructed of wood and sheet metal. Evidence of minor storage of chemicals was observed including empty tins of paint, oil and fuel containers.

Photo 6: Sheds on eastern boundary of the site, looking north-east.

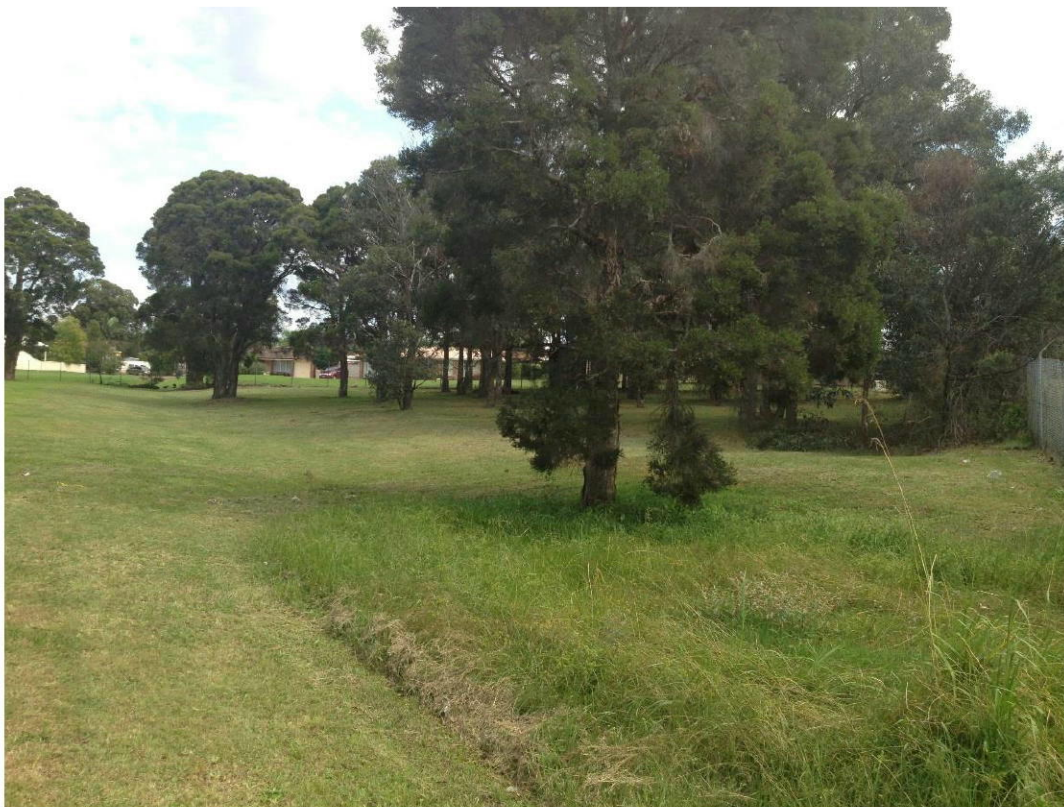
Photo 7: Drainage channel in centre of site with embankments either side of it, looking west.

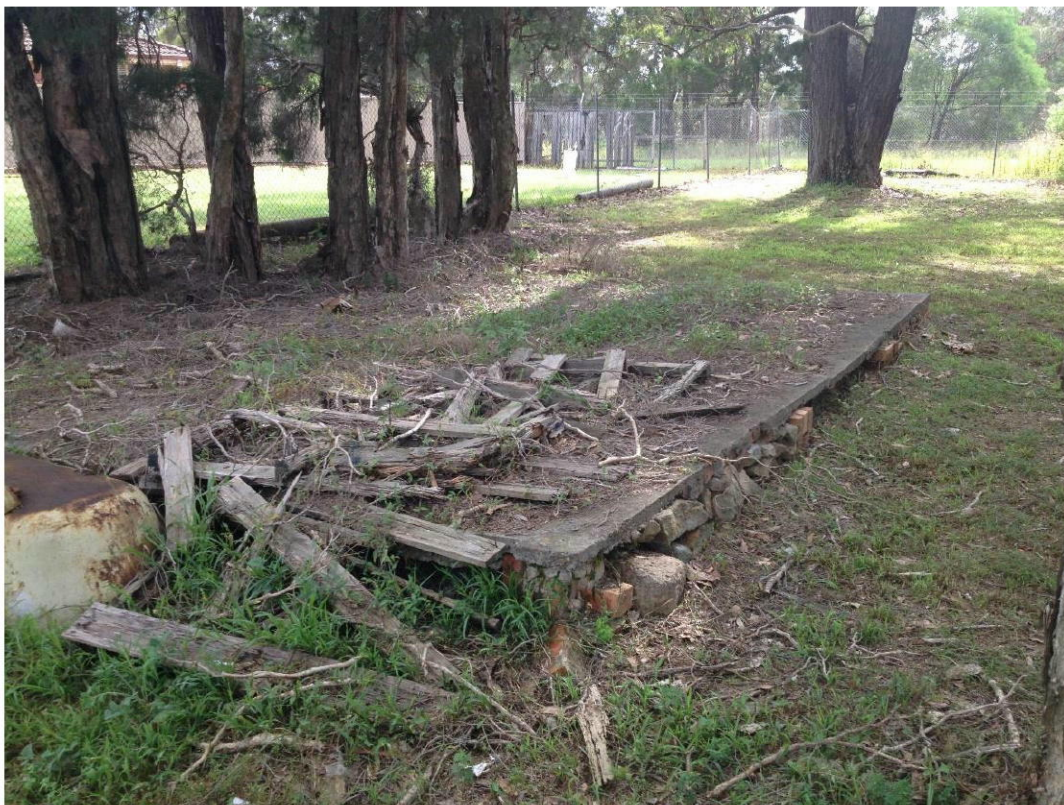
In addition, a concrete slab elevated on cobbles and small boulders was observed in the north-western corner of the site. Anecdotal evidence (provided by the site owner of over 30 years) indicated that this slab was constructed for a children's cubby house which was never completed.

Photo 8: Slab of former cubby house on western site boundary, looking north.

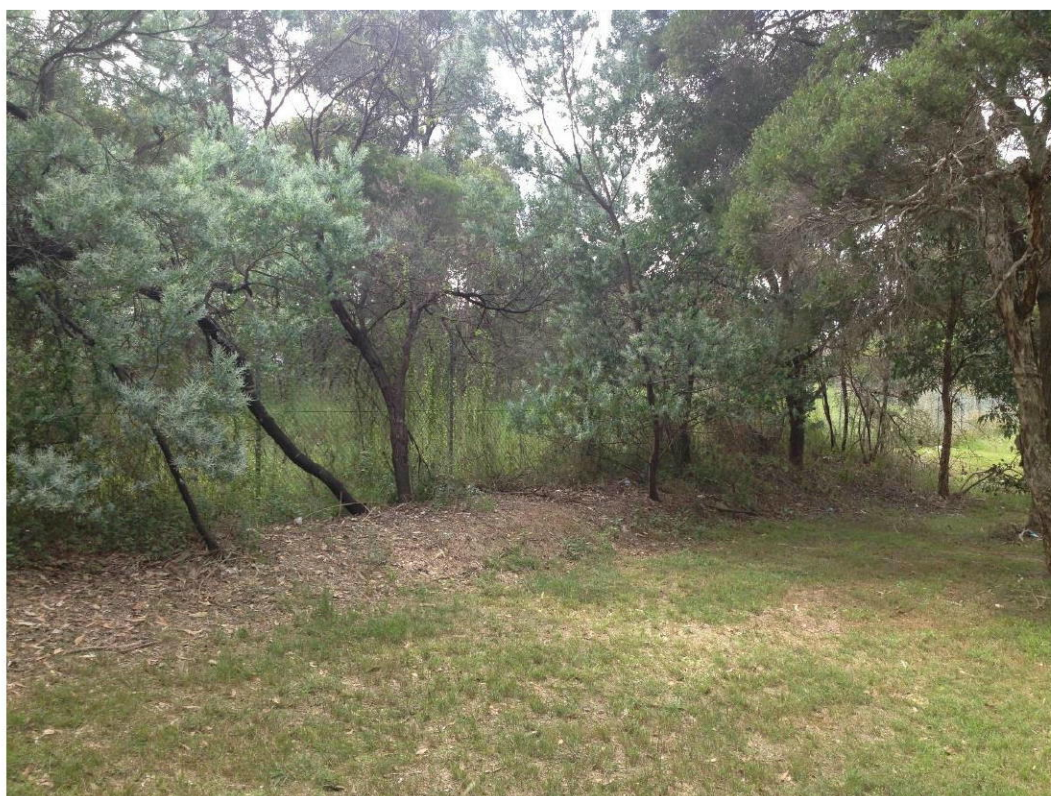
Photo 9: Suspected soil stockpile on western boundary of site, looking north-east.
