## **BASIC TREE ASSESSMENT**

Mr Georges Karam  
MGM Building

31 Second Ave., Kingswood

12<sup>th</sup> April 2018 - DA Issue

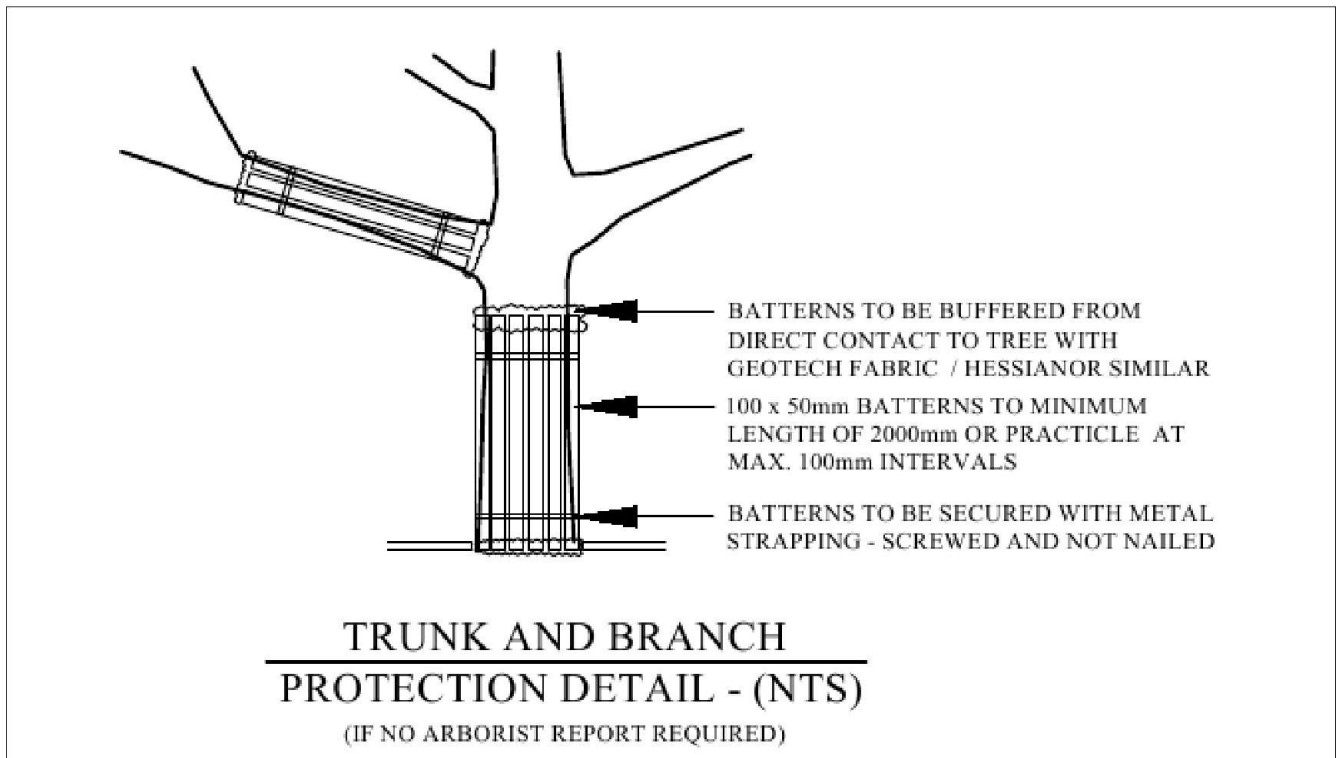
4.9 Tree 11 – Lophostemon confertus – 5m high x 5m wide – dbh 300mm. Tree is in good health but reasonable condition due to constant powerline lopping. Trunk protection should be conditioned by Council in accordance with AS4970-2009. Refer to section 6.

6.1 It is recommended Council condition that Tree 11 is to have trunk protection measures installed. Refer to AS4970-2009 and or detail below.

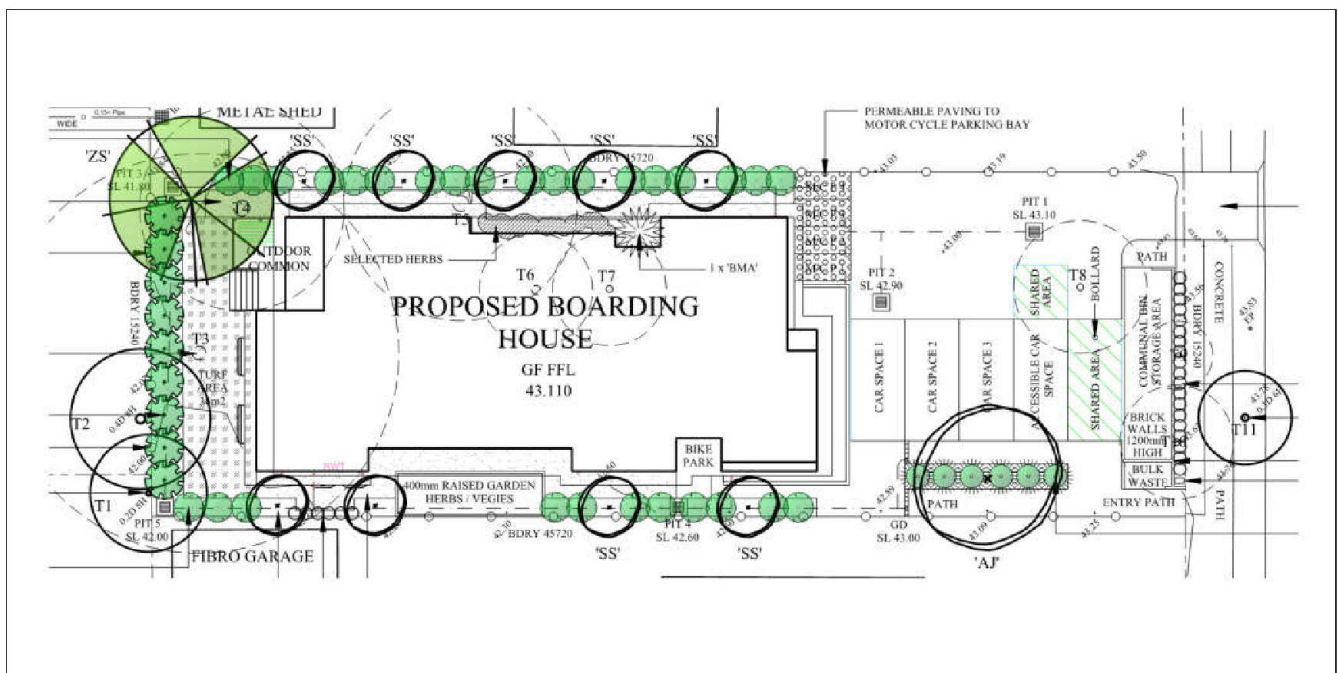
## 8. SITE PLAN – NTS – STRIPPED LANDSCAPE PLAN

4.3 Tree 3 – Callistemon saligna – 9m high x 8m wide – dbh 500mm. Tree is in good health and condition and a common species in the environment. The proposed development represents a significant encroachment into the SRZ and TPZ, hence the tree requires removal to facilitate the development in its current format.

4.4 Tree 4 - Callistemon saligna – 9m high x 8m wide – dbh 400mm. Tree is in good health and condition and a common species in the environment. The proposed development requires removal of tree to facilitate the development in its current format.
