Report Type: Preliminary Site Investigation
Site Address: 94 – 100 Explorers Way, St Clair, NSW
Report Number: 1842/ER-1-1
Report Date: 28th April 2015

RE: PRELIMINARY SITE INVESTIGATION – 94 – 100 EXPLORERS WAY, ST CLAIR, NSW

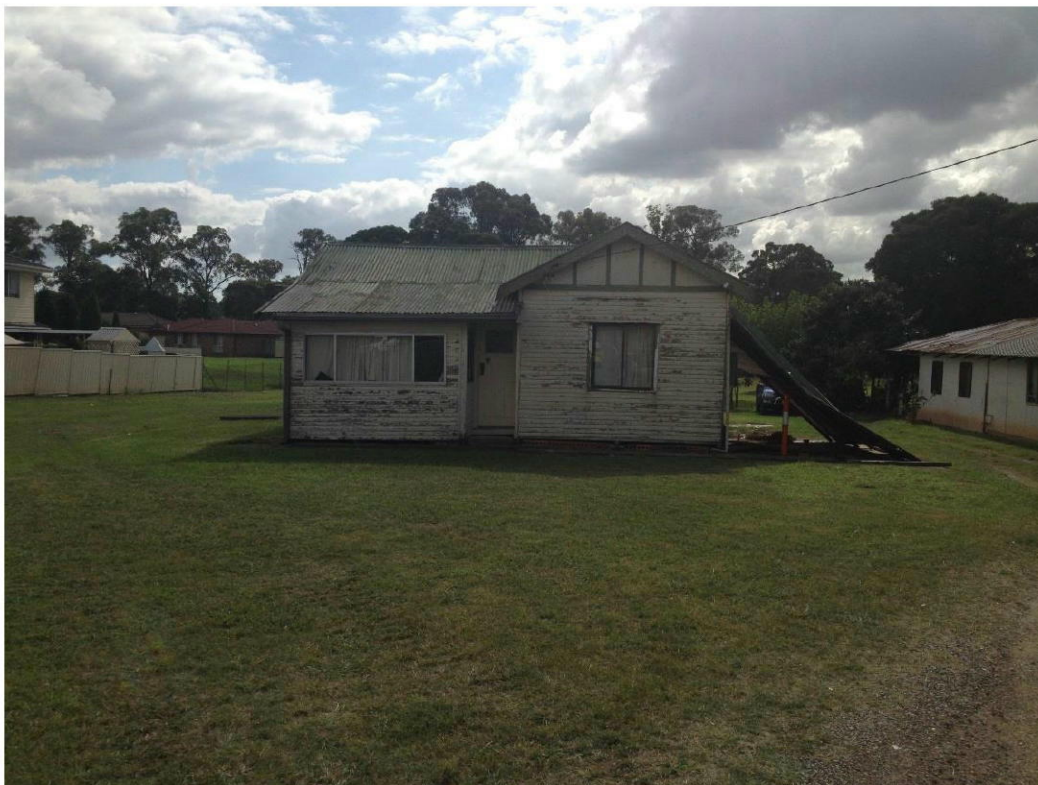
Photo 1: Front of small, wooden dwelling, looking north.

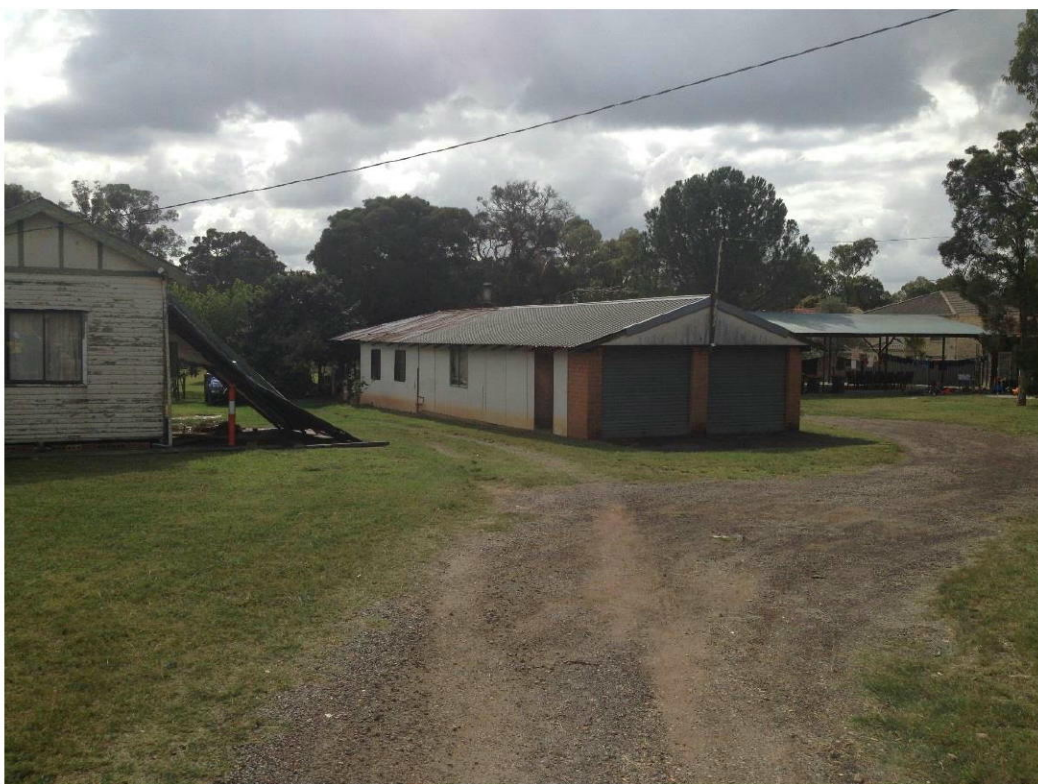
Photo 2: Front of garage with wooden dwelling to the left and the gazebo in the background to the right. Looking north-east.

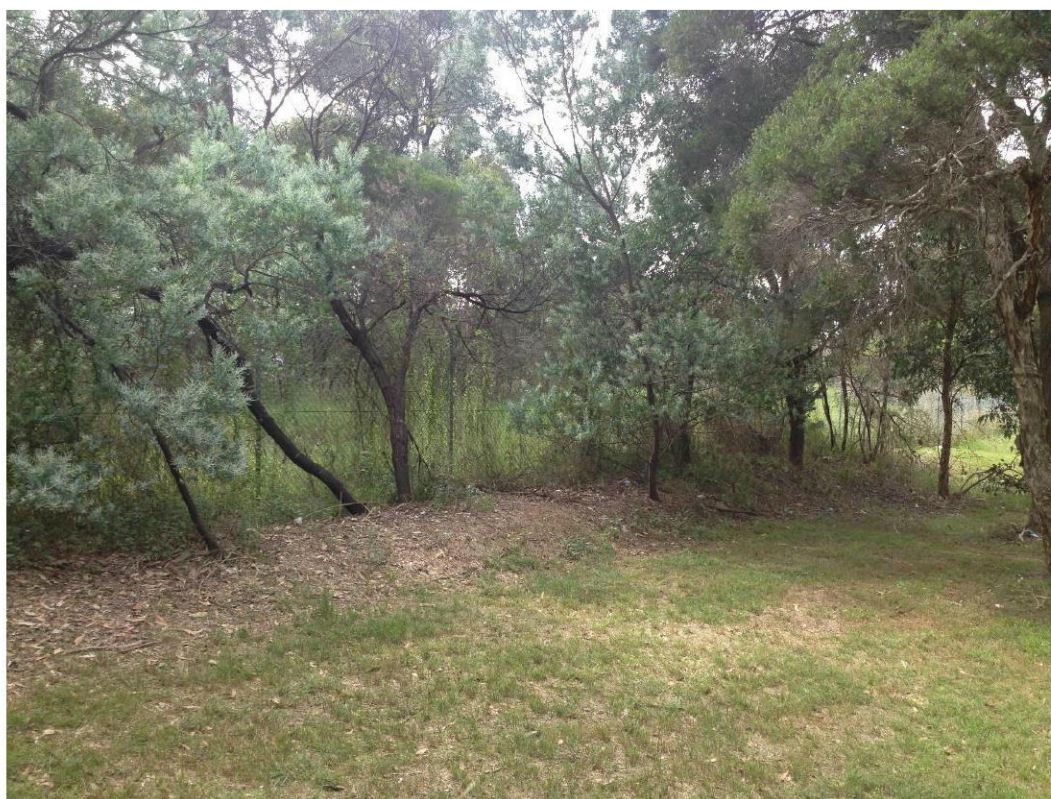
Photo 9: Suspected soil stockpile on western boundary of site, looking north-east.

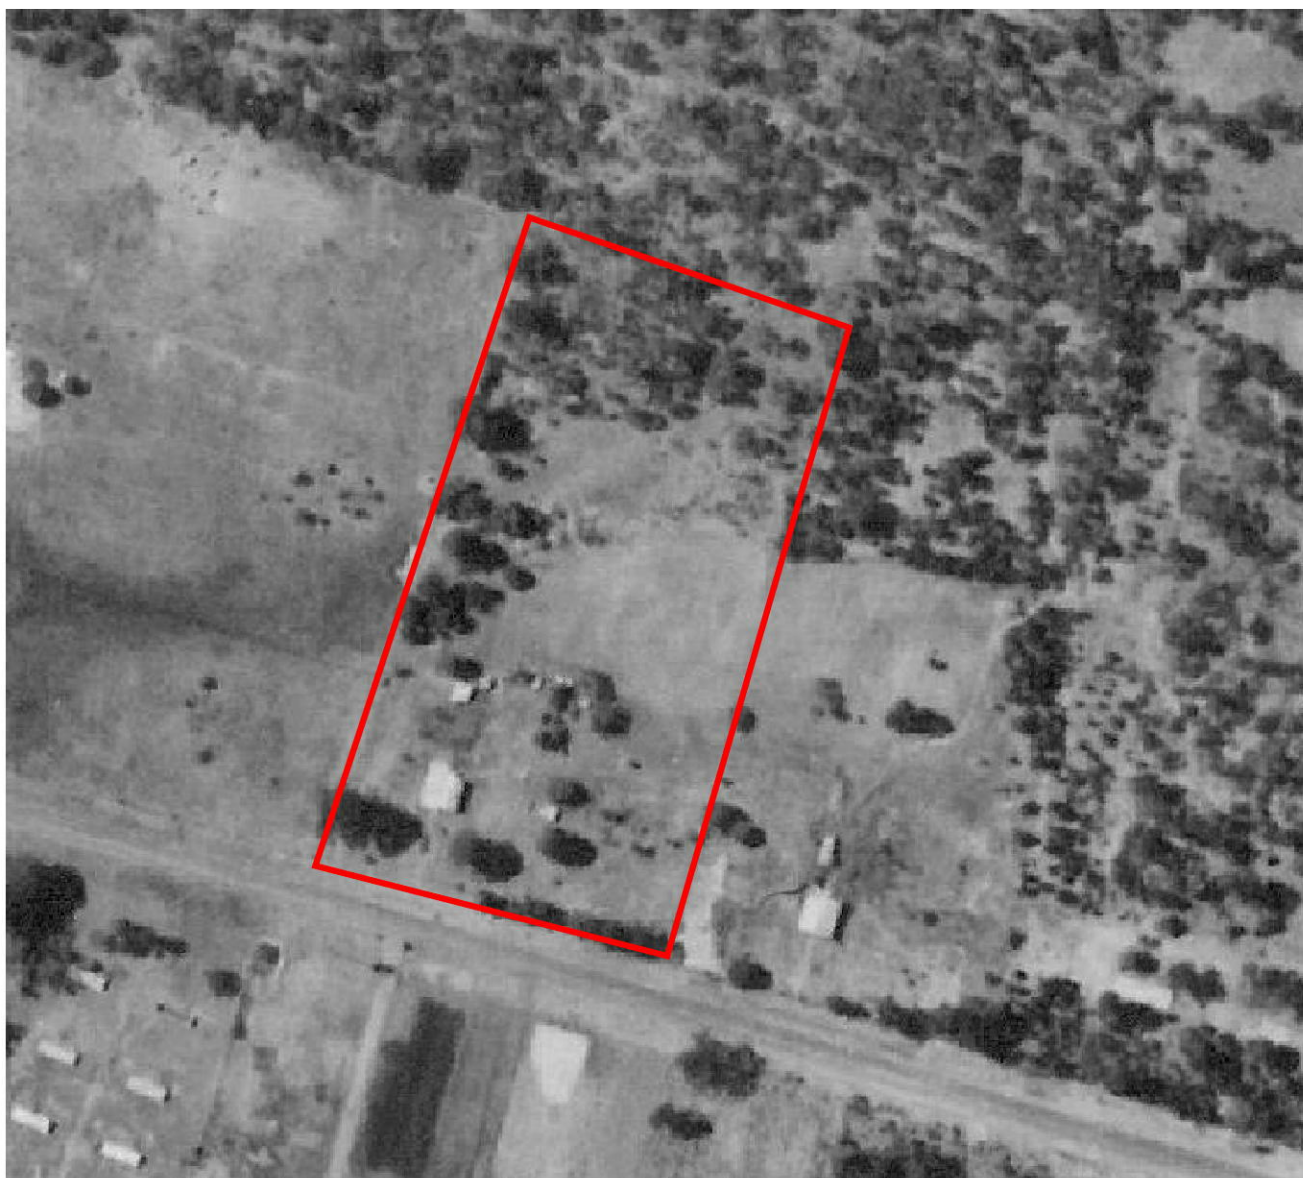
1947

- **1947:** The site appeared to comprise a rural residential property with a dwelling and a number of sheds in the southern portion of the site. The dwelling was consistent with the location of the present day, small wooden dwelling at the site. A drainage channel was located in the centre of the site, consistent with the location of the present day drainage channel. The adjacent area to the north appeared to comprise natural, heavily vegetated bushland. The adjacent areas to the east, south and west appeared to comprise rural residential land uses with cleared areas and small dwellings observed.

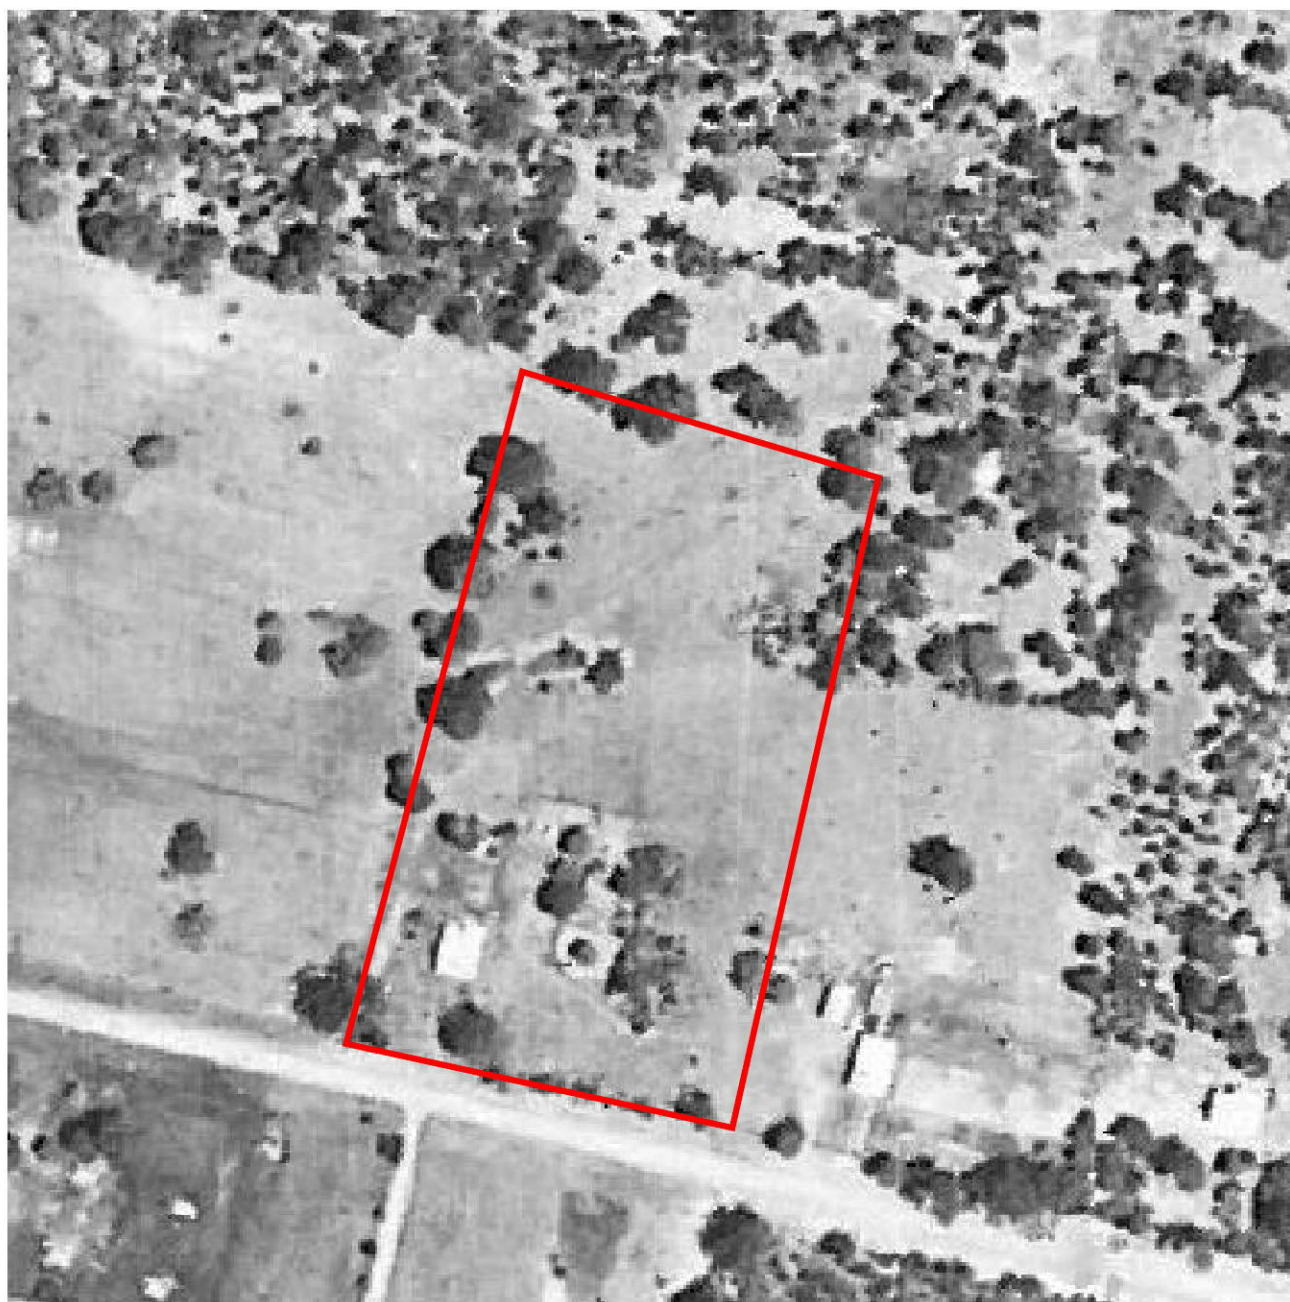
1955

- **1955:** A small man-made dam appeared to have been constructed at the centre of the western site boundary. The remainder of the site and surrounding areas appeared similar to the previous aerial photograph.

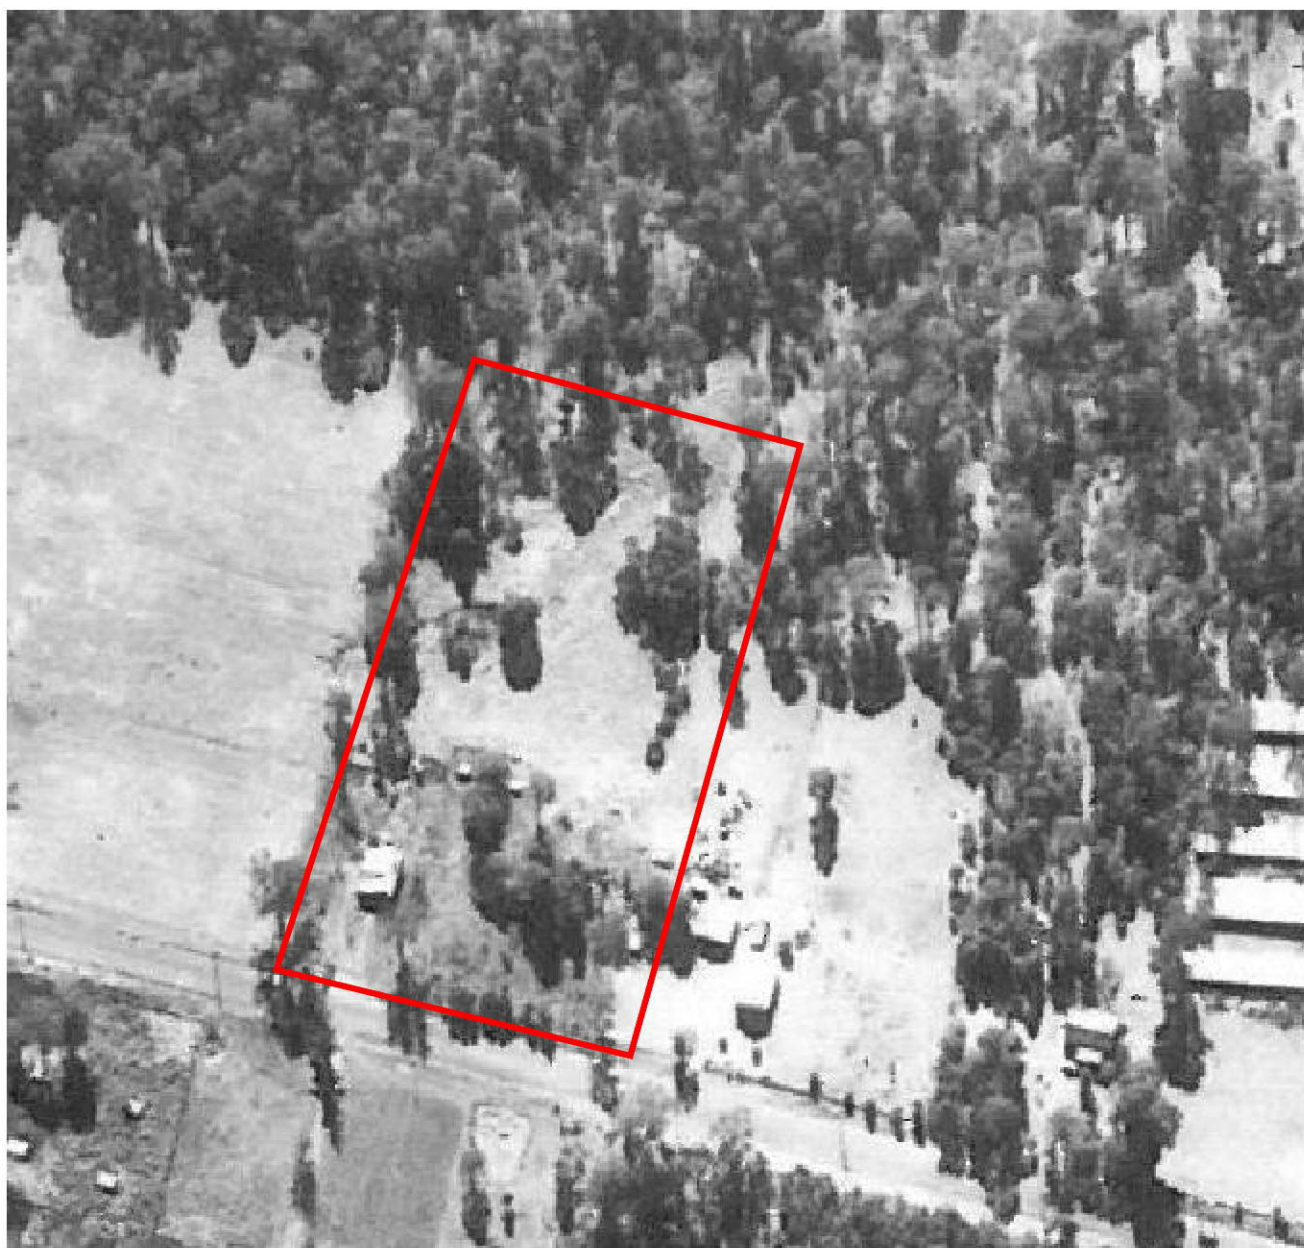
1970

- **1970:** A small dwelling had been constructed in the south-eastern corner of the site. Evidence of vegetation growth at the site was observed. A number of dwellings were constructed in surrounding areas and a number of industrial buildings were constructed to the east. All other areas appeared similar to the previous aerial photograph.

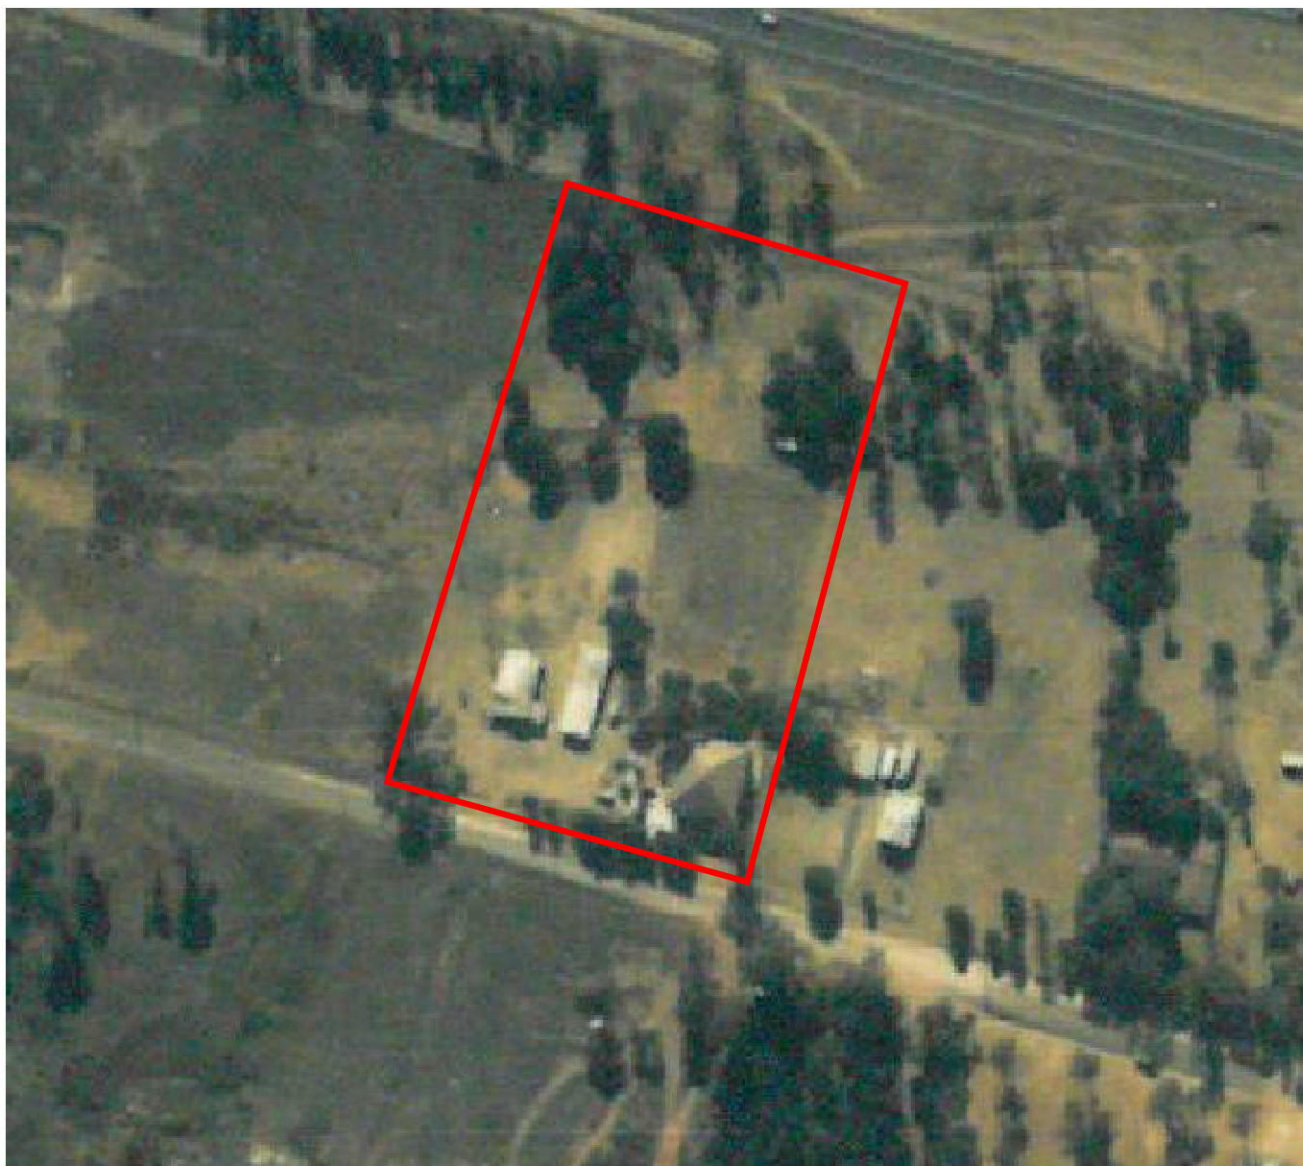
1986

- **1986:** The small dwelling that appeared in the south-eastern corner of the site in the previous aerial had been removed and a large dwelling was constructed in the location of the present day two storey dwelling. A small dwelling was constructed in the location of the middle dwelling and a shed was constructed in the location of the current day shed, on the eastern site boundary. The small man made dam had been filled. The bushland to the north of the site had been cleared and the M4 Motorway had commenced construction. Evidence of earthworks was observed at the adjacent property to the west.
