# TREE INSPECTION REPORT.

**On: Tree Specimen**

**Location: 76 Hobart Street Saint Marys  
NSW 2760**

For GPG Constructions Pty Ltd  
On. 3/5/2021

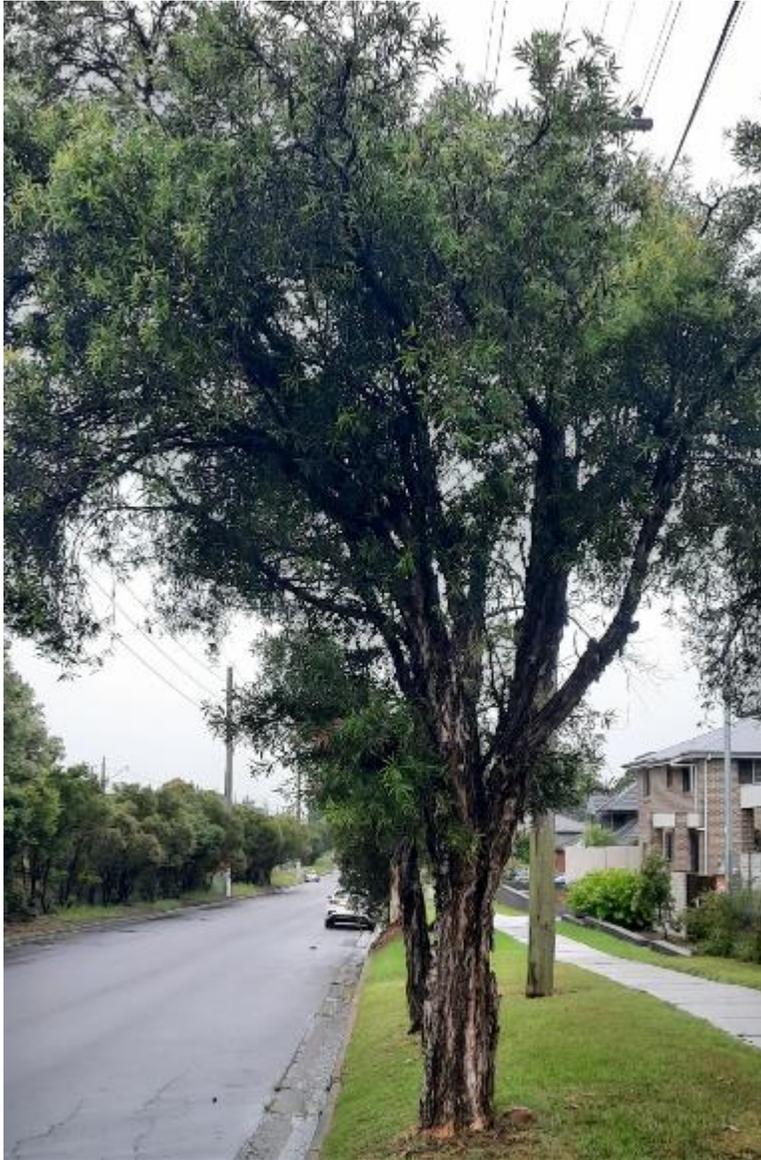
**4.1** Tree **T1** is a *Melaleuca saligna* or 'Willow Leaved Paperbark' which is a native species common to Northern Queensland. It has been planted in the nature strip to the North East of the Site (see Fig. 2).

The tree was in good health and vigour at the time of inspection with some sooty mould in the lower stem and branches.

The tree will experience a zero impact from the development and is of such a distance from the Site as to not warrant tree protection (See Appendix 2b).

Fig. 2. Photo of tree T1 a *Melaleuca saligna*

**6.2 T1**, Council's street tree, is to be retained and protected. Two additional street trees are proposed to be planted in the nature strip to the North of the Site (See Appendix 2c).

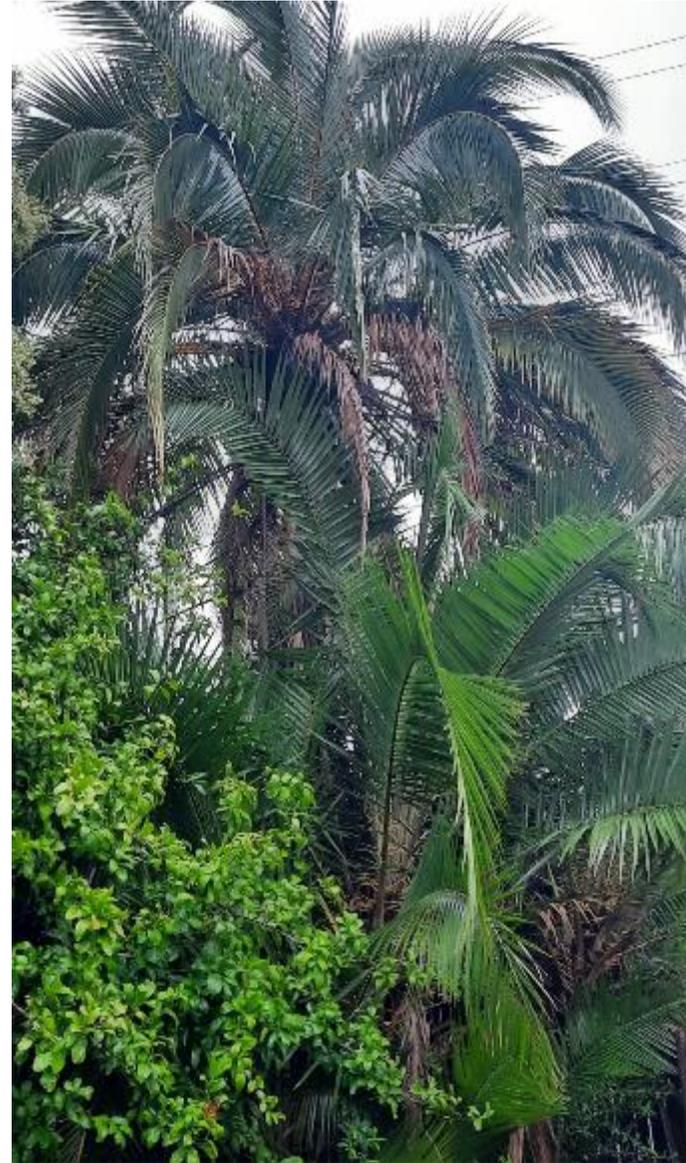
**4.2** Trees **T2 & T6** are both *Phoenix sylvestris* or 'Indian Date Palm' which is an exotic species that have been planted in the property in the Western portion of the site (See Figs. 3 & 7 ). Both trees were in good health and condition at the time of my inspection.

Tree **T2** will experience a Major encroachment from stormwater pipes to be placed within its TPZ and to be replaced with new tree plantings in the landscaping for the Development (See Appendix 2d).

Fig. 3. Photo of tree T2 a *Phoenix sylvestris*

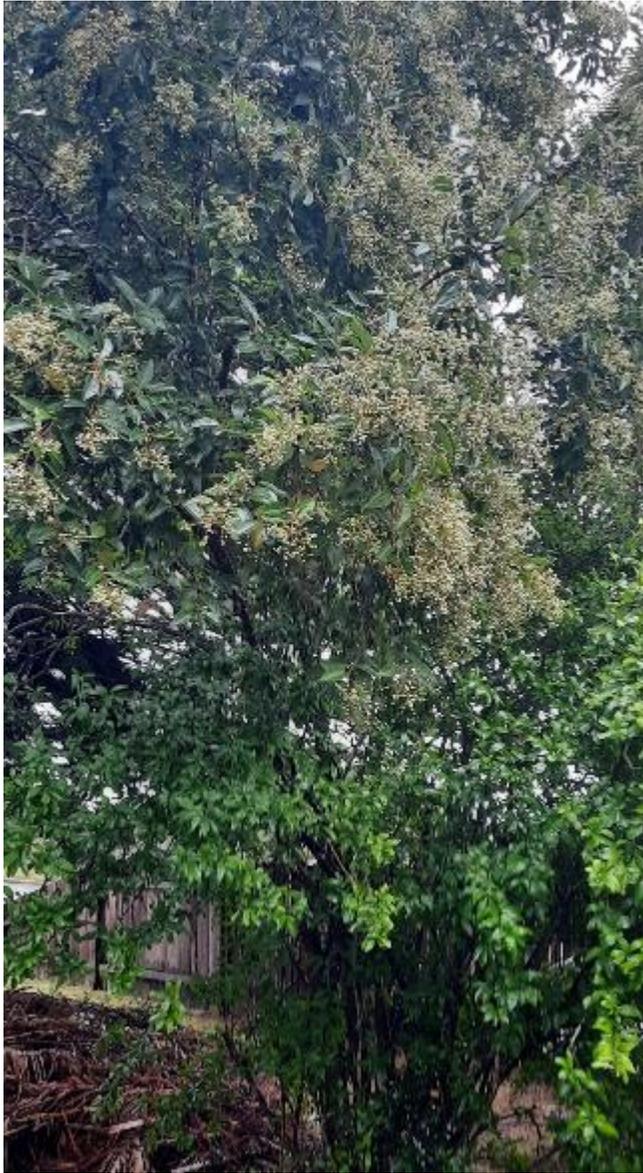
**4.3** Tree **T3** is a *Ligustrum lucidum* or 'Large Leaved Privet' which is an exotic tree which has growing in the neighbouring land to the East of the Site (See Fig. 7). The tree has weed properties and is listed as such in NSW Department of Primary Industries (DPI) as a significant weed species (Weedwise)

The specimen won't be affected by the development but is proposed for removal to make way for more desirable plantings in the new landscaping for the Site. (See Appendix 2b and 2c).

Fig. 4. Photo of tree T3 a *Ligustrum lucidum*.

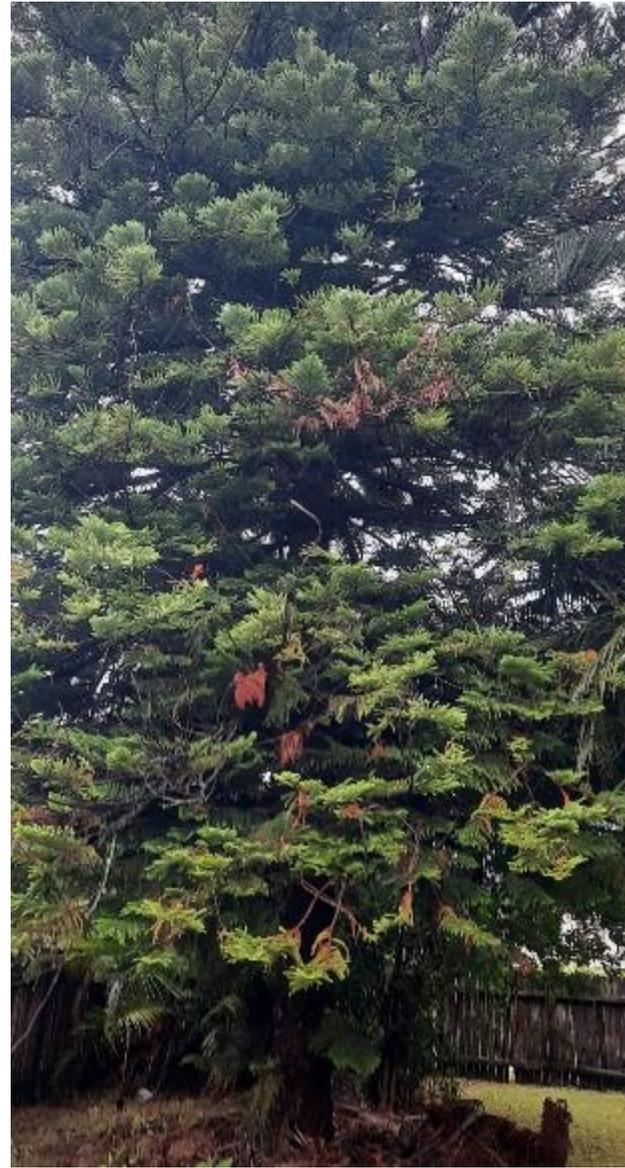
**4.4** Trees **T4 & T5** are both *Araucaria heterophylla* or 'or 'Norfolk Island Pine' which are native trees which has been planted in the property to the South of the site (See Fig. 3). The trees were in good health and condition at the time of my inspection.

Tree **T4** will be engulfed by the new driveway entrance and deep excavation for the Onsite Stormwater Detention tank (See Appendix 2d)

Fig. 5. Photo of Tree T4 an *Araucaria heterophylla*

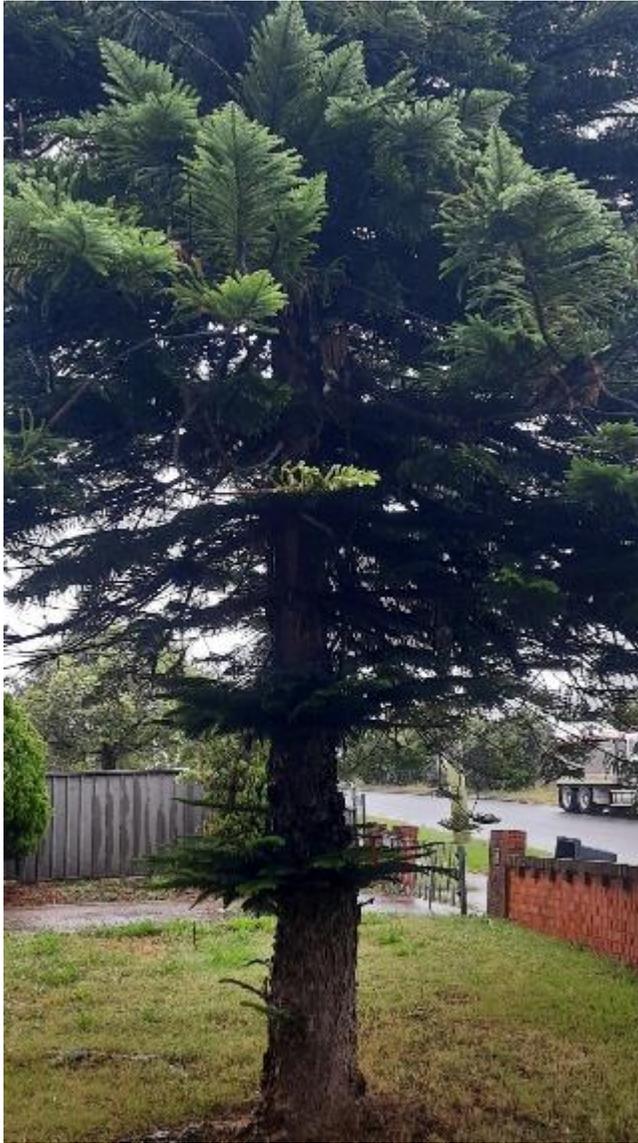
Tree **T5** is located where the from entrance path for the new building is proposed (See Appendix 2c).

Fig. 6. Photo of Tree T5 an *Araucaria heterophylla*

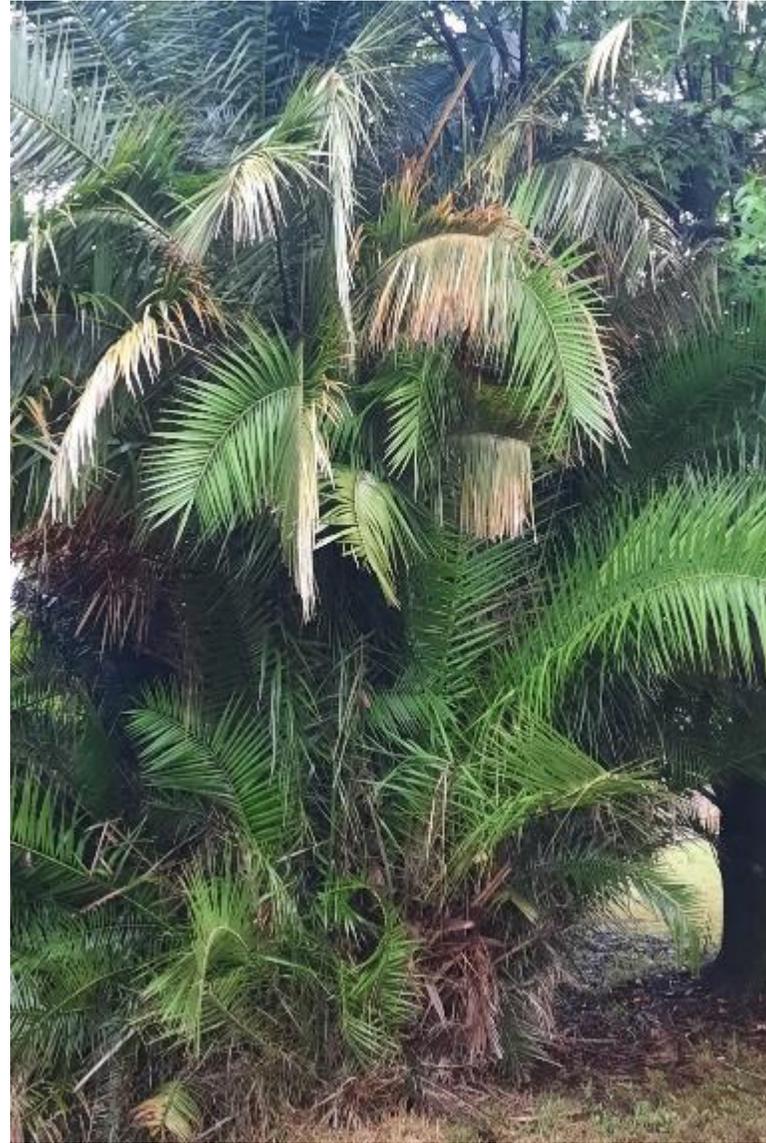
Tree **T6** will experience a Major Encroachment from the excavation for an Onsite Stormwater Detention (OSD) tank to be placed below the new carpark (See Appendix 2d).

Fig. 7. Photo of Trees T6 a *Phoenix sylvestris*

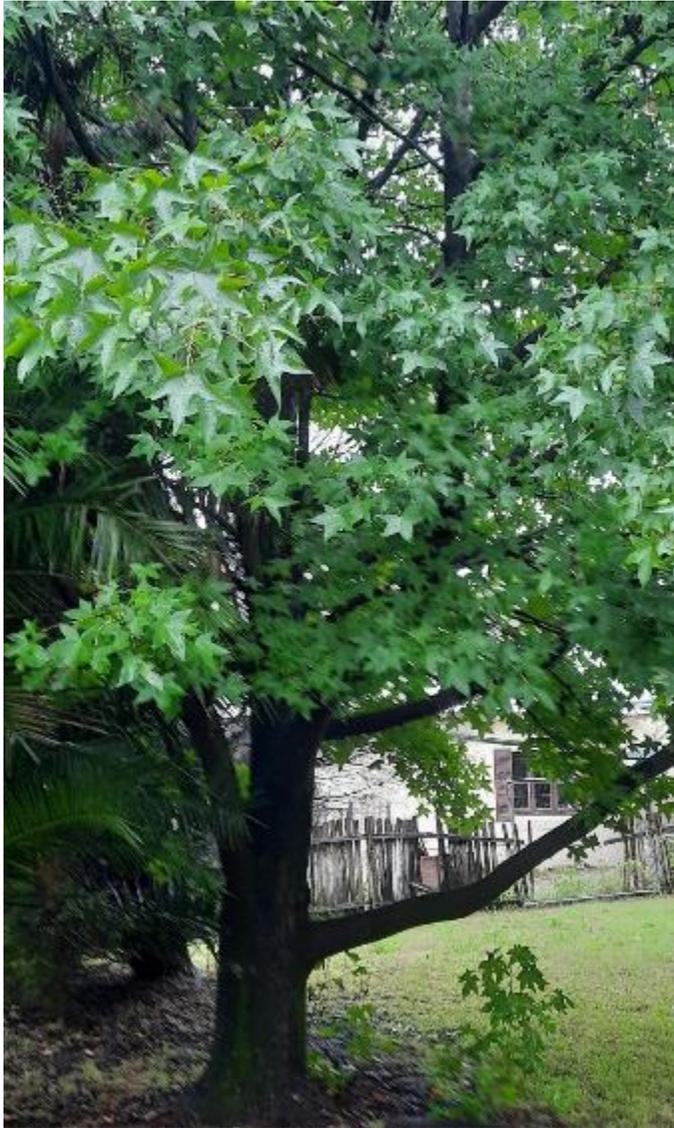
**4.5** Tree **T7** is a *Liquidamber styraciflua* or 'Liquidamber' which is a exotic tree which has growing in the Site to the West of the existing dwelling (See Fig. 7). The tree was in good health and condition at the time of my inspection.

The specimen will be engulfed by the new driveway entrance and deep excavation for the Onsite Stormwater Detention tank (See Appendix 2d) (See Appendix 2b and 2c).

Fig. 8. Photo of Tree T7 a *Liquidamber styraciflua*

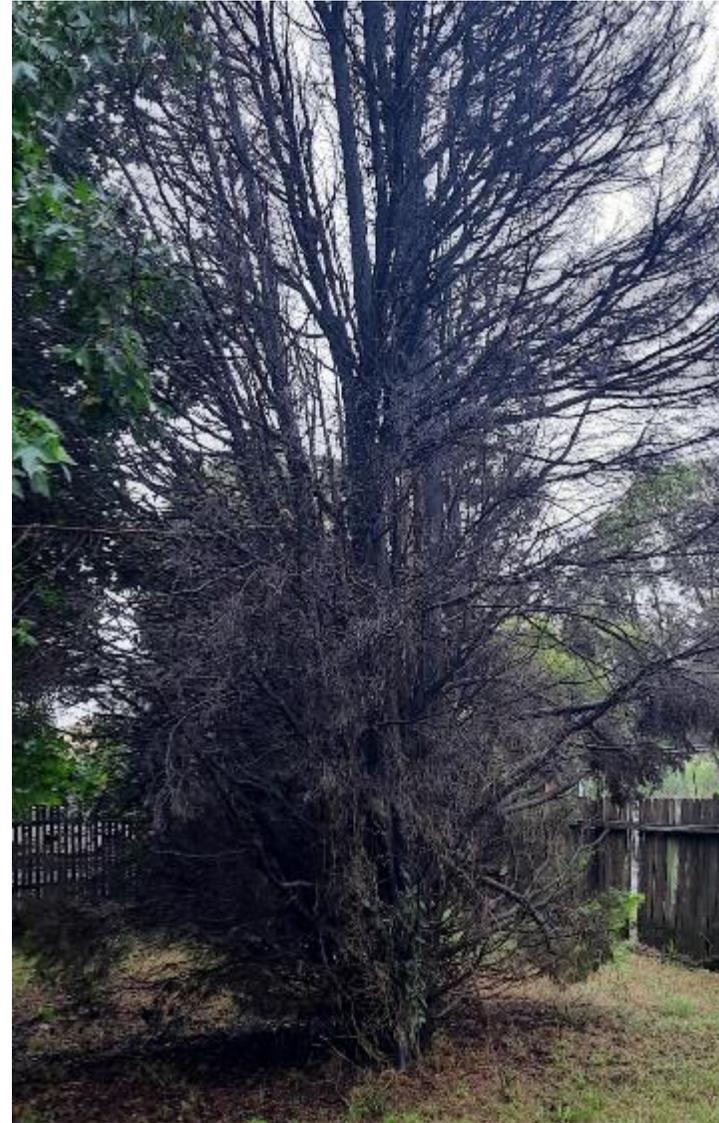
**4.6** Trees **T8 & T9** are dead.

Fig. 9. Photo of Tree T8 a dead tree.

Both trees are to be removed for the development to proceed as planned.

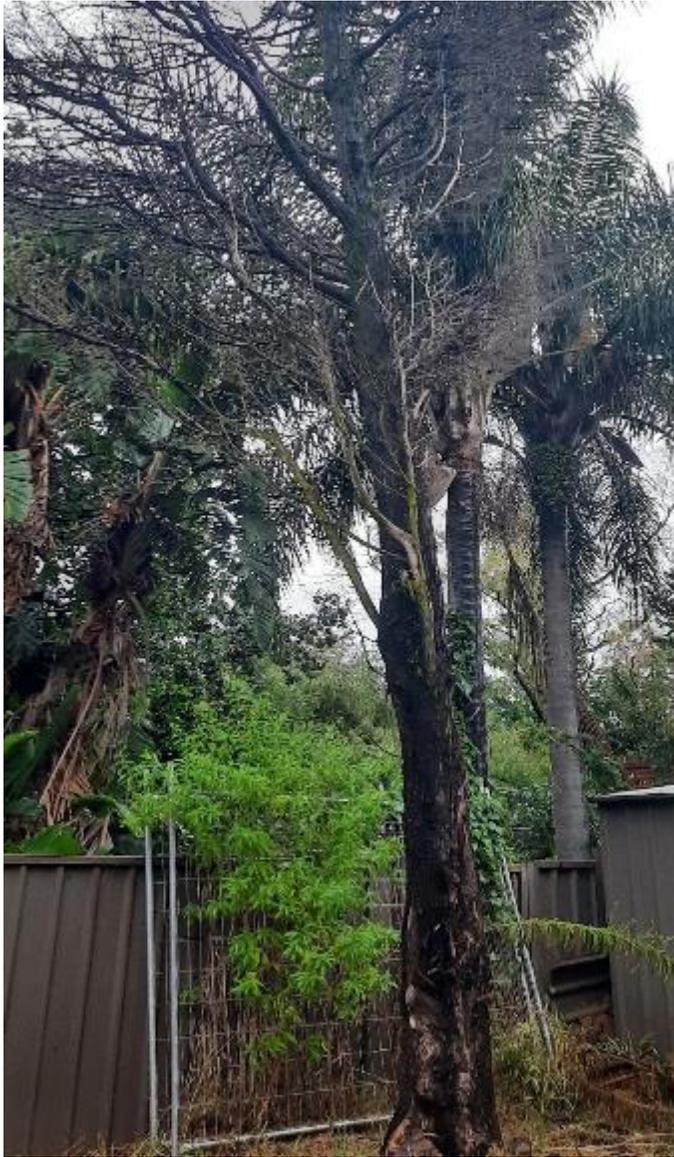
Fig. 10. Photo of Tree T9 a dead tree.

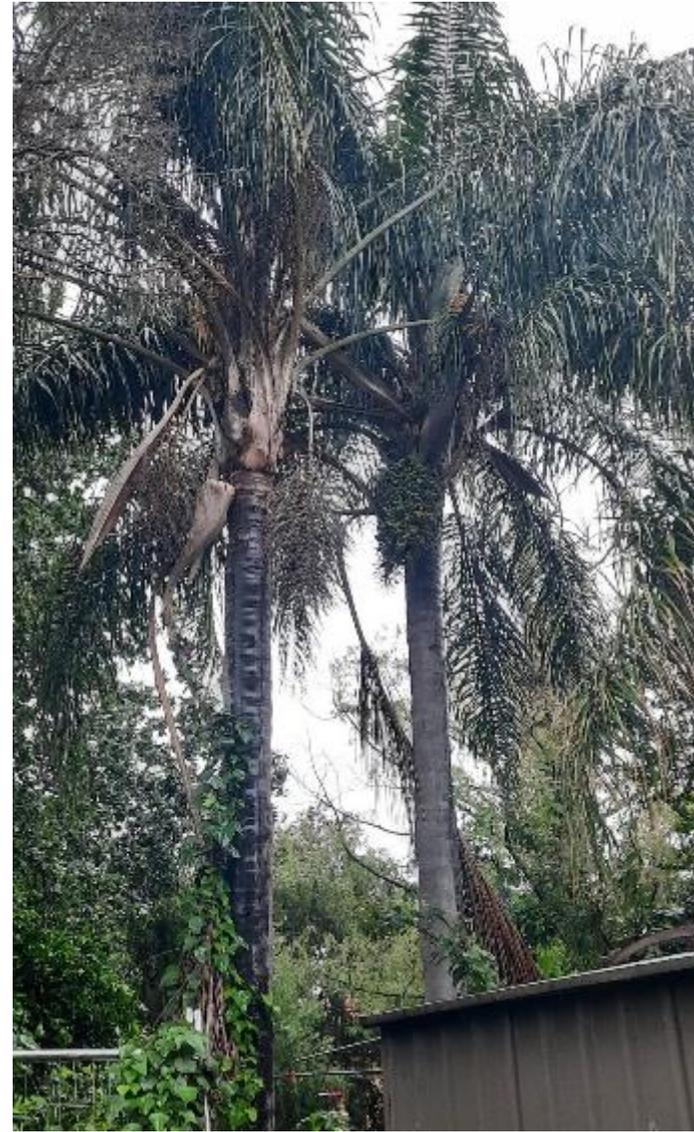
**4.7** Trees **T10, T11 & T12** are all *Syagrus romanzoffianum* or 'Cocos Palms' which is listed as an exempt species in the TPO.

Fig. 11. Photo of Trees T10 & T11 both *Syagrus romanzoffianum*.

All of these trees are to be removed for the development to proceed as planned.

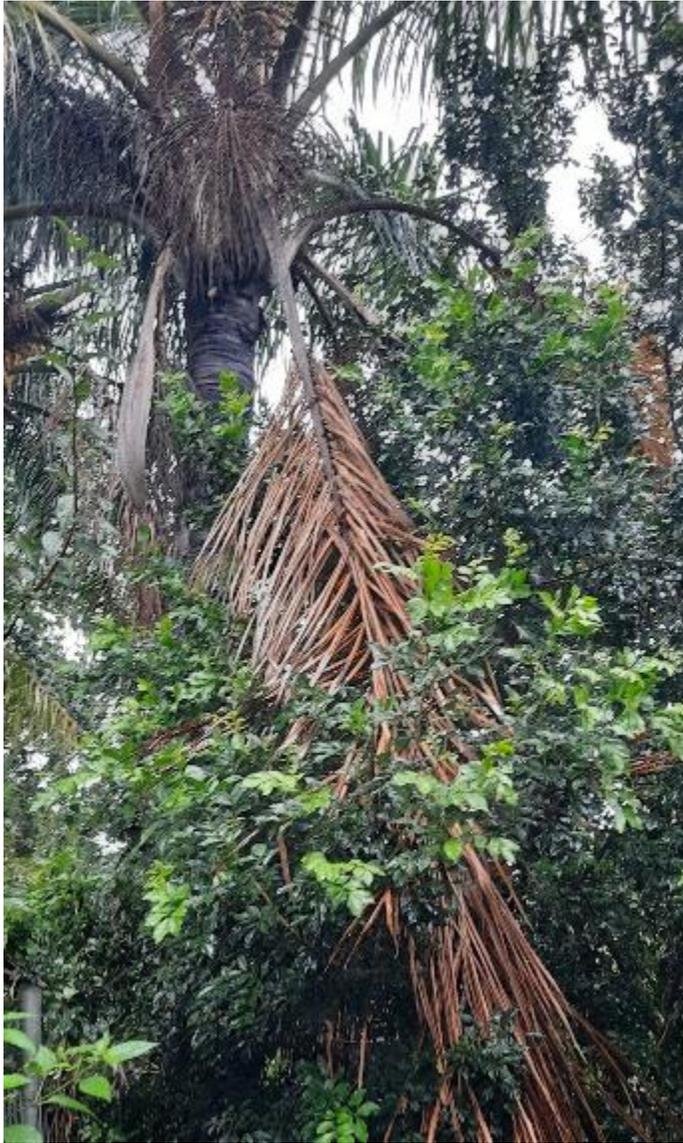
Fig. 12. Photo of Tree T12 a *Syagrus romanzoffianum*.

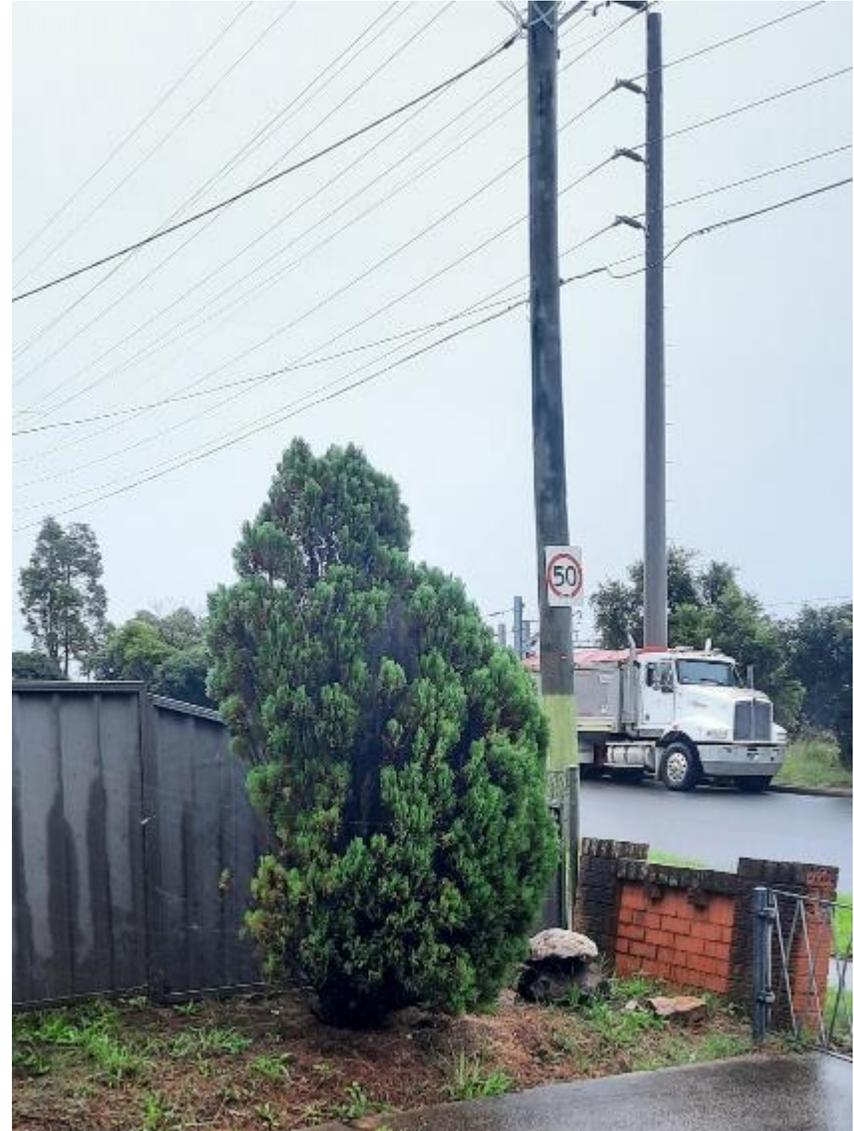
**4.8** Trees **T13, T14 & T15** are all *Platycladus orientalis* or 'Oriental Arbor vitae' which are all less than 3m in height and not subject to the TPO the TPO.

Fig. 13. Photo of Trees T13 a *Platycladus orientalis*.

All of these trees are to be removed for the development to proceed as planned.

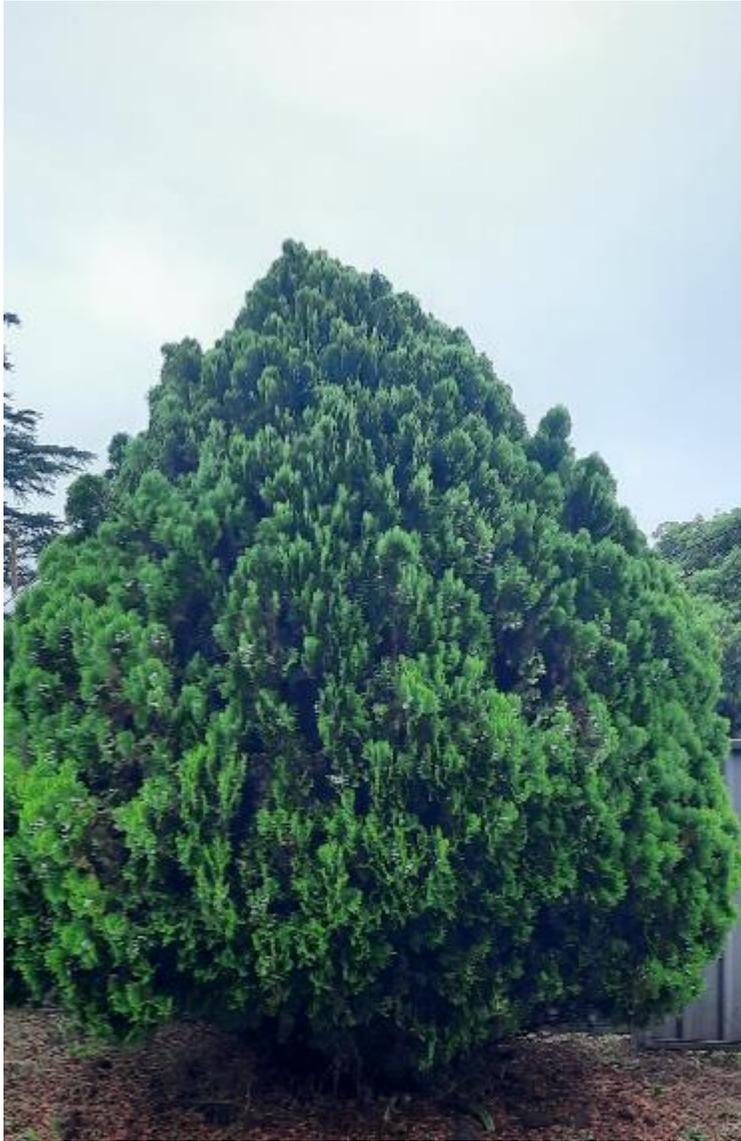
Fig. 14. Photo of Tree T14 a *Platycladus orientalis*.

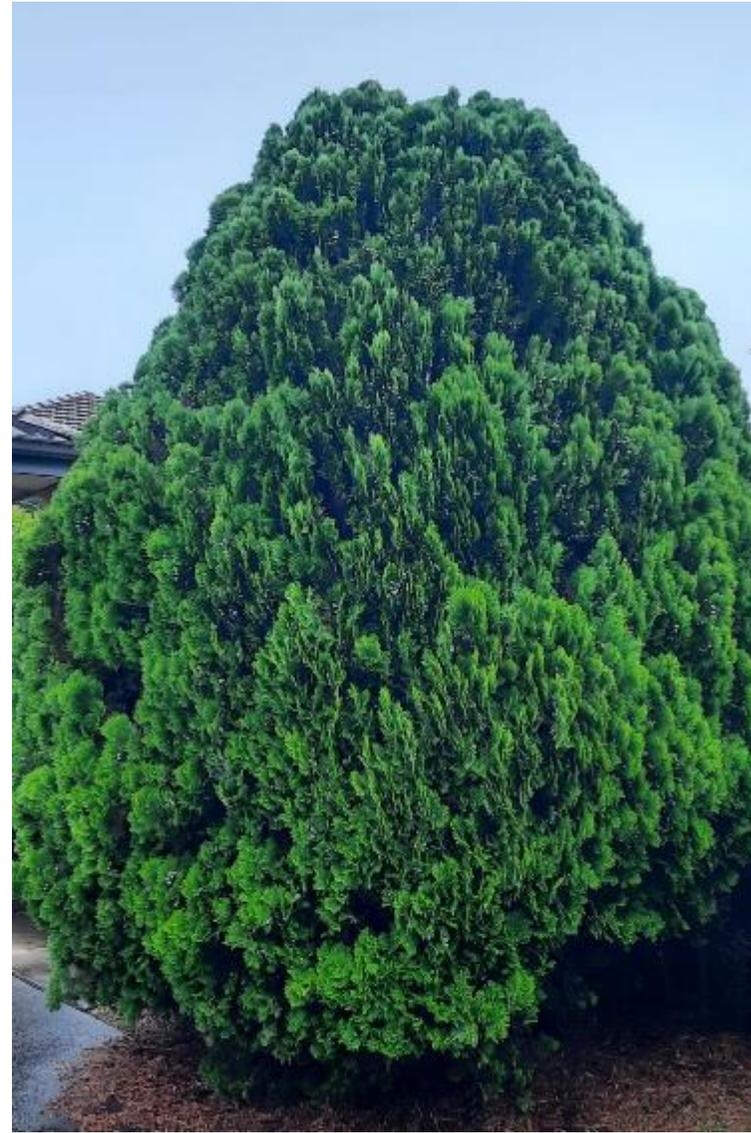
Fig. 15. Photo of Tree T15 a *Platycladus orientalis*.
