Asbestos Clearance Certificate

RE: Asbestos Clearance Inspection and Clearance Certificate

Site:	4 Punt Rd, Emu Plains NSW 2750
--------------	--------------------------------

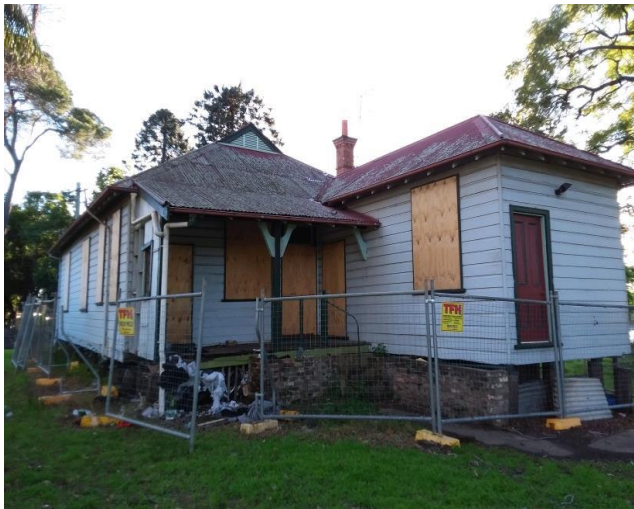
Notes: Overview of remediation area before remediation

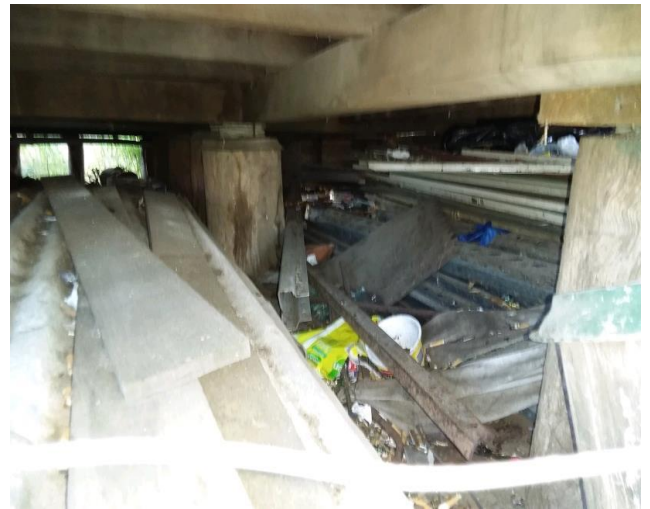
Notes: Overview of remediation area before remediation

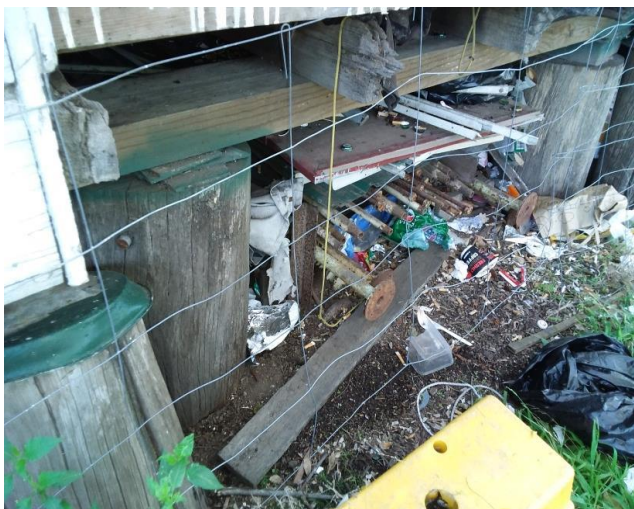
Notes: Overview of remediation area before remediation

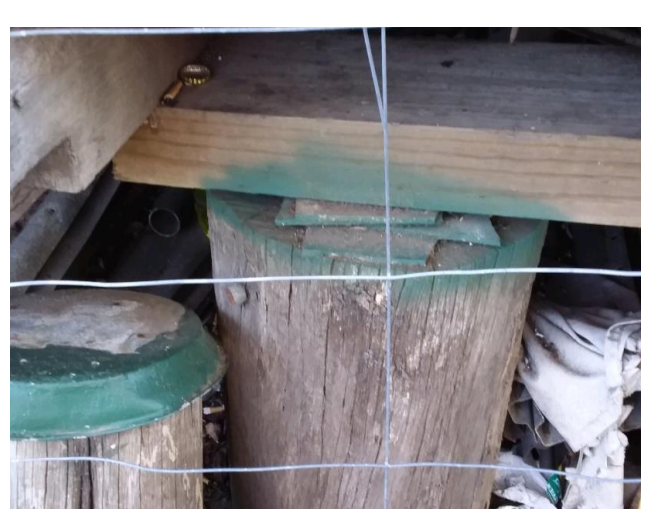
Notes: Condition of packing material

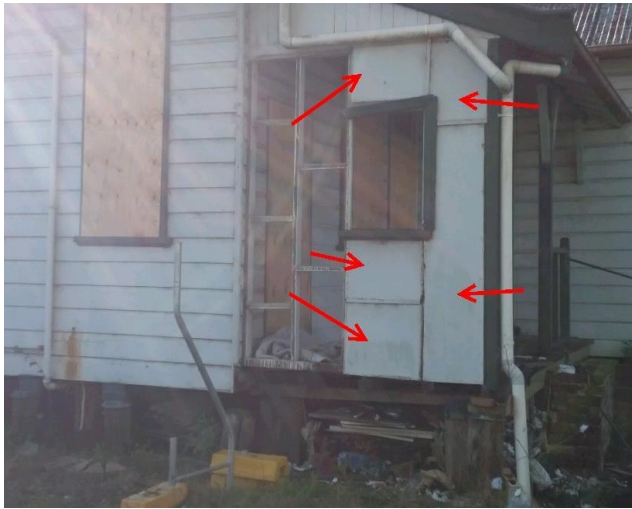
Notes: Overview of the removal item (wall panels)
next to the southern entrance

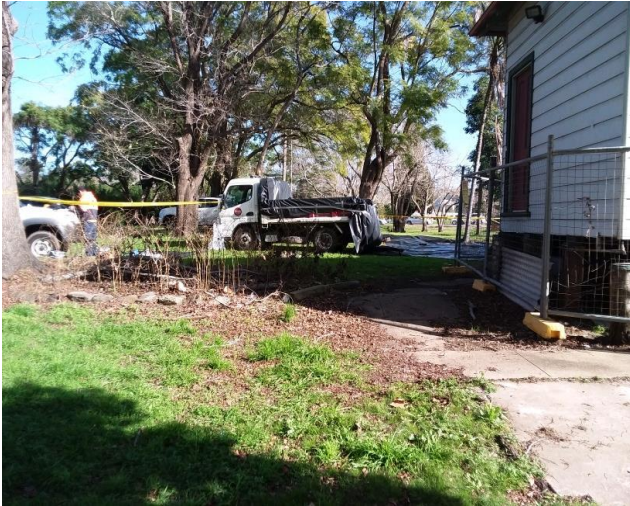
Notes: Overview of exclusion zone

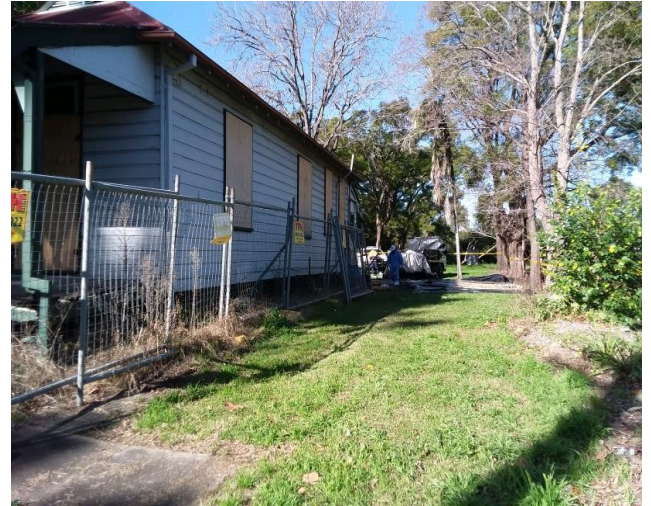
Notes: Overview of exclusion zone

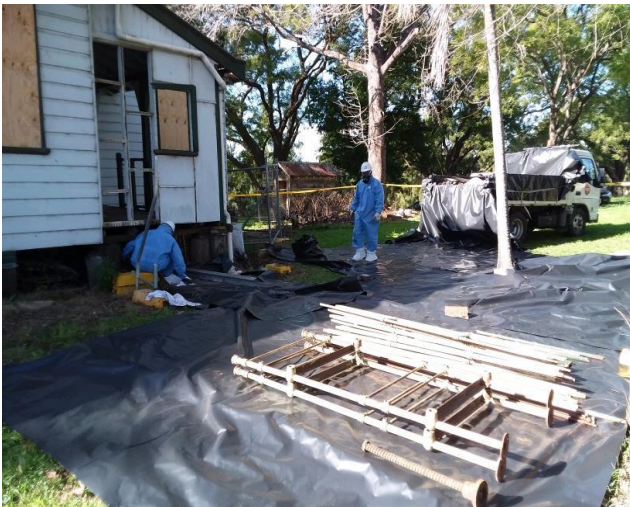
Notes: Safety control applied

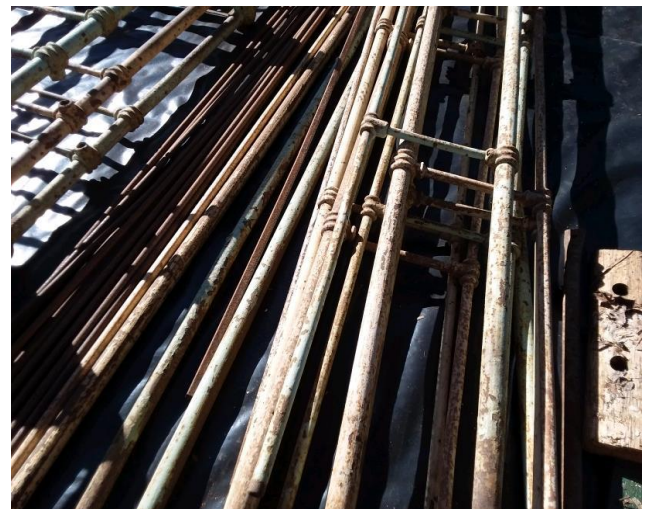
Notes: Visual inspection to the hard surface of recovered items

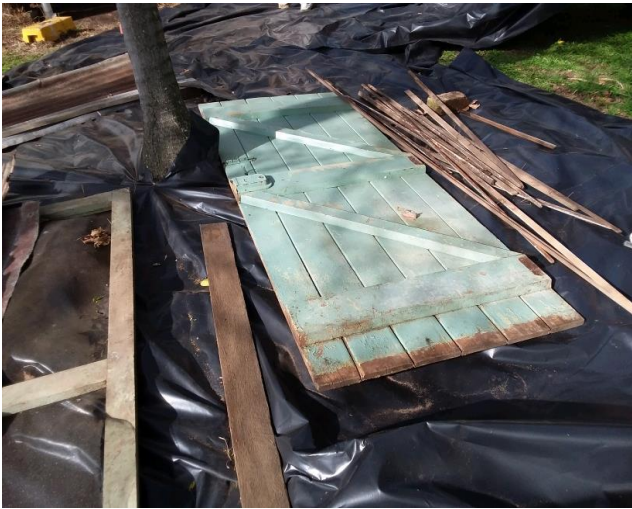
Notes: Visual inspection to the hard surface of recovery items

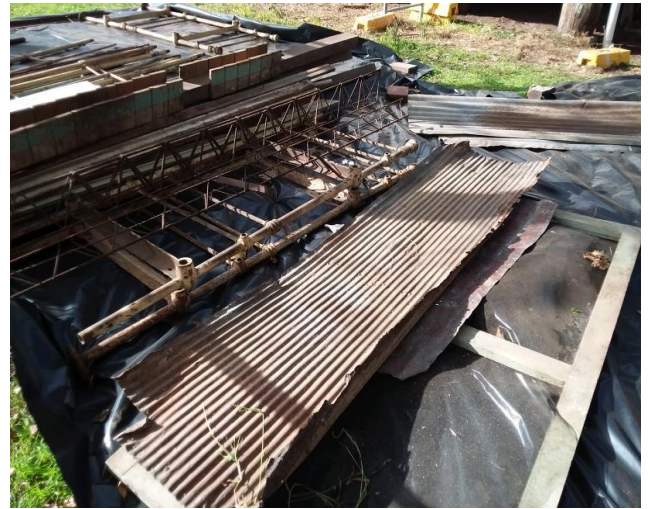
Notes: Visual inspection to the hard surface of recovery items

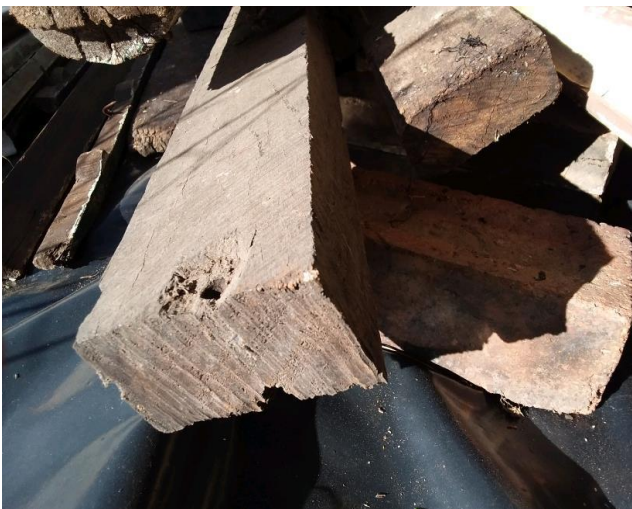
Notes: Close-up visual inspection to the hard surface of recovery items

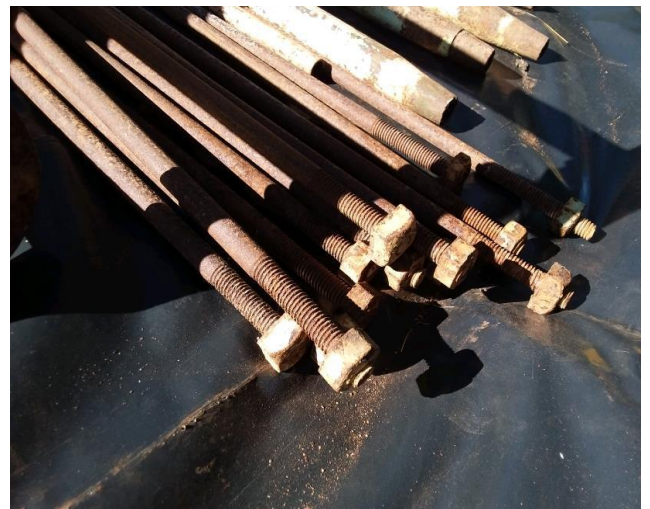
Notes: Close-up visual inspection to the hard surface of recovery items

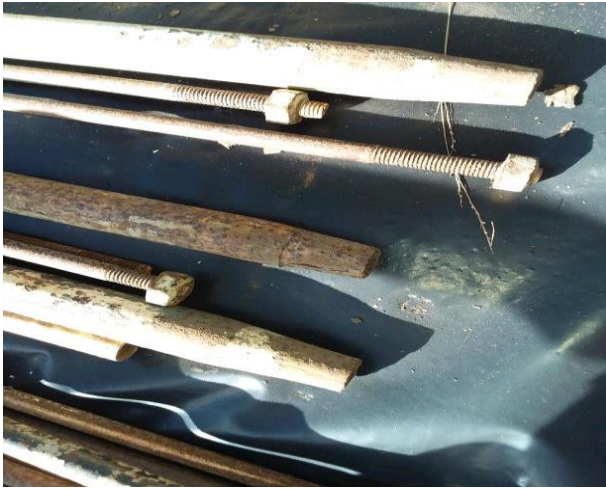
Notes: Close-up visual inspection to the hard surface of recovery items

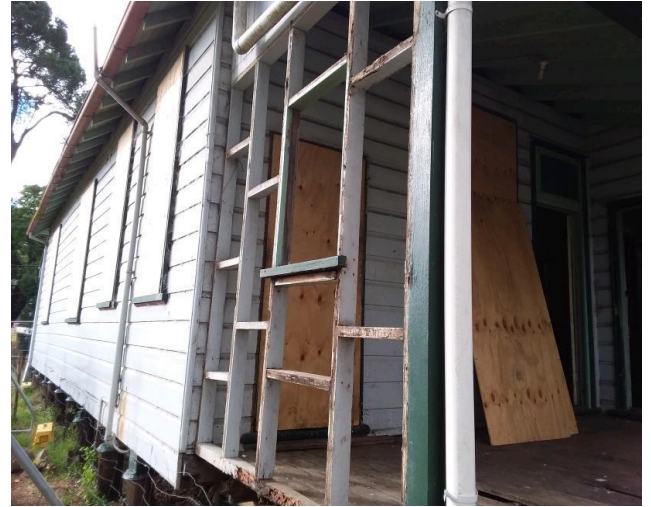
Notes: Overview of the removal item (walls panels to the southern entrance) following removal

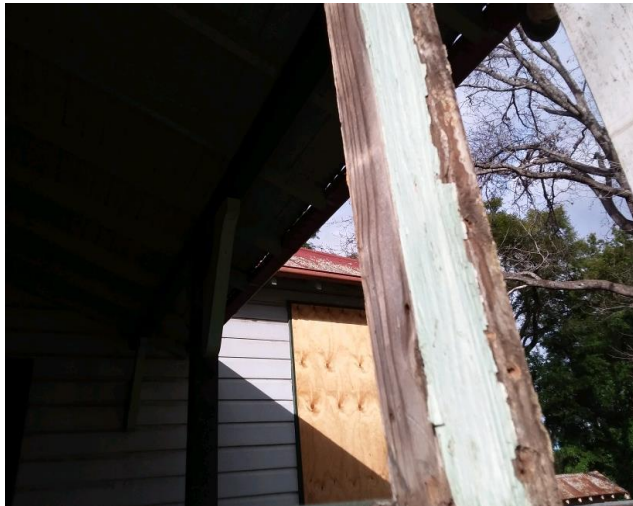
Notes: Close-up visual inspection to the removal area following removal

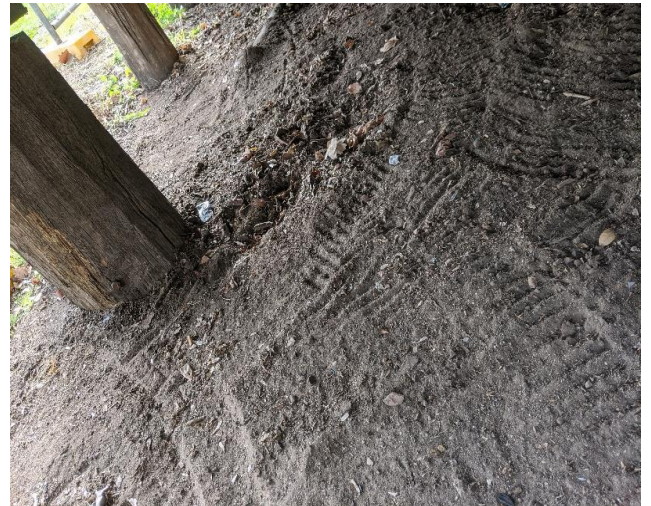
Notes: Overview of remediation area (subfloor) following remediation

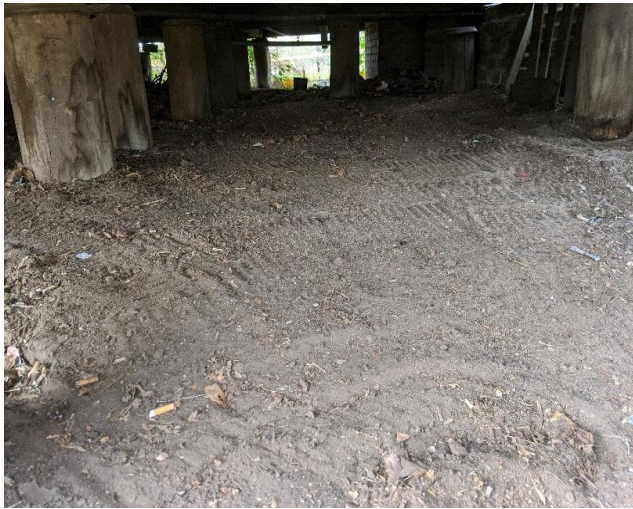
Notes: Overview of remediation area (subfloor) following remediation

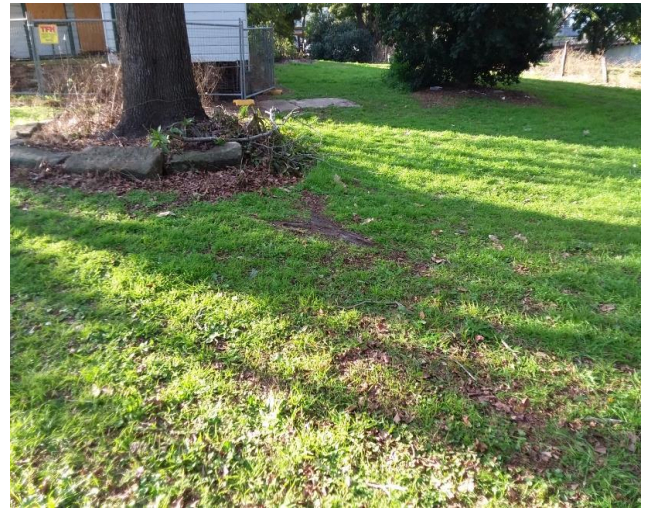
Notes: Visual inspection to the top surface of vicinity of remediation area

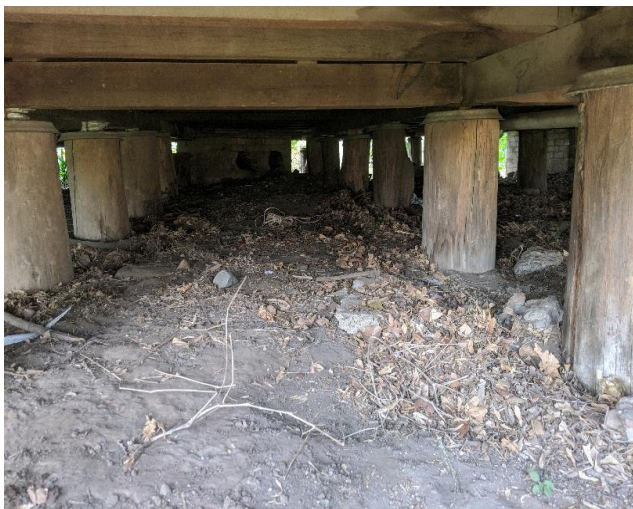
Notes: Overview of remediation area (subfloor) following remediation

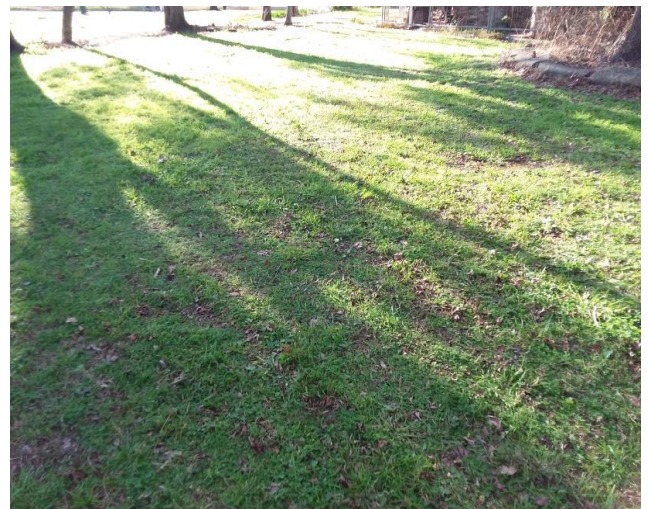
Notes: Visual inspection to the top surface of vicinity of remediation area

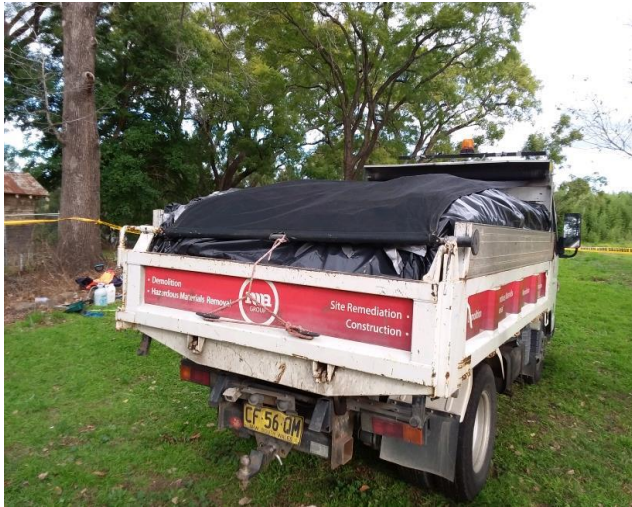
Notes: Waste disposal management

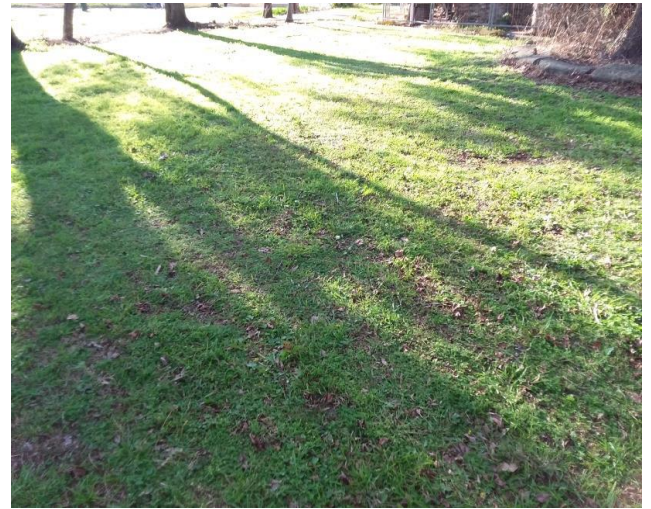
Notes: Visual inspection to the top surface of vicinity of remediation area

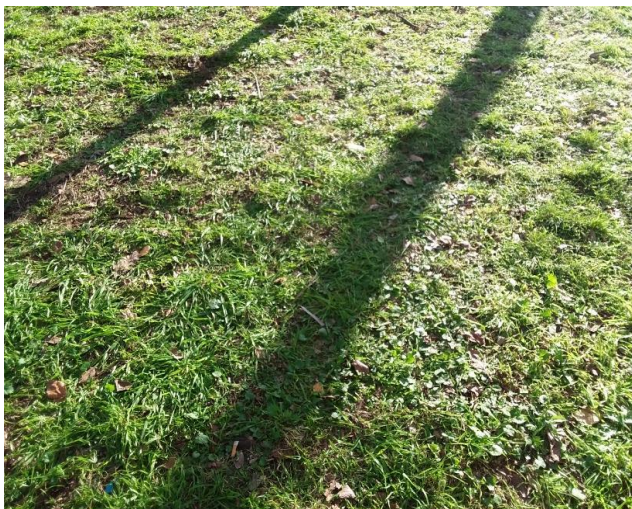
Notes: Close-up visual inspection to the top surface of vicinity of remediation area

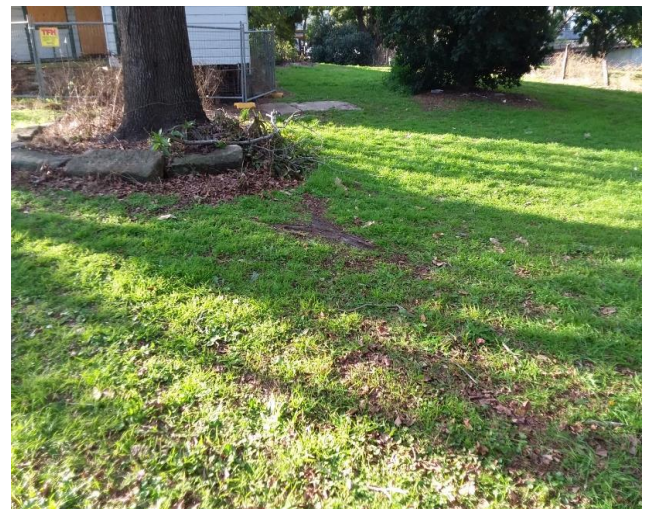
Notes: Visual inspection to the top surface of vicinity of remediation area

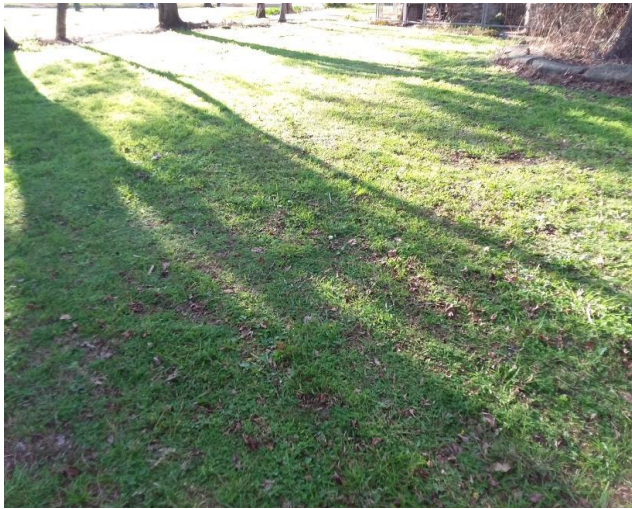
Notes: Close-up visual inspection to the top surface of vicinity of remediation area

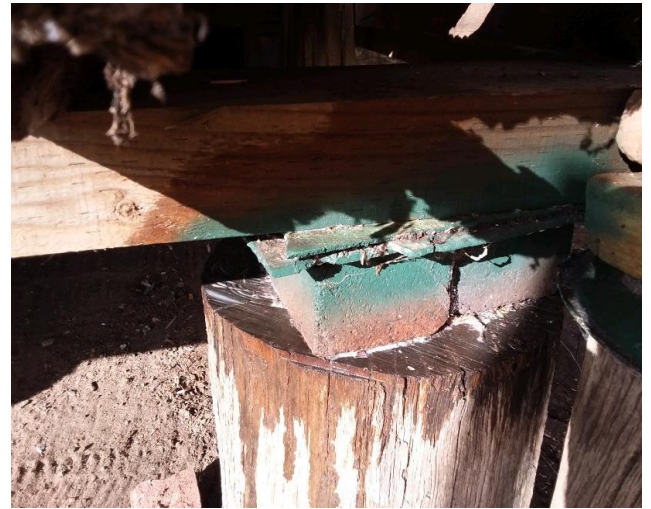
Notes: Visual inspection to the packing material following encapsulation

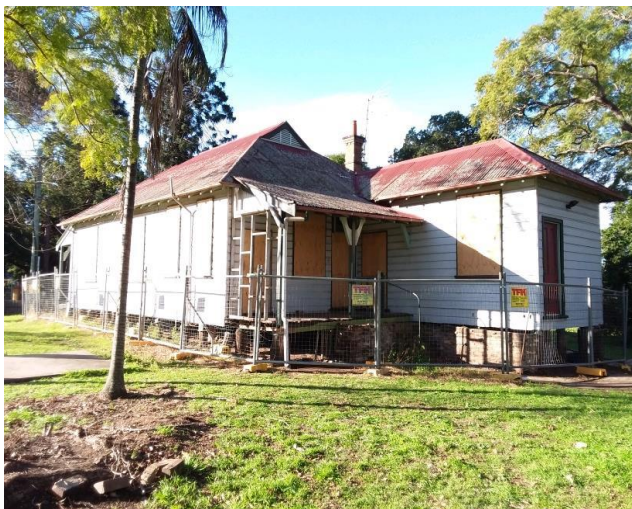
Notes: Overview of the remediation area following remediation
