Arborist development assessment report

Centro Nepean Station and Woodriff Streets Penrith NSW 2750

> 22nd May 2015 **Draft 1**

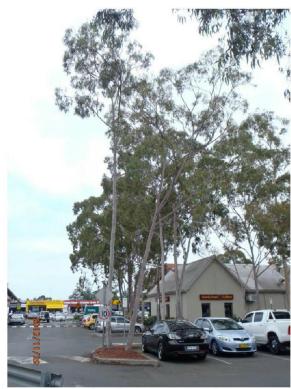
- 3.6 Trees 1- 9 are all native Lemon-scented gum trees (Corymbia citriodora) that are in varying conditions of health. Trees 1 and 2 are causing the least amount of problems to the surrounding kerb and gutter (Plates 1 and 2). The other specimens are in poor health or have had repair work occur within the Structural Root Zone (SRZ) of the tree as can be seen in Plates 3 and 4. This species develops long branchless stems that can and do fail either at the branch union or mid-way along the branch. With regards to branch drop from these trees there is no indication that they are in poor health or have faulty branch attachments. The phenomenon that is known as 'Summer branch drop' (Harris, 1983) could also be applied to the recent failures. This term has been used since the early Eighties to define the failure of seemingly healthy branches failing in calm weather conditions. Contrary to opinion, Summer branch drop does not occur to Eucaloptus species alone. It has been widely reported in peer reviewed papers that

Plate 1: Image showing Trees 1 and 2. P. Vezgoff.

4.1 Tree assessment: Trees 1-4 and 6-10 are proposed to be removed to allow kerb and

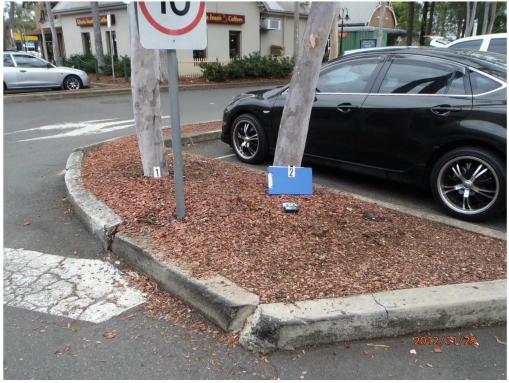
Plate 2: Image showing the base of Trees 1 and 2. P. Vezgoff.

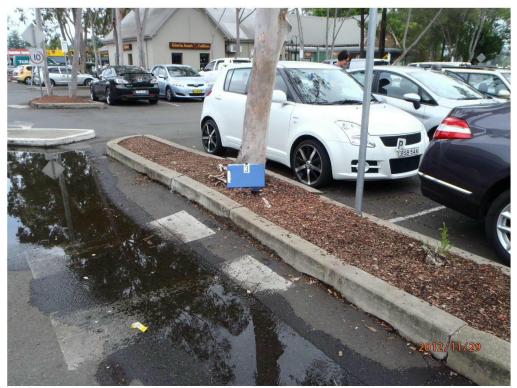
Plate 3: Image showing the base of Tree 3 with previous saw cuts within the SRZ distance. P. Vezgoff.

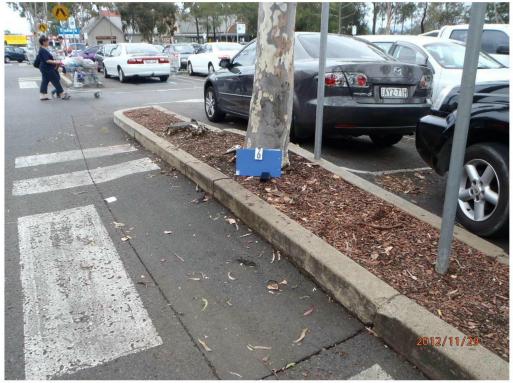
Plate 4: Another example of repairs within the SRZ distance on Tree 6. P. Vezgoff.

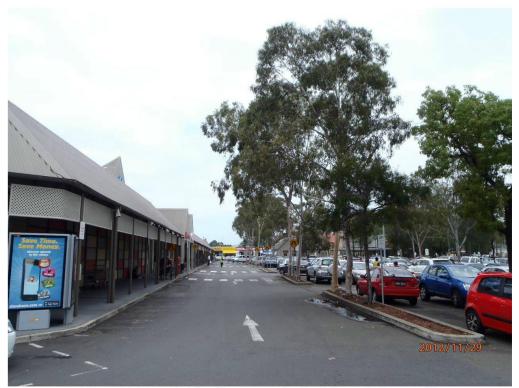
Plate 5: Tree 1-10 adjacent to the building. P. Vezgoff.

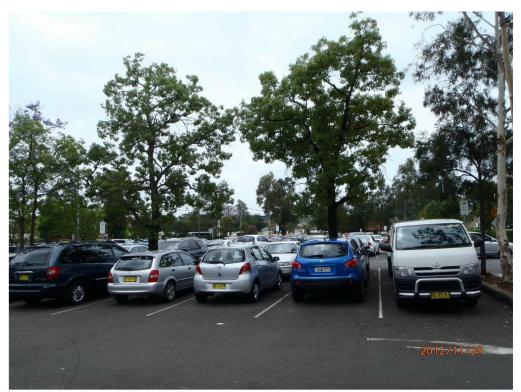
4.3 Replacement species: Brachychiton populneus is present on site and proving to be a

Plate 6: Kurrajong (Brachychiton populneus) examples in the car park. P. Vezgoff.

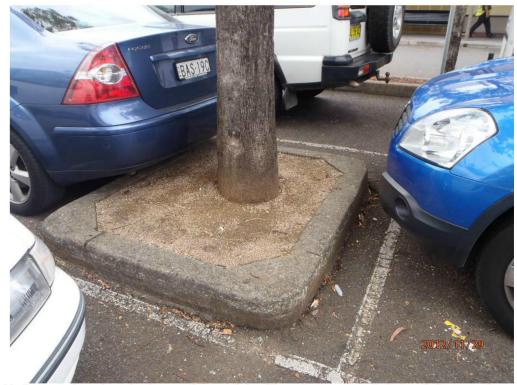
Plate 7: Image showing the base of one of the Kurrajong trees. Minimal damage is apparent at the base of these trees compared with the other native species present on site. P. Vezgoff.

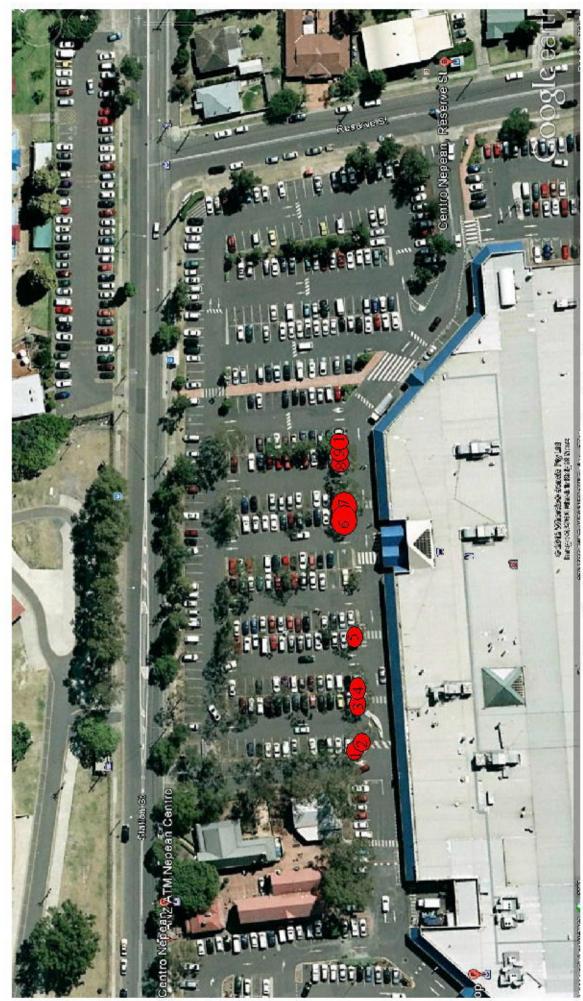
Plan 2: Proposed removals (Red)

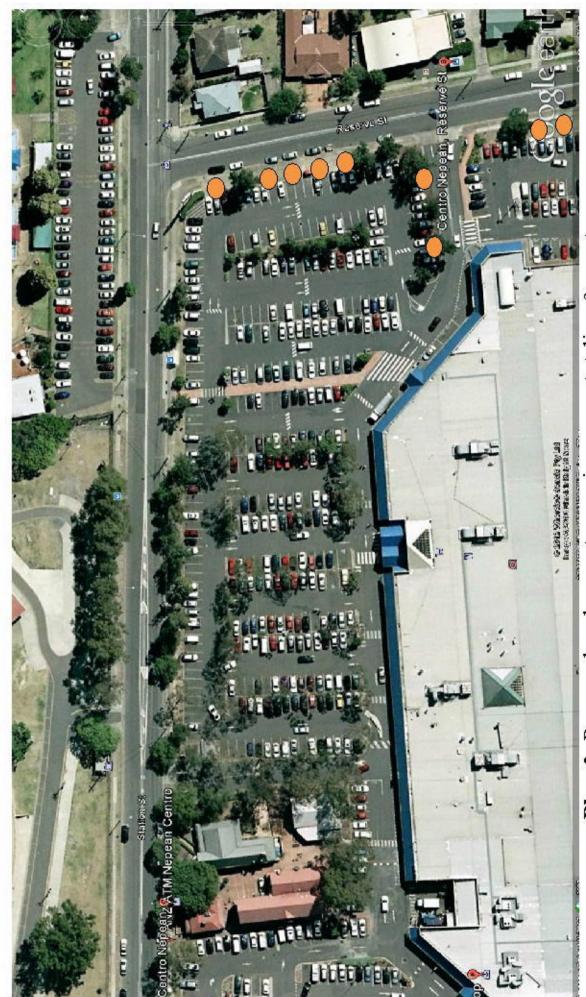
Plan 3: Proposed replacment areas in orange totaling 9 new trees.

- 4.4 Replacement locations: Nine (9) replacement specimens are recommended to be planted along Reserve Street between the nature strip and car park. The proposed replacement locations can be seen in Plan 3 (Appendix 1).
- 4.5 Planting techniques: In order to reduce damage to the surrounding infrastructure there are a variety of products on the market that will reduce root damage. There are also products that will ensure adequate moisture is directed to the root ball of each new tree. Flexible sheet root barrier can be installed in a circular manner or along the edge of each garden bed as seen in Diagram 3
