Asbestos Remedial Management Plan

Penrith City Council

**9a Dilga Crescent
ERSKINE PARK NSW 2759**

Report Number: 11538.02.ARCP

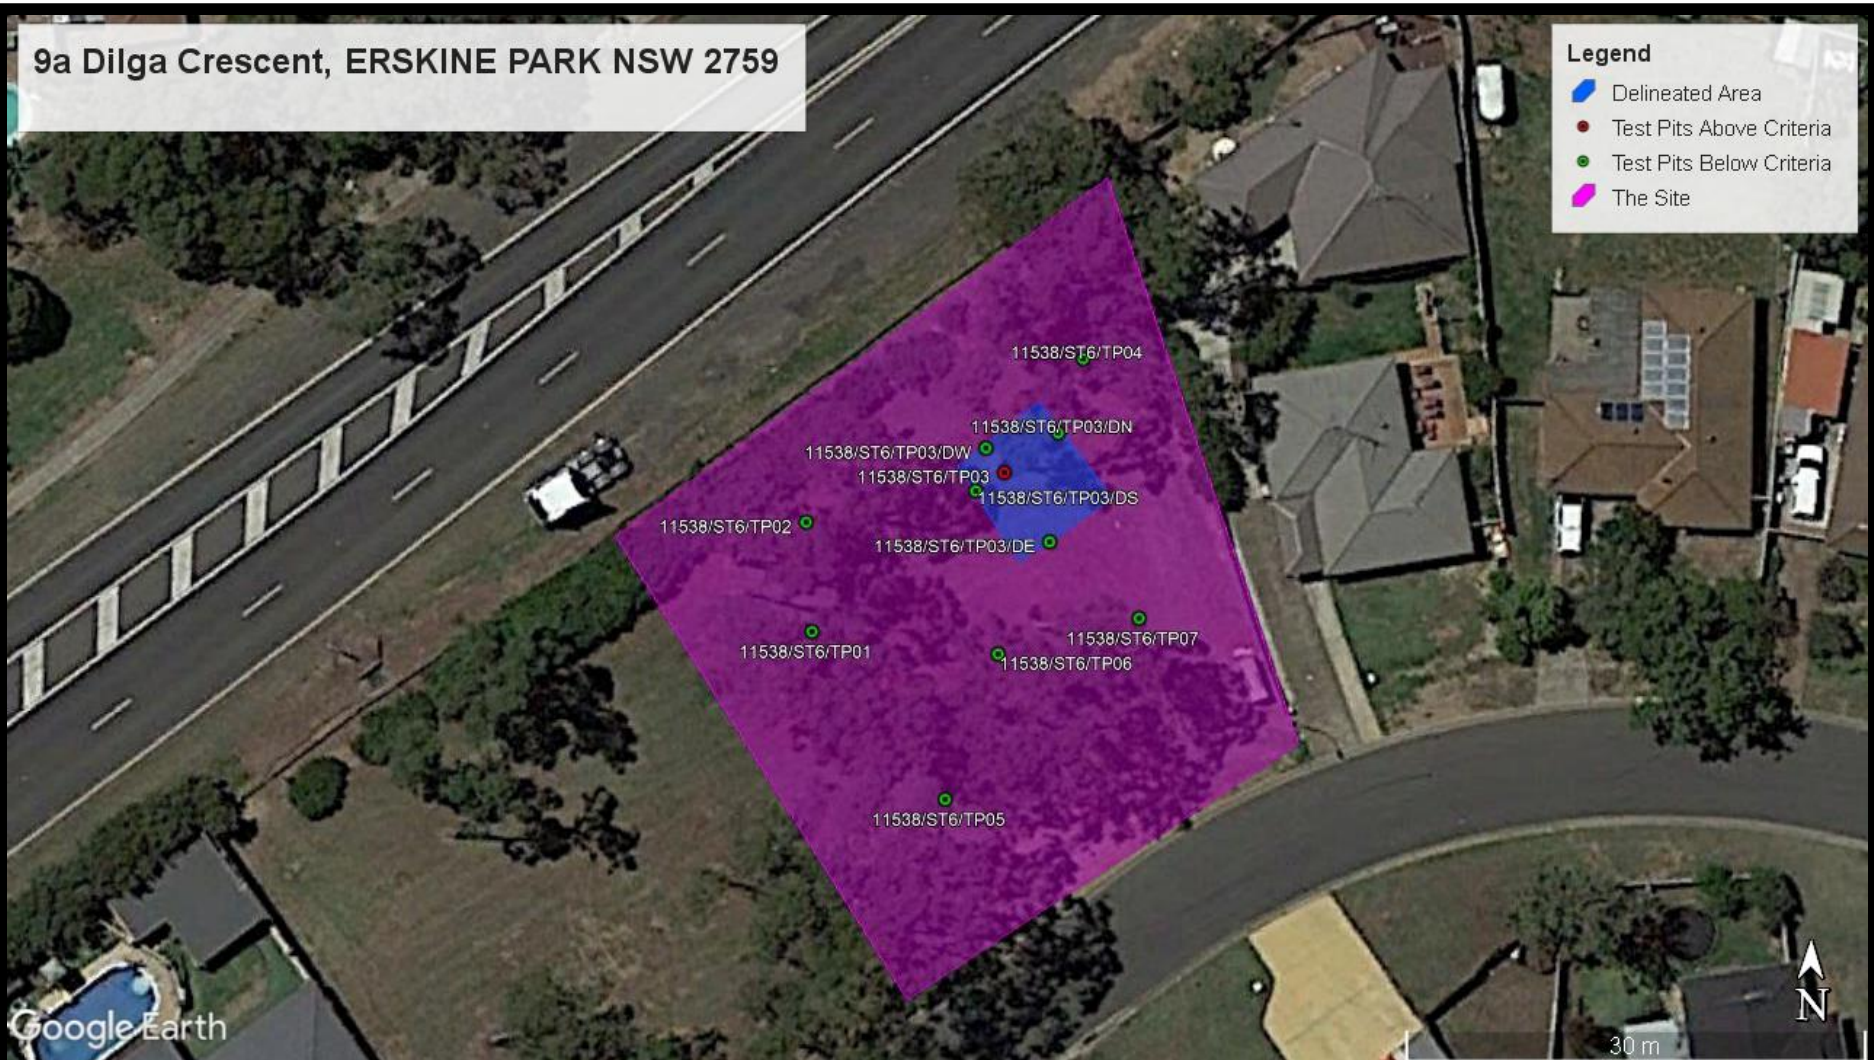
Site Map
9a Dilga Crescent, ERSKINE PARK NSW 2759
**Aerial image derived from Google Earth*

1. Area surrounding TP03 within the fill material and bounded by the following:
 - To the north by location TP03/DN (4.0m from TP03);
 - To the east by location TP03/DE (4.0m from TP03);
 - To the south by location TP03/DS (1.0m from TP03); and
 - To the west by location TP03/DW (1.5m from TP03).

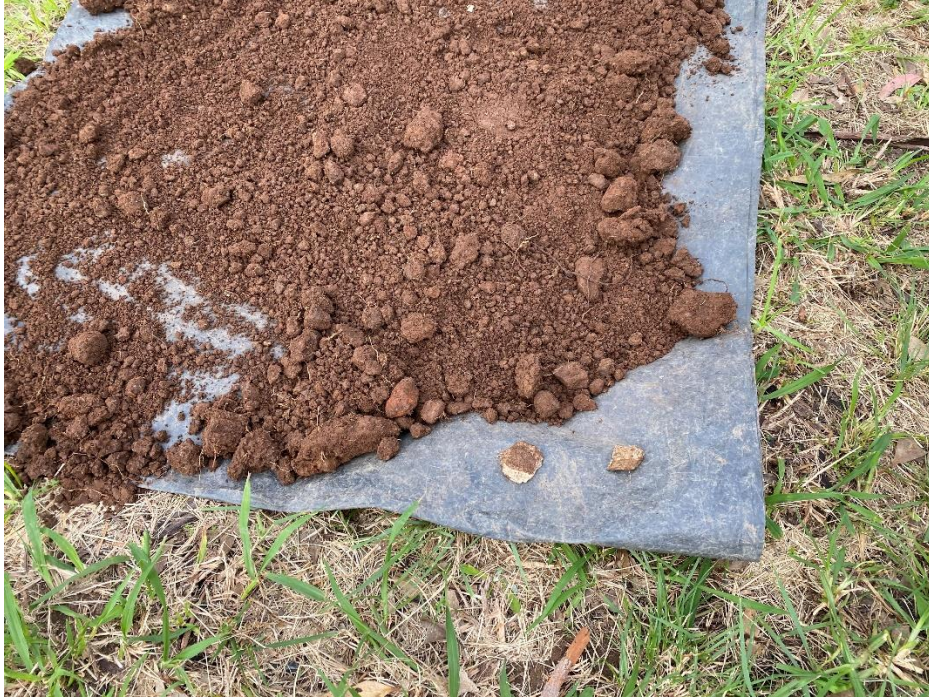
Photograph 1

Description of Material	Specific Location	Sample ID	Friable or Non-Friable	Condition	Risk Rating	Control Measures
Fill material containing asbestos cement debris	Within test pit TP03 at a depth of 0.25m.	11538/ST6/TP03/AS02	Non-Friable (bonded)	Fragments in sound condition	Low	Refer to Section 8

View of the Asbestos Cement Sheetting identified within test pit TP03.

- Excavate fill material and load into trucks with appropriate coverings.
- All fill material removed from the excavation is to be treated as asbestos waste.
- Excavate until there is no more signs of asbestos contamination.
- All trucks used to load the asbestos contaminated material into are to park as close as practicable to the material being removed and within the asbestos exclusion zone.
- When a truck is ready to leave site the wheels and sub-frame (i.e. tow bar of any trailers) are to be washed with a fine water spray to ensure no spilled material leaves the asbestos exclusion zone. The truck should also ensure that its load is fully covered before moving off.
- All asbestos waste must be disposed of appropriately at a waste facility that is licensed to accept asbestos waste.

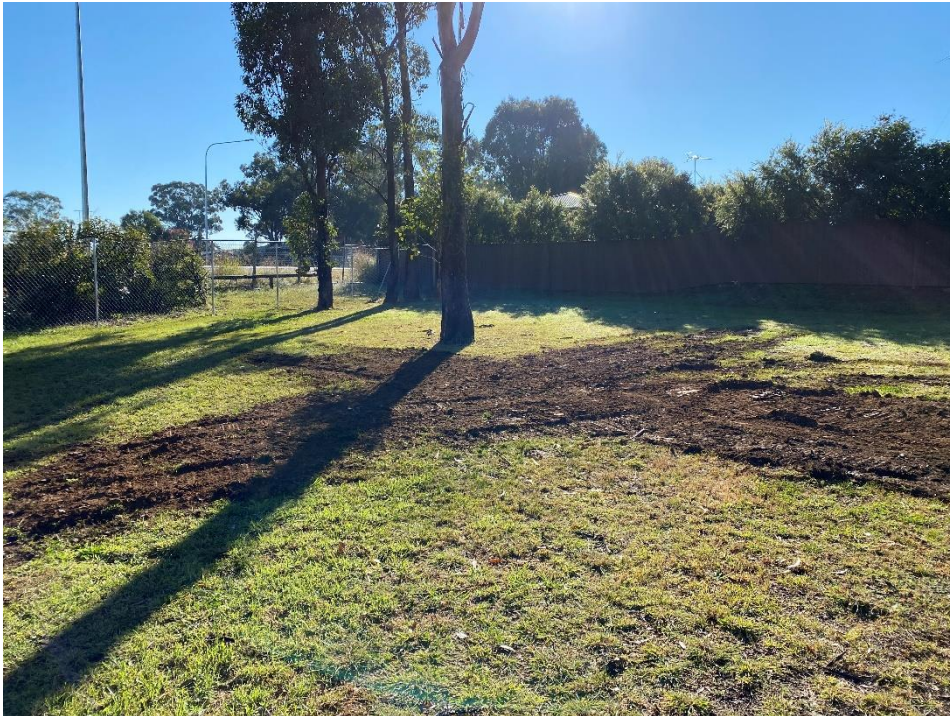
Photograph 2

View of the delineated area surrounding test pit TP03.
