# **ABOUT TREES**

**TREE SURVEY & REPORT**

**40-46 EVAN ST & 96-98 LETHBRIDGE ST**

**PENRITH**

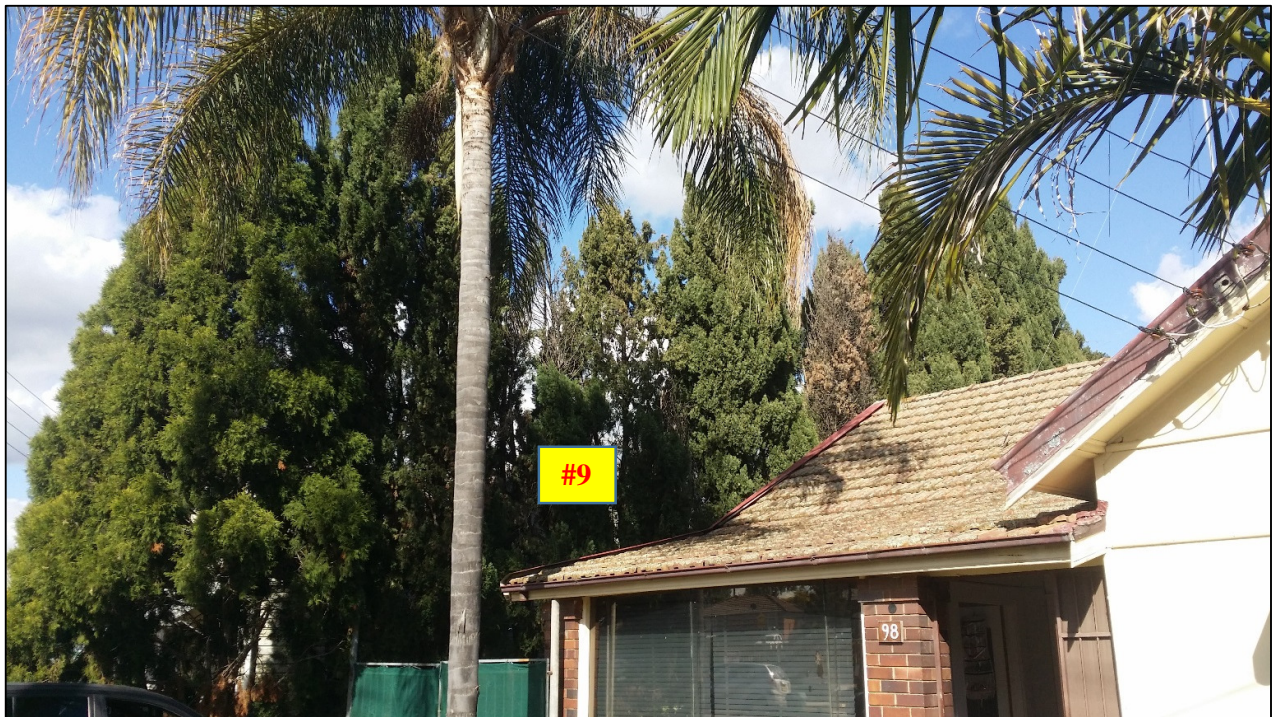
- a. **Health & Vitality:** Low – these trees are showing typical symptoms of Cypress Canker, and are in irreversible decline (see Plate 2 & 3).
- b. **Tree Form:** these trees combine to form a hedgerow with an east/west axis that is 18m in height, and a crown spread of 25x6m
- c. **Structural Condition:** Poor, retainable for 0 – 5 years

Plate 3 – showing tree No. 9 (over-mature hedgerow)

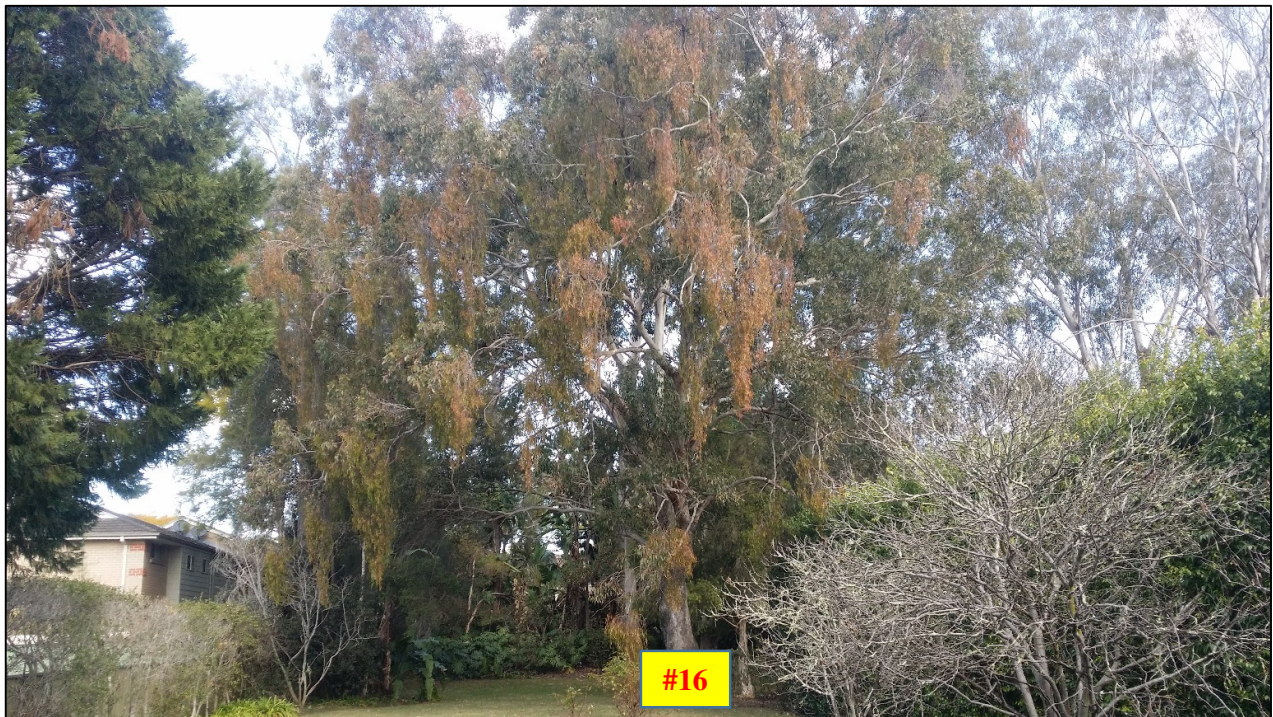
- a. **Health & Vitality:** – the foliage of this tree appears to be generally healthy and growing vigorously, with no visible symptoms of decline. However, it has been heavily colonised by mistletoe (see Plate 6).
- b. **Tree Form:** This tree has formed a single stem with DBH of 1100mm and a codominant, asymmetrical canopy towards the north that is 26m in height, with a crown spread of 33x29m.
- c. **Structural Condition:** Average to fair, this tree may be in the beginning of a decline spiral.

Plate 6 – showing tree 16 with a significant colonisation of mistletoe

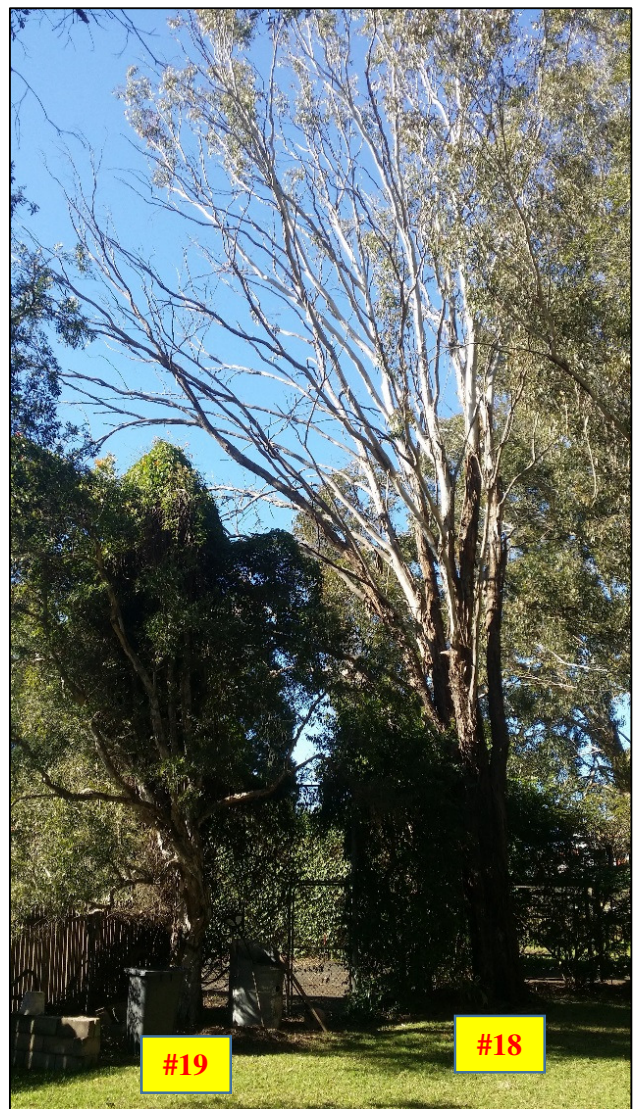
- a. **Health & Vitality:** Poor – this tree is in advanced stages of decline, and is considered to be unsuitable for retention (see Plate 8).
- b. **Tree Form:** This tree has formed a single stem with DBH of 750mm and a codominant canopy with a significant bias towards north that is 26m in height, with a crown spread of 13x17m.
- c. **Structural Condition:** Poor – A large canker wound originating from the root crown has killed a significant amount of cambium (sapwood). The symptoms are consistent with Armillaria Root Decay, and is highly probable that its root system is also compromised (see Plate 9 and [Appendices 9.](#) )

Plate 8 – showing tree No. 18, in advanced stages of decline

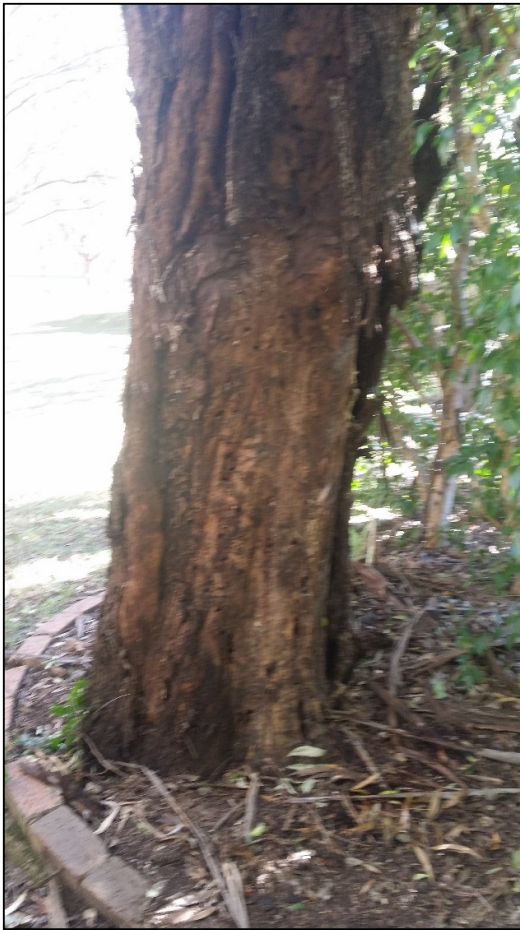
- **Tree No. 60 (*Corymbia citriodora*)** has significant dieback in its canopy and fruiting bodies of root decaying fungus on its root crown. The type of fungus was not identified, but another tree in close proximity (No. 18) has typical symptoms associated with Armillaria Root Decay (see additional information in Appendices 9.8)

Plate 9 – Armillaria Root Decay on trunk of tree 18

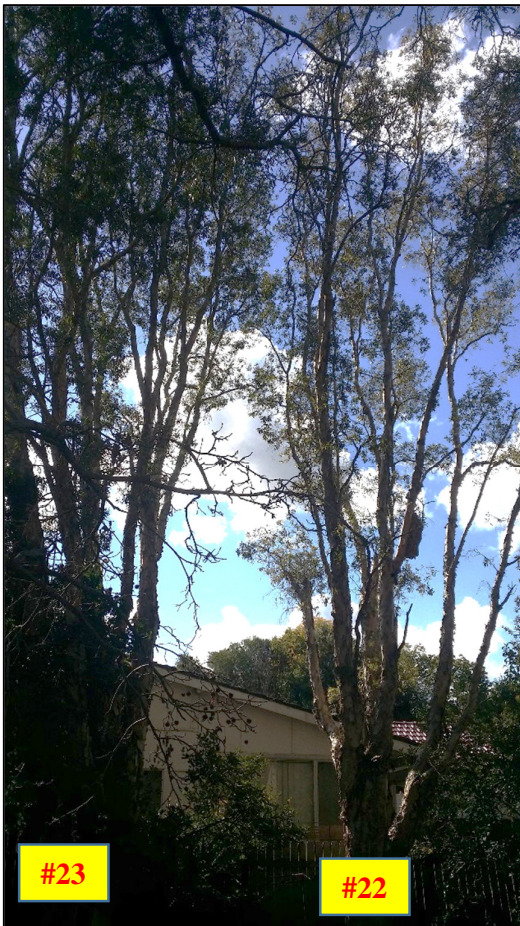
- b. **Health & Vitality:** Low – the dominant tree within the stand (No's 22 & 23) have very sparse foliage, while No. 21 is dead, and No. 20 has a significant asymmetrical canopy towards the east (see Plate 10).
- c. **Tree Form:** These trees have formed a codominant stand and No's 22 – 23 are considered to be unsuitable for retention.
- d. **Structural Condition:** Poor – The removal of No' 21 – 23 will leave the recently exposed asymmetrical canopy of No. 20 to unaccustomed wind loading, and this will increase its failure potential. Retainable for 0 – 5 years

Plates 11 & 12 – showing dieback and decline of tree No's 21 - 23

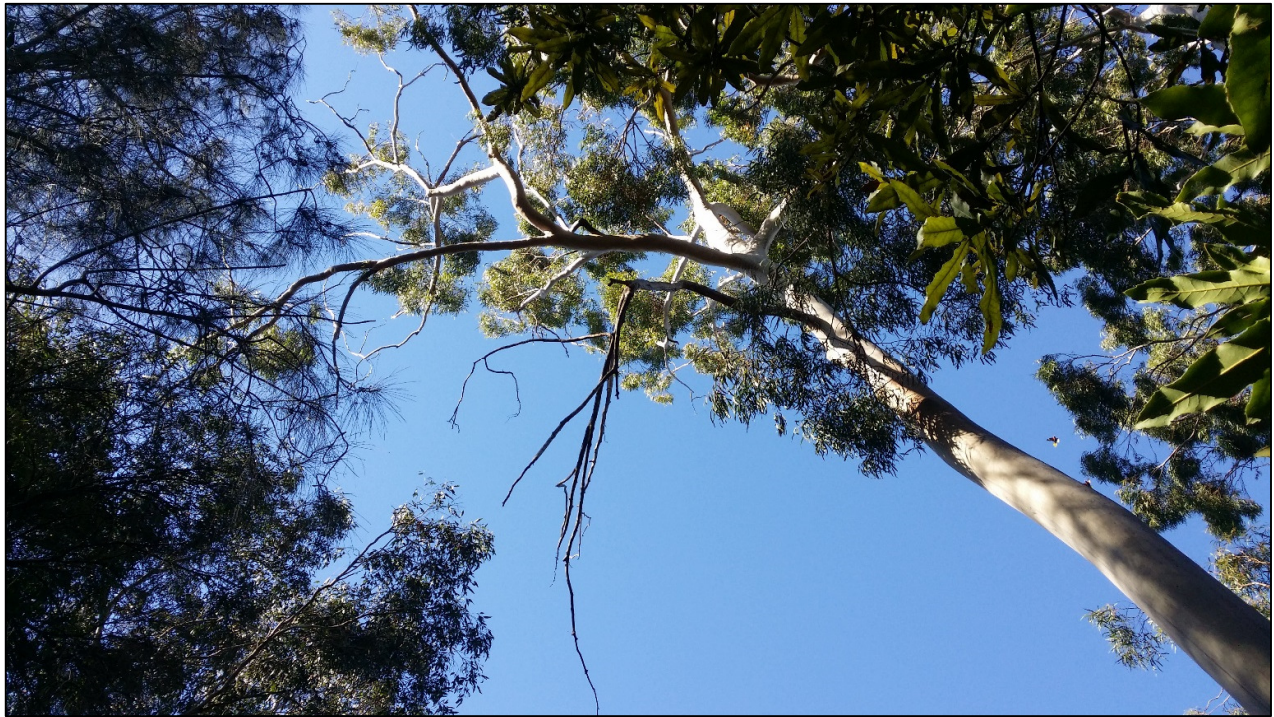
Plate 22 – showing canopy of tree 60, in advanced stages of decline, with a natural trunk lean of 30° towards the north

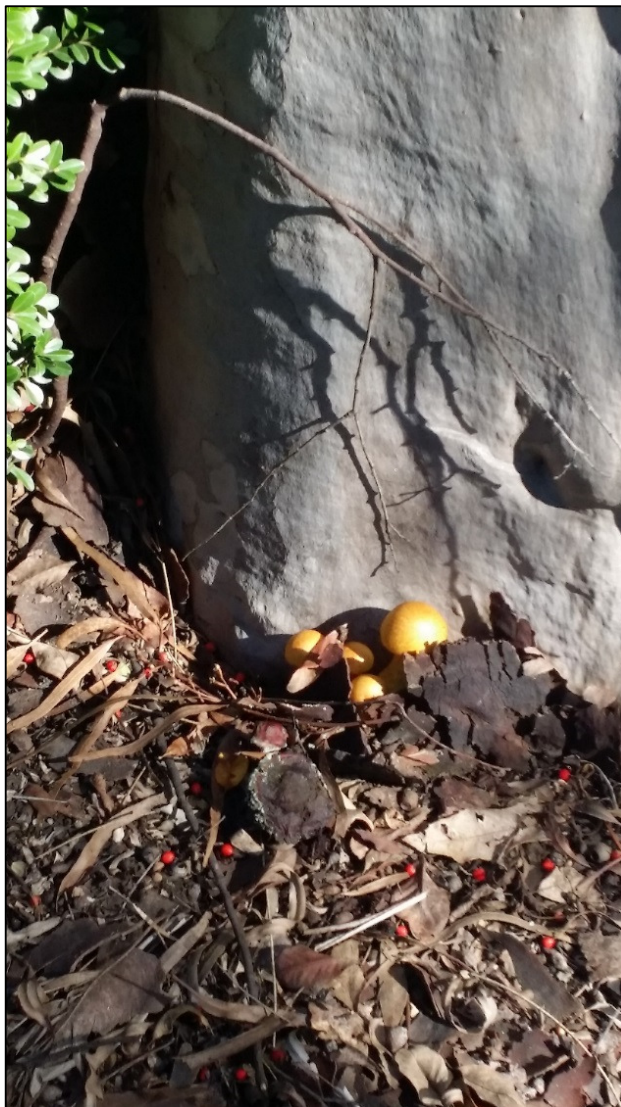
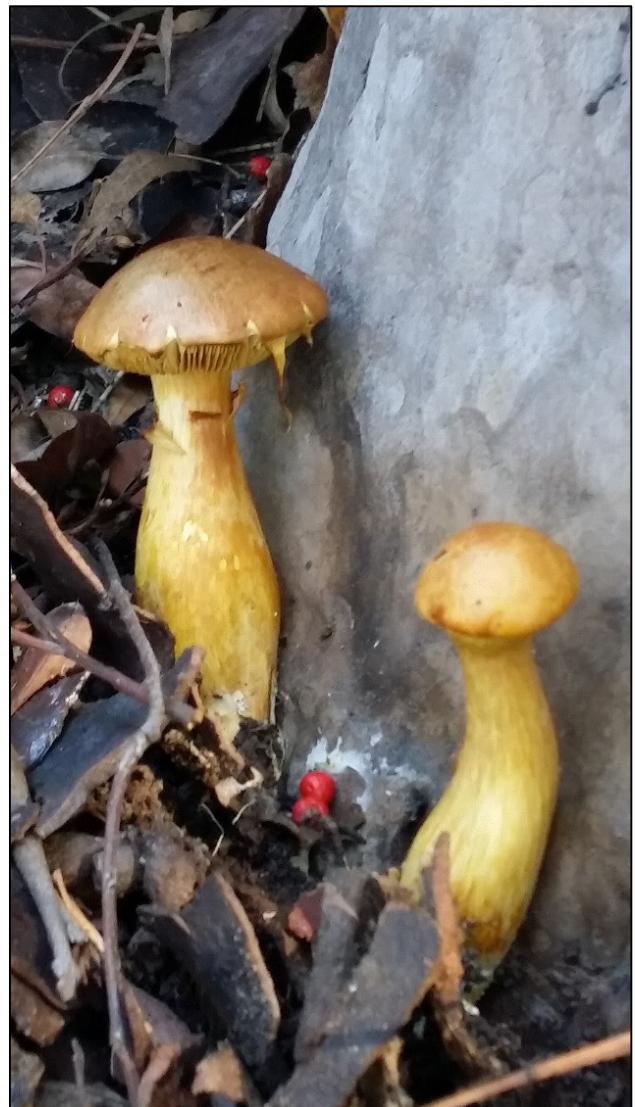
Plates 23 & 24 – showing fruiting bodies of *Meripilus* on rootcrown

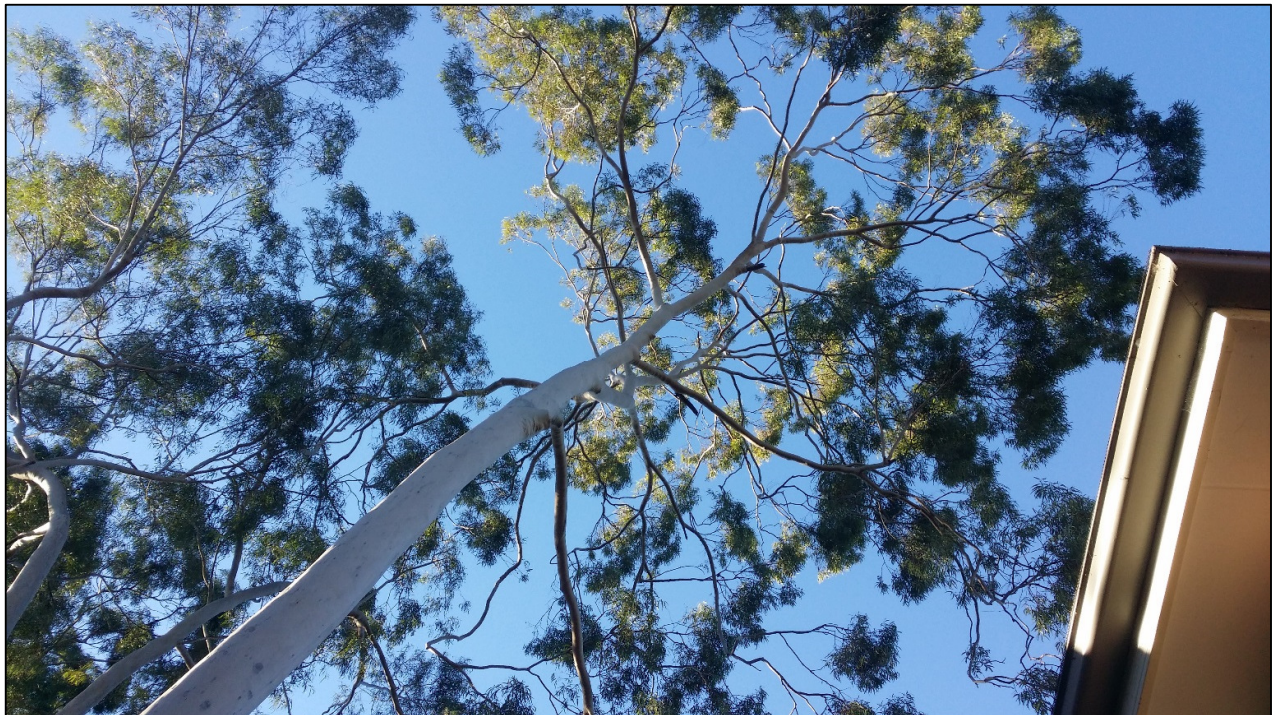
- **Tree No. 72 (*Corymbia citriodora*)** has formed a significant asymmetrical canopy towards the east, and most of its tall canopy overhangs a unit on No. Derby Street. The potential for a whole tree failure is considered unlikely at this stage, but the species is prone to Summer Branch Drop (Appendices 9.12)

Plate 27 – showing significant asymmetrical canopy of tree No. 72

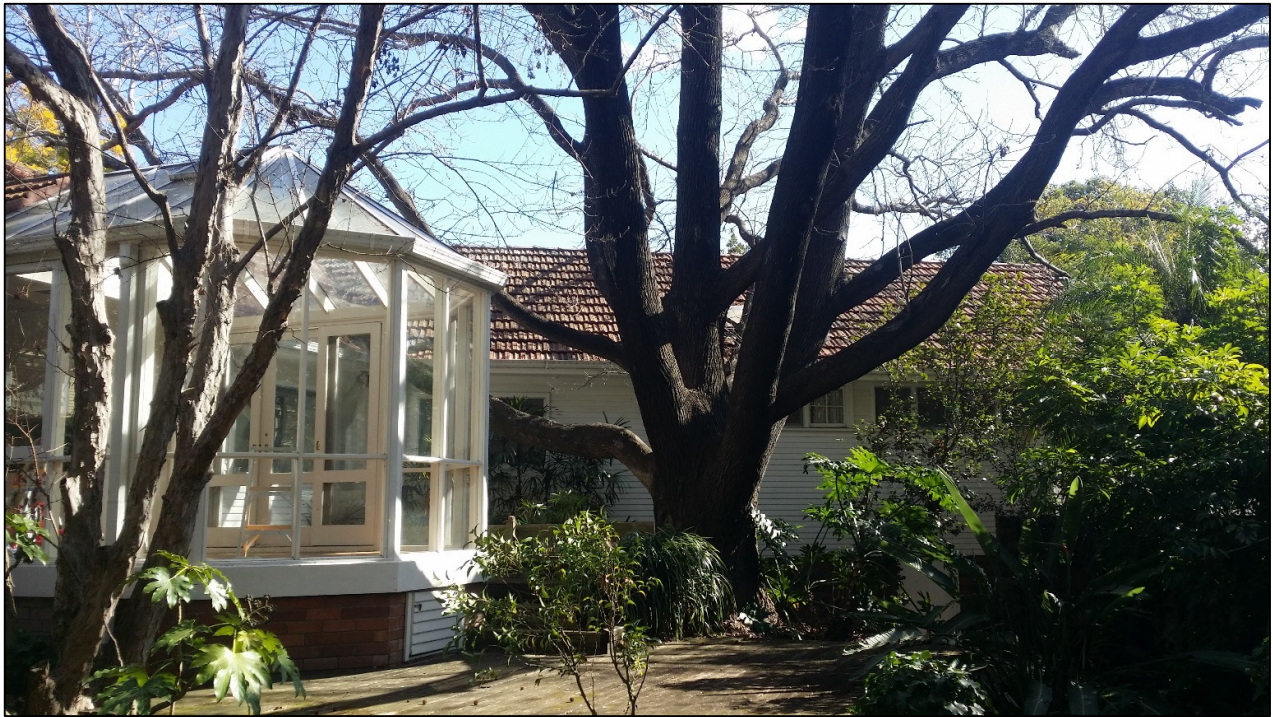
- **Tree No. 85 (*Liquidamber styraciflua*)** is a mature tree with a wide spreading canopy. Some of these branches are receiving mechanical support from the dwelling in its dripline, and the proposed demolition of this building will result in probable to imminent failures

Plate 35 – showing tree No's 84 & 85

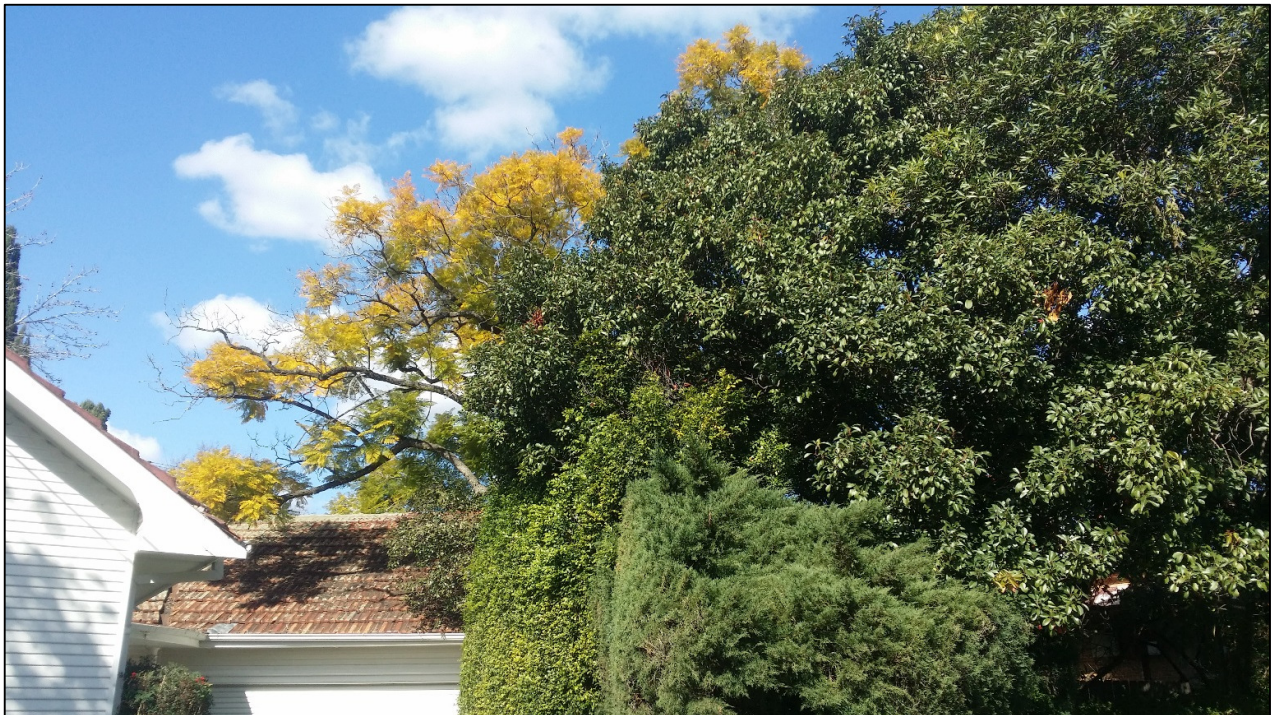
- **Tree No. 92 (*Jacaranda mimosifolia*)** is an over-mature tree with two equal sized diameter, codominant ascending branches and a partially failed weak junction. This has a probable to imminent failure potential.

Plate 40 – showing trees 91 - 93
