# Dilapidation Report

Proposed Works - Jordan Springs Stage 2 Retirement Living

James Sae Siew  
5<sup>th</sup> March 2019  
Revision 1

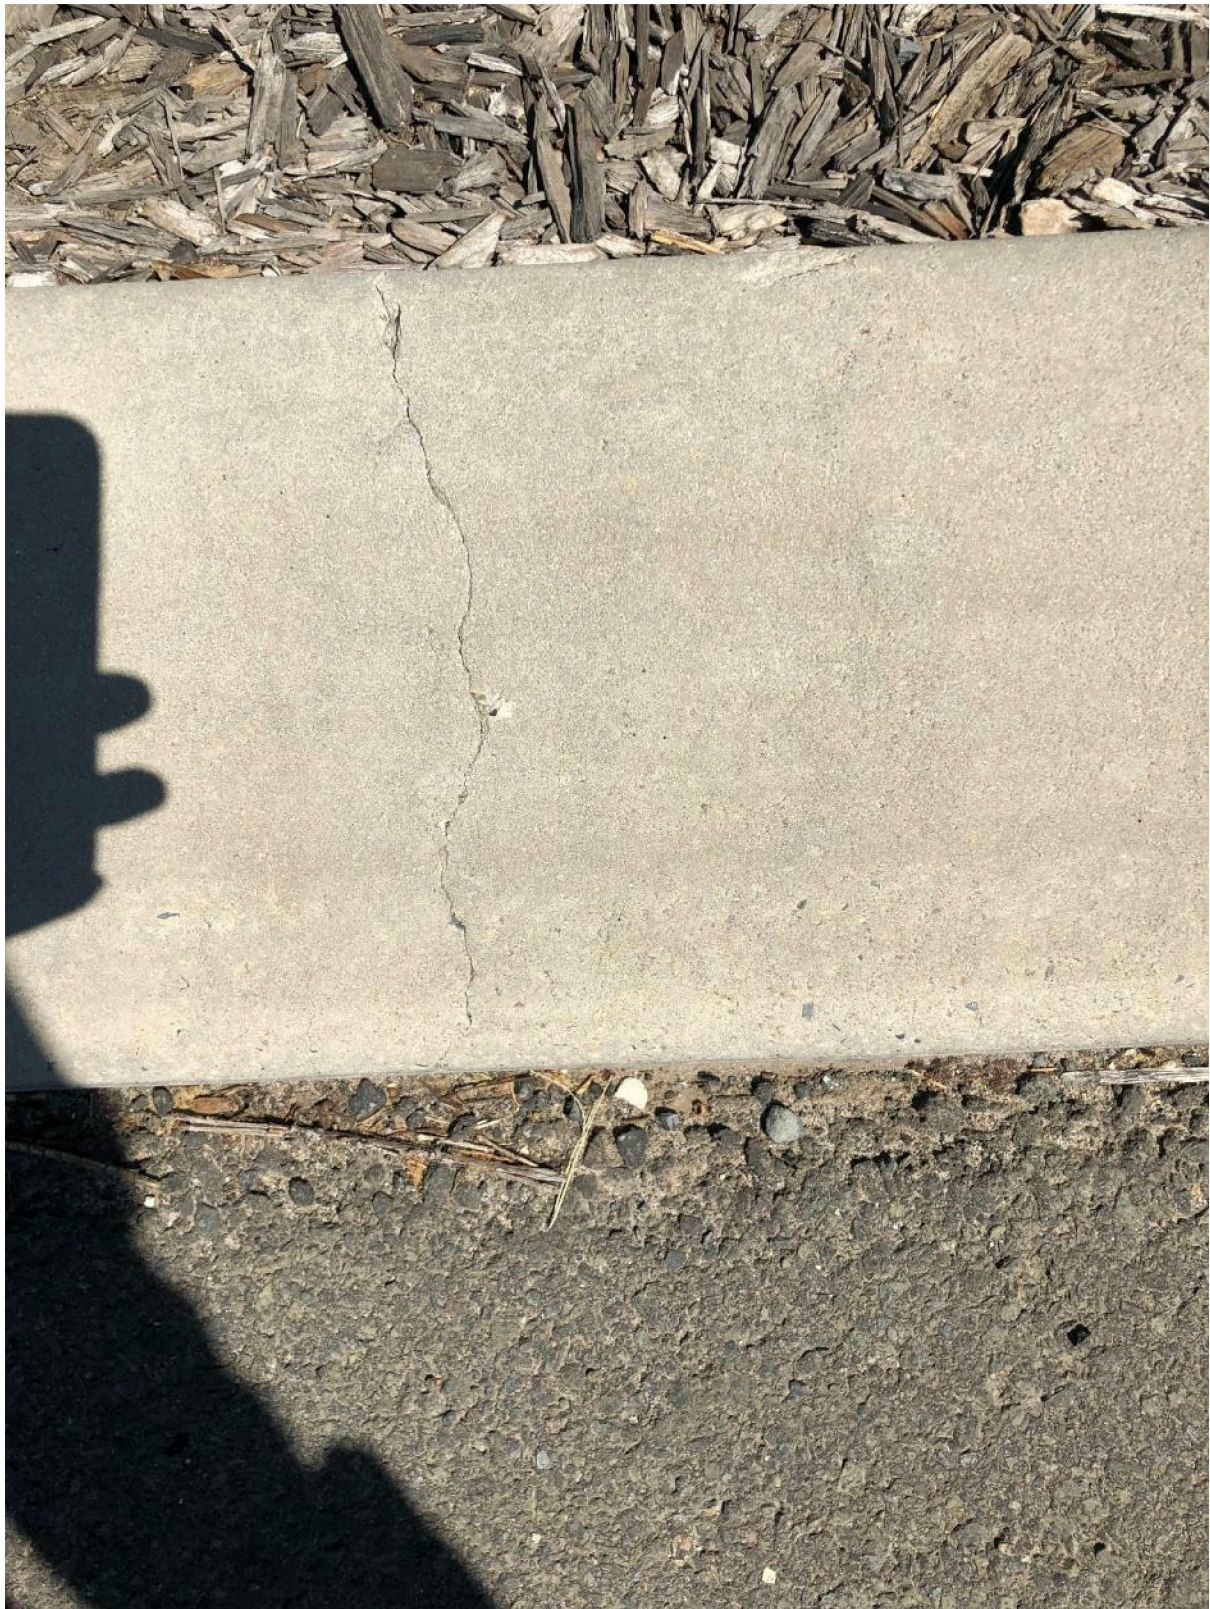
*Figure 1: chips in median strip kerb (facing The Northern Road)*

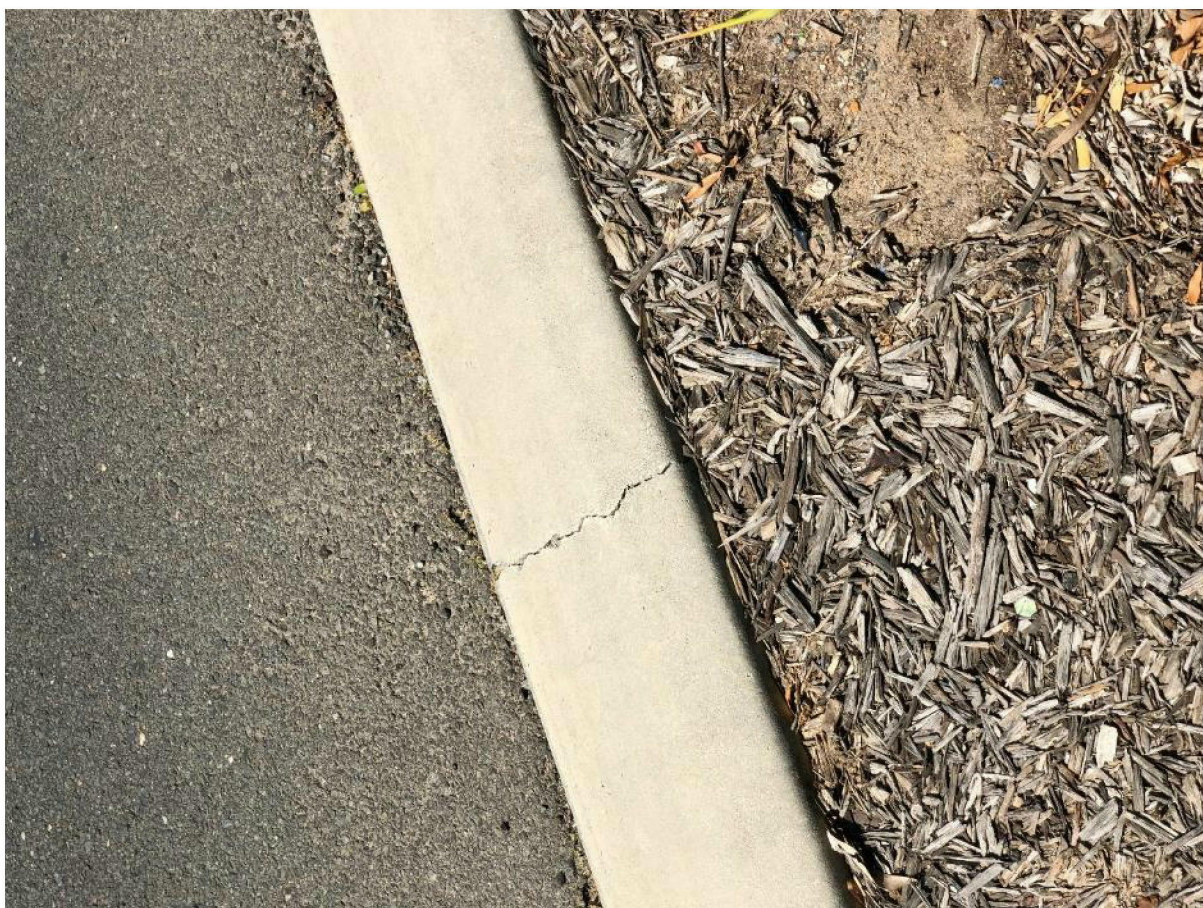
*Figure 2: crack in median strip kerb.*

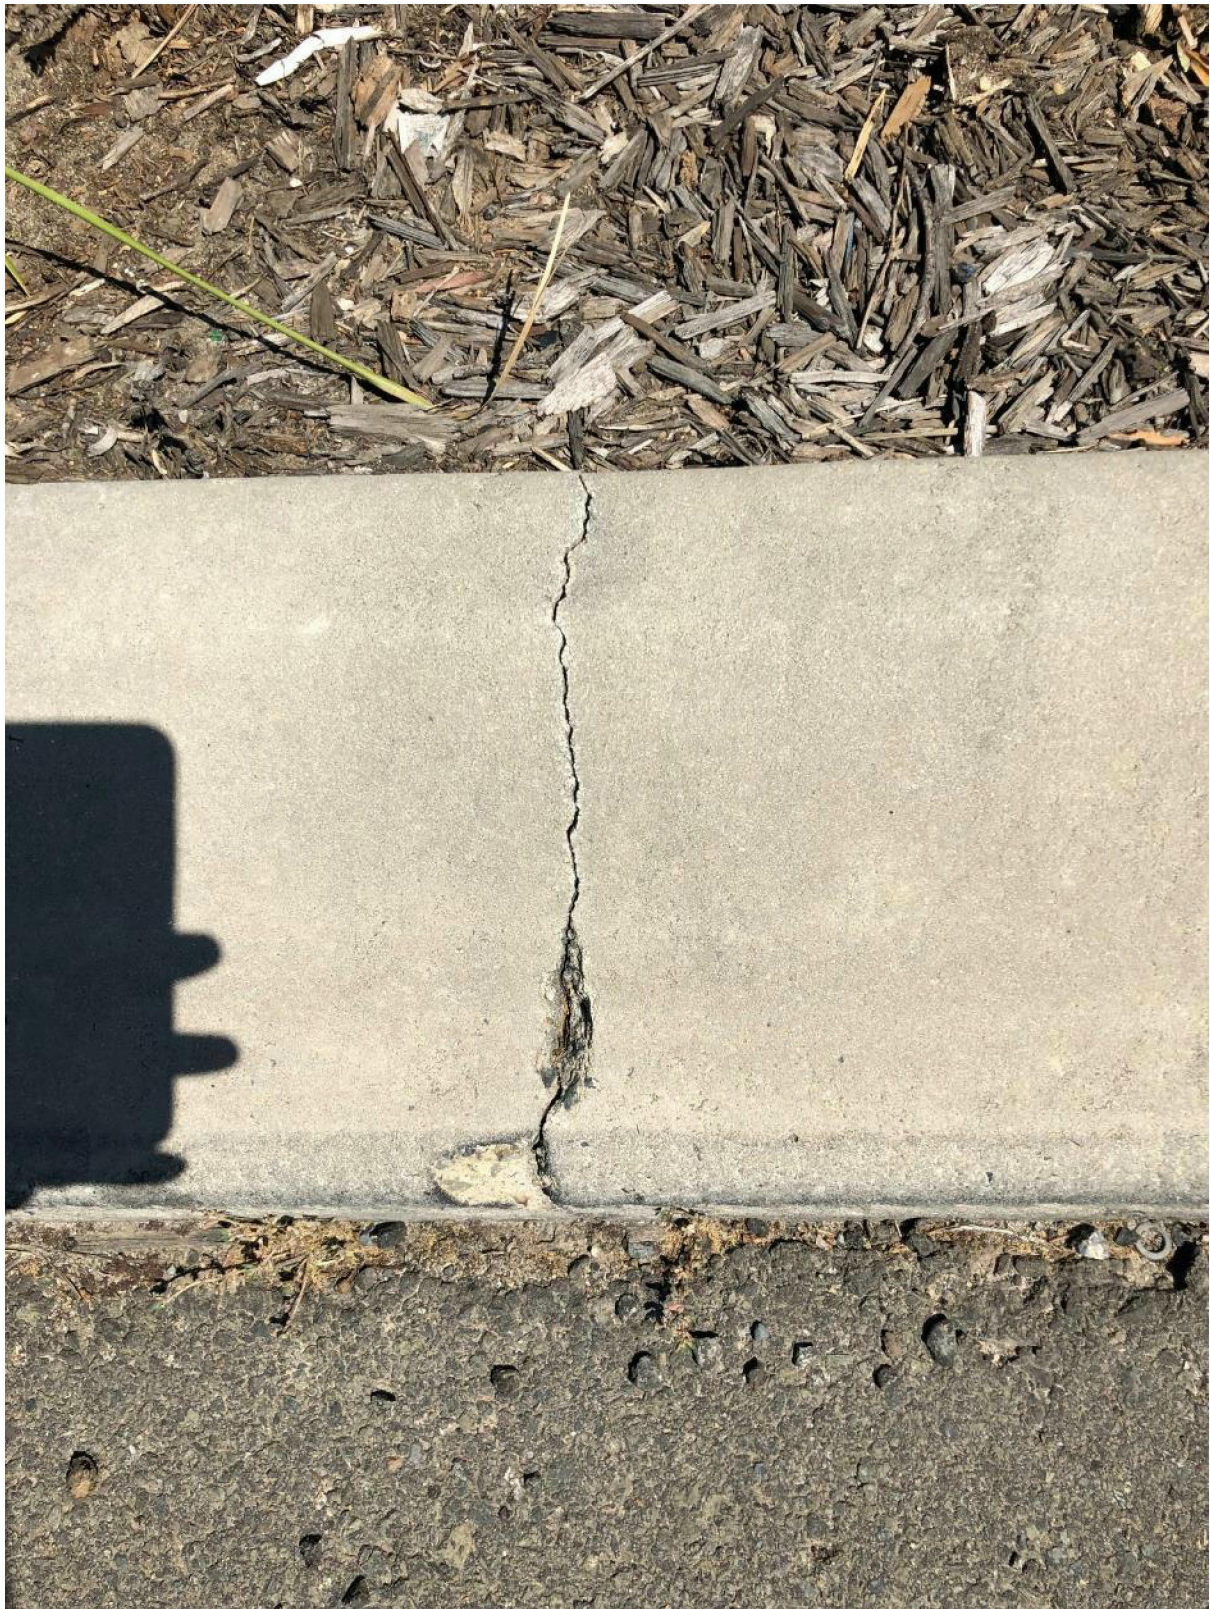
*Figure 3: crack in median strip kerb.*

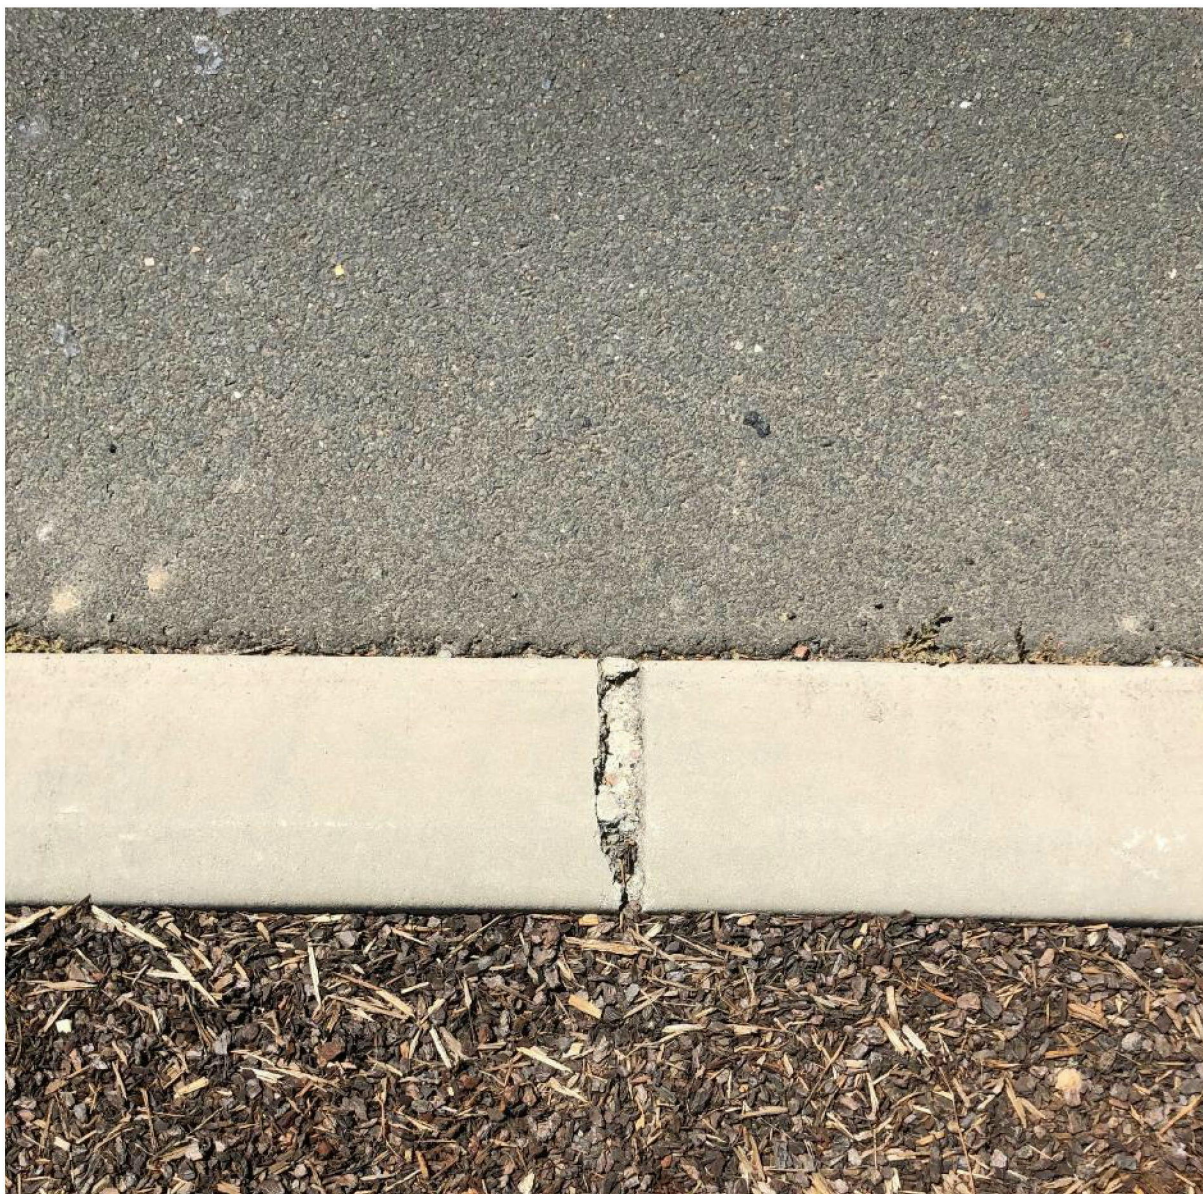
*Figure 4: crack in median strip kerb.*

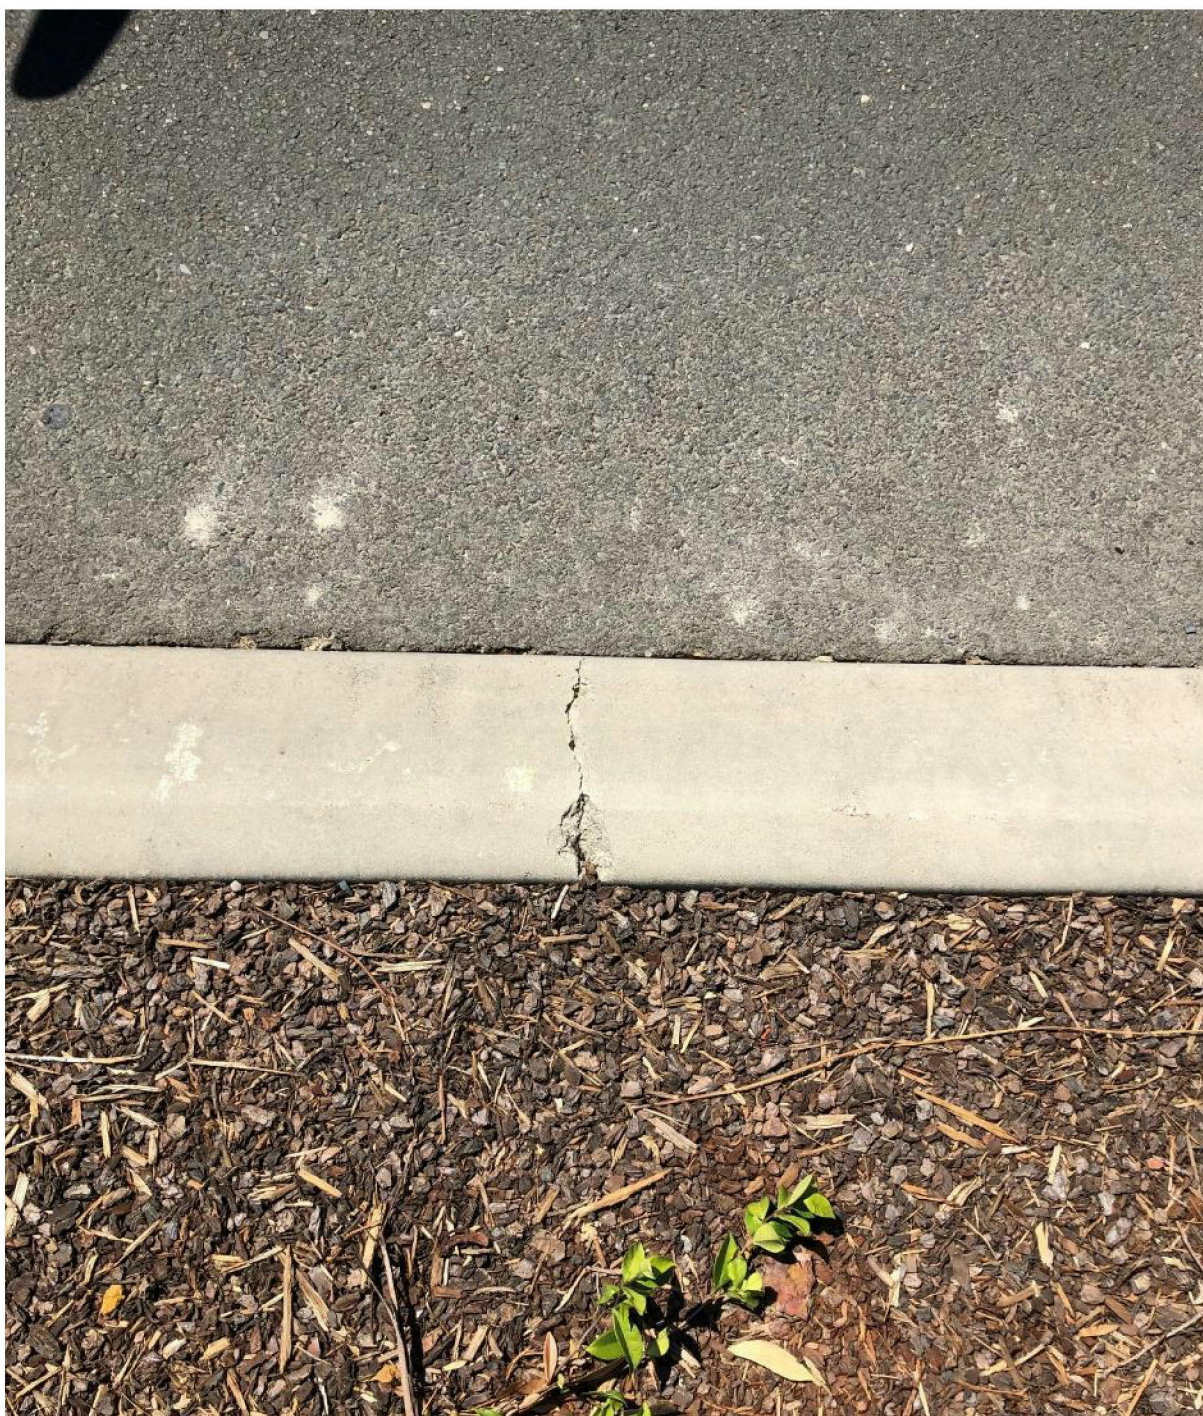
*Figure 5: separation at construction joint interface.*

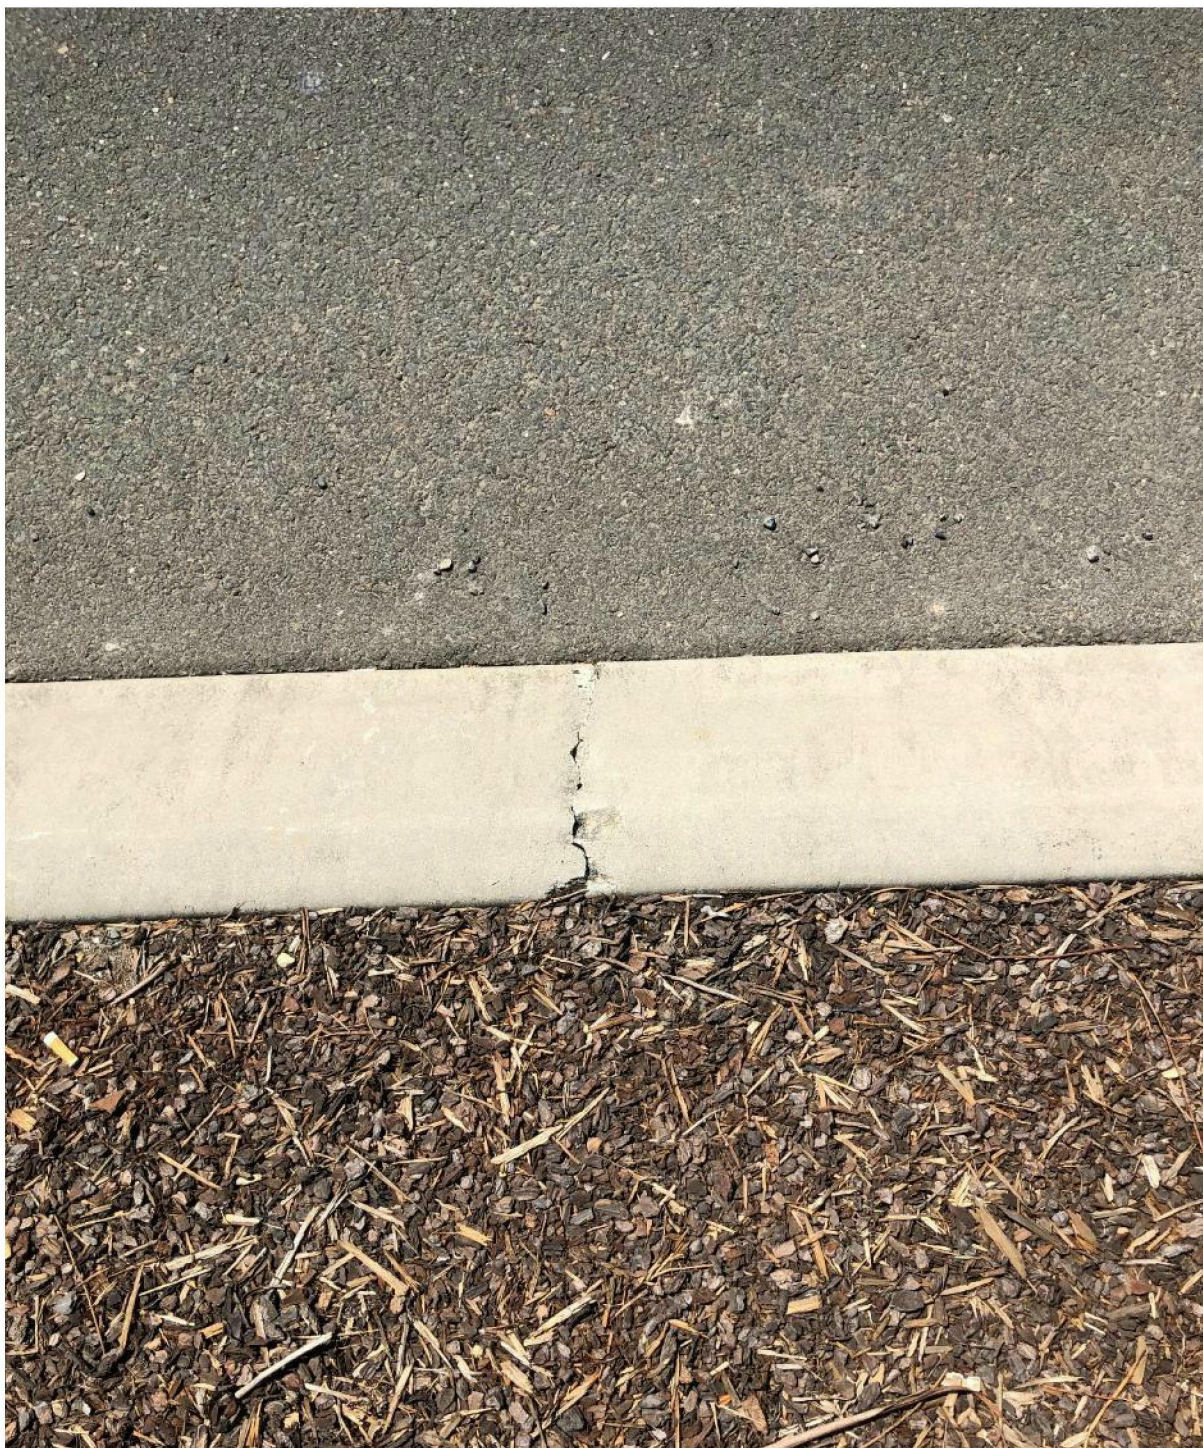
*Figure 6: cracking to median strip kerb.*

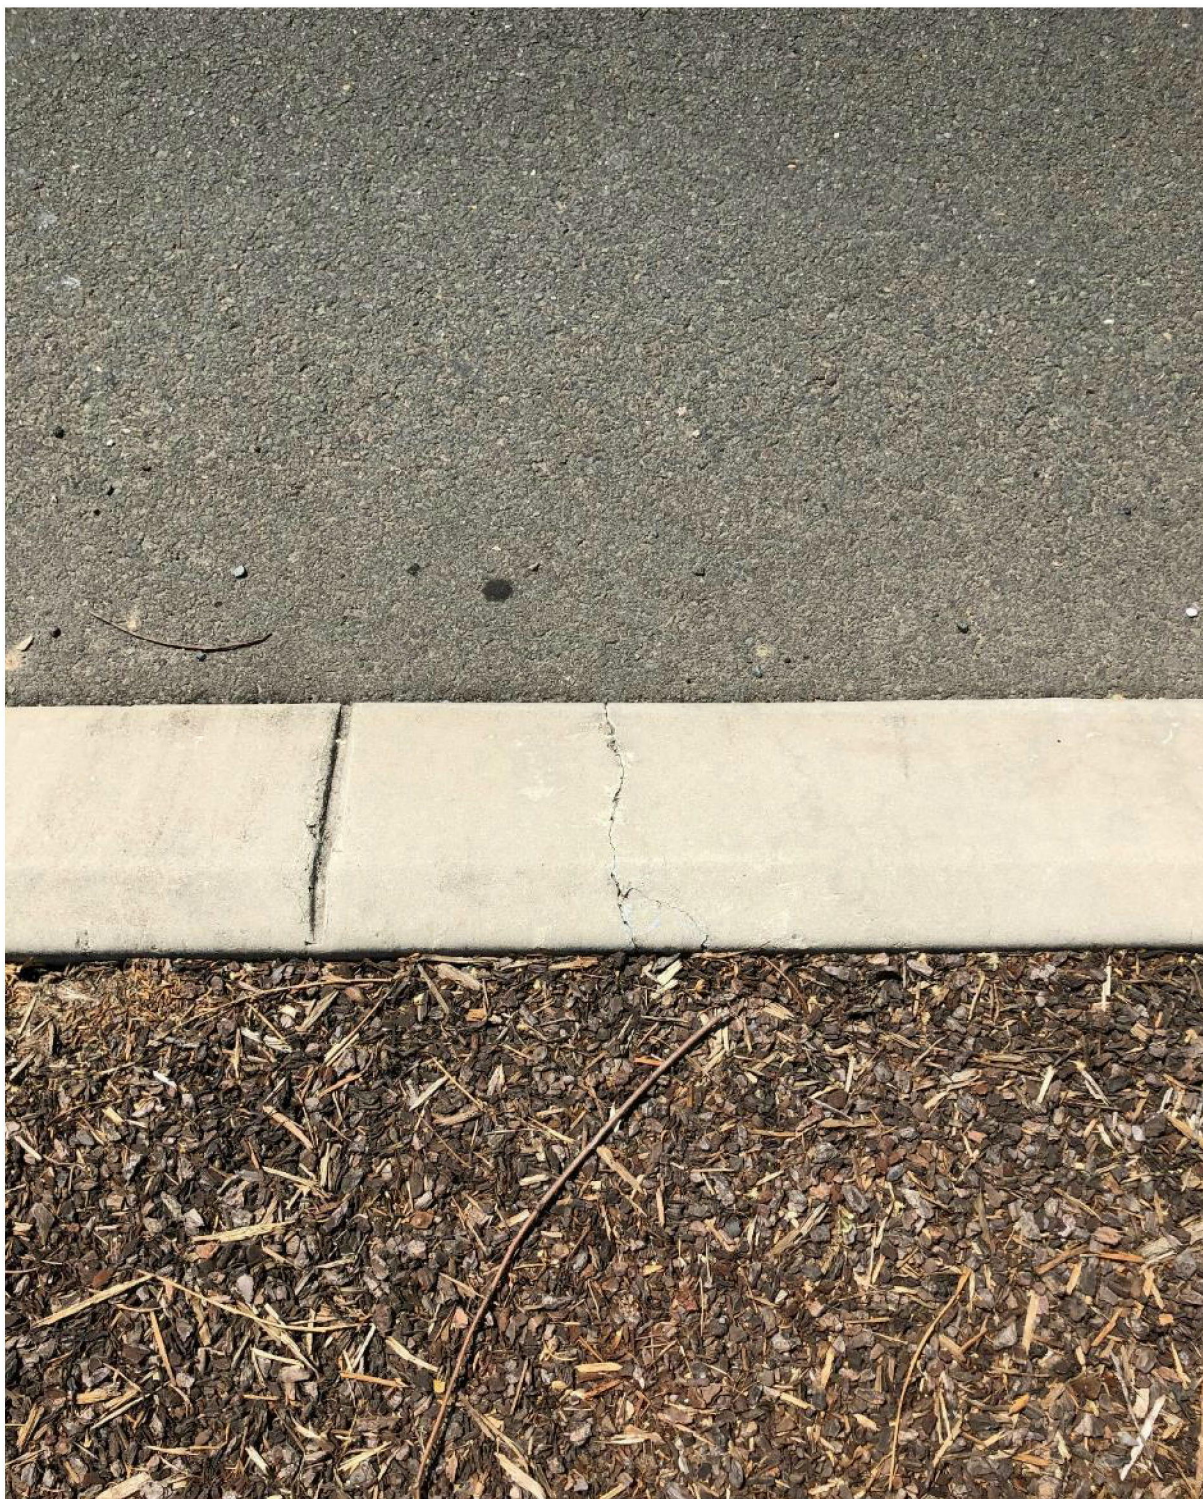
*Figure 7: cracking to median strip kerb.*

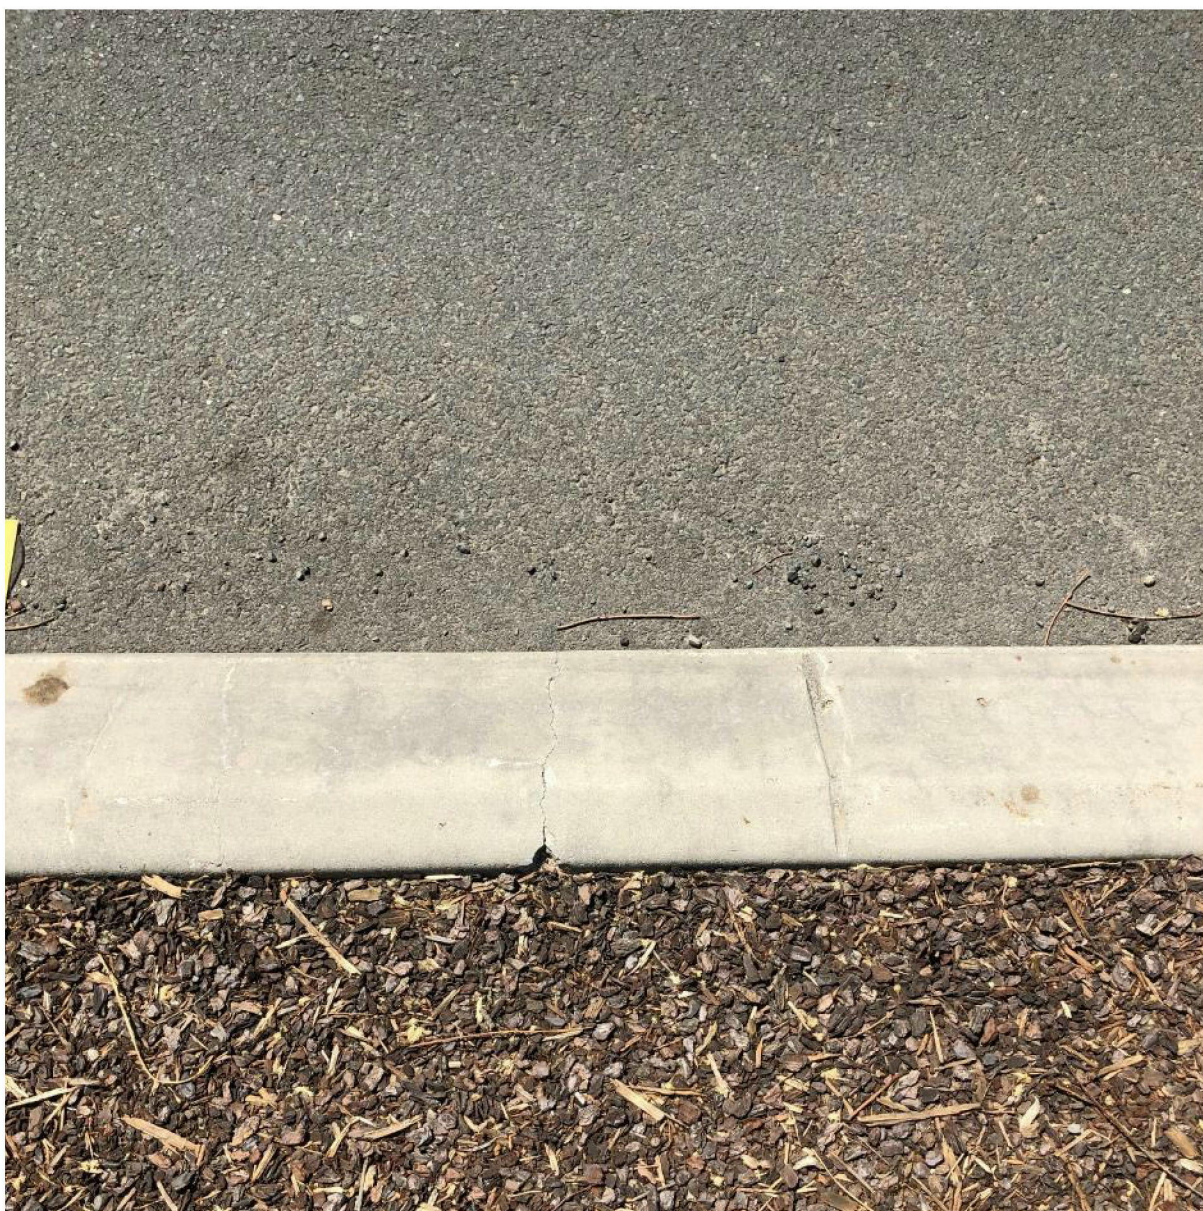
*Figure 8: cracking to median strip kerb.*

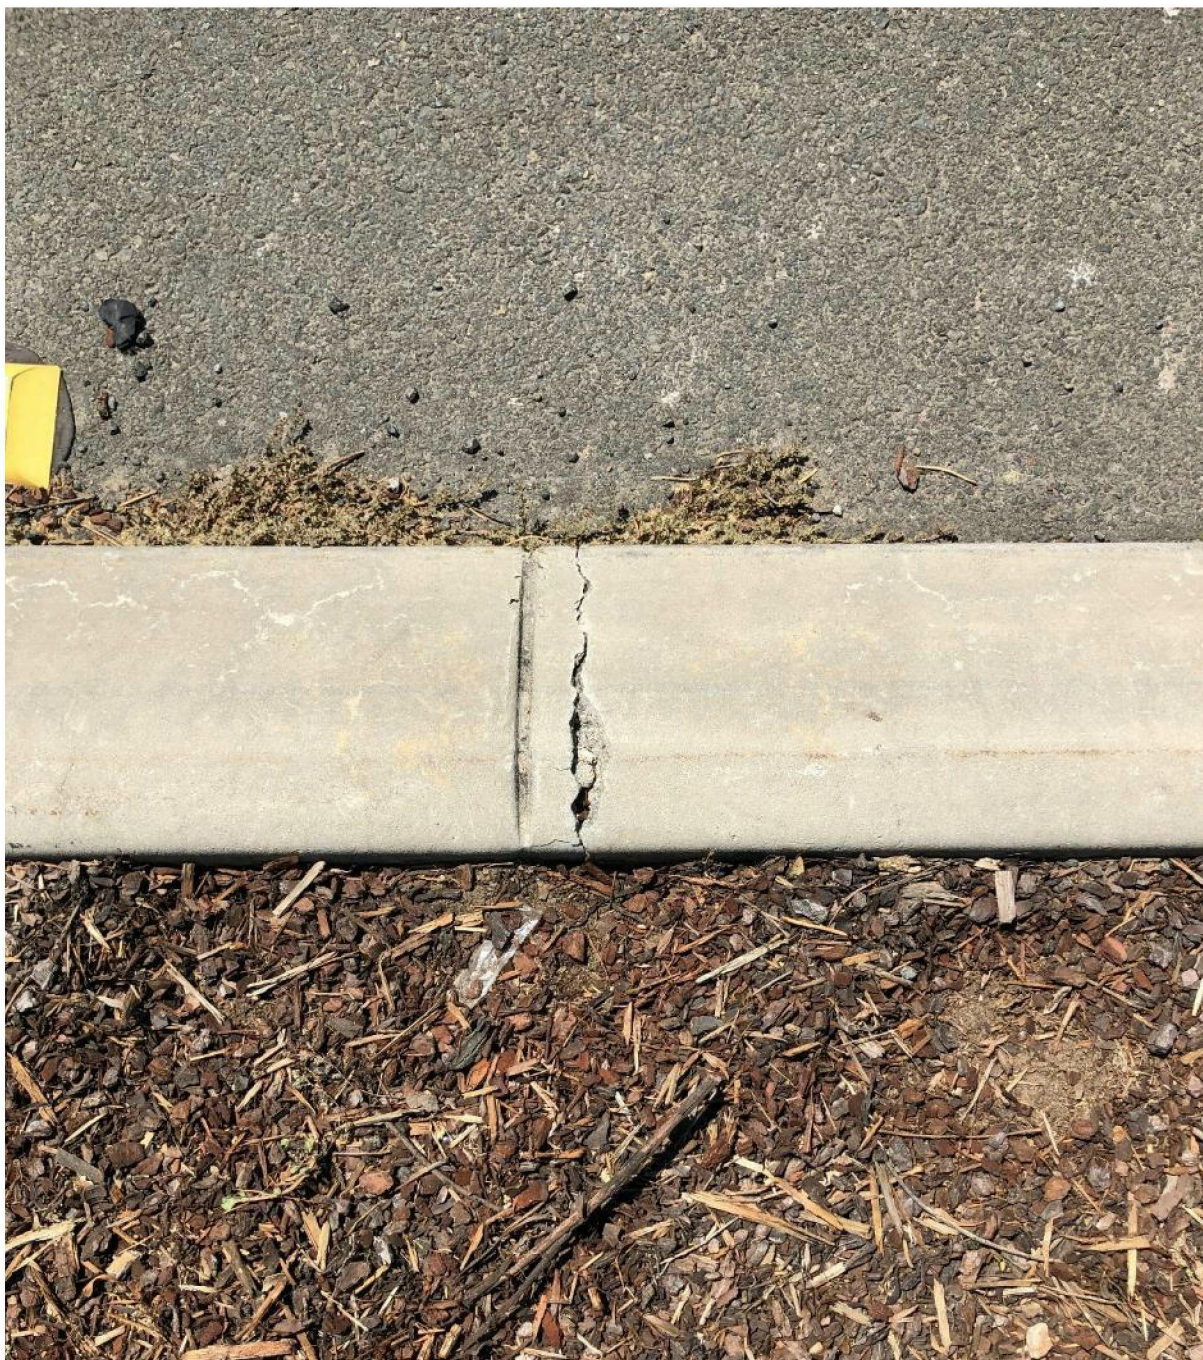
*Figure 9: cracking to median strip kerb.*

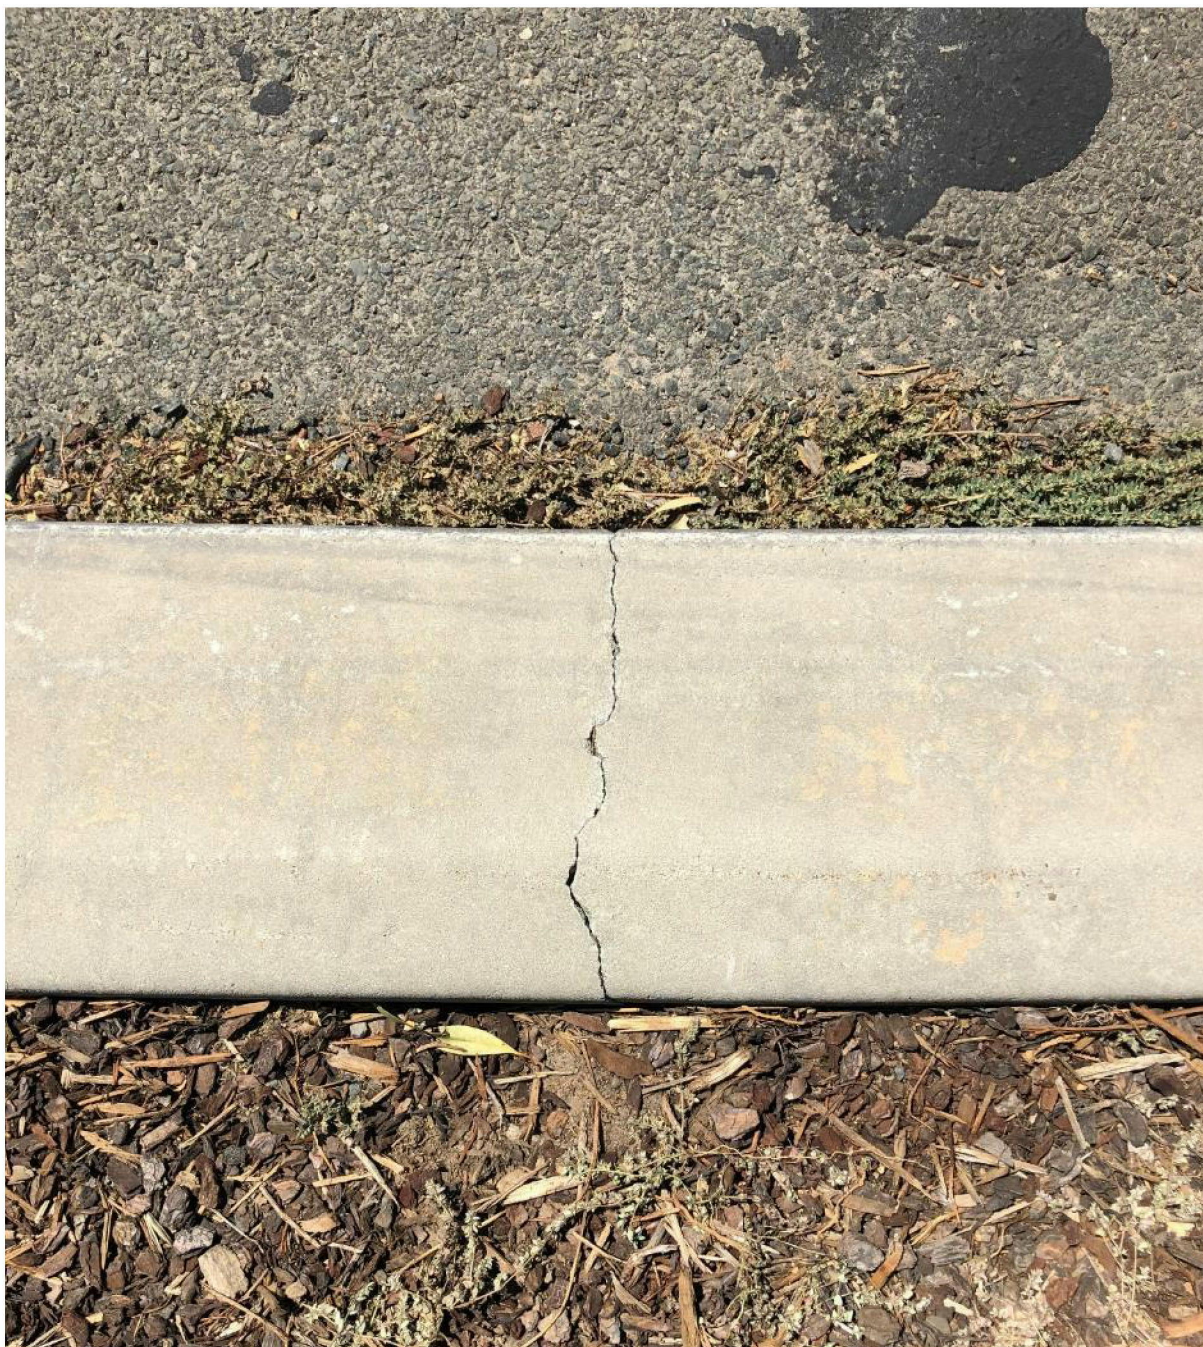
*Figure 10: cracking to median strip, adjacent to construction joint.*

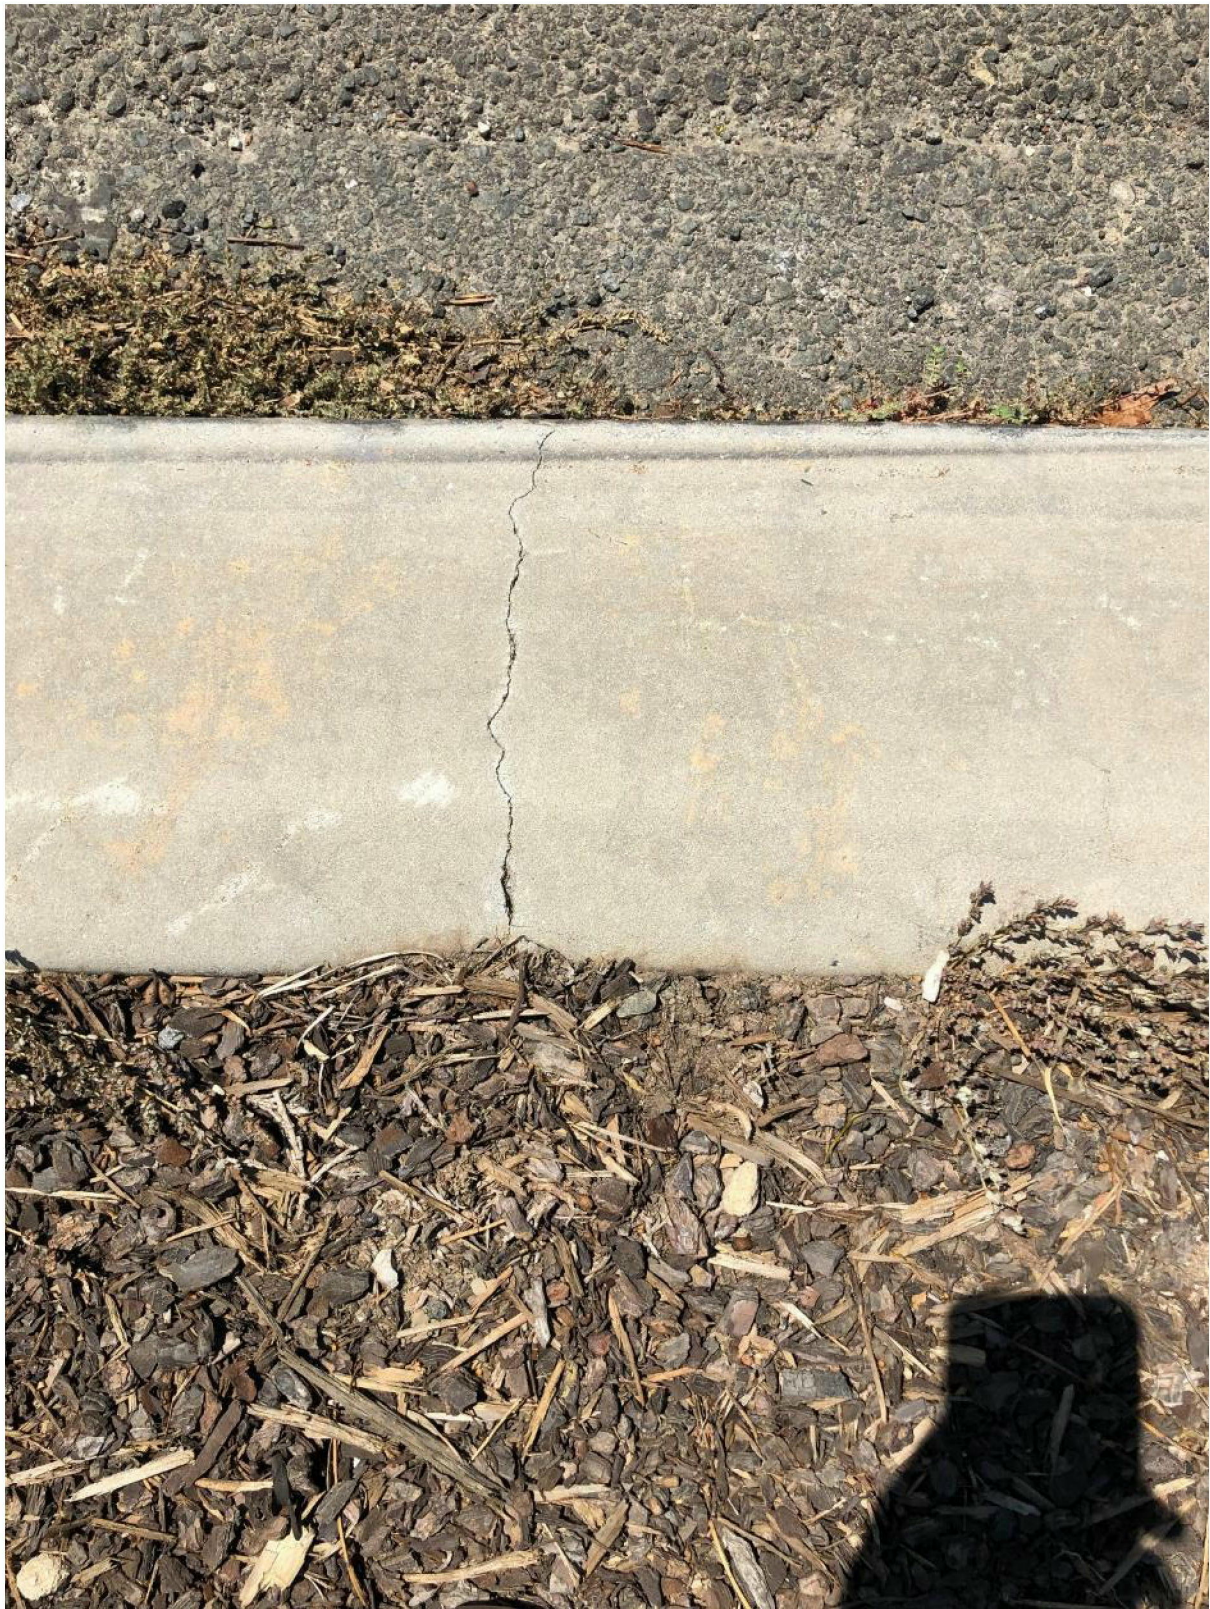
*Figure 11: cracking to median strip kerb.*

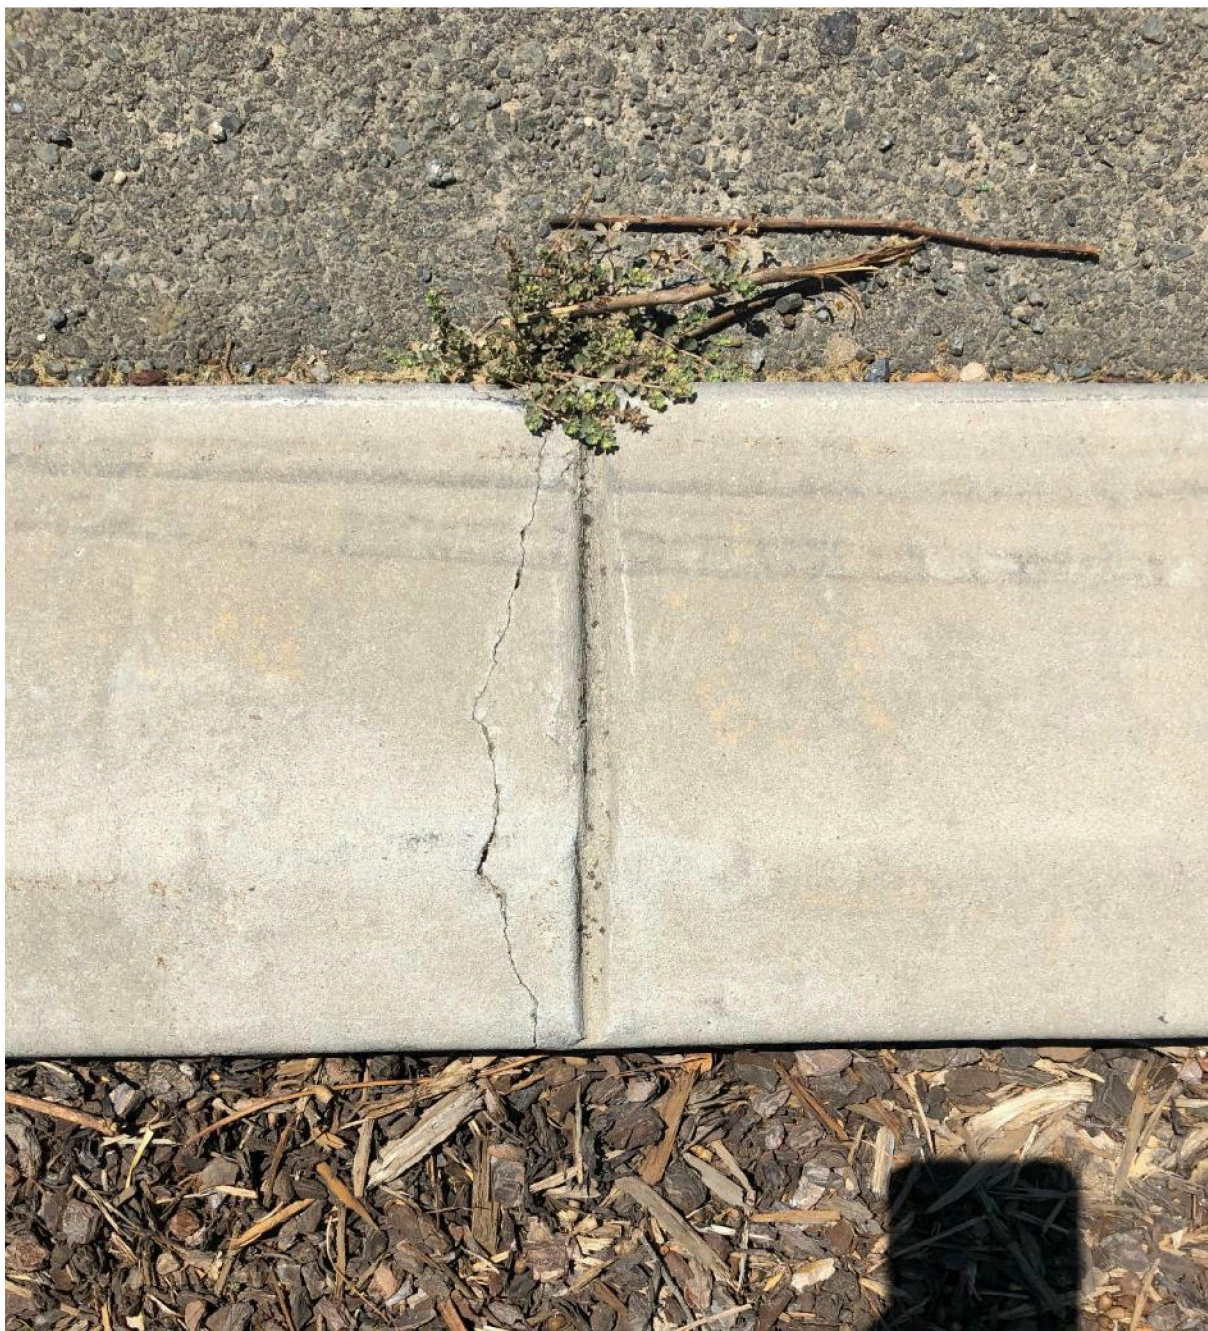
*Figure 12: cracking to median strip kerb.*

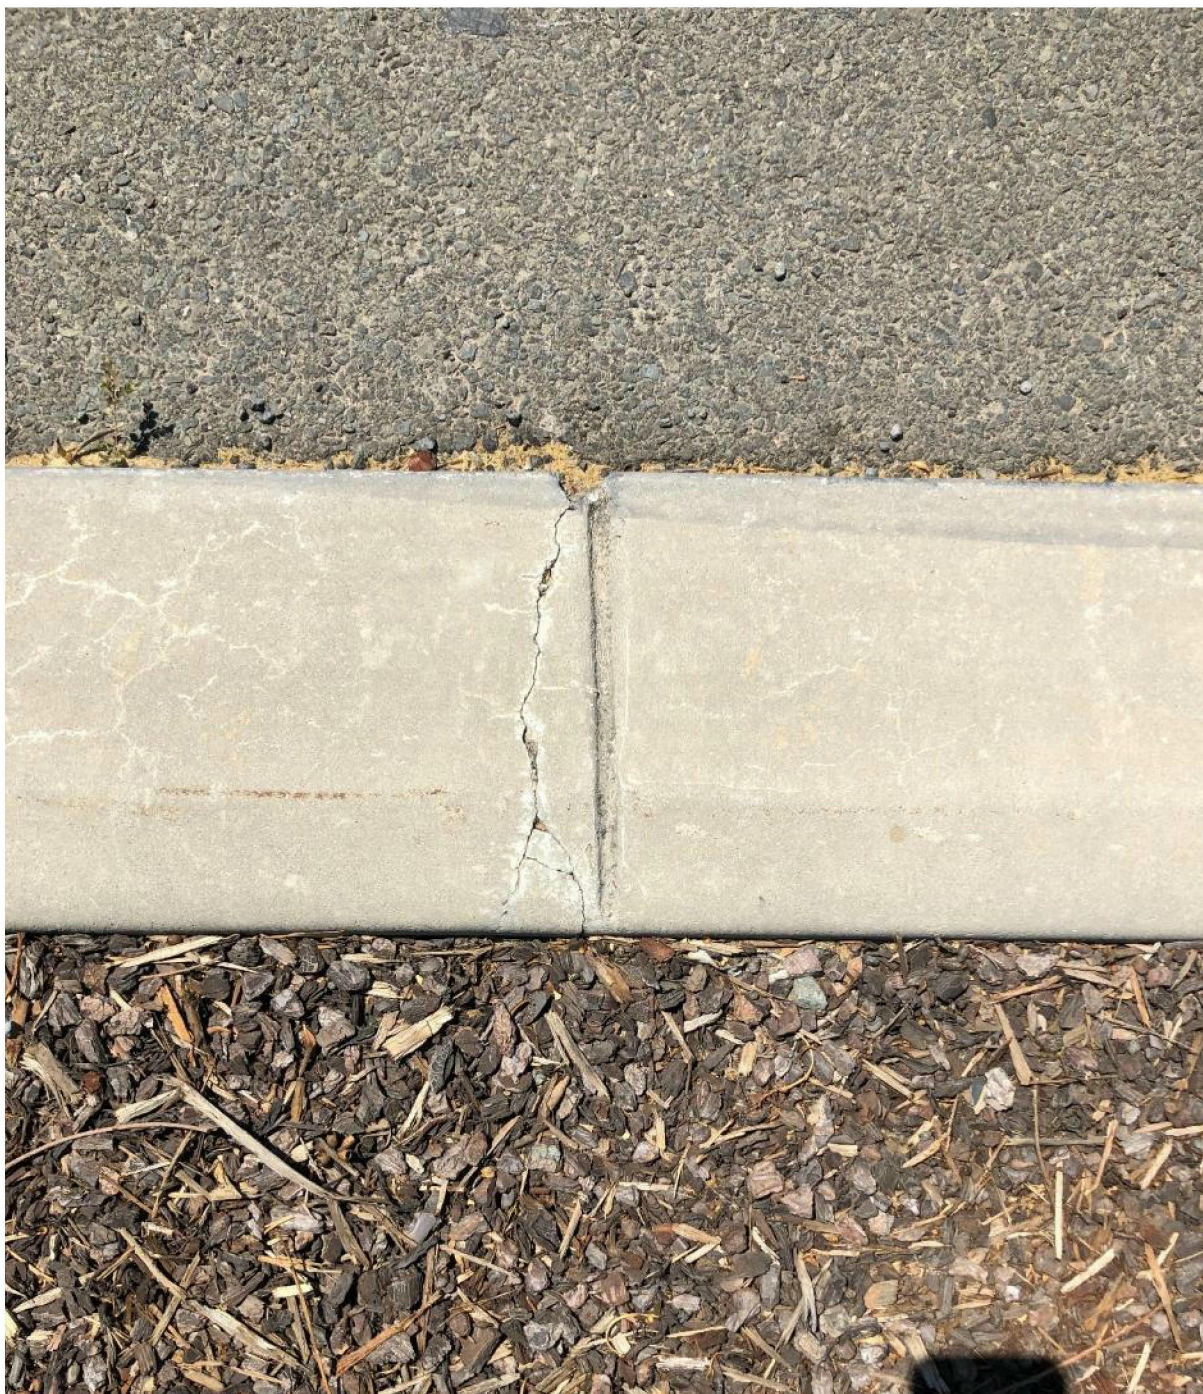
*Figure 13: cracking to median strip kerb.*
