# Dilapidation Report

Proposed Works - Jordan Springs Stage 2 Retirement Living

James Sae Siew  
5<sup>th</sup> March 2019  
Revision 1

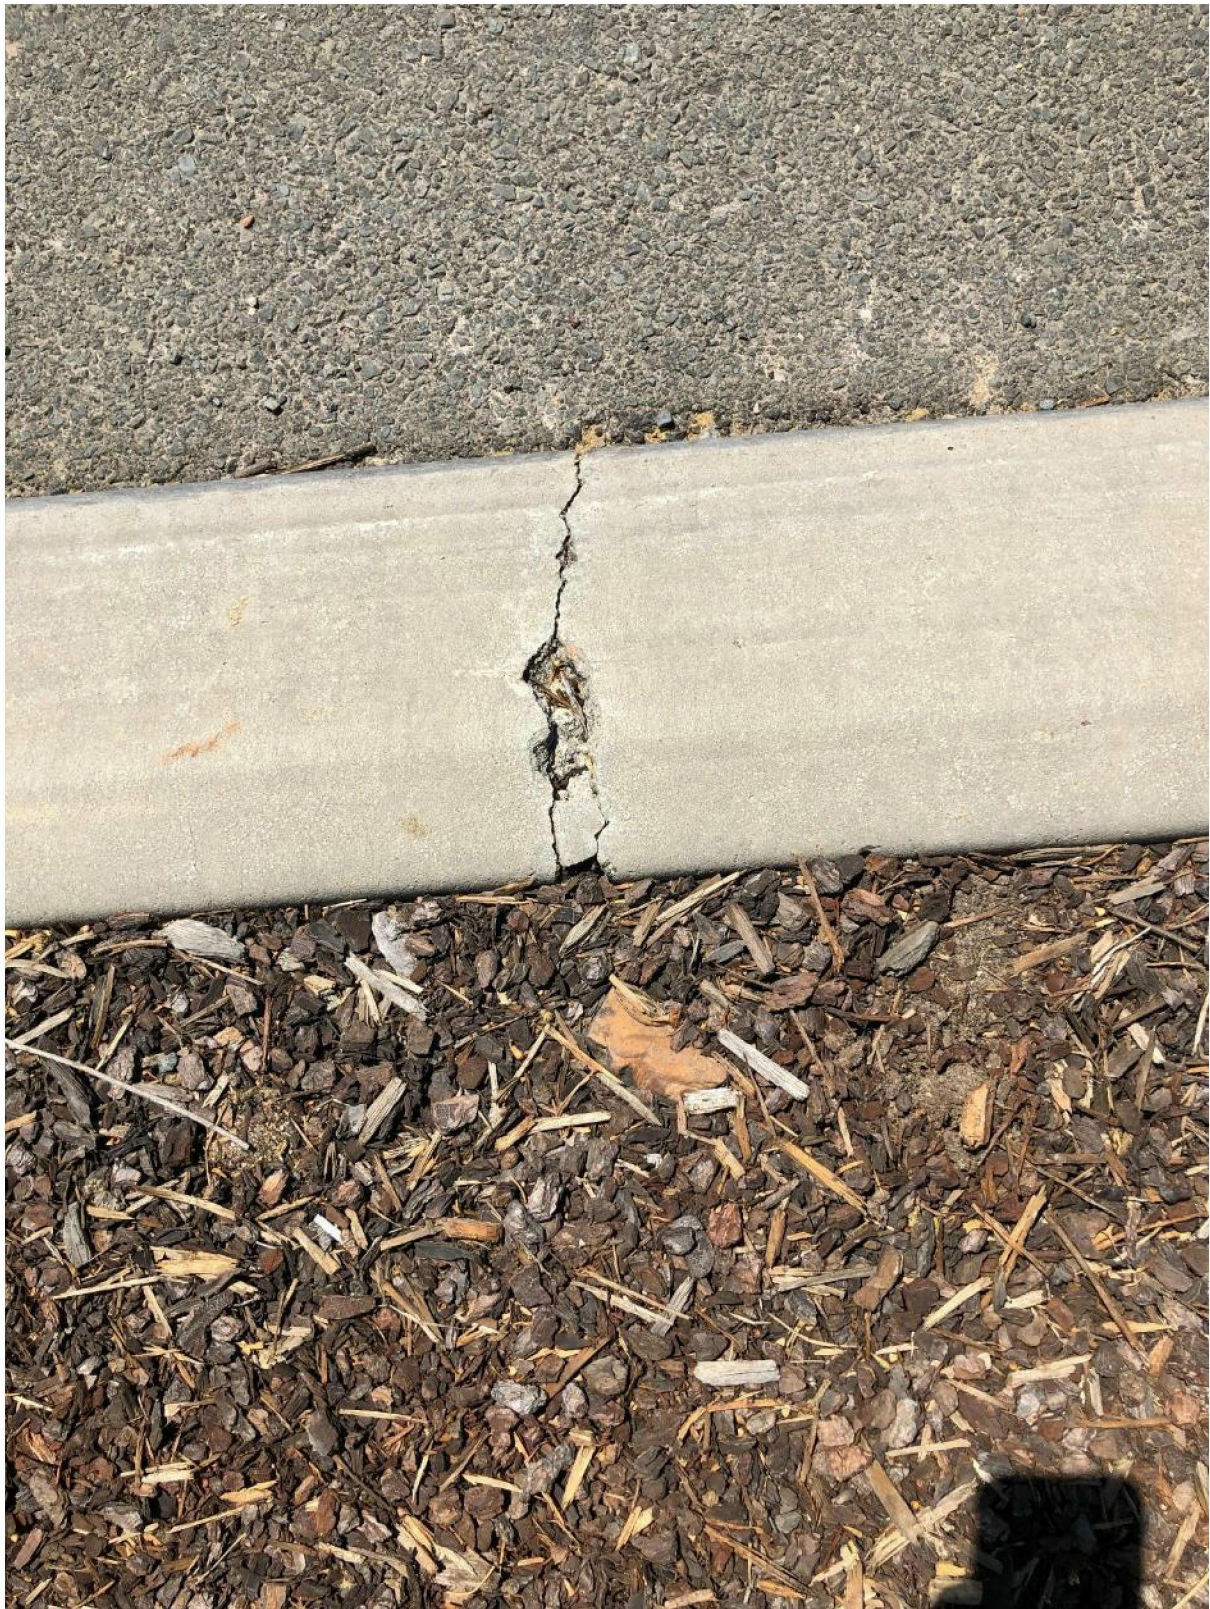
*Figure 14: cracking to median strip kerb.*

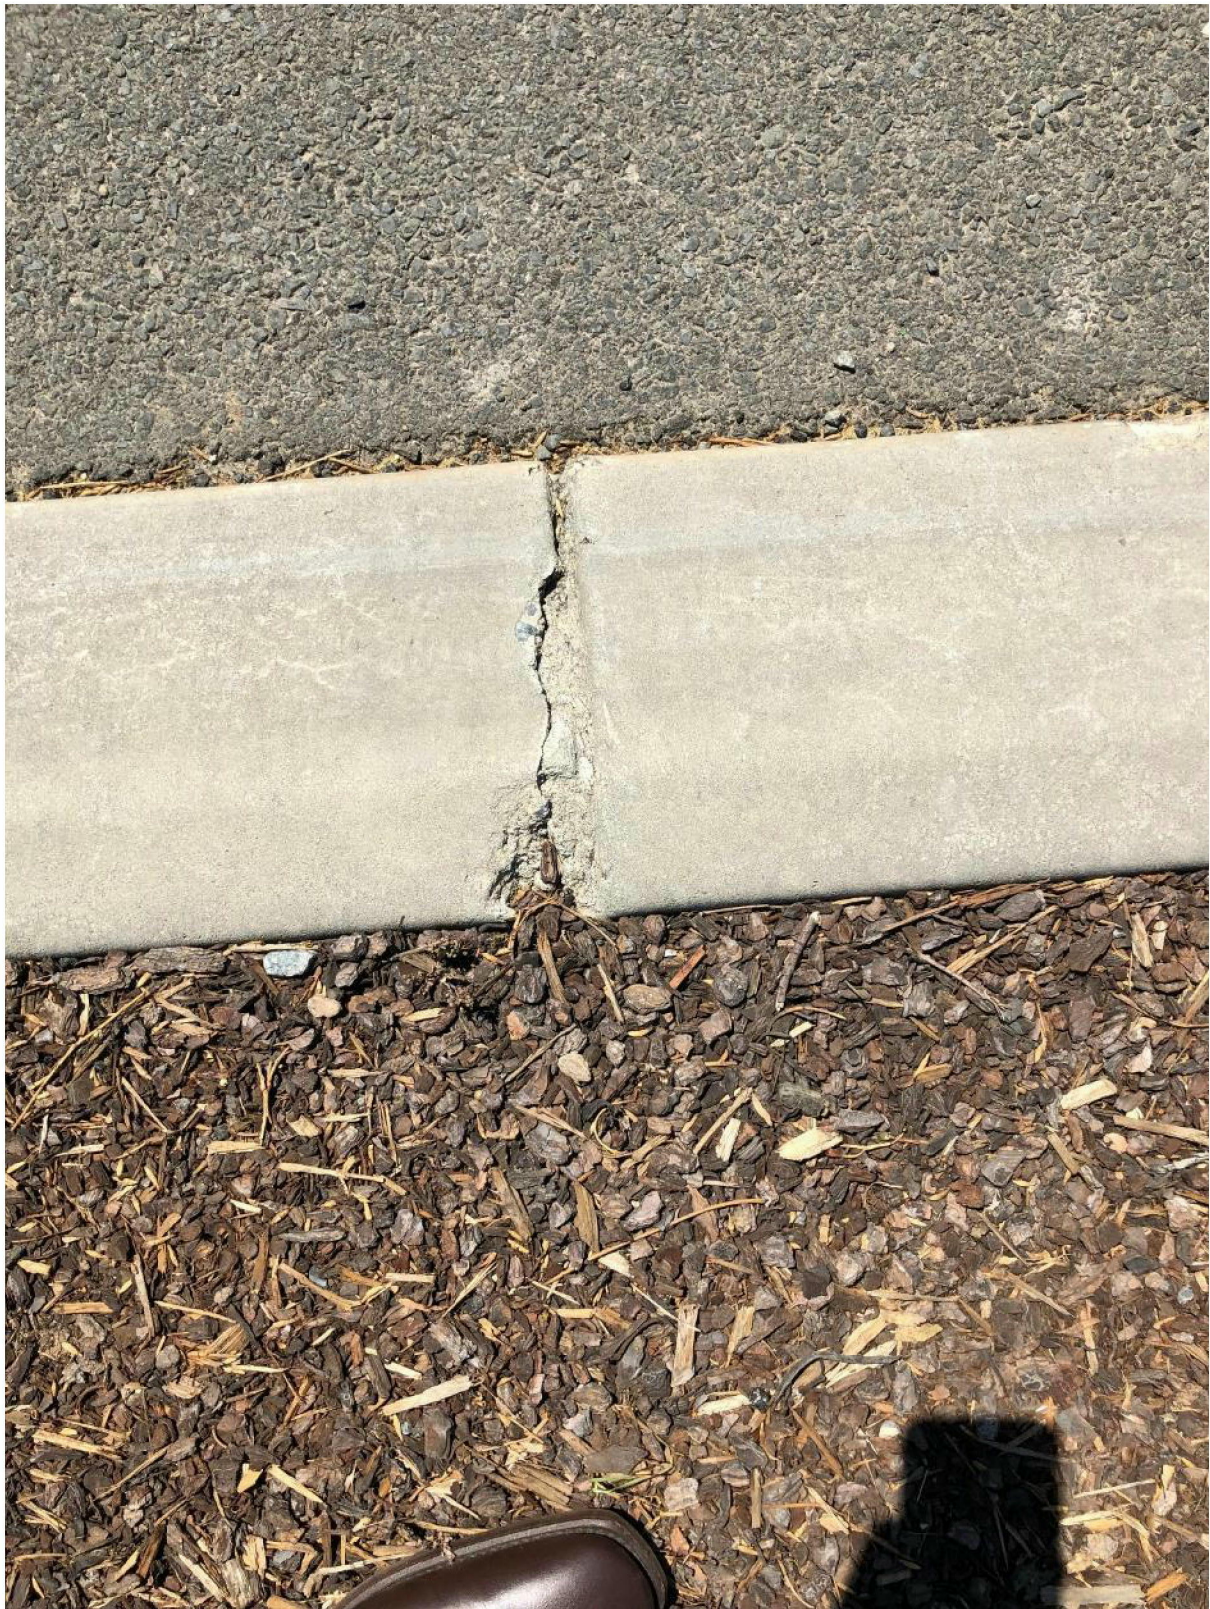
*Figure 15: cracking to median strip kerb.*

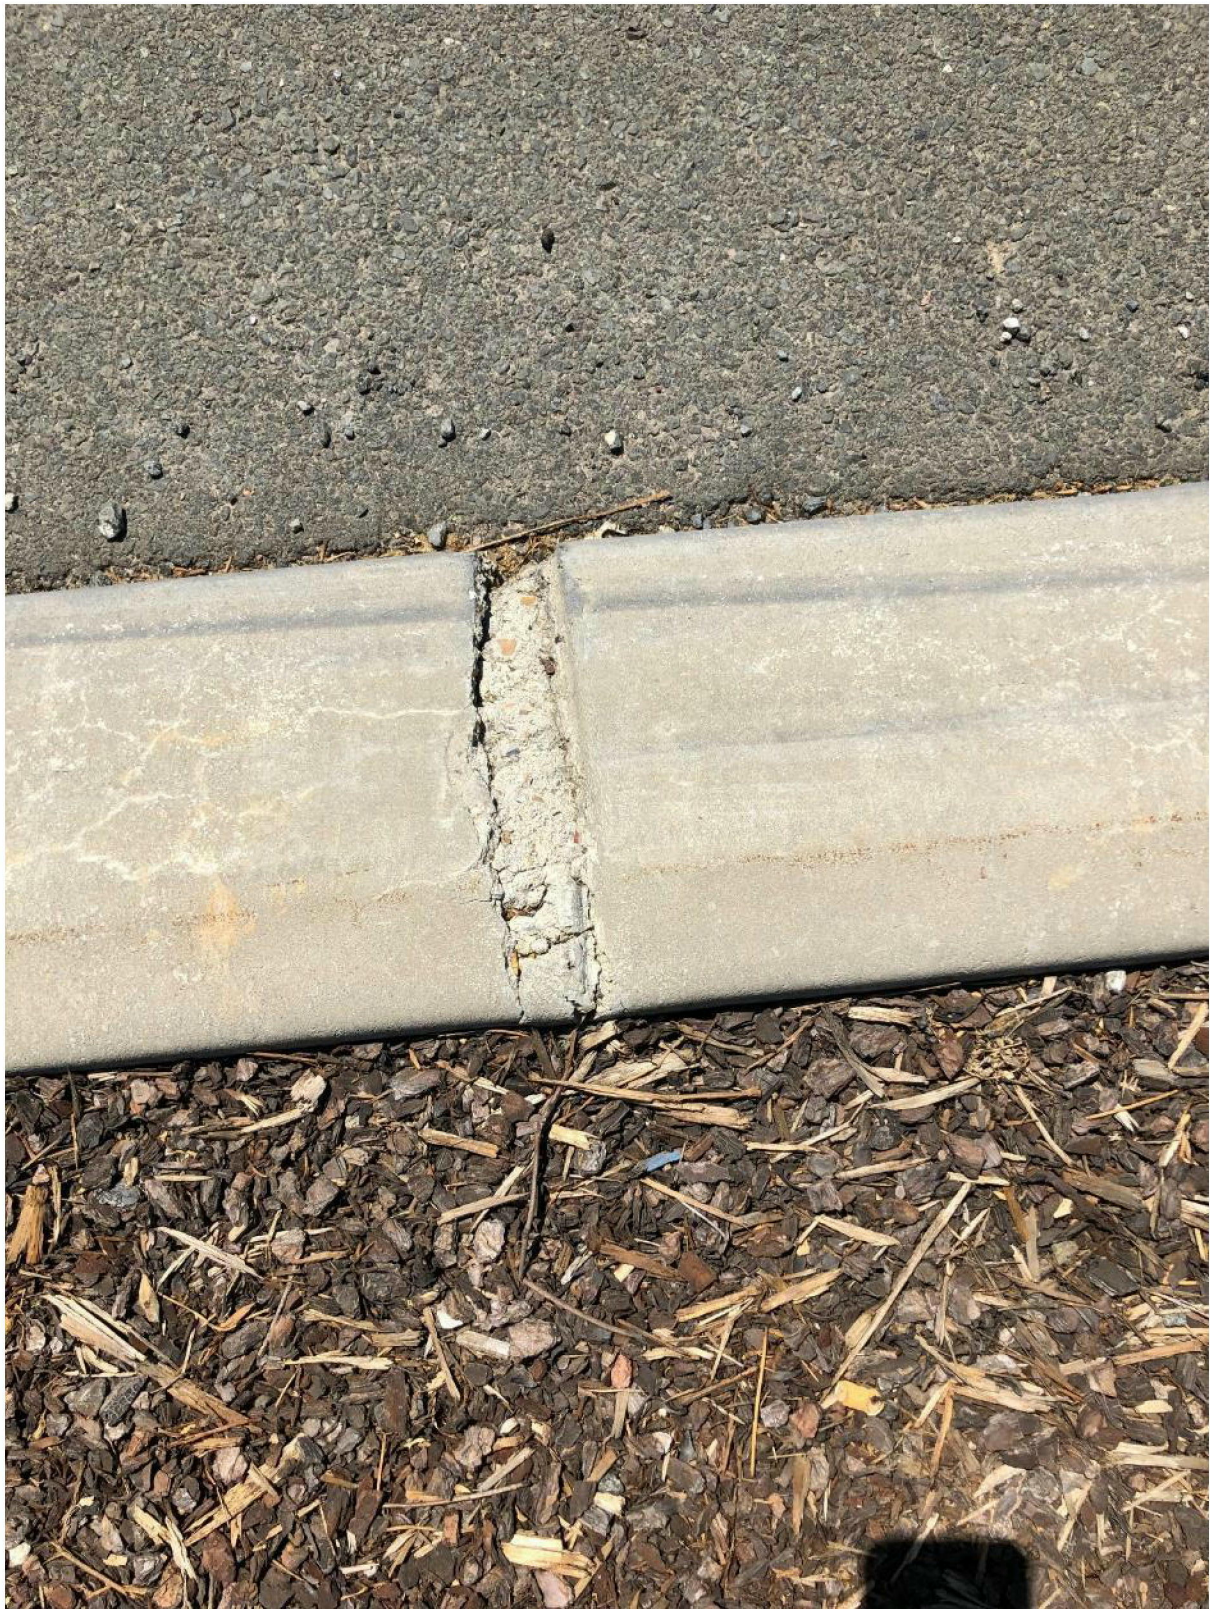
*Figure 16: cracking on construction joint interface.*

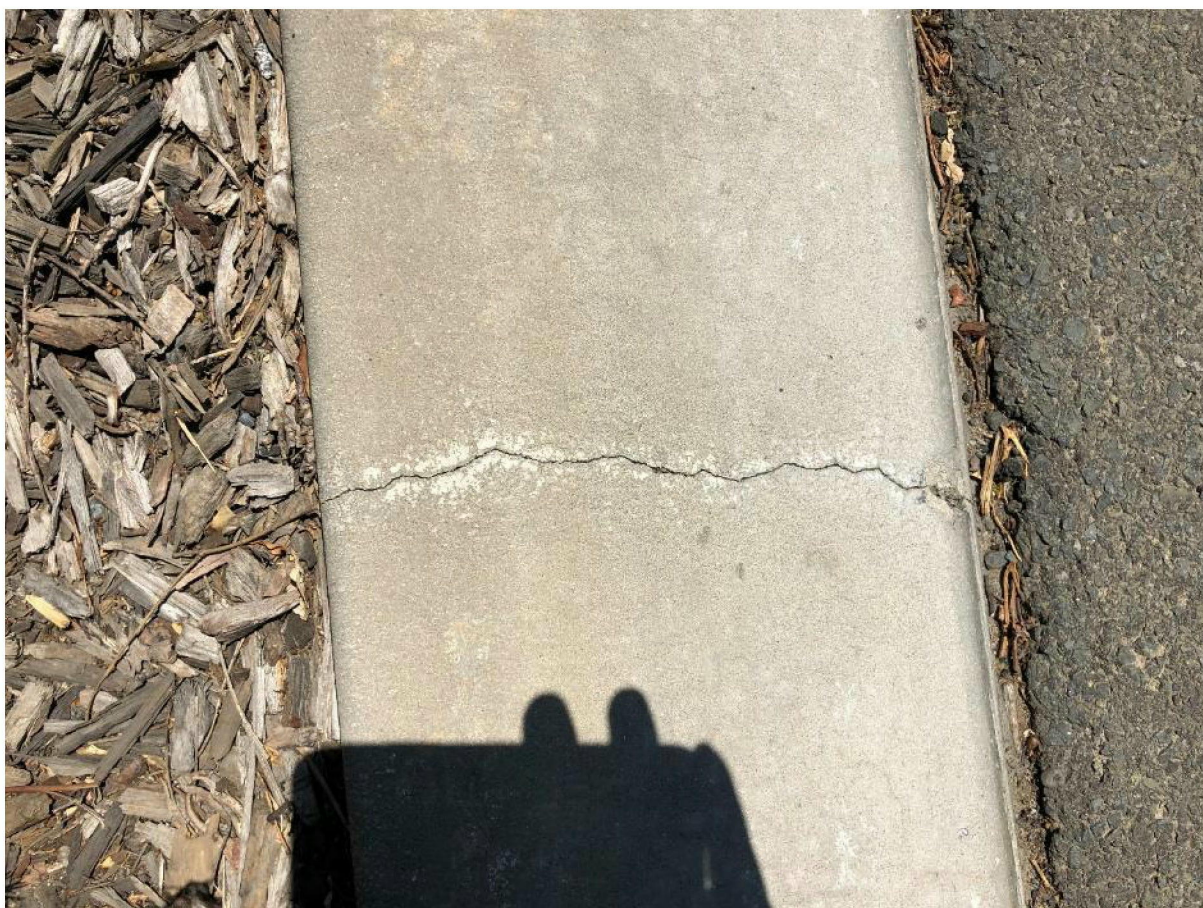
*Figure 21: cracking to median strip kerb.*

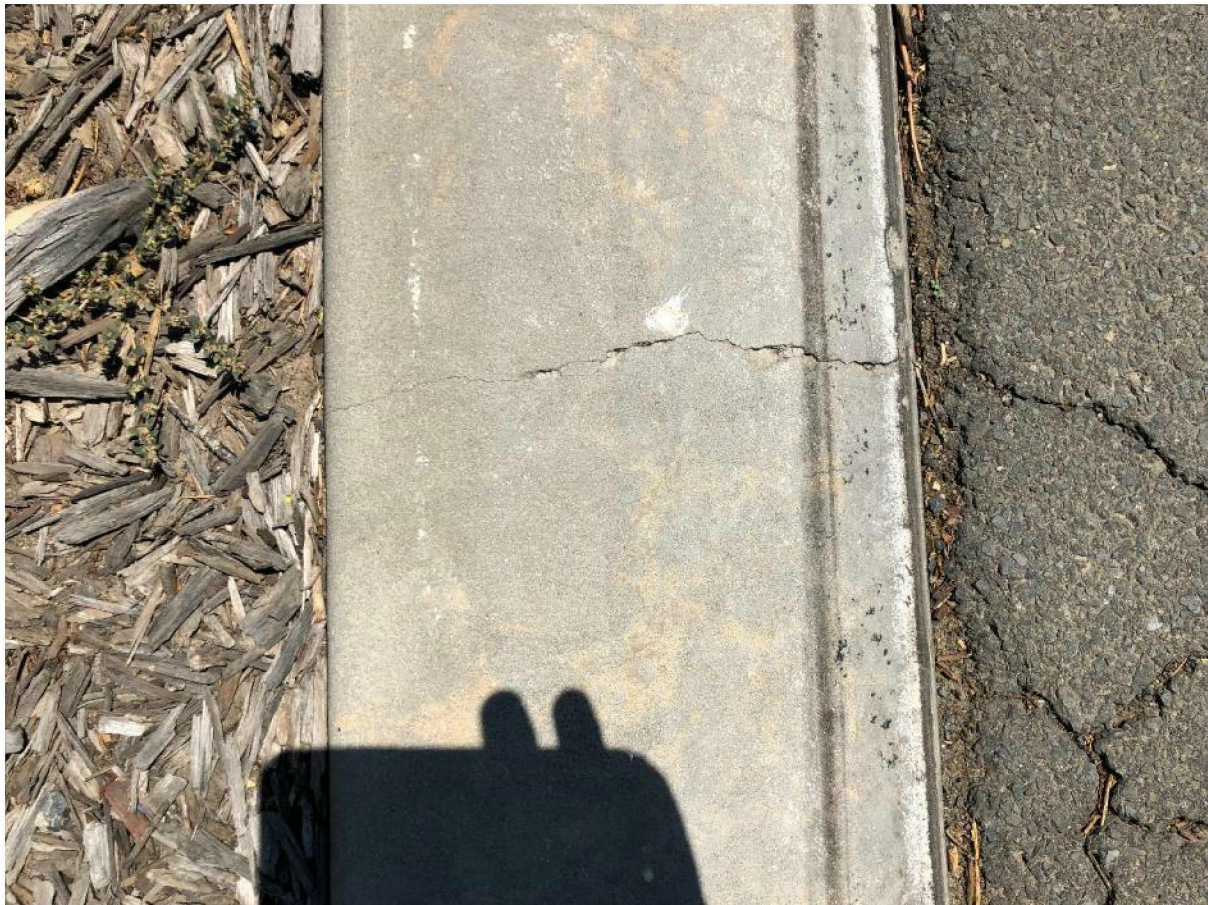
*Figure 22: cracking to median strip kerb.*

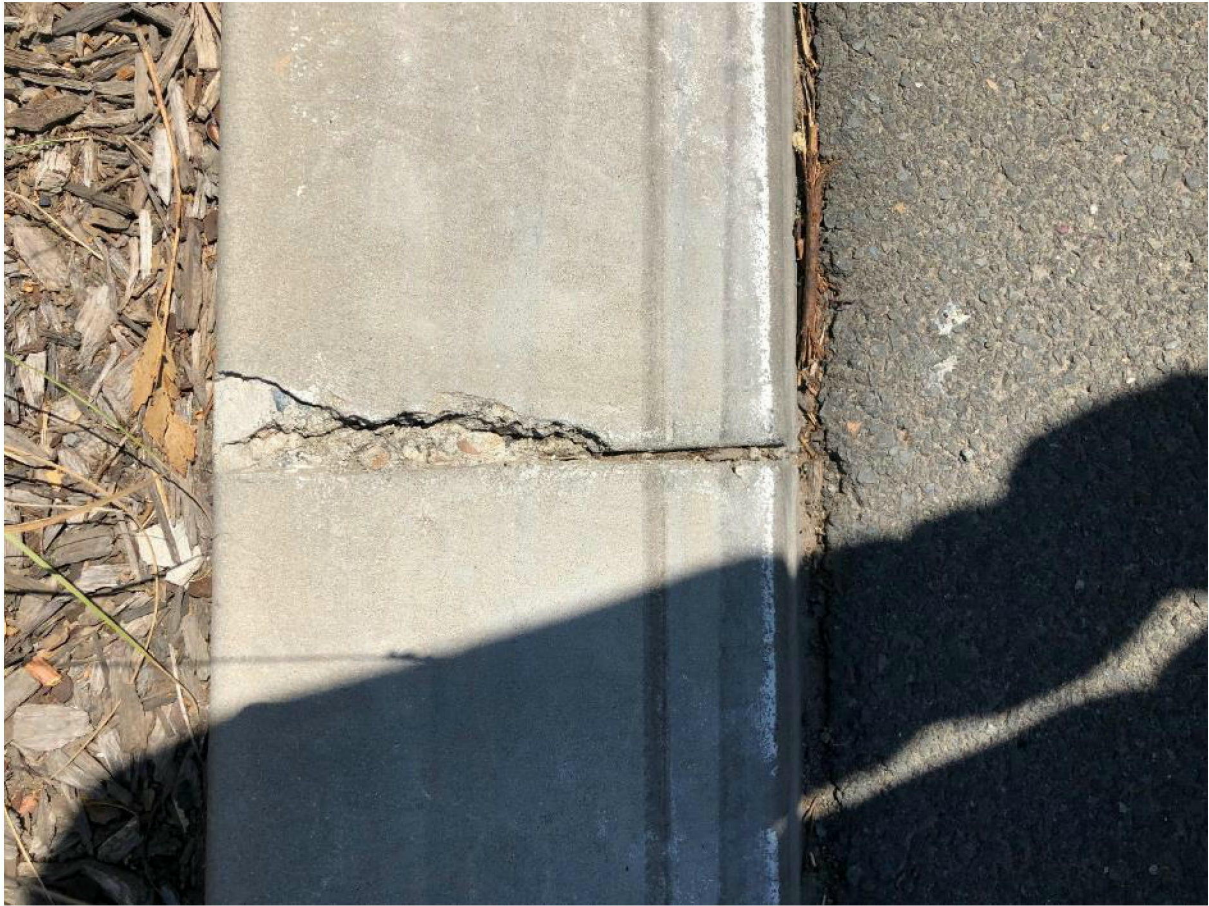
*Figure 23: spalling at construction joint interface.*

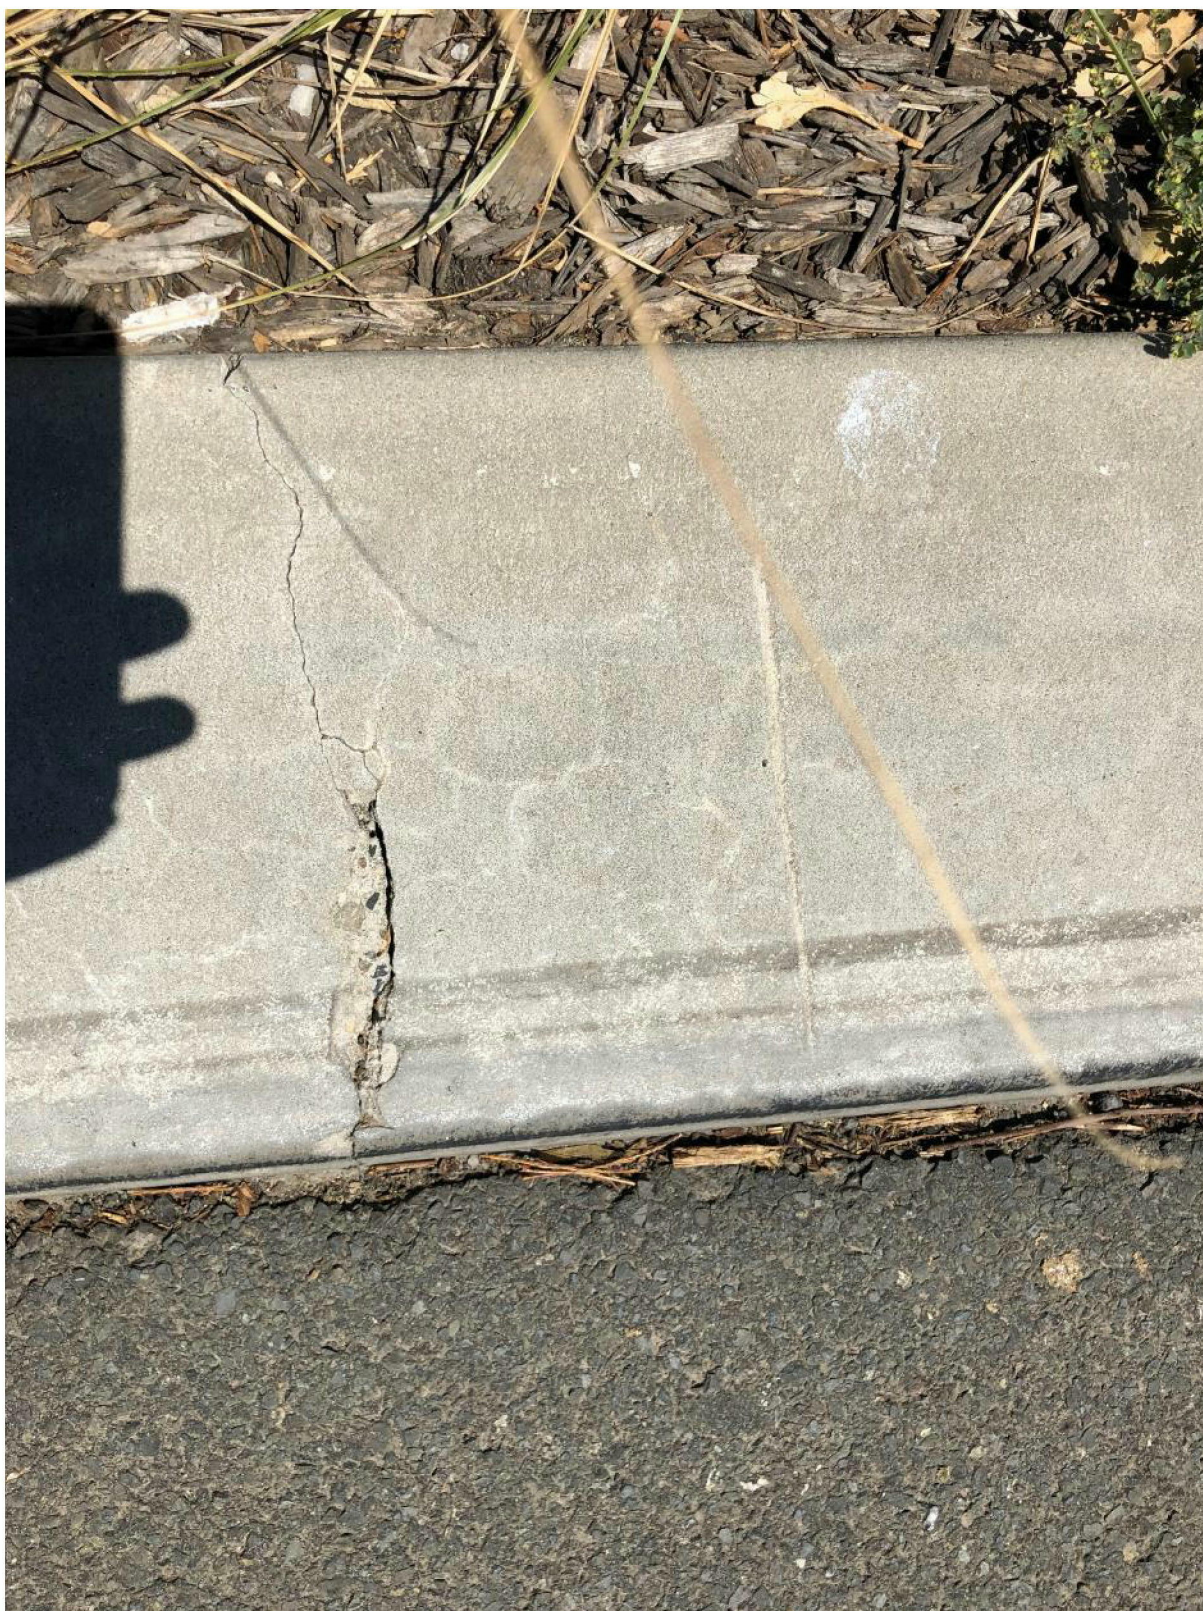
*Figure 24: cracking to median strip kerb.*

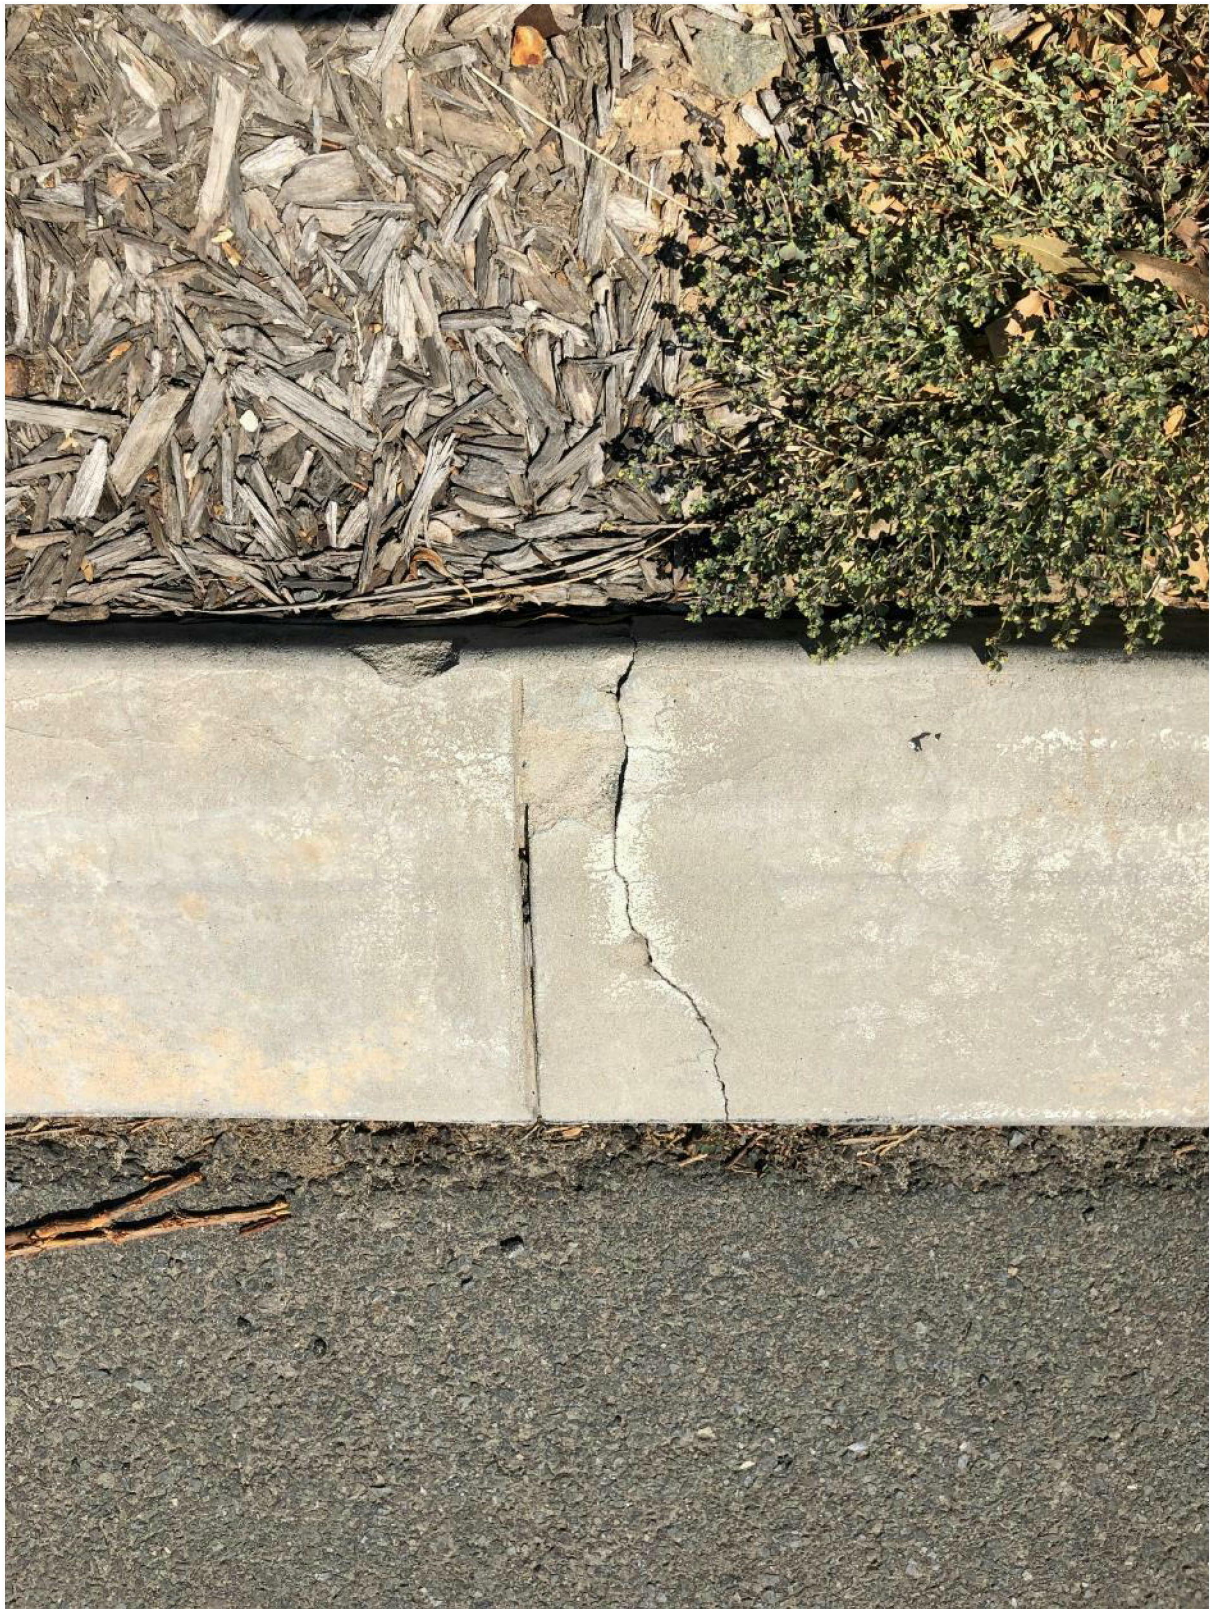
*Figure 25: cracking to median strip kerb.*

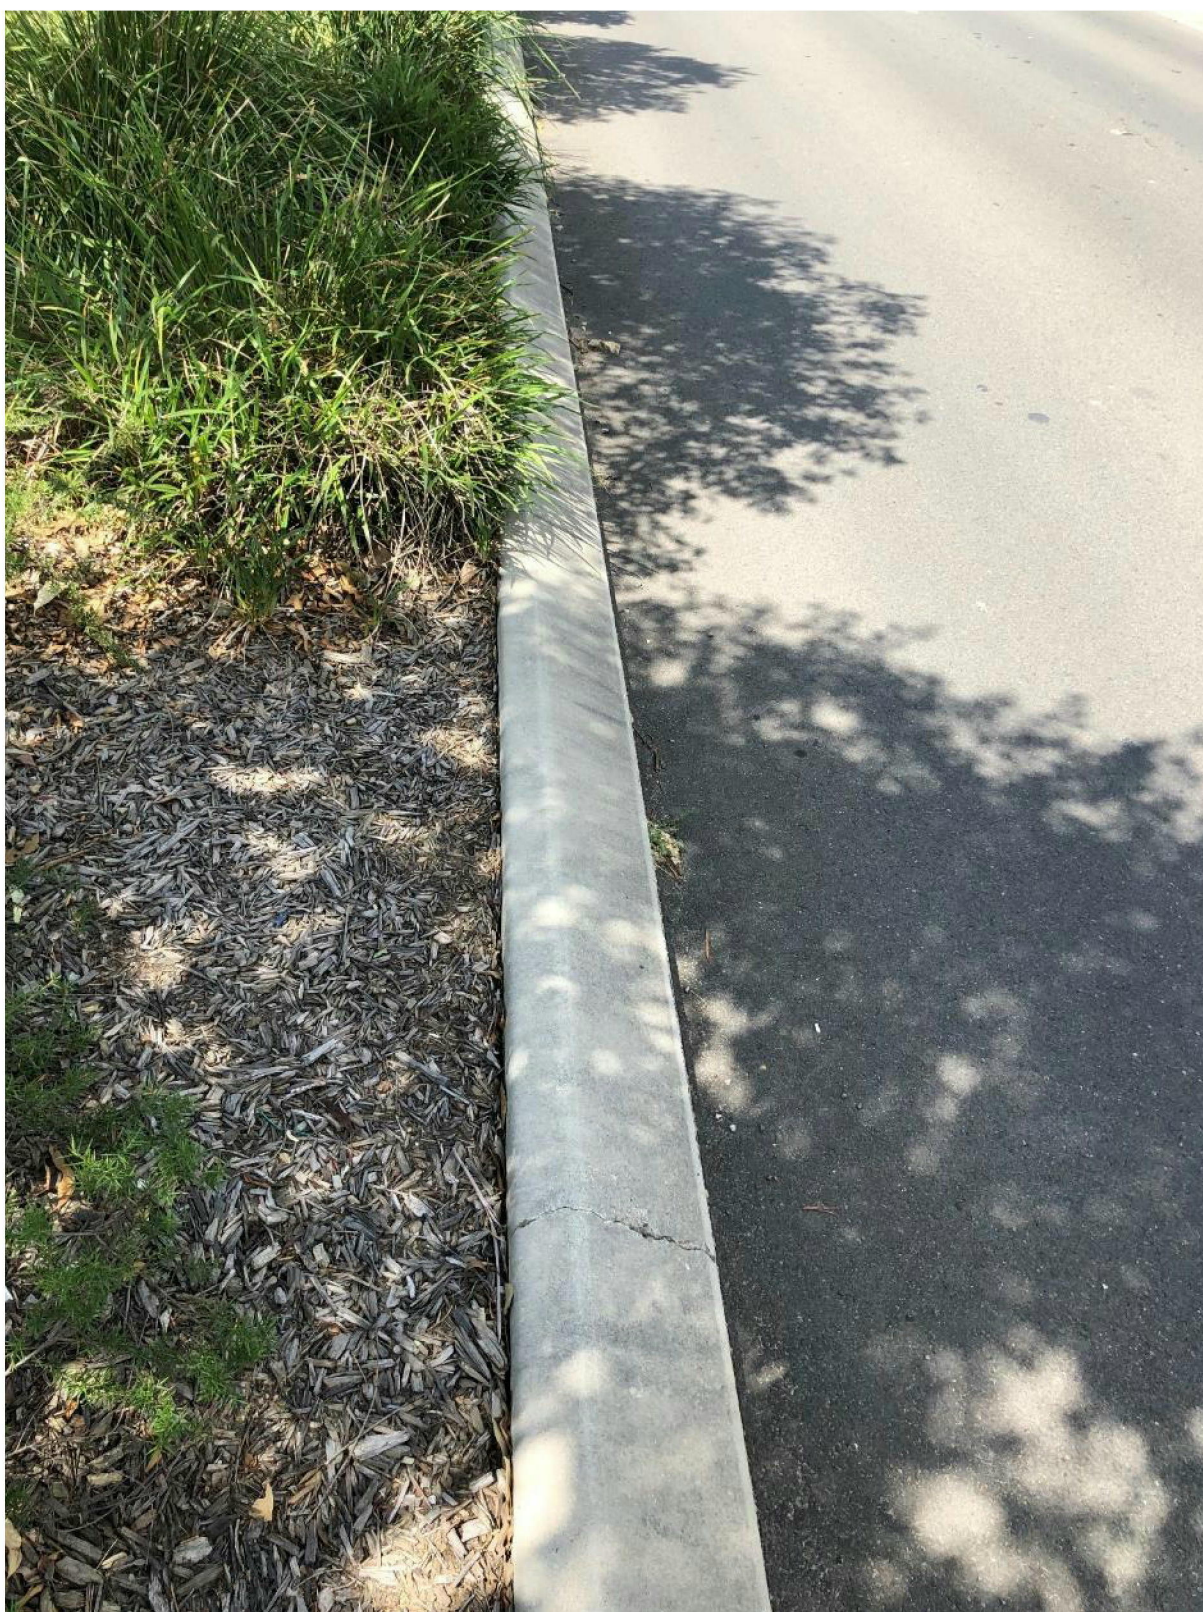
*Figure 27: cracking to median strip kerb.*

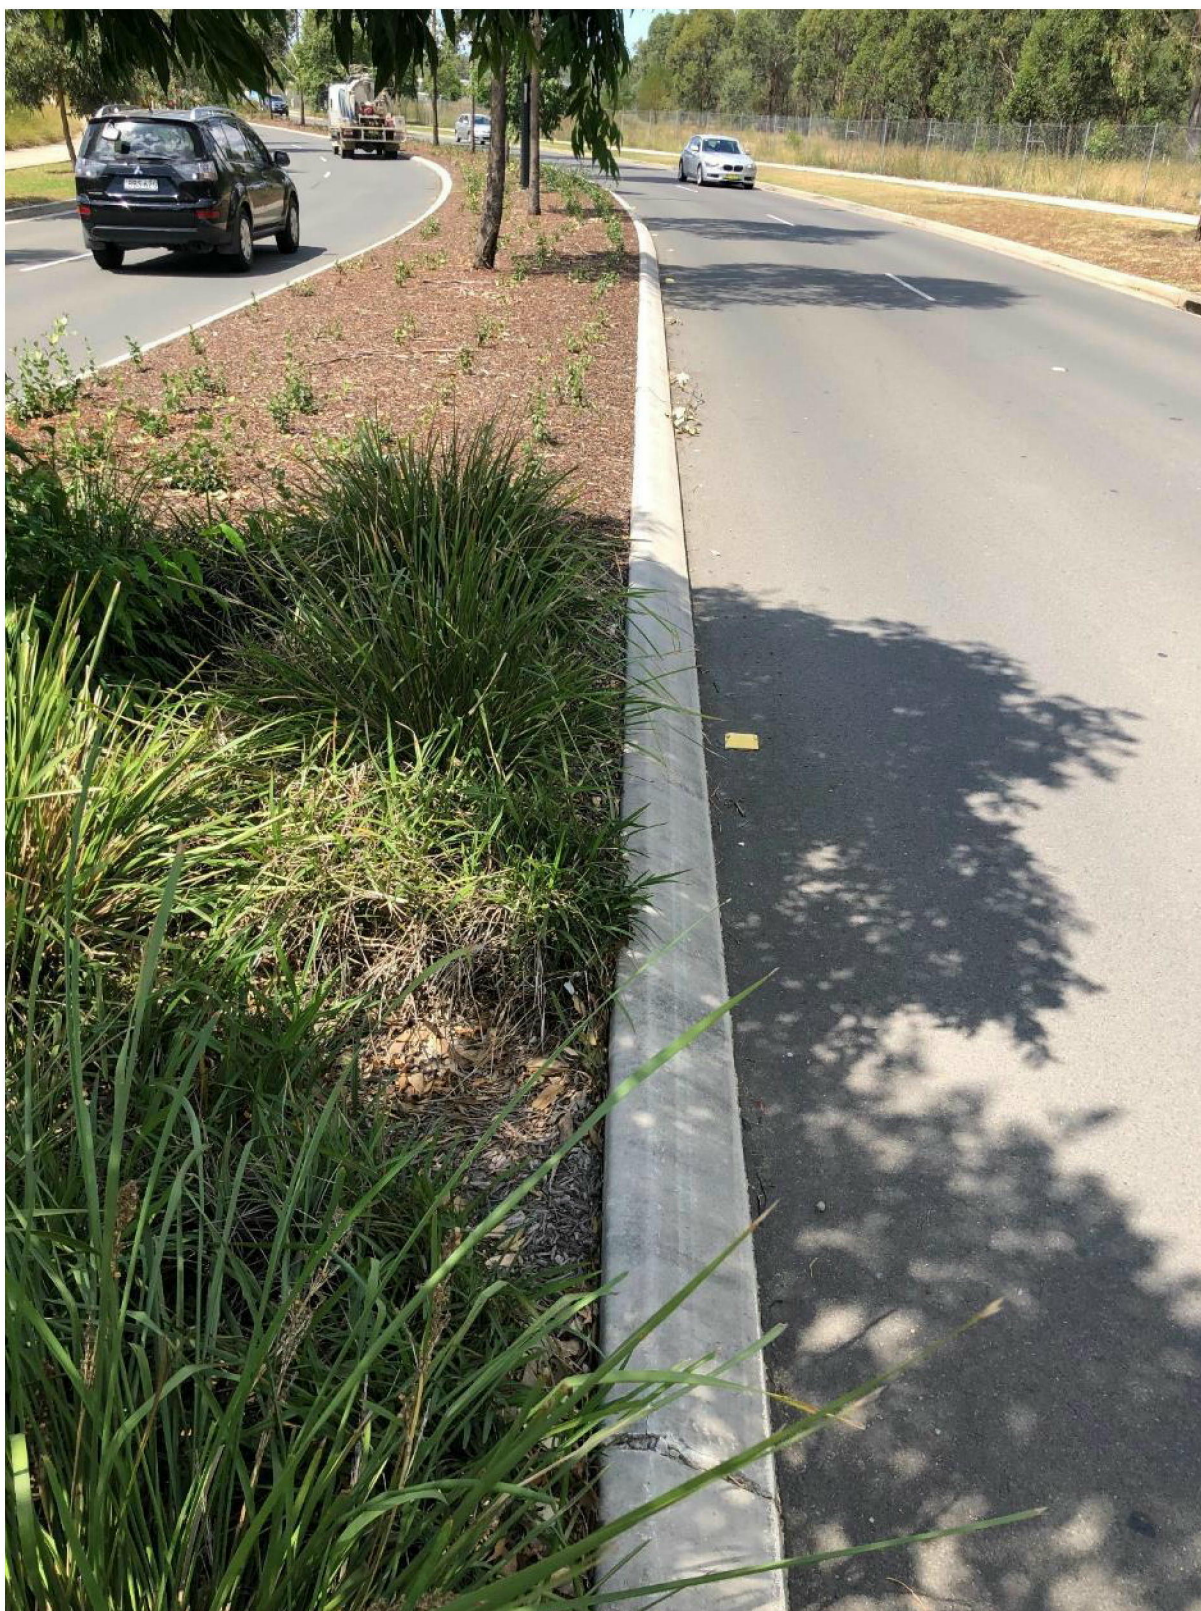
*Figure 28: damage at joint interface of median strip kerb.*

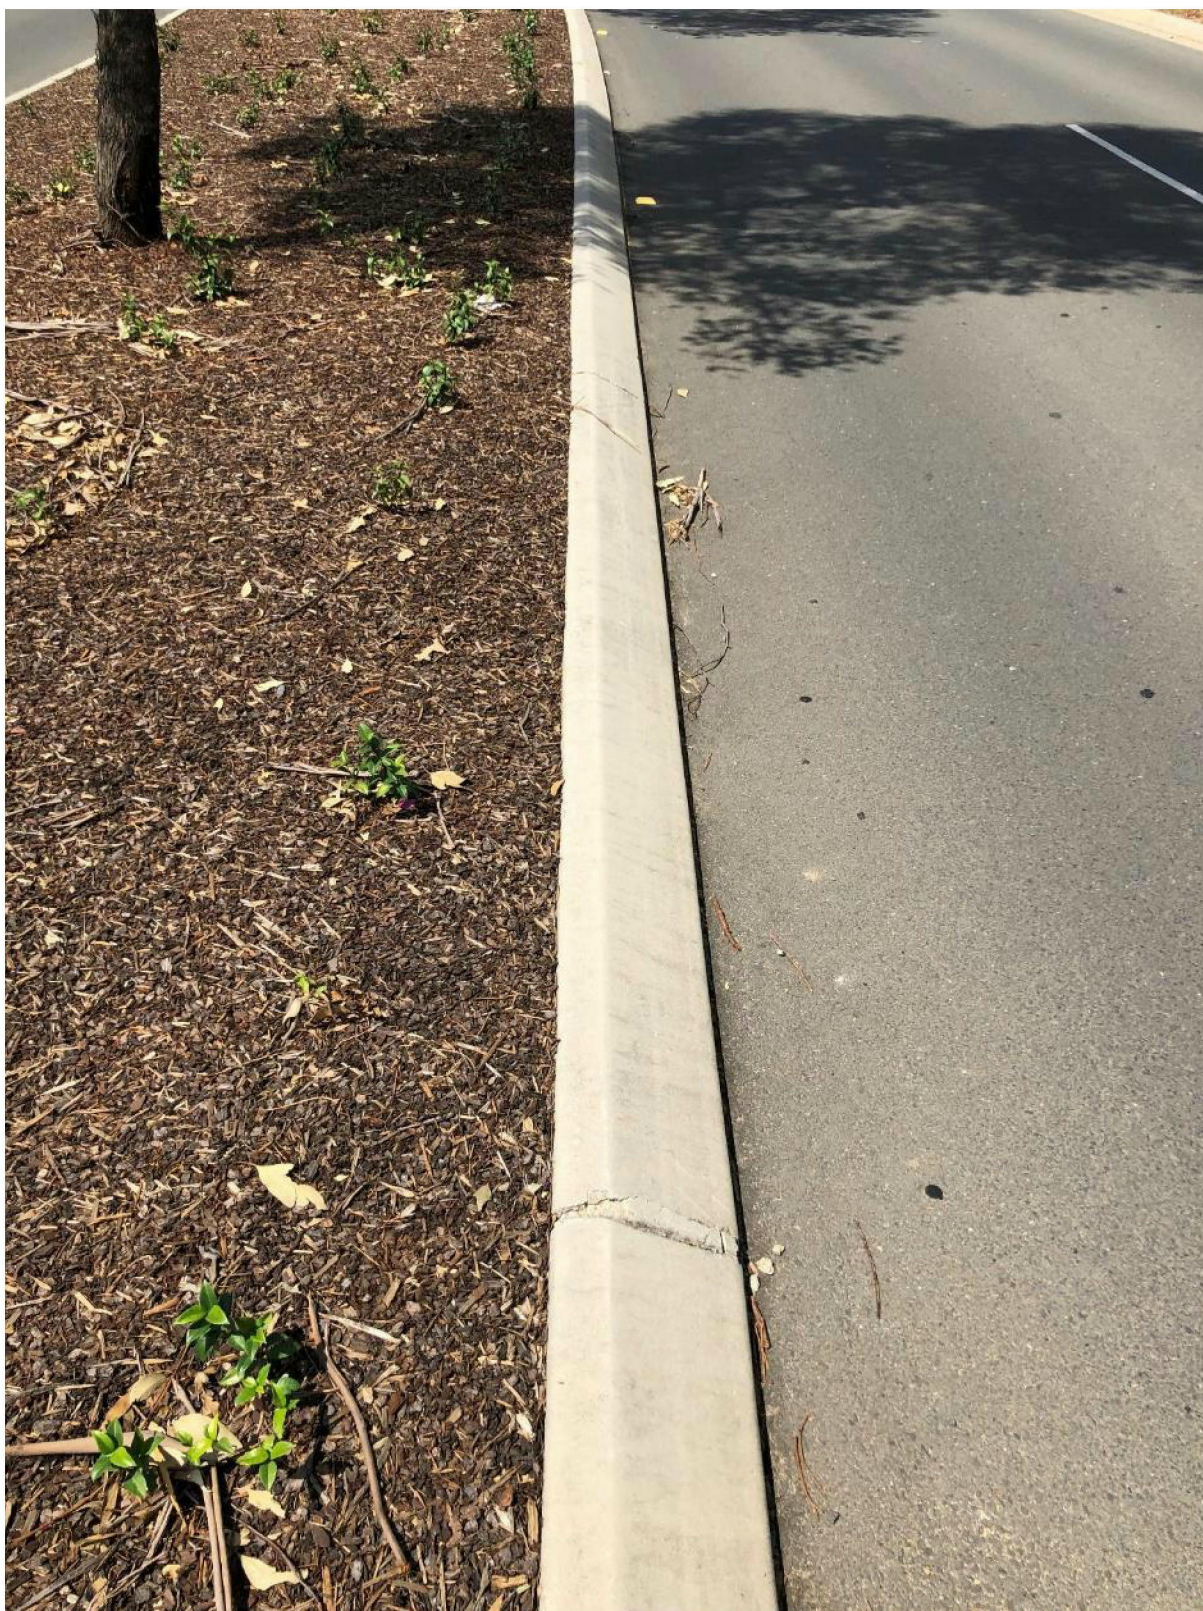
*Figure 29: cracking on median strip kerb (adjacent to construction joint).*

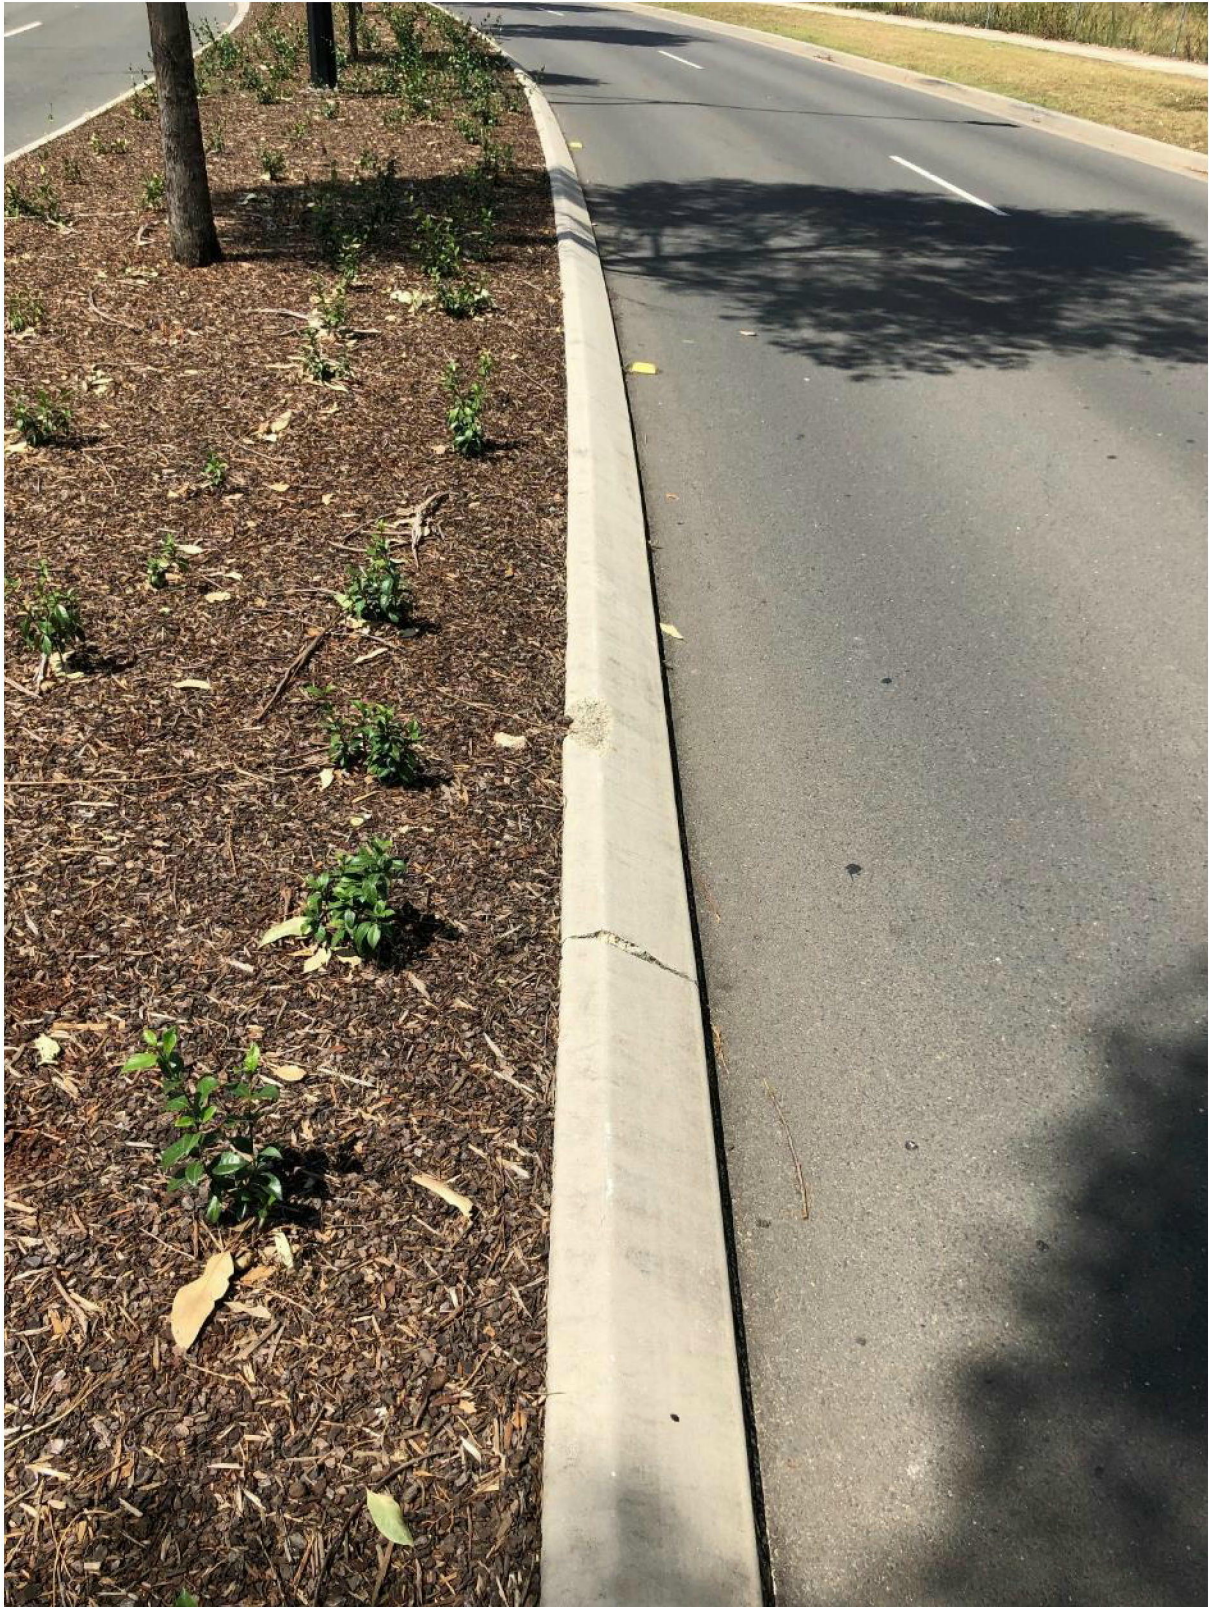
*Figure 30: damage on construction joint interface.*

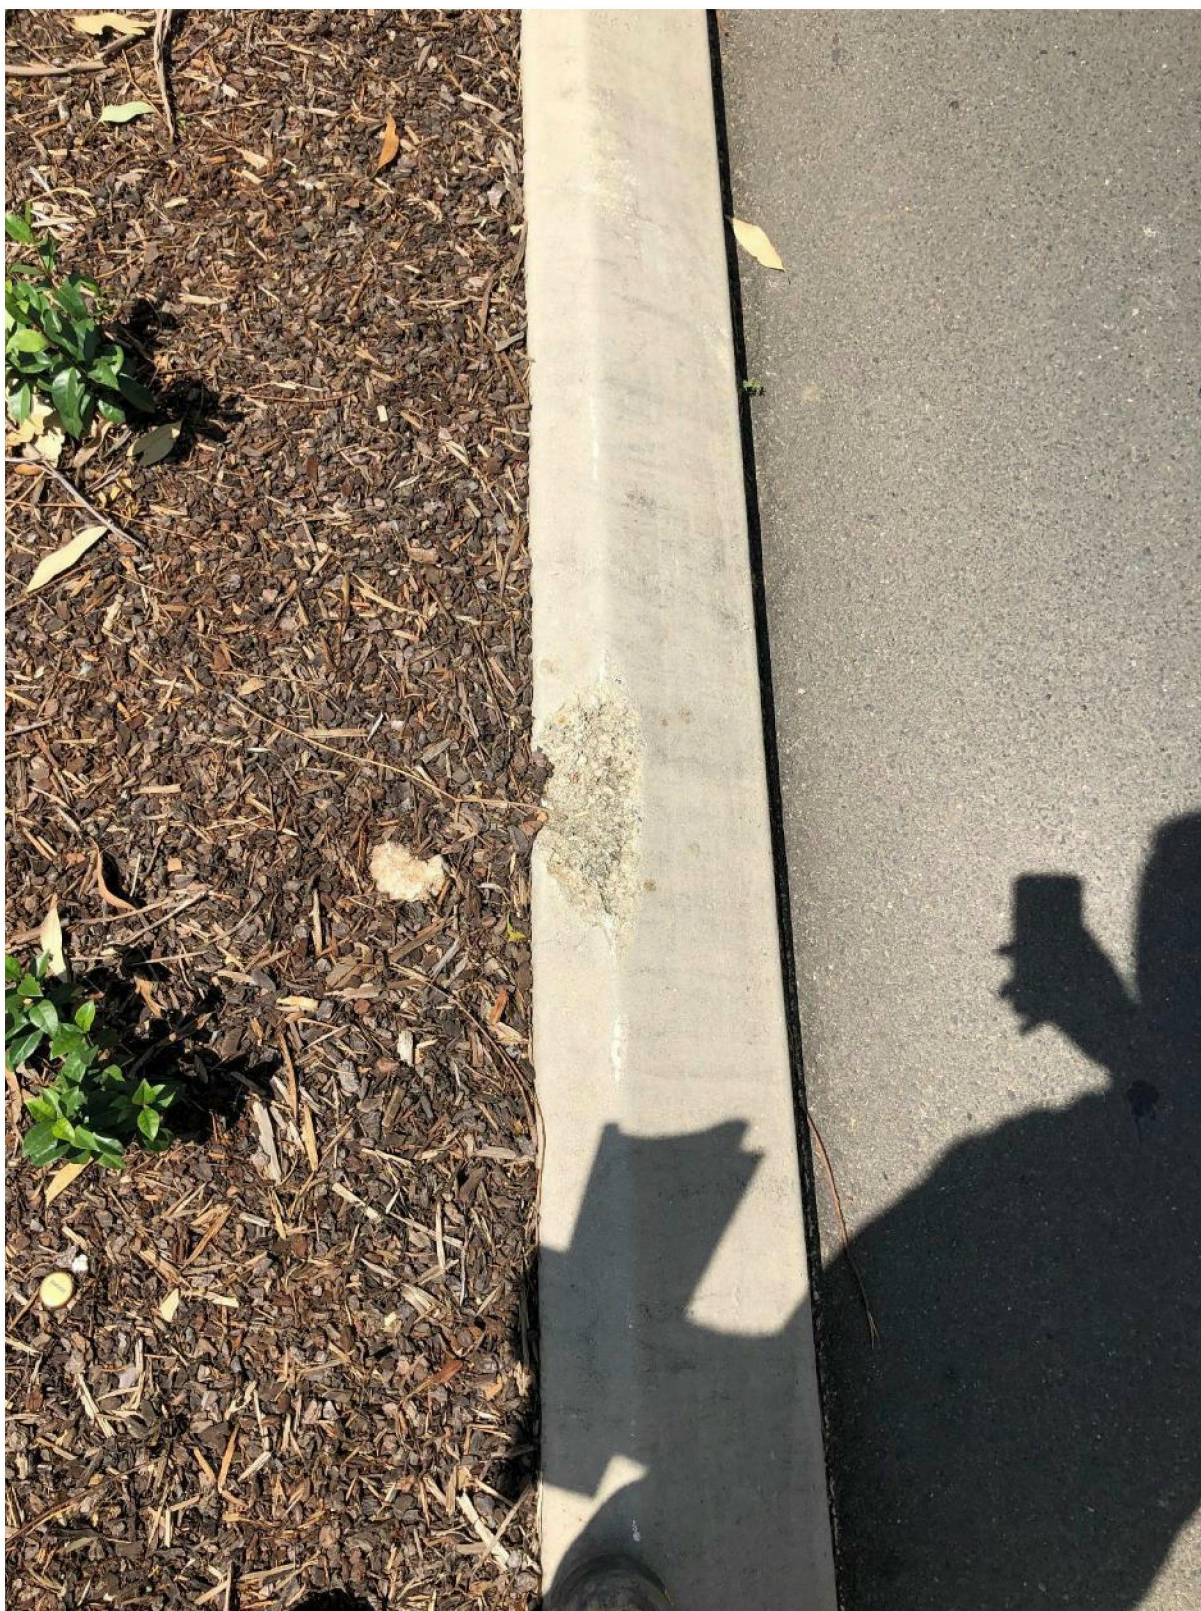
*Figure 31: chip on top of median strip kerb.*
