# Dilapidation Report

Proposed Works - Jordan Springs Stage 2 Retirement Living

James Sae Siew  
5<sup>th</sup> March 2019  
Revision 1

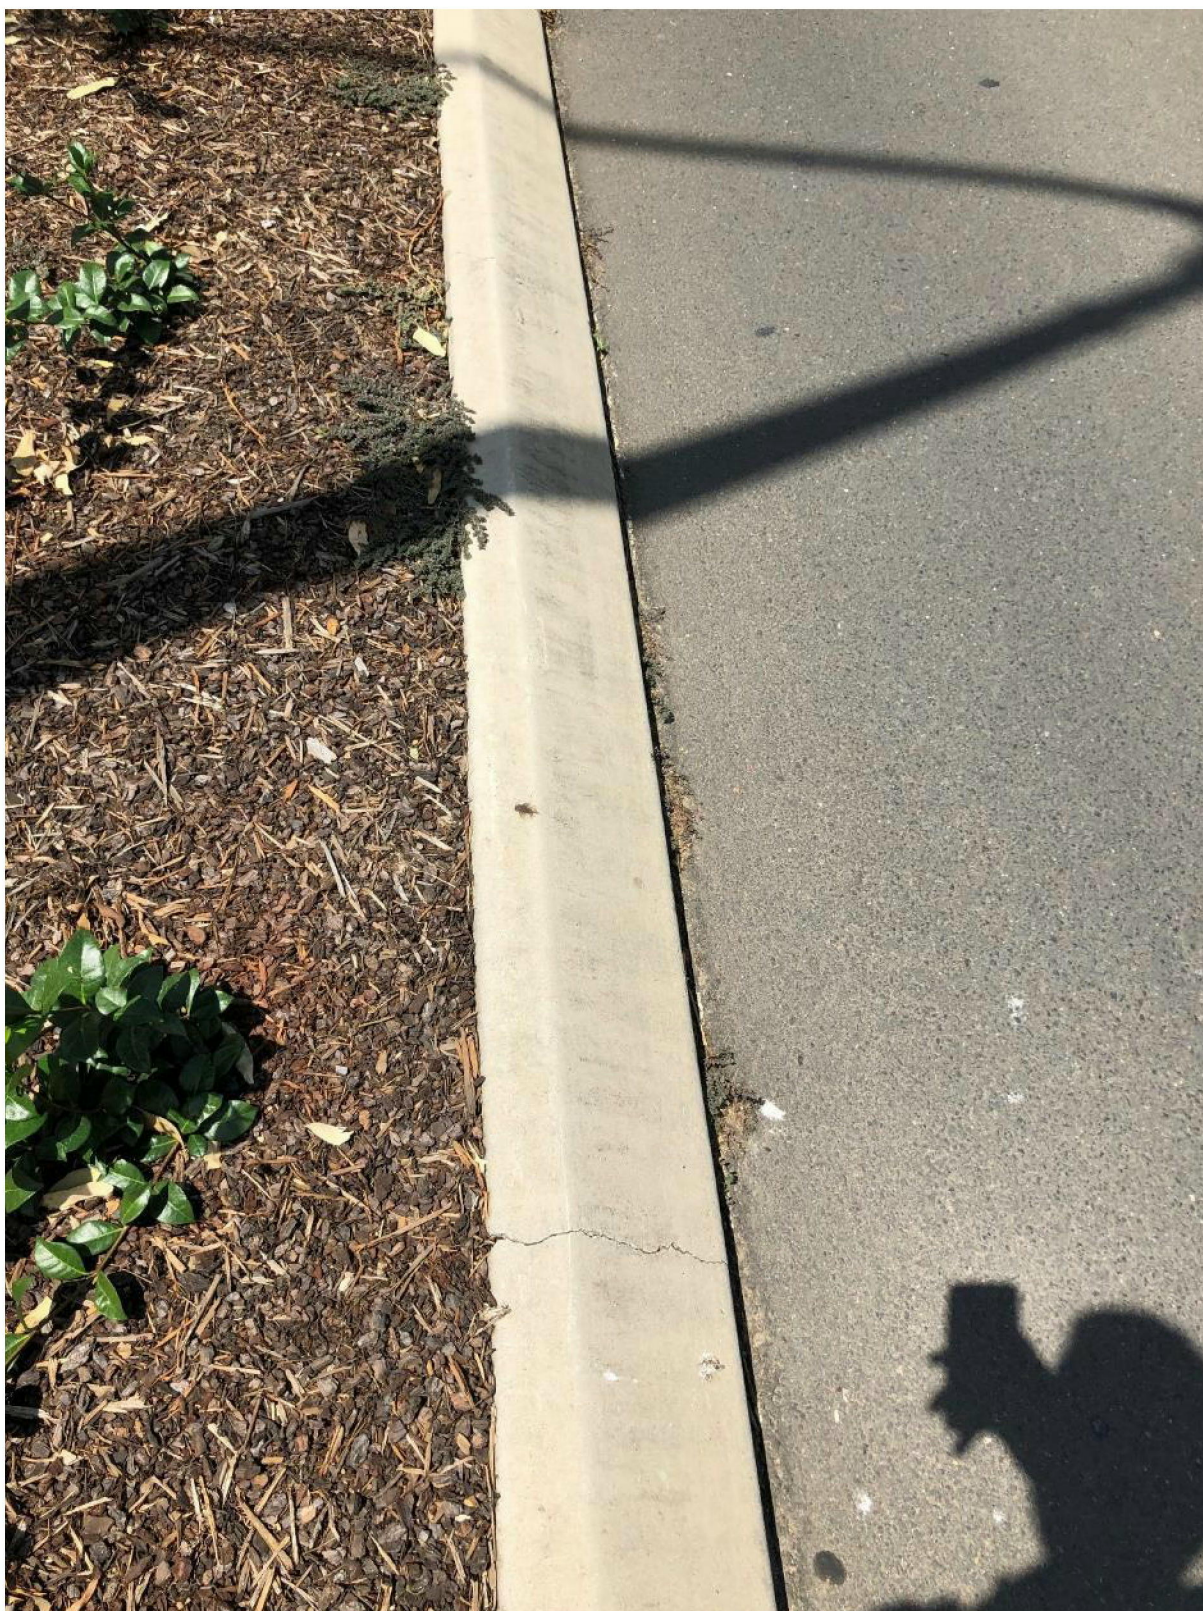
*Figure 32: cracking to median strip kerb.*

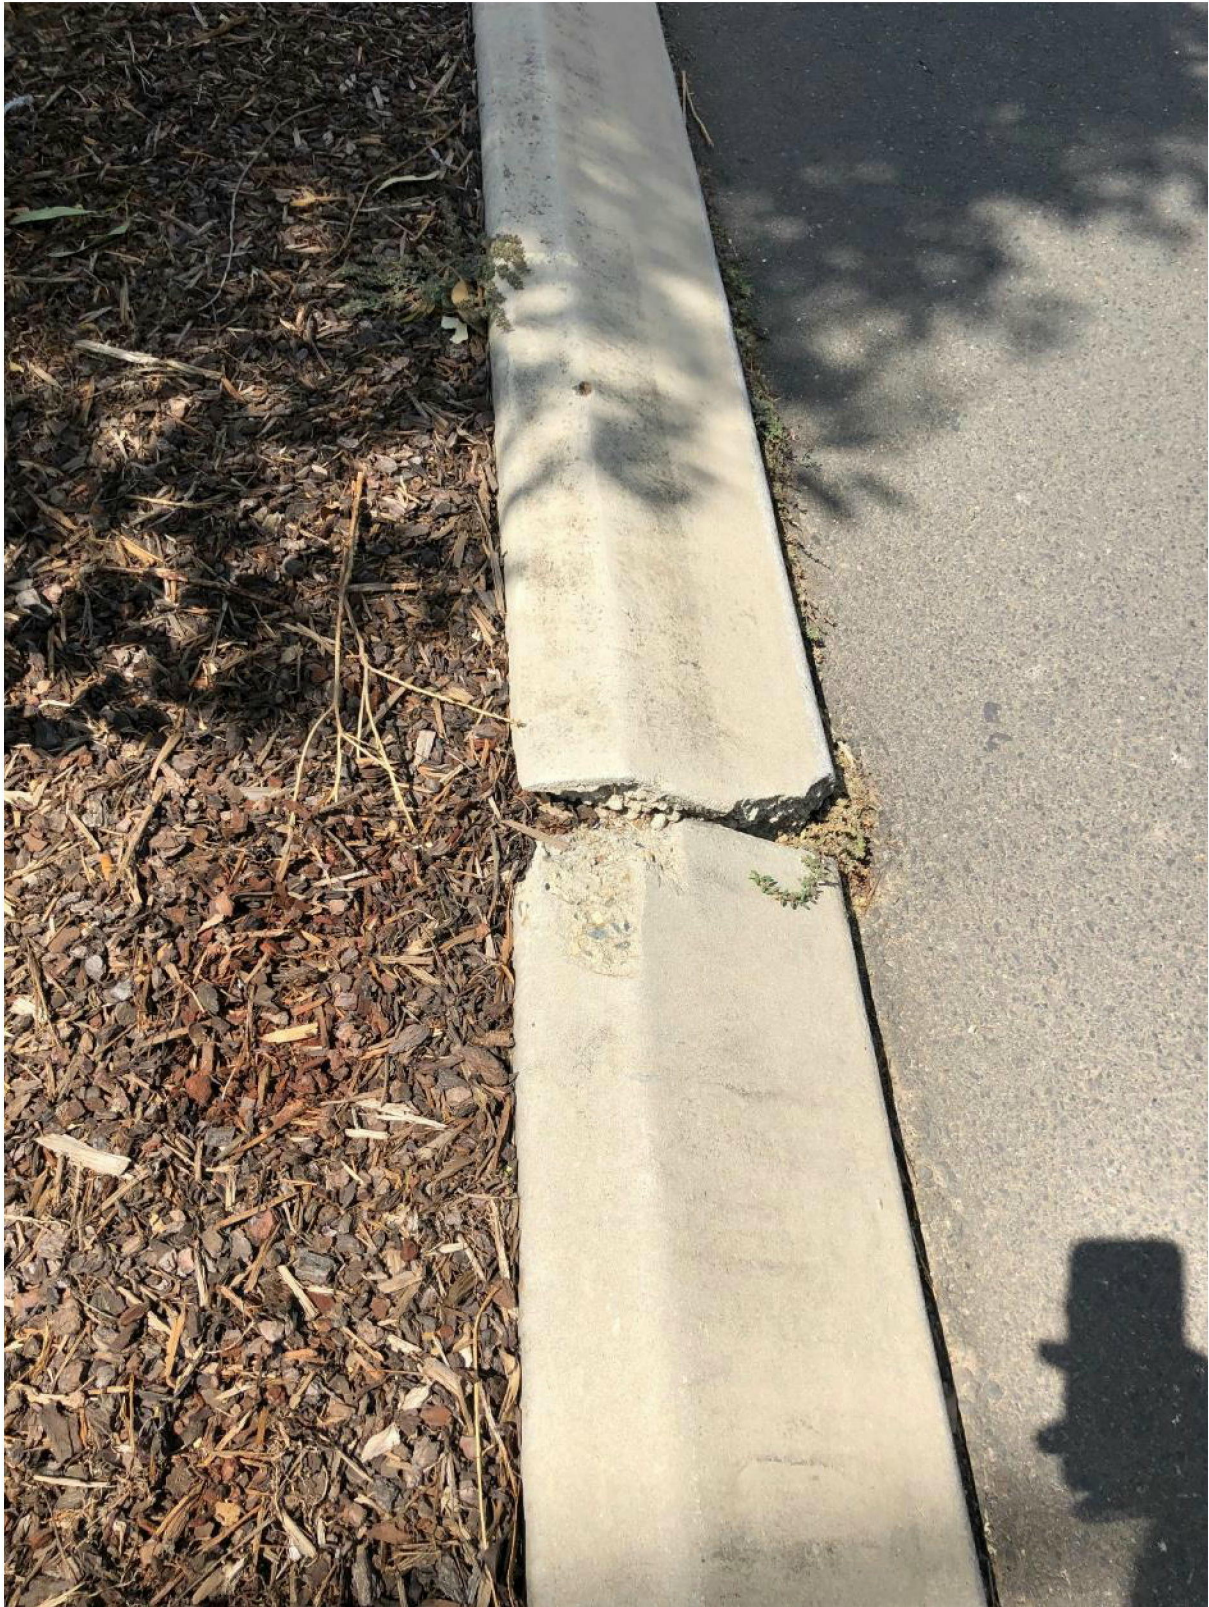
*Figure 33: separation at construction joint interface.*

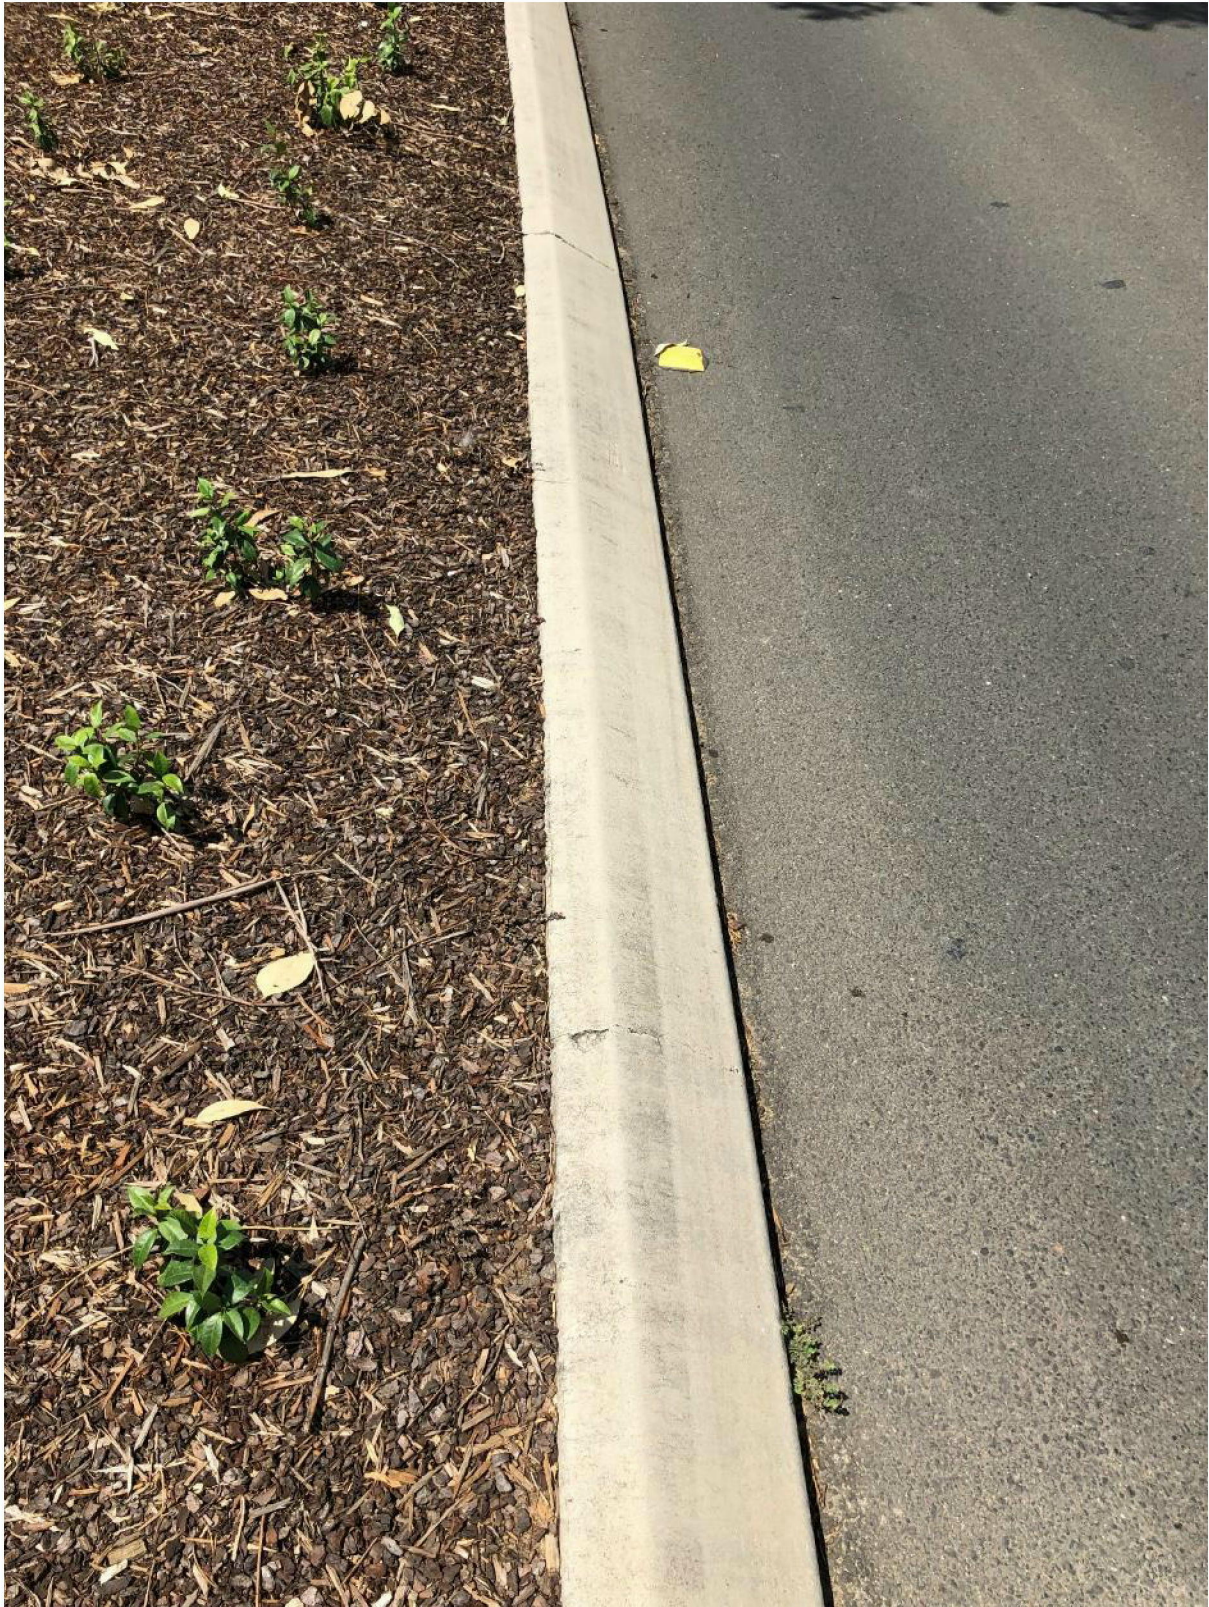
*Figure 34: cracking to median strip kerb.*

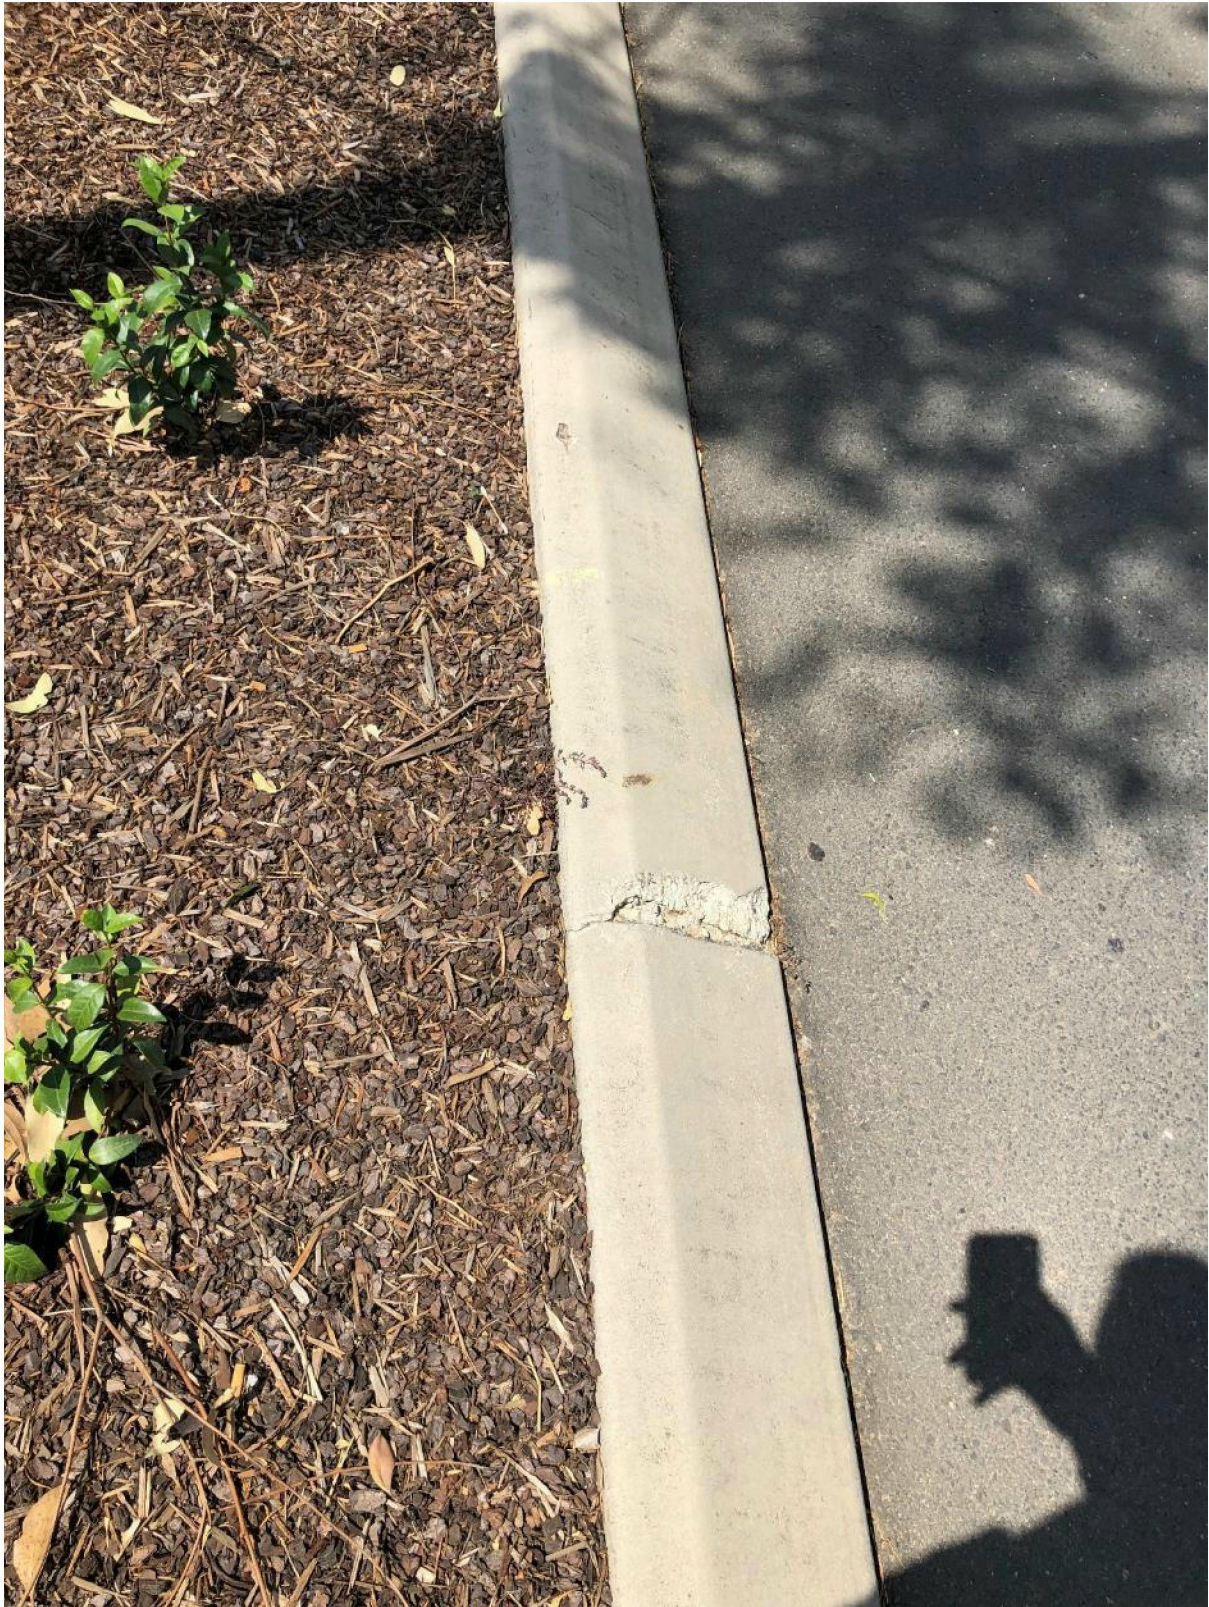
*Figure 35: damage on construction joint interface.*

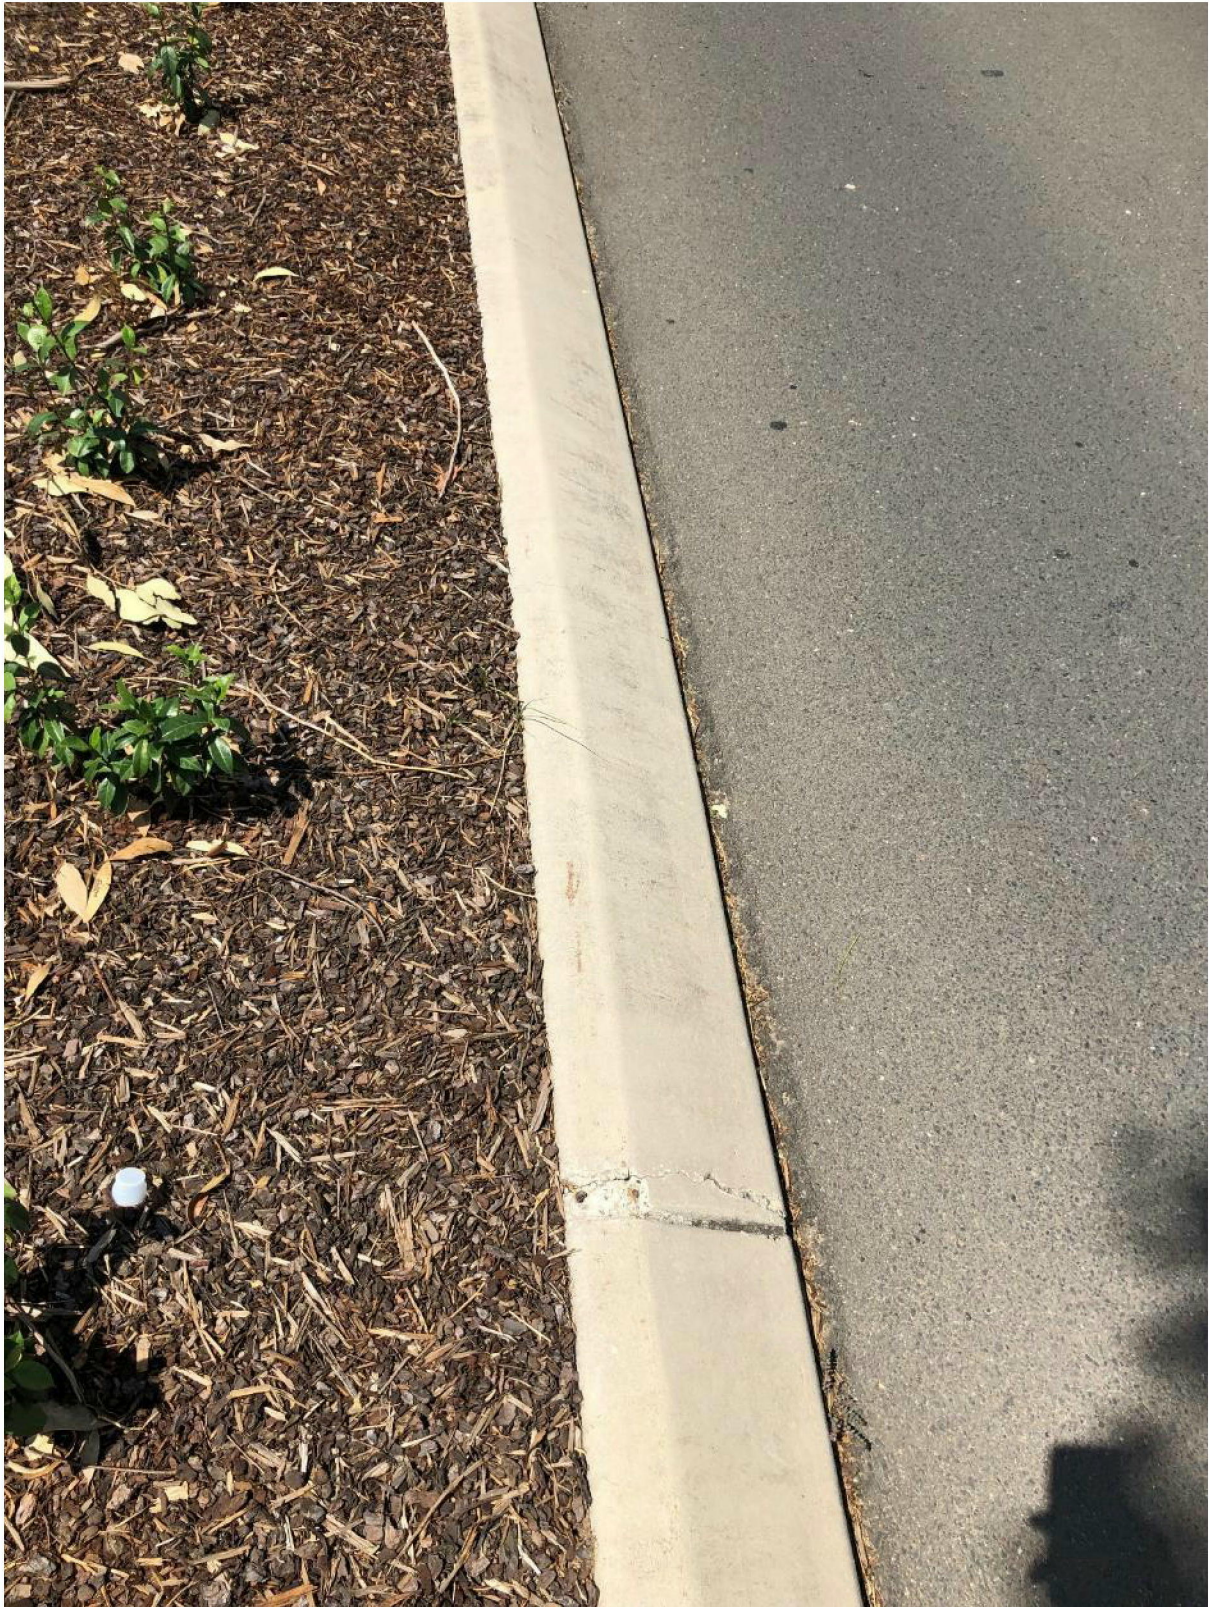
*Figure 36: spalling on construction joint interface.*

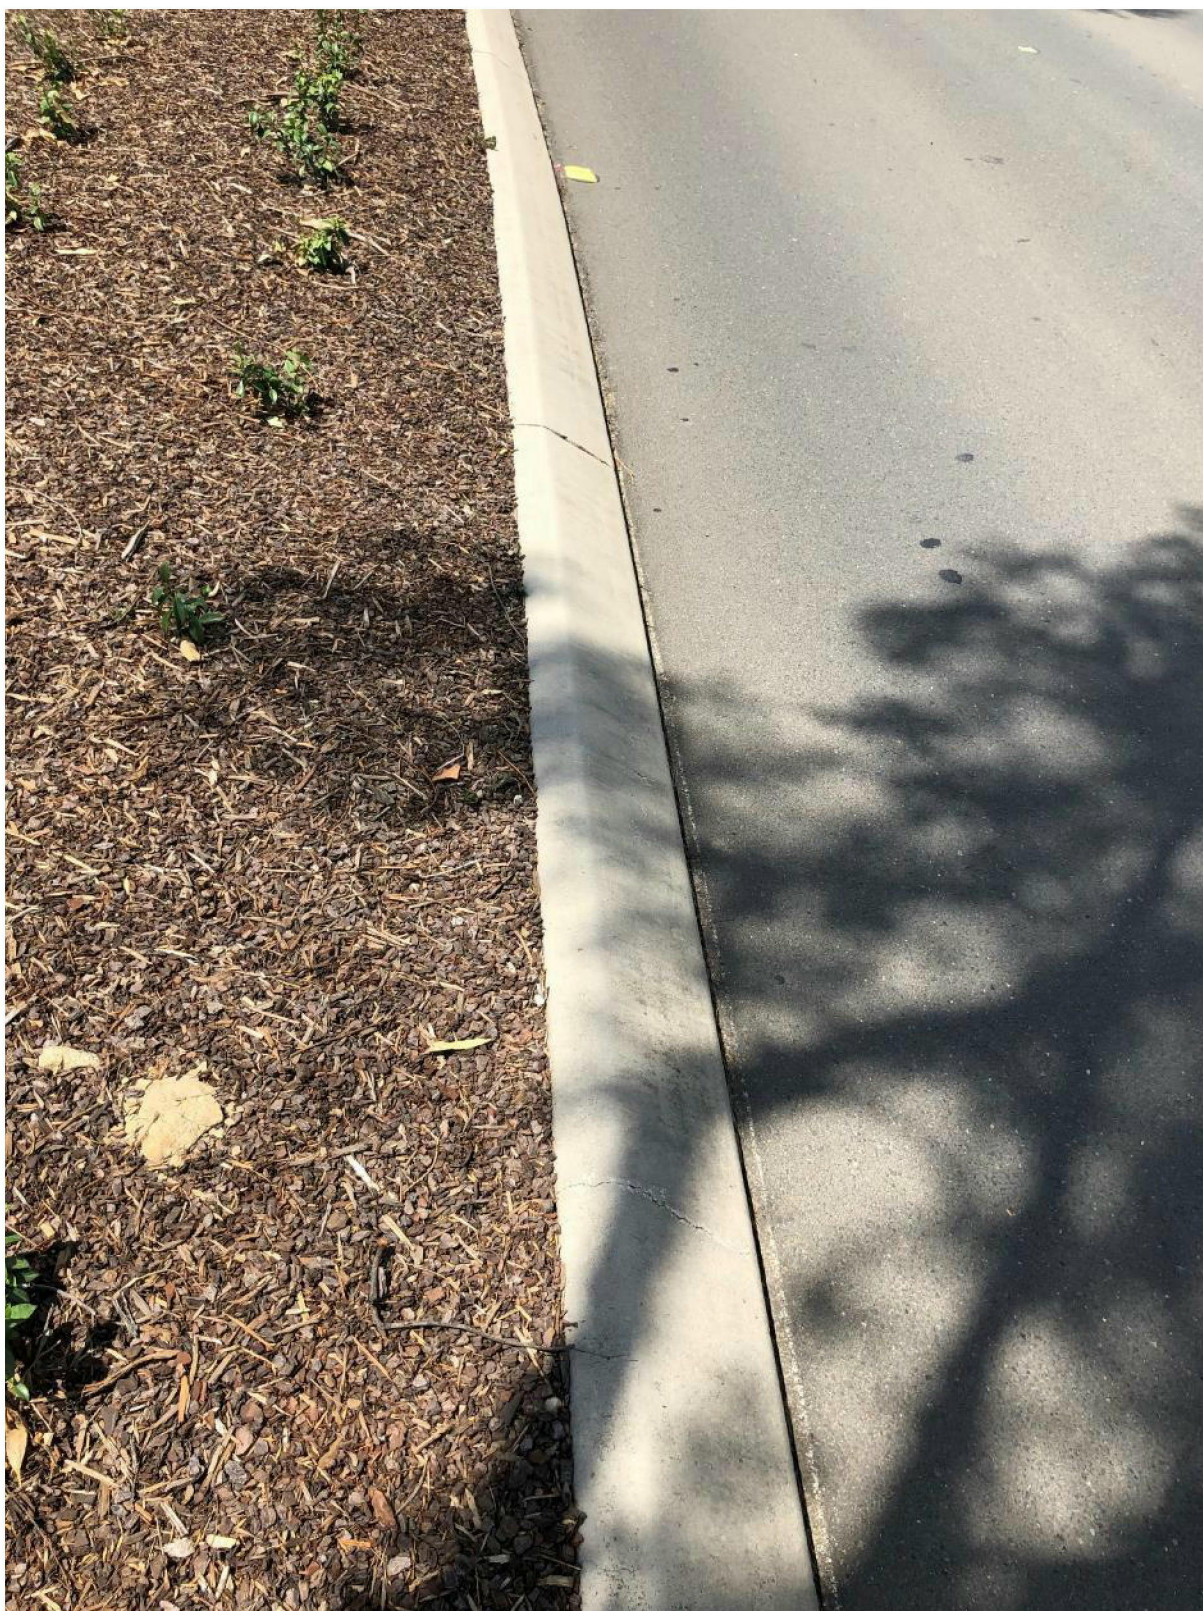
*Figure 37: cracking to median strip kerb.*

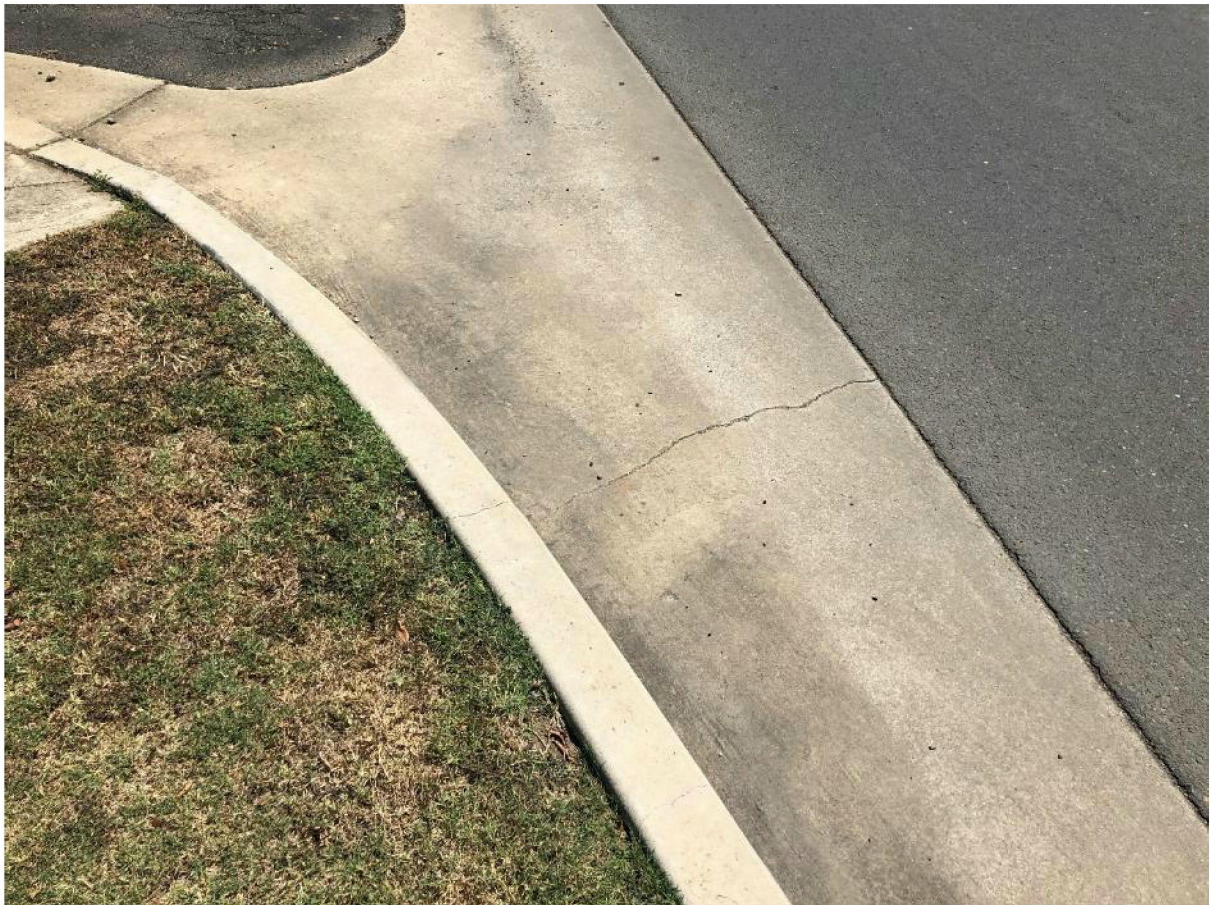
*Figure 43: cracking to kerb and gutter.*

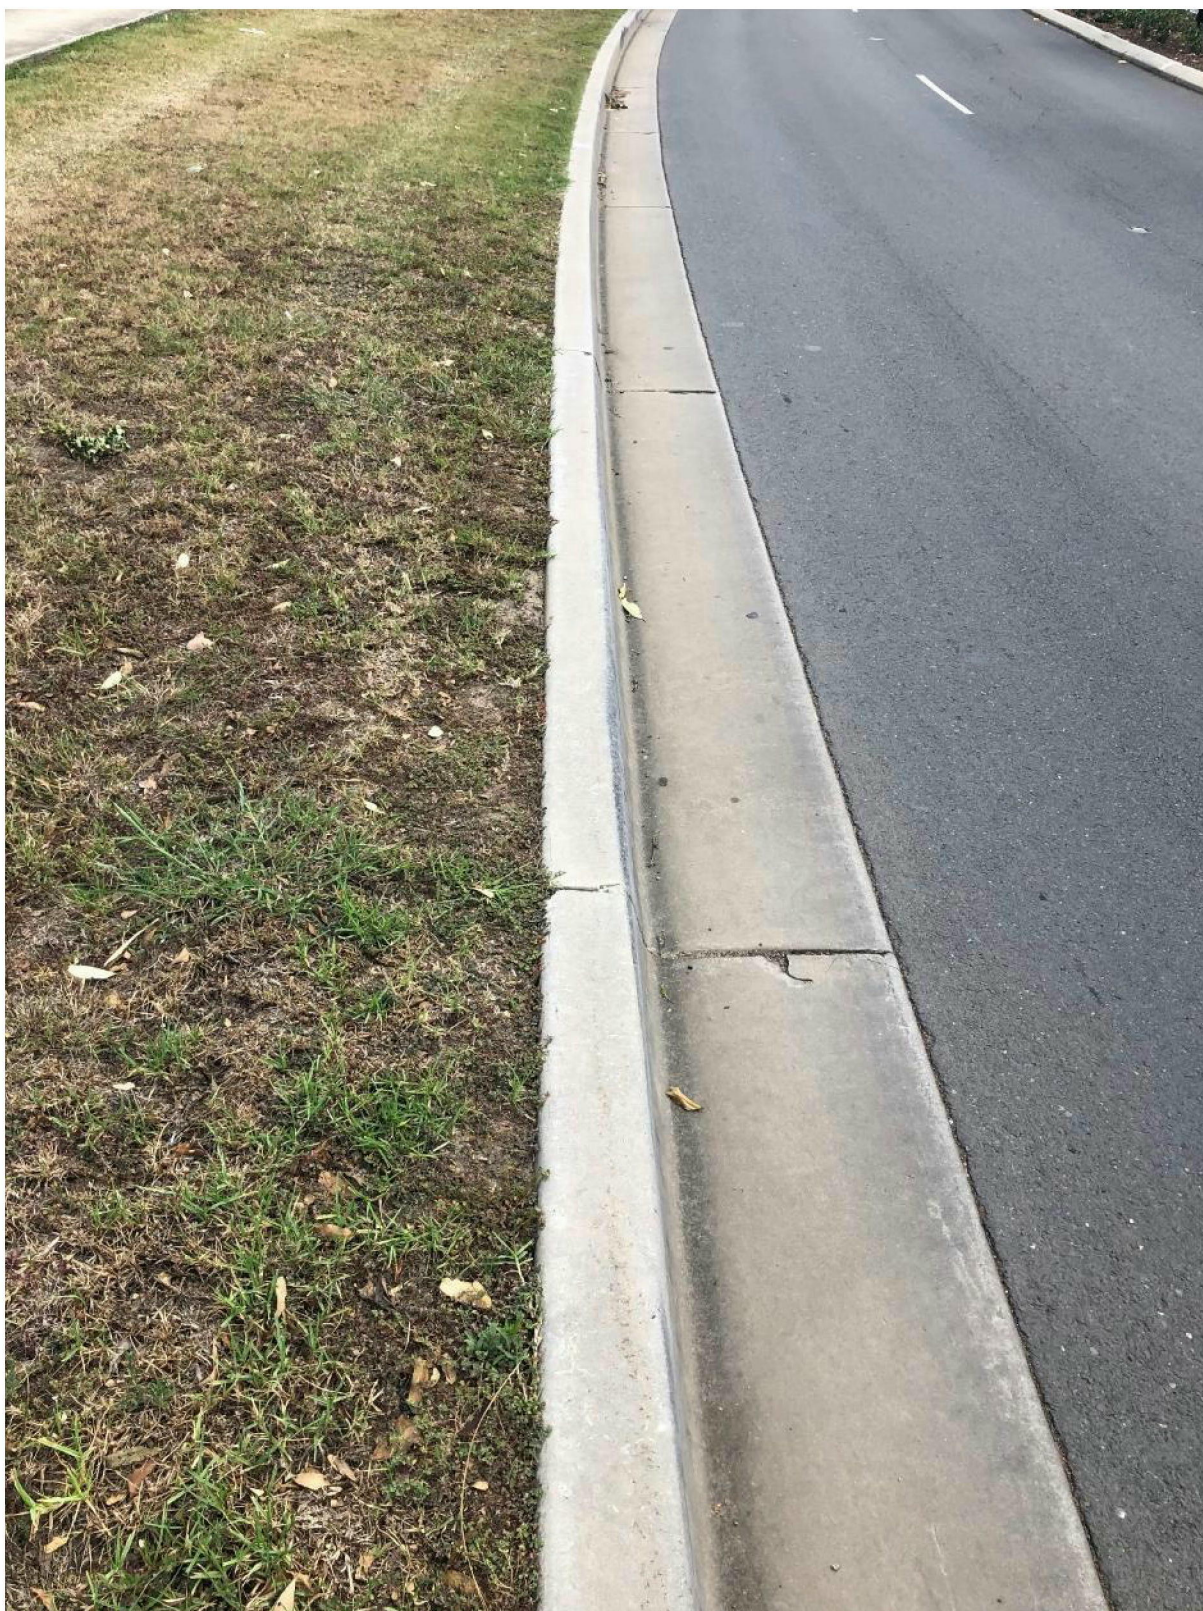
*Figure 44: chip on construction joint interface on kerb and gutter.*

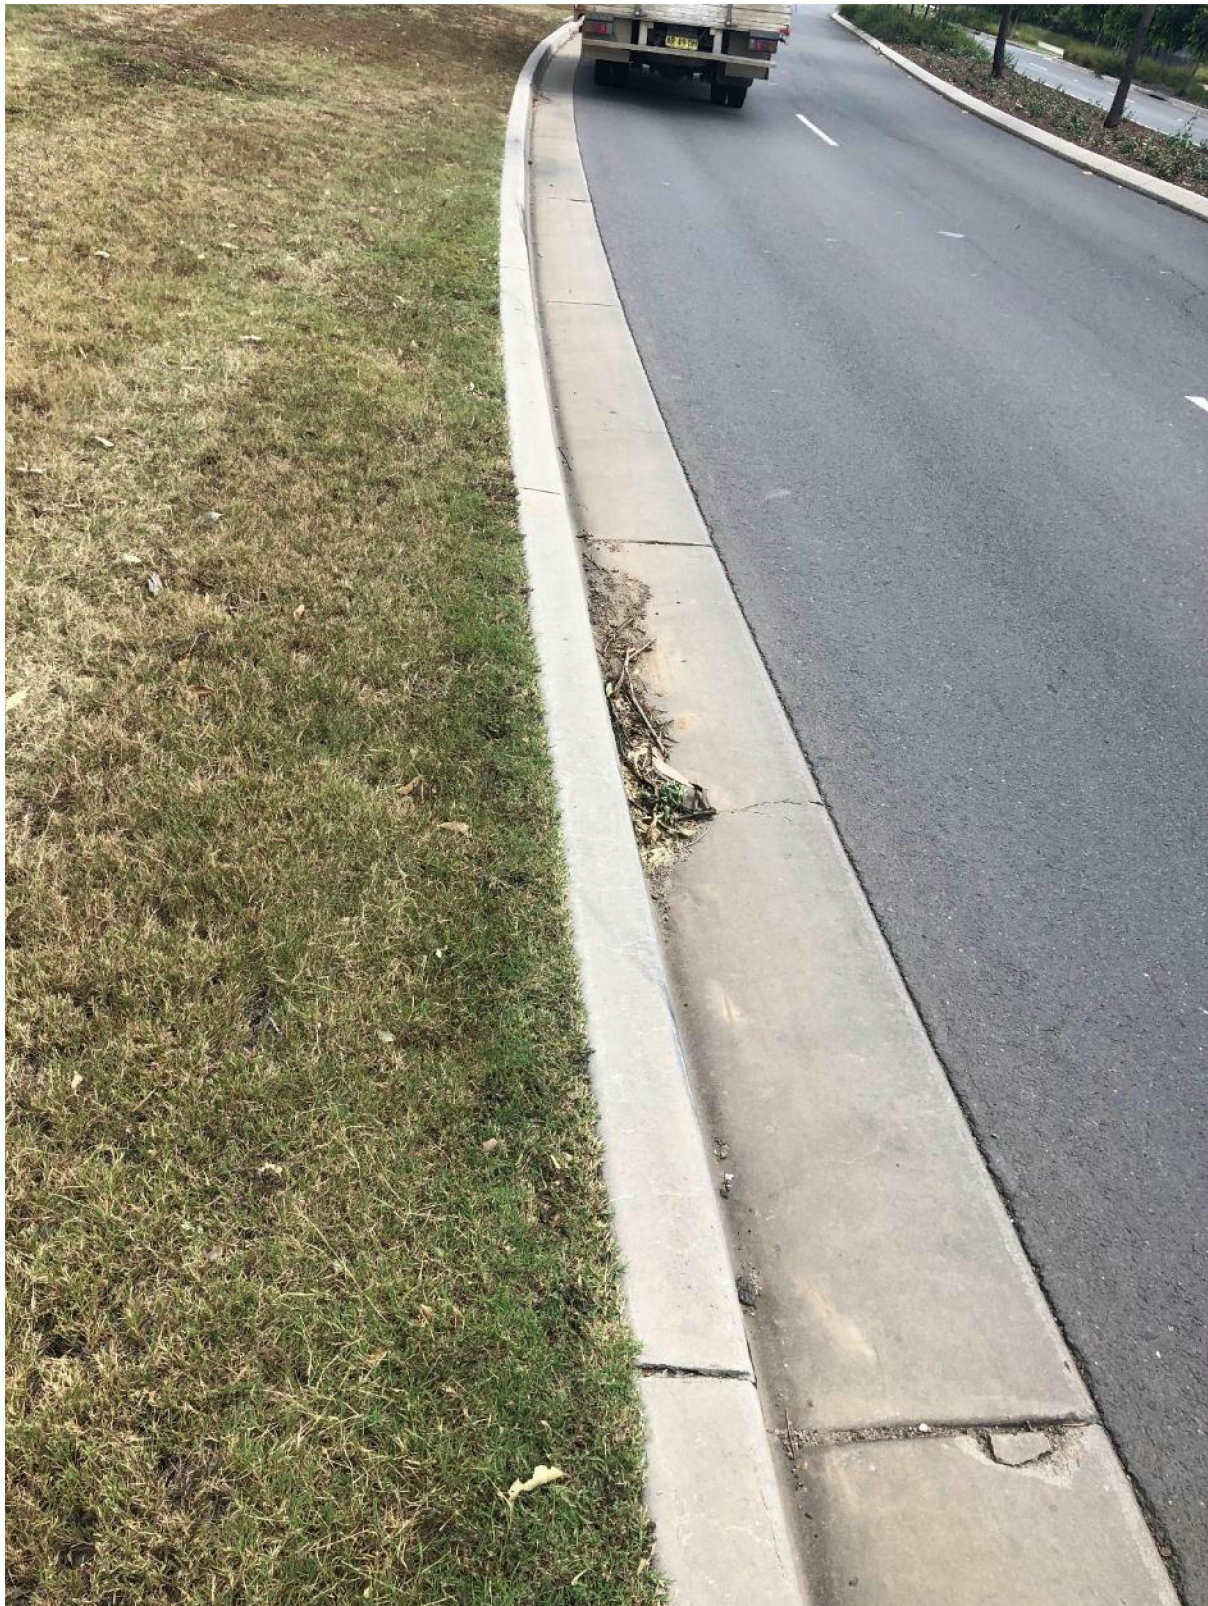
*Figure 45: chip damage to kerb & gutter construction joint interface and cracking.*

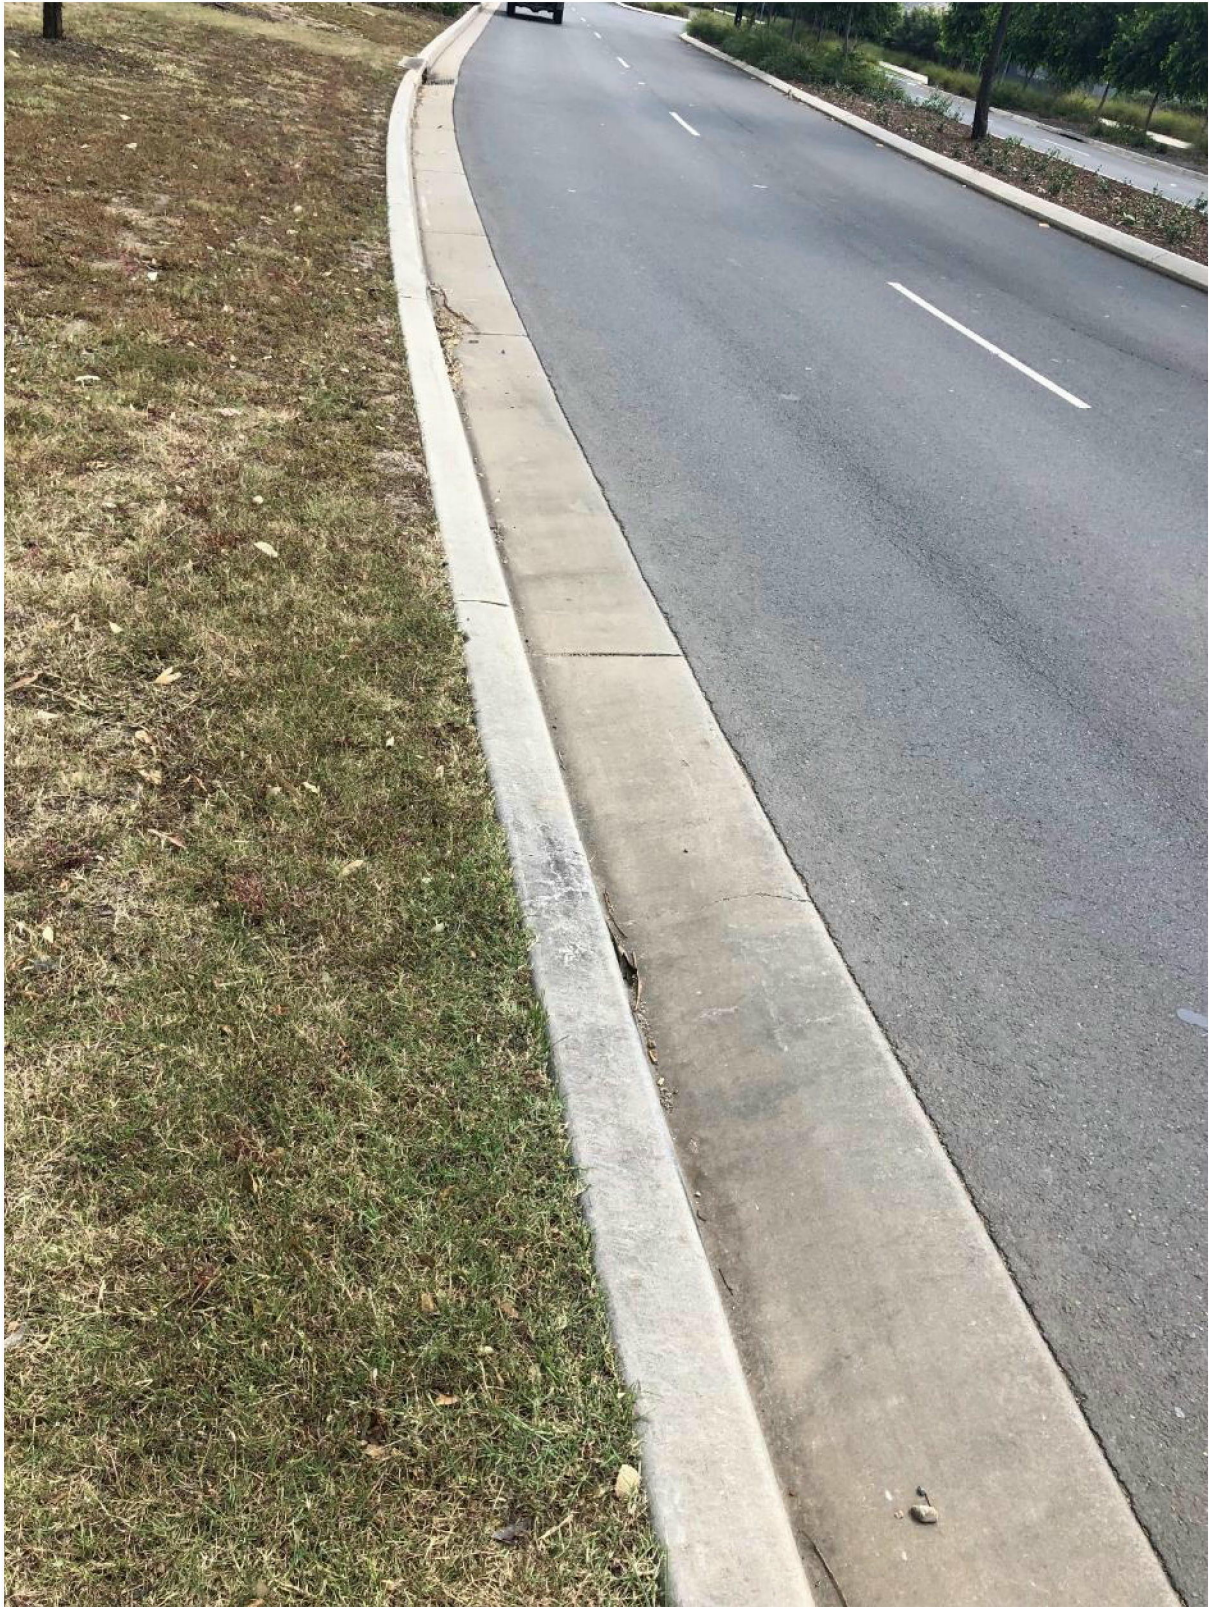
*Figure 46: minor cracking to gutter.*

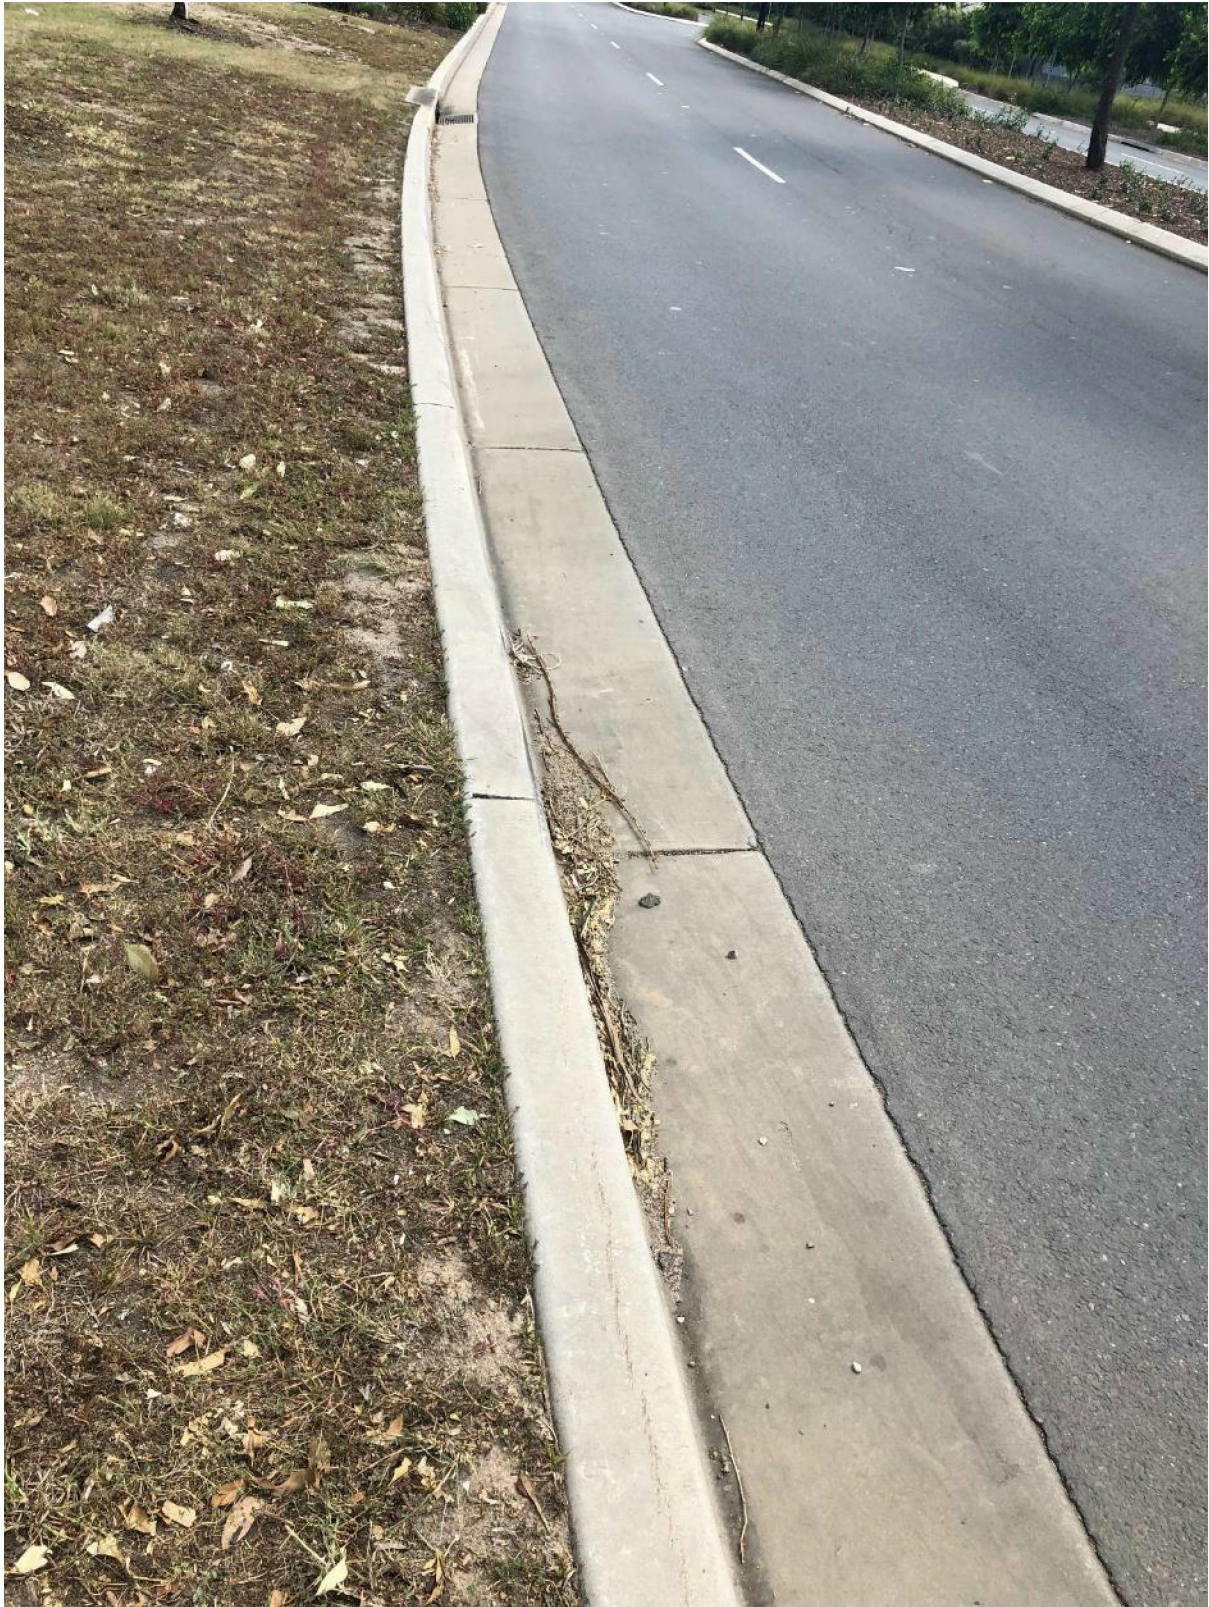
*Figure 47: indentation to concrete gutter.*

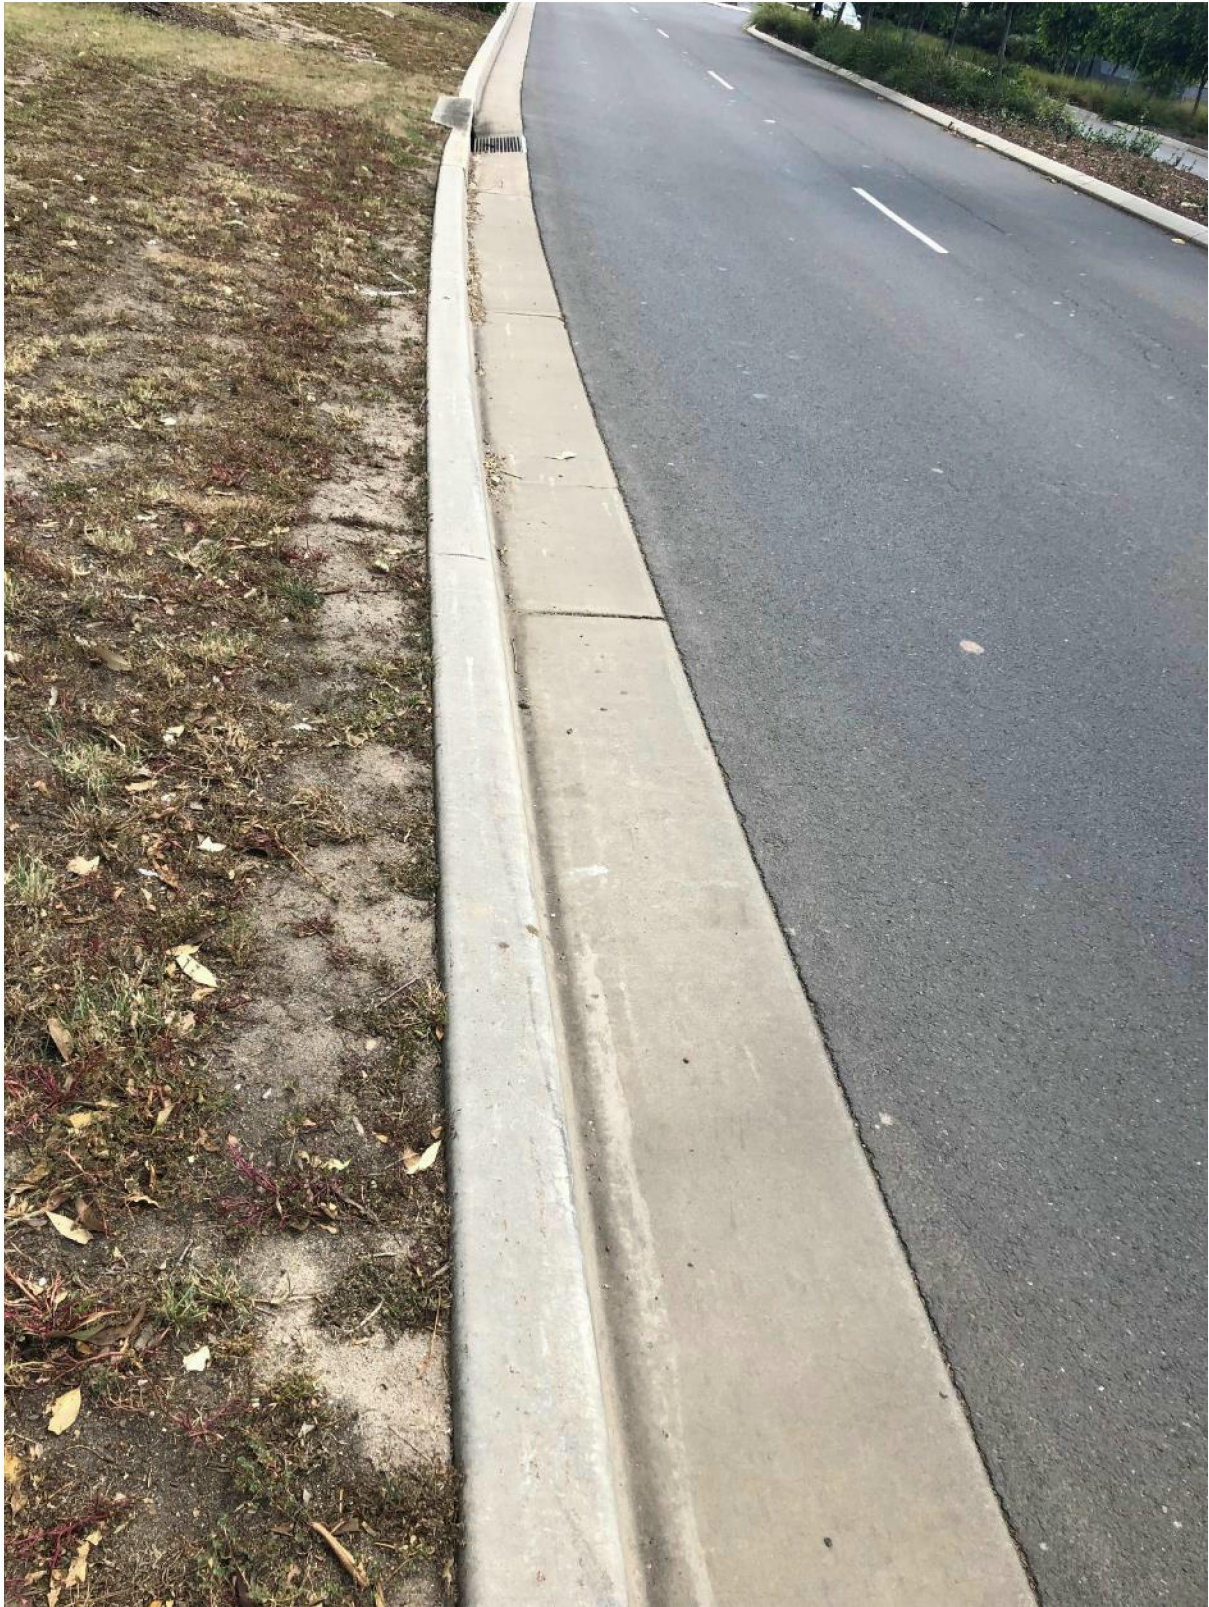
*Figure 48: crack on concrete gutter.*
