# Dilapidation Report

Proposed Works - Jordan Springs Stage 2 Retirement Living

James Sae Siew  
5<sup>th</sup> March 2019  
Revision 1

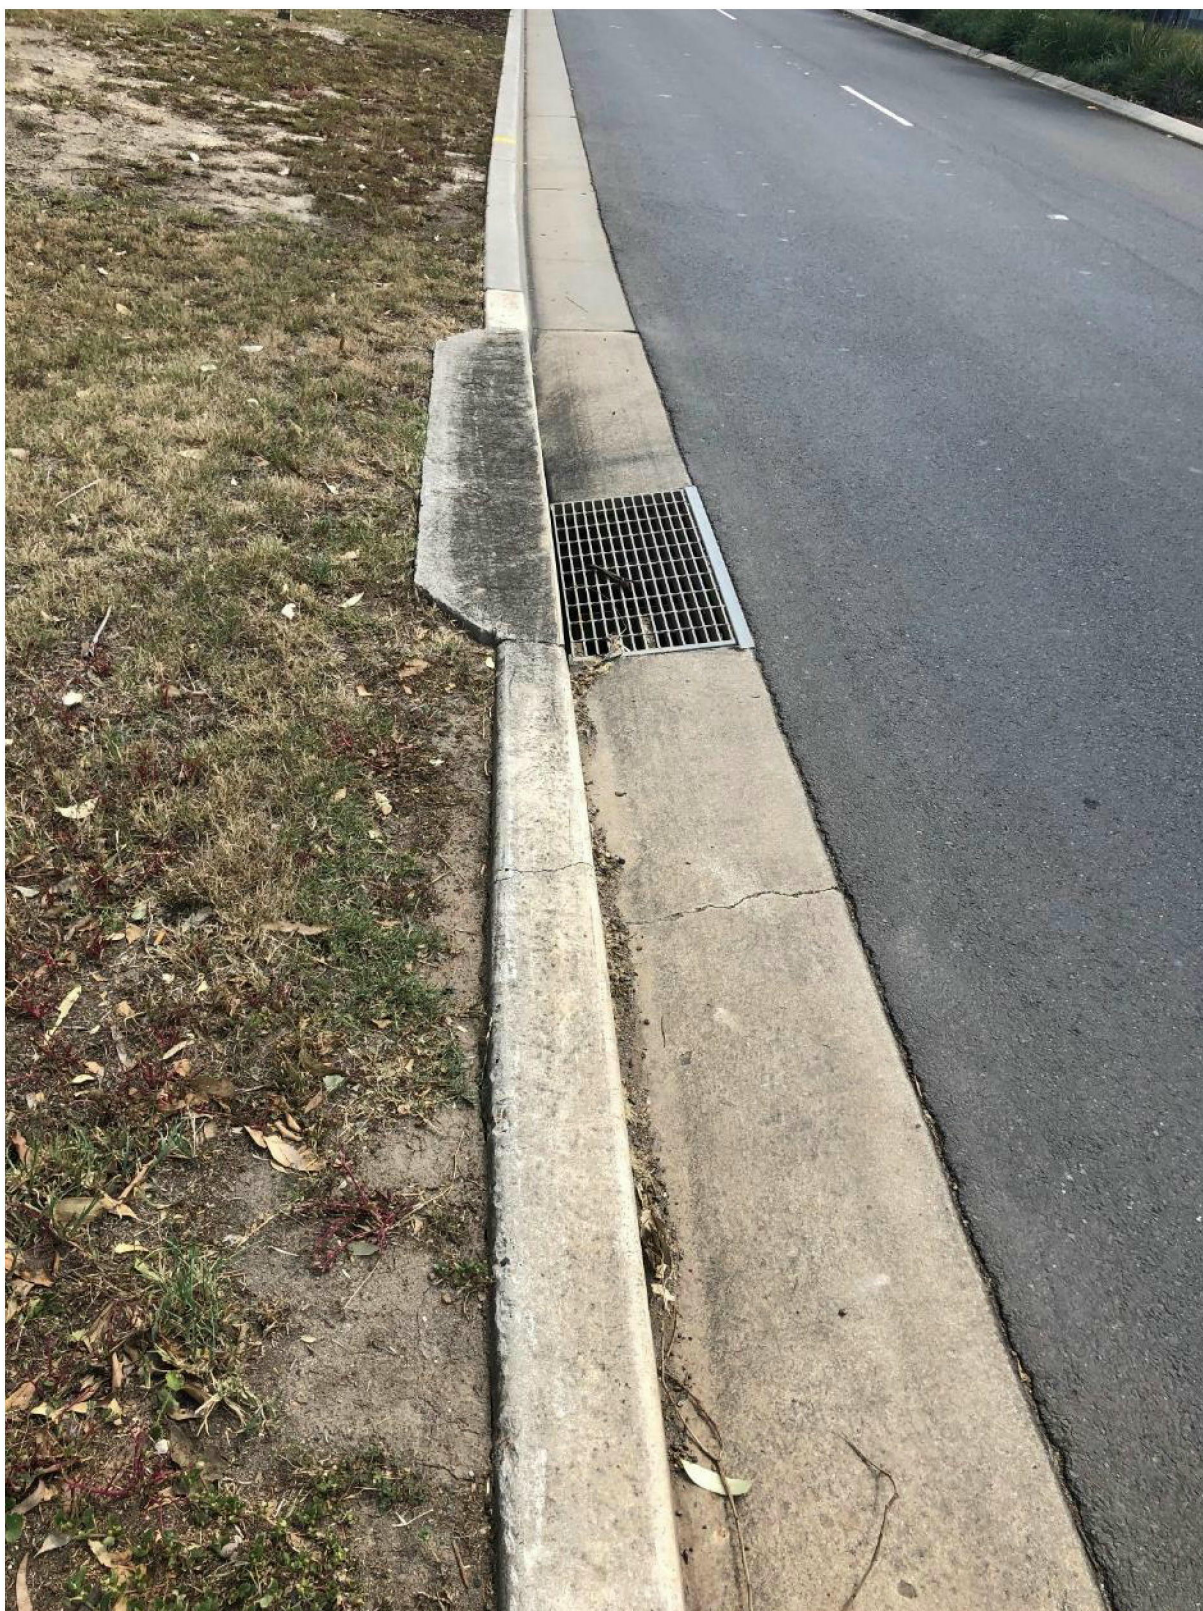
*Figure 49: cracking on kerb and gutter, adjacent to SW pit.*

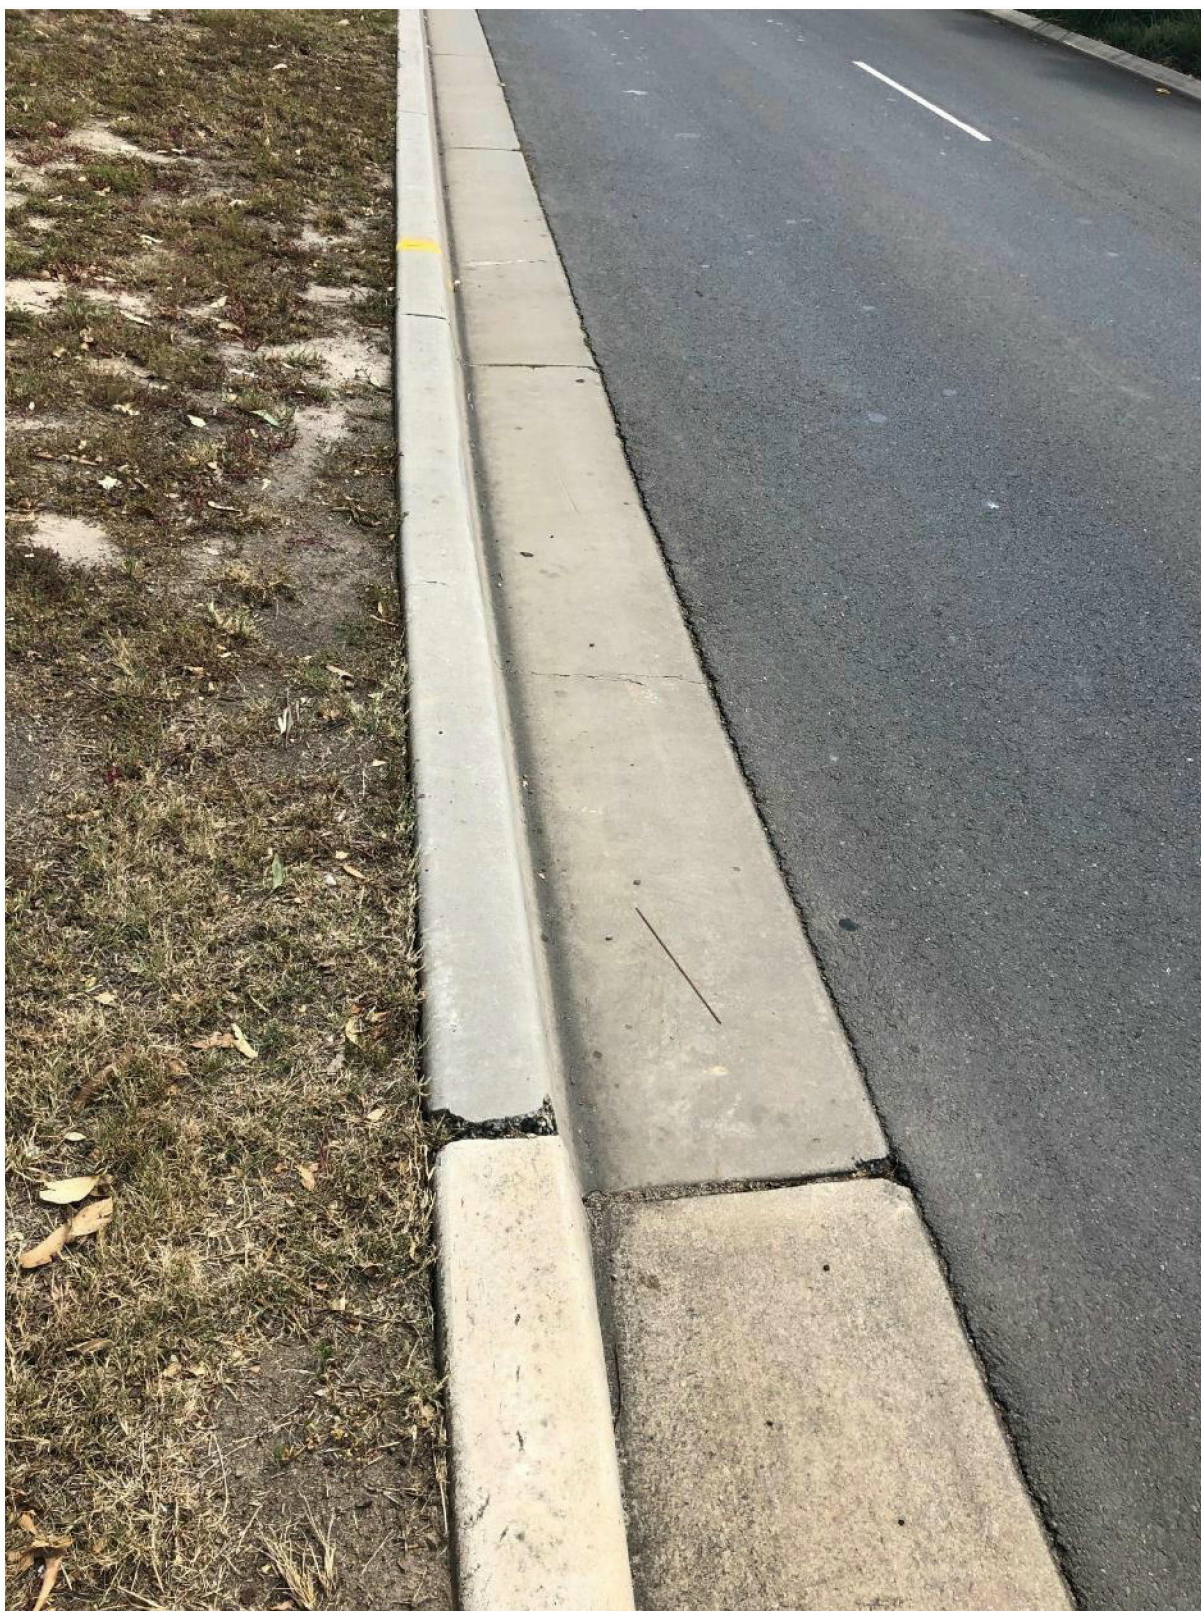
*Figure 50: damage to expansion joint interface on kerb and gutter.*

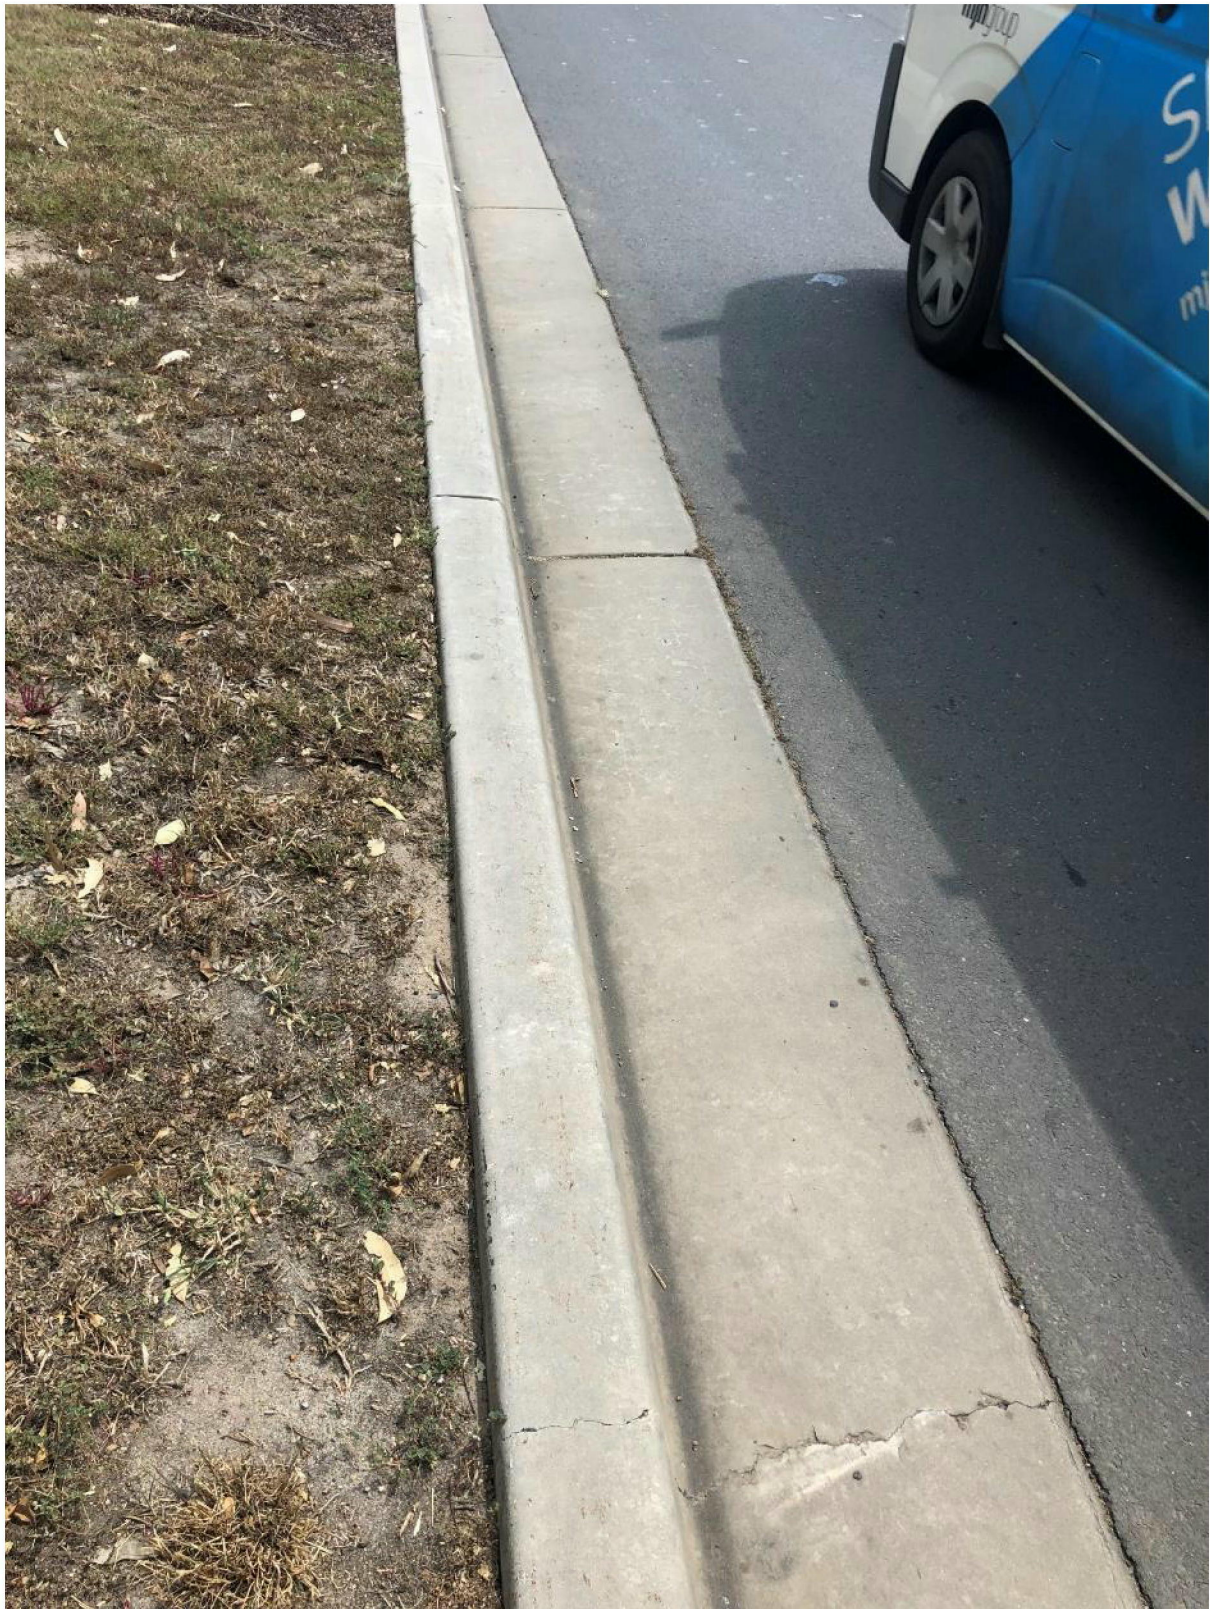
*Figure 51: cracking to kerb and gutter.*

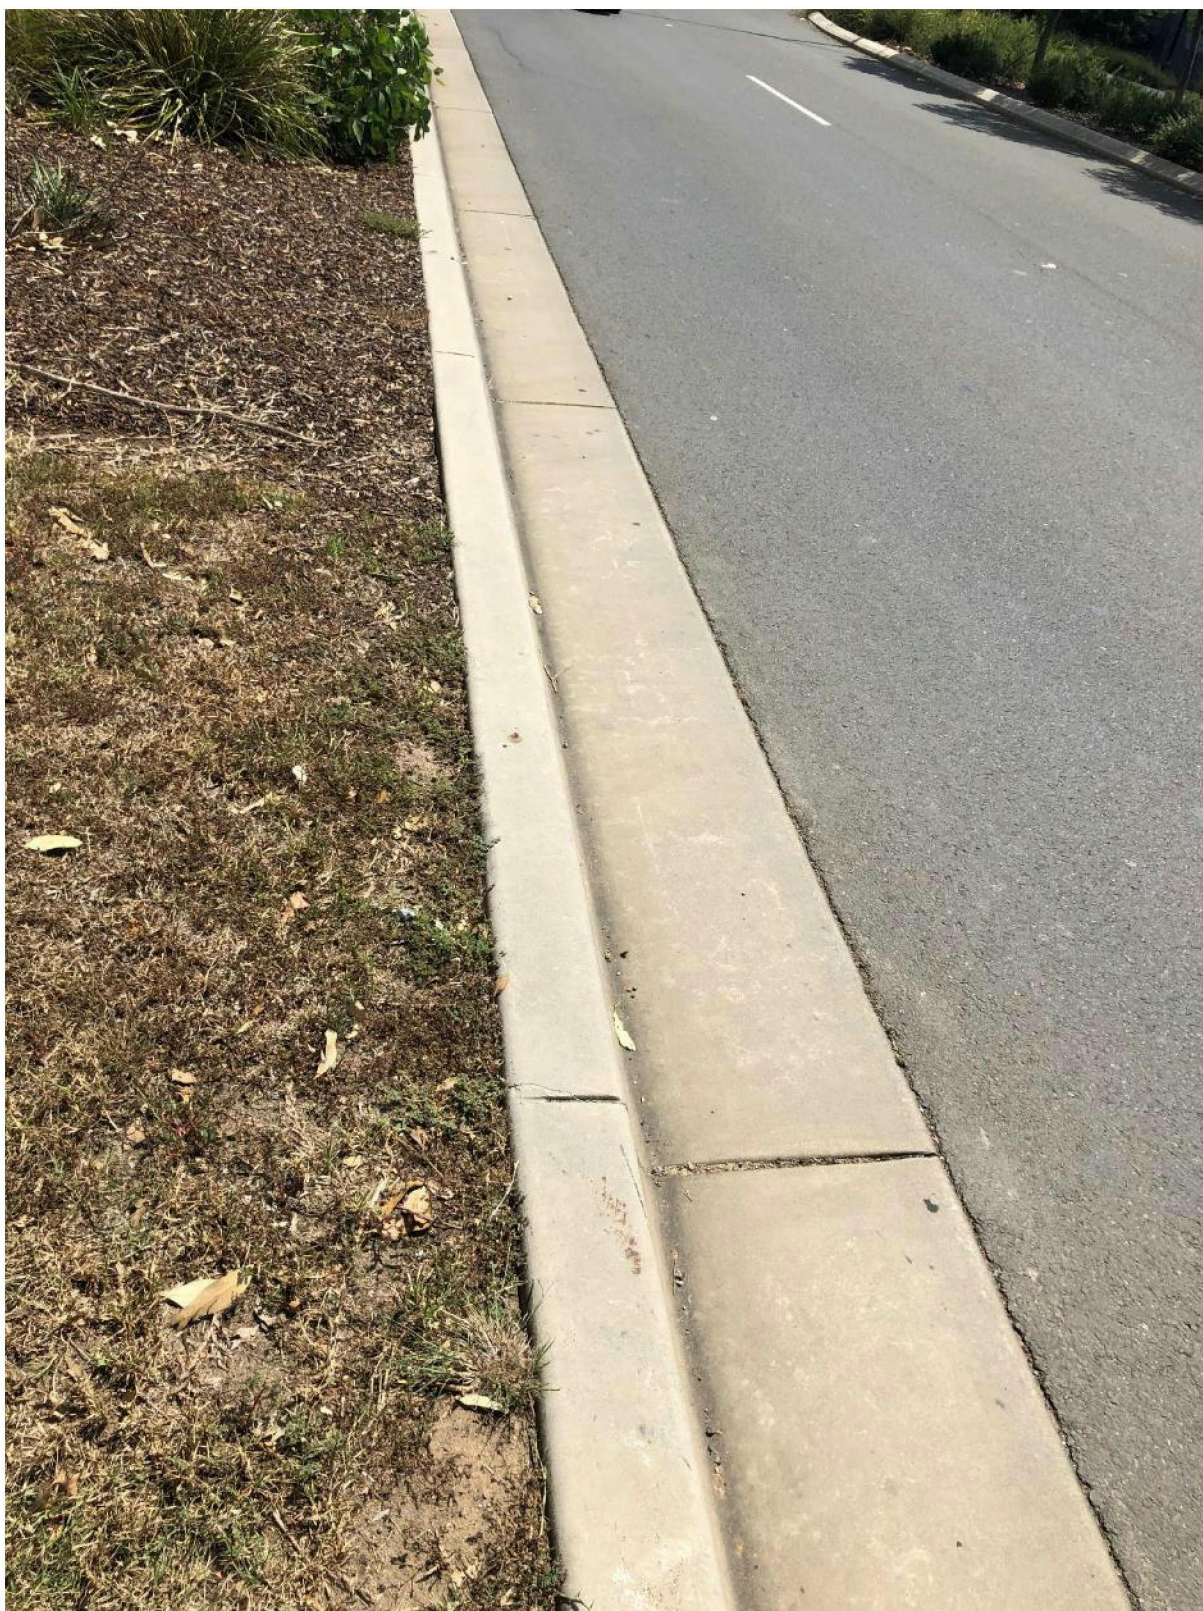
*Figure 52: cracking to top of kerb.*

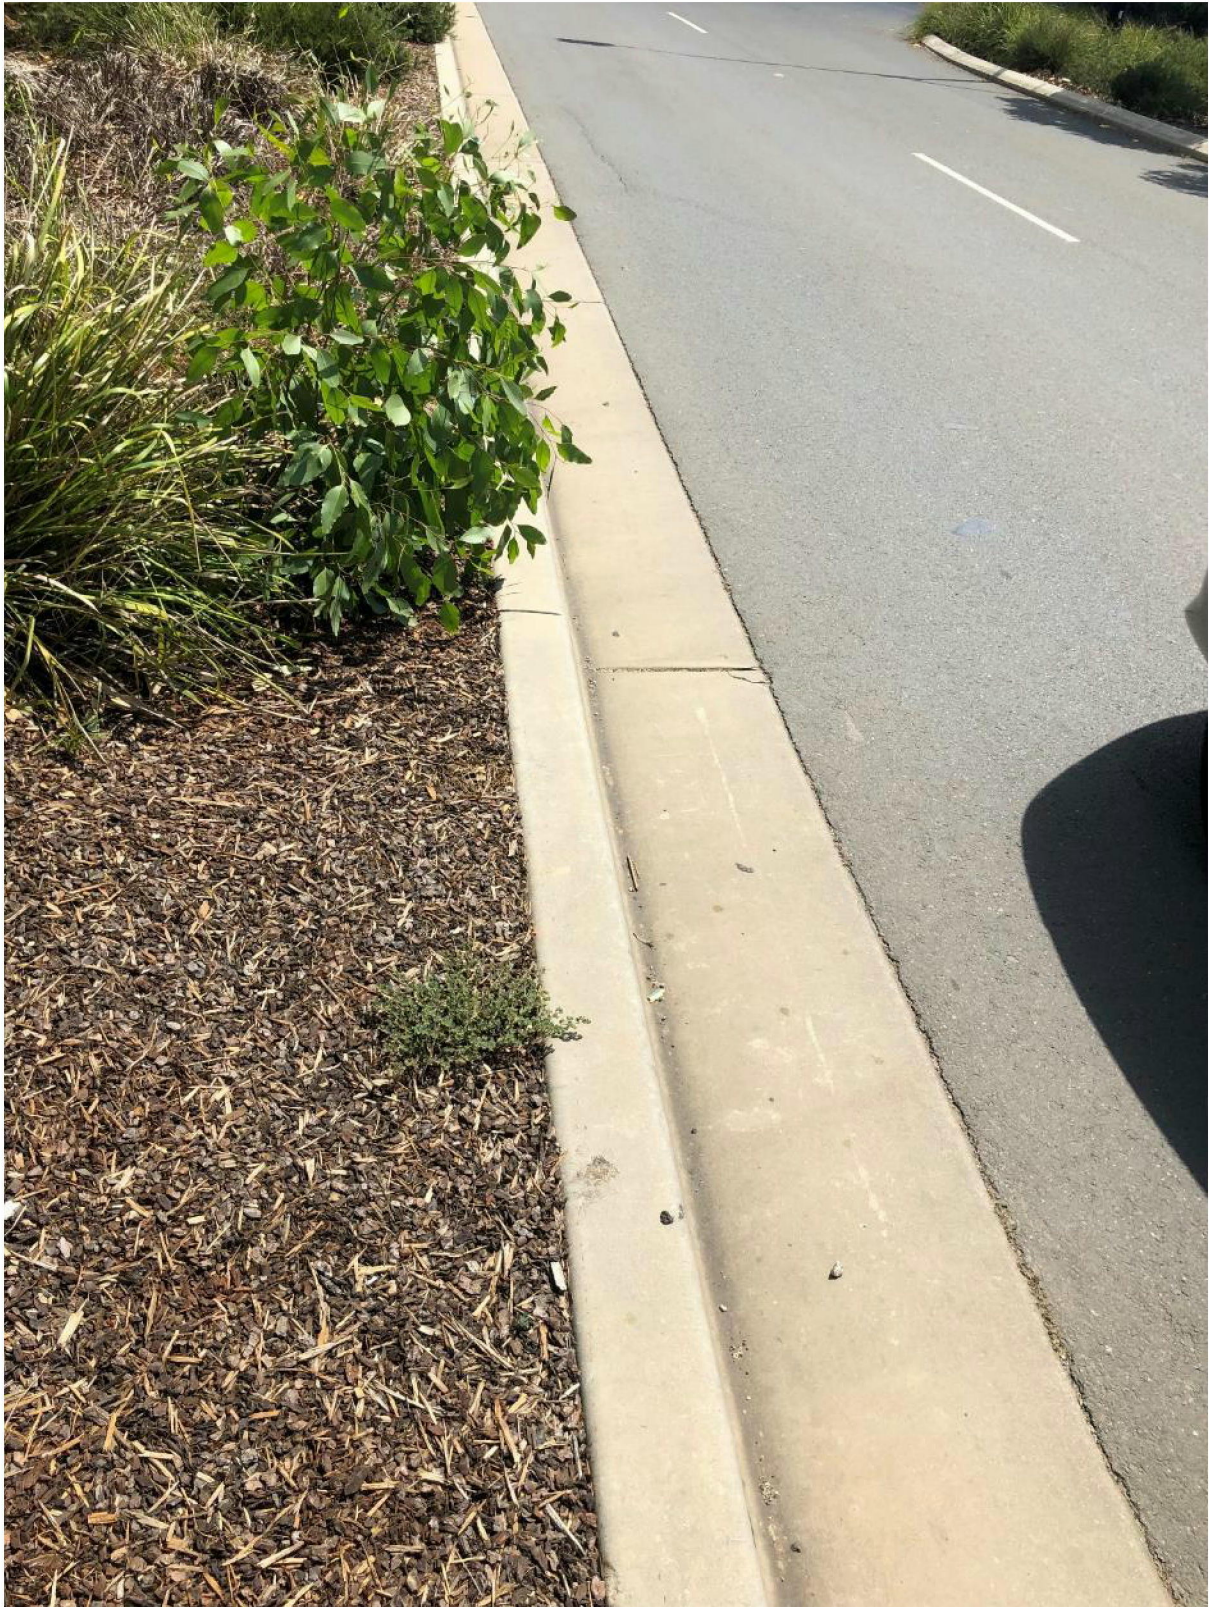
*Figure 53: diagonal cracking at construction joint interface.*

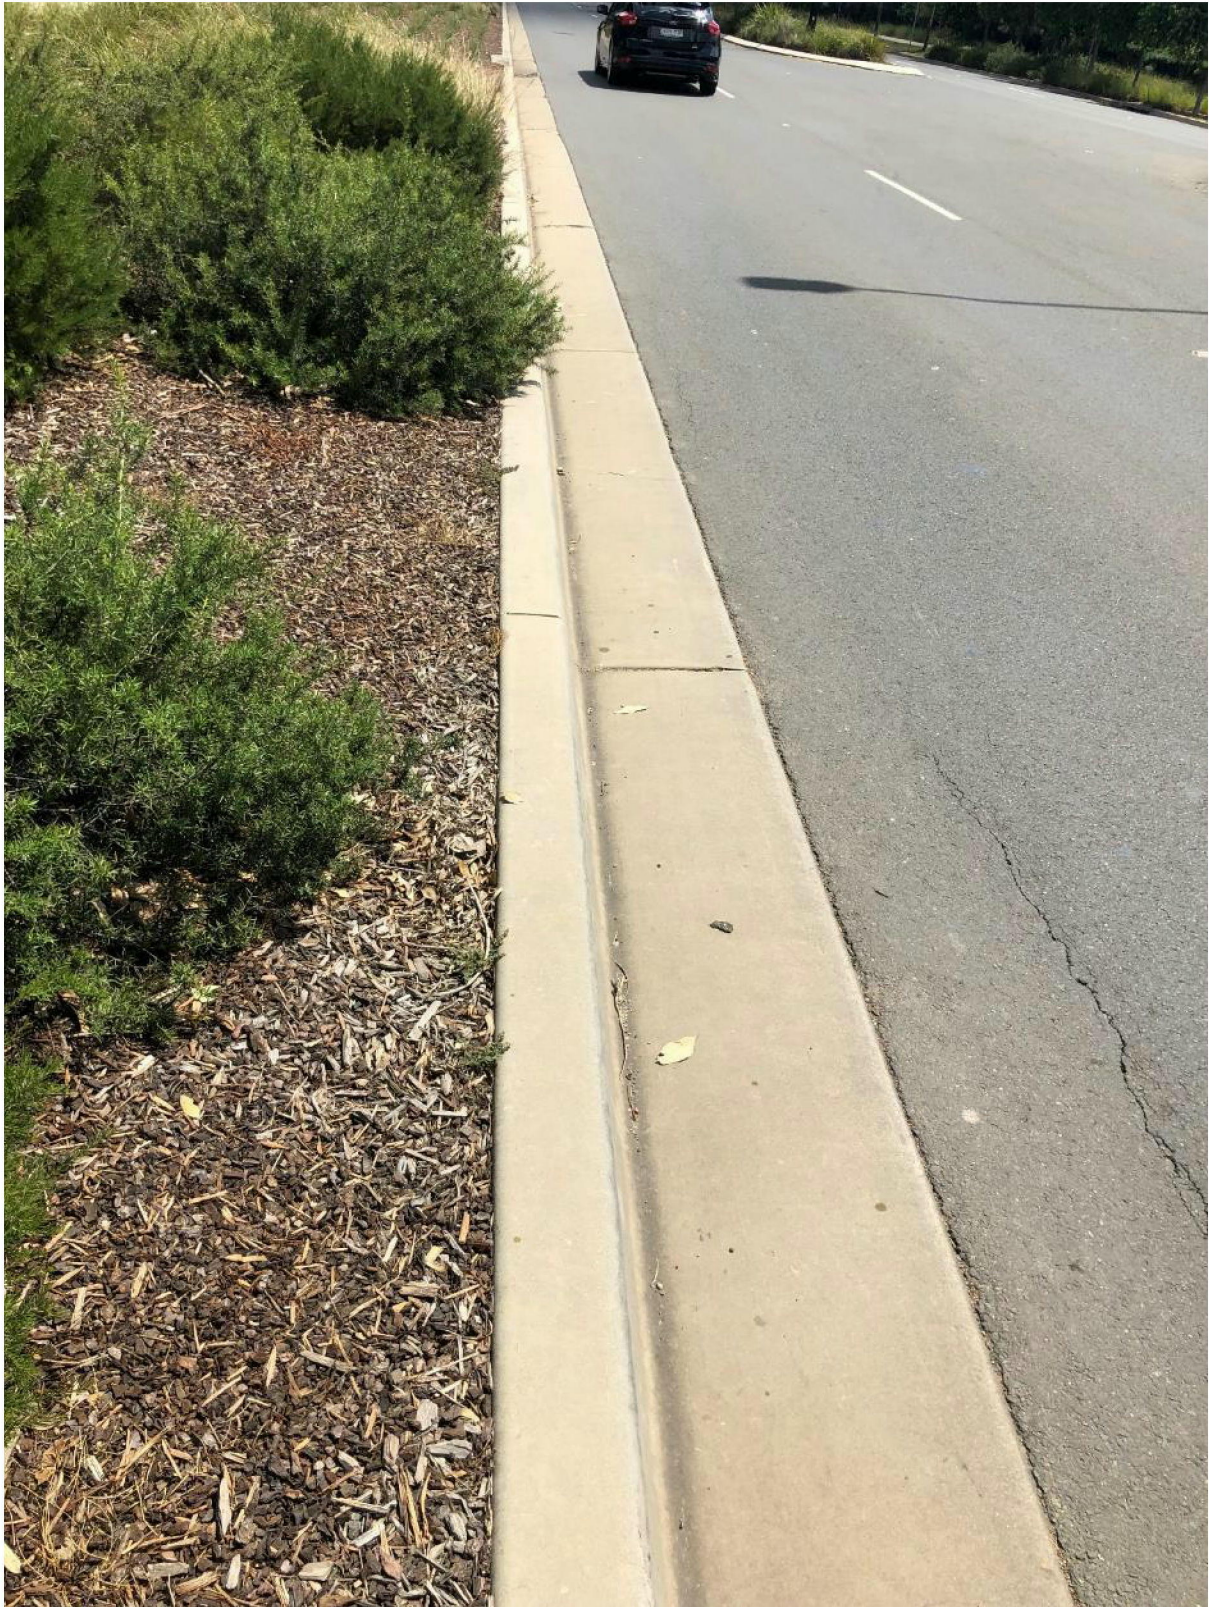
*Figure 54: crack on asphalt, adjacent to gutter.*

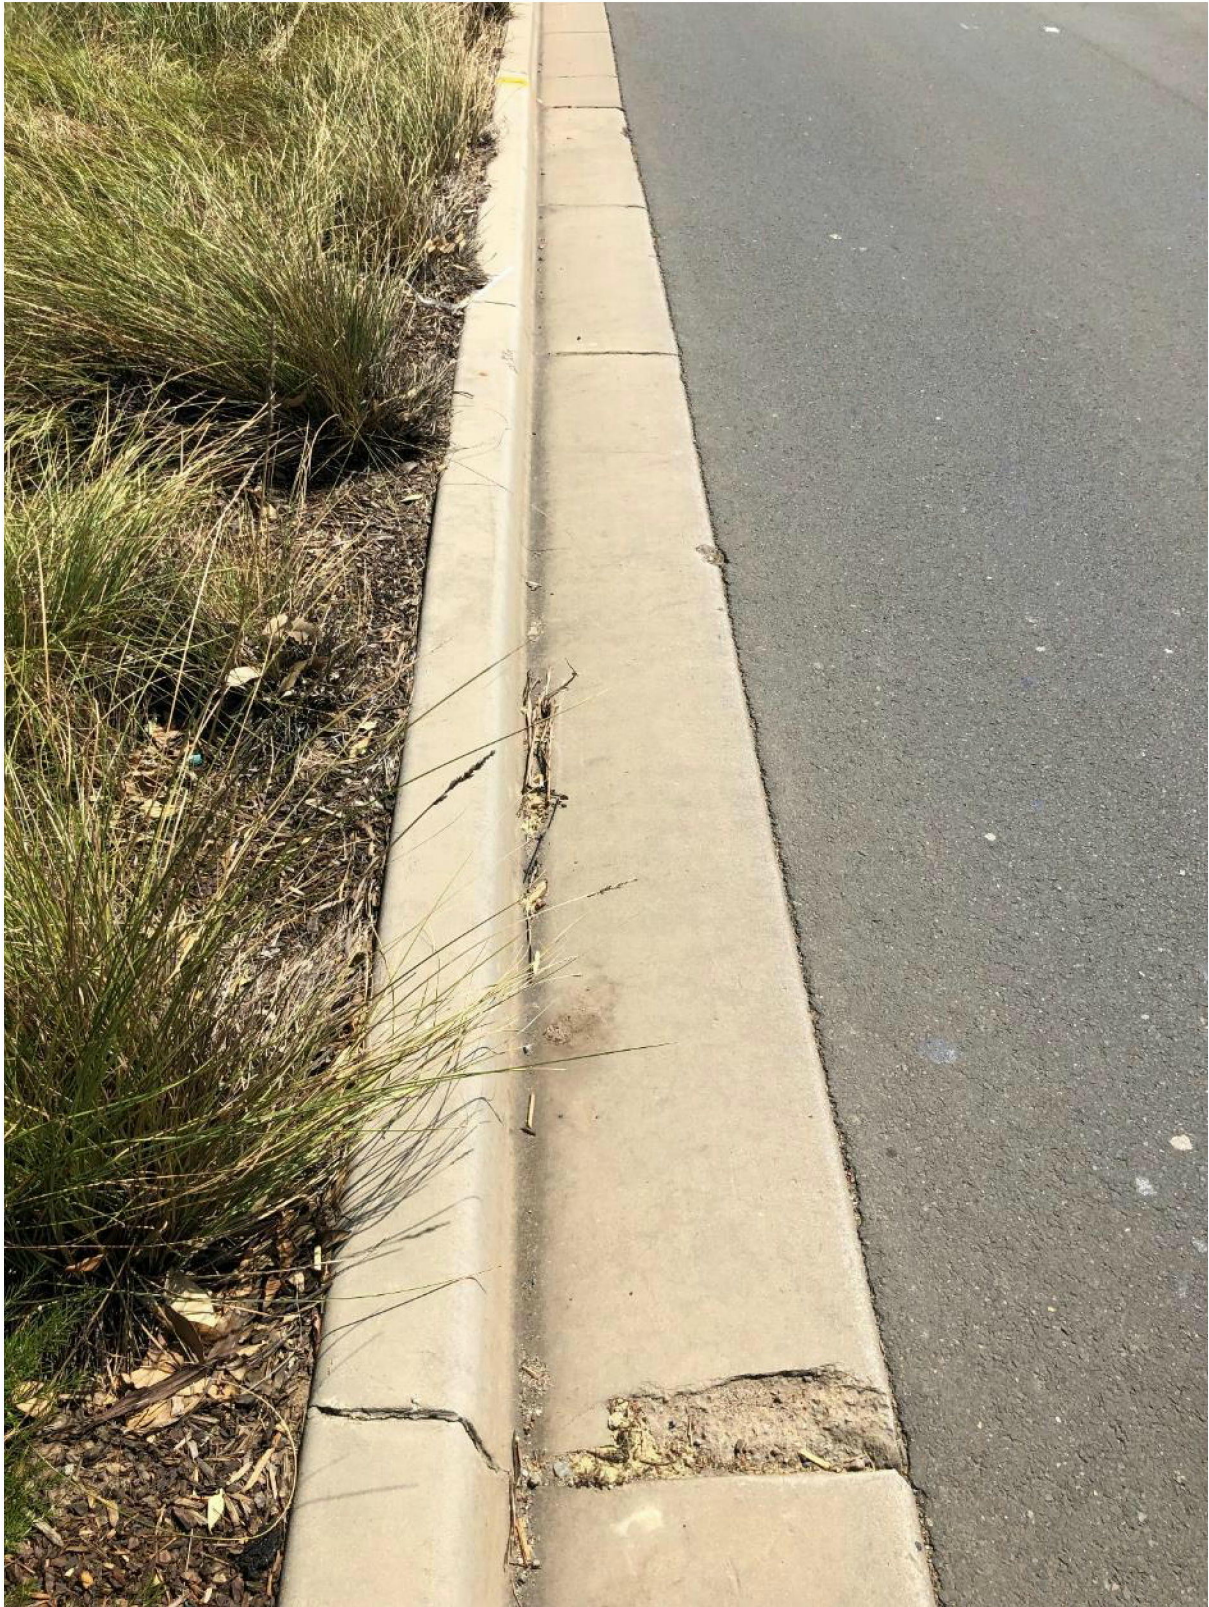
*Figure 55: spalling to gutter, expansion joint interface.*

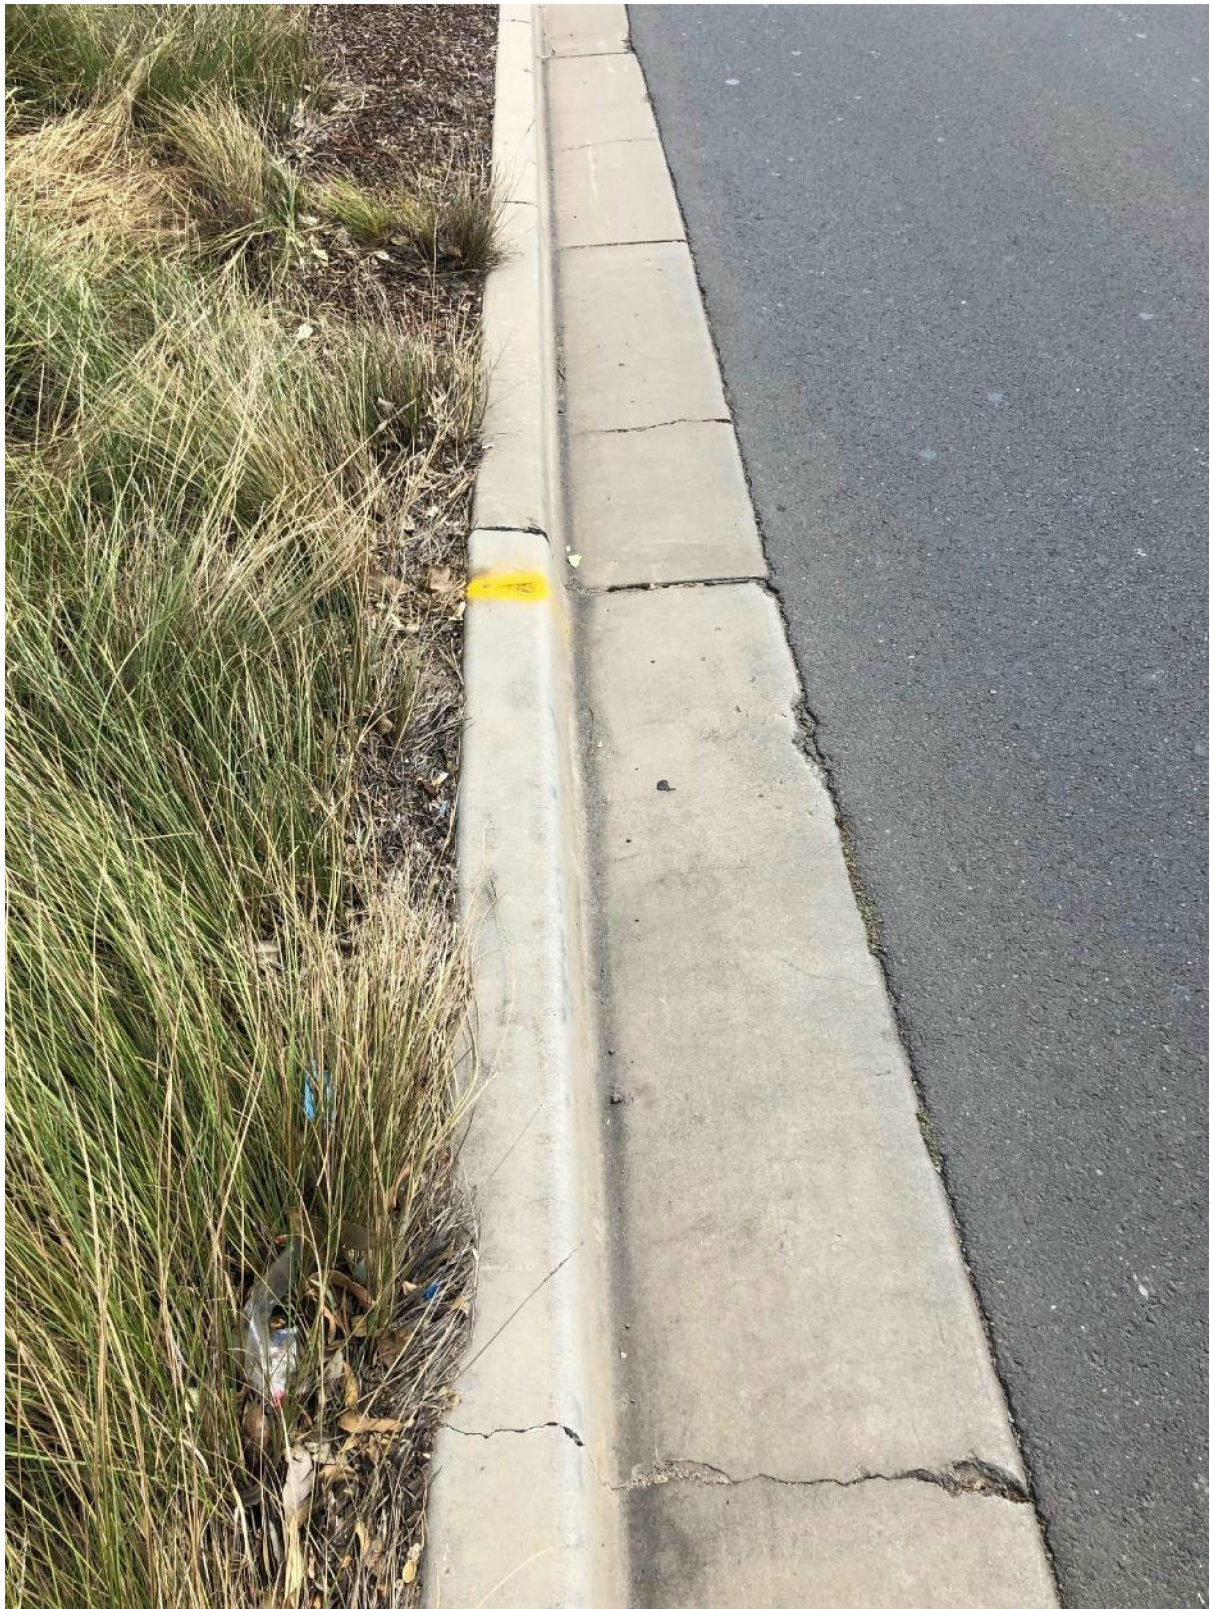
*Figure 56: crack on kerb and gutter.*

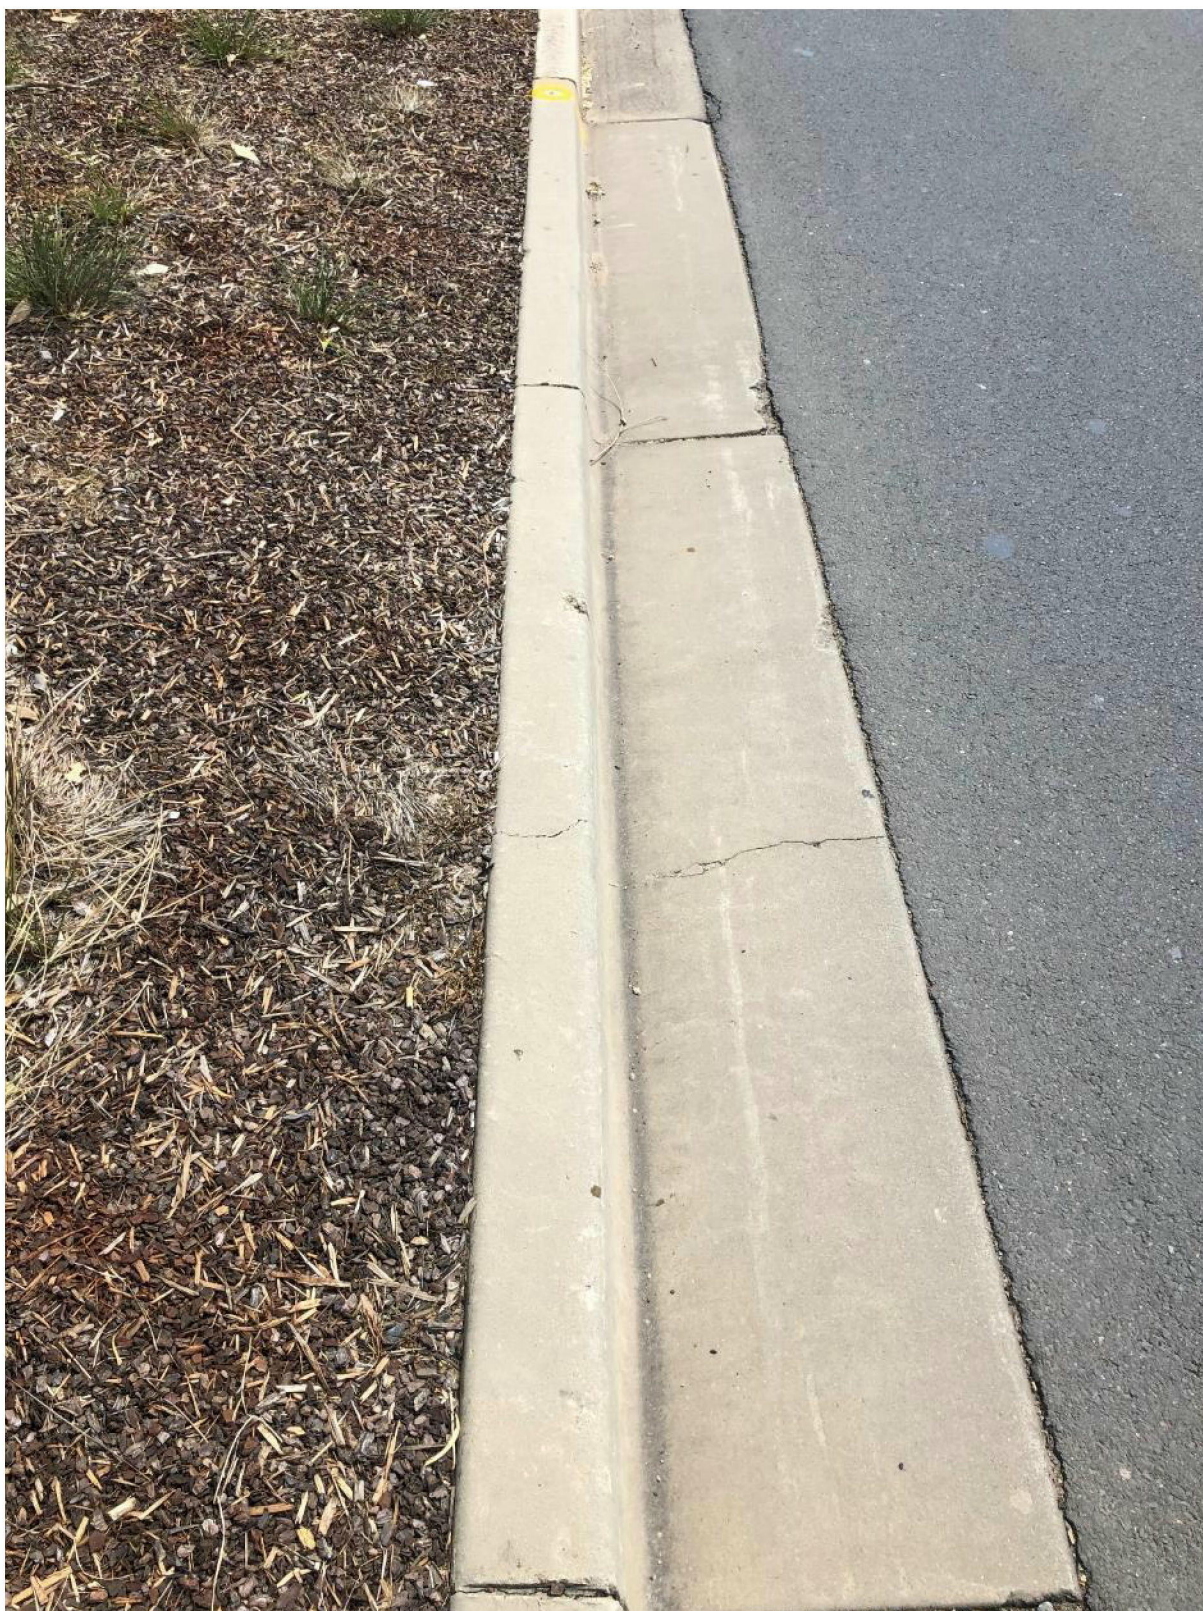
*Figure 57: cracking on kerb and gutter as well as chips to gutter.*

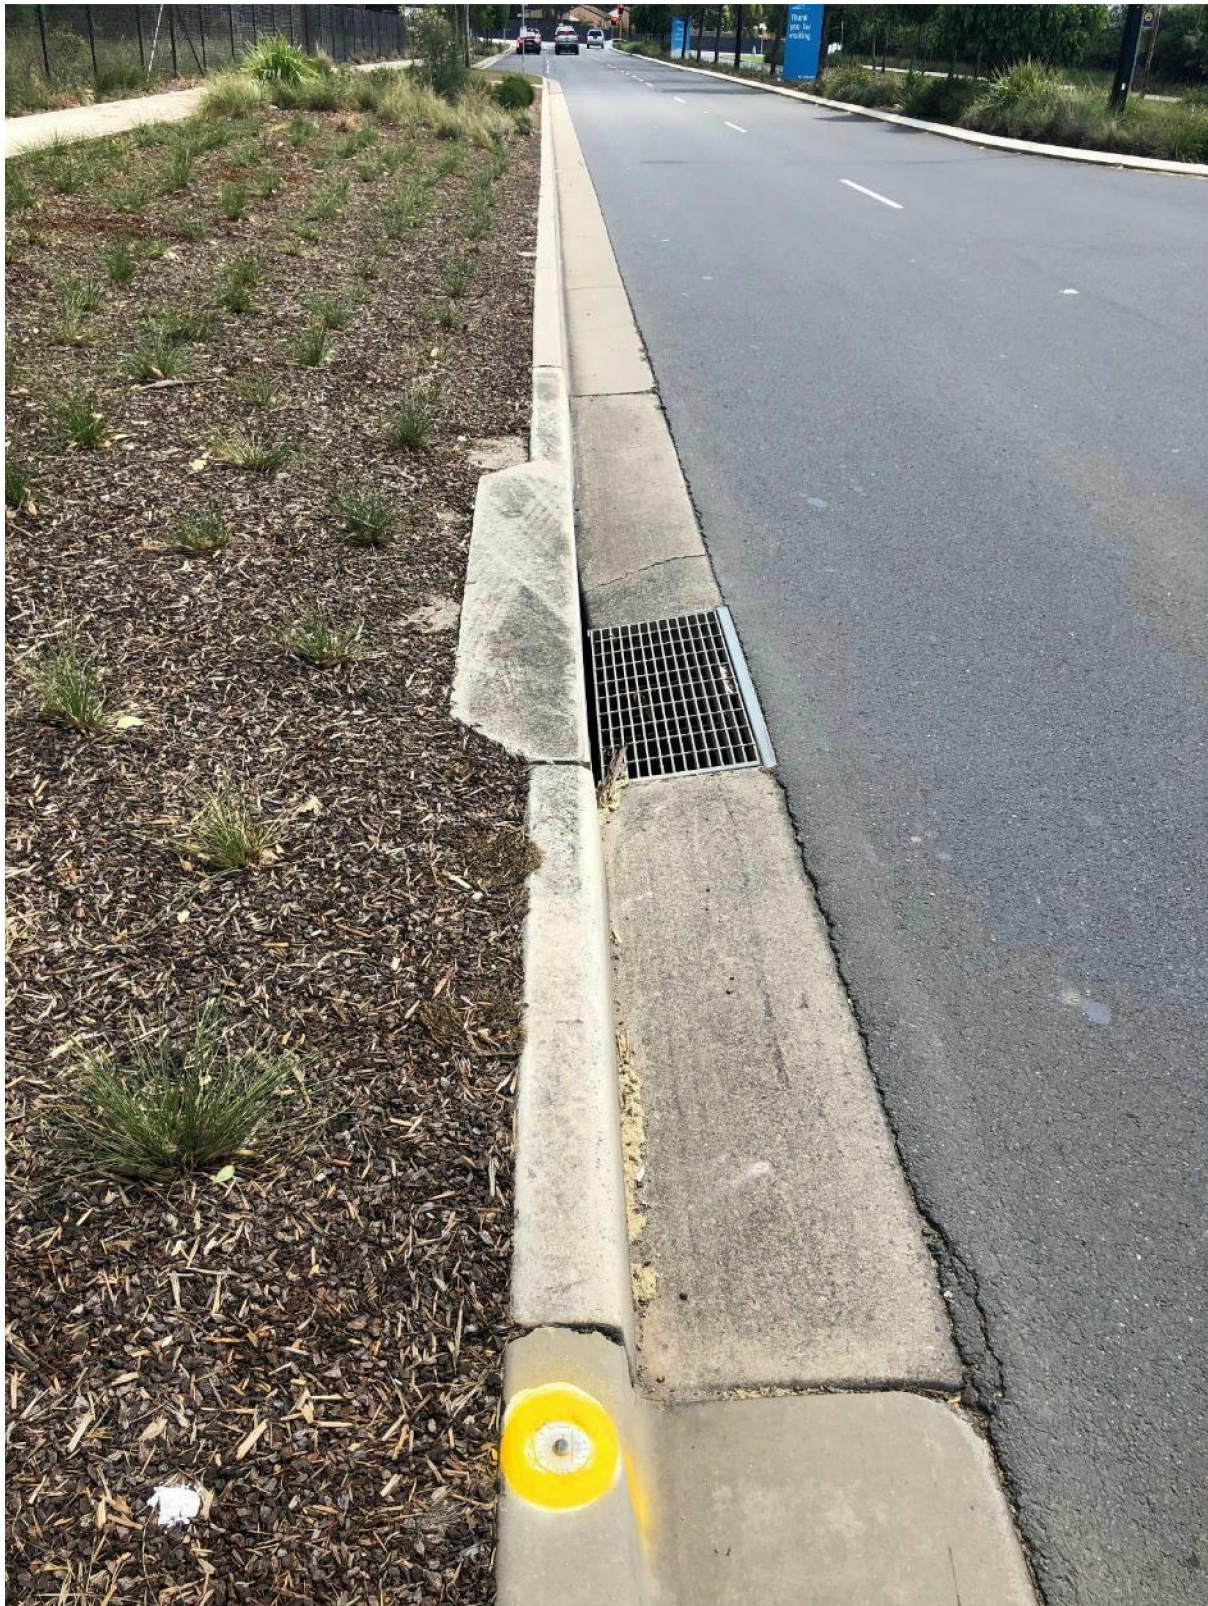
*Figure 58: damage to asphalt (adjacent to expansion joint), cracking to gutter (adjacent to SW pit) and damage to top of gutter (expansion joint interface).*

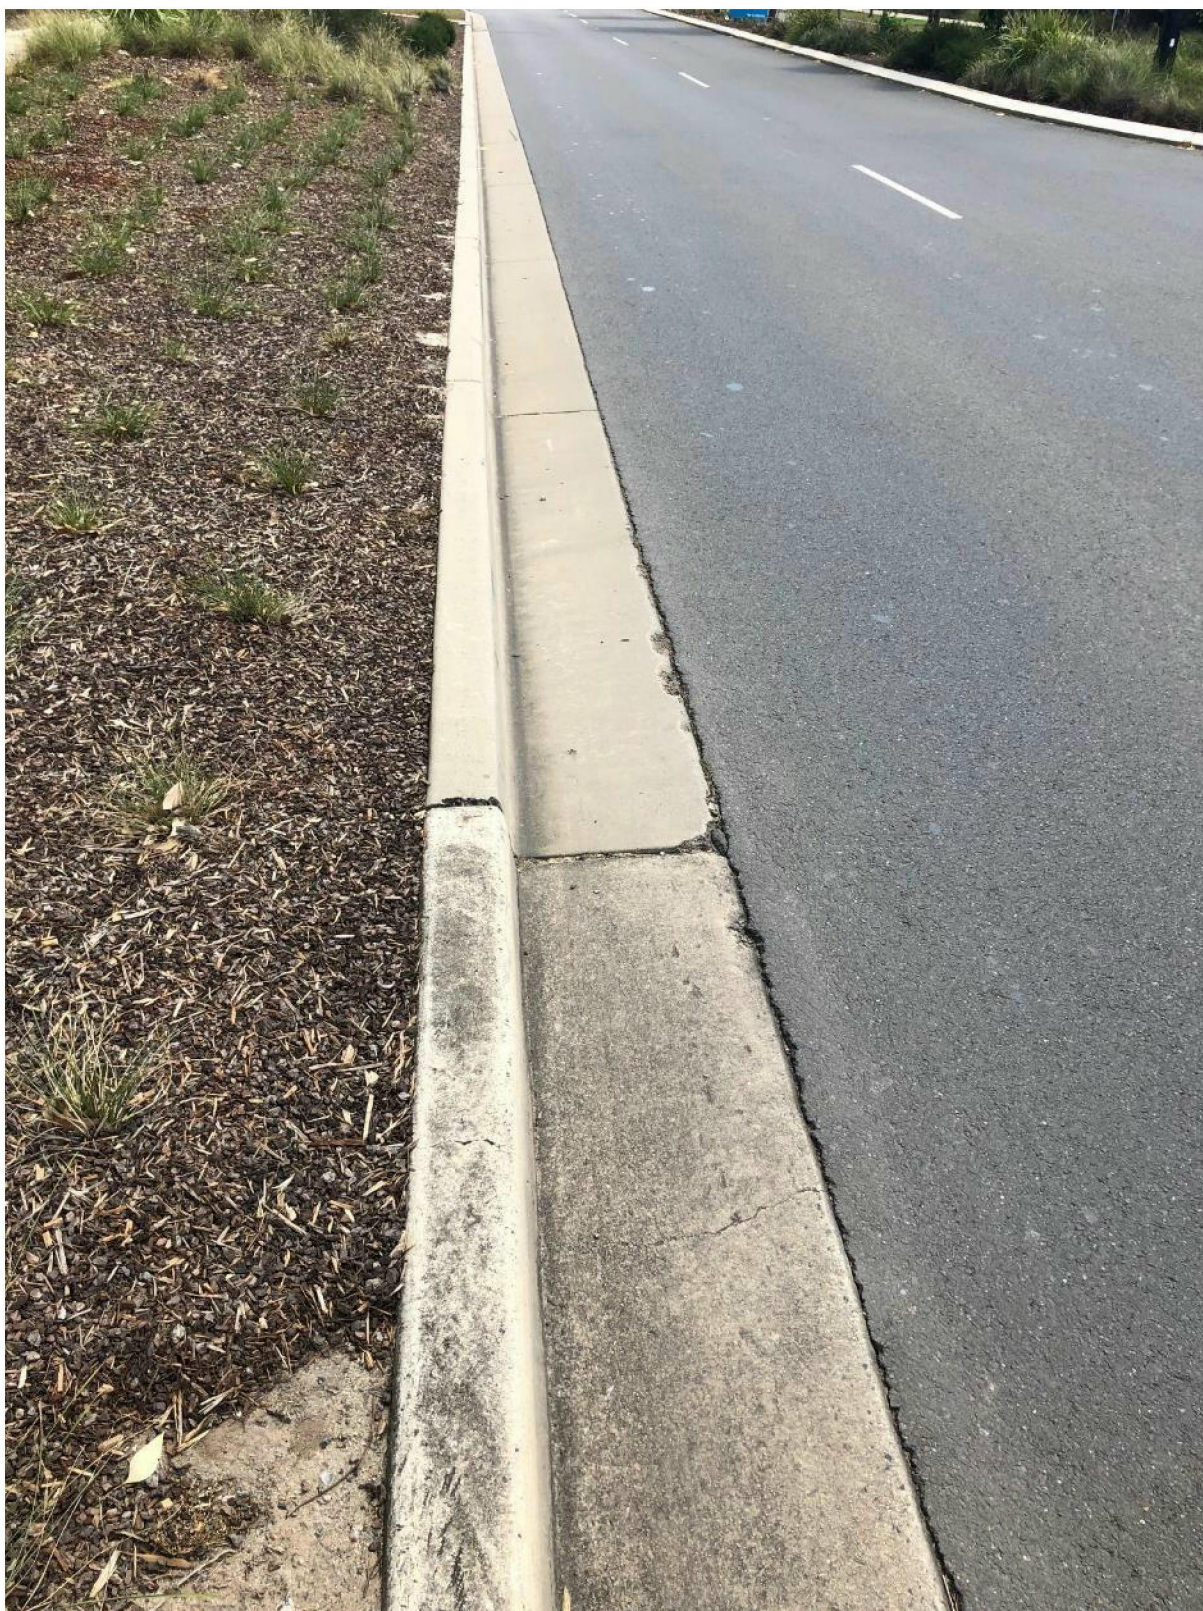
*Figure 59: chip to gutter and cracking to kerb and gutter.*
