# Dilapidation Report

Proposed Works - Jordan Springs Stage 2 Retirement Living

James Sae Siew  
5<sup>th</sup> March 2019  
Revision 1

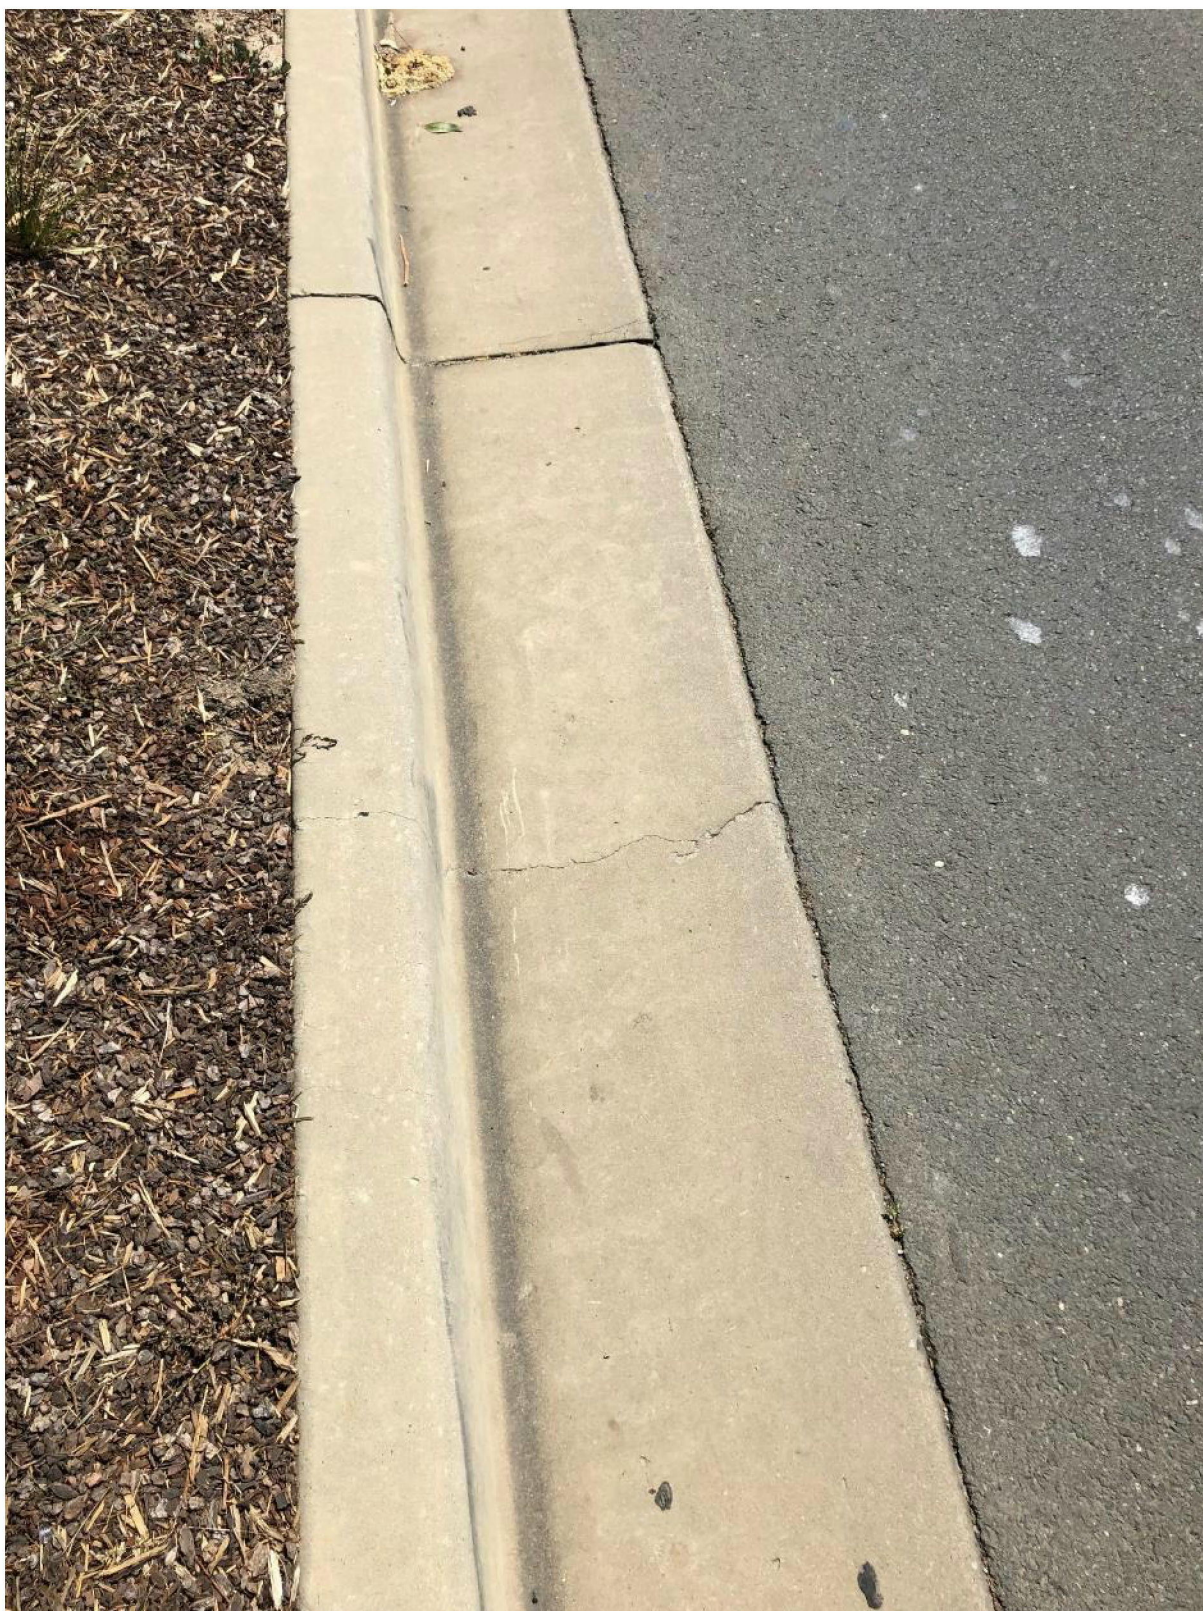
*Figure 60: cracking to kerb and gutter.*

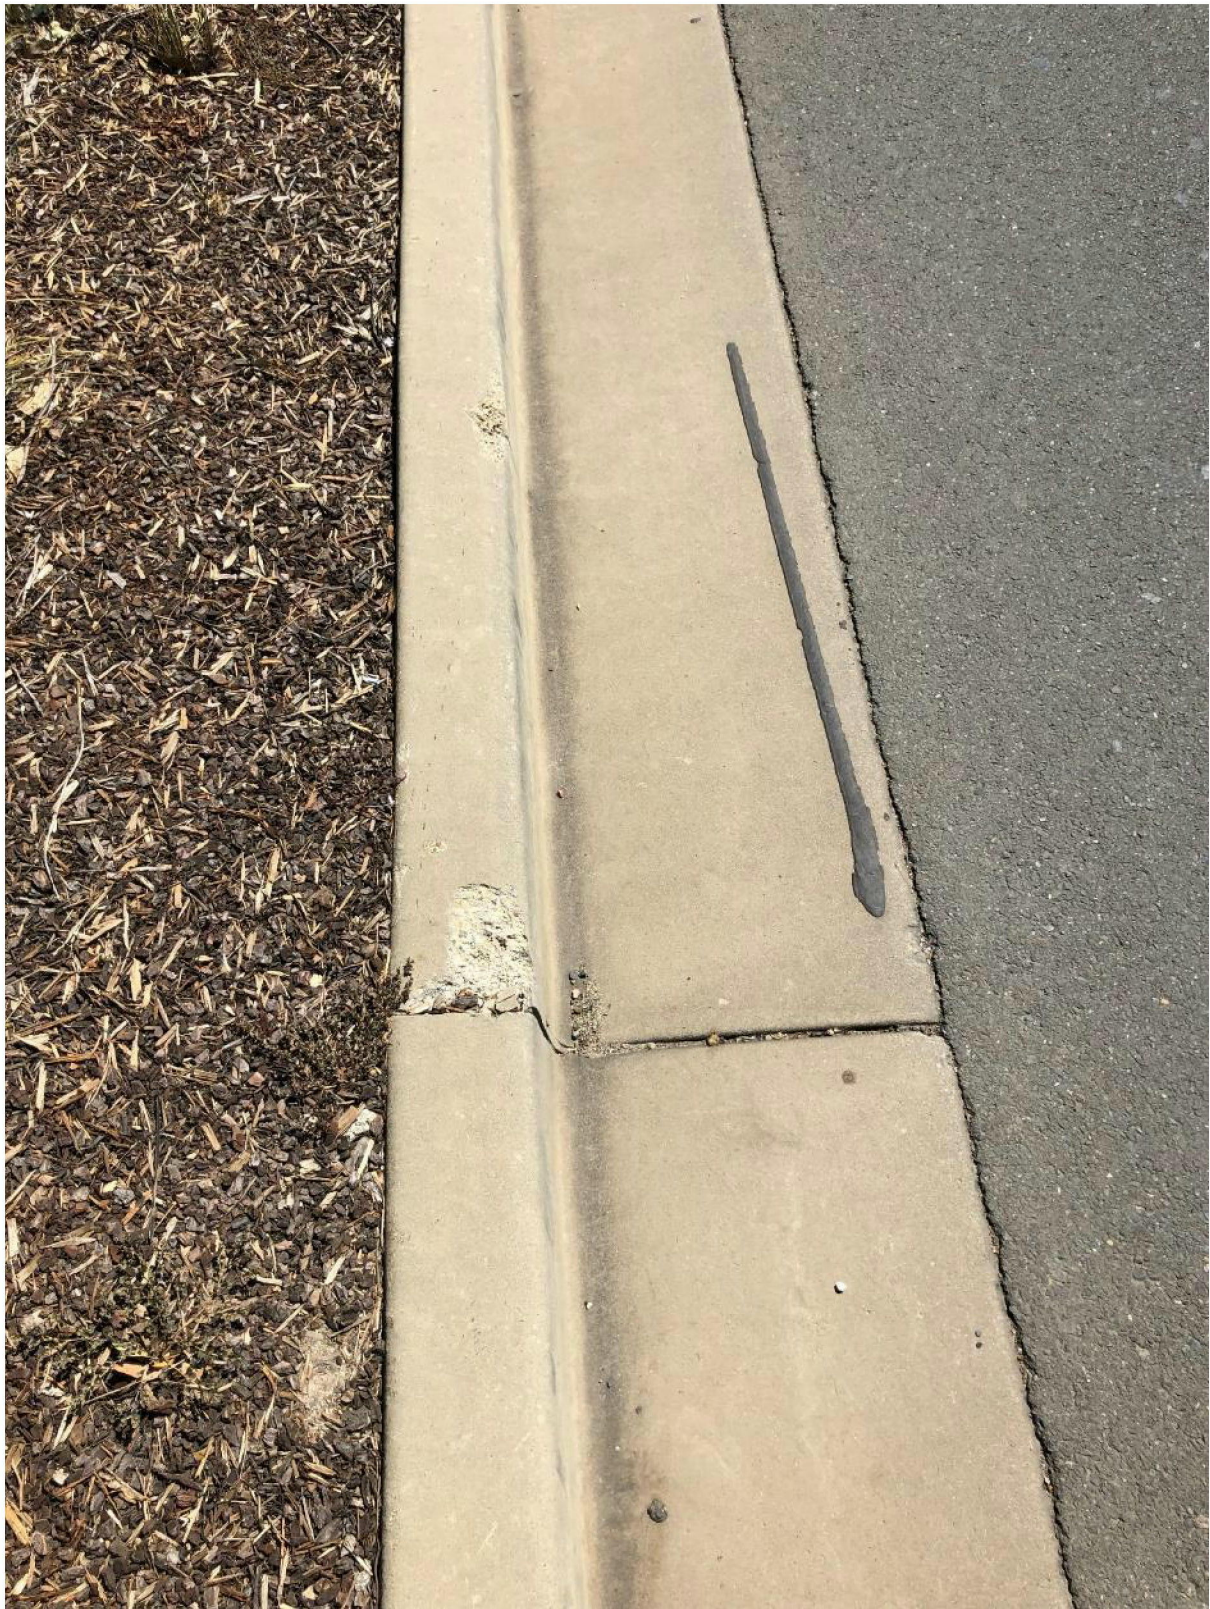
*Figure 61: chip to top of kerb. Crack seal residue on gutter.*

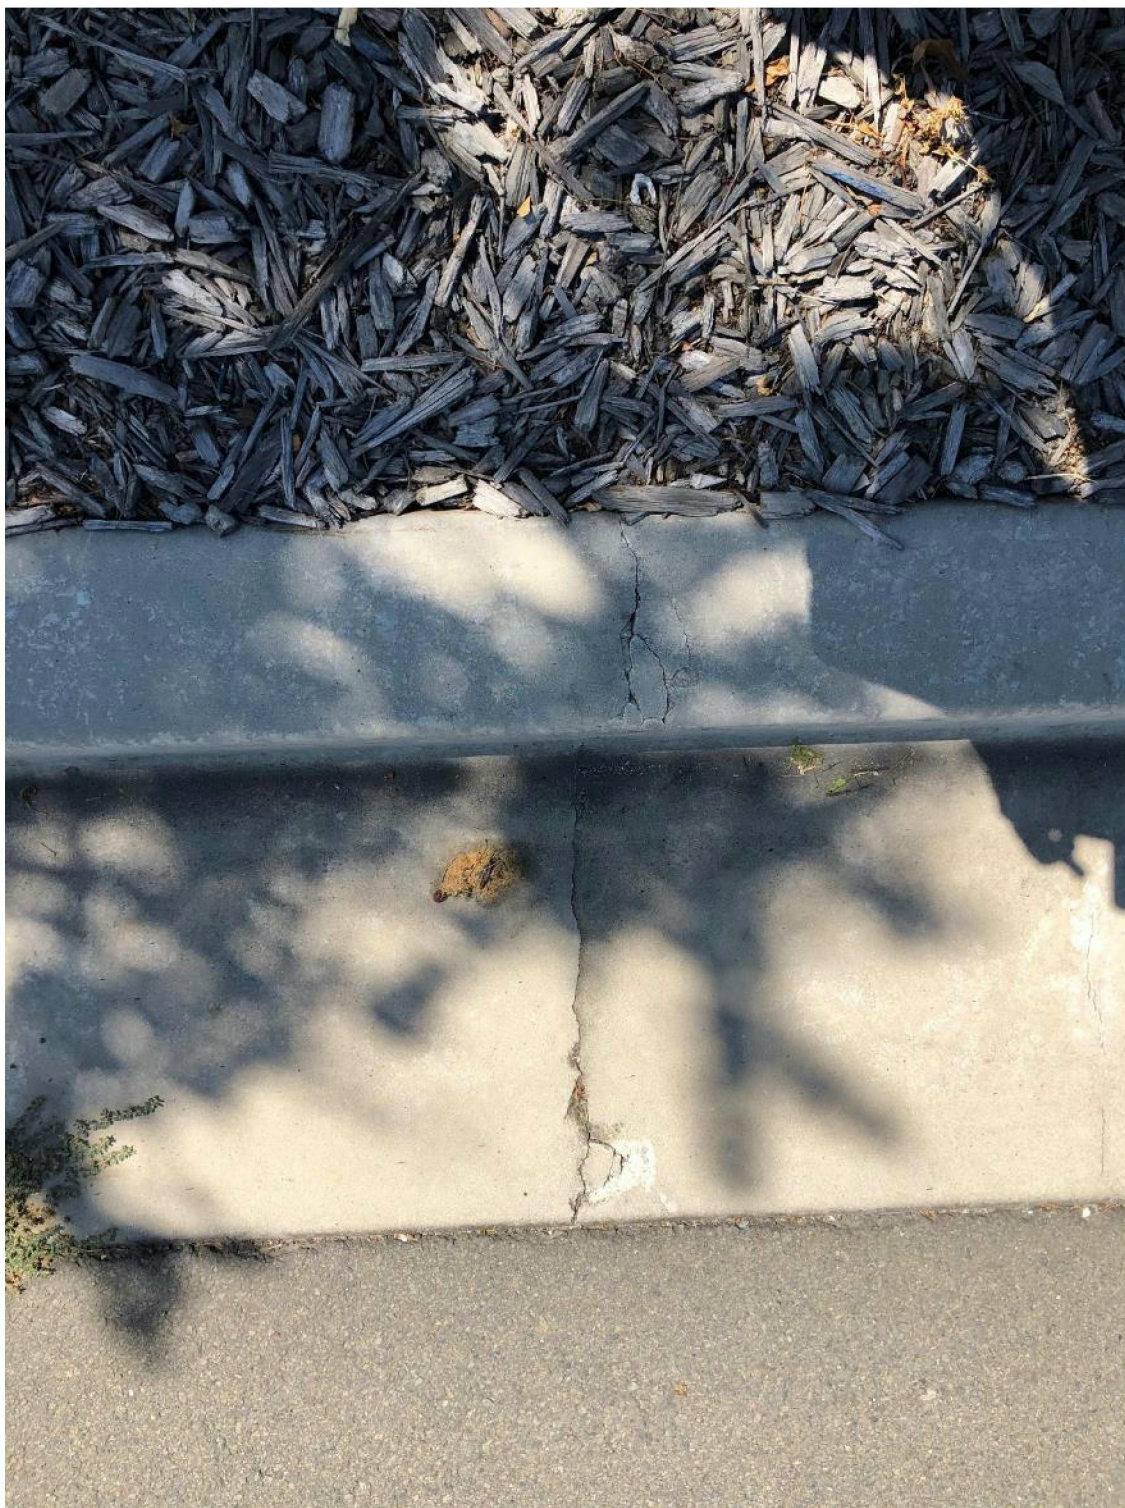
*Figure 62: cracking to kerb and gutter.*

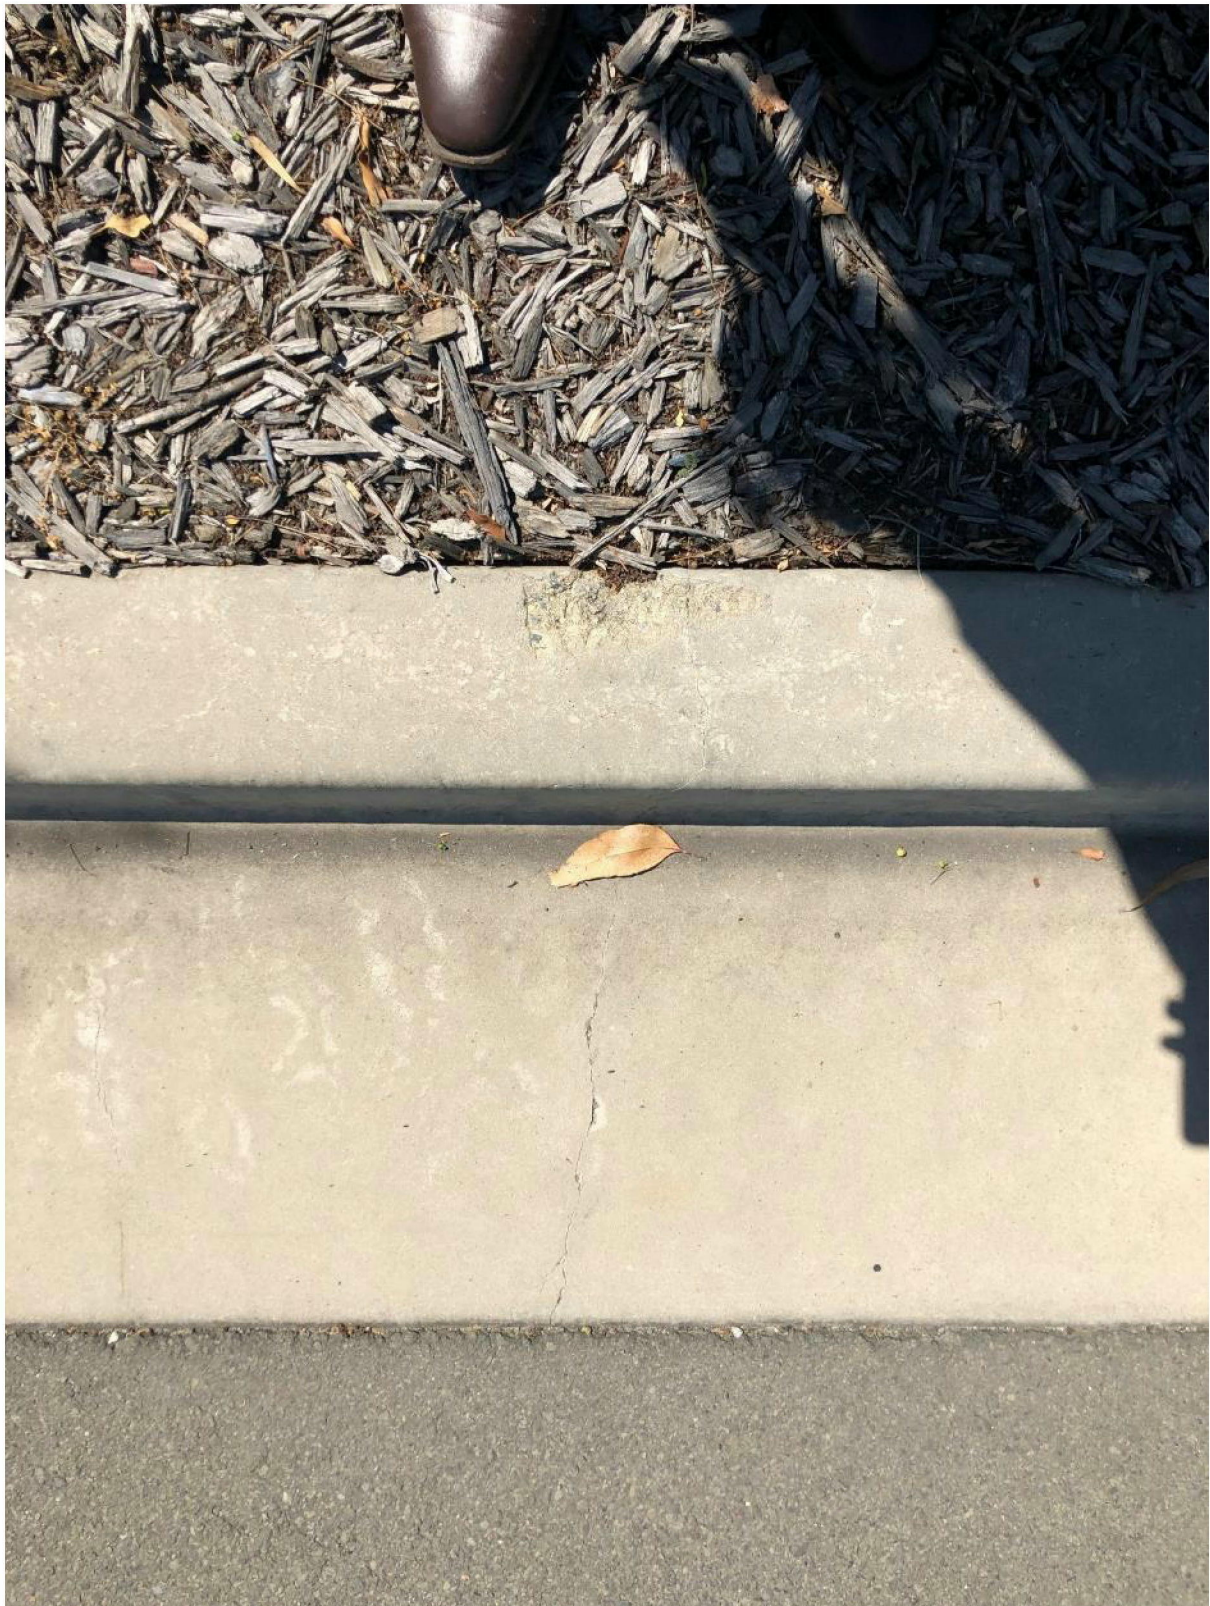
*Figure 63: chip on top of kerb and minor cracking on gutter.*

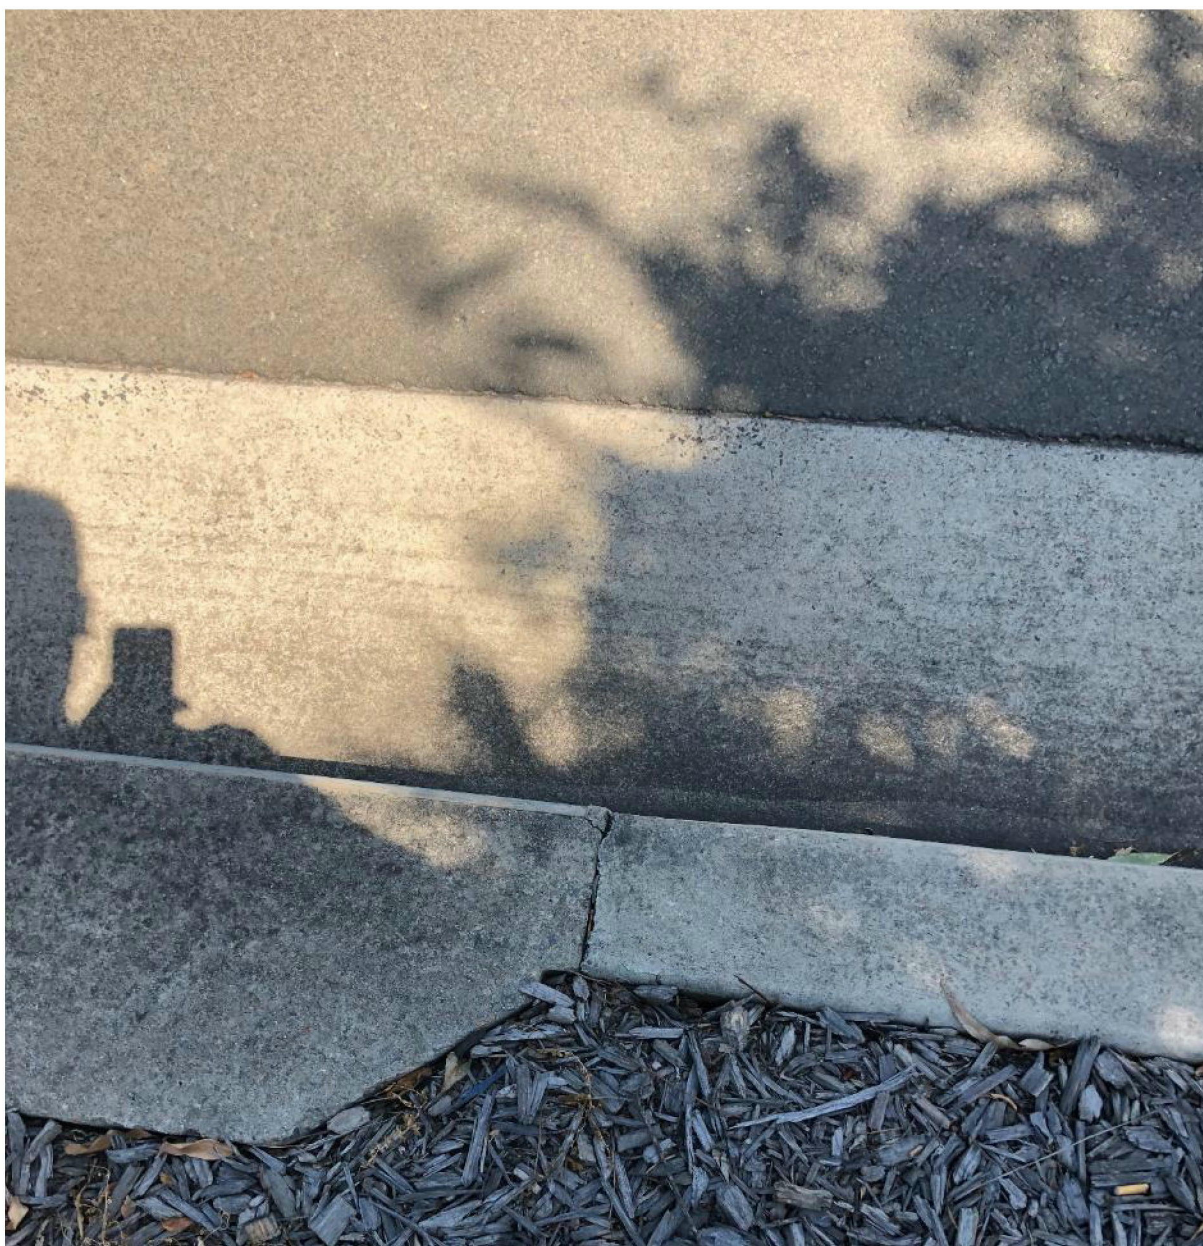
*Figure 64: cracking at lintel and kerb joint (both sides of lintel).*

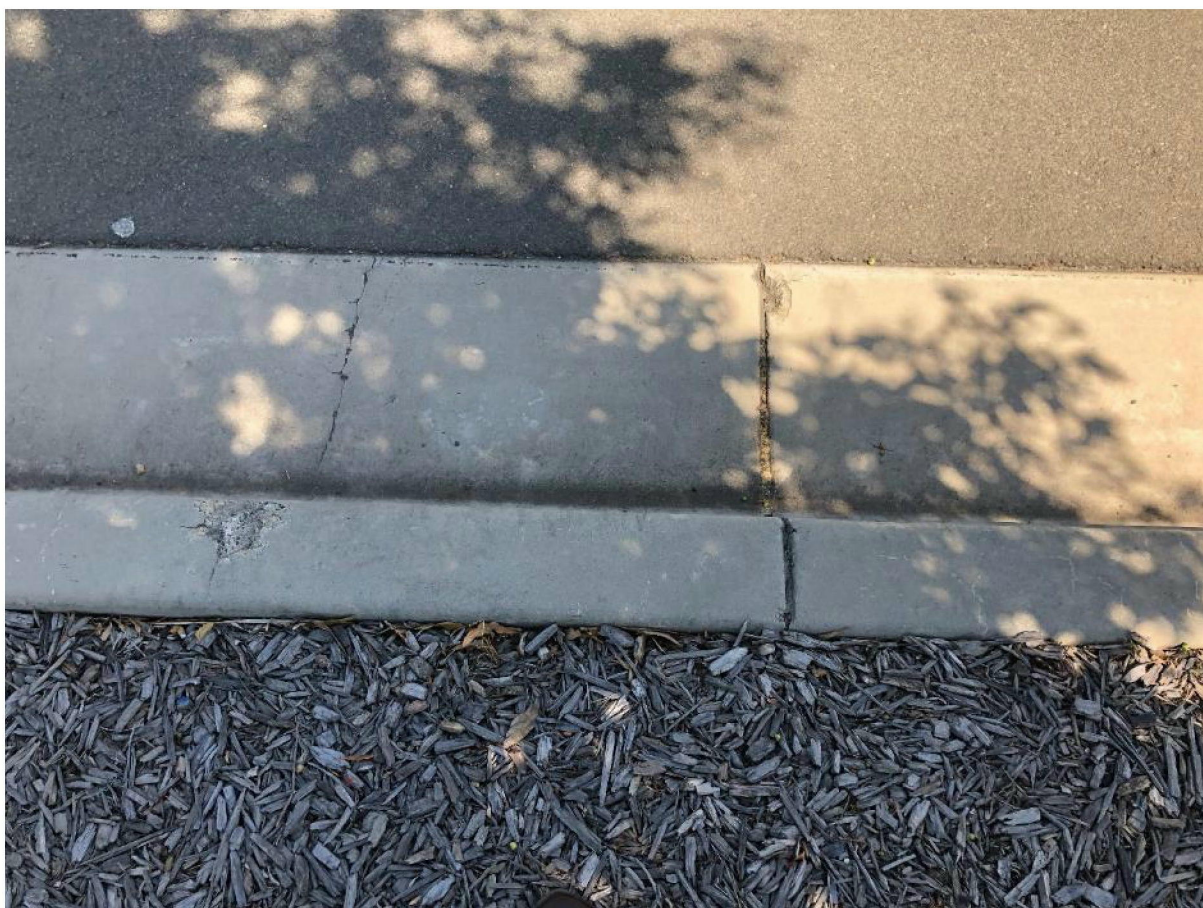
*Figure 66: chip to top of kerb and cracking on gutter.*

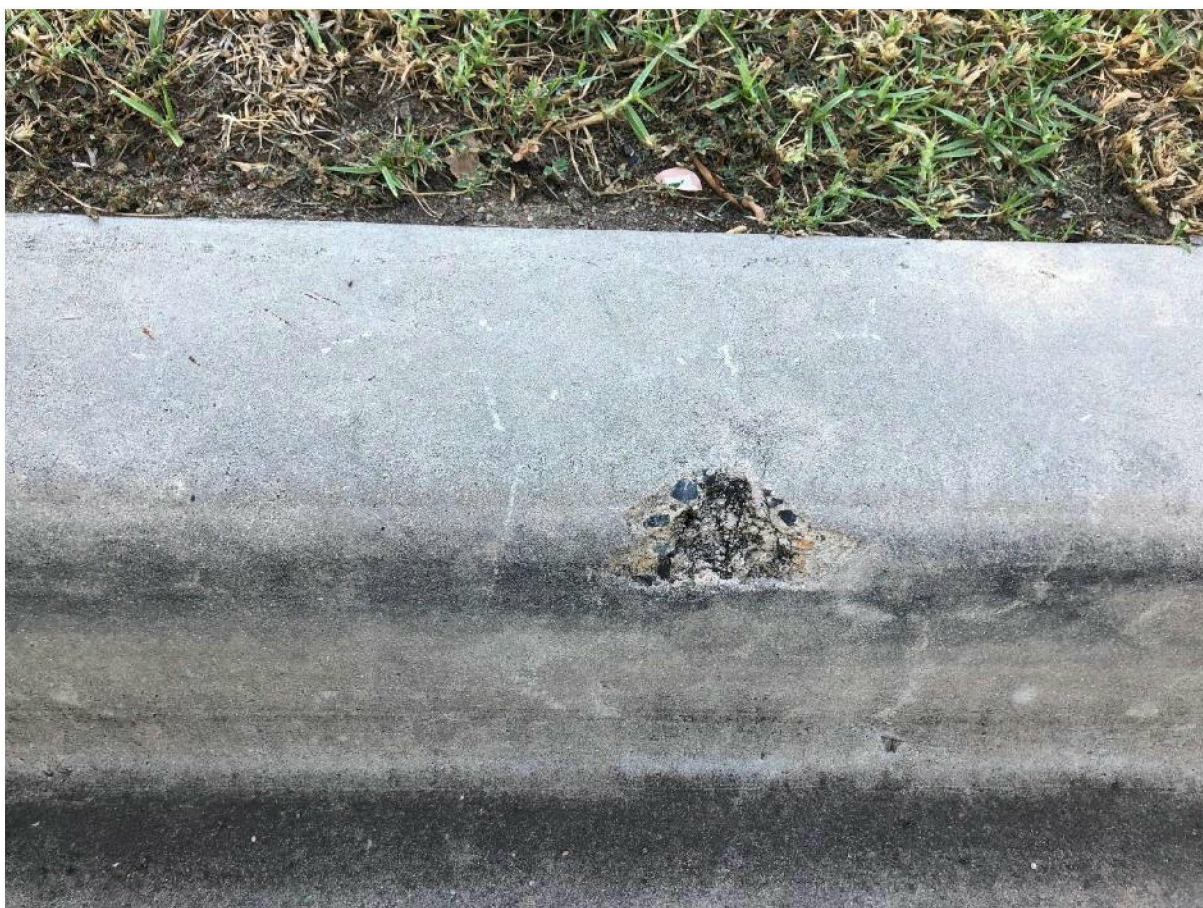
*Figure 67: chip on top of kerb.*

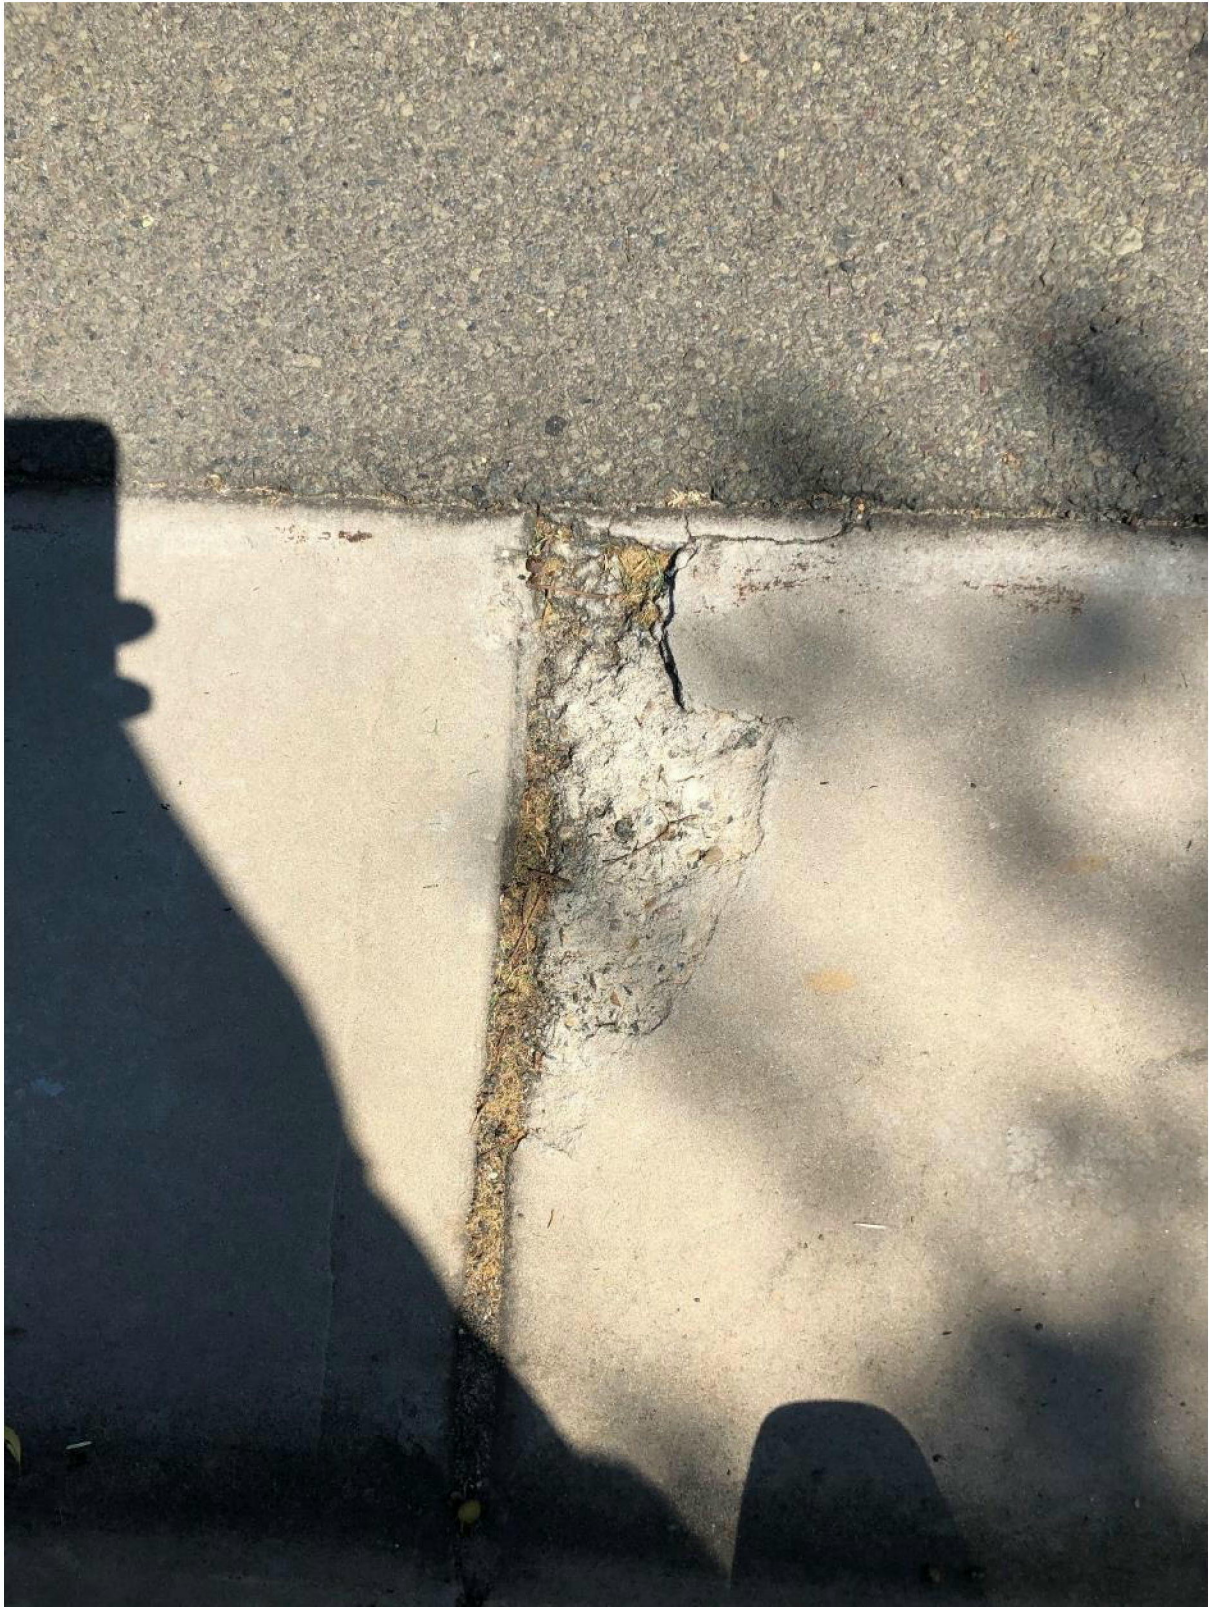
*Figure 68: spalling to gutter construction joint interface.*

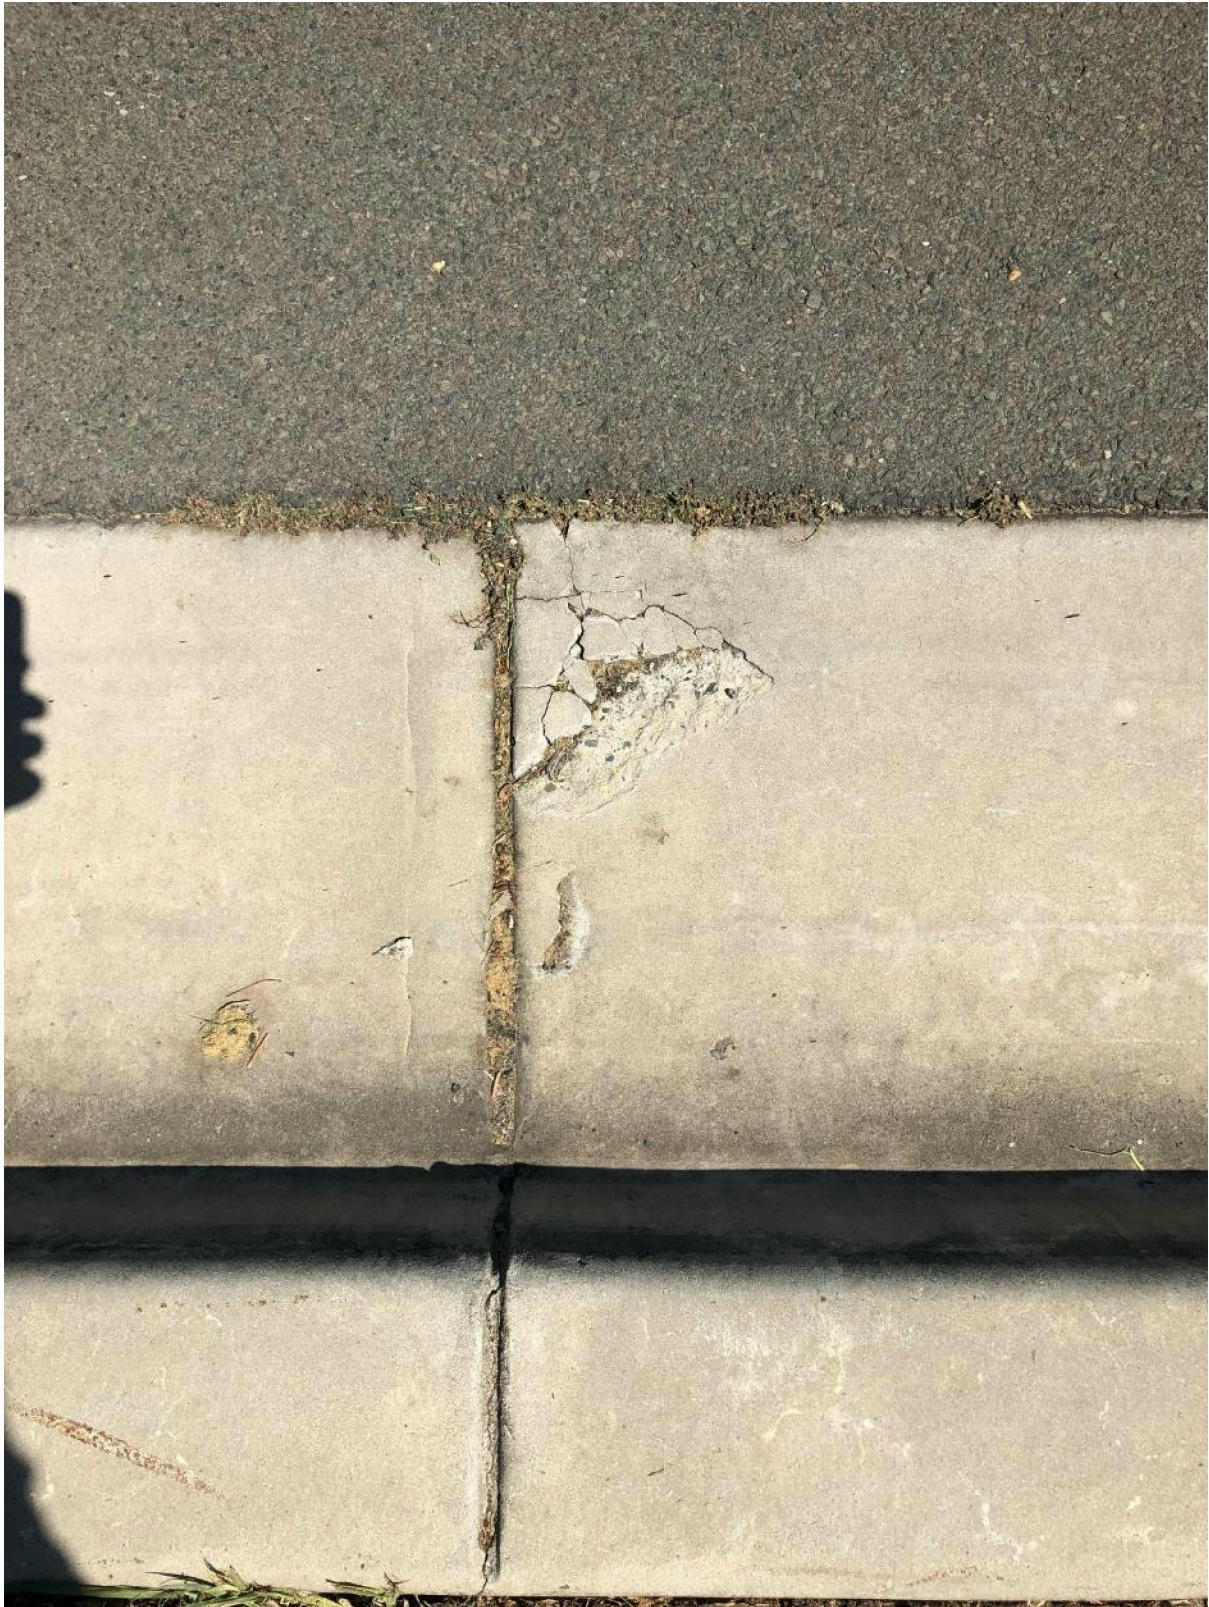
*Figure 69: chip to gutter construction joint interface.*

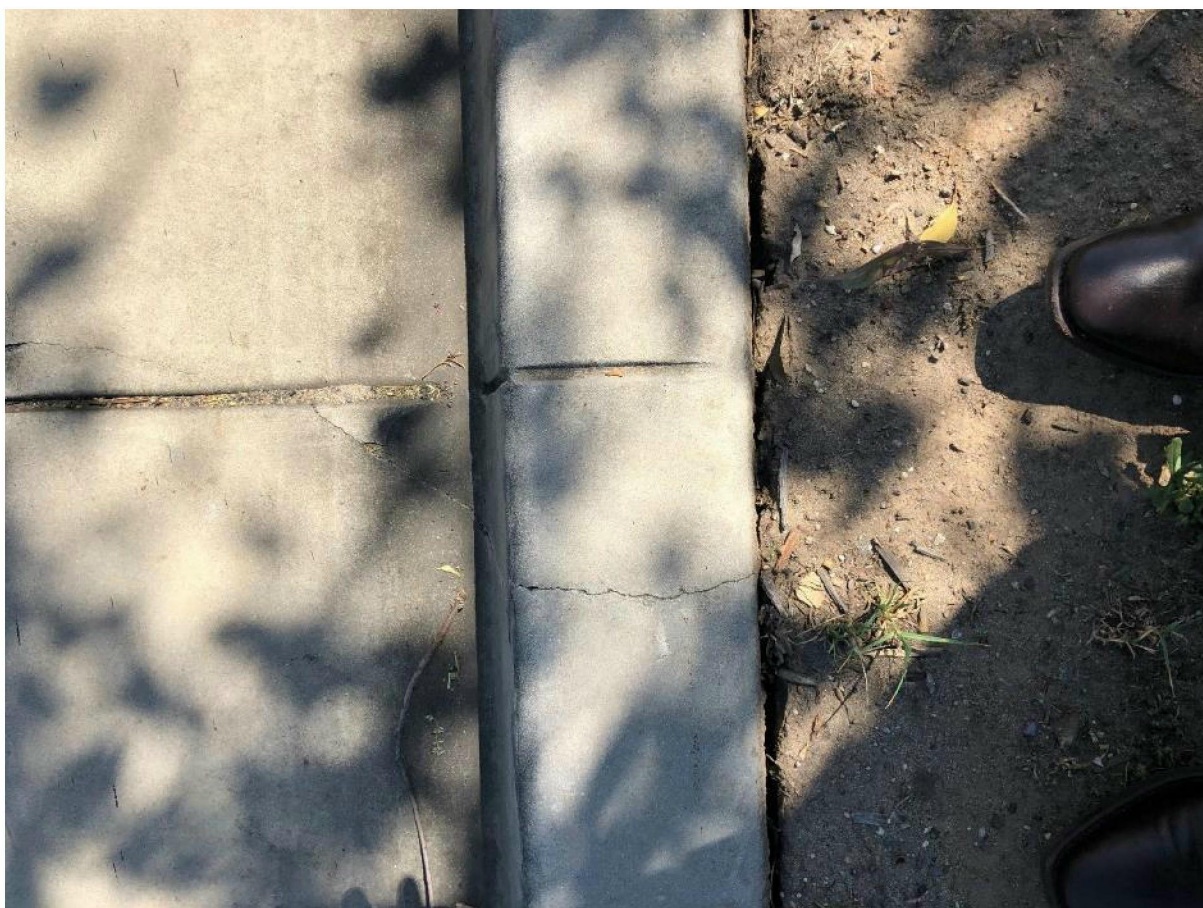
*Figure 70: cracking to kerb and gutter.*

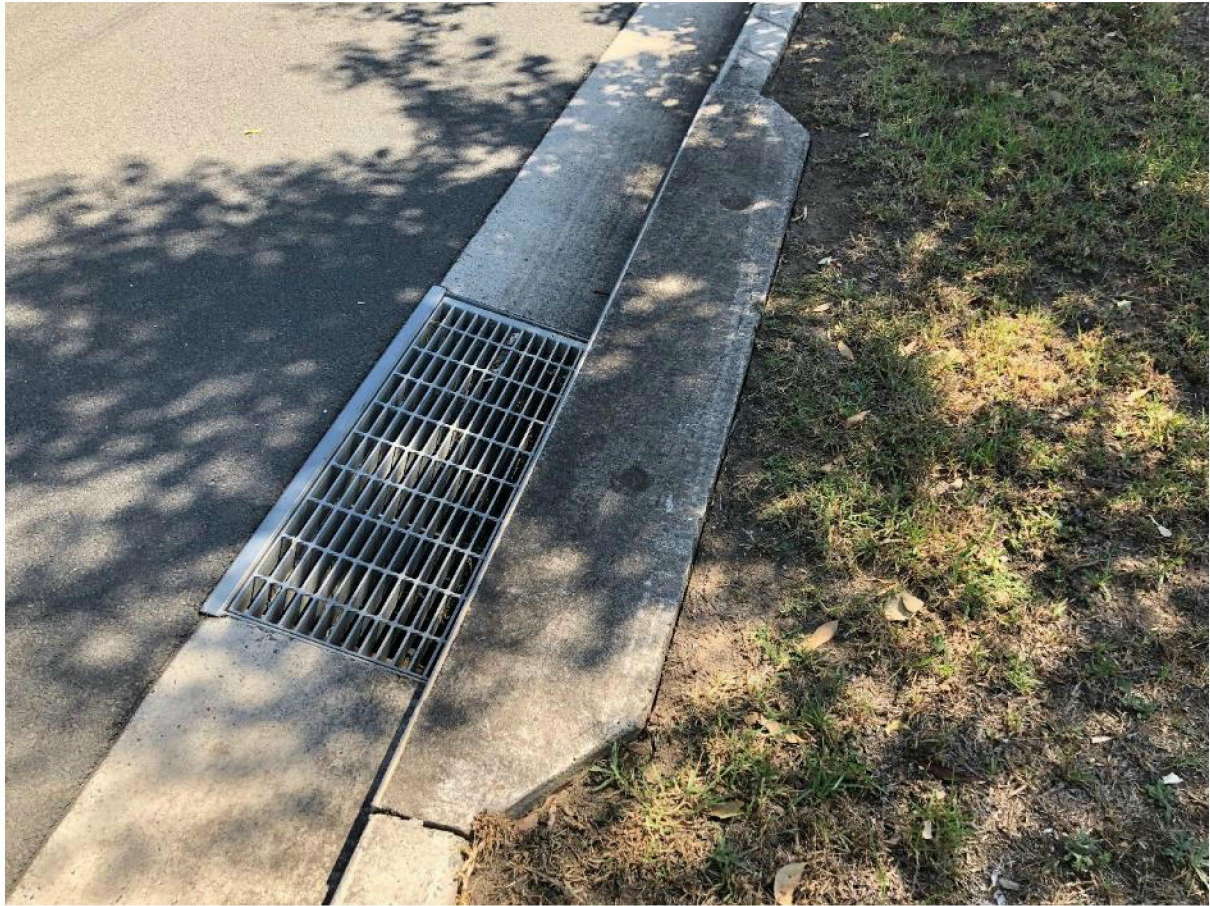
*Figure 71: cracking to lintel and kerb joint (both sides).*

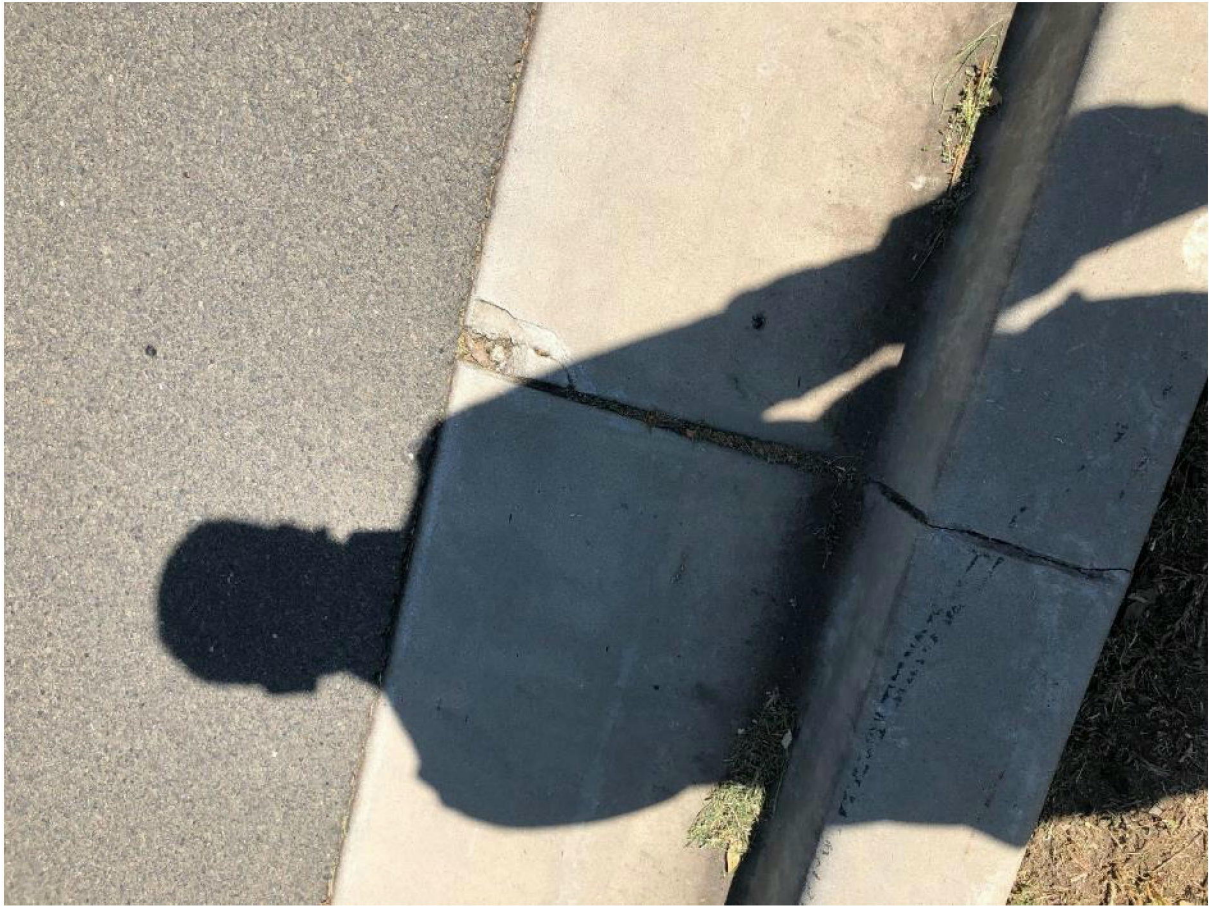
*Figure 72: chip to gutter at construction joint interface.*

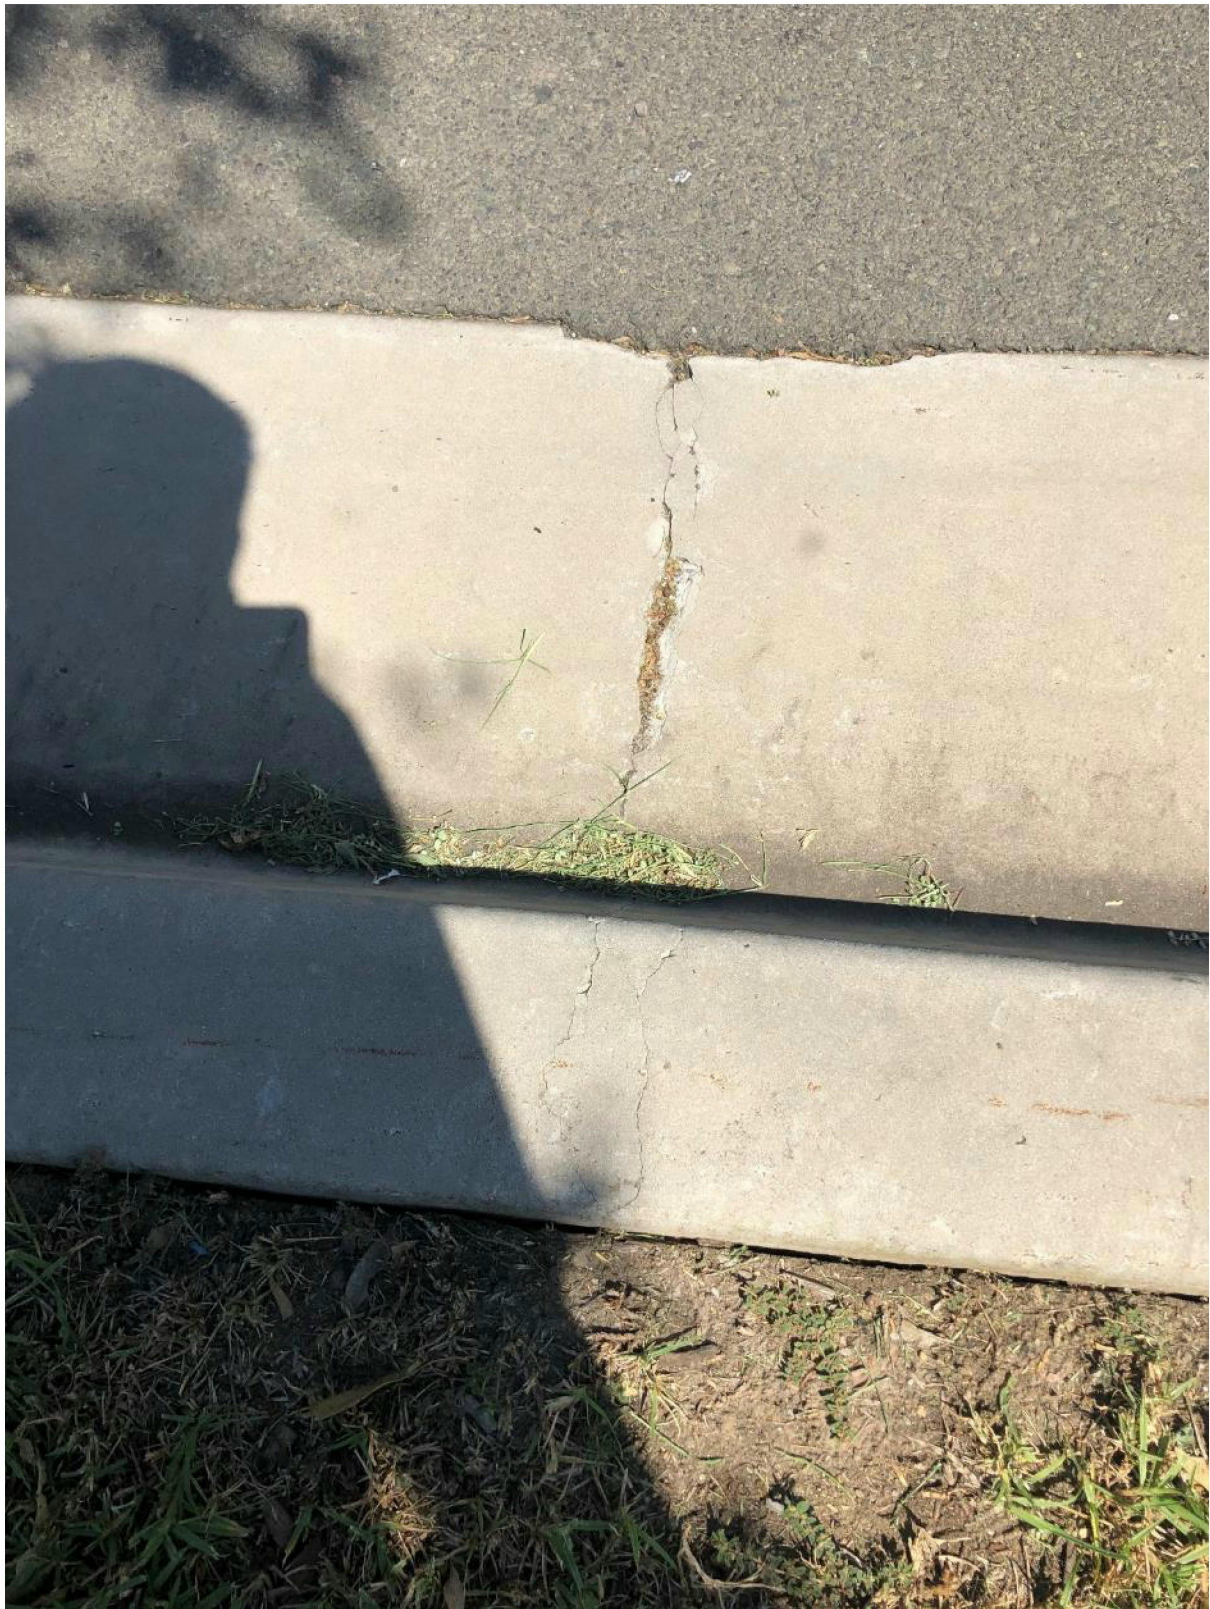
*Figure 73: cracking to gutter and top of kerb.*

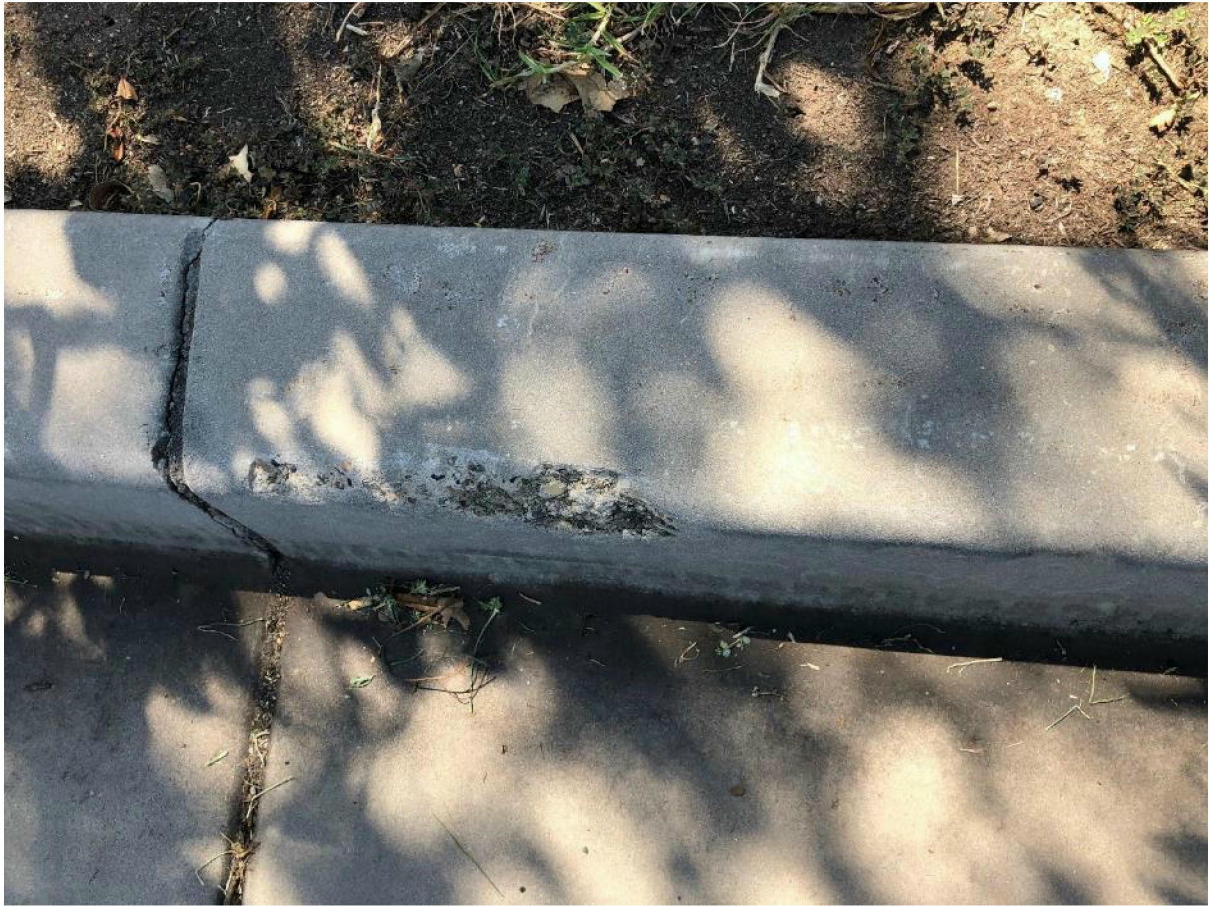
*Figure 74: chip to top of gutter.*

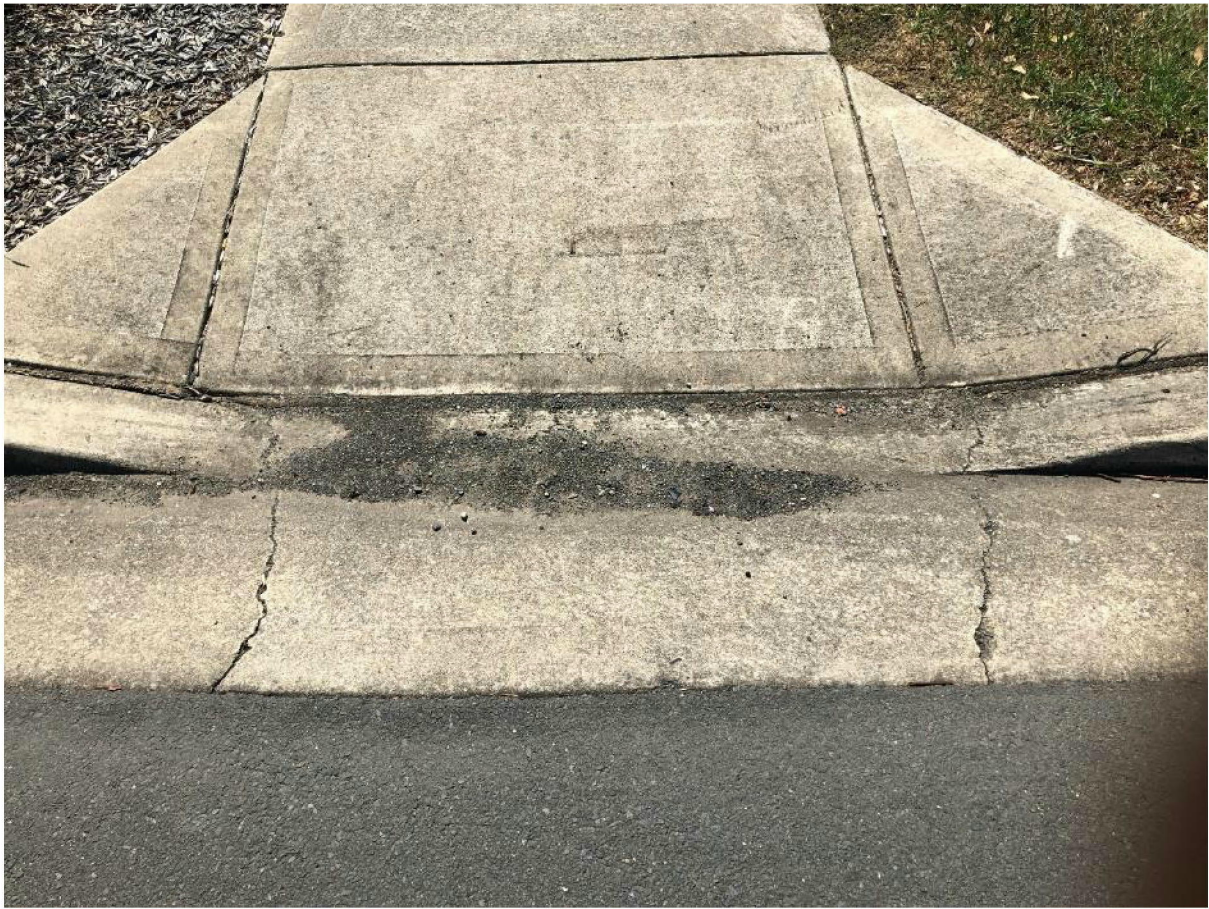
*Figure 81: cracking to gutter, adjacent to flat portion of eastern pram ramp.*
