# Dilapidation Report

Proposed Works - Jordan Springs Stage 2 Retirement Living

James Sae Siew  
5<sup>th</sup> March 2019  
Revision 1

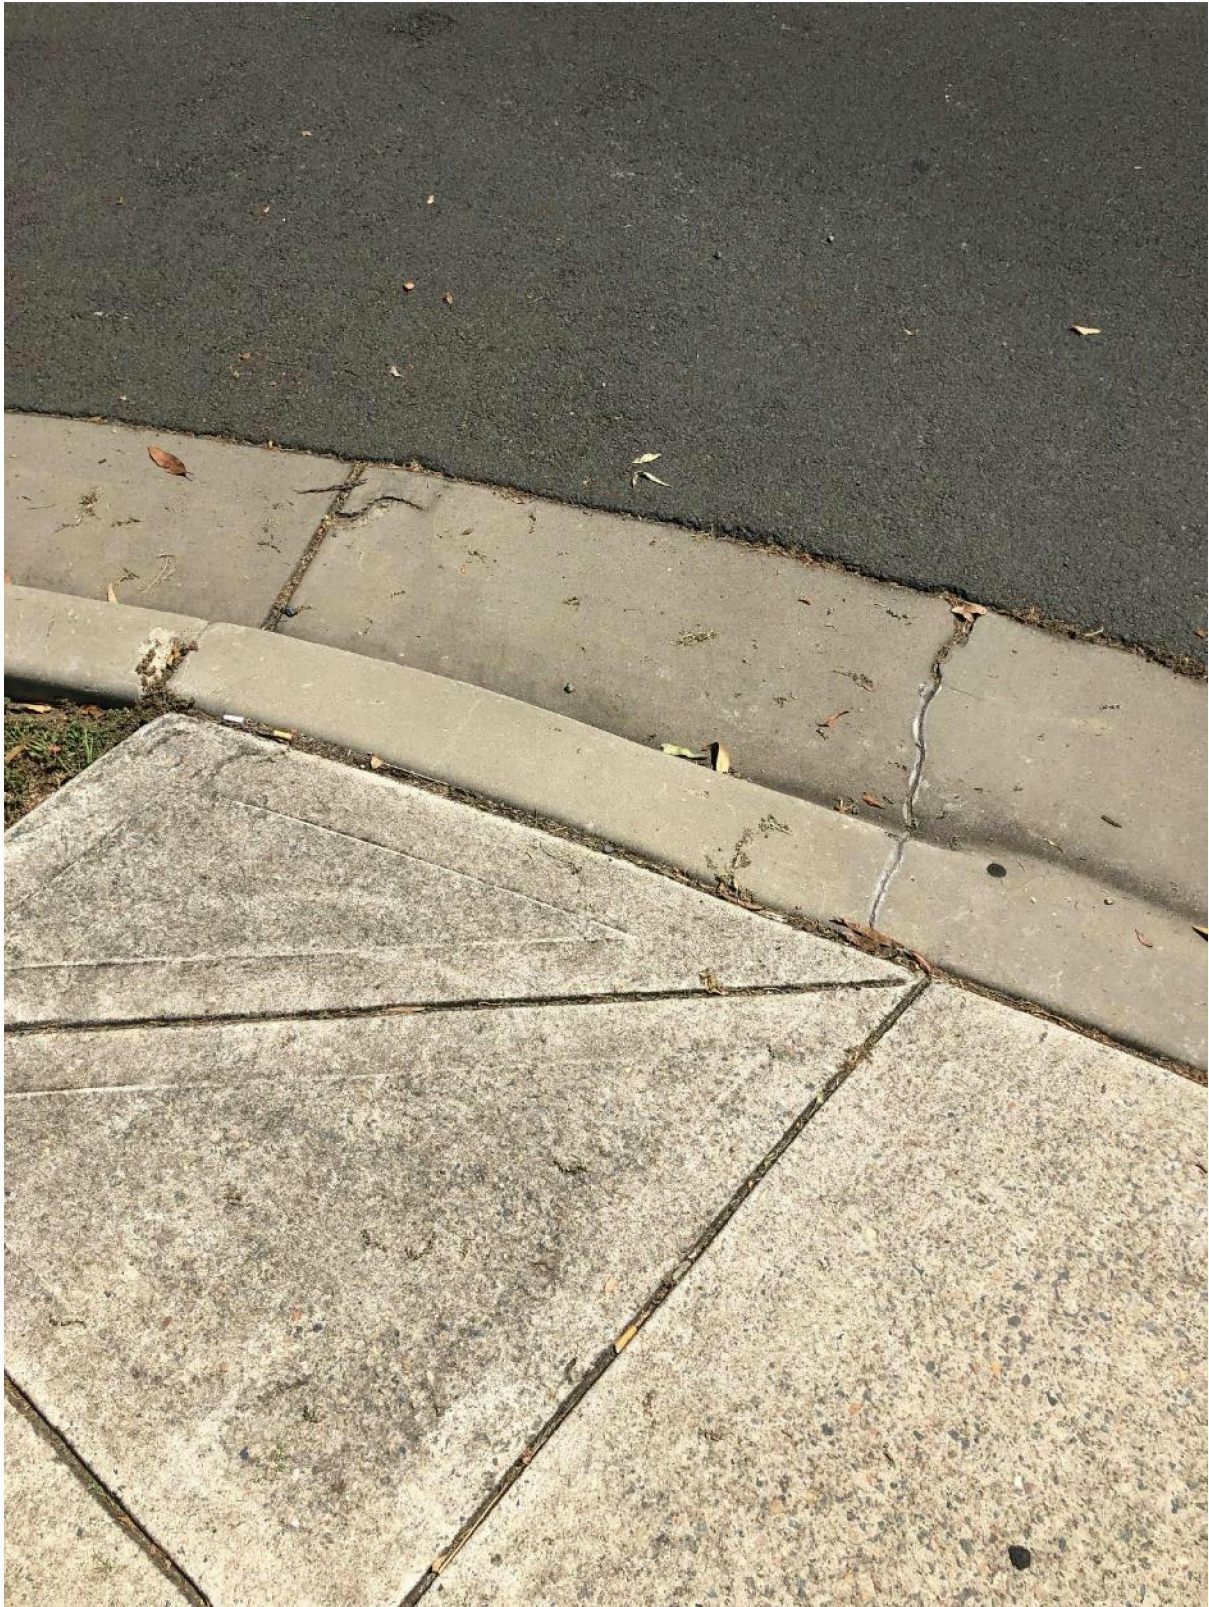
*Figure 82: cracking to kerb and gutter, adjacent to right portion bottom of wing.*

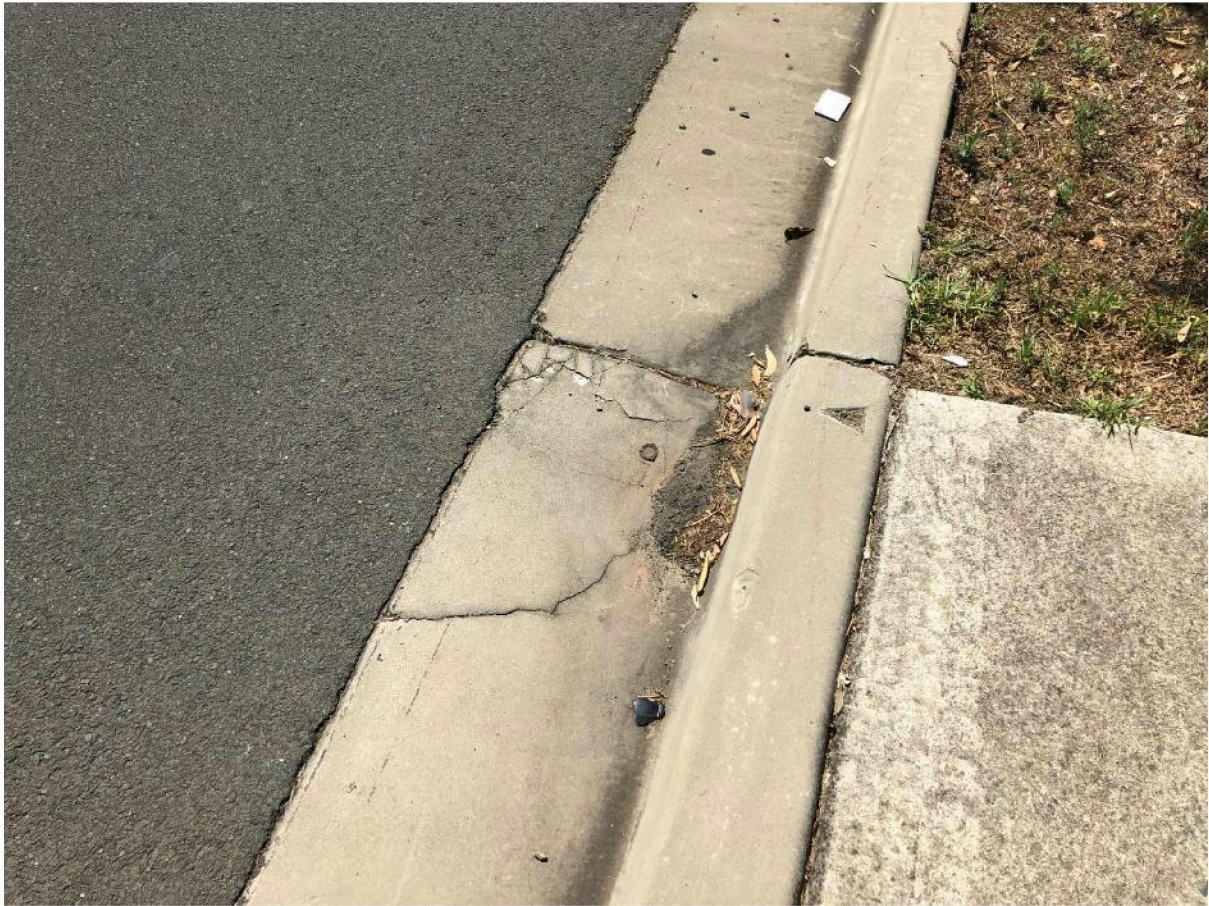
*Figure 83: cracking to gutter, adjacent to top of left wing.*

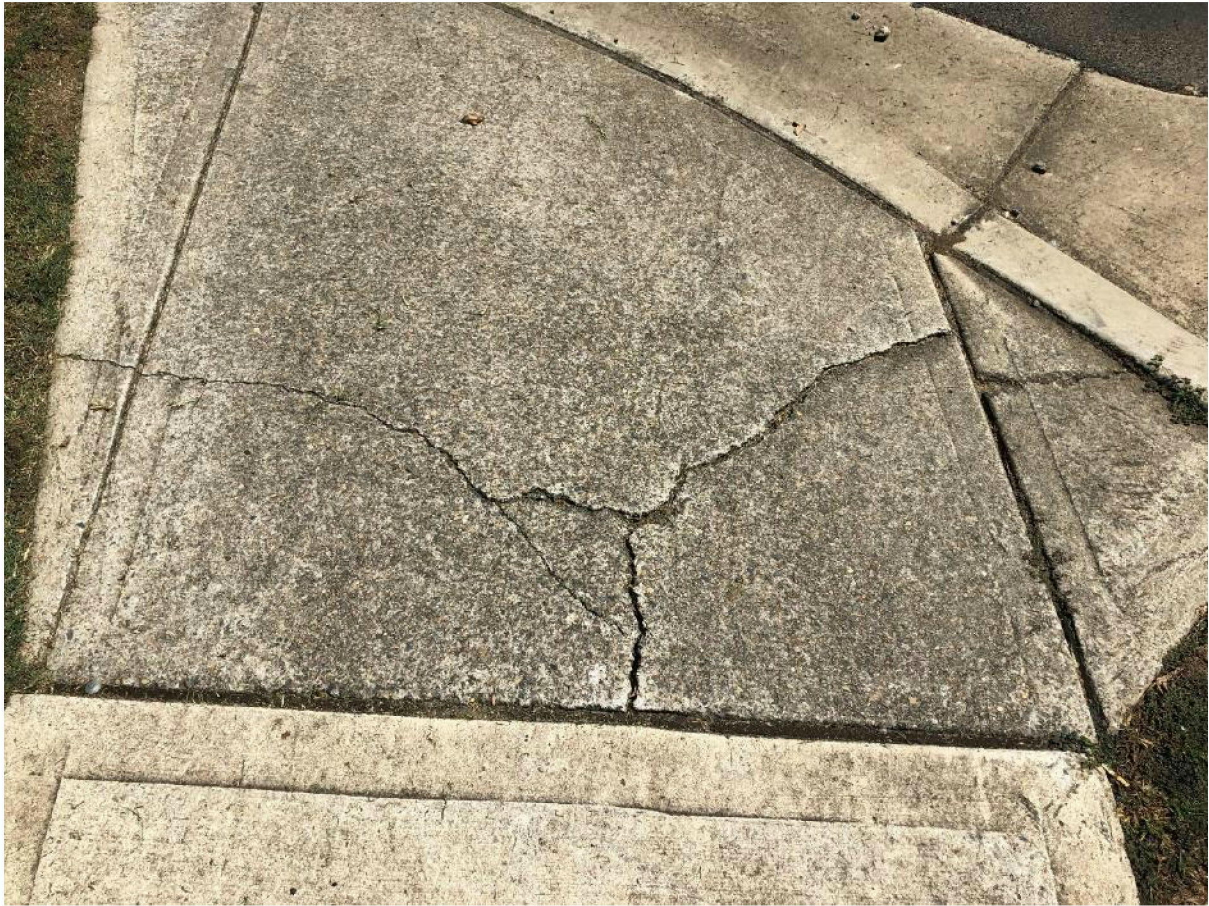
*Figure 85: cracking to pram ramp located left of proposed site entry.*

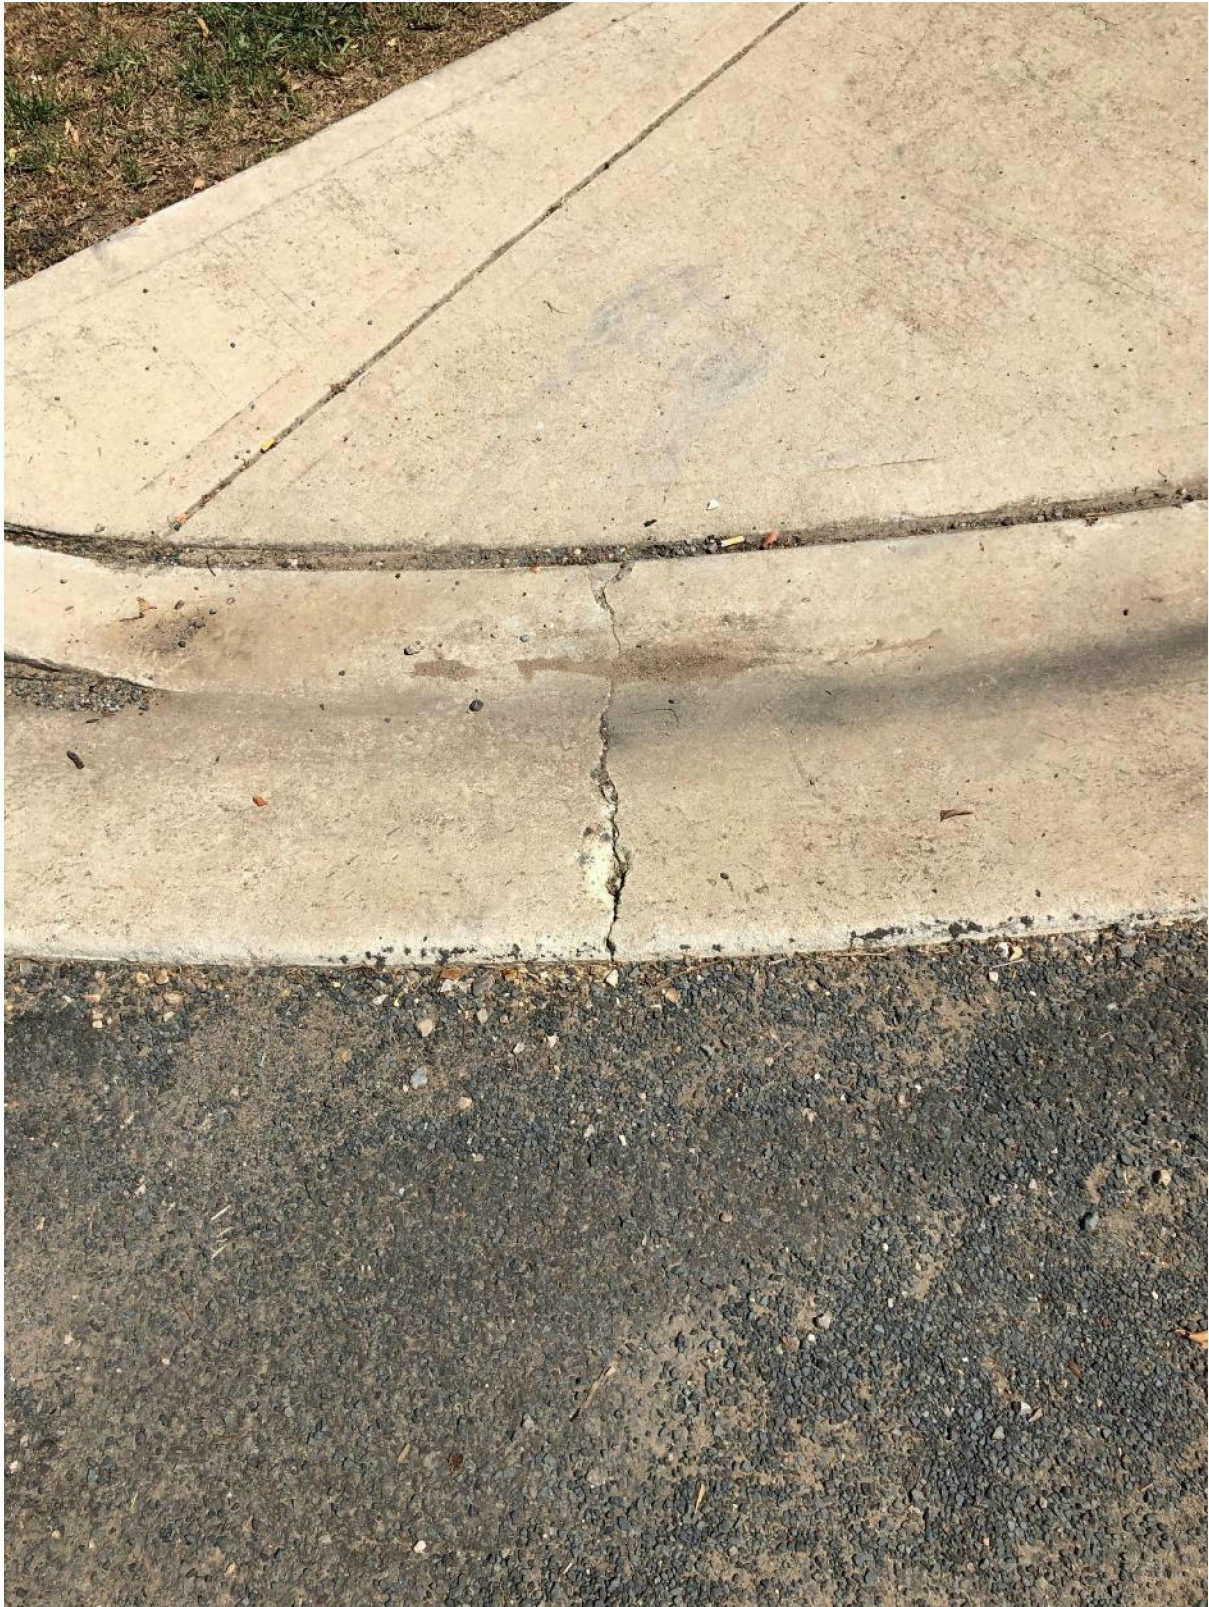
*Figure 86: cracking to gutter, adjacent to pram ramp located right of proposed site entry.*

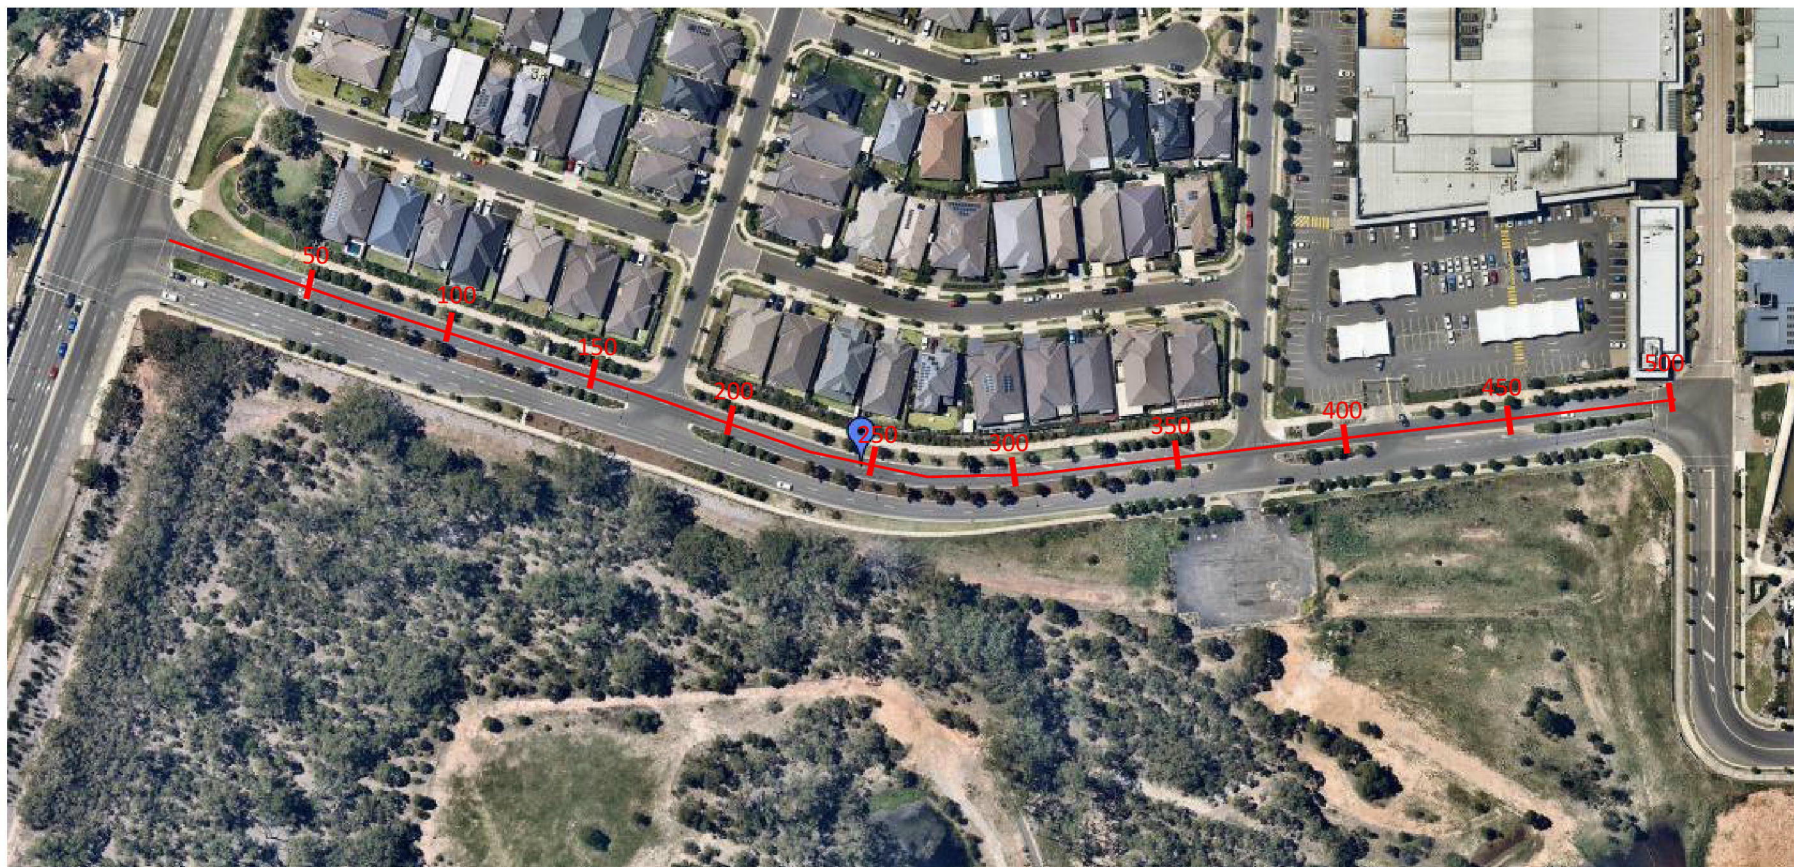
Figure 88: Approx CH250 EB pavement failure (P53)

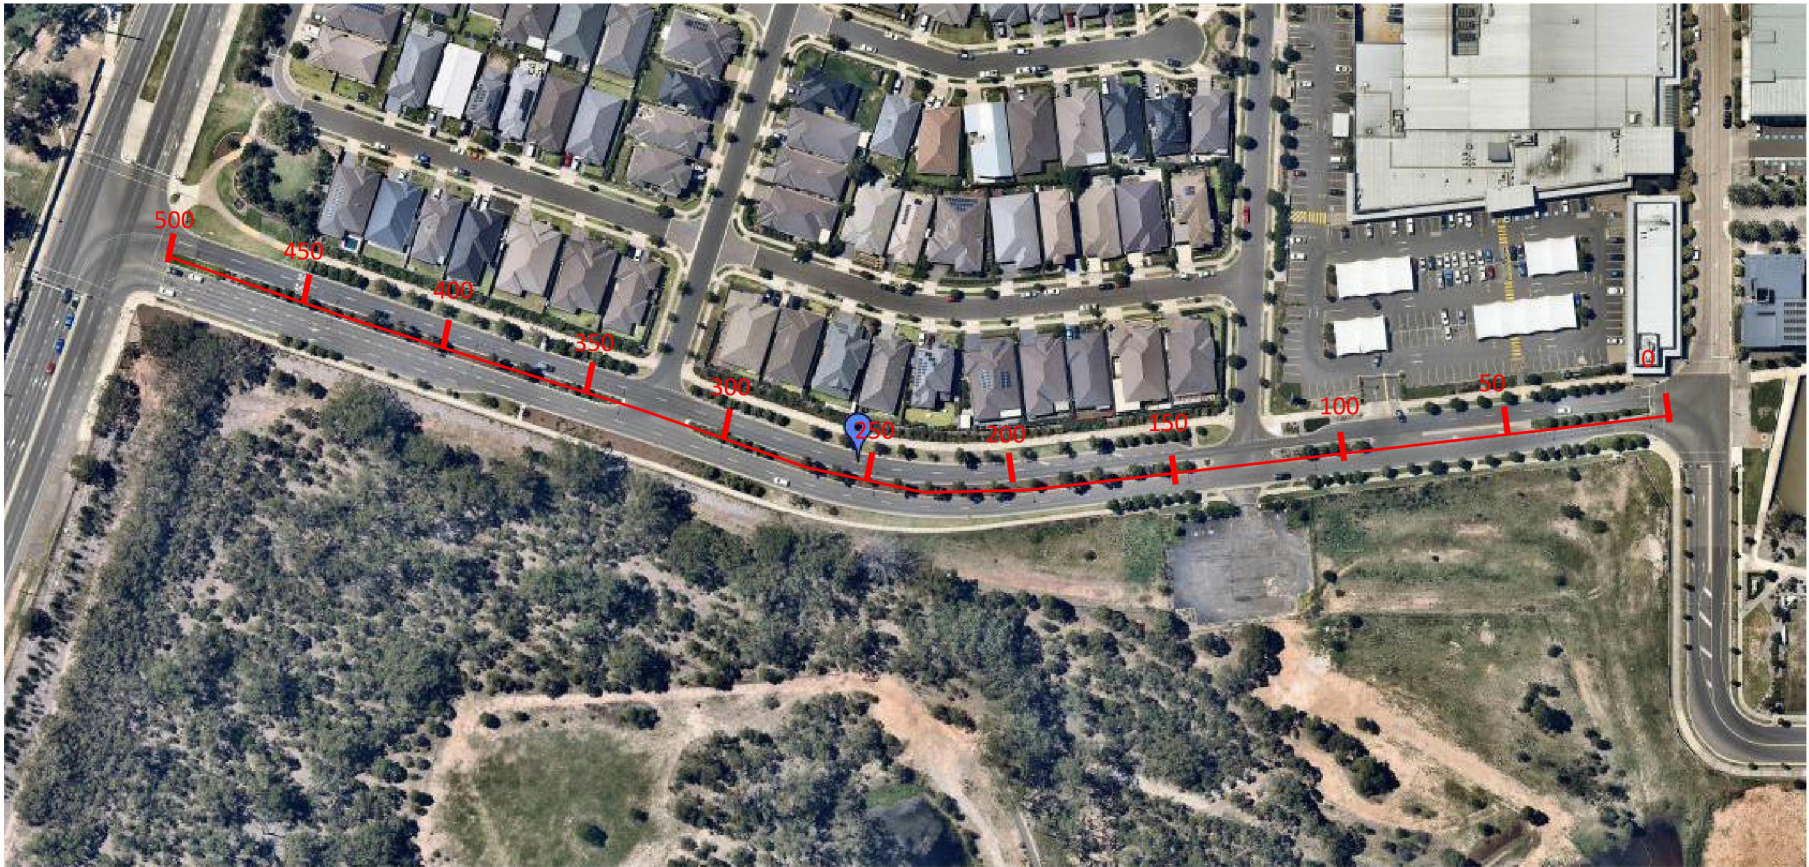
Figure 94: Approx CH200 WB horizontal crack
