Project 76652.03
3 December 2019
R.001.Rev1
CKM

Contamination Cover Letter
Proposed Development - Nepean Gardens
Wallacia Golf Course, 13 Park Road, Wallacia, NSW

Report on
Preliminary Site Investigation - Contamination

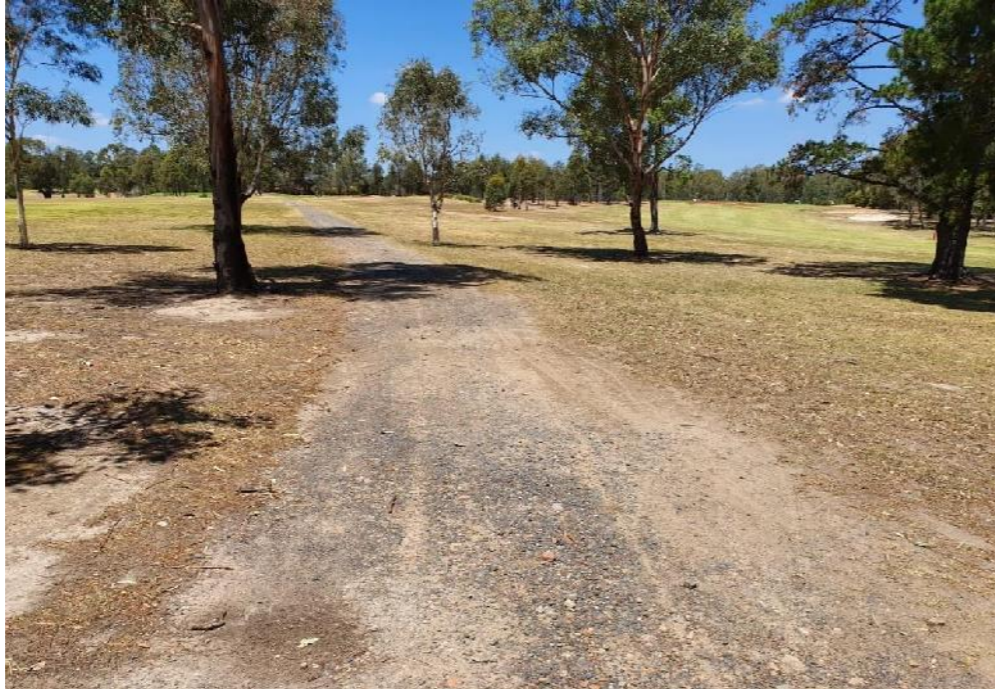
- Graded aggregate material, containing demolition waste (i.e. brick, tile and concrete) was observed along access tracks throughout the site. The presence of demolition waste was considered to be an indicator of potential asbestos, therefore the graded aggregate along access ways is assigned as PAEC 16 (Photograph 1);

Photo 1 - Graded aggregate on the surface of an access way (facing east)

Therefore, considering the presence of PAEC, and as per the PSI, DP recommends that further assessment for contamination should be undertaken at the site with reference to the ASC NEPM. Further assessment should include intrusive investigations, sampling, analysis and assessment to determine land use suitability. Further investigations should focus principally on the identified PAEC.

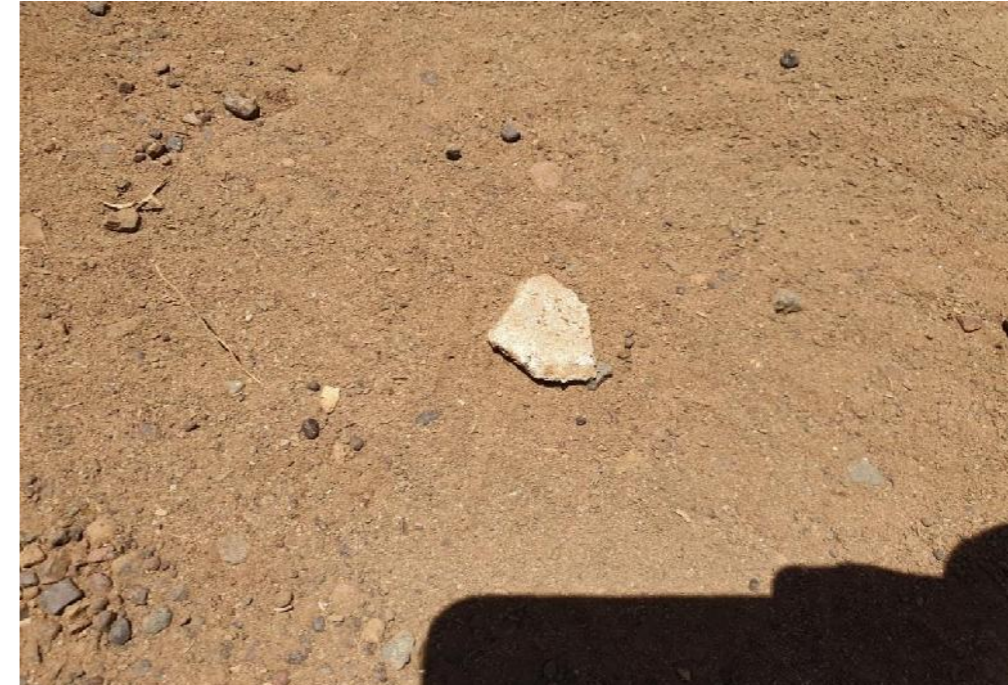
- Two fragments of suspected bonded asbestos-containing material (ACM) was observed and collected from the surface of exposed fill within an access way (Photograph 2). Whole and partial bricks and concrete were also exposed on the surface (Photograph 3). Considering the presence of potential ACM, the access way is assigned as PAEC 17;

Photo 2 - Potential ACM observed on the surface of fill in an access way

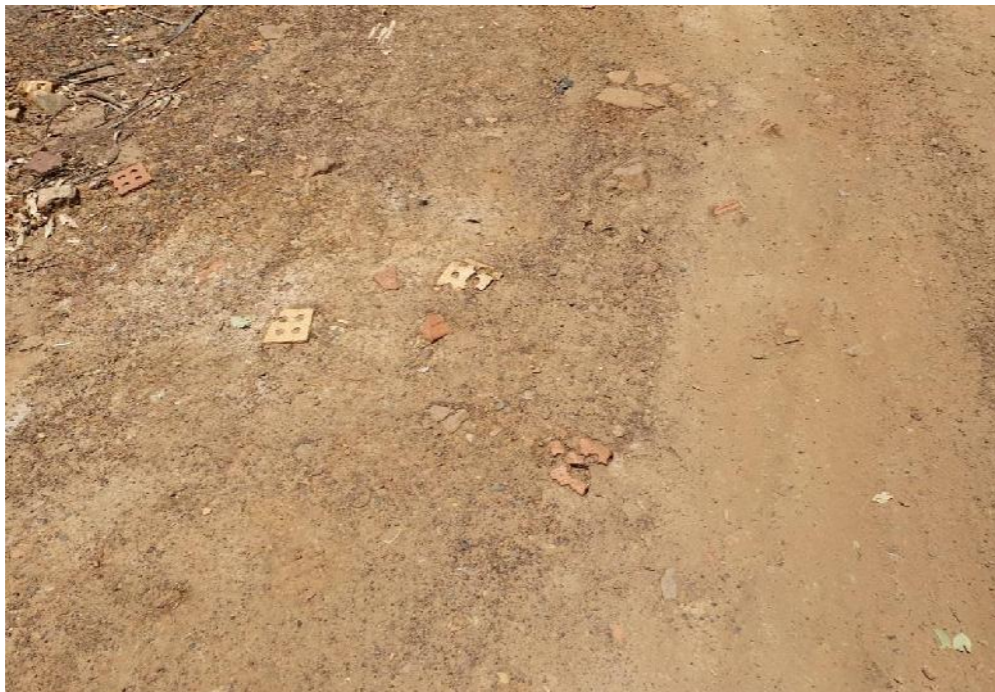
Photo 3 - Bricks and concrete observed adjacent to the potential ACM in the fill access way

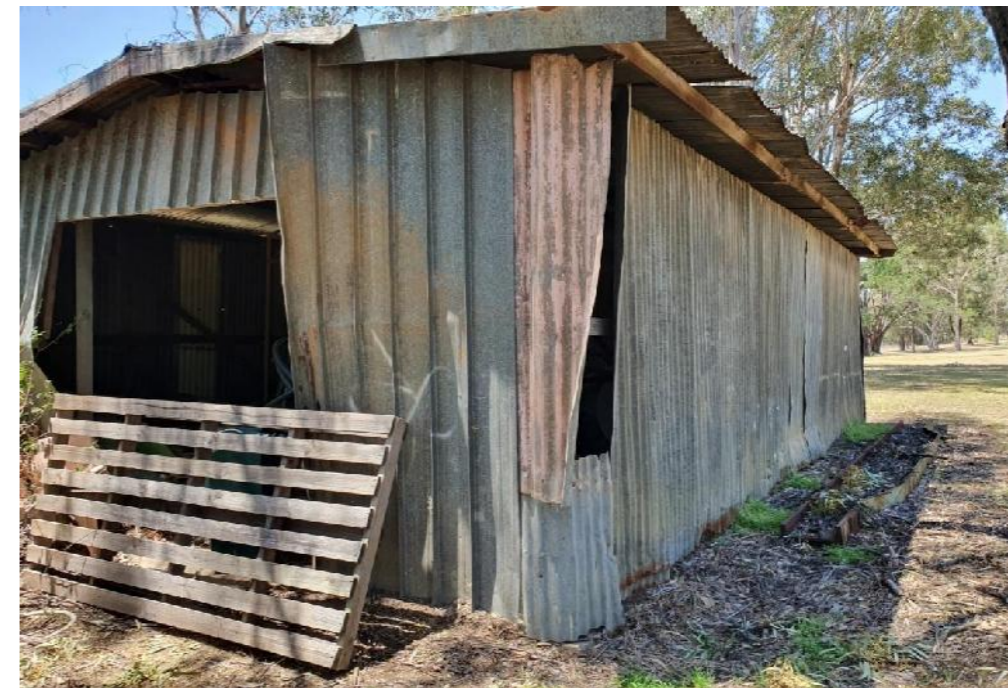
- Due to recent clearing of trees and shrubs, two aged metal sheds had been exposed in the northwest of the site since issue of the PSI (Photographs 4 and 5). The easternmost shed appeared to have been utilised as a storage area for miscellaneous materials including irrigation pipes and refuse, with two blue storage containers observed in the rear of the shed (Photograph 6). The westernmost shed was significantly dilapidated, and appeared to be no longer in use. Considering the apparent age of the sheds and thus the potential for the leaching of metals into the surrounding soils, and the potential storage and spillage of chemicals within the sheds (e.g. fuels, oils and pesticides), they have been assigned as PAEC 18;

Photo 4 - Easternmost shed (facing east)

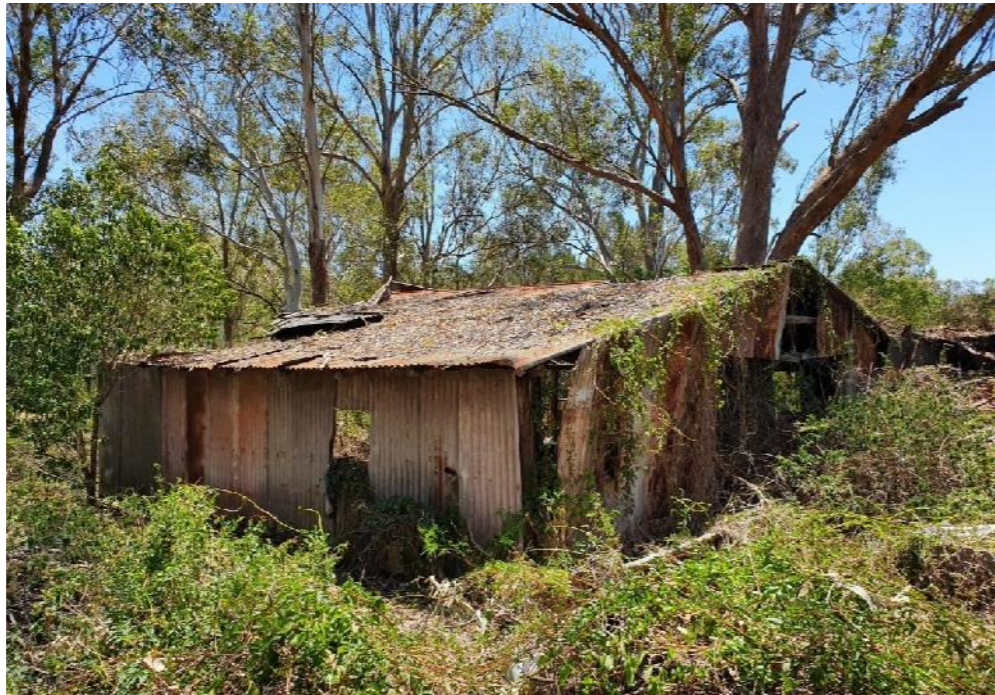
Photo 5 - Westernmost shed (facing north)

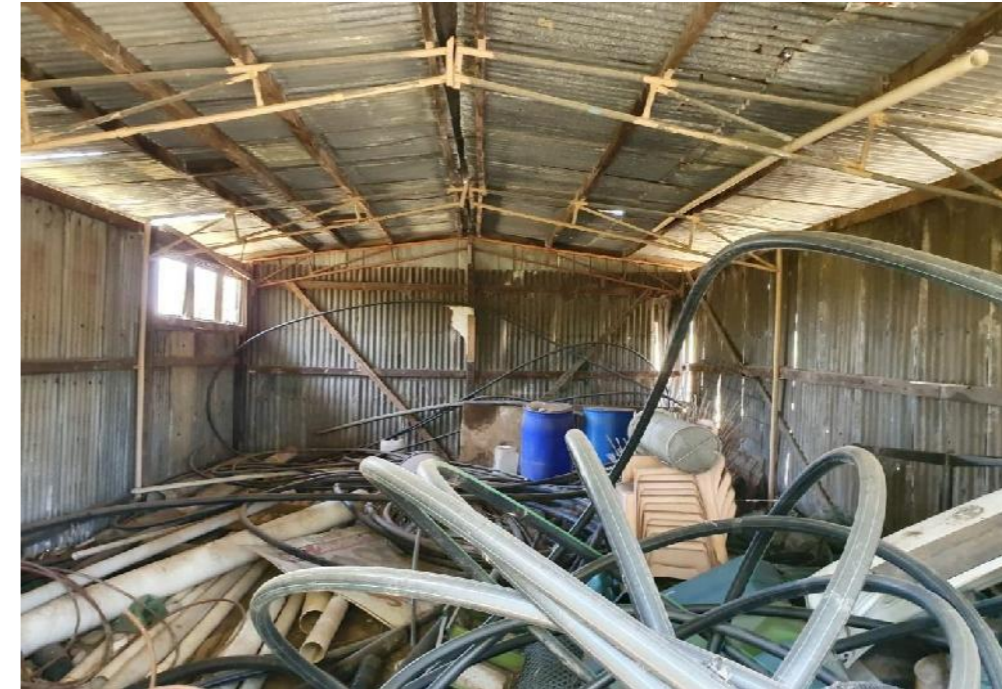
Photo 6 - Waste materials and drums stored in the easternmost shed

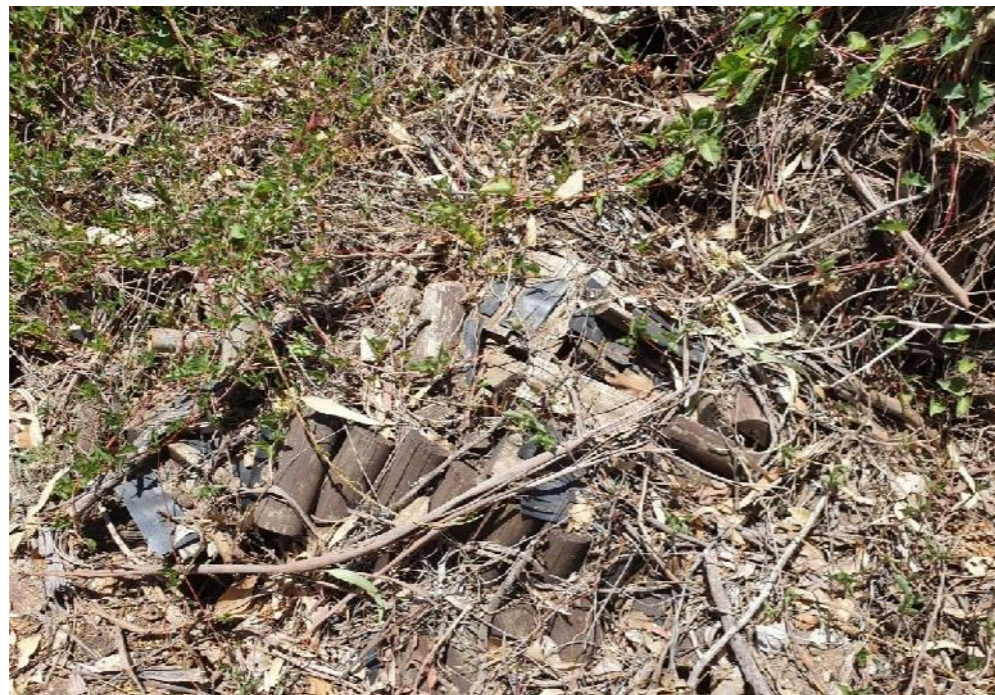
- Several vegetated small stockpiles with trace refuse (i.e. brick and tin) were also observed in the vicinity of the sheds (Photographs 7 and 8). Due to the unknown composition of the stockpiles, contamination cannot be ruled out. Therefore the stockpiles have been assigned as PAEC 19;

Photo 7 - Refuse observed on the surface of stockpiles adjacent to the sheds

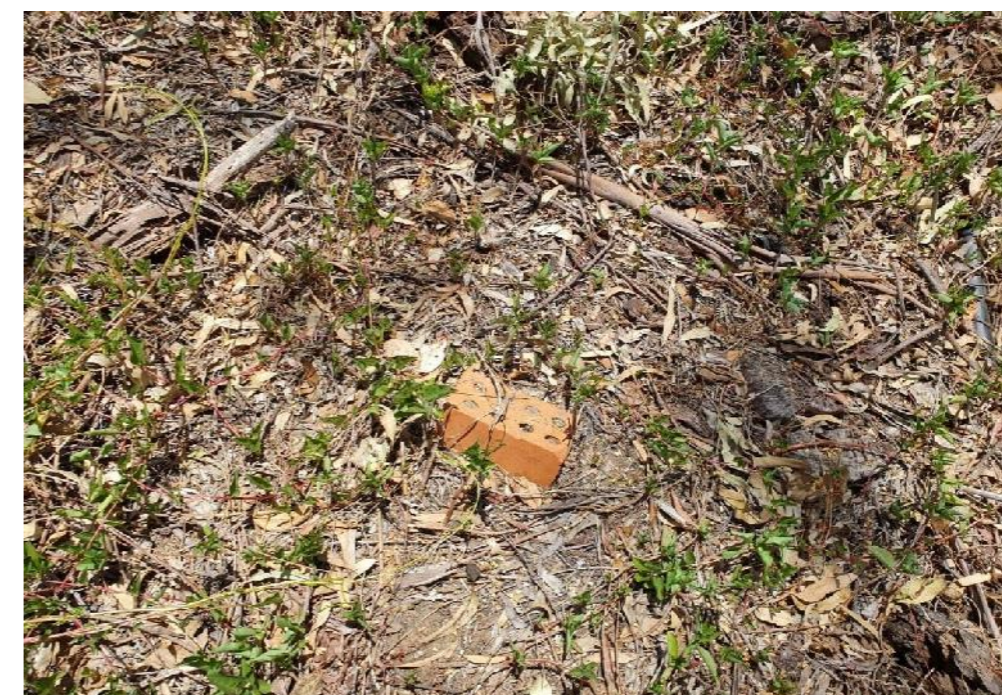
Photo 8 - A brick observed on the surface of a stockpile adjacent to the sheds
