Friday, 27 January 2017

DL3991_S006108

Re: Review of RAP and Remediation Requirements – 117 O’Connell Street, Caddens, NSW 2747

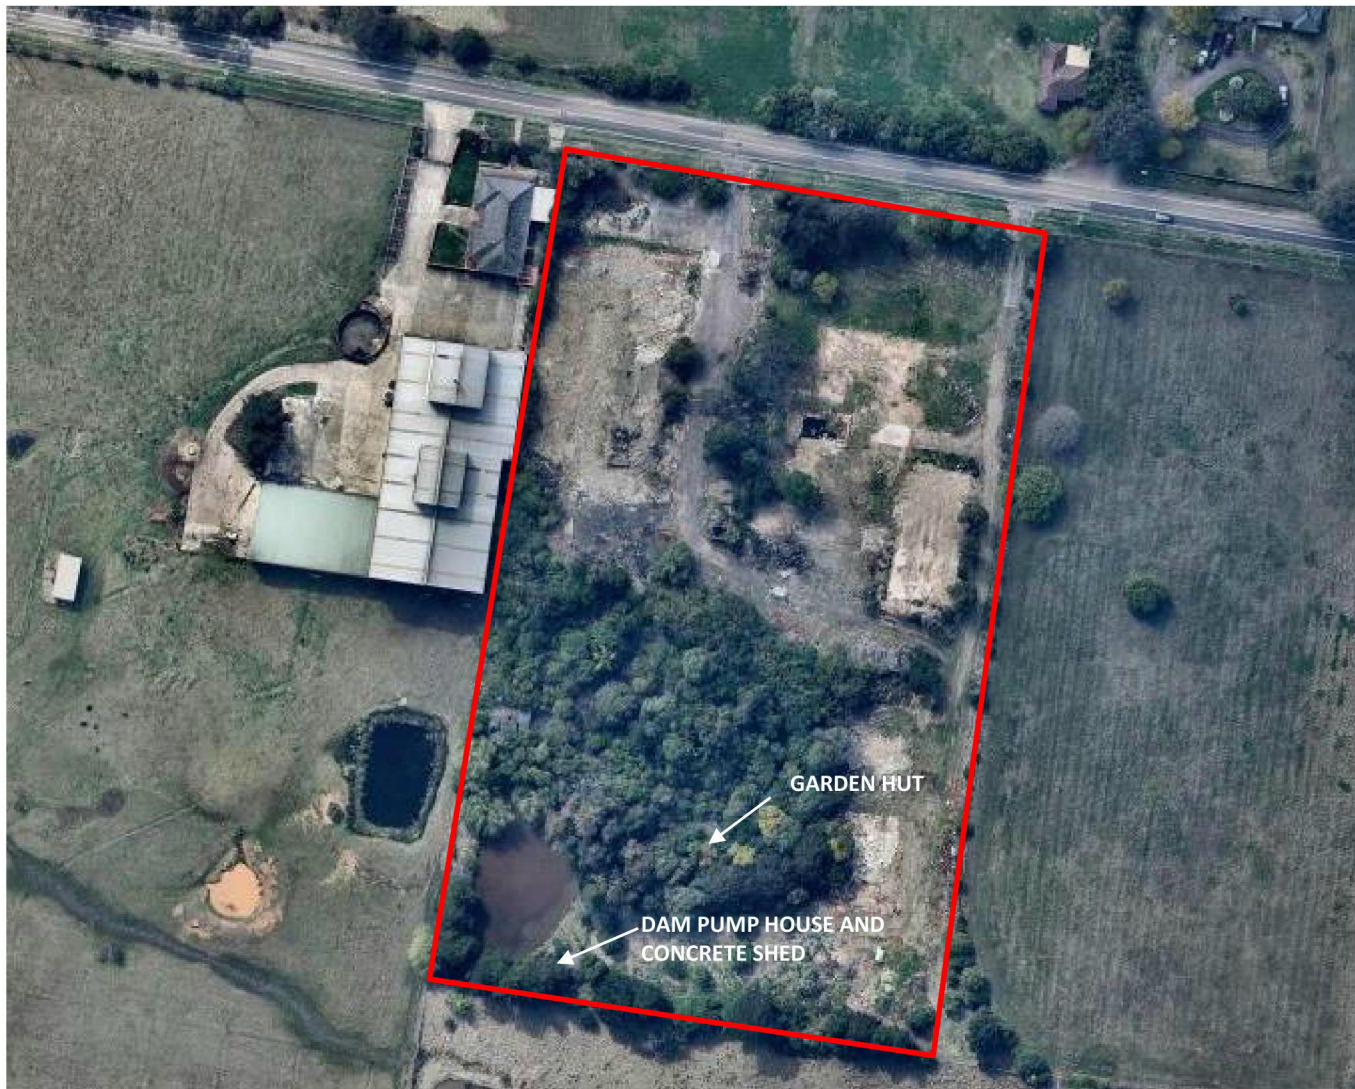
FIGURE 1 – Asbestos Clearance

A visual inspection of the structures and fencing at the Site was conducted on Thursday 27th of October 2016 by a Licensed Asbestos Assessor. This inspection, which was of a visual nature only and was carried out in accordance with the Certification as required by Clause 473 and 474 of the NSW WHS Regulations 2011. The clearance involved a visual inspection of a small outdoor open timber garden hut and a smaller storage area constructed from concrete and timber. Following the removal of asbestos containing sheet materials in the structure was related to the roof only. Asbestos containing capping sheets were removed from the fence.

Visual inspections have confirmed that the buildings and fencing have had all asbestos containing materials removed. It is therefore considered that these structures subject to this Clearance Certificate have been remediated in a safe and effective manner to allow for normal activities to proceed. These areas can now be accessed without risk to health or the environment generally.

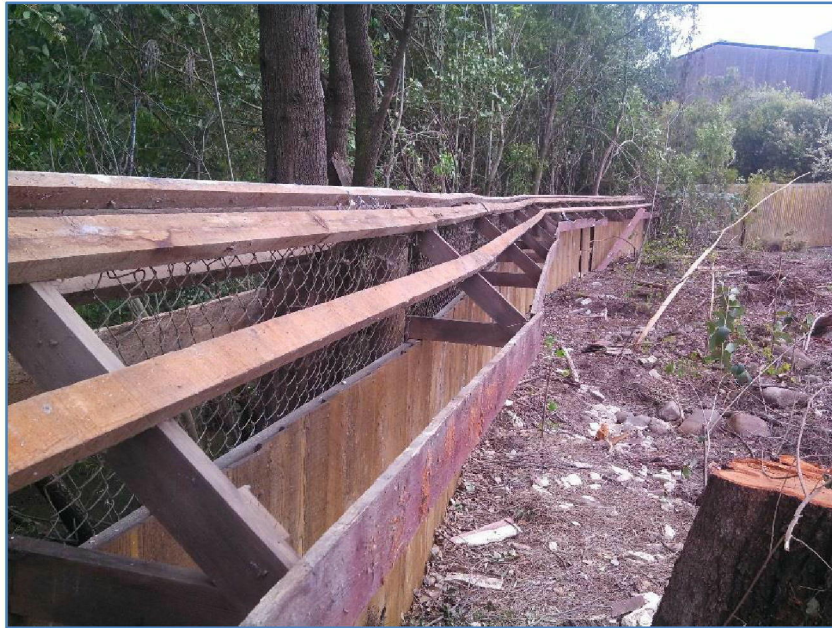
Print 001

Fence Railing – ACM Sheets Removed

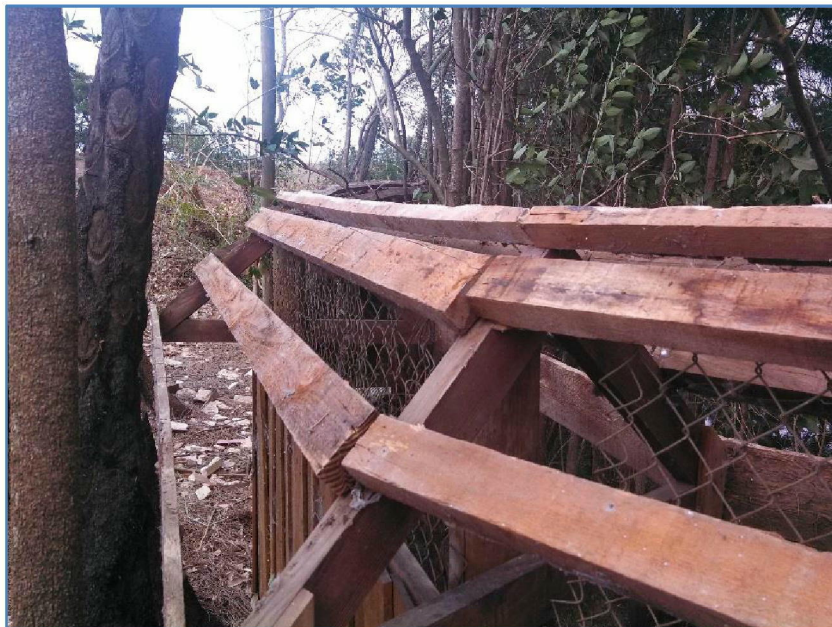
Print 002

Fence Railing – ACM Sheets Removed

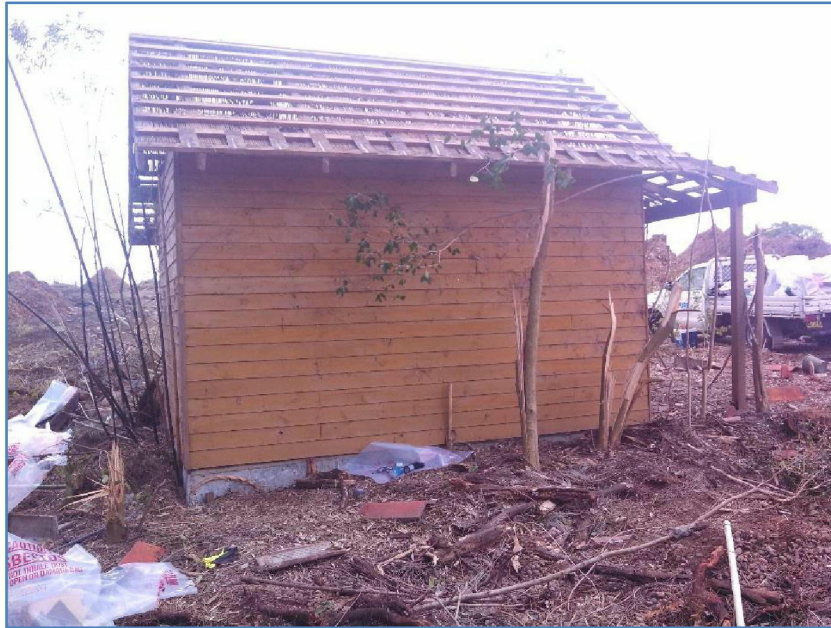
Print 003

Garden Hut – External Roof

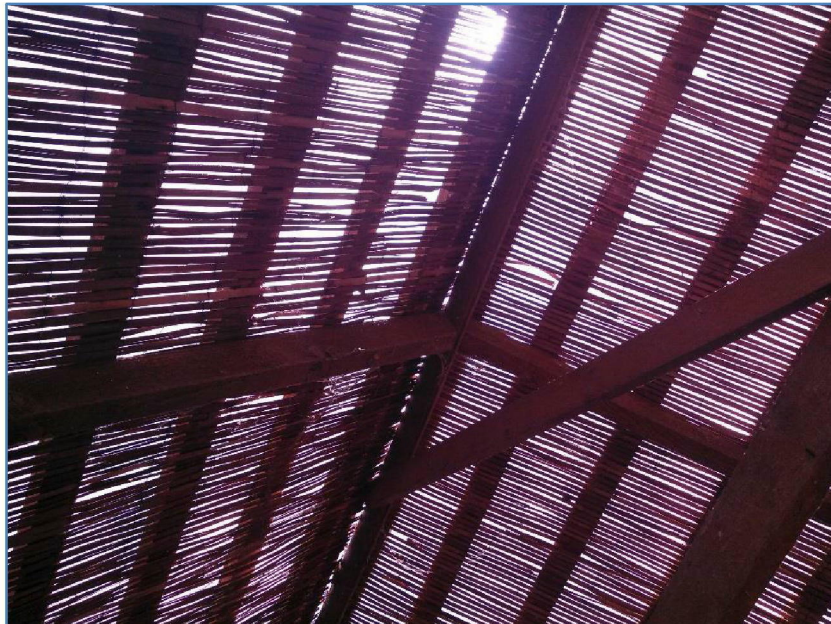
Print 004

Garden Hut – Internal Roof

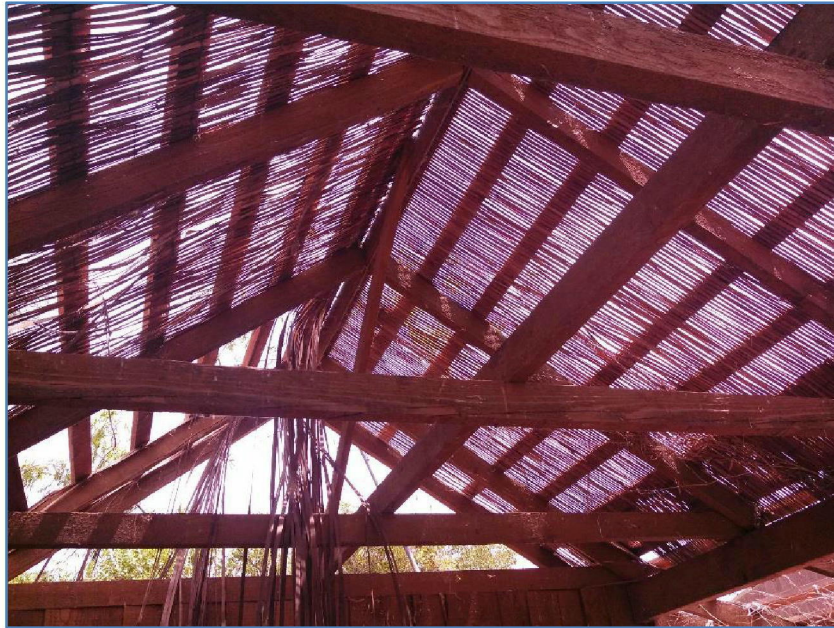
Print 005

Garden Hut – Internal Roof Frame

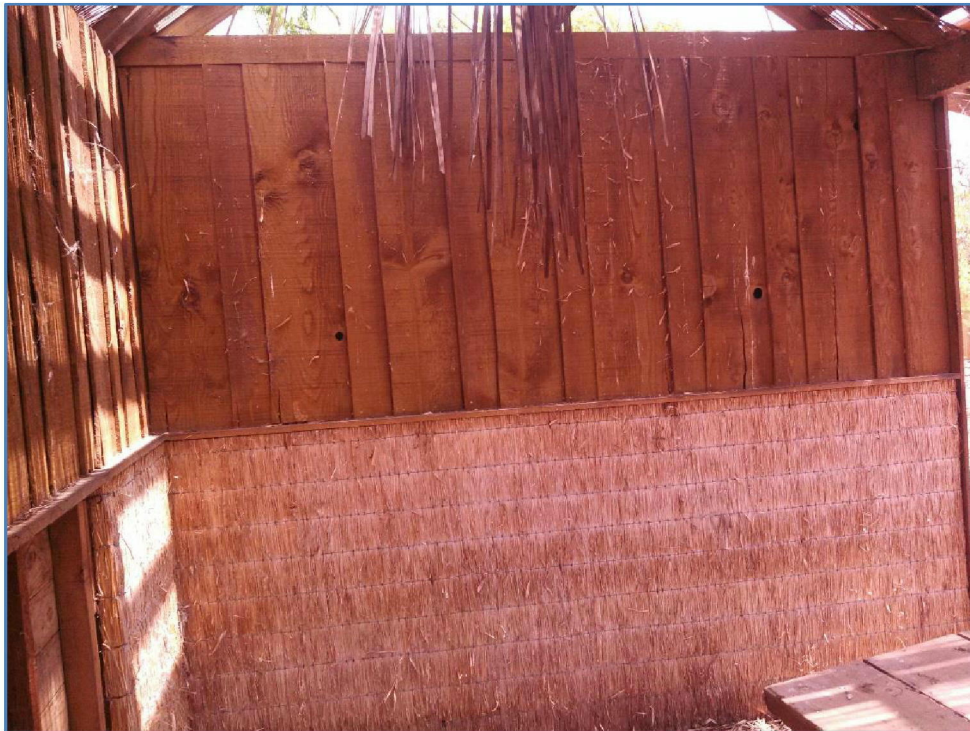
Print 006

Garden Hut – Internal walls

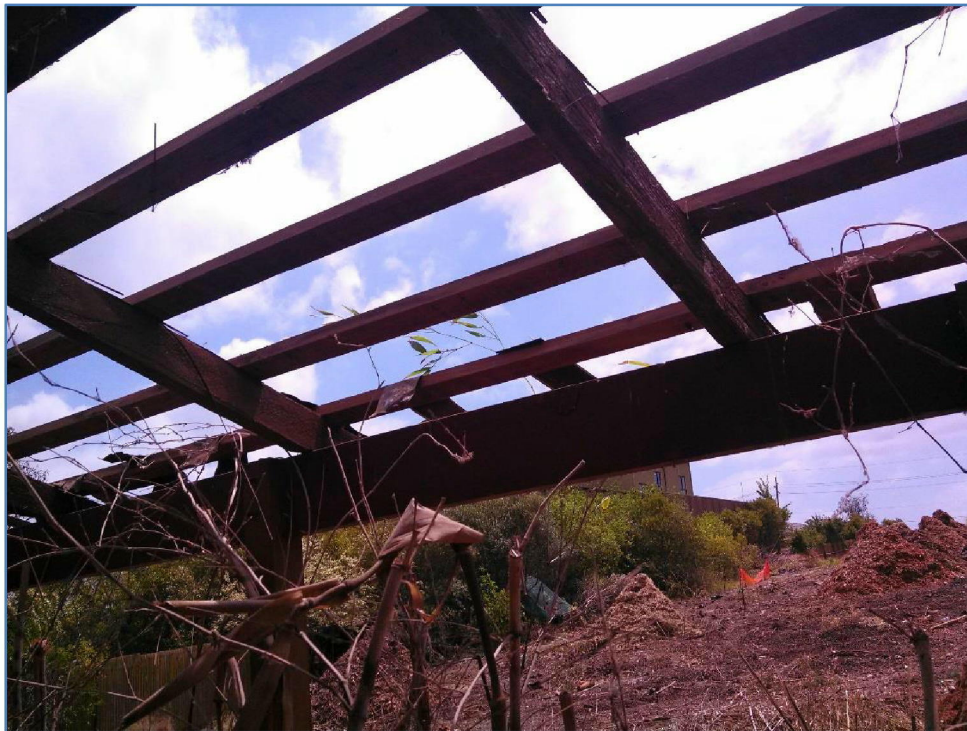
Print 007

Concrete Shed with timber roof frame

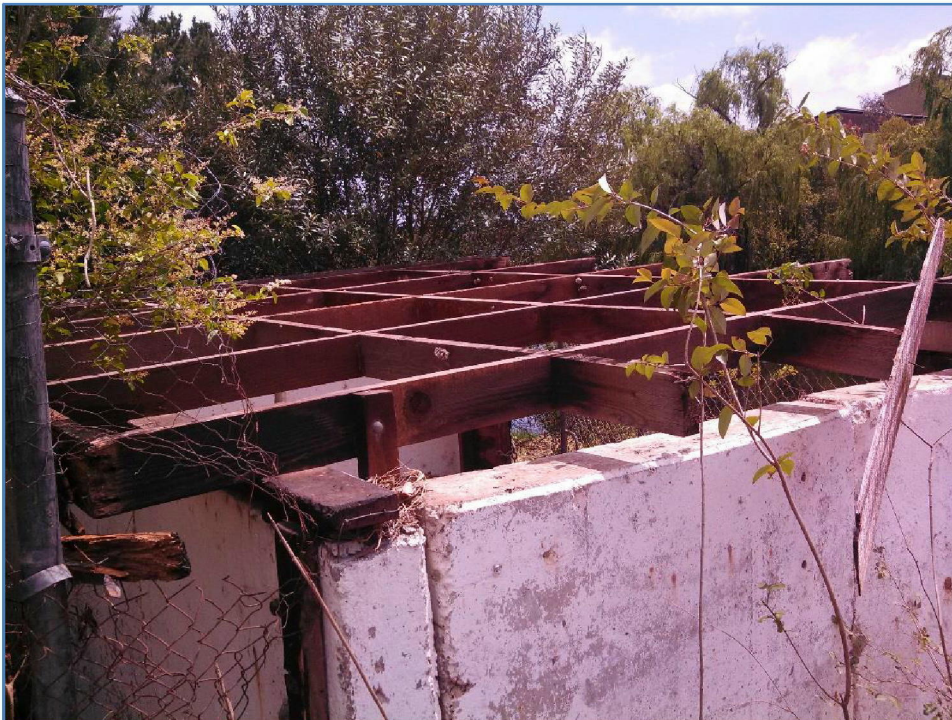
Print 008

Concrete Shed with timber roof frame

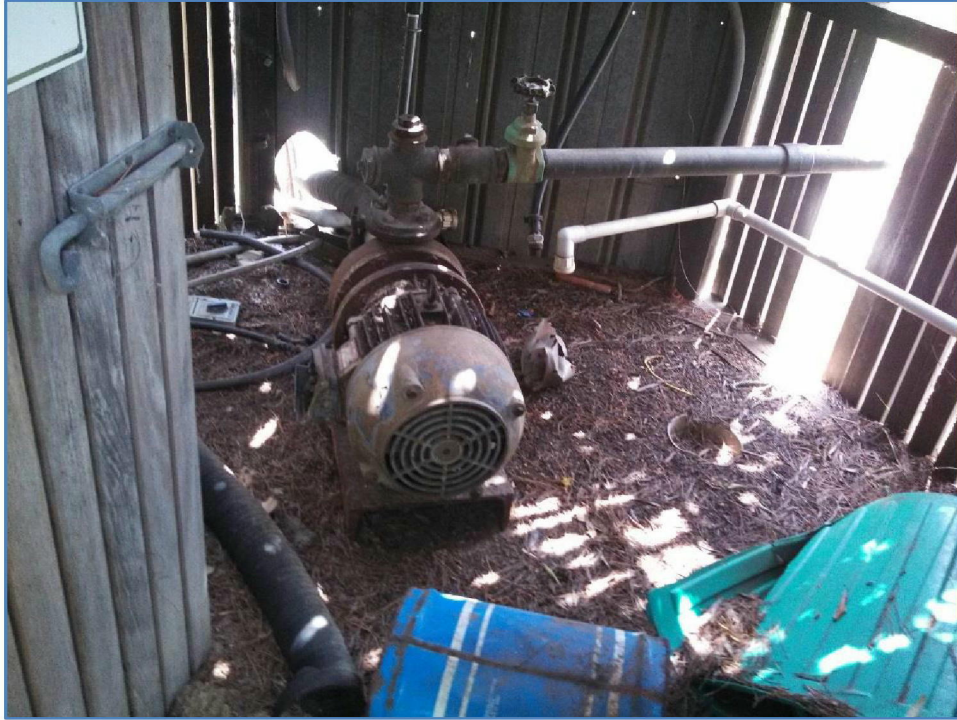
Print 009

Dam Pump house – Timber and Sheet Metal construction

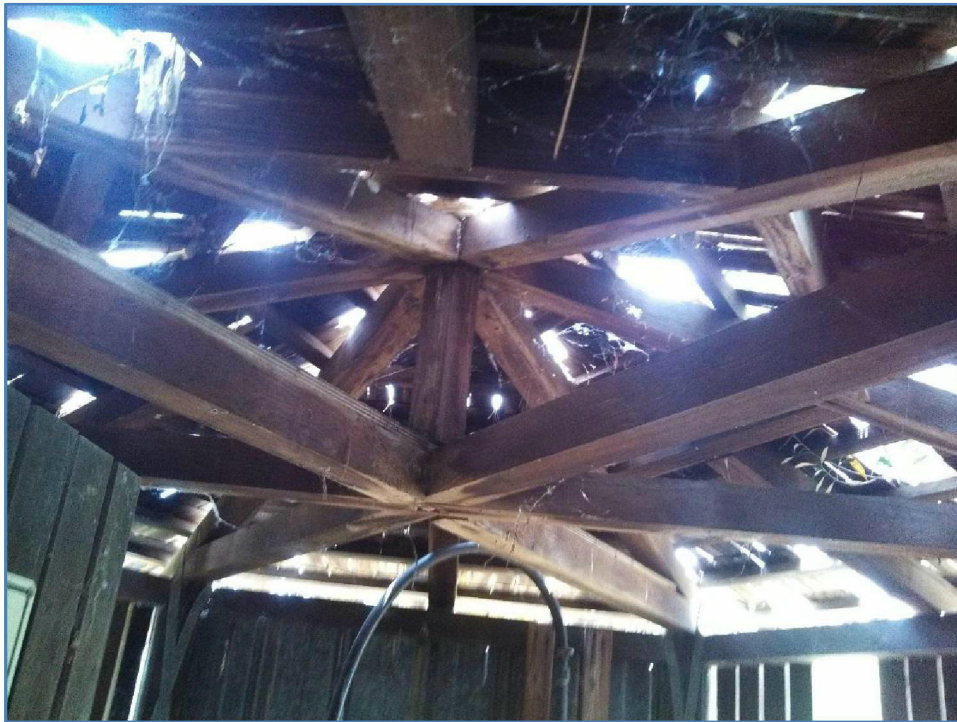
Print 010

Dam Pump House wooden roof frame

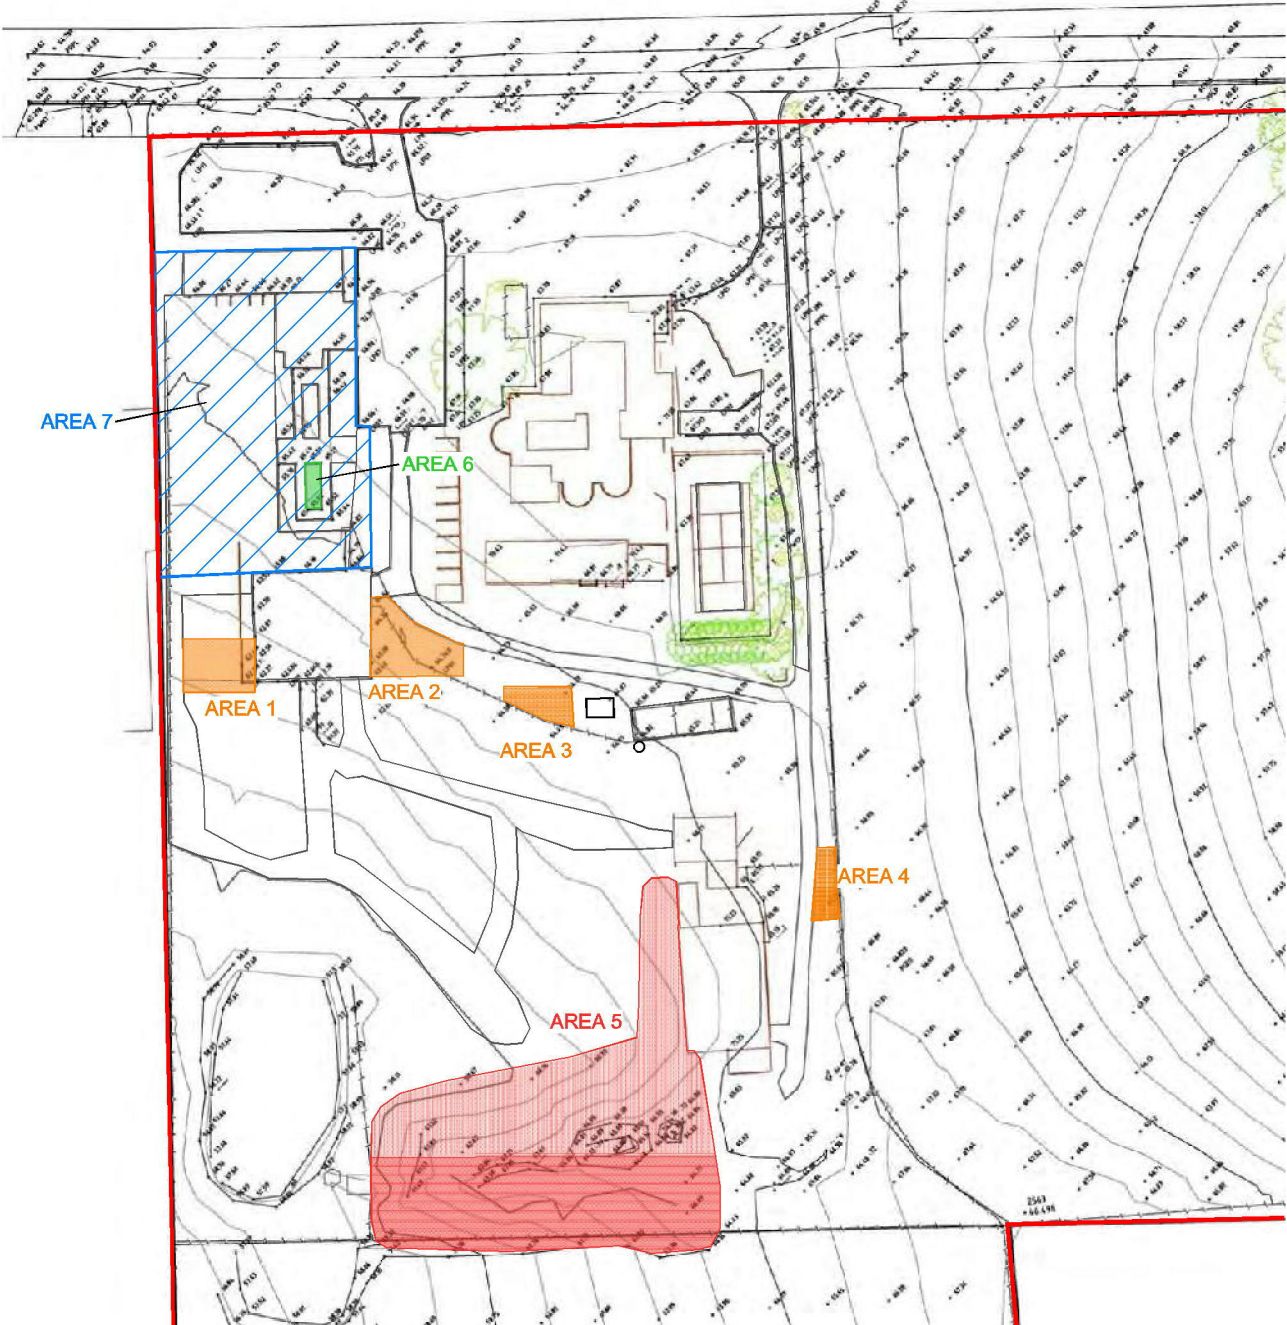
FIGURE 1 – SITE REMEDIATION AREAS 1-4

Geotechnique's Detailed Contamination Assessment and Remedial Action Plan Report No 12486/2-AA Dated the 10th of October 2011 identified Areas 1-4 in **Figure 1** as containing heavy metal exceedances. Upon excavation and assessment of these areas Geotechnique requested an asbestos clearance certificate is required to ensure the material was free of asbestos.

The visual inspection and soil sampling did not identify asbestos within remediation areas 1-4 and therefore no risk to human health or the environment can be inferred from these areas. These area can now be accessed without risk to health or the environment generally.

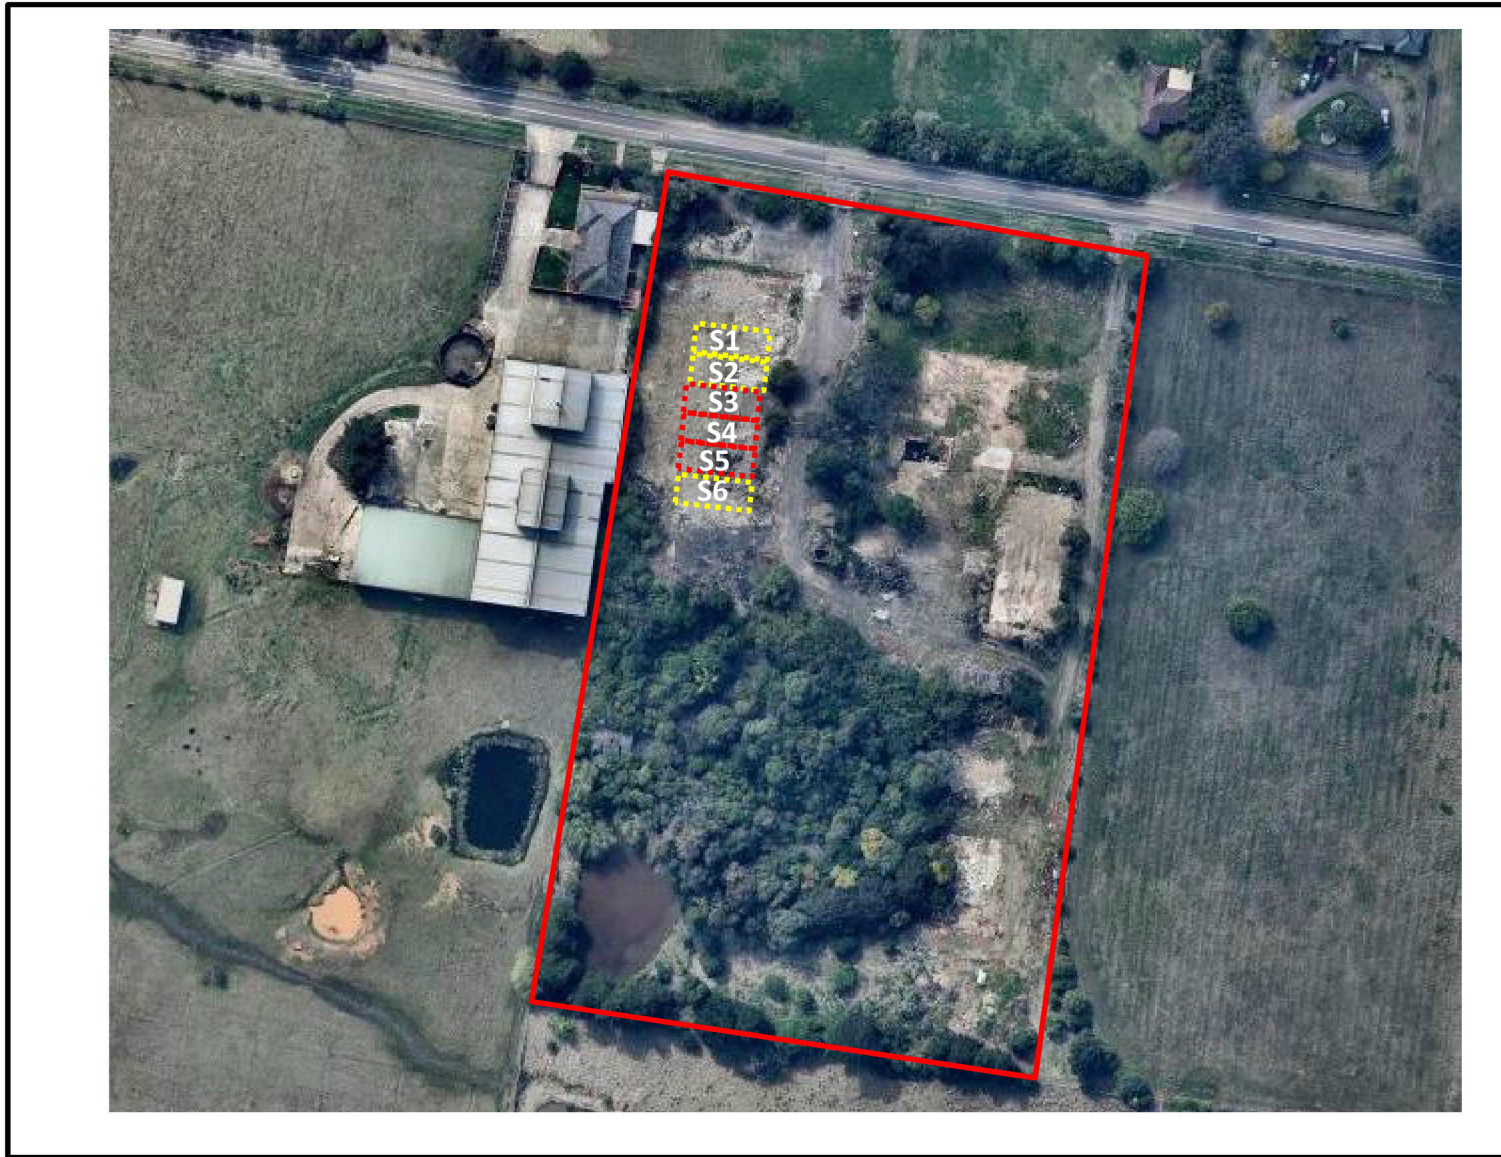
FIGURE 1 – Site Layout and Sample Locations

The laboratory analysis of the ACM sample confirmed that the fibre cement material contained asbestos. Surface soil samples indicated the presence asbestos fibres within two of the bulk samples areas. A small ACM fragment was also present within a soil sample. Three of the sampled areas did not report asbestos in soils. Refer to **Table 1** below:

A Class A licenced asbestos contractor is required for the contaminated materials to be removed and disposed of off-site. An alternative remediation strategy to allow materials to remain onsite may also be undertaken incorporating handpicking, further sampling and analysis to confirm compliance with Site criteria for asbestos.

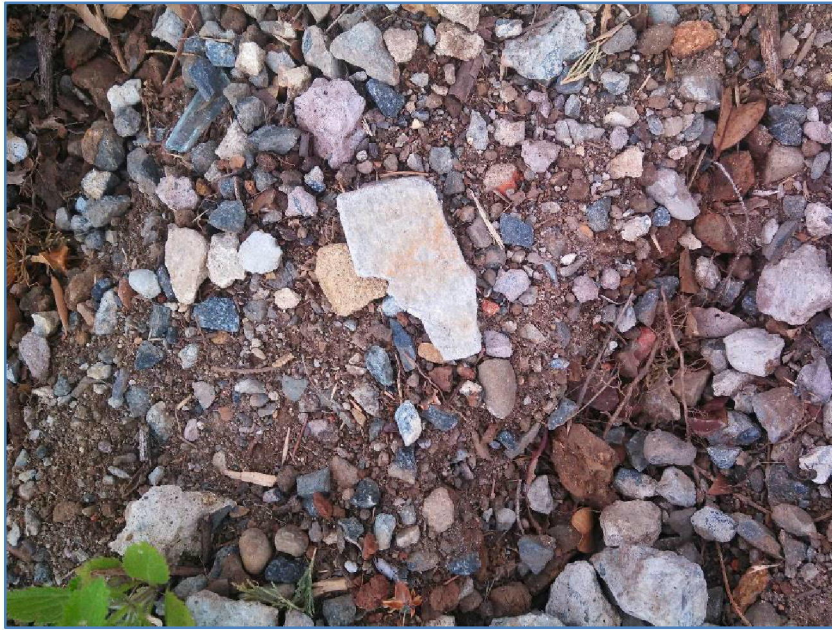
Print 001

Surface ACM

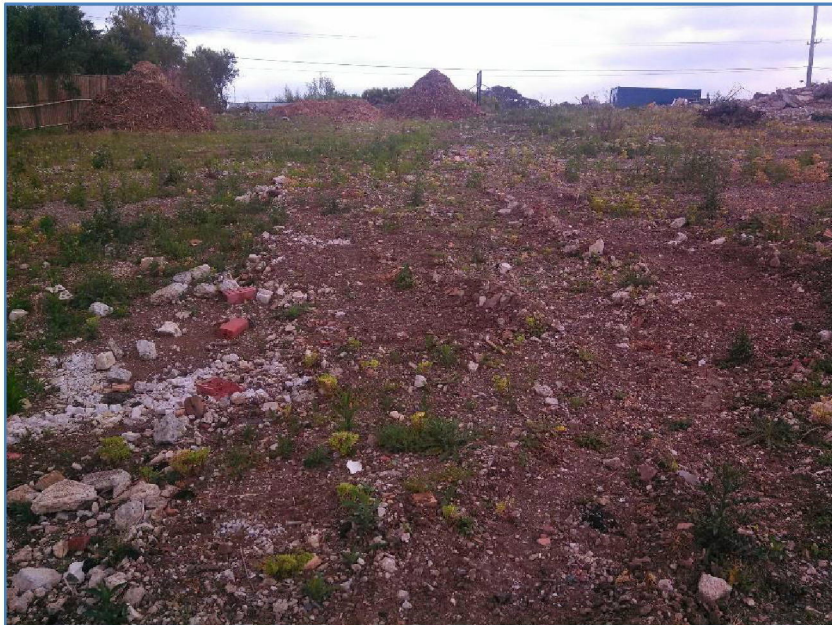
Print 002

Asbestos surface impacted soils view to north.

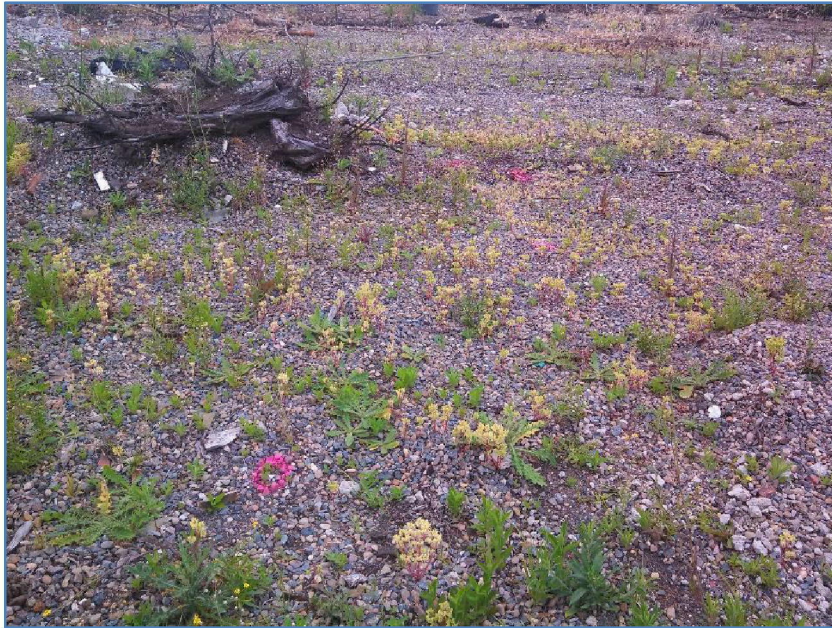
Print 003

Sample S5 – Asbestos Fibres Detected

Sample No. 5. ASET53685 / 56865 / 5. S5.
Approx dimensions 10.0 cm x 10.0 cm x 8.4 cm
The sample consisted of a mixture of clayish sandy soil, stones, plant matter, fibers[^], fragments of plaster, cement, brick and glass.
Chrysotile[^] (Estimated Approximate weight of fibre bundle = 0.008g) asbestos detected.

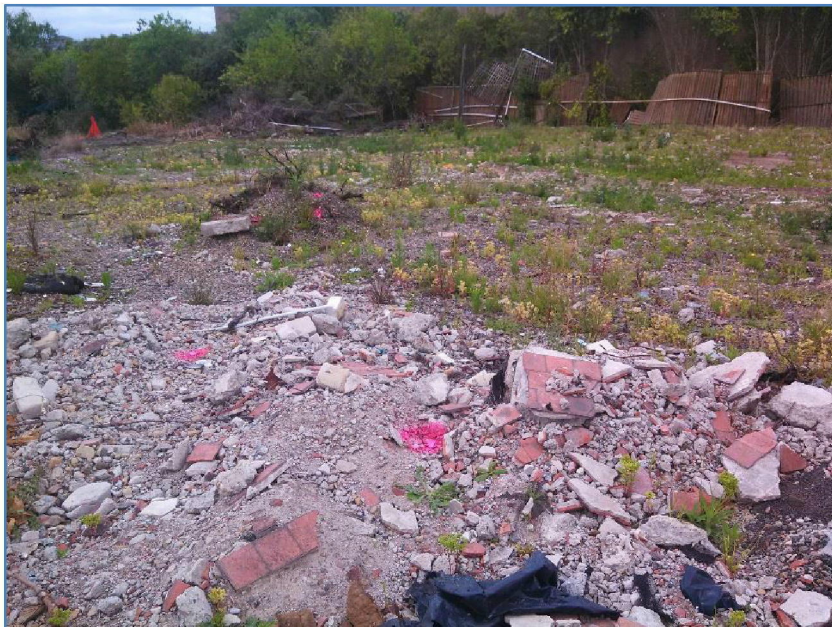
Print 004

Northern end of area viewing to south west.

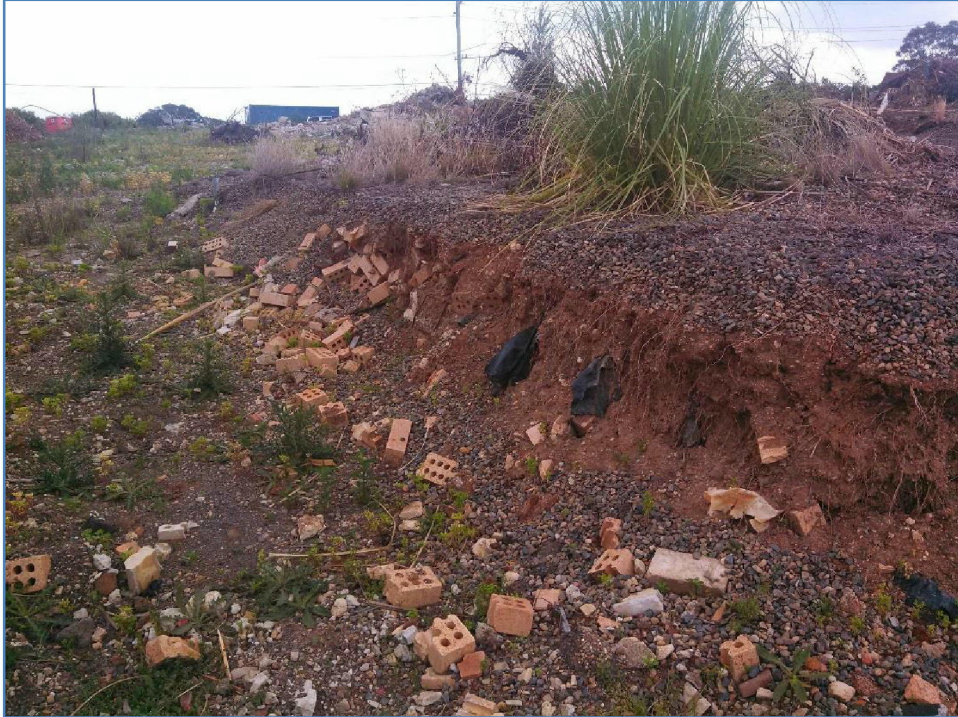
Print 005

South-West part of investigation area.

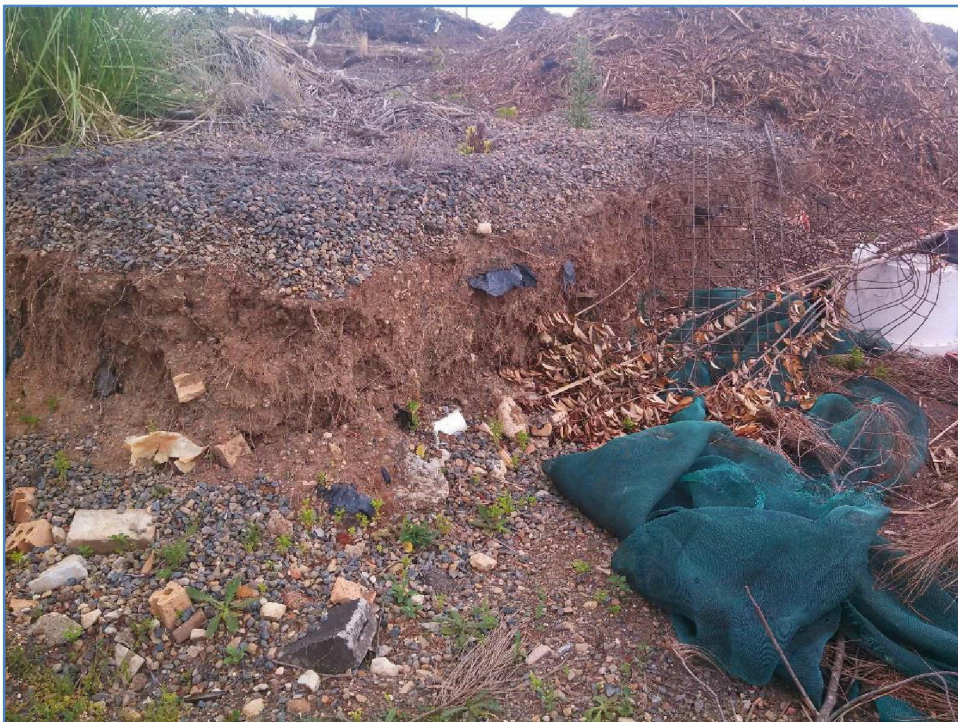
Print 006

South-East part of investigation area.
