QUA004 - DILAPIDATION & SITE INSPECTION REPORT

Customer/Project Name: Lendlease - Village		ase - Village O	val, Jordan S	prings.						
Customer/Project Address: Cnr Alinta Promenad					de & Greenwood Parkway, Jordan Springs					
Job No.	28	45	Contract No).	724		Date:	21/07/	2015
Prepared by: Luke Cranson					Photos en	closed:	Yes 🖂	No [
Inspection	1				Notes & Co	omments				
Water		Nearside	⊠ Fa	r-side 🖂						
Electricity	•	Aerial 🛛	Unde	erground 🛛						
Sewer		Yes 🖂	No 🗌							MIL .
Septic		Yes 🗌	No 🛛		Туре					
Kerb & Gu	itter	Yes 🖂	No 🗌		Damage	Yes 🖂	No 🗌			
Layback		Yes 🖂	No 🗌		Damage	Yes 🛛	No 🗌			
Footpath Yes		Yes 🖂	No 🗌		Damage	Yes 🖂	No 🗌			
Vehicle Ac	ccess	Good 🛛	Need	s Work 🗌						
Boundary Pegs		Yes 🗌	No 🛚				TOM:			
Existing Fe	encing	Yes 🖂	No 🗌		Туре	Builder	s Temporar	y, chain lir	nk perimet	er fence
Subsoil		Existing		1						
Excavation		Yes 🖂	No 🗌							
Trees Yes 🗵		Yes 🖂	No 🗌					DEC	EIVE	
	Stor	mwater							MGT	
Other:								2 3	JUL 2015

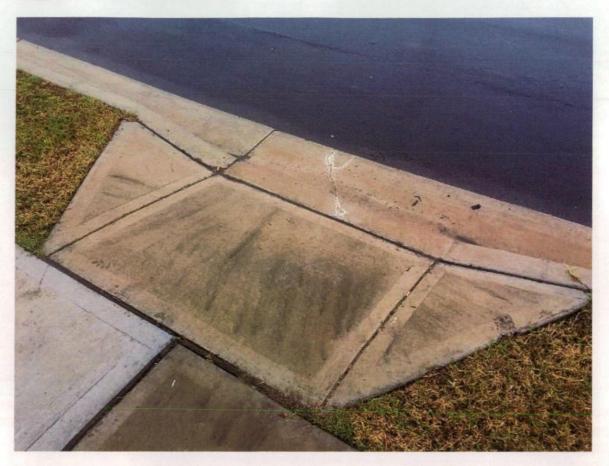
Figure 1 Cracks in pavement, stains on pram ramp.

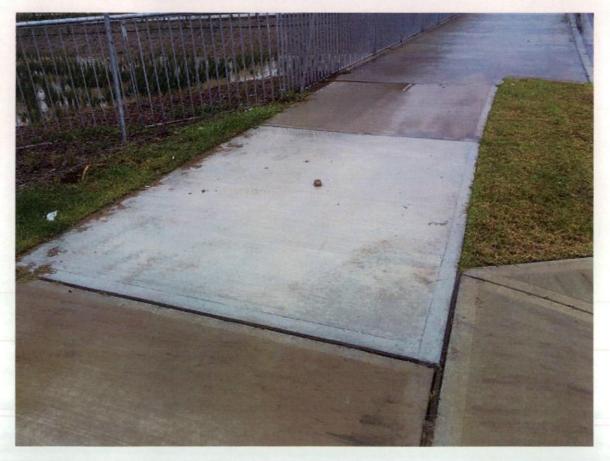
Figure 2 Pavement stains and surface cracking

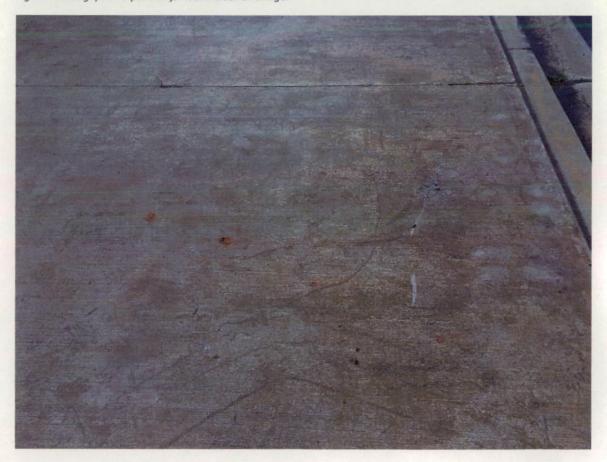
Figure 4 Pavement scratched and stained

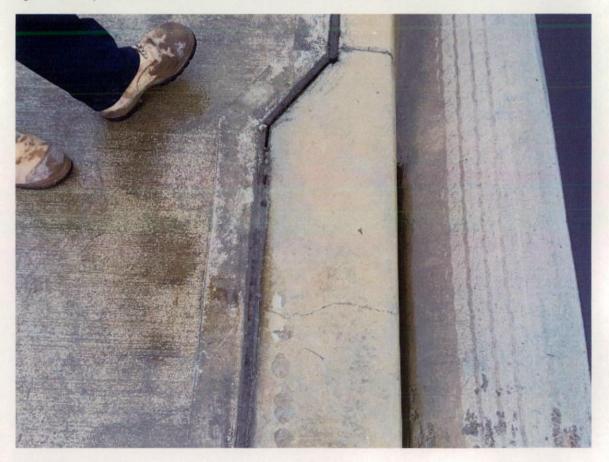
Figure 8 Crack in lintel

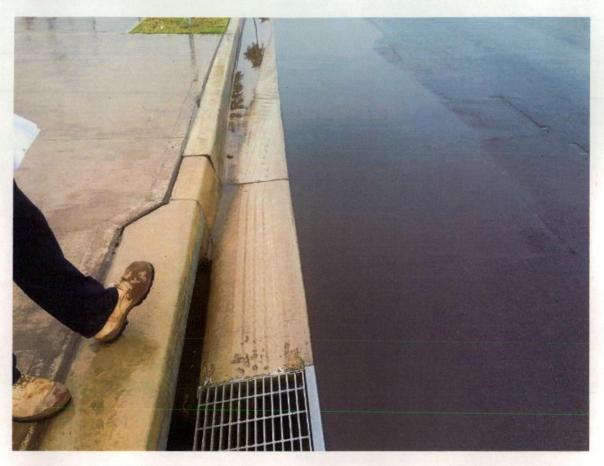
Figure 9tyre tracks and damage to stormwater grate.

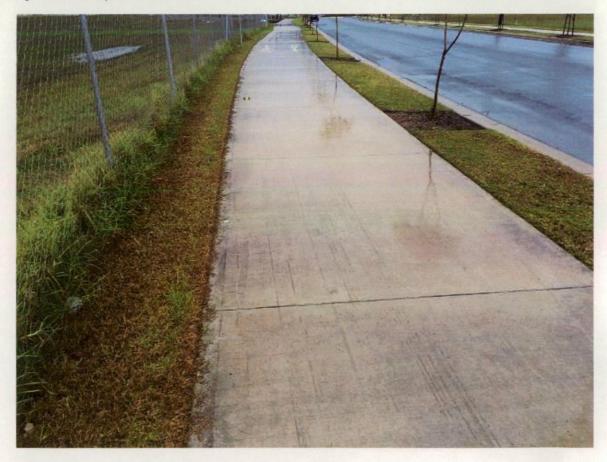
Figure 16 Marks and damage to footpath surface.

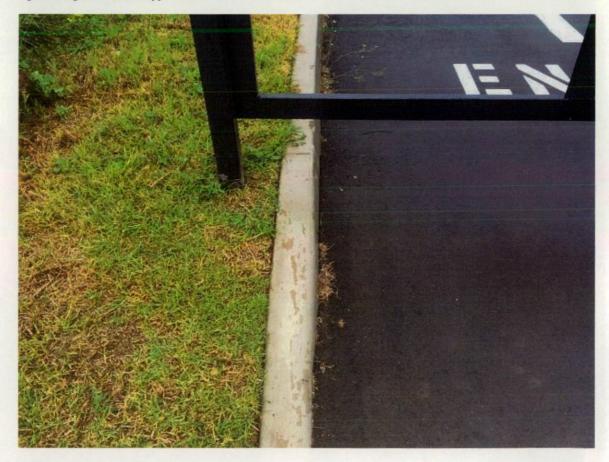
Figure 36 Staining to kerb.

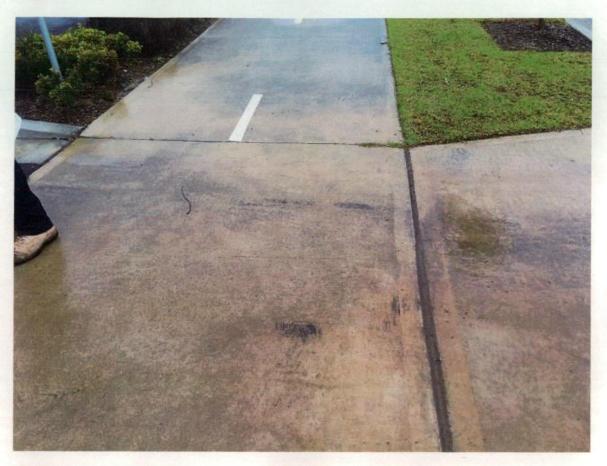
Figure 37 Staining to footpath surface.

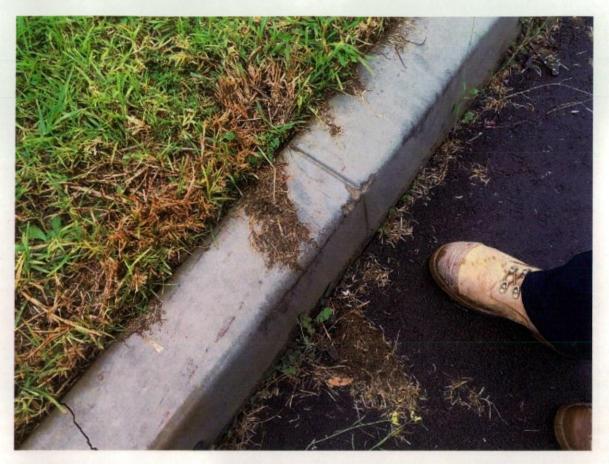
Figure 49 Damage to kerb.

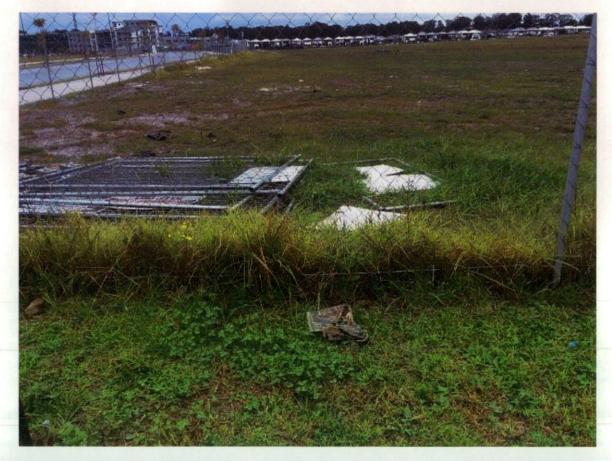
Figure 50 Temp fencing left in field.

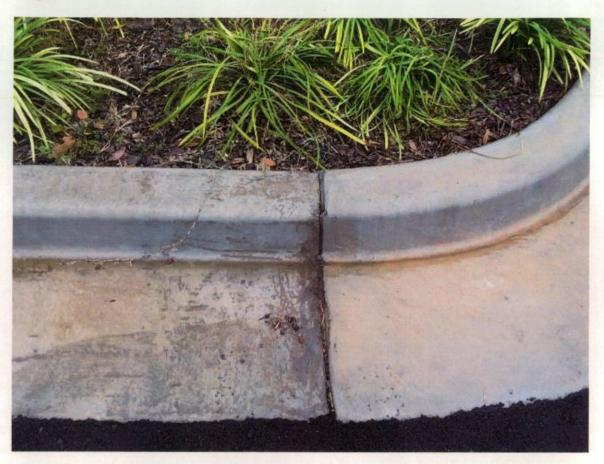
Figure 57 Concrete splatter on kerb.

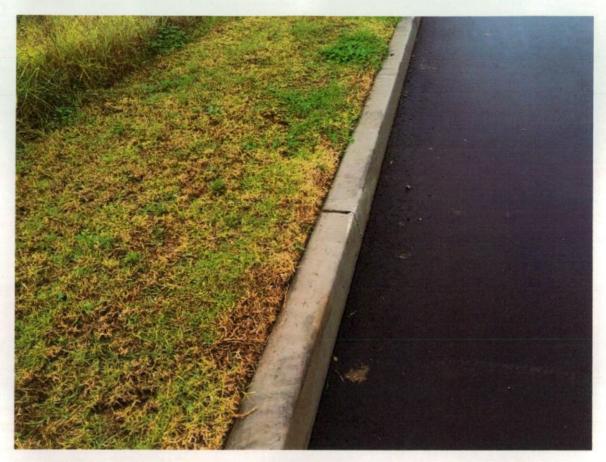
Figure 61 Surface staining to kerb and patching work on kerb.

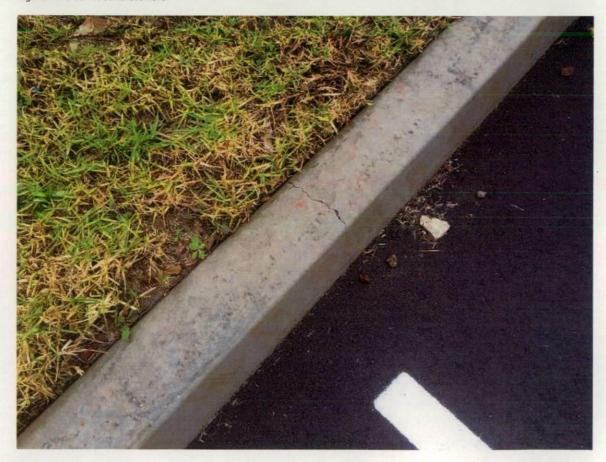
Figure 80 Damage to kerb.

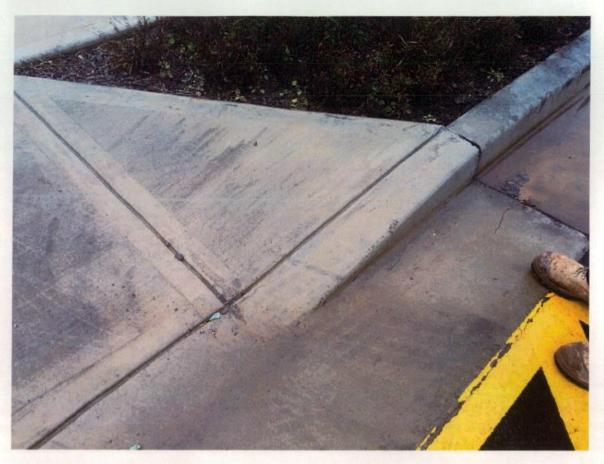
Figure 89 Damage to existing pram ramp.

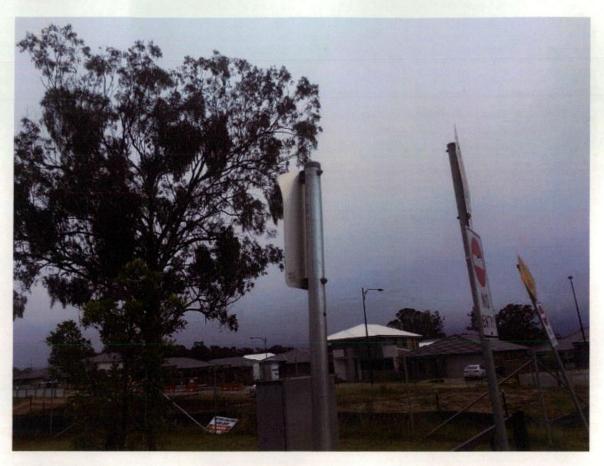
Figure 93 Street sign damaged.

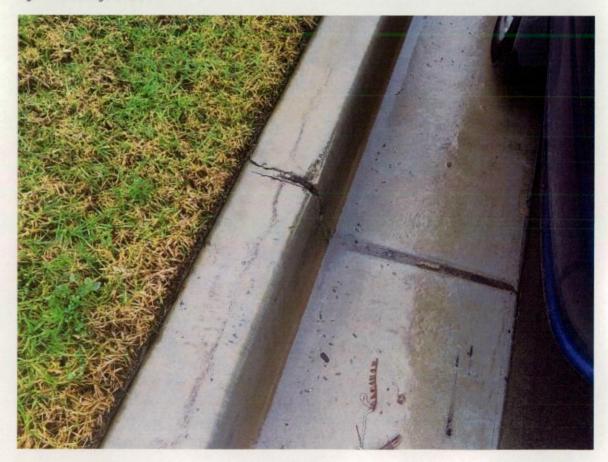
Figure 104 Damage to K&G.

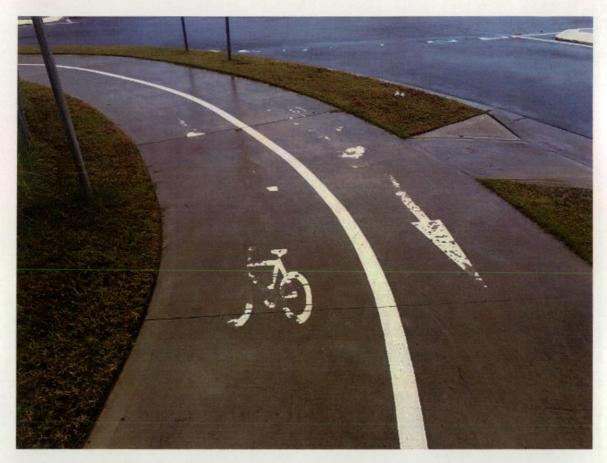
Figure 111 Painted shared cycleway line marking damaged.

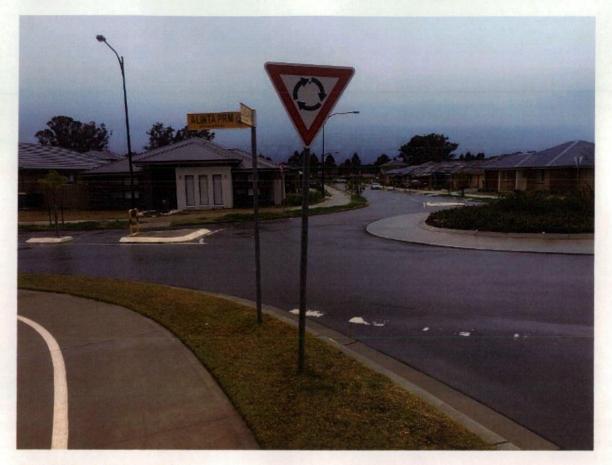
Figure 113 Street signs not straight.

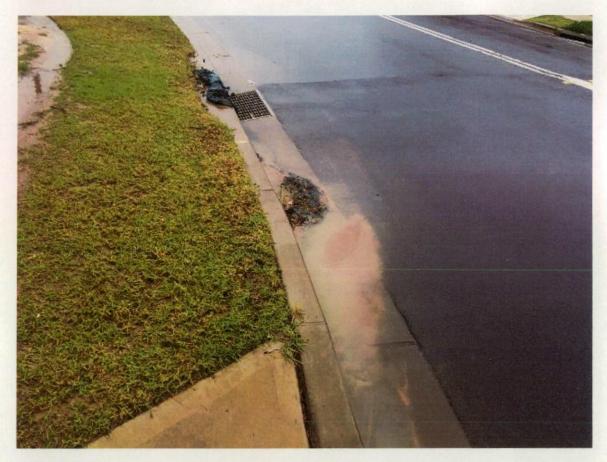
Figure 119 Existing sediment controls in disrepair.

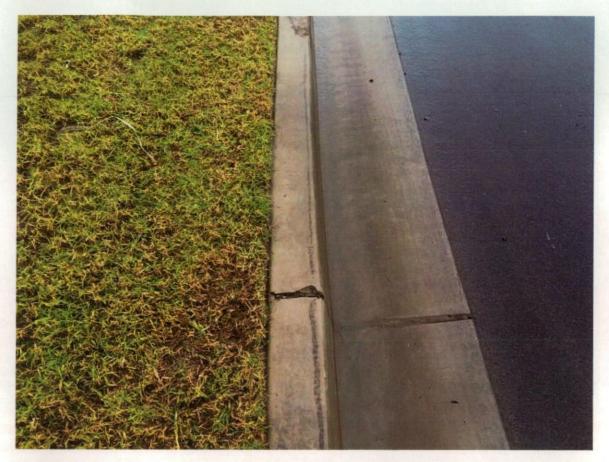
Figure 131 damage to joint.

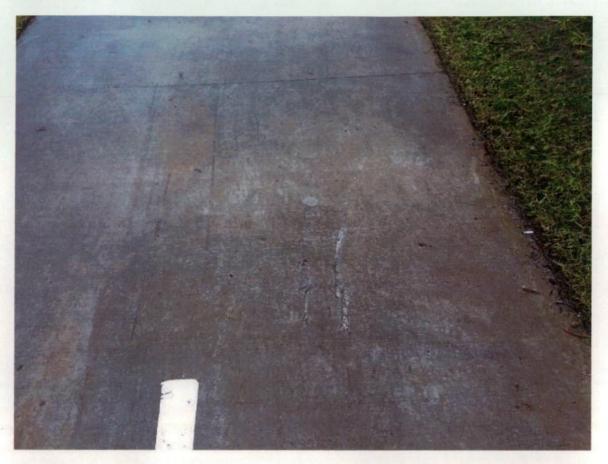
Figure 139 Gouges to footpath surface.

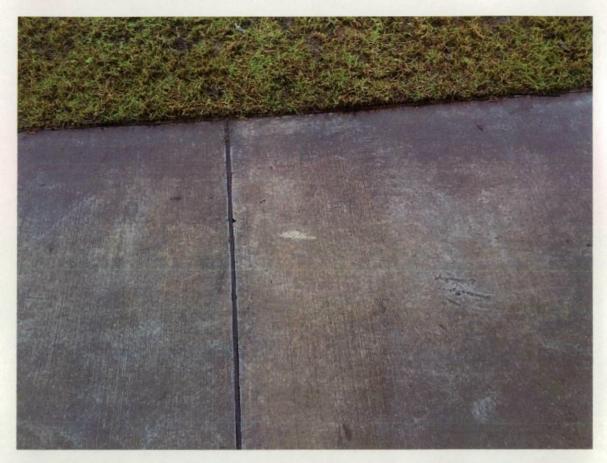
Figure 145 Surface damage to footpath.

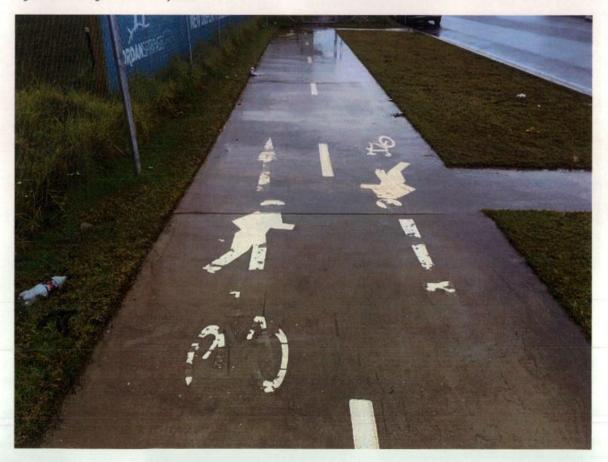
Figure 148 Damage to cycleway line marking.

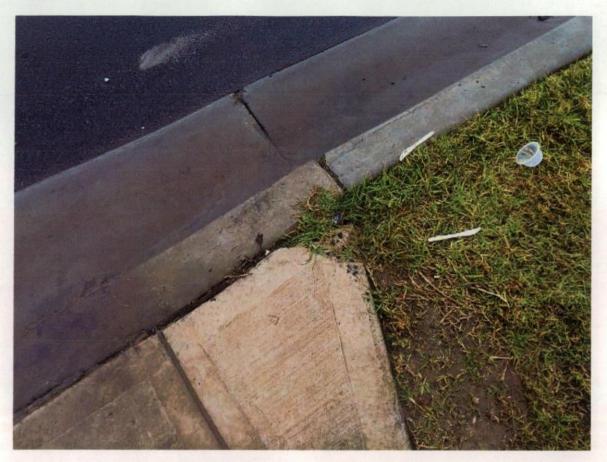
Figure 151 Damage to pram ramp wing.

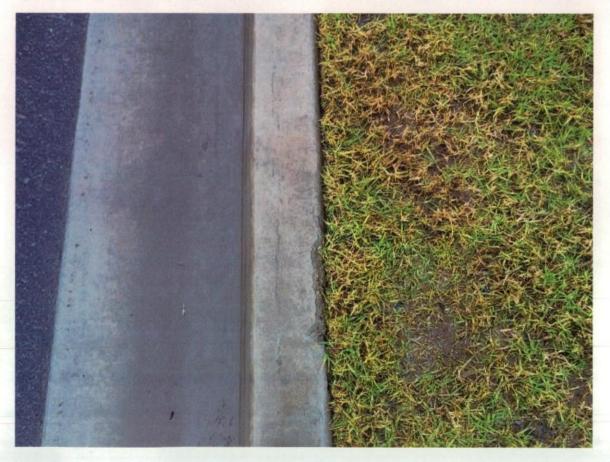
Figure 152 Damage to back of kerb.

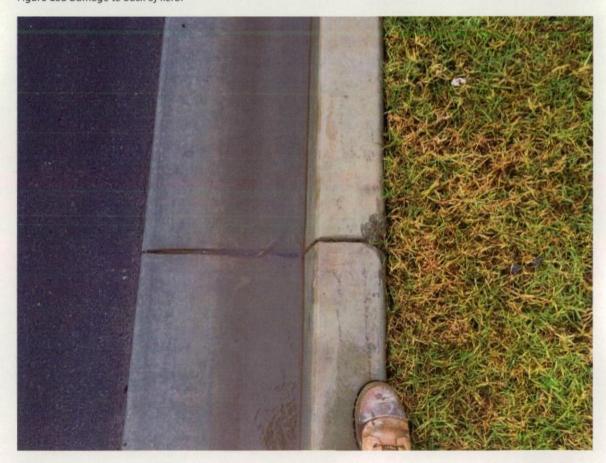
Figure 154 Damage to back of kerb.

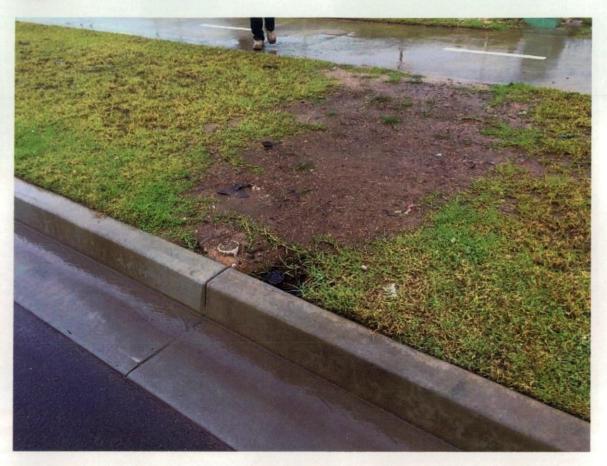
Figure 155 Damage to turf and areas where soil is low.

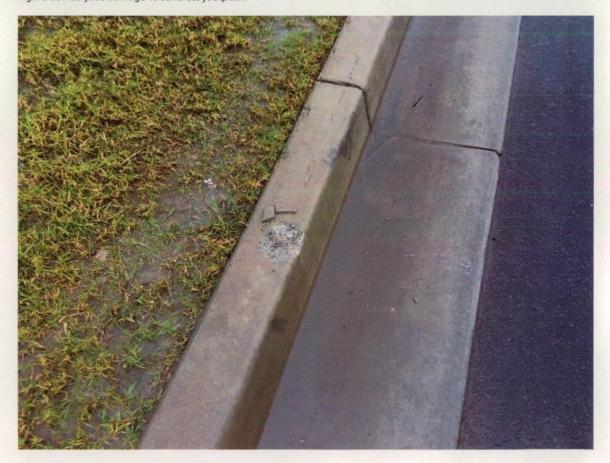
Figure 158 Damage to kerb, water retained in wheel ruts.

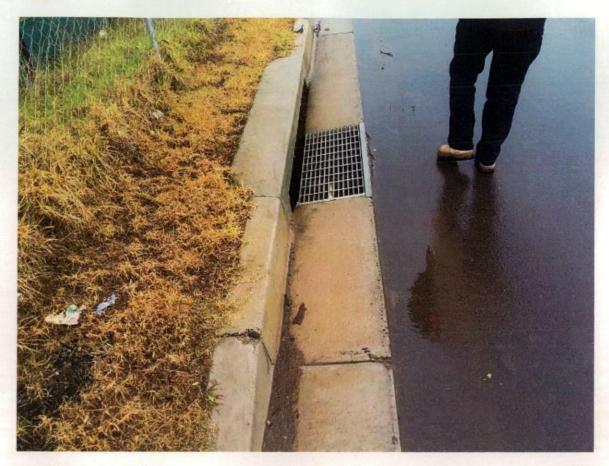
Figure 179 Damage to lintel joint.

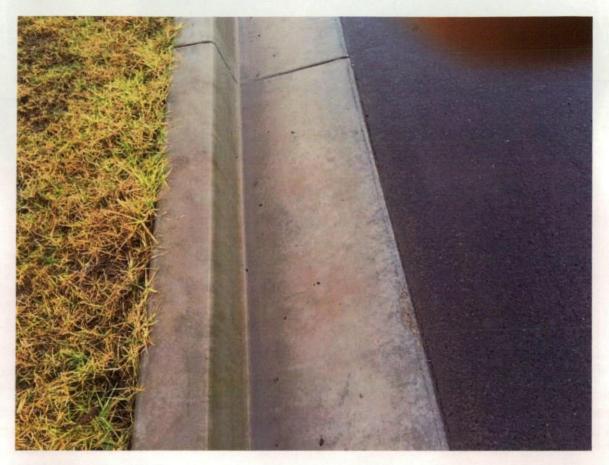
Figure 191 Damage on gutter lip.

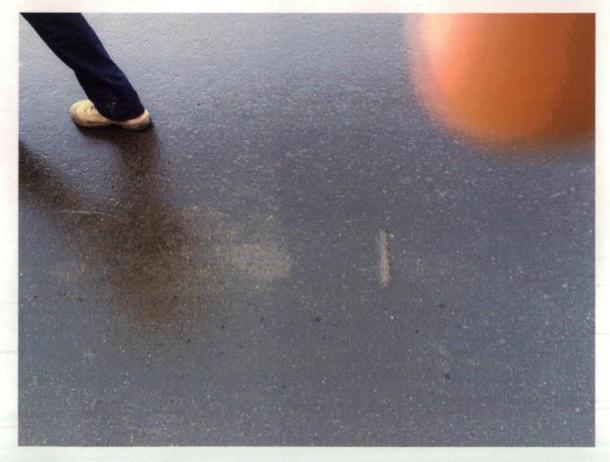
Figure 192 Damage to road surface.

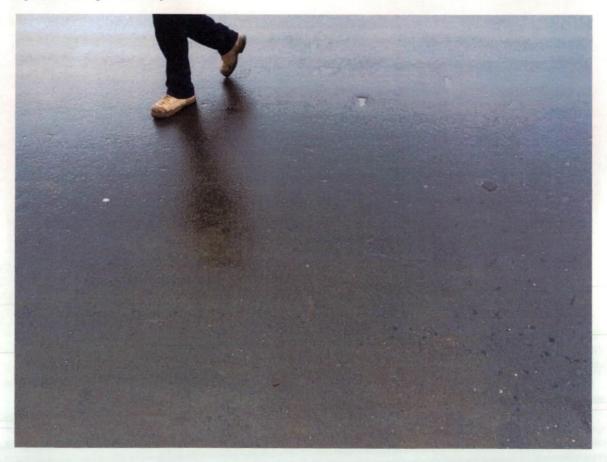
Figure 196 Damage to road surface.

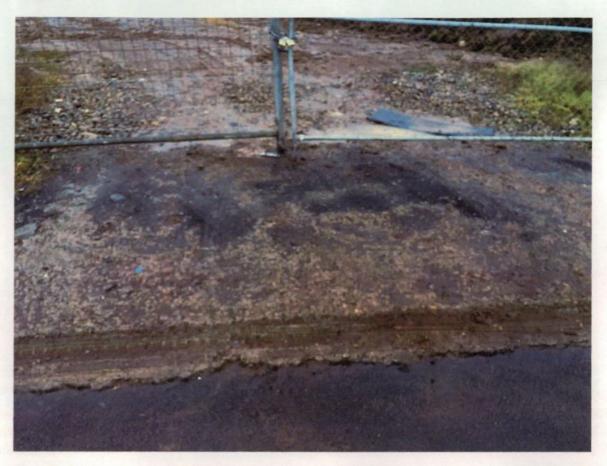
Figure 199 Site entry, ensure no damage to kerb underneath.

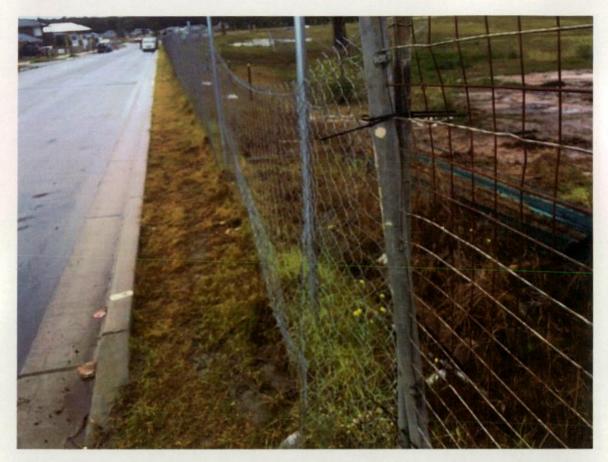
Figure 201 Damage to existing fence.

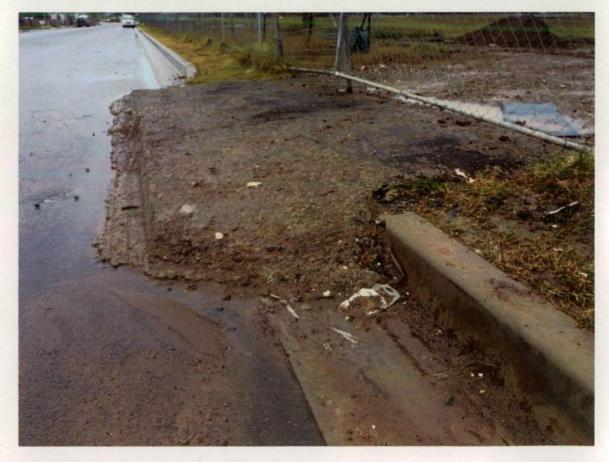
Figure 202 Kerb damage and staining from site access.

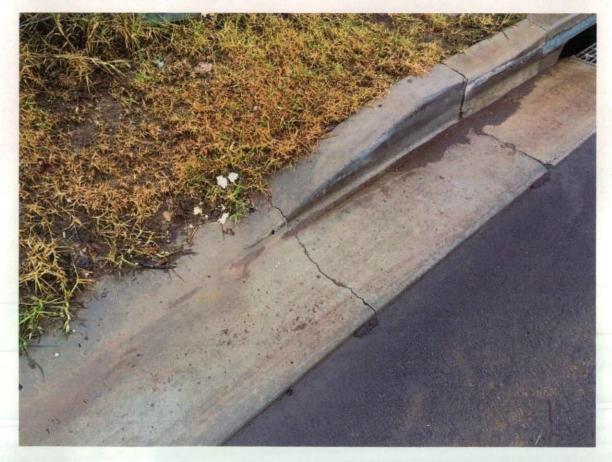
Figure 208 Crack in pram ramp gutter.

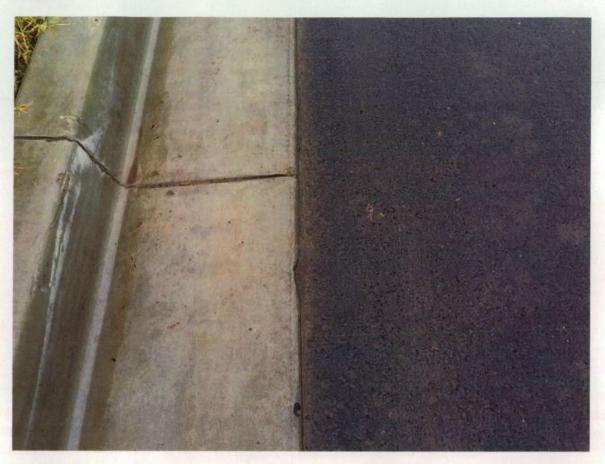
Figure 219 Damage to gutter lip.

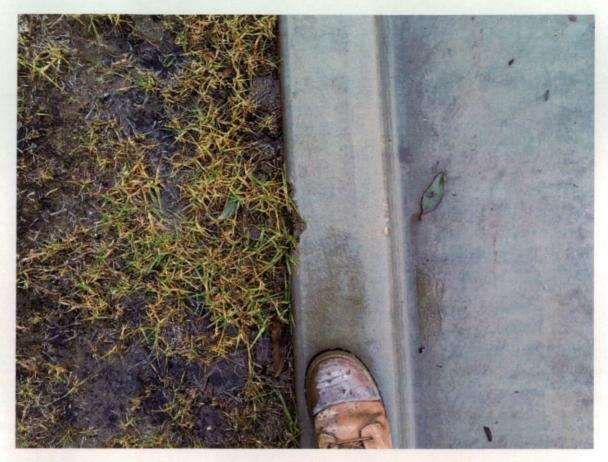
Figure 229 Damage on back of kerb.

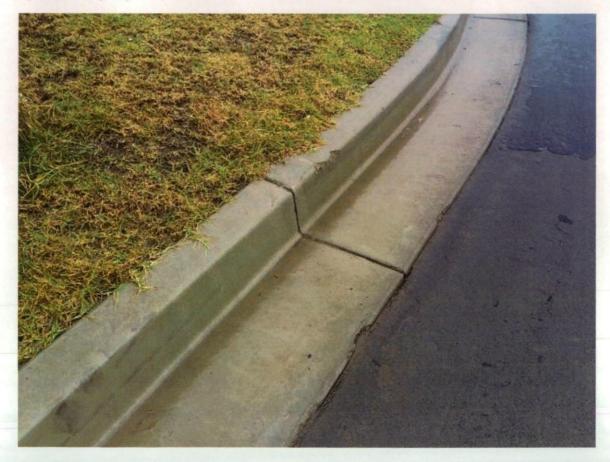
Figure 234 Damage and staining on kerb face.

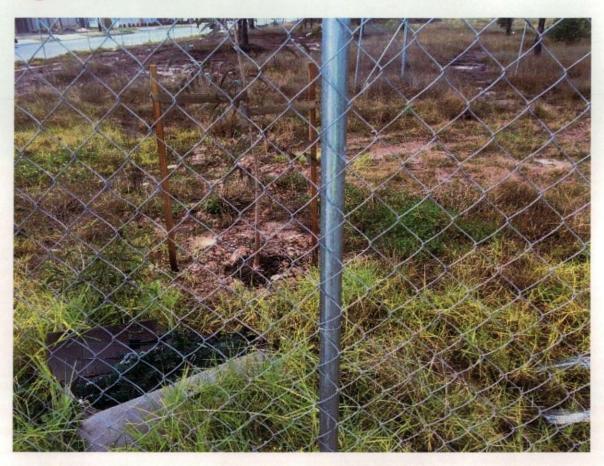
Figure 251 Damage to fence.

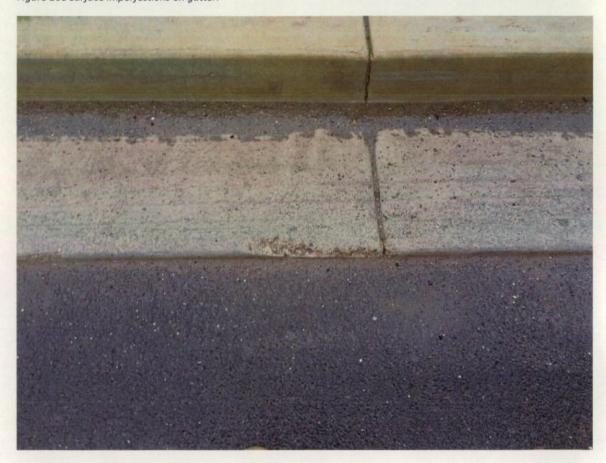
Figure 269 Damage to gutter lip.

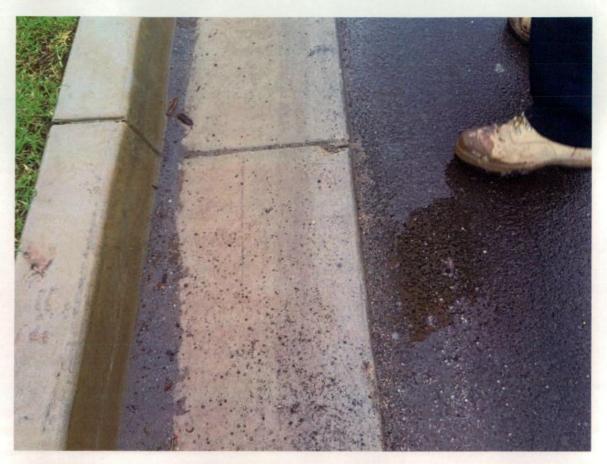
Figure 270 Damage to kerb joint.

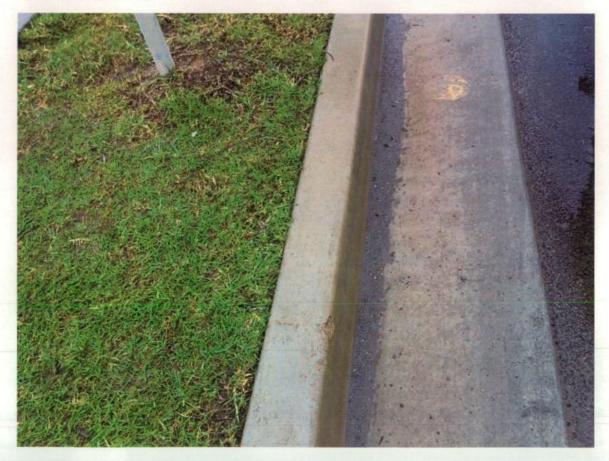
Figure 271 Damage to kerb.

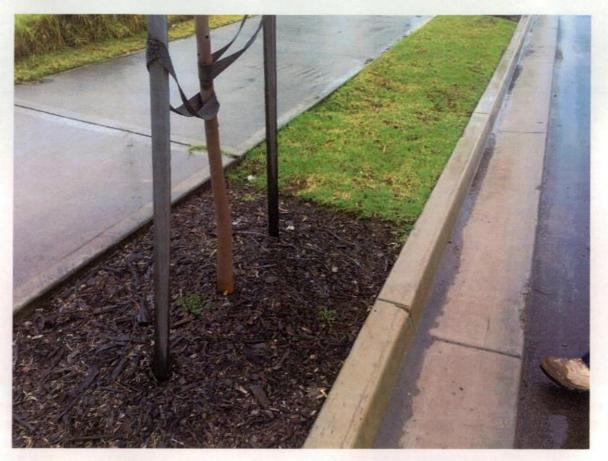
Figure 274 Trees stakes loose.

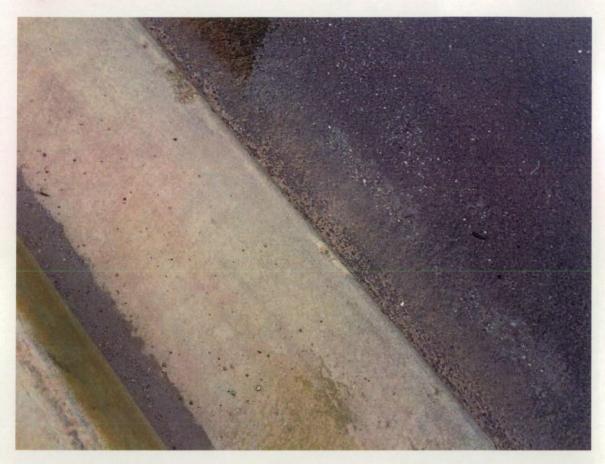
Figure 276 Damage to gutter lip.

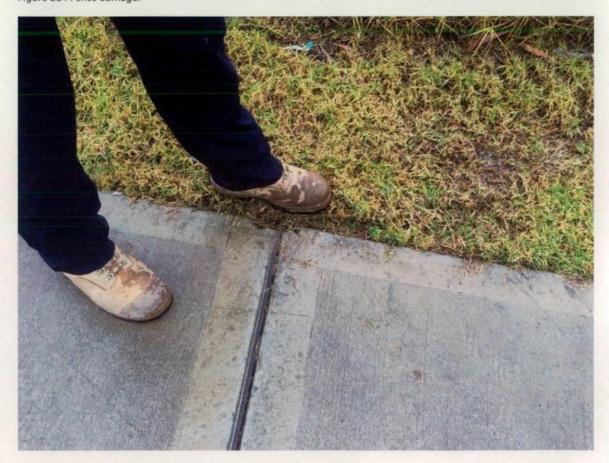
Figure 285 Damage to edge of footpath.

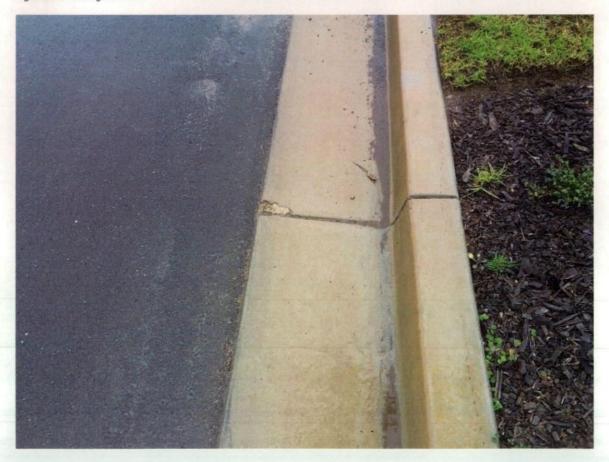
Figure 287 Damage to gutter.

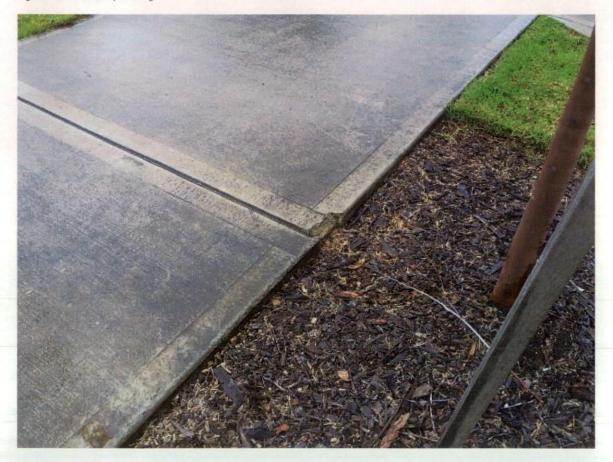
Figure 291 Damage to edge of footpath.

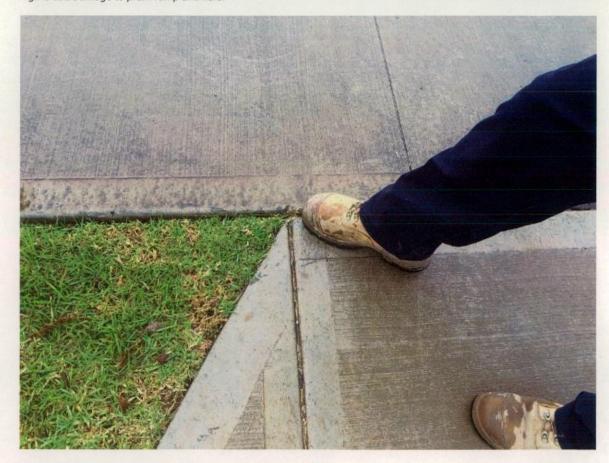
Figure 293 Damage to edge of footpath.

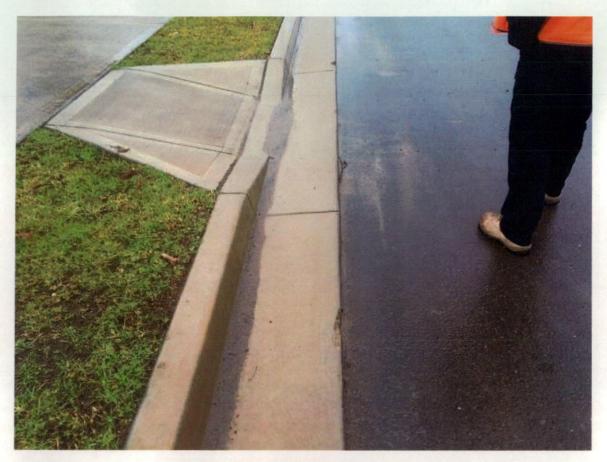
Figure 298 Damage to gutter.

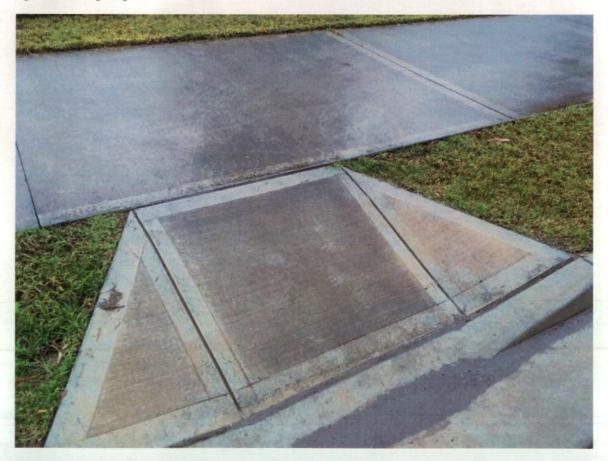
Figure 299 Surface marks on pram ramp.

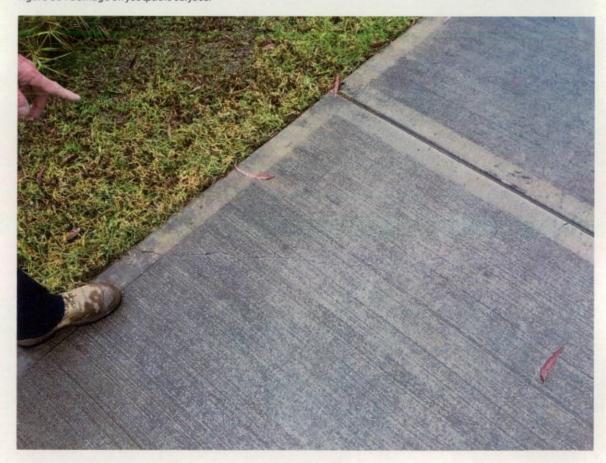
Figure 305 Crack in concrete footpath.

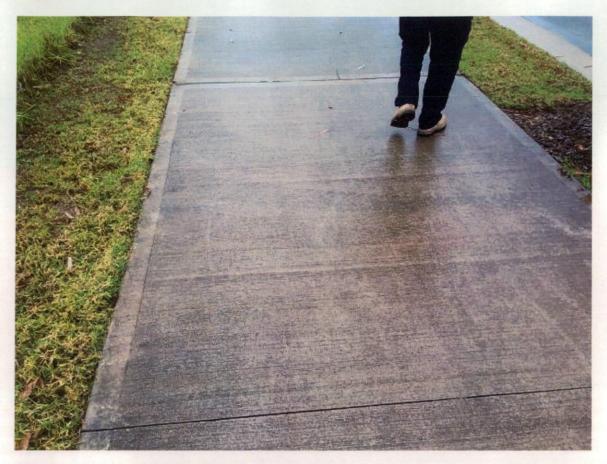
Figure 306 Surface damage on concrete footpath.

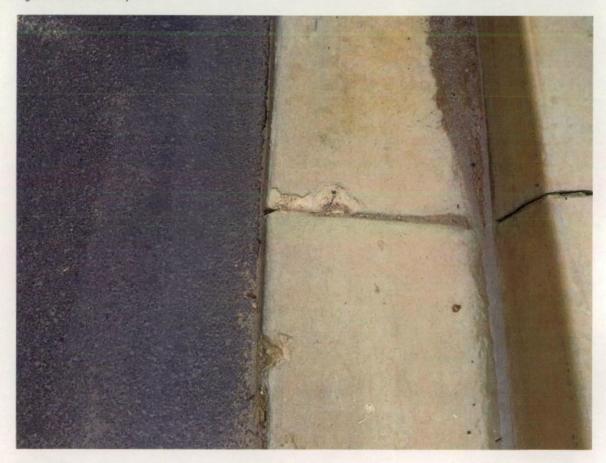
Figure 309 Damage to concrete joint.

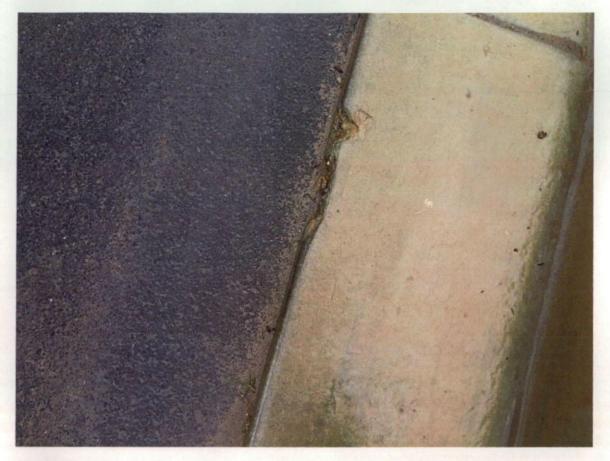
Figure 310 Damage on gutter lip.

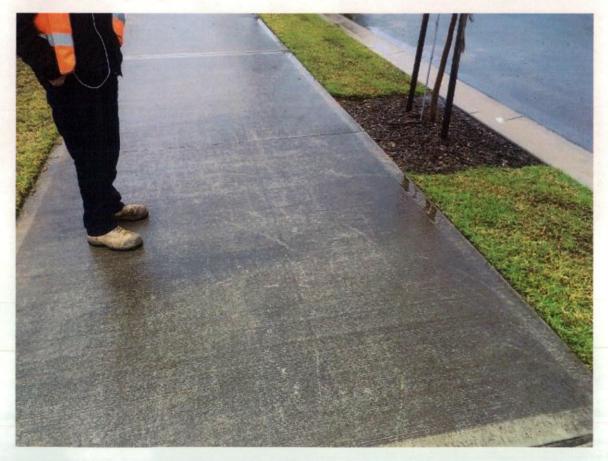
Figure 311 Surface damage on footpath.

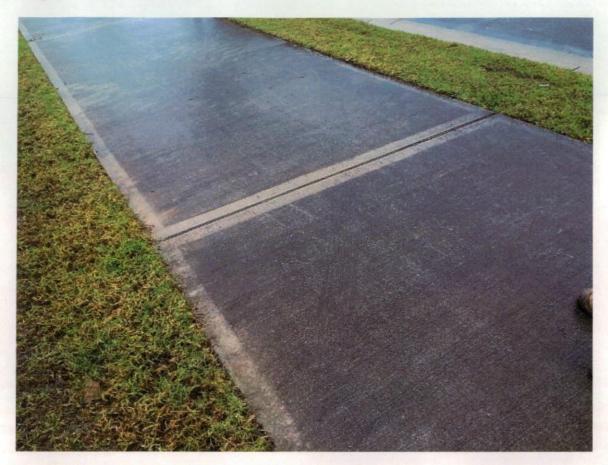
Figure 314 Tyre marks on footpath.

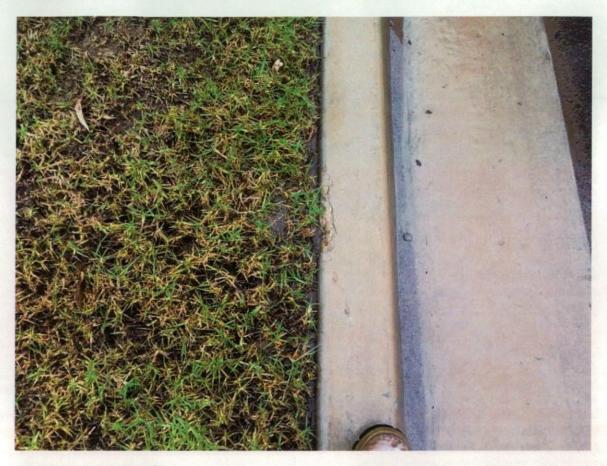
Figure 318 Damage to back of kerb.

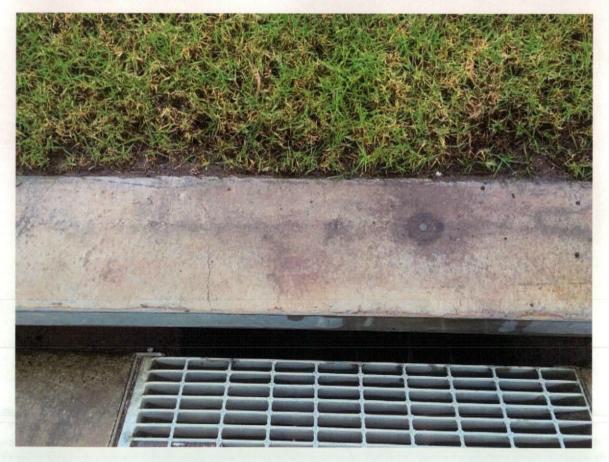
Figure 323 Surface cracks on concrete lintel.

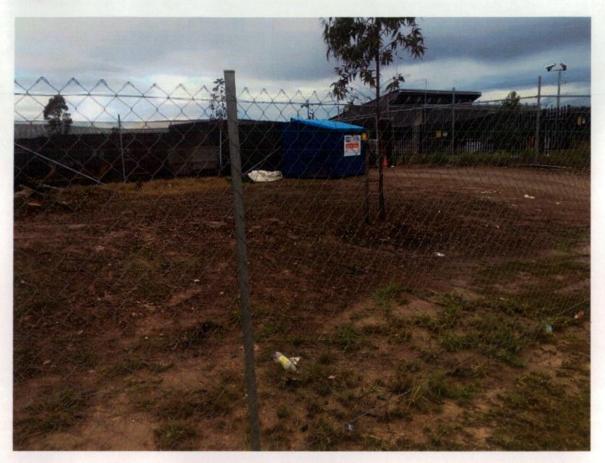
Figure 334 Existing chain link fence near LS compound.

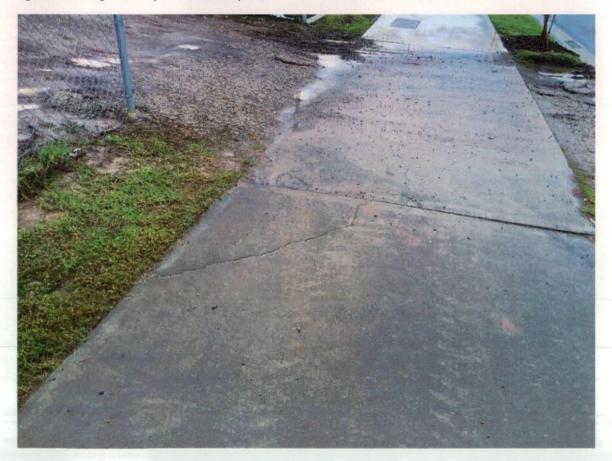
Figure 335 Crack/tyre marks in concrete footpath.

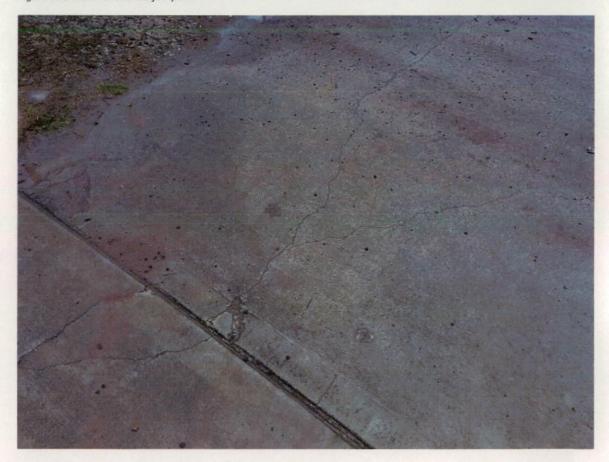
Figure 337 Crack in concrete footpath.

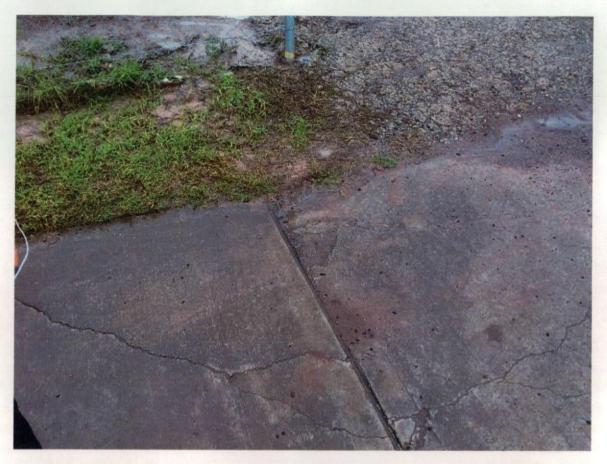
Figure 338 Crack in concrete footpath.

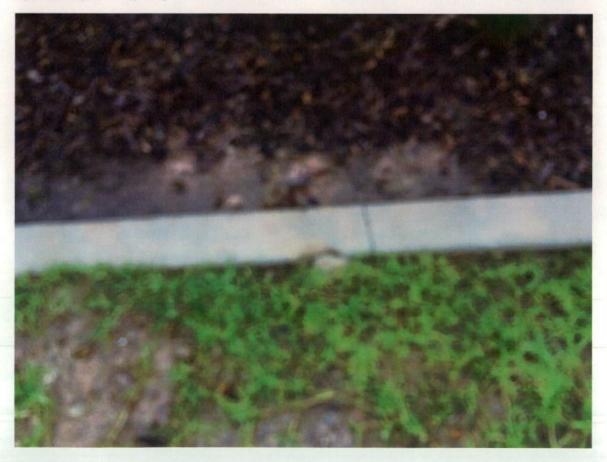
Figure 350 Damage to concrete garden edging.

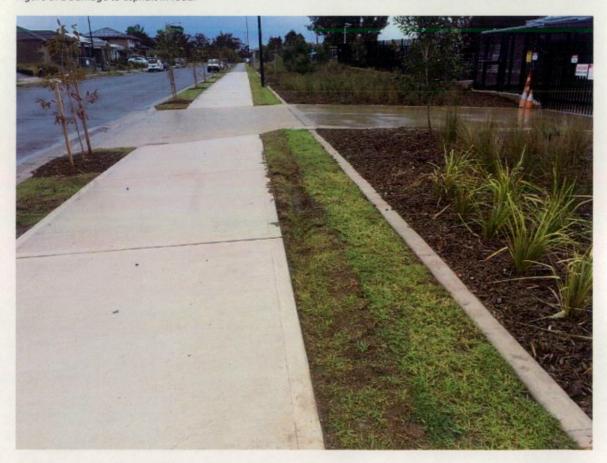
Figure 372 Wheel ruts in turf area.

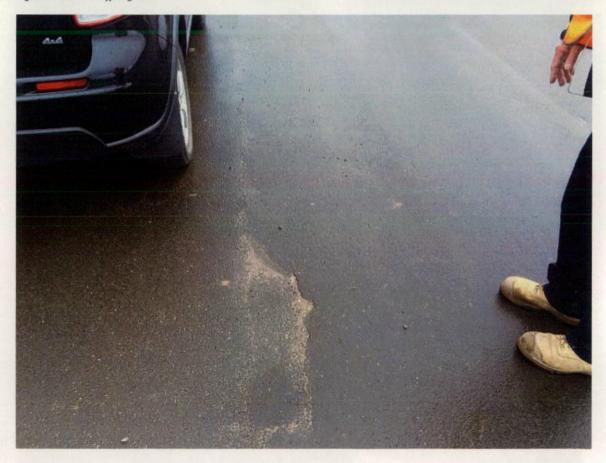
Figure 384 Damage to asphalt surface.

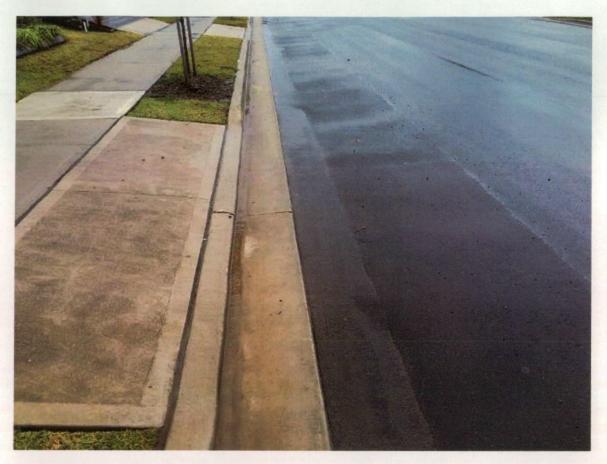
Figure 385 Existing state of driveways opp. site.

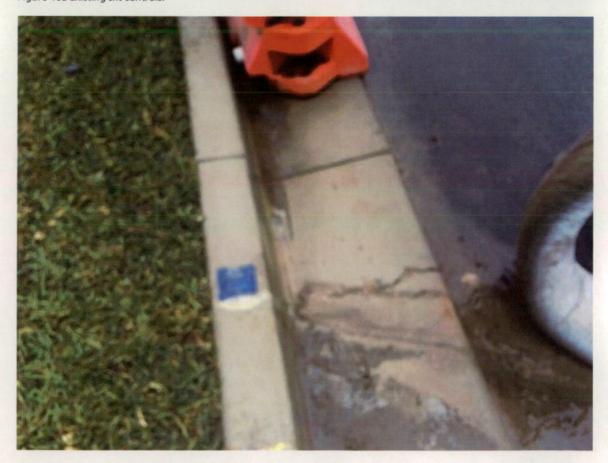
Figure 404 Crack in K&G under silt control.

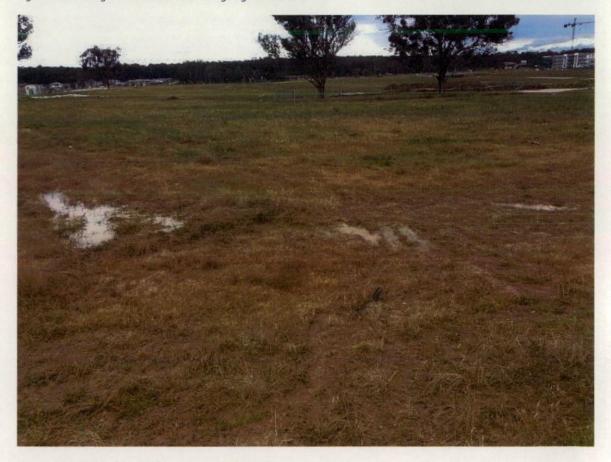
Figure 420 Interior of site holding water and wheel ruts.
