31 August 2020

Andrew Boustred  
Home Consortium Property Limited  
PO Box 10  
Double Bay NSW 2028

## Re: Summary of Contaminated Land Condition Proposed Childcare Development, 72-80 Mulgoa Road, Penrith

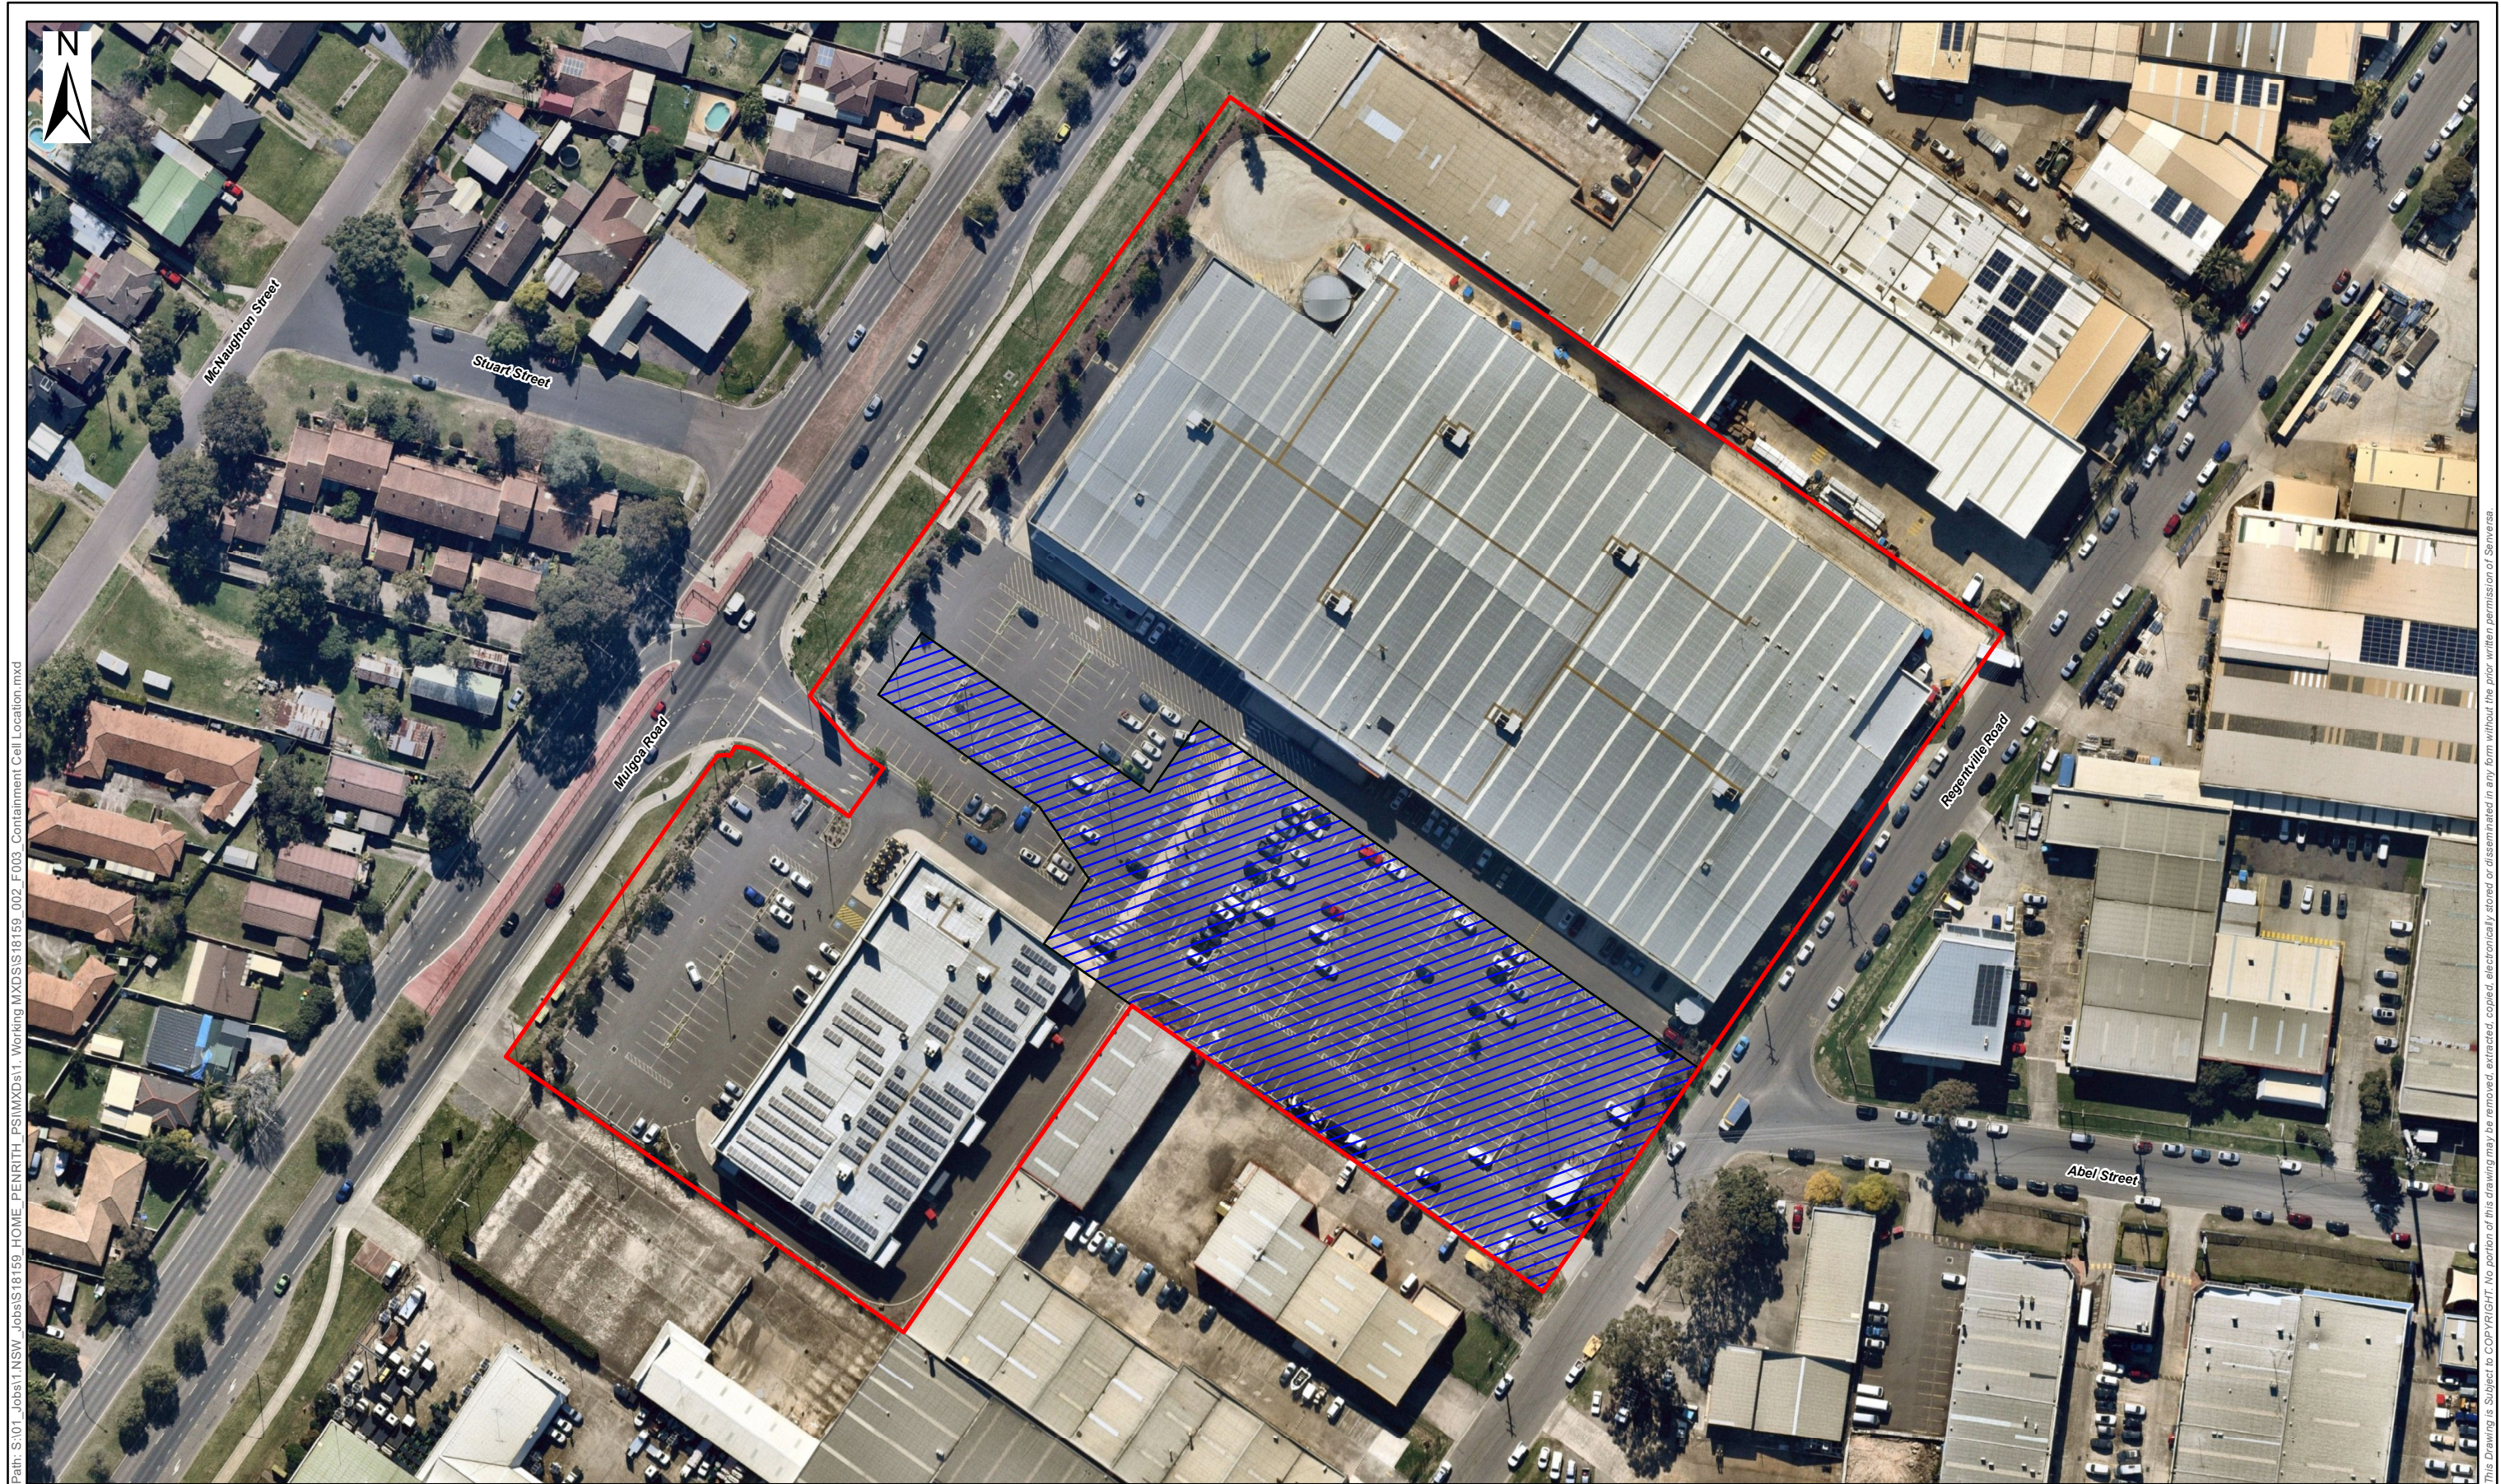
<b>Figure No:</b>	<b>3</b>
<b>Title:</b>	<b>Containment Cell Location</b>
Project:	Due Diligence Report
Location:	72 Mulgoa Road, Penrith
Client:	Home Consortium Pty Ltd

<b>On-site Contamination Remaining</b>	Fill containing elevated lead and asbestos containing material was retained on-site in a capped containment cell. This source of contamination could potentially pose a risk to on-site receptors should the capping be breached. It is considered that implementation of the long-term environmental management plan (LTEMP) would ensure this source-receptor pathway is incomplete.

- Provided the capping layer is constructed as report and is not breached, there does not appear to be a complete source-pathway-receptor linkage with regard to the encapsulated material. The risk to users of the childcare centre is considered low, however;
  - it is noted that the capping layer is less than 250 mm thick, which is unlikely to be sufficient to protect intrusive maintenance workers during development works, and ongoing/future service maintenance works. Consideration should be given to this during development through preparation and implementation of an appropriate construction environmental management plan and appropriate workplace health and safety measures.
