Hazardous Materials Survey

170 Derby Street

Penrith NSW 2750

E20160-1

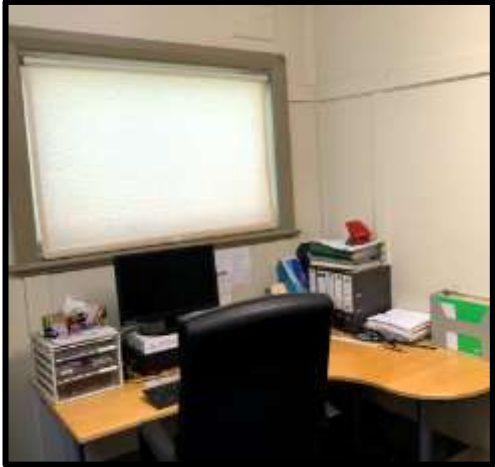
Occurrence	Friability	Status	Occurrence Details	Comments and Risk Assessment	Image
ASBESTOS					
Material within the wall of the office.	Non-Friable	Negative	First Recorded: 30.10.20 Reinspection Due: 30.10.25 Labelled: Yes Removed: Yes Sample Tested: Yes Name: S1 No Asbestos Detected	Low Risk There was minimal risk in obtaining the sample. However, it is recommended that appropriate PPE should be worn by field technician to minimise risk of injury.

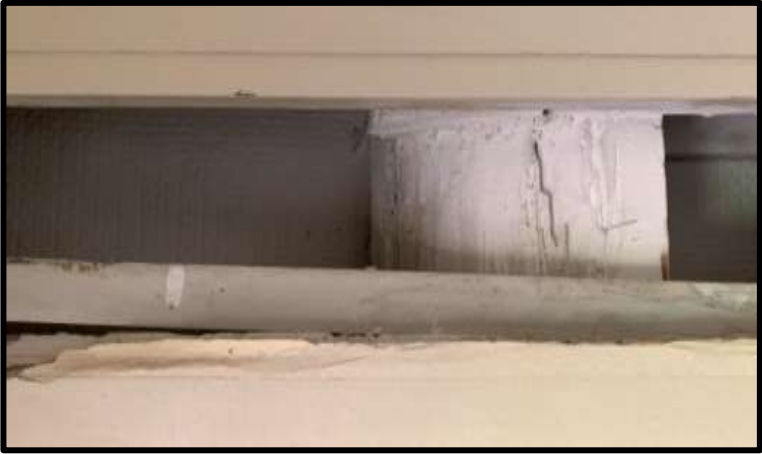
Material within the wall	Non-Friable	Positive	<p>First Recorded: 30.10.20 Reinspection Due: 30.10.25 Labelled: Yes Removed: Yes Sample Tested: Yes</p> <p>Name: S2</p> <p>No Asbestos Detected</p> <p>Lead Paint: 0.002 %w/w</p>	<p>Low Risk</p> <p>It is recommended that appropriate PPE should be worn by field technician to minimise risk of injury.</p>

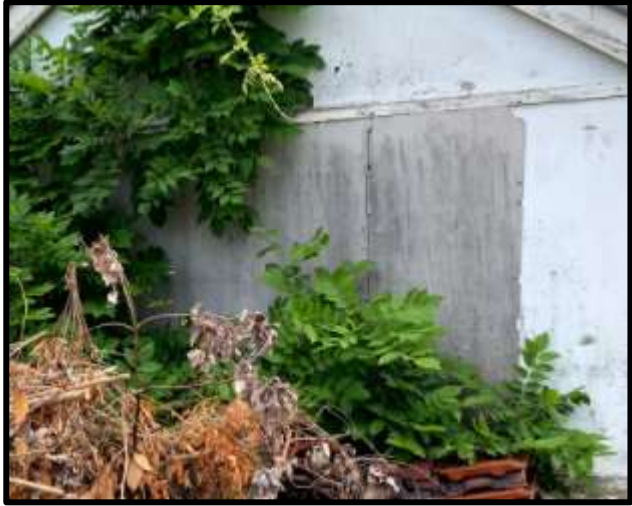
Material used at the back of the shed.	Non - Friable	Negative	<p>First Recorded: 30.10.20 Reinspection Due: 30.10.25 Labelled: Yes Removed: Yes Sample Tested: Yes</p> <p>Name: S6</p> <p>No Asbestos Detected</p>	<p>Low Risk</p> <p>It is recommended that appropriate PPE should be worn by field technician to minimise risk of injury if/when sample if being collected.</p>

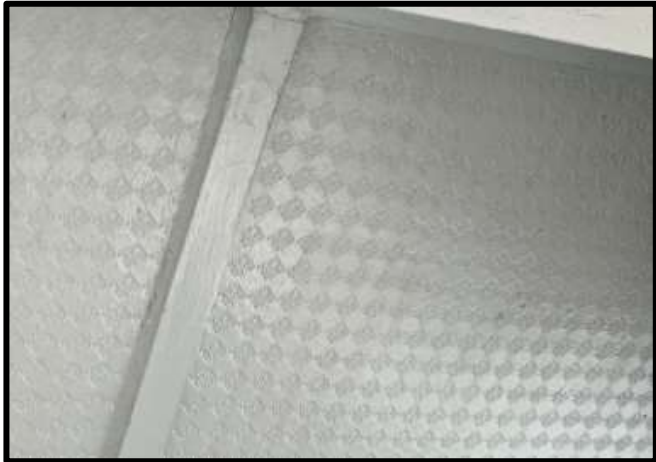
Material used for ceiling	Non - Friable	Negative	First Recorded: 30.10.20 Reinspection Due: 30.10.25 Labelled: No Removed: No Sample Tested: No	<p>Low Risk</p> <p>No sample was taken due to the height of the ceiling.</p> <p>It is recommended that appropriate PPE should be worn by field technician to minimise risk of injury if/when sample if being collected.</p>

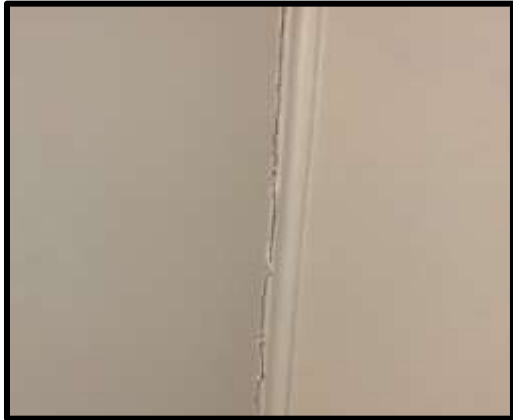
Edges along the corner of the room	N/A	Positive	First Recorded: 30.10.20 Reinspection Due: 30.10.25 Labelled: Yes Removed: Yes Sample Tested: Yes Name: S3 Lead Paint: 0.001 %w/w	<p>Low Risk</p> <p>There was minimal risk in obtaining the sample. However, it is recommended that appropriate PPE should be worn by field technician to minimise risk of injury.</p>

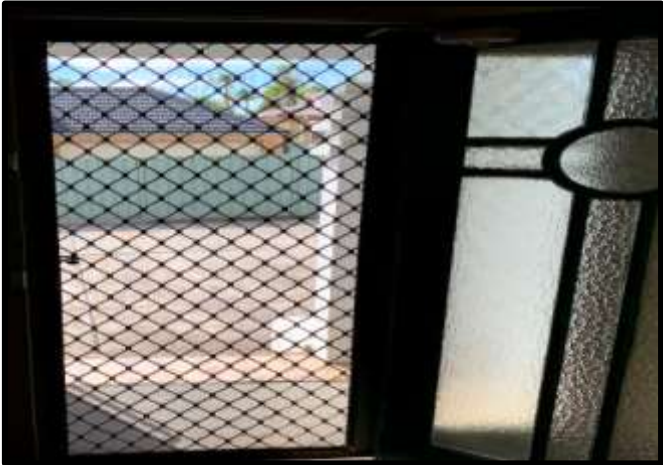
Paint from the door	N/A	Positive	<p>First Recorded: 30.10.20 Reinspection Due: 30.10.25 Labelled: Yes Removed: Yes Sample Tested: Yes</p> <p>Name: S4</p> <p>Lead Paint: 0.002 %w/w</p>	<p>Low Risk</p> <p>There was minimal risk in obtaining the sample. However, it is recommended that appropriate PPE should be worn by field technician to minimise risk of injury.</p>

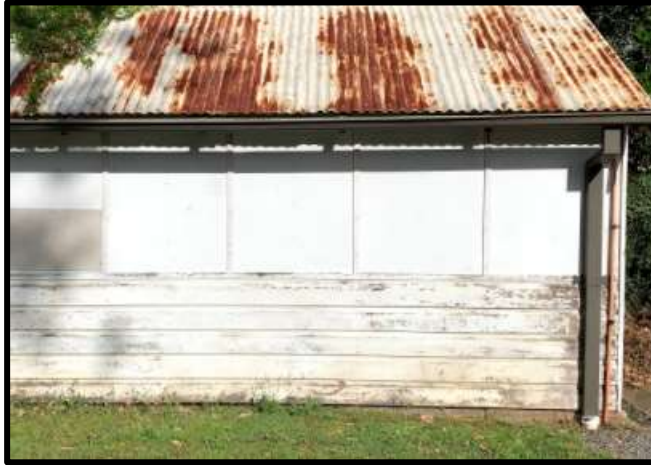
Peeled paint from the shed.	N/A	Positive	<p>First Recorded: 30.10.20 Reinspection Due: 30.10.25 Labelled: Yes Removed: Yes Sample Tested: Yes</p> <p>Name: S5</p> <p>Lead Paint: 17 %w/w</p>	<p>Low Risk</p> <p>There was minimal risk in obtaining the sample. However, it is recommended that appropriate PPE should be worn by field technician to minimise risk of injury.</p>

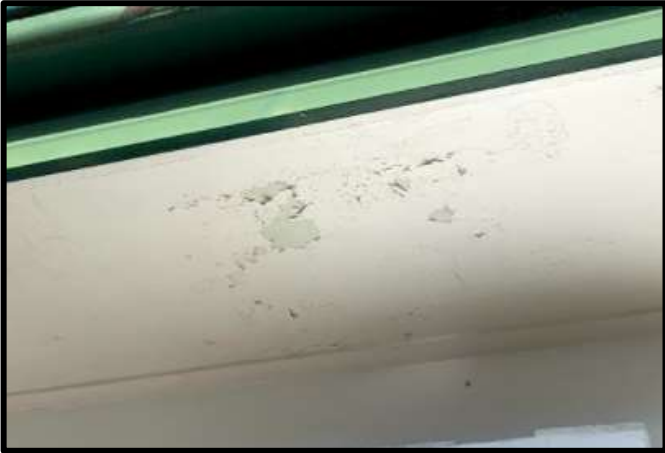
<p>Peeling paint from eaves of the property.</p>	<p>N/A</p>	<p>Negative</p>	<p>First Recorded: 30.10.20 Reinspection Due: 30.10.25 Labelled: No Removed: No Sample Tested: No</p>	<p>Low Risk</p> <p>No sample was taken due to the height of the ceiling.</p> <p>It is recommended that appropriate PPE should be worn by field technician to minimise risk of injury.</p>

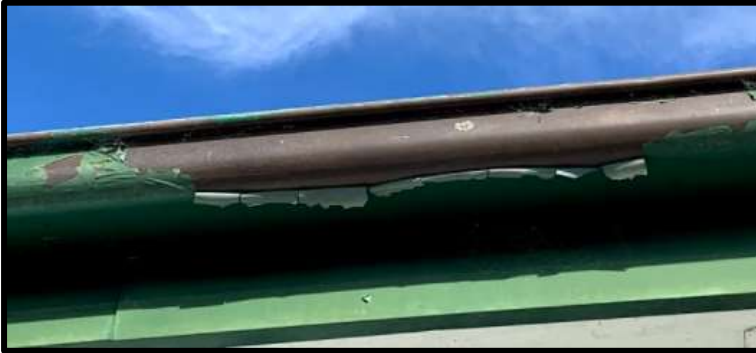
<p>Peeling paint from gutter of the property.</p>	<p>N/A</p>	<p>Negative</p>	<p>First Recorded: 30.10.20 Reinspection Due: 30.10.25 Labelled: No Removed: No Sample Tested: No</p>	<p>Low Risk</p> <p>No sample was taken due to the height of the ceiling.</p> <p>It is recommended that appropriate PPE should be worn by field technician to minimise risk of injury.</p>

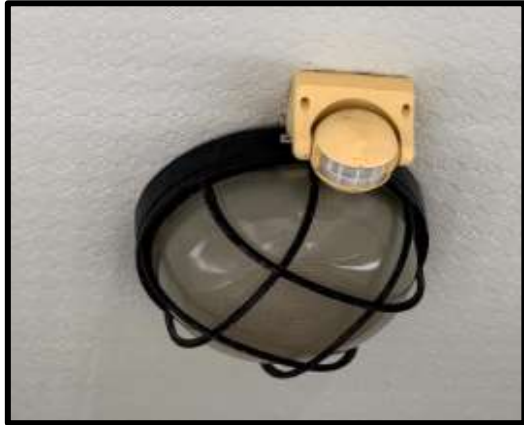
Front porch light.	N/A	Assumed positive	First Recorded: 30.10.20 Reinspection Due: 30.10.25 Labelled: No Removed: No Sample Tested: No	Low Risk No sample was taken due to the light being in viable condition. It is recommended that appropriate PPE should be worn by field technician to minimise risk of injury.

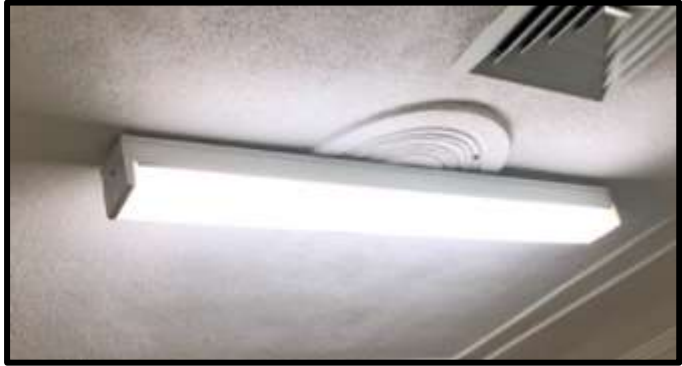
Lights within the residential structure	N/A	Assumed positive	First Recorded: 30.10.20 Reinspection Due: 30.10.25 Labelled: No Removed: No Sample Tested: No	Low Risk It is recommended that appropriate PPE should be worn by field technician to minimise risk of injury. No sample was taken due to the light being in viable condition.

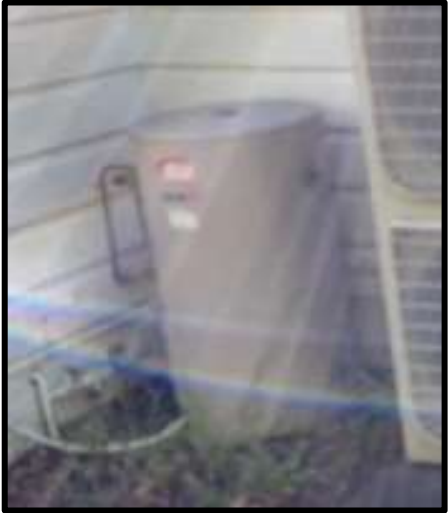
Water Heater located outside the property	N/A	Assumed positive	First Recorded: 30.10.20 Reinspection Due: 30.10.25 Labelled: No Removed: No Sample Tested: No	Low Risk It is recommended that appropriate PPE should be worn by field technician to minimise risk of injury. No sample was taken due to the water heater being in viable condition.

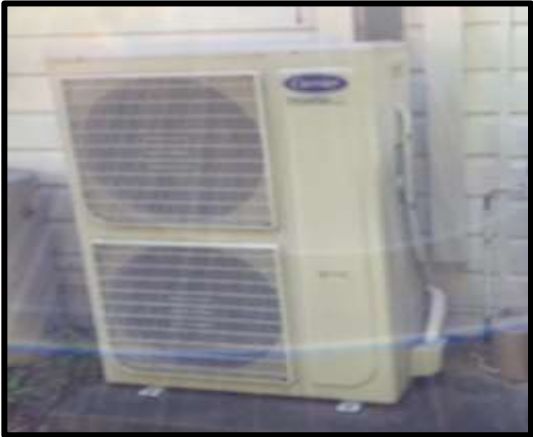
Air conditioner	N/A	Assumed positive	First Recorded: 30.10.20 Reinspection Due: 30.10.25 Labelled: No Removed: No Sample Tested: No	Low Risk It is recommended that appropriate PPE should be worn by field technician to minimise risk of injury. No sample was taken due to the air conditioner being in viable condition.

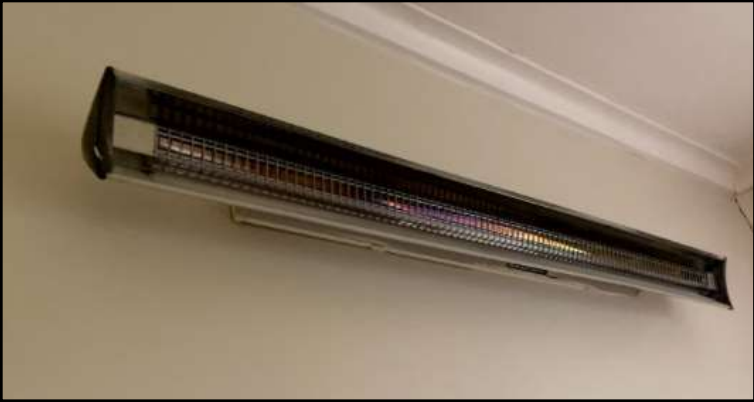
<p>Heater within the property</p>	<p>N/A</p>	<p>Assumed positive</p>	<p>First Recorded: 30.10.20 Reinspection Due: 30.10.25 Labelled: No Removed: No Sample Tested: No</p>	<p>Low Risk</p> <p>It is recommended that appropriate PPE should be worn by field technician to minimise risk of injury.</p> <p>No sample was taken due to the air conditioner being in viable condition.</p>
