Report on
Preliminary Site Investigation - Contamination

Proposed Cemetery
Wallacia Golf Course, Wallacia, NSW

Prepared for
Catholic Metropolitan Cemeteries Trust

Project 76652.02
June 2017

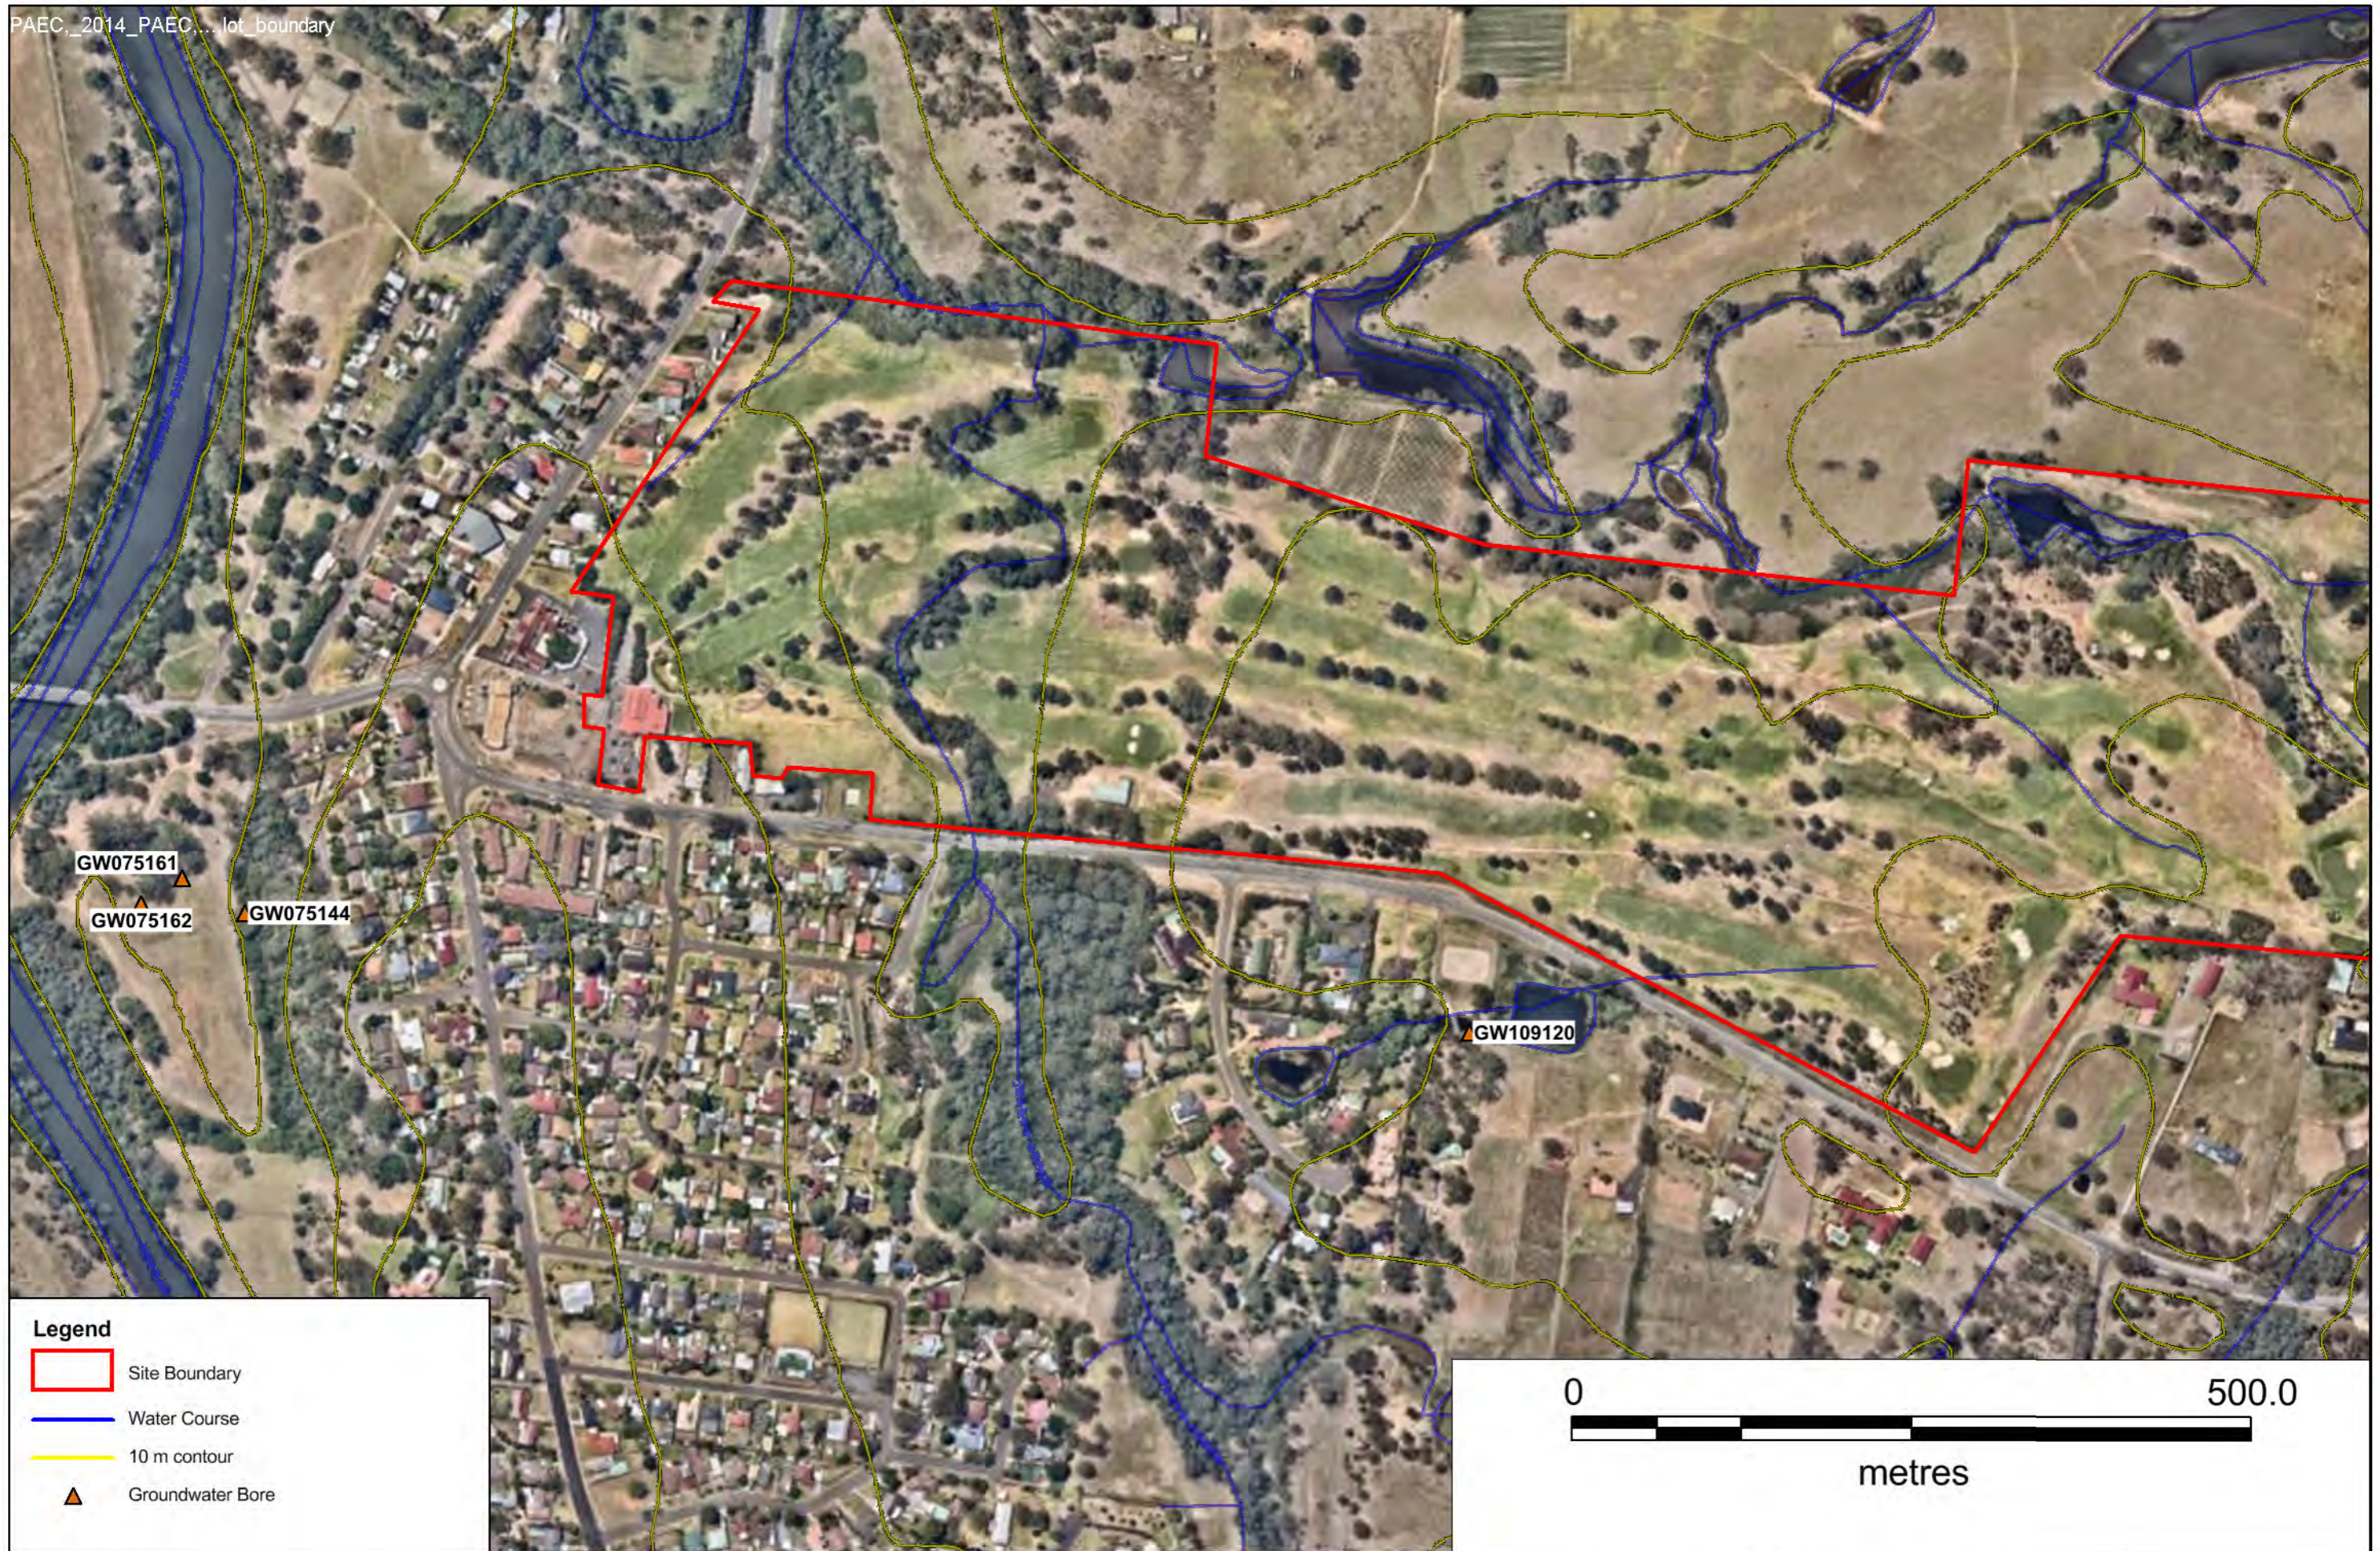
PROJ No: 76652.02.R1
 DRAWING No: 2
 REVISION: A

Topographic contours and watercourses within and surrounding the site are shown on Drawing 2 (Appendix A).

A search of the NSW Office of Water groundwater bore data was undertaken by DP on 30 May 2017 and identified four bores within 1km of the site as shown on Drawing 2 (Appendix A) and detailed in Appendix B. Table 2 below provides a summary of information for each bore.

With the exception of GW109120, all wells are down hydraulic gradient of the site.

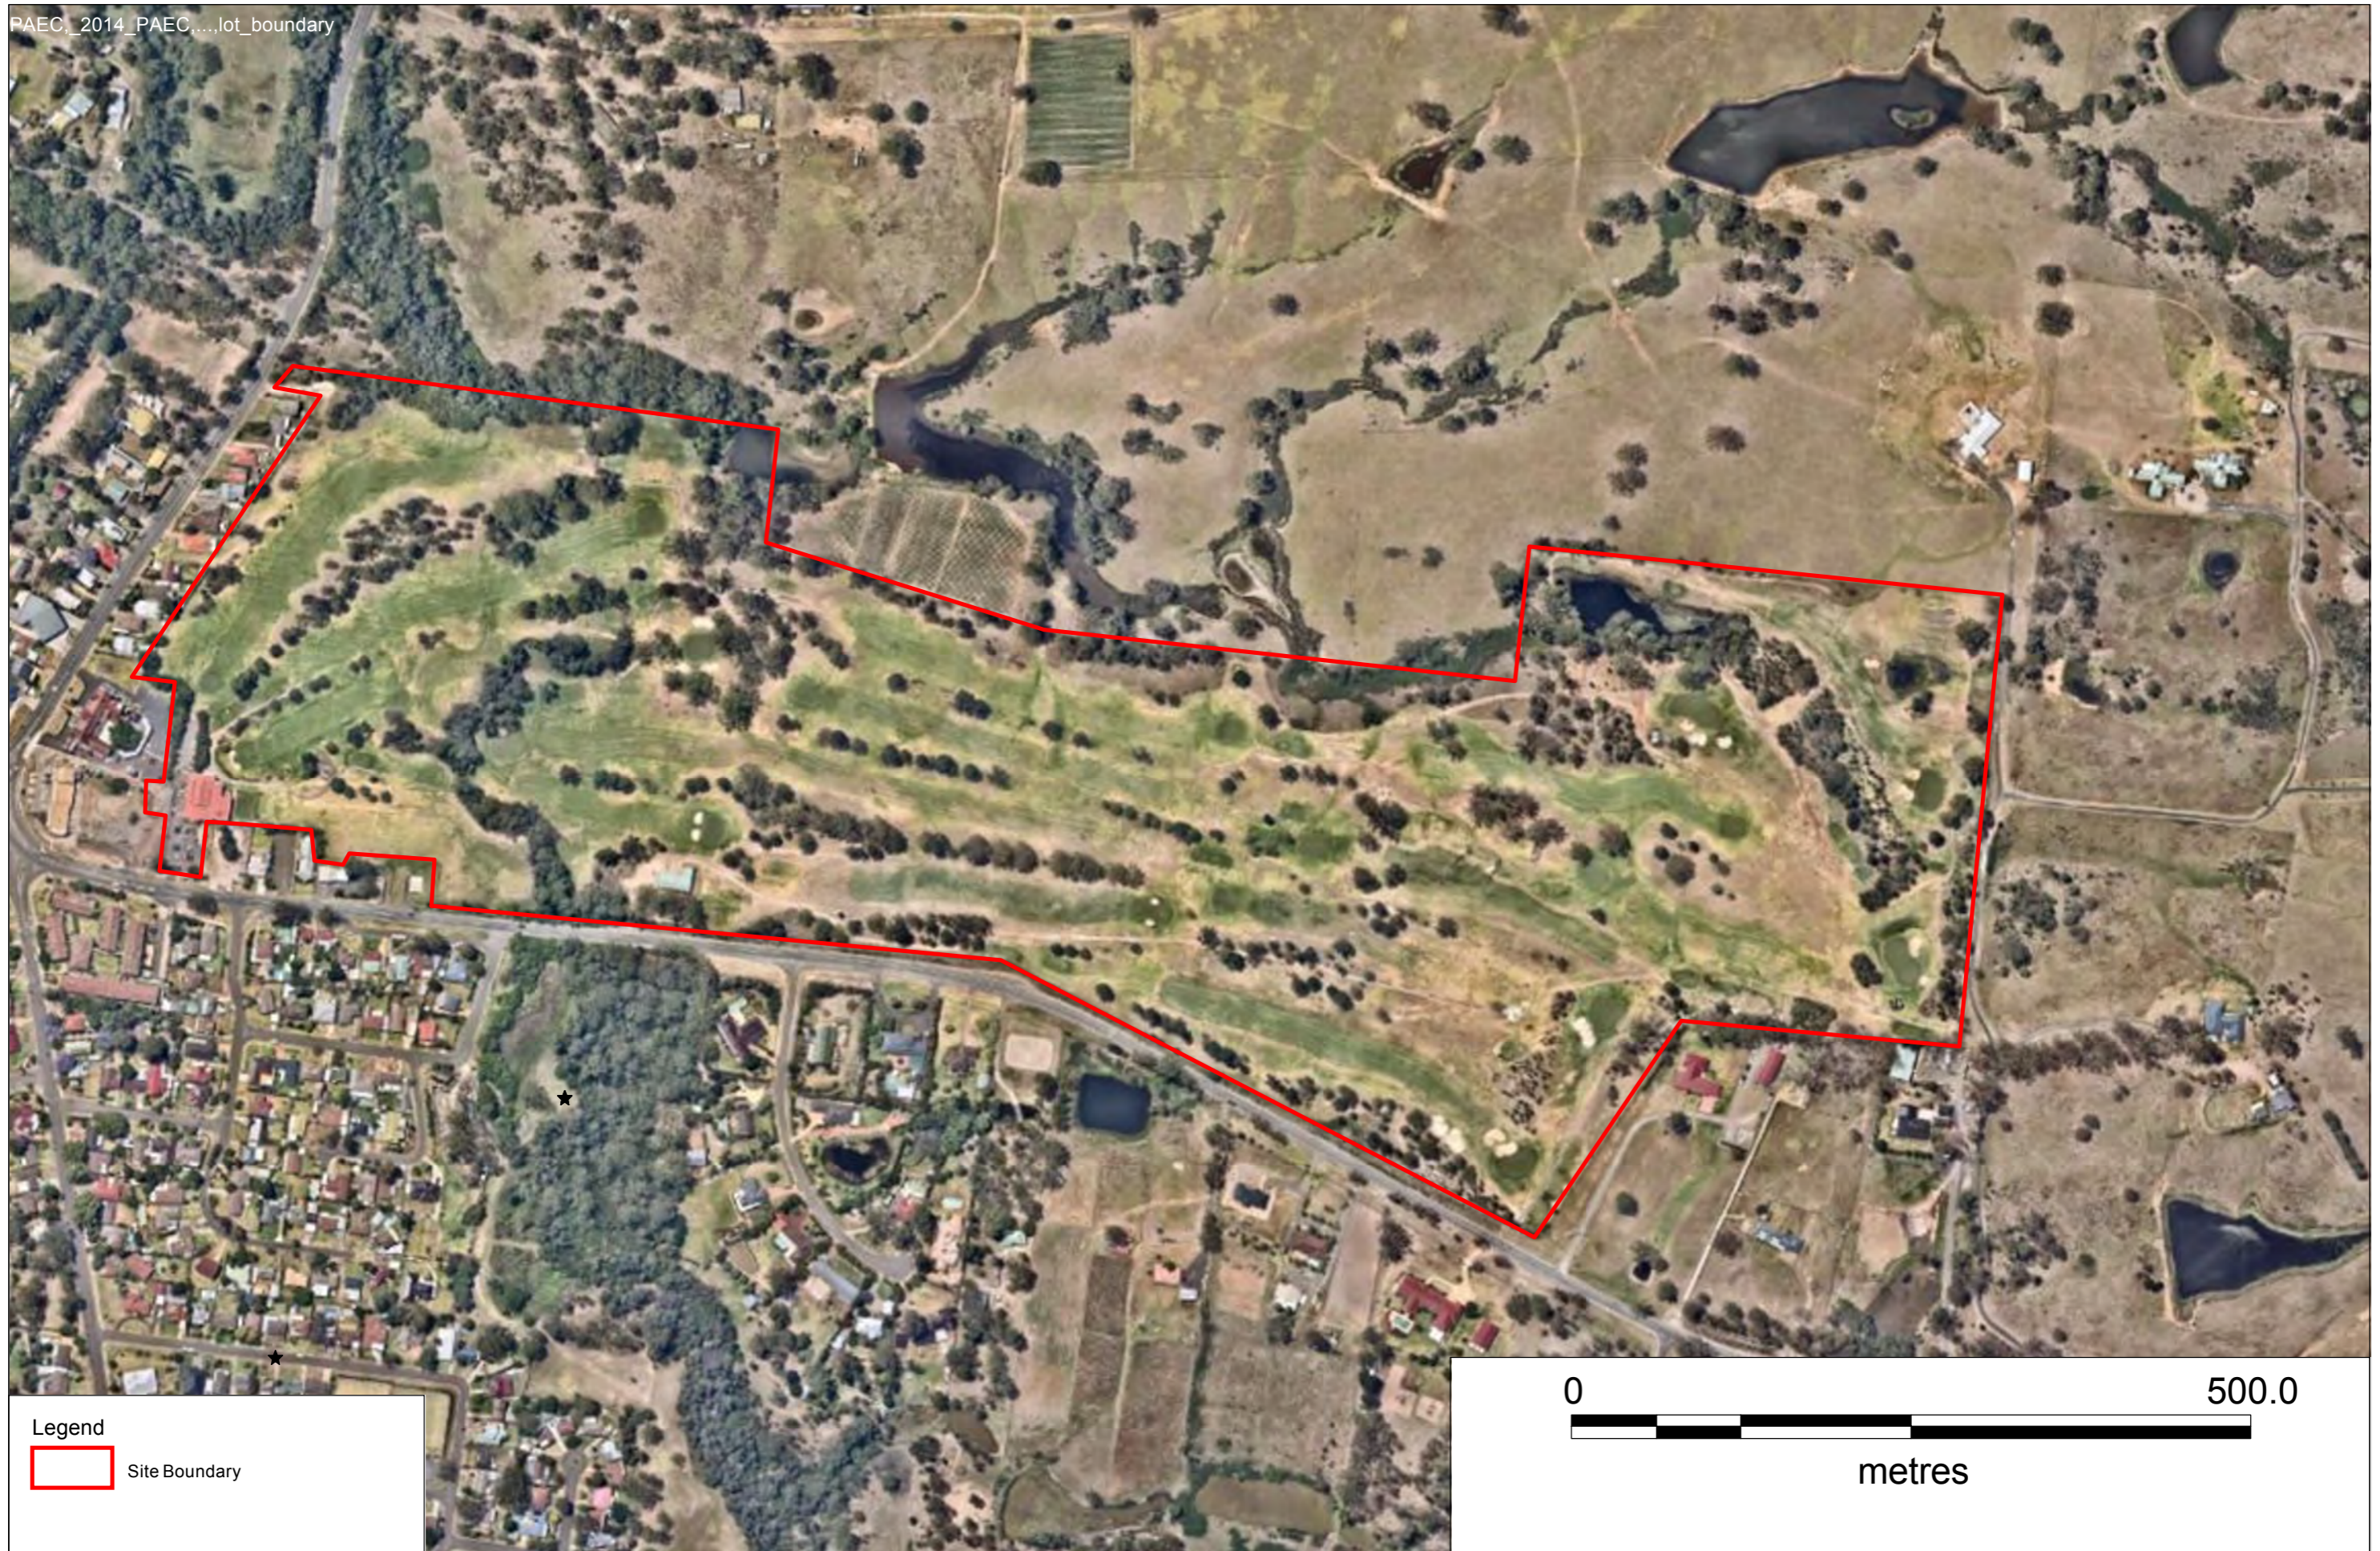
DRAWING No: 3

Reference to the 1:100 000 Penrith Geological Series Sheet indicates that the majority of the site (as shown on Drawing 3, Appendix A) is underlain by Bringelly Shale (mapping unit Rwb) of the Wianamatta Group of Middle Triassic period. This formation typically comprises shale, carbonaceous claystone, claystone, laminate, fine to medium-grained lithic sandstone, rare coal and tuff. An area of fluvial sediments (mapping unit Qa1) of the Quaternary period is present within the south-western portion of the site associated with the alignment of a tributary of Jerry's Creek. This formation typically comprises fine grained sand, silt and clay.

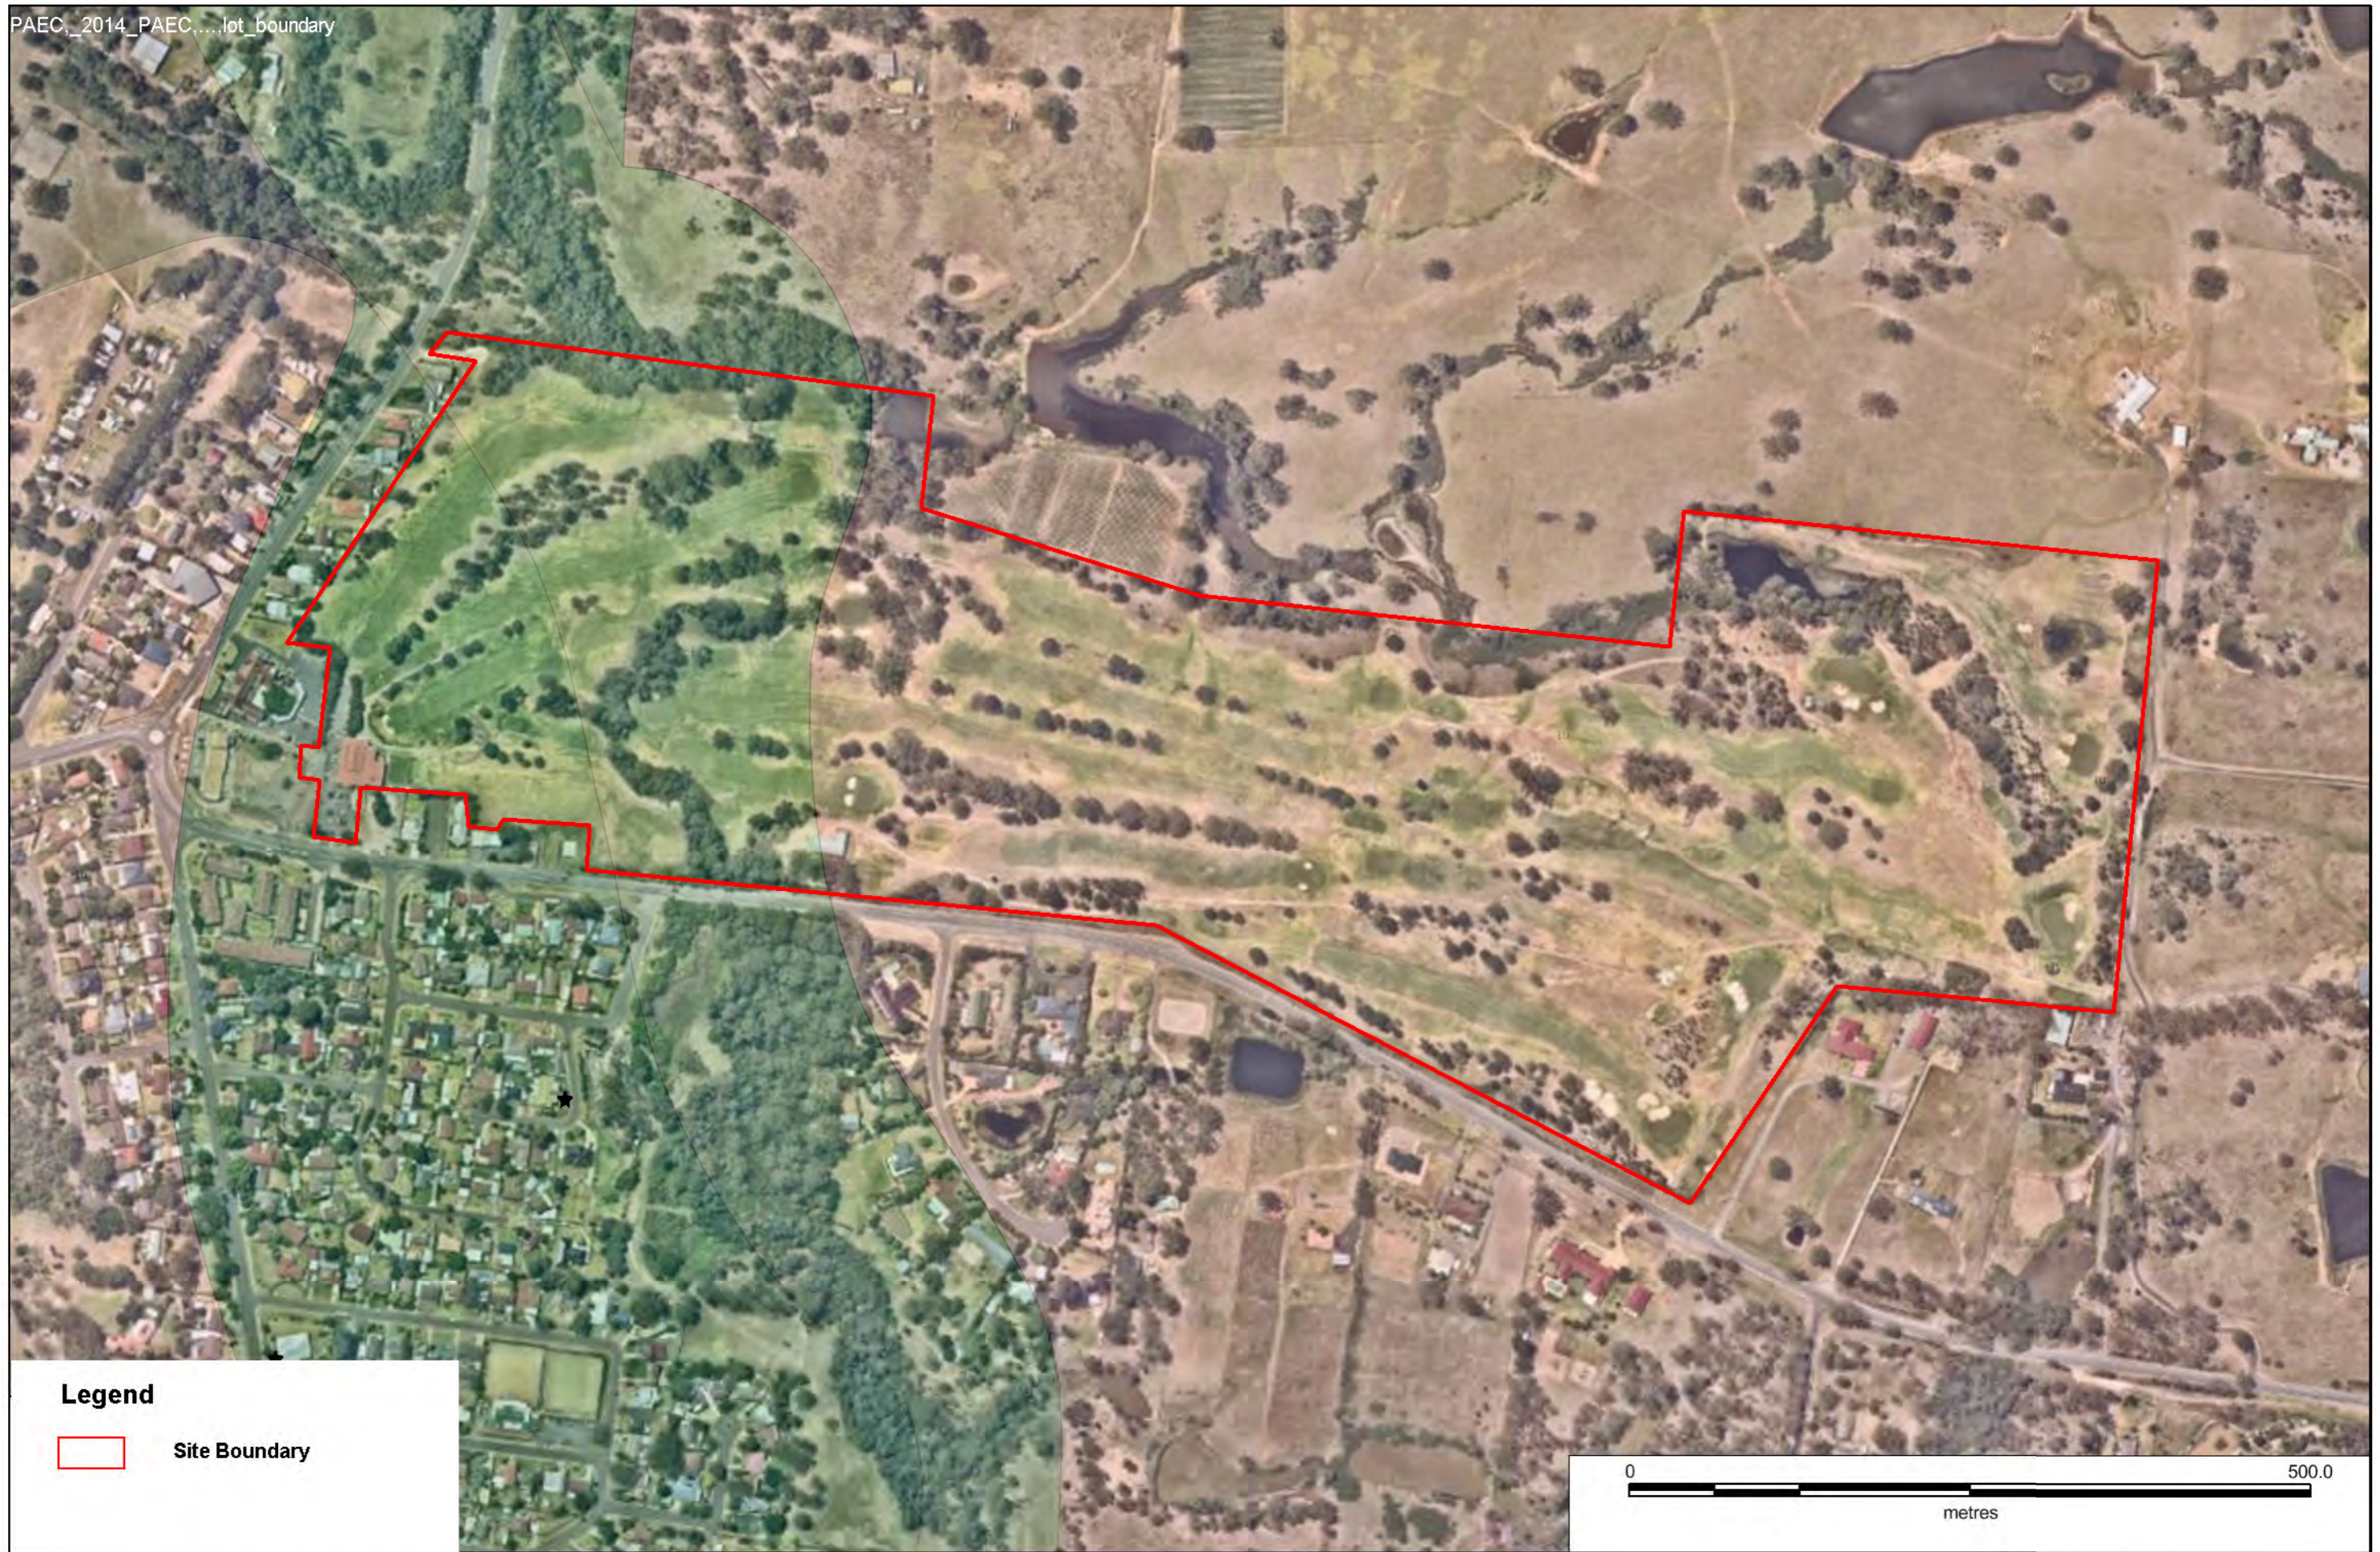
PROJ No: 76652.02.R1
 DRAWING No: 4
 REVISION: A

The Penrith 1:100,000 Soils Landscape Sheet indicates that the majority of the site (as shown on Drawing 4, Appendix A) is within the Luddenham Soil Landscape which is associated with erosional processes. Limitations associated with the Luddenham Soil Landscape include high erosion hazard, localised impermeable plastic subsoil and moderate reactivity.

An area of the Richmond Soil Landscape is present in part of the southern-western portion of the site which is associated with alluvial processes and a tributary to Jerry's Creek. Limitations associated with the Richmond Soil Landscape include high erosion hazard on terrace edges and localised flooding. The south-western most portion of the site comprises the Blacktown Soil Landscape which is associated with residual soil processes. Limitations associated with the Blacktown Soil Landscape include moderately reactive highly plastic subsoil, low soil fertility and poor soil drainage.
