Electrical & Mechanical Services Report

**For Wattle Glen And Tandara Child Care Centres
At Penrith, NSW**

JOB NUMBER
18-0677

DATE
August 2018

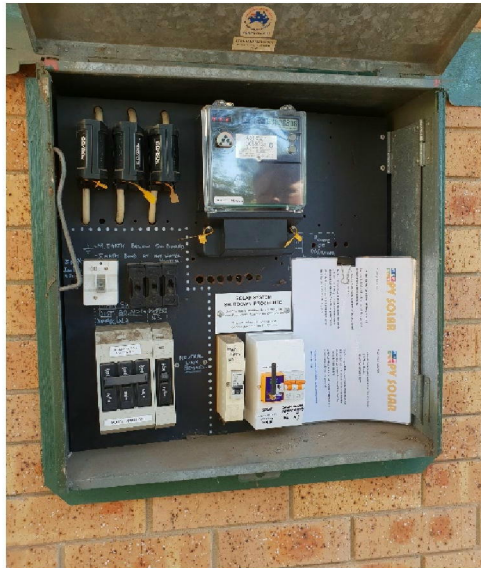
The MSB/meter panel of the site is currently fed via underground conduit from the adjacent child care centre switchboard and is located on the outside wall of the centre. The existing feed is 80A three phase supply which appears to be adequate however being situated on a different lot Wattle Glen child care centre should have a separate power supply from the electrical pillar located on the footpath on Trinity Drive. This will require application to power supply authority, new conduit and trenching and cabling. This work can be done as a separate exercise from the refurbishment project, however the site MSB shall be replaced as this is well passed its service life and does not comply with current regulation.

Fig - Site MSB

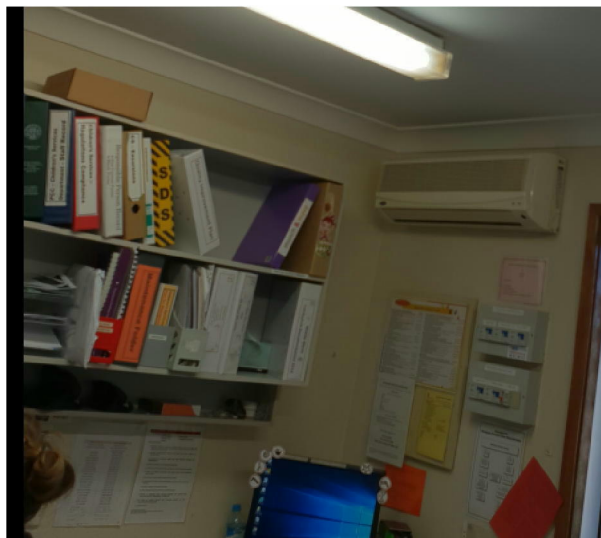
There are two off distribution switchboards located in the existing office room that feed lighting, power, hot water and air-conditioning system. These switchboards shall also be replaced and relocated as they do not comply with current standards.

Fig - Switchboards

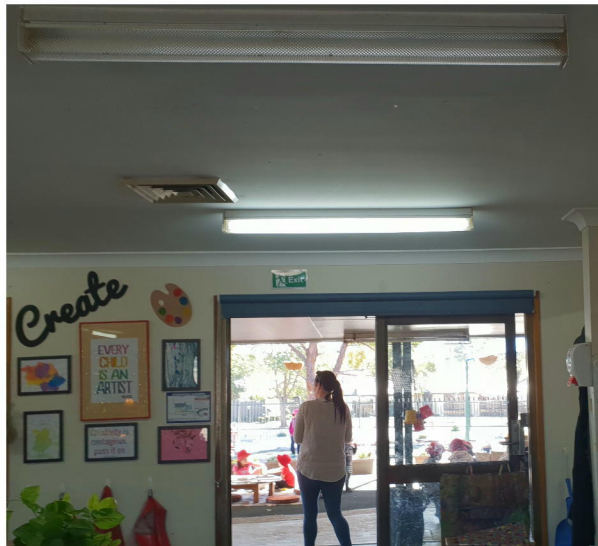
Existing internal and external light fittings use either T8 fluorescent lamps or compact fluorescent lamp which are not energy efficient. Some of existing light switches height do not comply with disable code requirement. No emergency lighting system was found in the facility. All internal and external lighting shall be removed and new energy efficient LED lighting system shall be designed. A proper lighting control scheme shall be employed to comply with NCC section J6. Emergency lighting and exit sign shall also be designed. New ceiling fans can be installed according to client's requirement.

Fig – Lighting and Emergency lighting

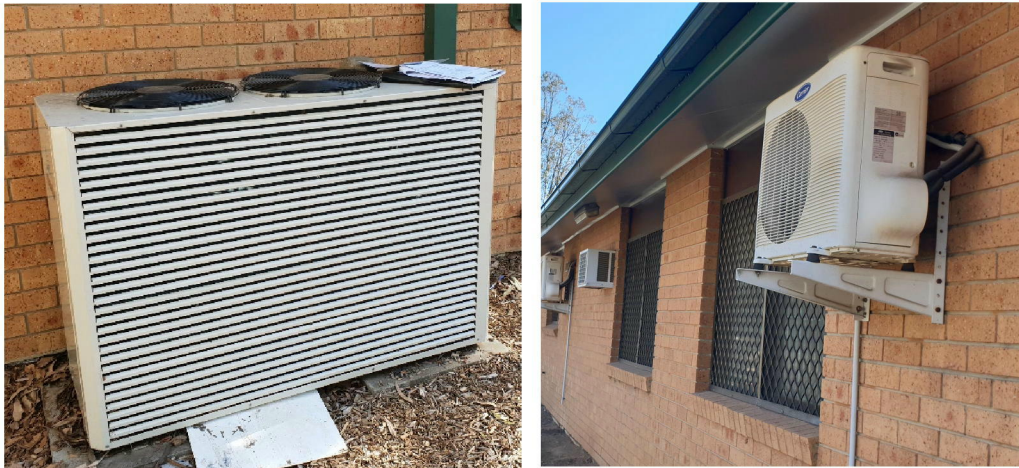
The condition of the existing air-conditioning and ventilation systems is poor. The equipment installed is of varying ages and seems to have had very little maintenance completed on it with the smaller spaces now being served by small split systems and the larger ducted systems serving the open spaces. The existing ventilation system in laundry and toilets is not adequate and causing damage to the building element.

Fig – Air-Conditioners

In general, it is suggested, for both quality of air-conditioning and ongoing maintenance and breakdown resilience that all split systems are replaced, however 2 off Actron split ducted units serving the larger spaces can remain as they were manufactured in 2013 and are still operating effectively. The duct used on these units is of poor quality and will not last much longer before completely losing its insulation properties and is exposed to the risk of rupturing and not only providing poor quality air supply into the rooms but also higher electricity costs. New lightweight rigid duct is to be installed to reduce the waste in energy, increase system performance whilst also being ready for an upgrade in the future should one of the units fail. It is suggested that the grilles mounted on the ceiling are also replaced as an aesthetic choice due to their appearance.

The smaller rooms shall be provided with new split systems. The replacement of the smaller split system will extend the lifespan of the ducted units due to the reduced overall building load placed on the ducted air-conditioning systems. The replacement of these systems will also be more energy efficient than what is currently installed whilst providing better performance.

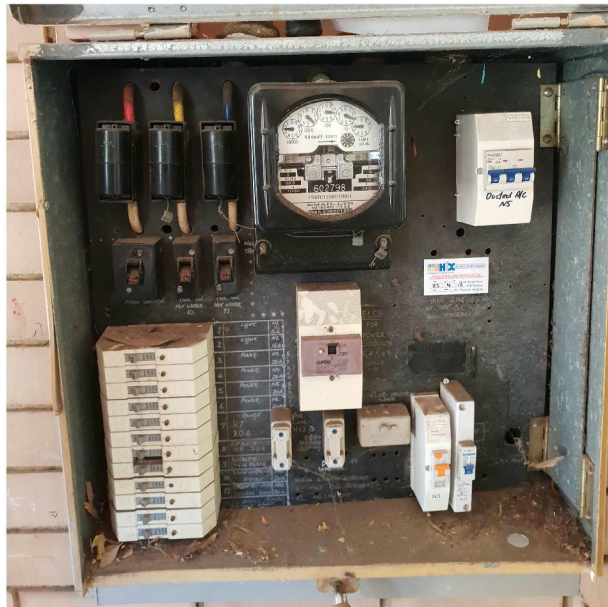
The MSB/distribution switchboard of the site is currently fed via underground conduit from Evan street. The existing feed appears to be 80A three phase supply however an electrician shall check and confirm the cabling and fuse size. The existing site MSB shall be replaced as this is well passed its service life and does not comply with current regulation. The location of MSB also does not comply as it is located on the exit path from the children’s room.

Fig –Site MSB

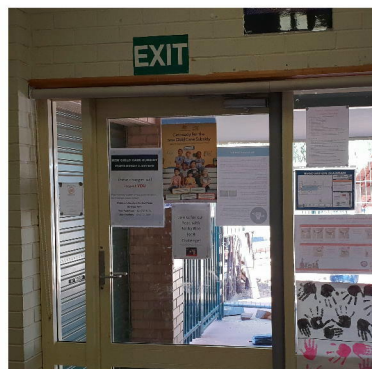
Existing internal and external light fittings are poor quality fluorescent lamps based. Both recessed and surface mounted lighting found in the facility. Some of existing light switches height do not comply with disable code requirement. No emergency lighting system was found in the facility. All internal and external lighting shall be removed and new energy efficient LED lighting system shall be designed. A proper lighting control scheme shall be employed to comply with NCC section J6. Emergency lighting and exit sign shall also be designed. New ceiling fans should be installed in the children room with new controllers.

Fig –Emergency Lighting

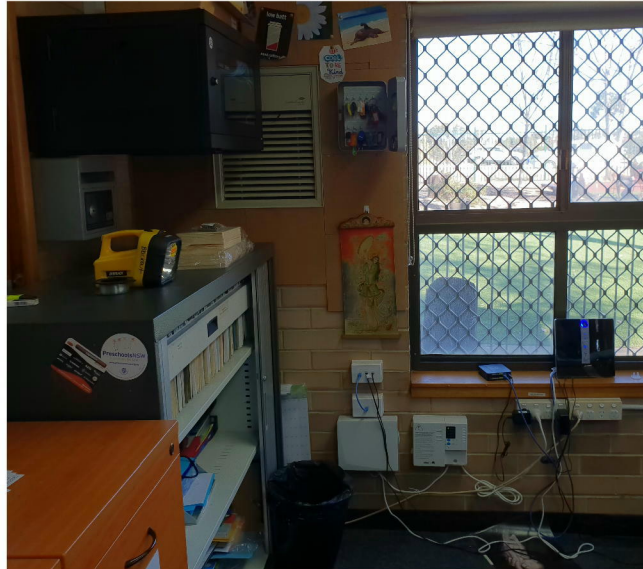
Power outlets have been installed using surface mounted ducts in many places. Some of general power outlets do not meet the height requirement for child care centre according to legislations. New power outlets shall be installed throughout the building including re-wiring to new switchboard. New wall sheeting shall be provided to run cabling from ceiling space to power and data outlets. Skirting duct for mounting power and data outlets can also be used if walls are not provided with new sheeting.

Fig –NBN equipment and power/data outlets

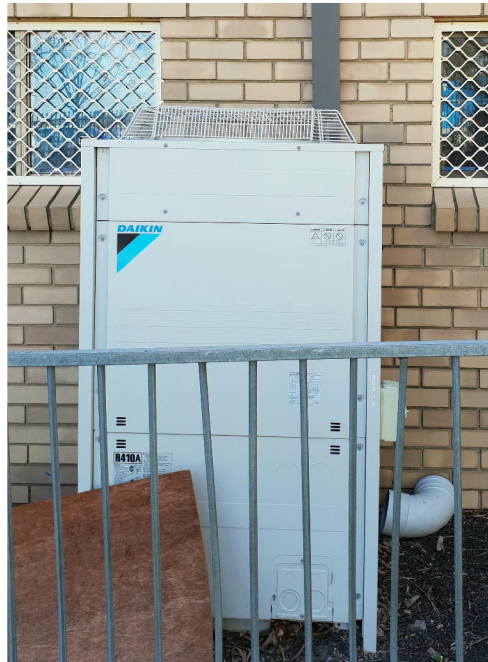
The condition of the existing air-conditioning and ventilation systems is poor. The Daikin unit shown below is of 2011 manufacture and would be expected to fail within the next 5 years. If the capital is available for its replacement, then it should be replaced. If this is not possible then the ducting should be replaced in the same fashion as mentioned in the report above for Wattle Glen for future connection to a replacement, should it be required.

Fig – Air-conditioner
