Friday, 27 January 2017

DL3991_S006108

Re: Review of RAP and Remediation Requirements – 117 O’Connell Street, Caddens, NSW 2747

Re: Asbestos Clearance Certificate – 117 O’Connell Street, Caddens, NSW 2747

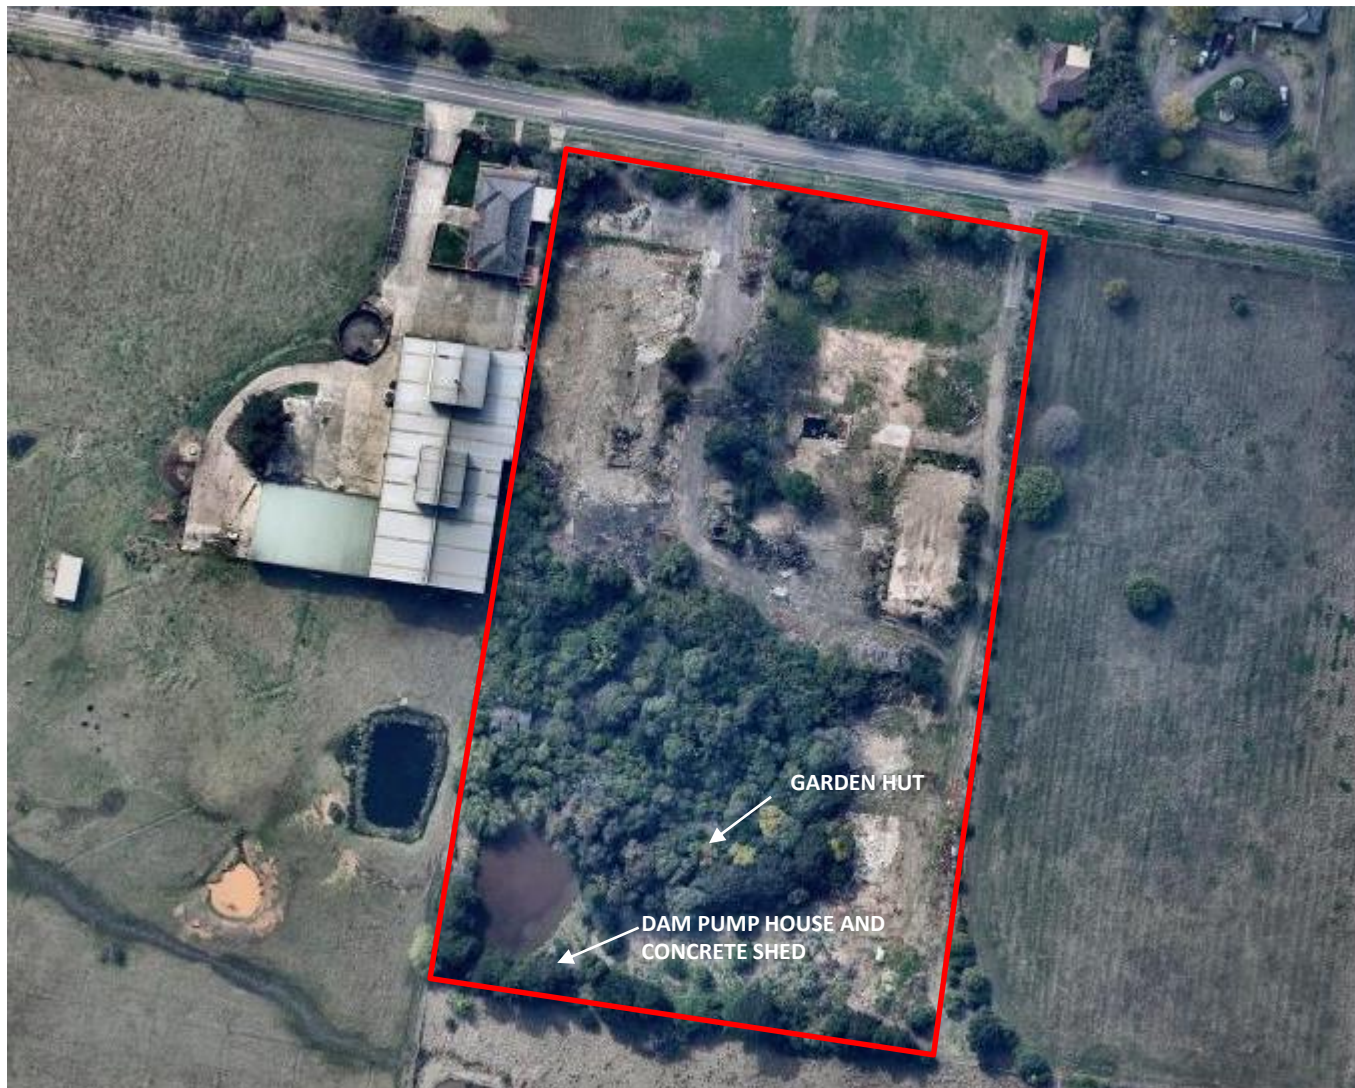
FIGURE 1 – Asbestos Clearance

A visual inspection of the structures and fencing at the Site was conducted on Thursday 27th of October 2016 by a Licensed Asbestos Assessor. This inspection, which was of a visual nature only and was carried out in accordance with the Certification as required by Clause 473 and 474 of the NSW WHS Regulations 2011. The clearance involved a visual inspection of a small outdoor open timber garden hut and a smaller storage area constructed from concrete and timber. Following the removal of asbestos containing sheet materials in the structure was related to the roof only. Asbestos containing capping sheets were removed from the fence.

Visual inspections have confirmed that the buildings and fencing have had all asbestos containing materials removed. It is therefore considered that these structures subject to this Clearance Certificate have been remediated in a safe and effective manner to allow for normal activities to proceed. These areas can now be accessed without risk to health or the environment generally.

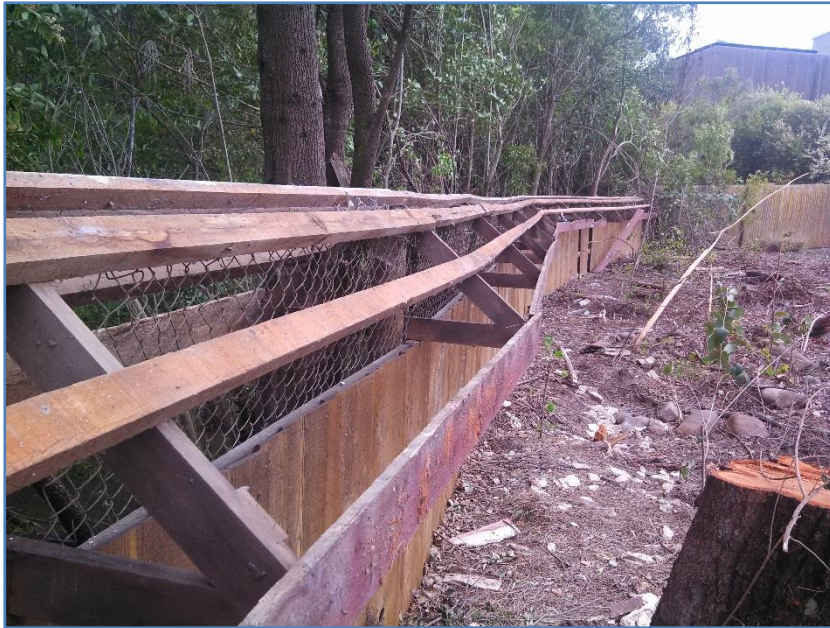
Print 001

Fence Railing – ACM Sheets Removed

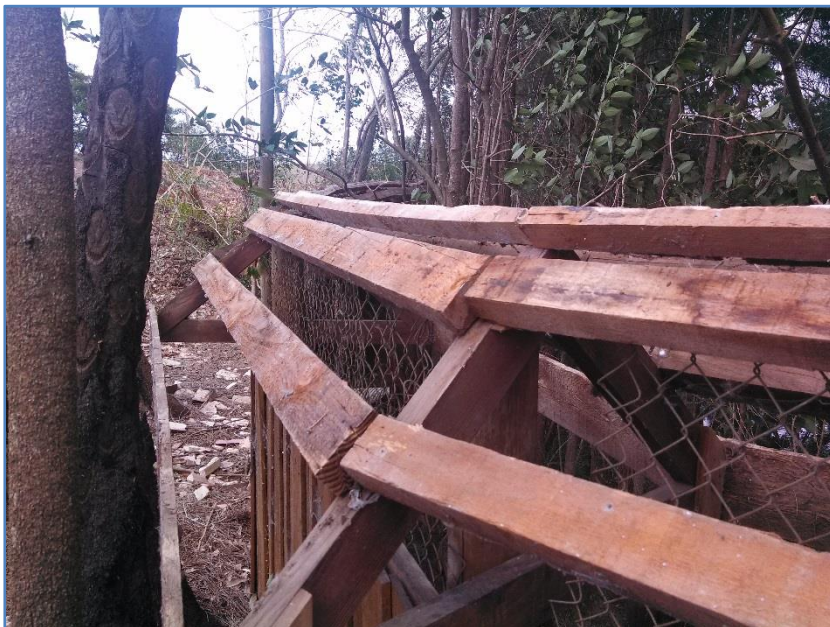
Print 002

Fence Railing – ACM Sheets Removed

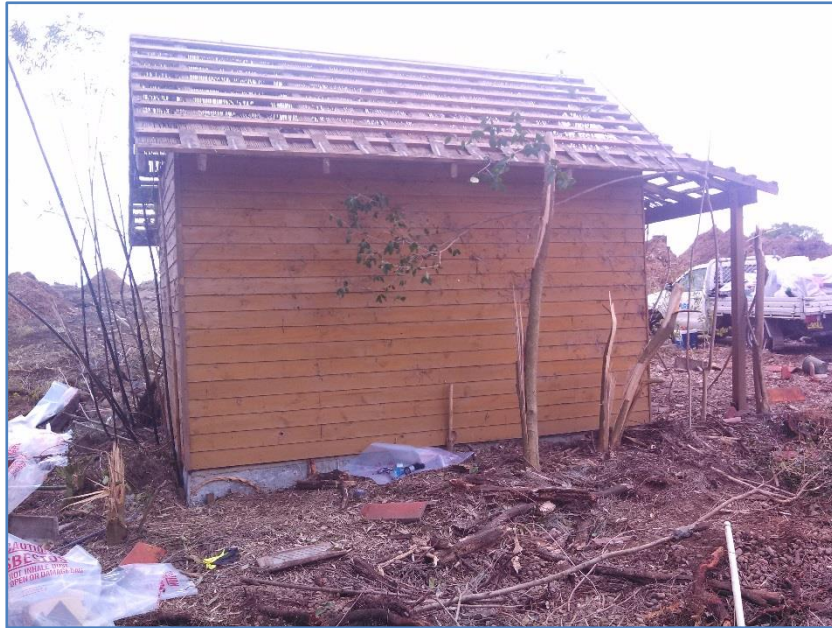
Print 003

Garden Hut – External Roof

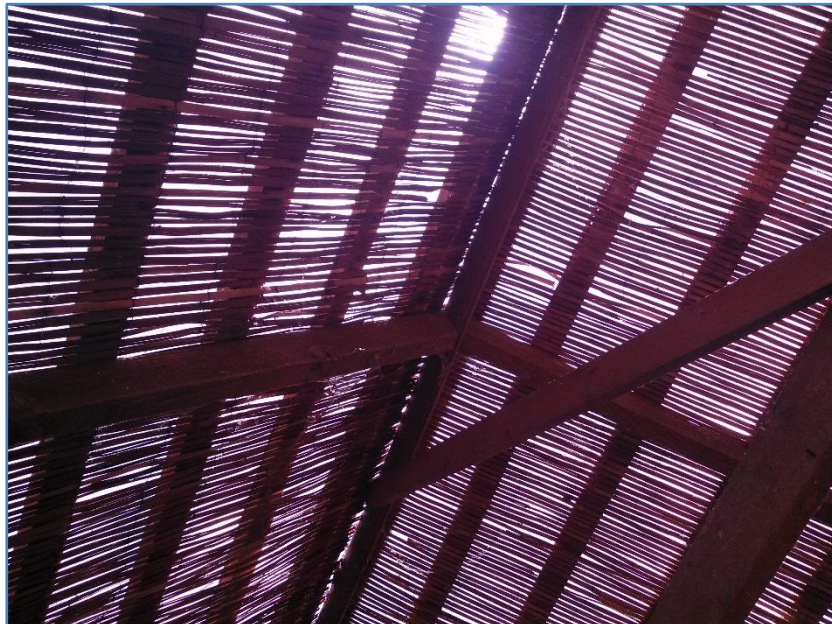
Print 004

Garden Hut – Internal Roof

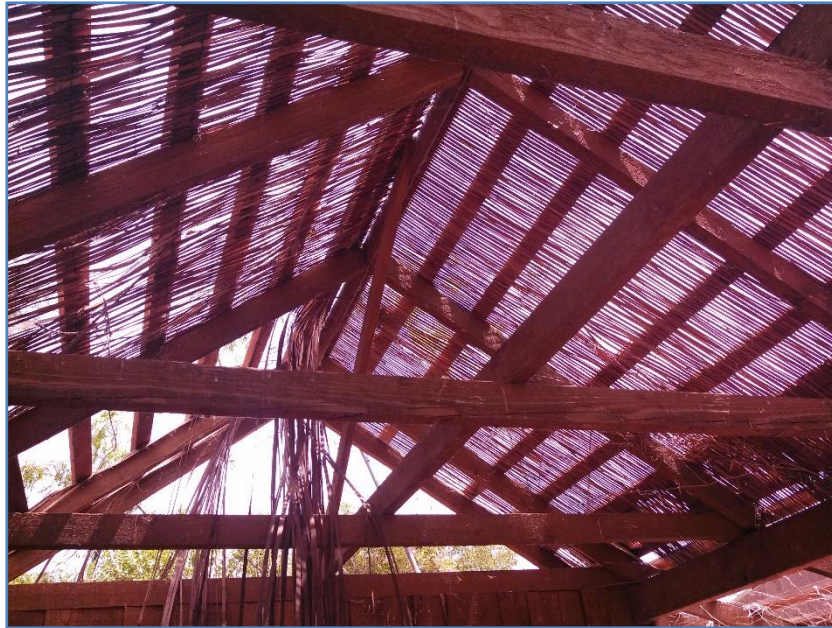
Print 005

Garden Hut – Internal Roof Frame

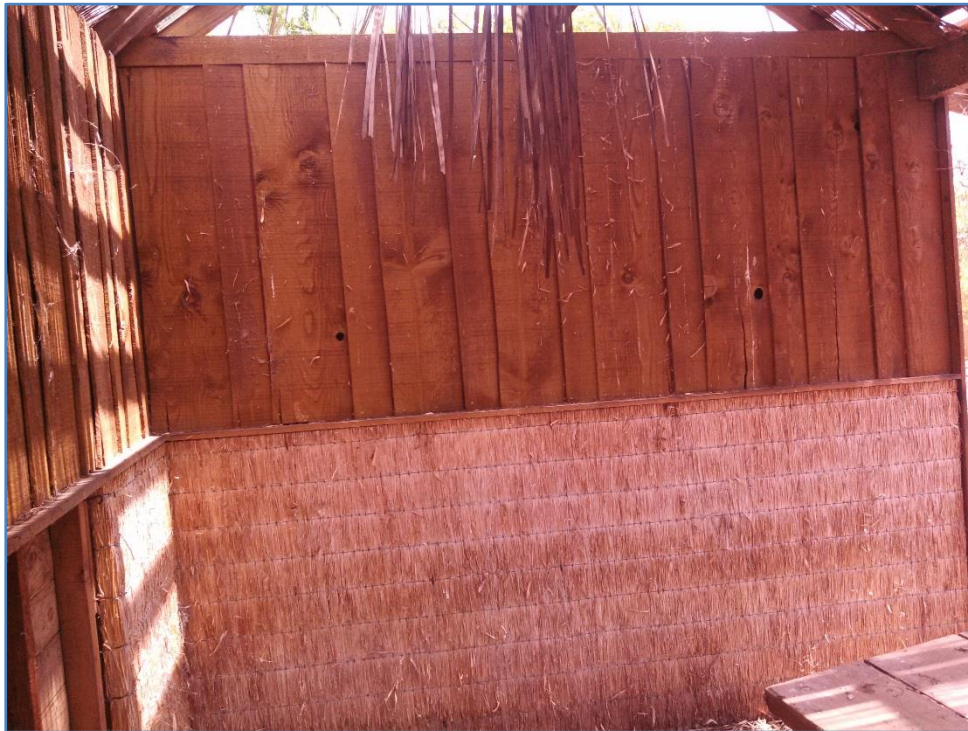
Print 006

Garden Hut – Internal walls

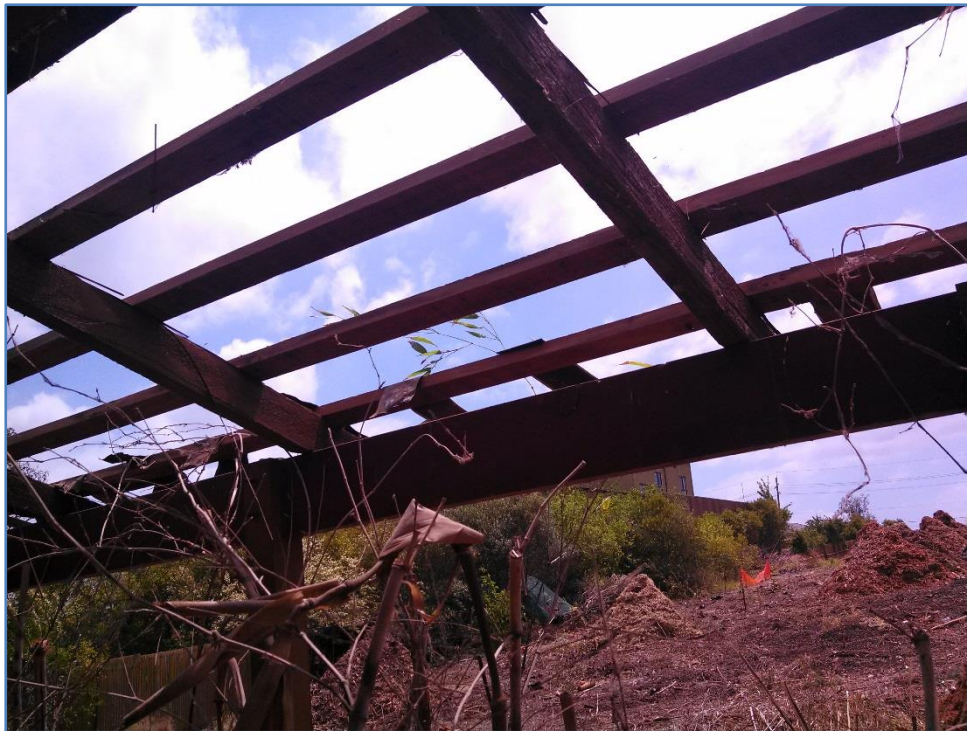
Print 007

Concrete Shed with timber roof frame

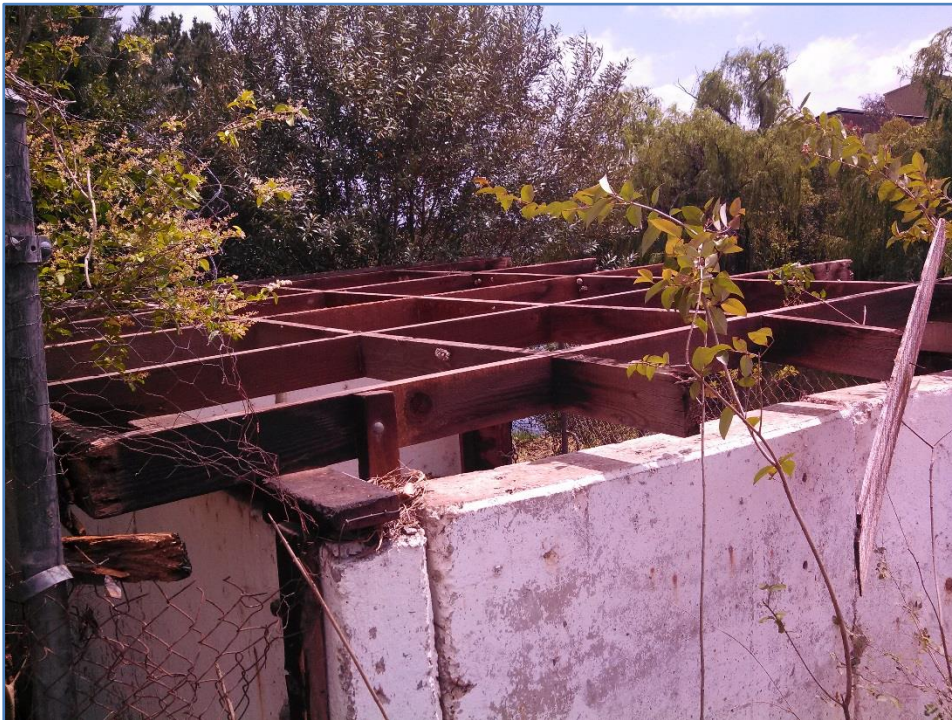
Print 008

Concrete Shed with timber roof frame

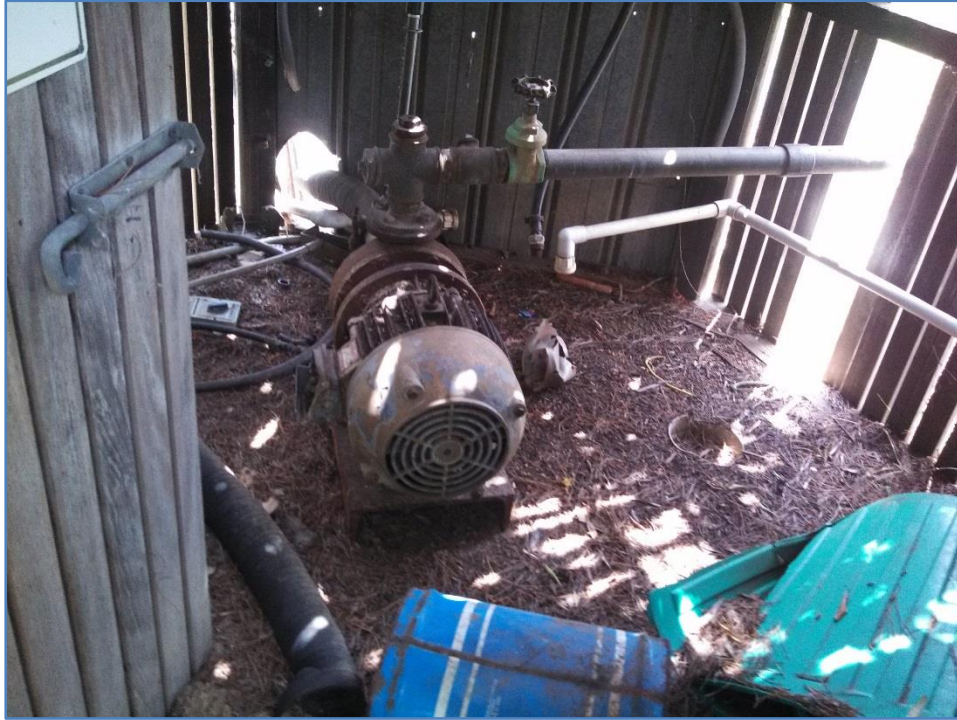
Print 009

Dam Pump house – Timber and Sheet Metal construction

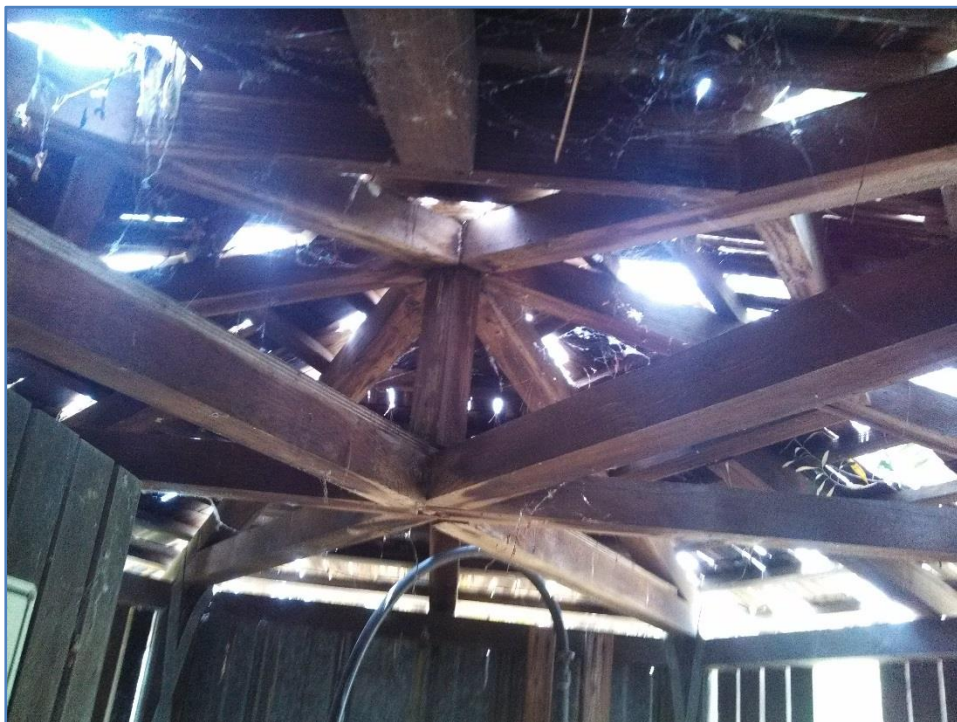
Print 010

Dam Pump House wooden roof frame

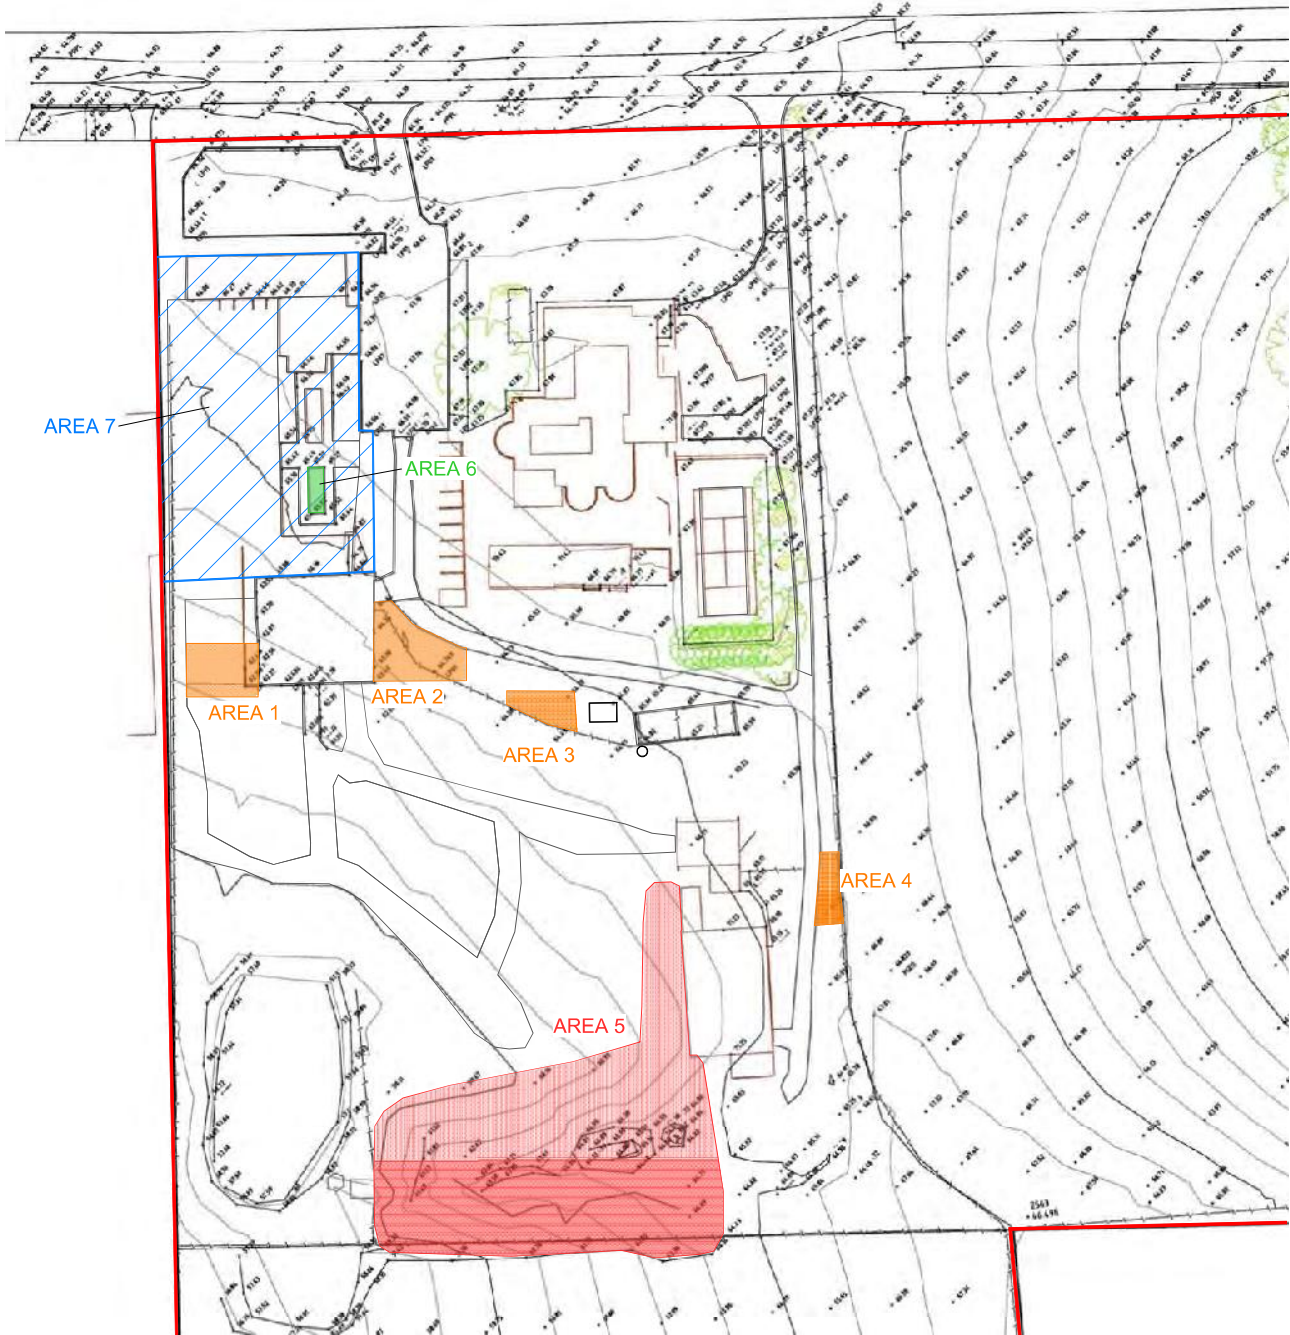
FIGURE 1 – SITE REMEDIAITON AREAS 1-4

Geotechnique's Detailed Contamination Assessment and Remedial Action Plan Report No 12486/2-AA Dated the 10th of October 2011 identified Areas 1-4 in **Figure 1** as containing heavy metal exceedances. Upon excavation and assessment of these areas Geotechnique requested an asbestos clearance certificate is required to ensure the material was free of asbestos.

The visual inspection and soil sampling did not identify asbestos within remediation areas 1-4 and therefore no risk to human health or the environment can be inferred from these areas. These area can now be accessed without risk to health or the environment generally.

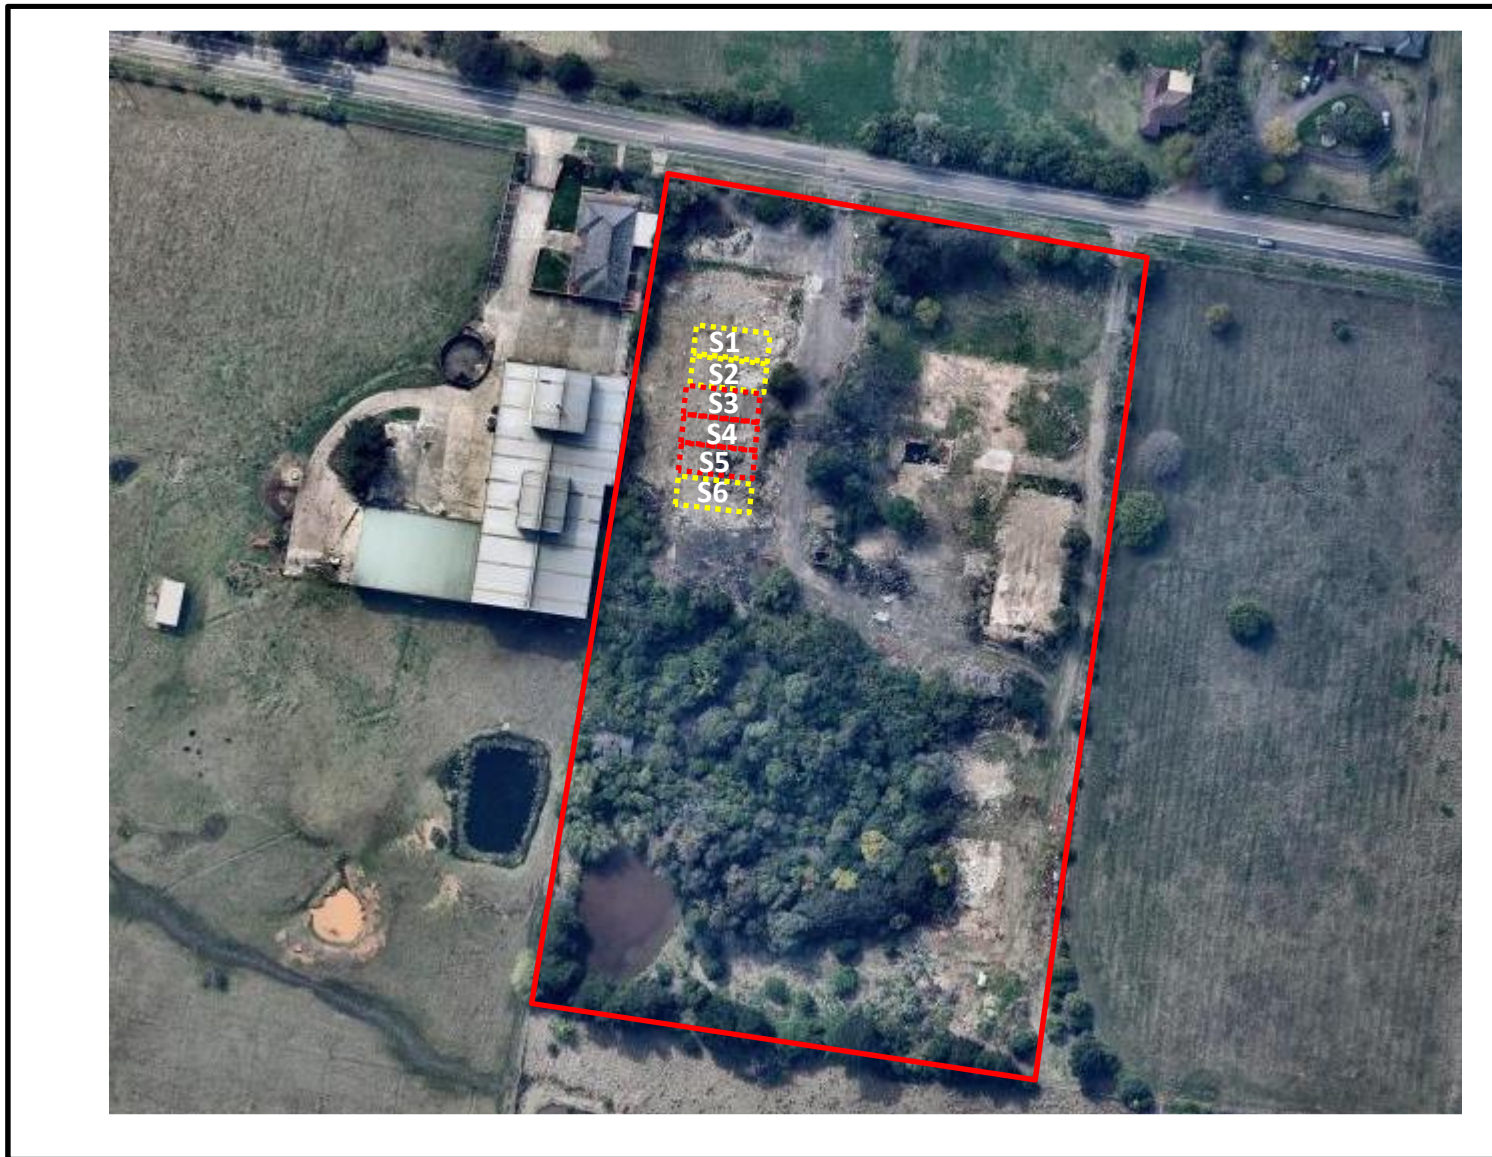
FIGURE 1 – Site Layout and Sample Locations

The laboratory analysis of the ACM sample confirmed that the fibre cement material contained asbestos. Surface soil samples indicated the presence asbestos fibres within two of the bulk samples areas. A small ACM fragment was also present within a soil sample. Three of the sampled areas did not report asbestos in soils. Refer to **Table 1** below:

A Class A licenced asbestos contractor is required for the contaminated materials to be removed and disposed of off-site. An alternative remediation strategy to allow materials to remain onsite may also be undertaken incorporating handpicking, further sampling and analysis to confirm compliance with Site criteria for asbestos.

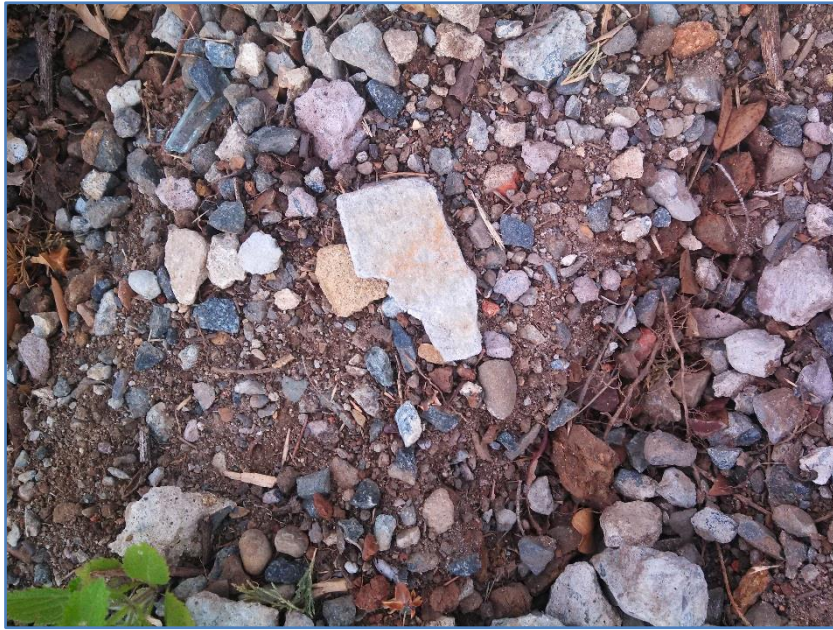
Print 001

Surface ACM

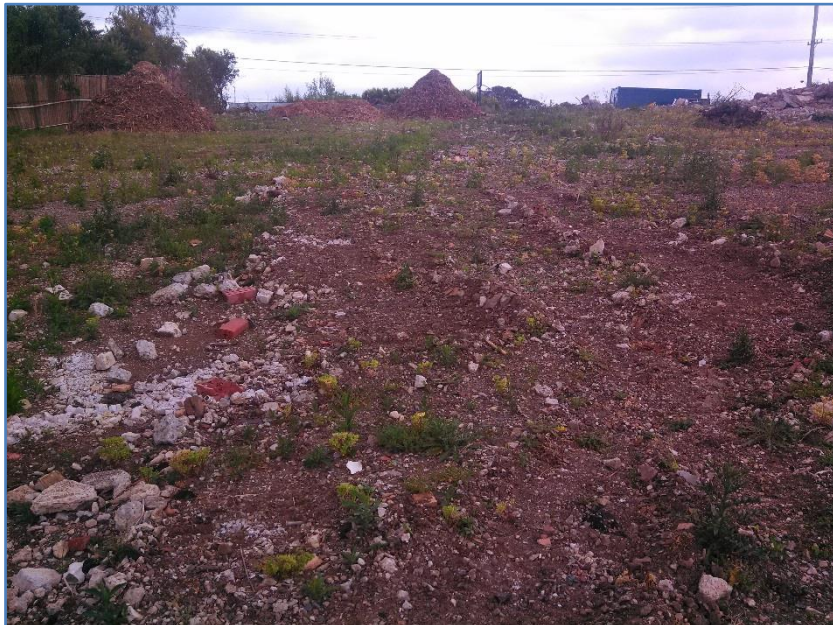
Print 002

Asbestos surface impacted soils view to north.

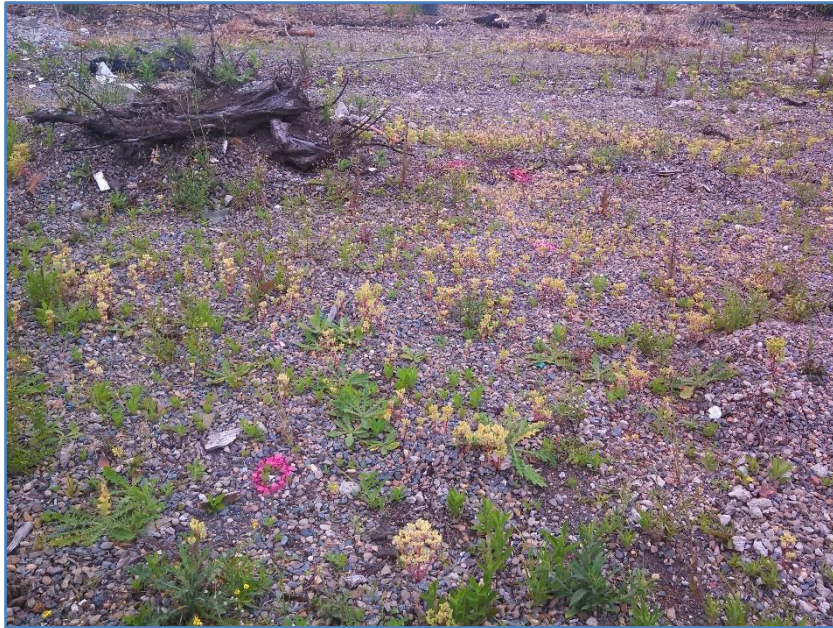
Print 003

Sample S5 – Asbestos Fibres Detected

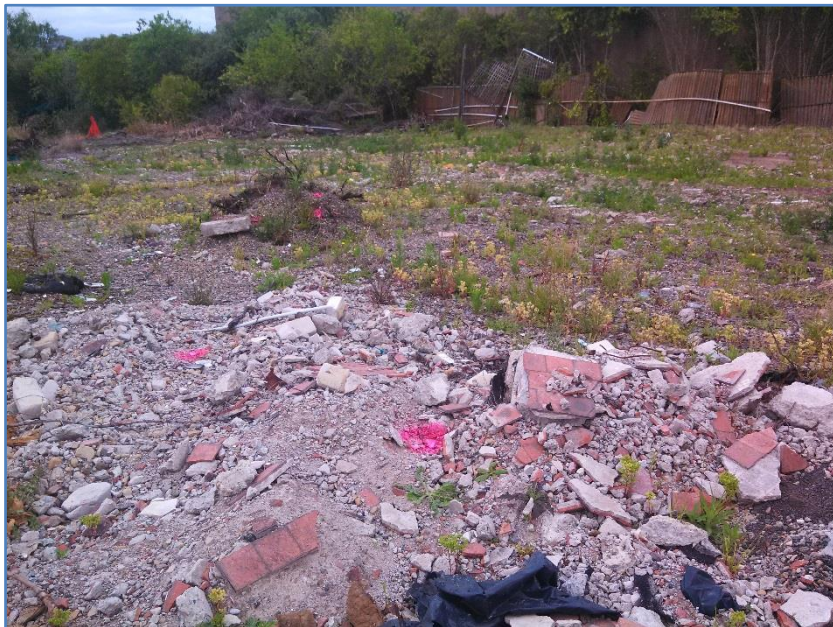
Print 004

Northern end of area viewing to south west.

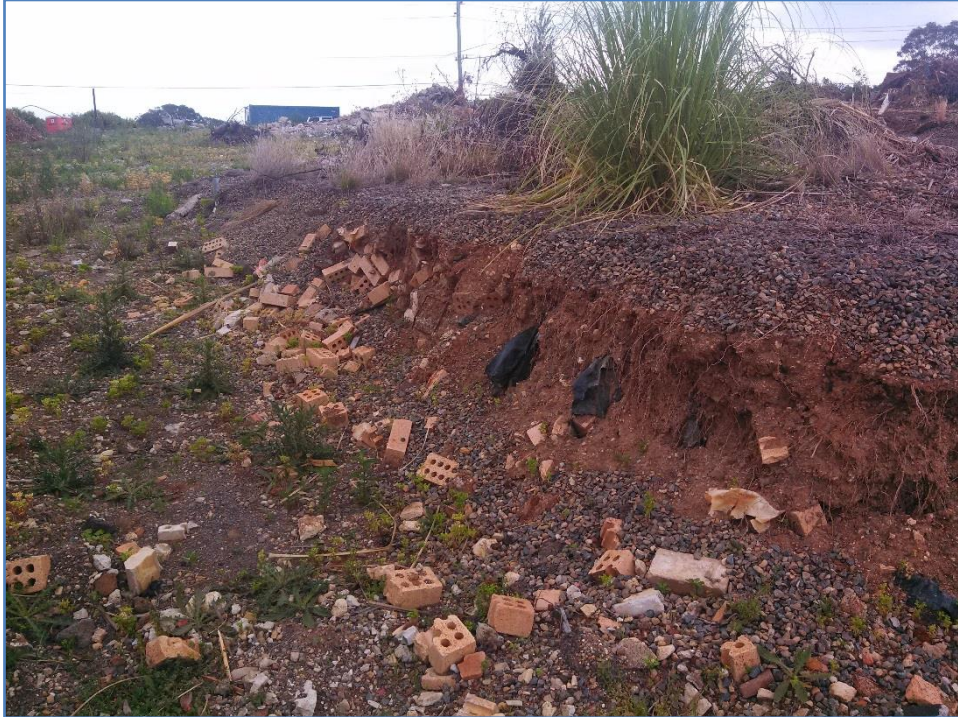
Print 005

South-West part of investigation area.

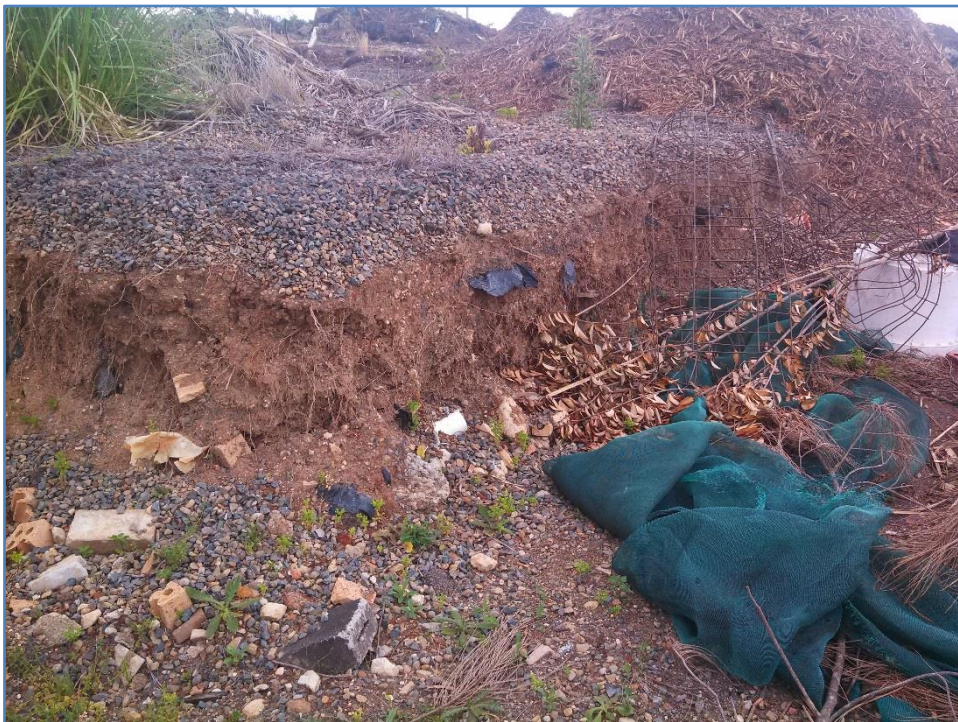
Print 006

South-East part of investigation area.
