**TREE SURVEY & REPORT**

**40-46 EVAN ST & 96-98 LETHBRIDGE ST**

**PENRITH**

05/08/19  
Ref. # 2042

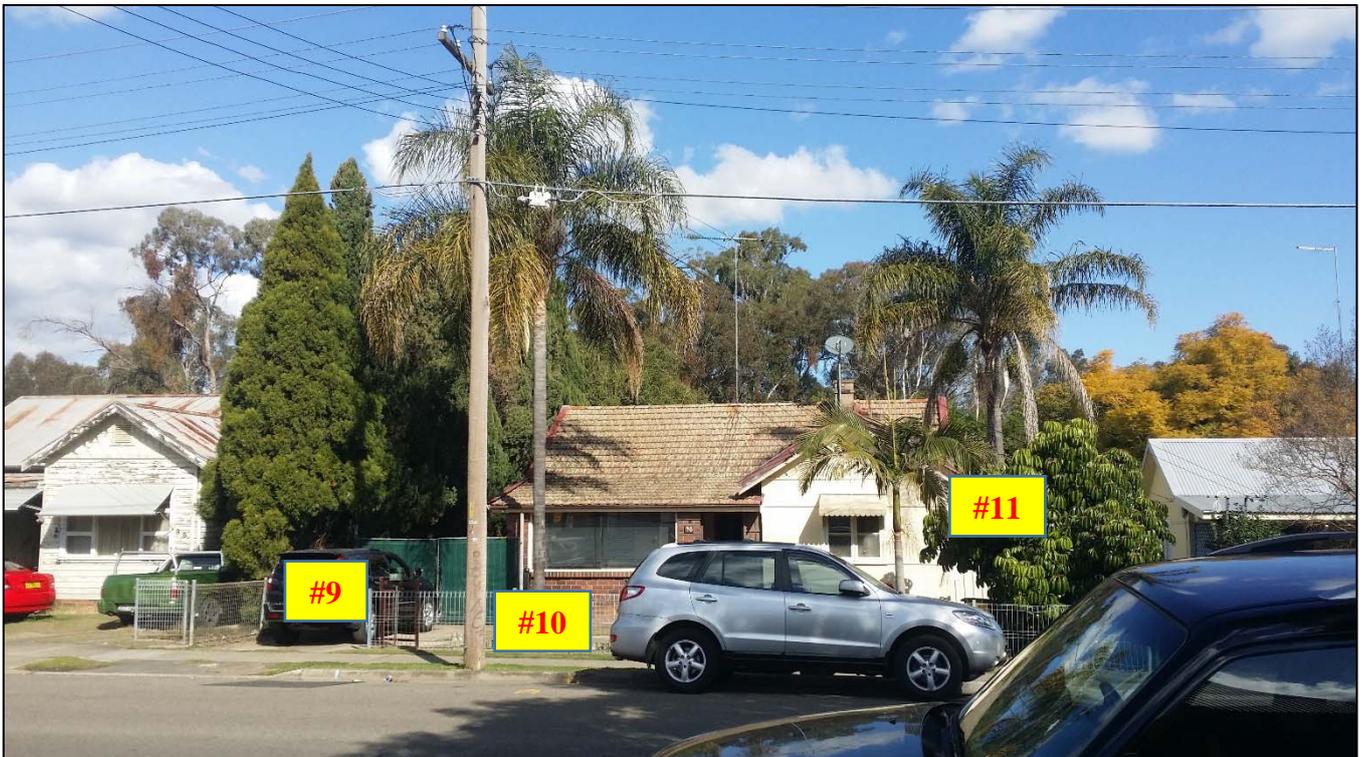
- **Tree No. 9 (*Cupressus sempervirens*)** is an over-mature hedgerow. They have typical symptoms associated with Cypress Canker, of which there is no effective control (see Appendices 9.7)
- **Tree No. 18 (*Eucalyptus moluccana*)** is in advanced stages of decline and has typical symptoms of Armillaria Root Decay (see Appendices 9.8)
- **Tree No's 21 (*Melaleuca quinquenervia*)** This tree is dead and is exempt from Clause 5.9 of Penrith LEP 2010
- **Tree No. 22 & 23 (*Melaleuca quinquenervia*)** have sparse foliage, and appear to be in declining health and vitality (see Appendices 9.9)
- **Tree No. 64 & 67 (*Grevillia robusta*)** are in advanced stages of decline, and treatment and or tree surgery techniques are unlikely to increase their safe life expectancies (see Appendices 9.9)

- a. **Health & Vitality:** Low – these trees are showing typical symptoms of Cypress Canker, and are in irreversible decline (see Plate 2 & 3).
- b. **Tree Form:** these trees combine to form a hedgerow with an east/west axis that is m in height, and a crown spread of 25x6m
- c. **Structural Condition:** Poor, retainable for 0 – 5 years

Plate 2 – showing tree No’s 9 – 11

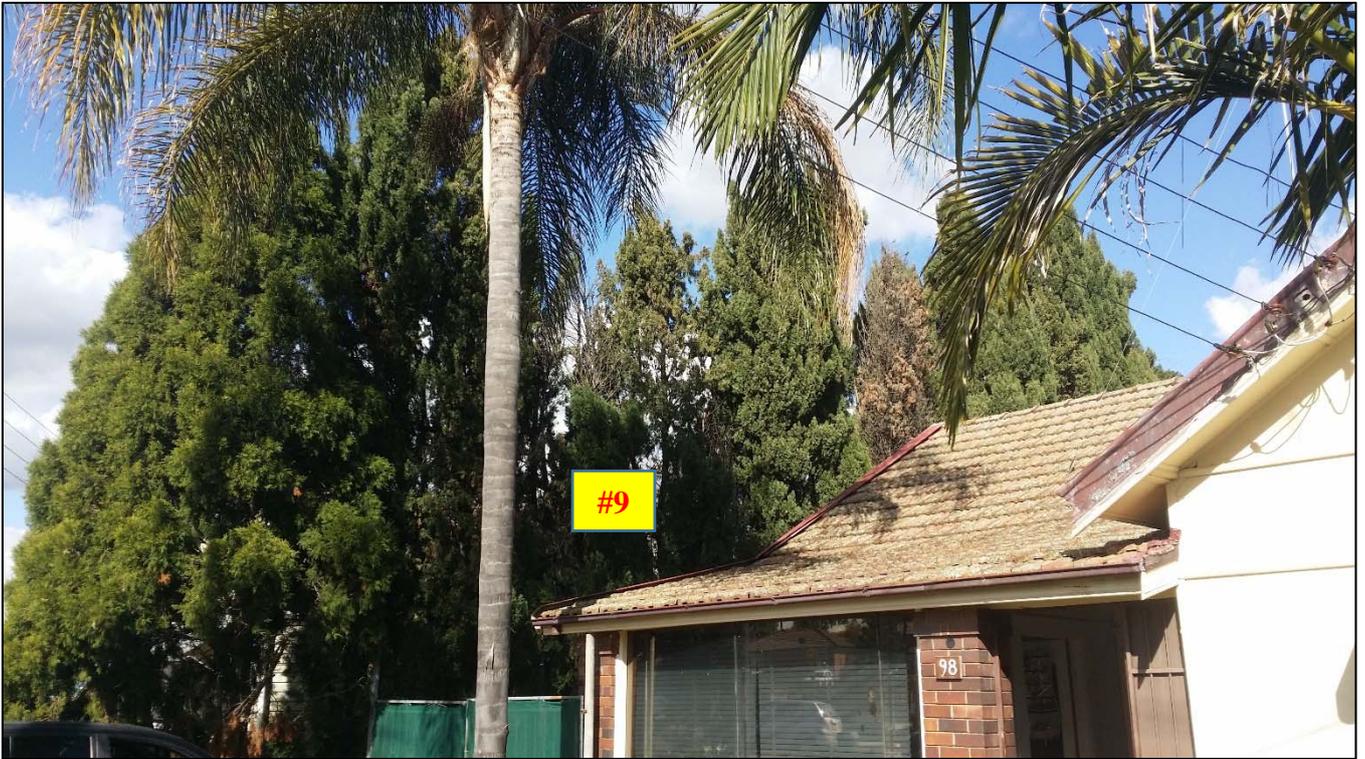
Plate 3 – showing tree No. 9 (over-mature hedgerow)

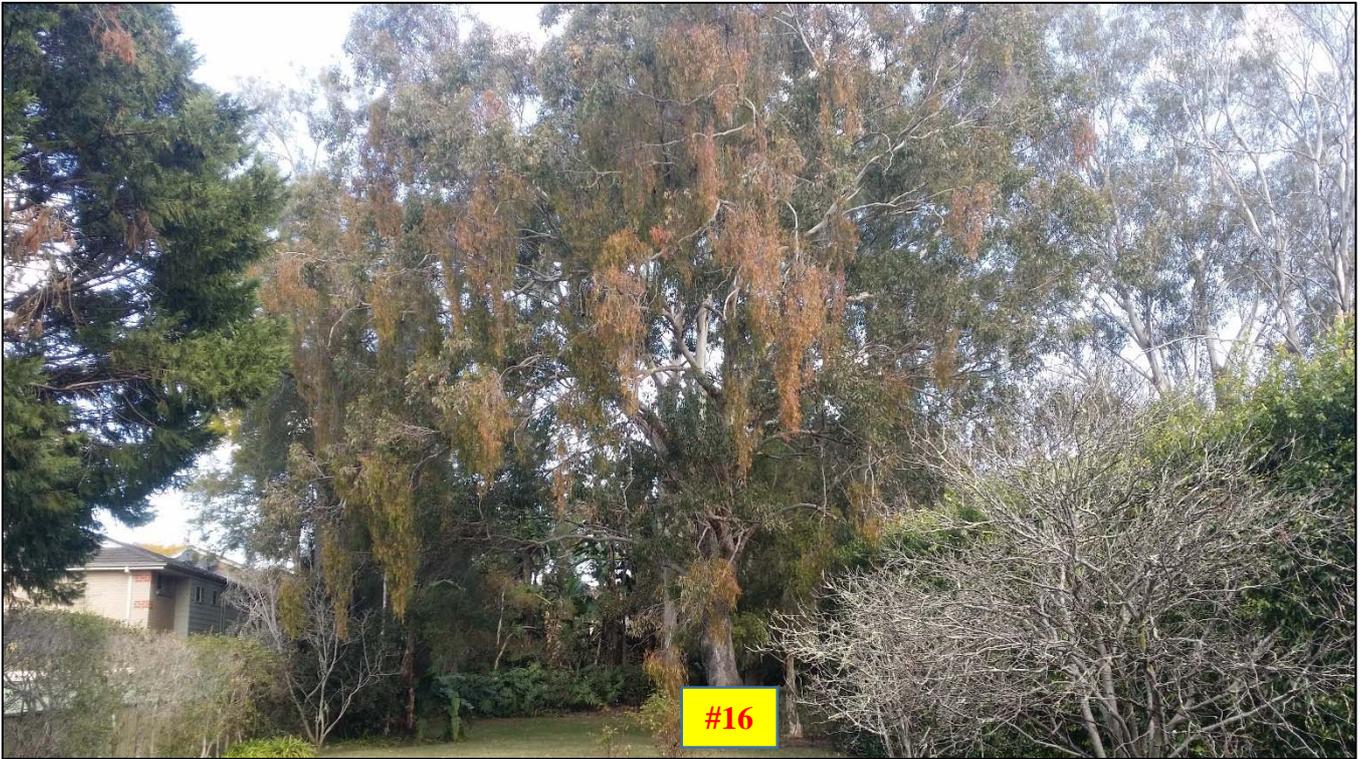
Plate 6 – showing tree 16 with a significant colonisation of mistletoe

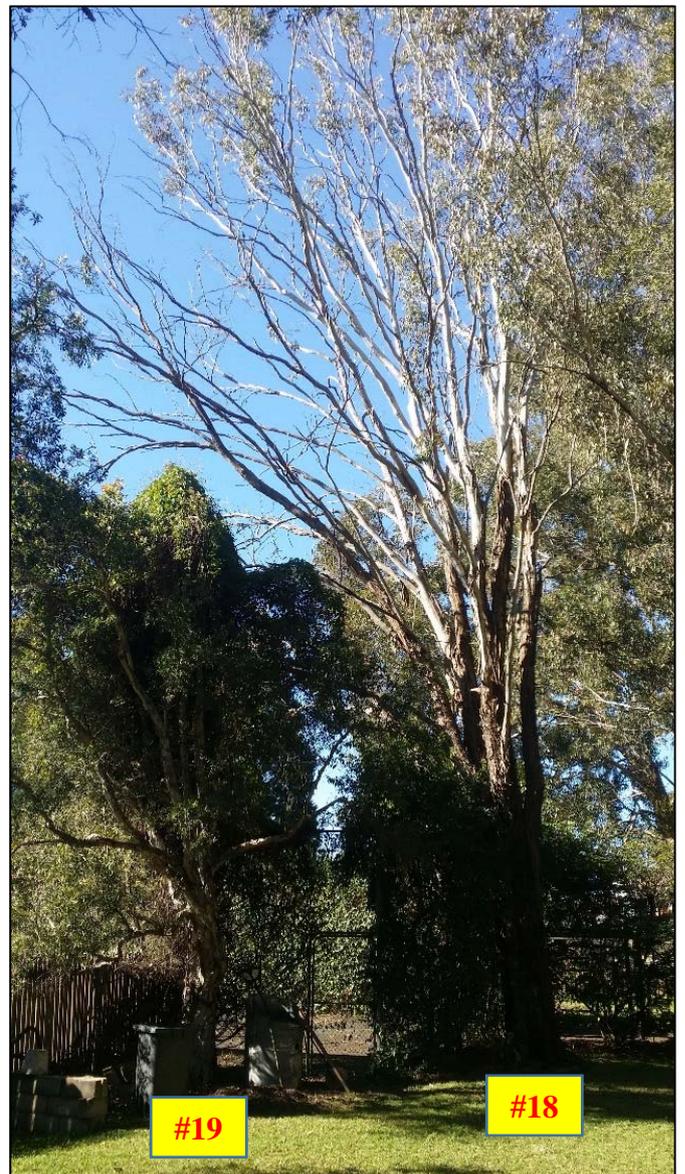
Plate 8 – showing tree No. 18, in advanced stages of decline

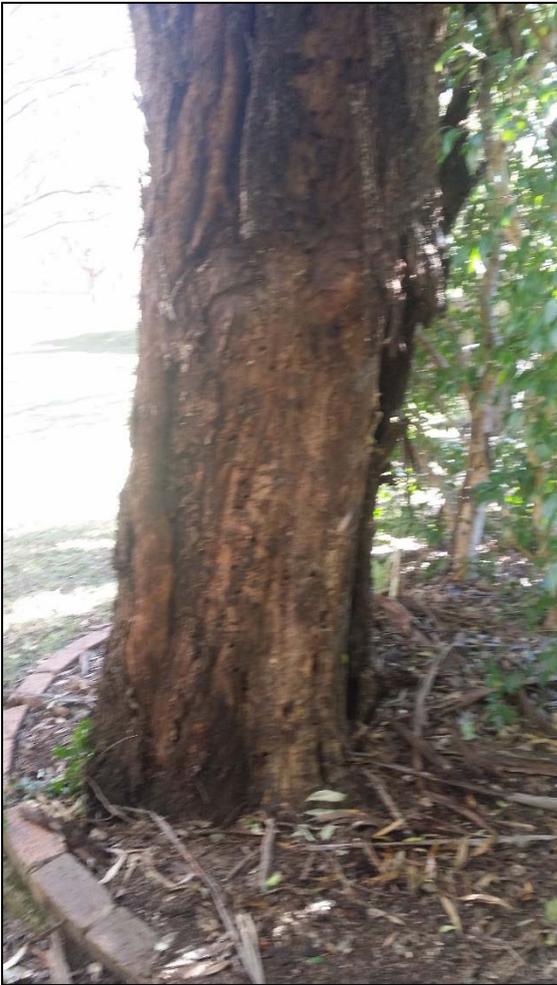
- **Tree No. 60 (*Corymbia citriodora*)** has significant dieback in its canopy and fruiting bodies of root decaying fungus on its root crown. The type of fungus was not identified, but another tree in close proximity (No. 18) has typical symptoms associated with Armillaria Root Decay (see additional information in Appendices 9.8)

Plate 9 – Armillaria Root Decay on trunk of tree 18

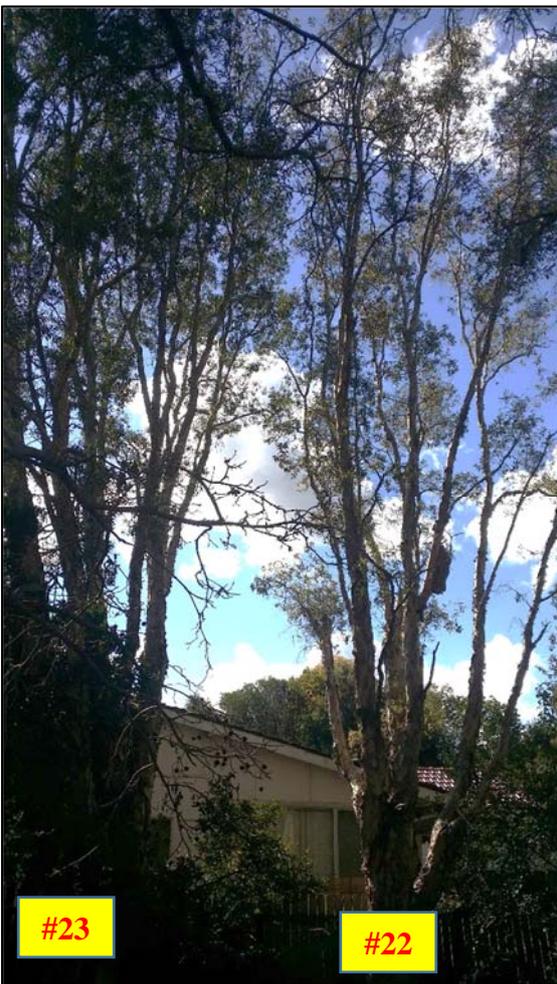
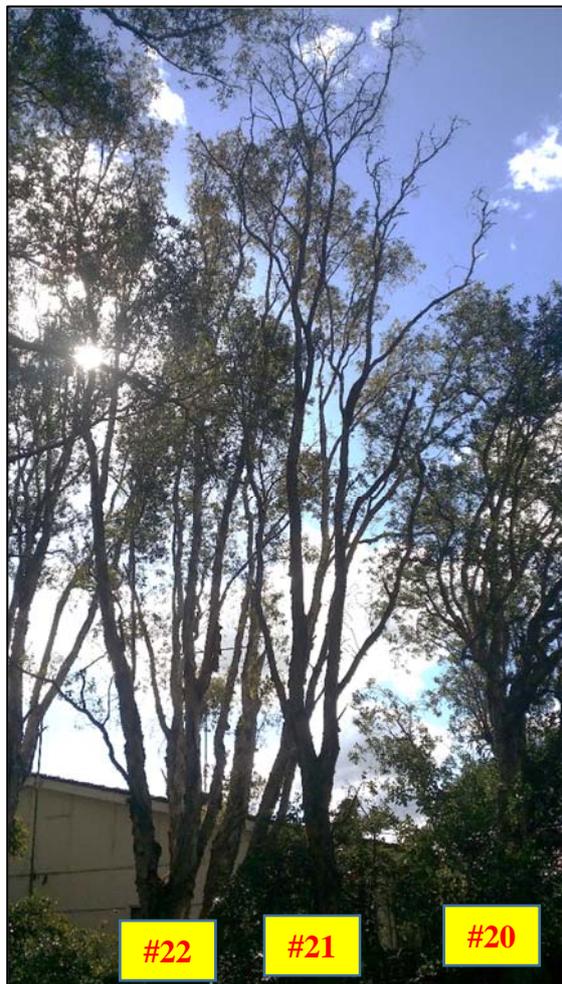
Plates 11 & 12 – showing dieback and decline of tree No's 21 - 23

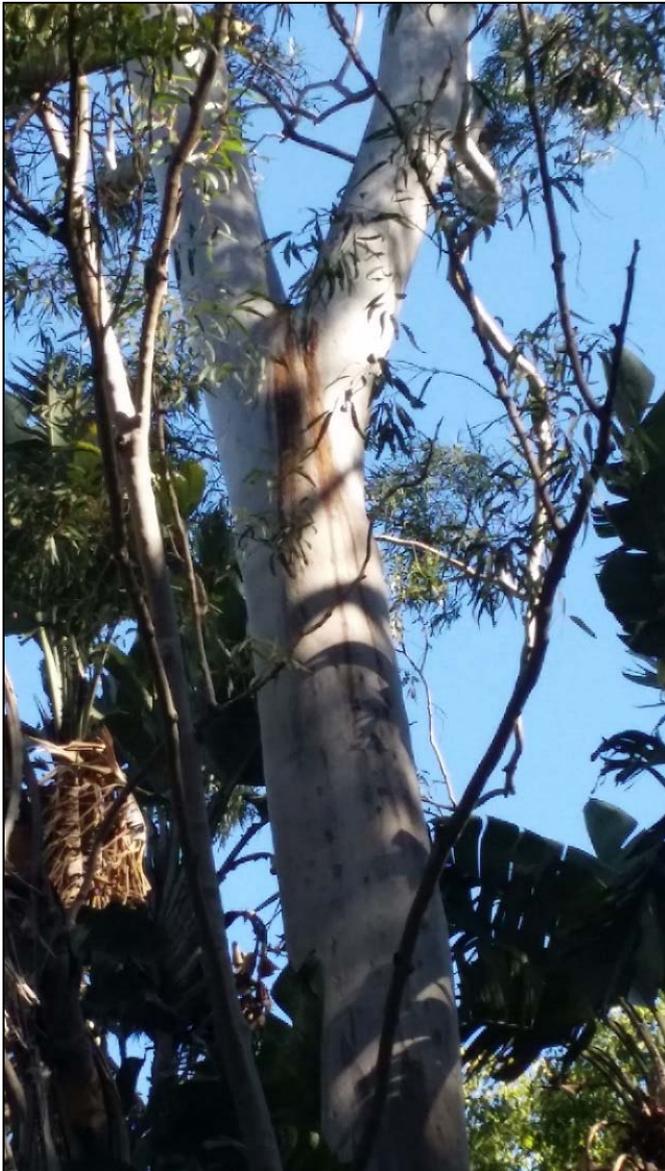
- **Tree No. 61 (*Corymbia citriodora*)** has a two equal sized, codominant ascending branches at about 15m high on the main trunk. Staining along the trunk beneath this junction is a symptom of an internal crack, and it has a possible to imminent potential of failure (see Appendices 9.10 & 9.11)
- **Tree No. 62 (*Corymbia citriodora*)** has been heavily suppressed by the more dominant forms of No's 60 & 61. This has resulted in the formation of a significant asymmetrical canopy towards the northwest, and it will have a probable to imminent potential of failure if the more dominant trees are removed.

Plate 25 – sap weeping from junction in of tree 61

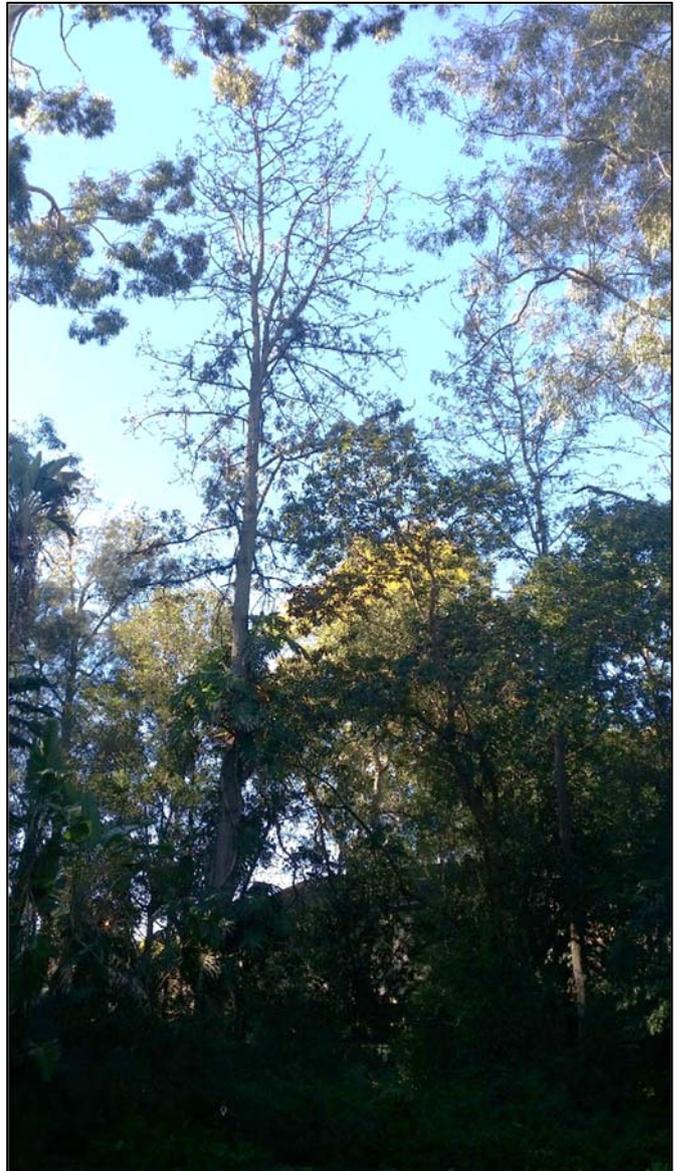
- a. **Health & Vitality:** Poor – the foliage of this tree is very sparse and it appears to be in advanced decline (see Plate 26).
- b. **Tree Form:** This tree has formed a single stem with DBH of 350mm and a canopy that is 22m in height, with a crown spread of 12x9m.
- c. **Structural Condition:** Poor – Retainable for 0 – 5 years

- a. **Health & Vitality:** Poor – the foliage of this tree is very sparse and it appears to be in advanced decline (see Plate 26).
- b. **Tree Form:** This tree has formed a single stem with DBH of 250mm and a codominant canopy that is 14m in height, with a crown spread of 8x8m.
- c. **Structural Condition:** Poor – Retainable for 0 – 5 years

Plate 26 – showing dieback in canopy of tree No's 64 & 68

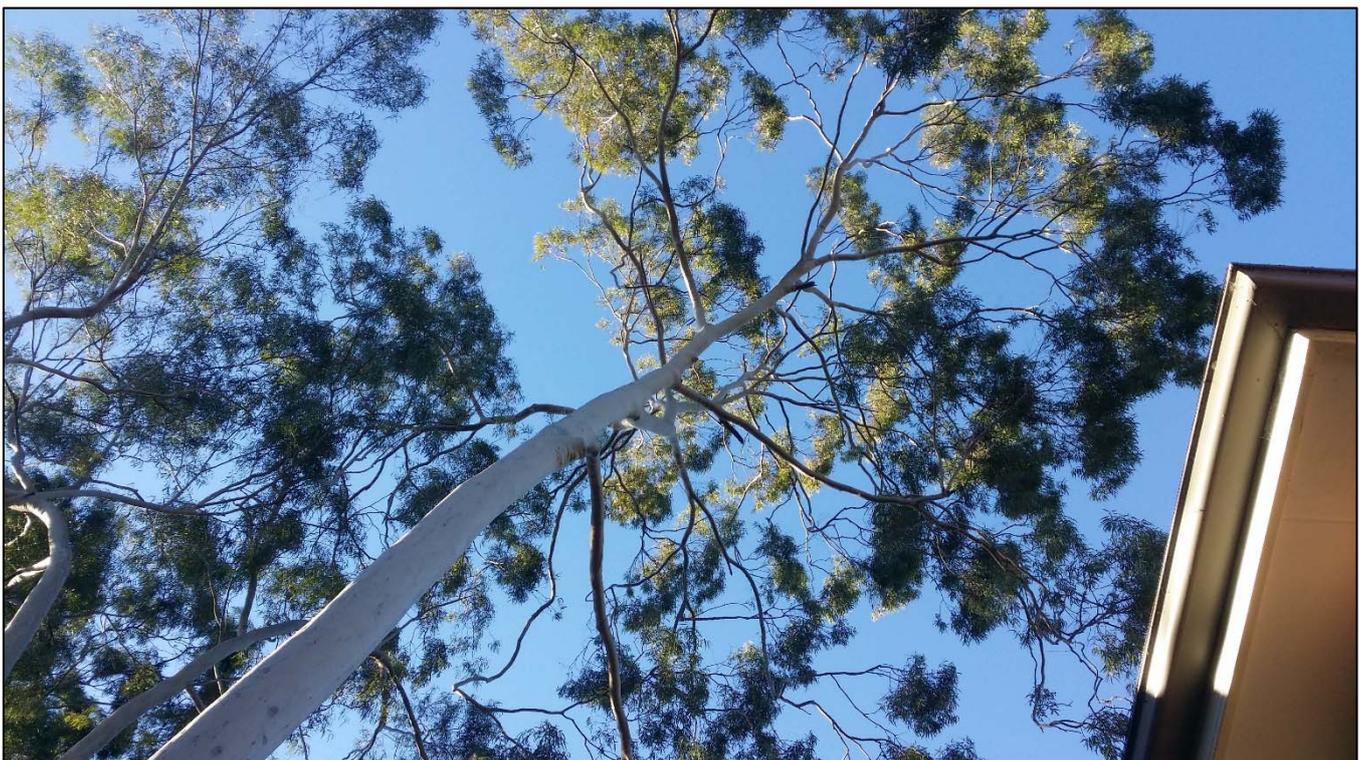
- **Tree No. 72 (*Corymbia citriodora*)** has formed a significant asymmetrical canopy towards the east, and most of its tall canopy overhangs a unit on No. Derby Street. The potential for a whole tree failure is considered unlikely at this stage, but the species is prone to Summer Branch Drop (Appendices 9.12)

Plate 27 – showing significant asymmetrical canopy of tree No. 72

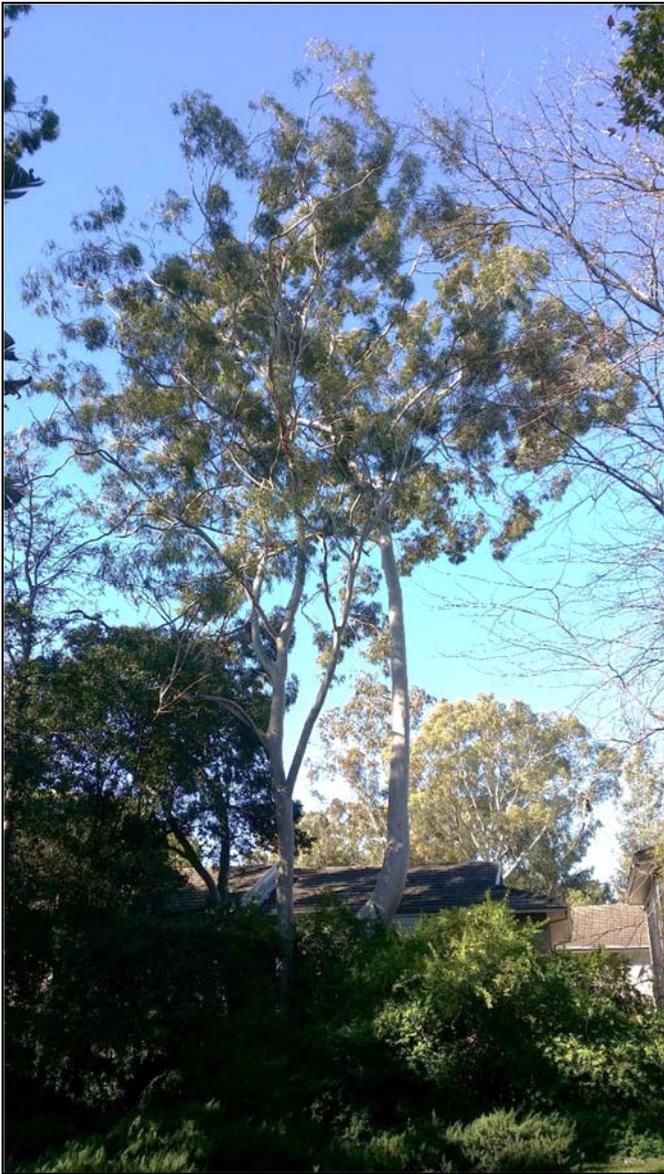
- **Tree No's 71 and 72 (*Corymbia citriodora*)** both have significant asymmetrical canopies, and their retention will be dependent on the retention of Tree No. 72. The removal of No. 72 will expose the edge type canopies of the remaining trees to uncustomed wind loading, and this will increase their failure potentials.

Plate 28 – showing codominant stand of tree No’s 70 – 72

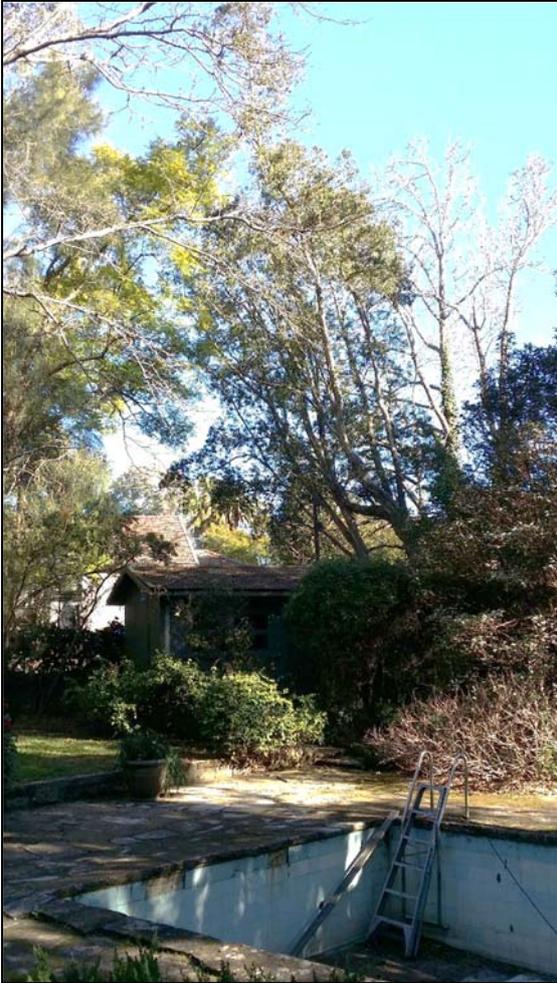
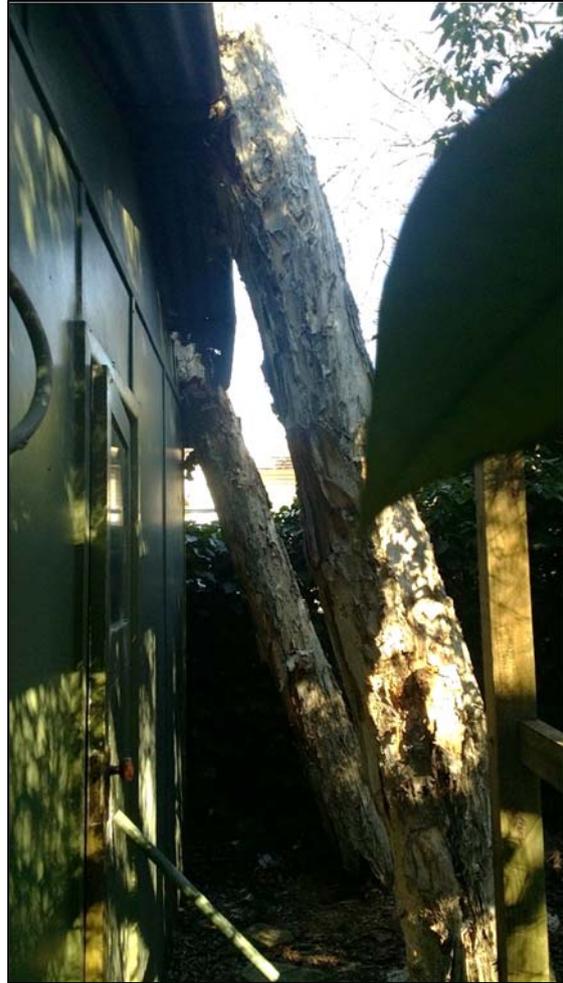
- **Tree No's 80 & 81 (*Melaleuca quinquenervia*)** are semi-mature trees with ° leans towards the east. They are being supported by the change rooms within their driplines, and the proposed demolition of this building will result in probable to imminent failures

Plates 31 & 32 – showing tree No's 80 & 81, with a significant lean towards the east

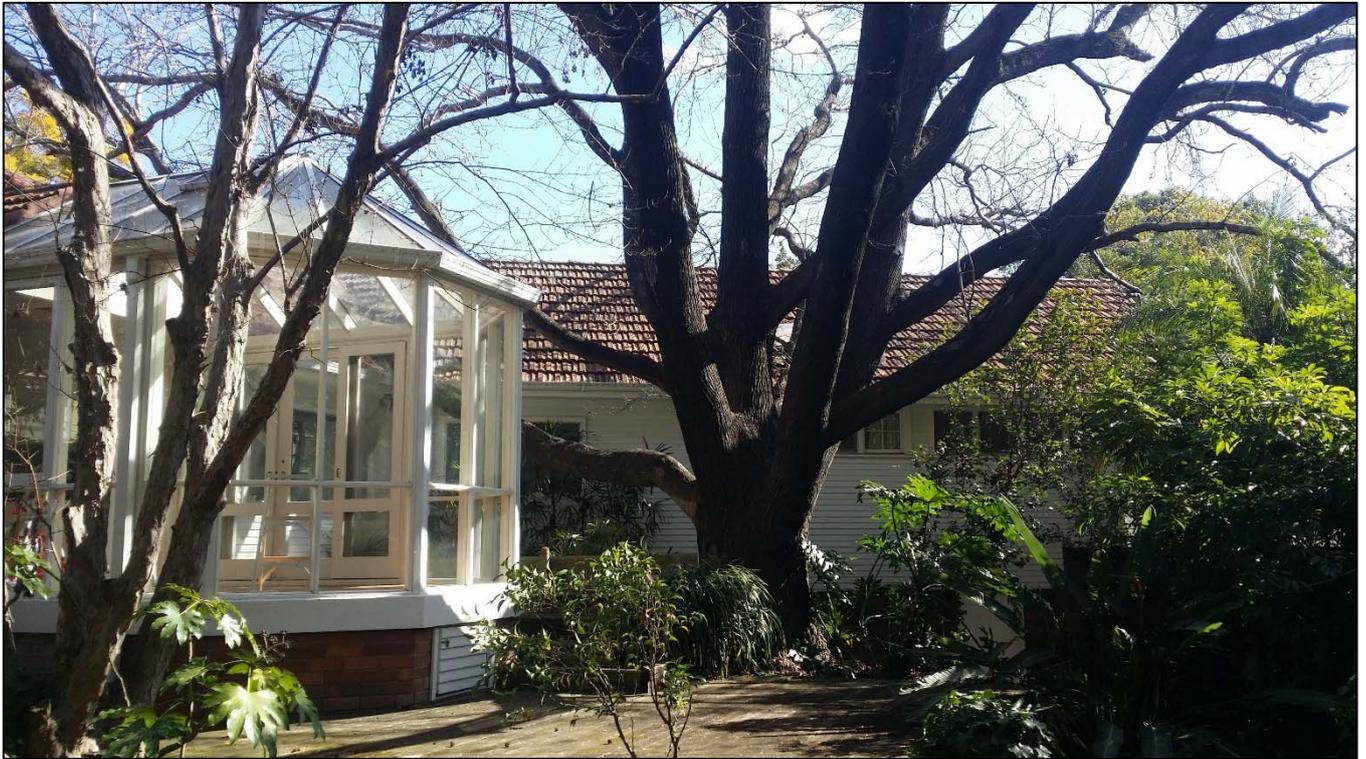
- **Tree No. 85 (*Liquidamber styraciflua*)** is a mature tree with a wide spreading canopy. Some of these branches are receiving mechanical support from the dwelling in its dripline, and the proposed demolition of this building will result in probable to imminent failures

Plate 35 – showing tree No's 84 & 85

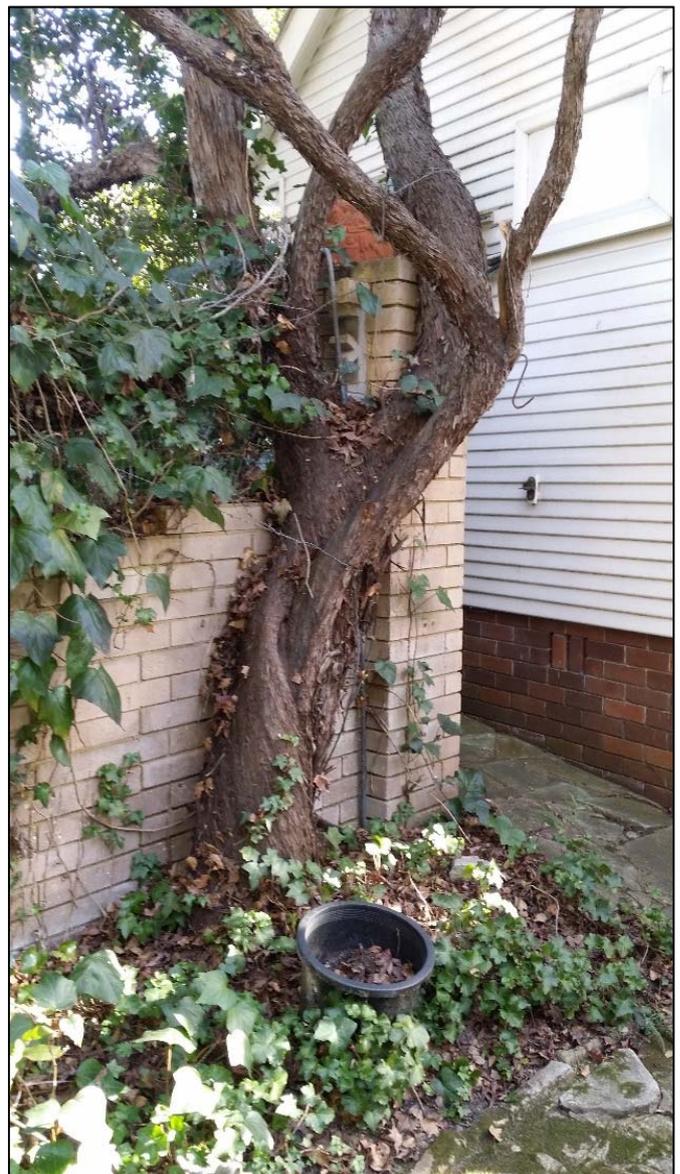
- Health & Vitality:** Average – the foliage of this tree appears to be generally healthy and growing vigorously, with no visible symptoms of decline (see Plate 37).
- Tree Form:** This tree has formed a single stem with DBH of 350mm and a codominant, asymmetrical canopy with a bias towards the south that is 8m in height, with a crown spread of 8x4m.
- Structural Condition:** Poor, this tree is receiving mechanical support from the brick boundary fence. It is likely to damage the fence, and has a high potential of failure if the fence is removed. Retainable for 0 – 5 years

Plate 37 – showing tree 86

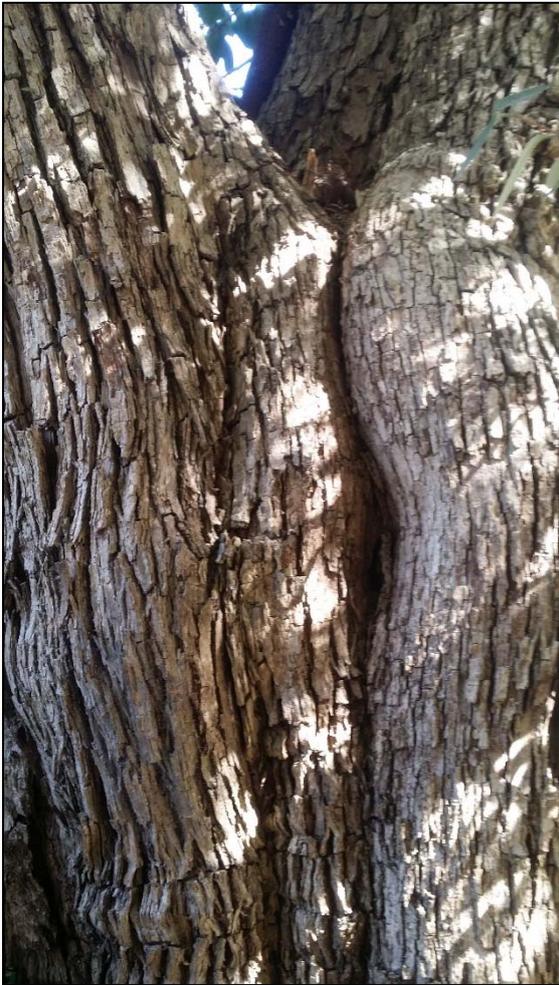
- c. **Structural Condition:** Poor – Two codominant first order branches at about 2m high on the main trunk have a weak junction with a high failure potential (see Plate 41) Retainable for 0 – 5 years

Plate 41 – showing tree 91

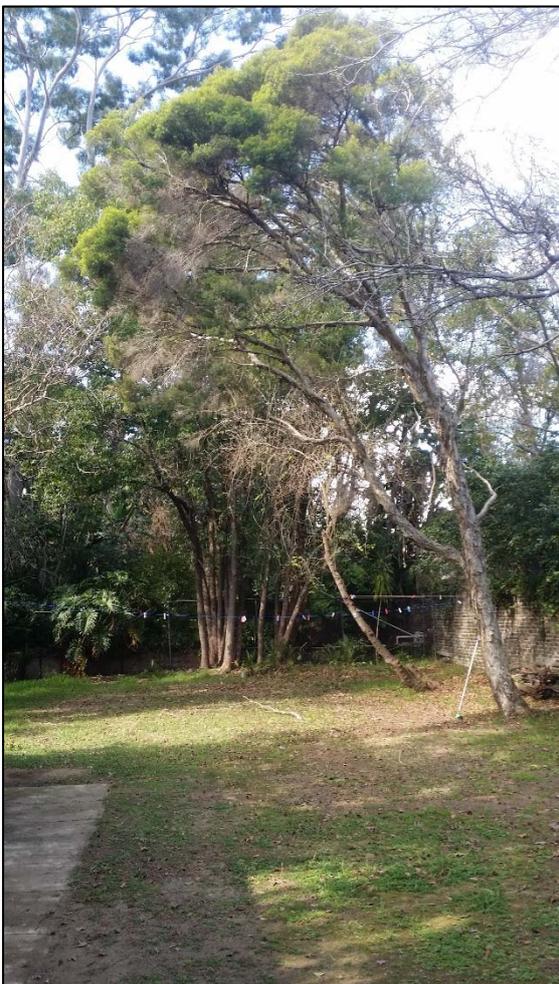
- a. **Health & Vitality:** Average – the foliage of this tree appears to be generally healthy and growing vigorously, with no visible symptoms of decline (see Plate 43).
- b. **Tree Form:** This tree has formed a single stem with DBH of 300mm and a heavily suppressed, asymmetrical canopy with a bias towards the north that is 14m in height, with a crown spread of 8x9m.
- c. **Structural Condition:** Poor – retainable for 0 – 5 years

Plate 43 – showing tree No's 100 - 104
