Report on
Preliminary Site Investigation (Contamination)

Glenmore Park Town Centre Development
Town Terrace, Glenmore Park

Prepared for
Home Consortium

Project 208929.00
September 2021

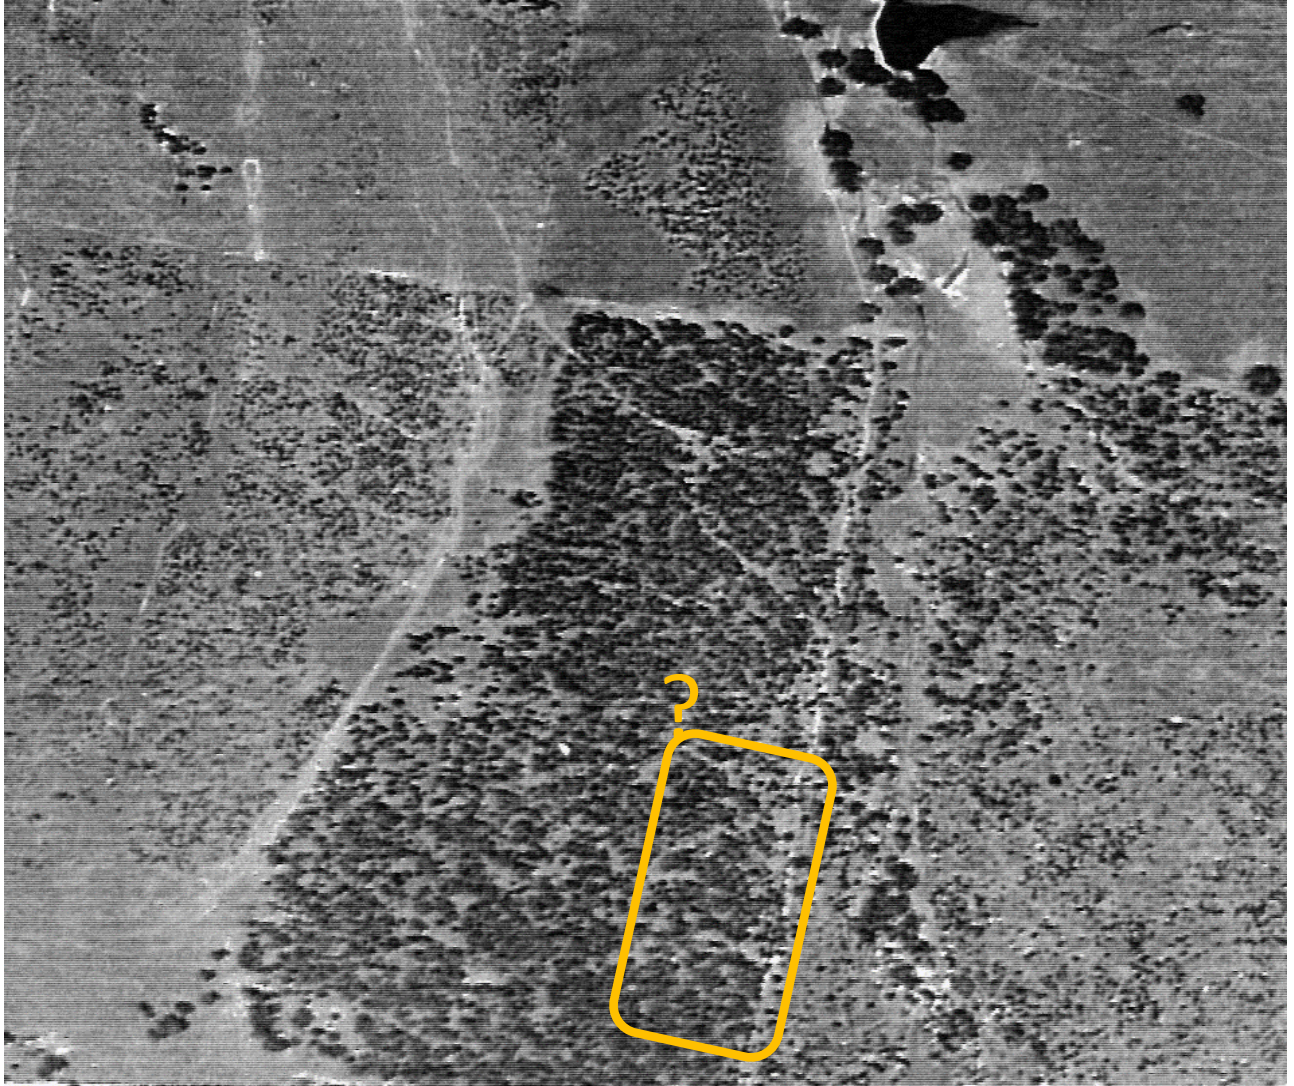
1947 Aerial Photograph	PROJECT: 208929.00
	Glenmore Park Town Centre	PLATE No: D1
	Town Terrace, Glenmore Park	REV: 0
	CLIENT: Home Consortium	DATE: 10-Sep-21

Year	Land Use and Features
1947	The site and surrounding land were vacant. For this reason, the exact site location cannot be determined. The site appears to have had some native vegetation and may have been used for animal grazing
1970	The site and surrounding land appear to have had vegetation clearance since 1947. The land was probably used for grazing.
1986	The site and surrounding land appear to have had more dense vegetation since 1970. The land was probably used for grazing.
1994	The site appears to have been vacant. Some vegetation was present. Residential development had occurred at some of the nearby surrounding land. Neighbouring land to the east had been cleared, probably for recreational purposes.
2005	The shopping centre had been developed. The site comprised mainly walkways and landscaping for the shopping centre. Adjacent to the west of the site was the main shopping centre building and car parking. A service station had been established further to the west. Adjacent to the north of the site was vehicle access and a commercial building. Adjacent to the west of the site was car parking and playing fields. Adjacent to the south was a commercial building and car parking.

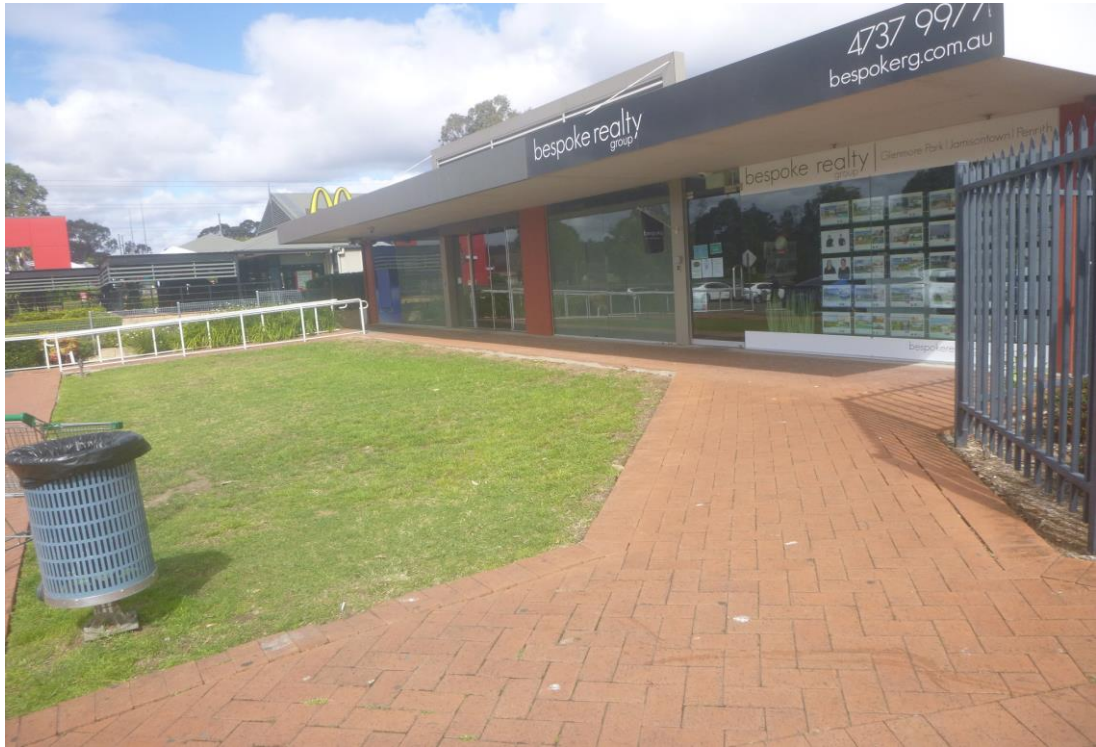
The southern end of the site was occupied by a one-storey building which was partially being used by a realty office / shop and was partially vacant. To the west of the one-storey building is a loading dock for the shopping centre which is at the western site boundary. The remainder of the site comprises pedestrian walkways and landscaping for the shopping centre. The walkway to the north of the one-storey building slopes down to the north. Slopes at the site are otherwise generally down to the east and north-east. Pavements at the site appeared to be in good condition. Vegetation (trees, shrubs and lawn) was in a healthy condition.

Photo 1: Commerical building at south of site

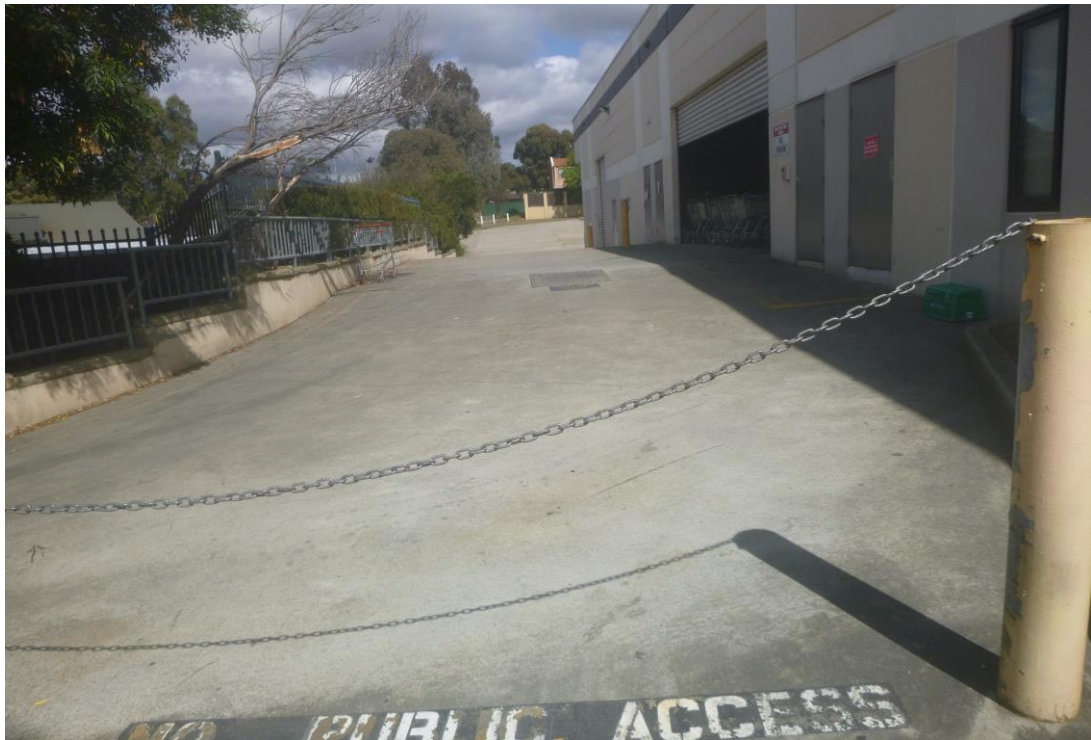
Photo 2: Loading dock

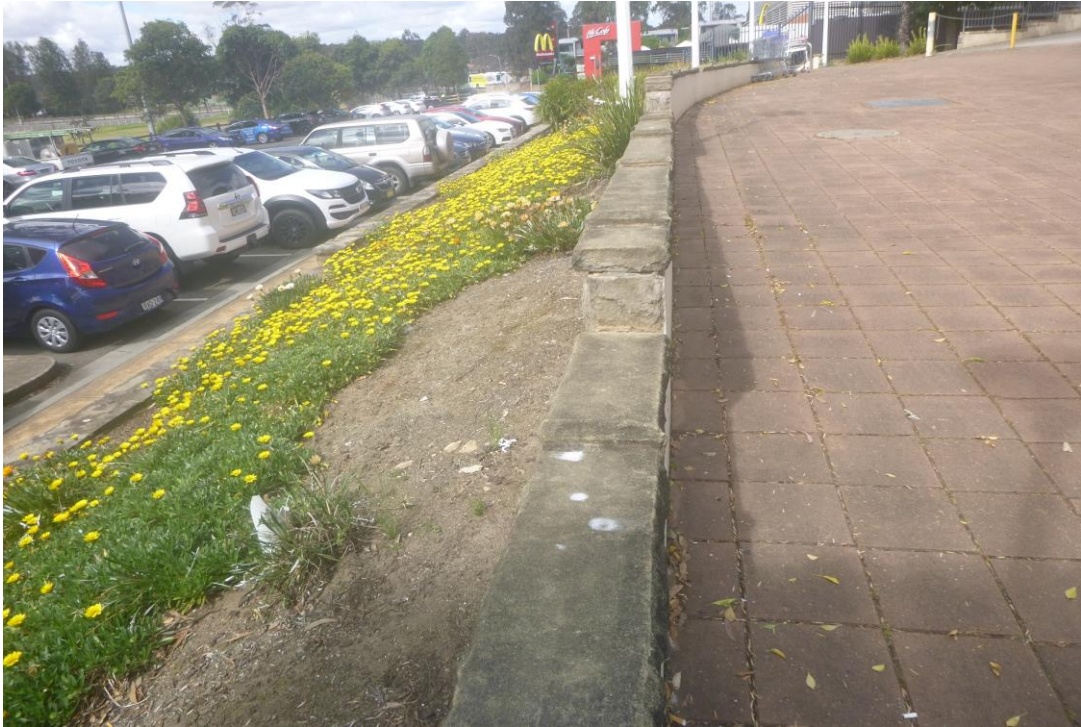
Numerous retaining walls, mainly associated with landscaping, of up to approximately 2 m high were observed at the site. A batter slope was also present to the north of the one-story building.

Photo 3: Batter slope near western site boundary

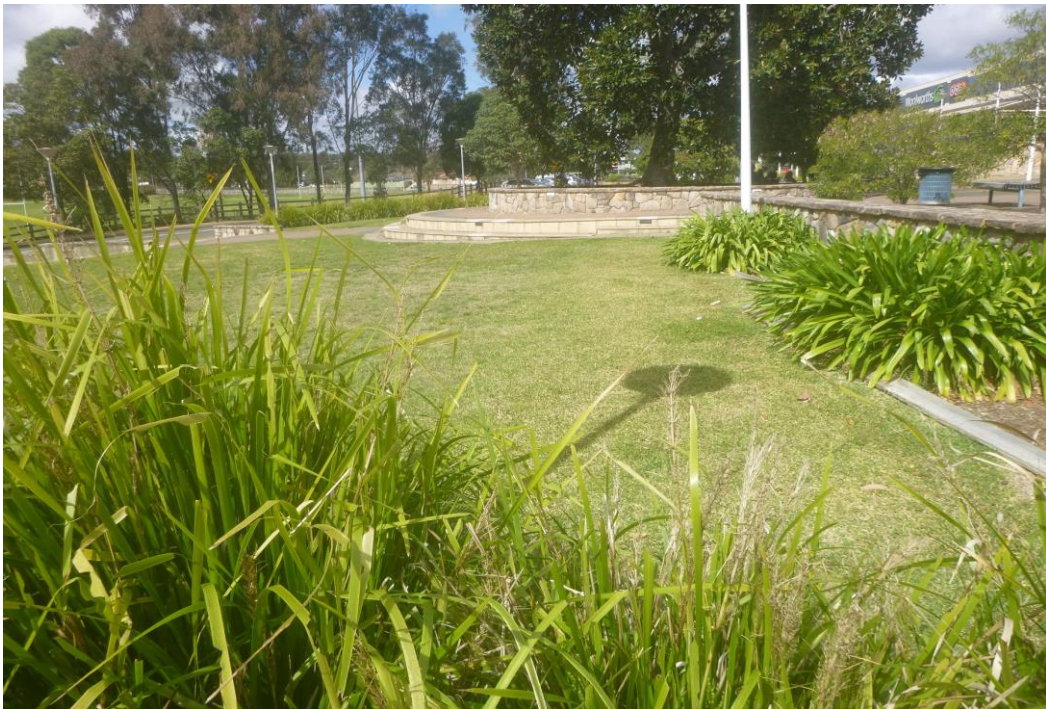
Photo 4: Landscaped area with retaining walls at north of site

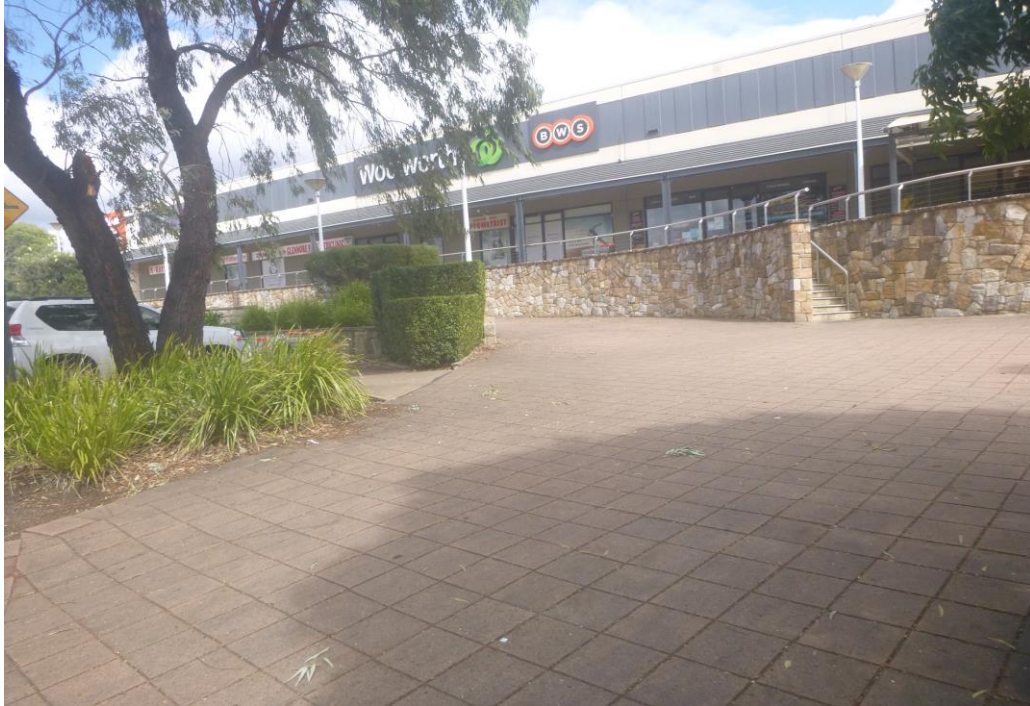
Photo 5: Retaining walls at site

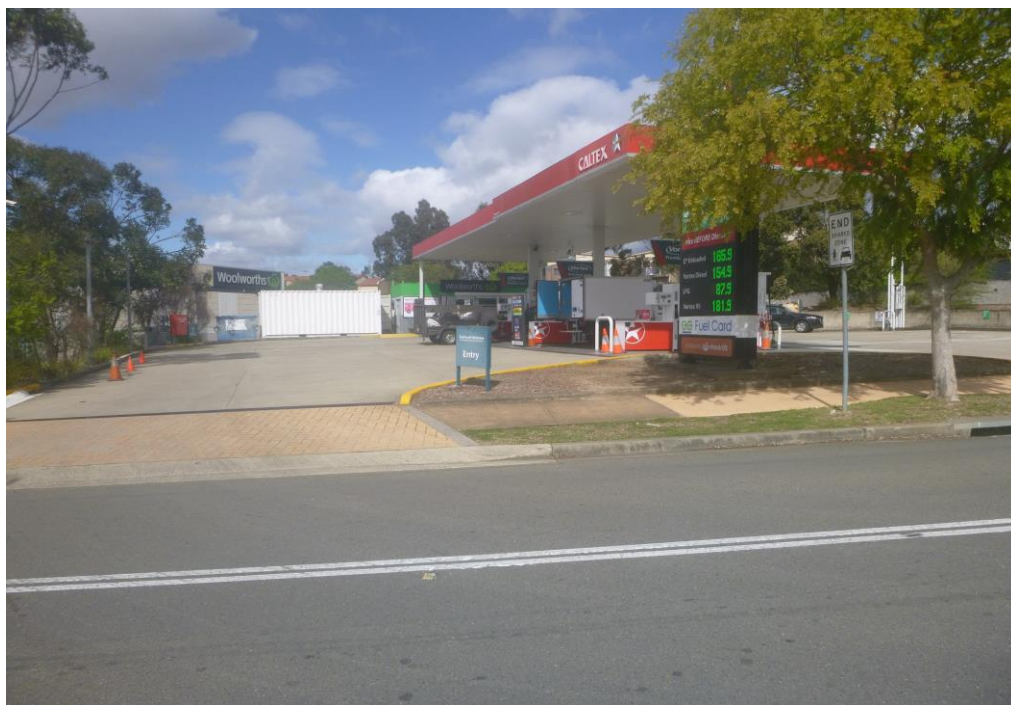
A service station was located approximately 100 m to the west (up-gradient) of the site, on the other side of the shopping centre building. Groundwater monitoring well Gatic covers were observed at the service station. The underground storage tank dip / fill points were observed on the western side of the service station property.

It is noted that the service station, although up-gradient of the site, is not in close proximity of the site and has not been listed by the EPA as a contaminated site. It is also noted that the service station is less than 25 years old and appears to have a leak detection system (groundwater monitoring wells).

Photo 6: Service station (off-site)
