J K Williams Contracting Pty Ltd

Dilapidation Report

Proposed Works - Jordan Springs Stage 2 Retirement Living

James Sae Siew
5th March 2019
Revision 1

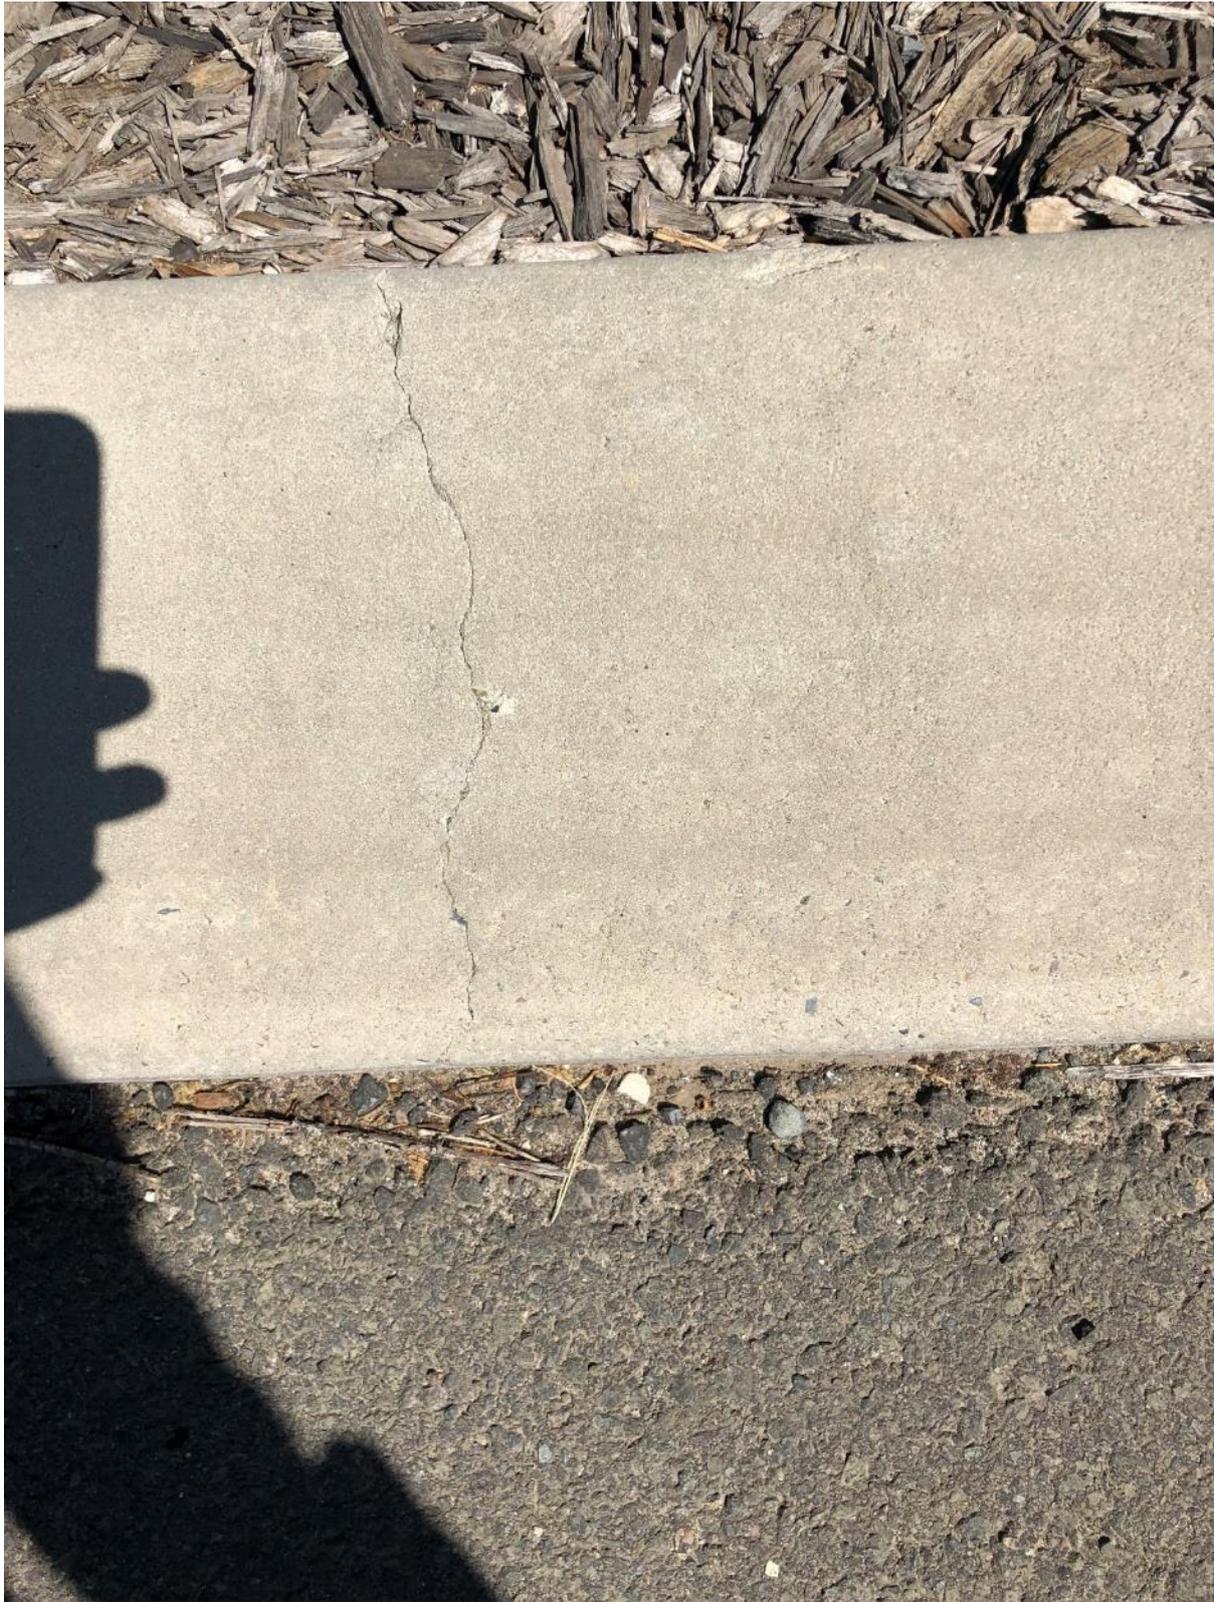
Figure 2: crack in median strip kerb.

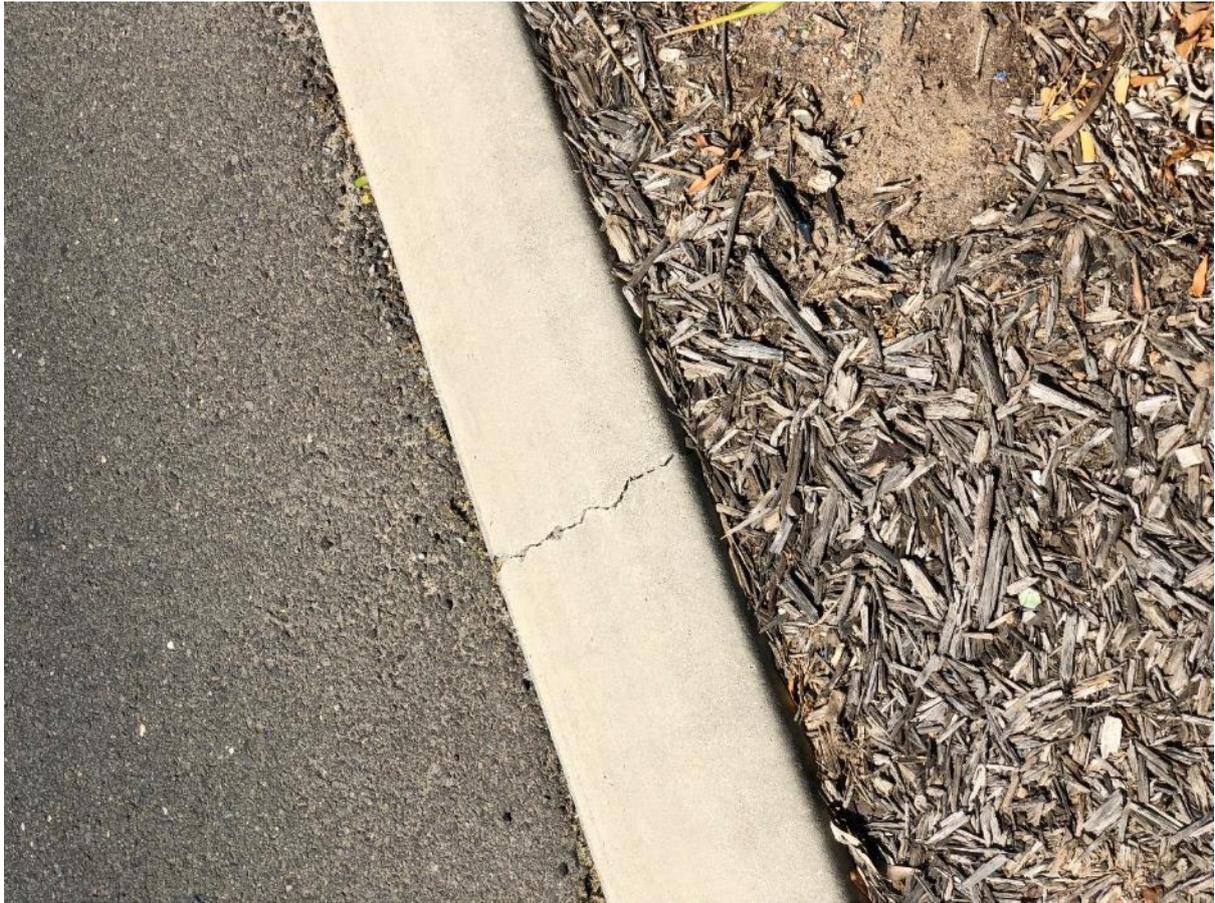
Figure 3: crack in median strip kerb.

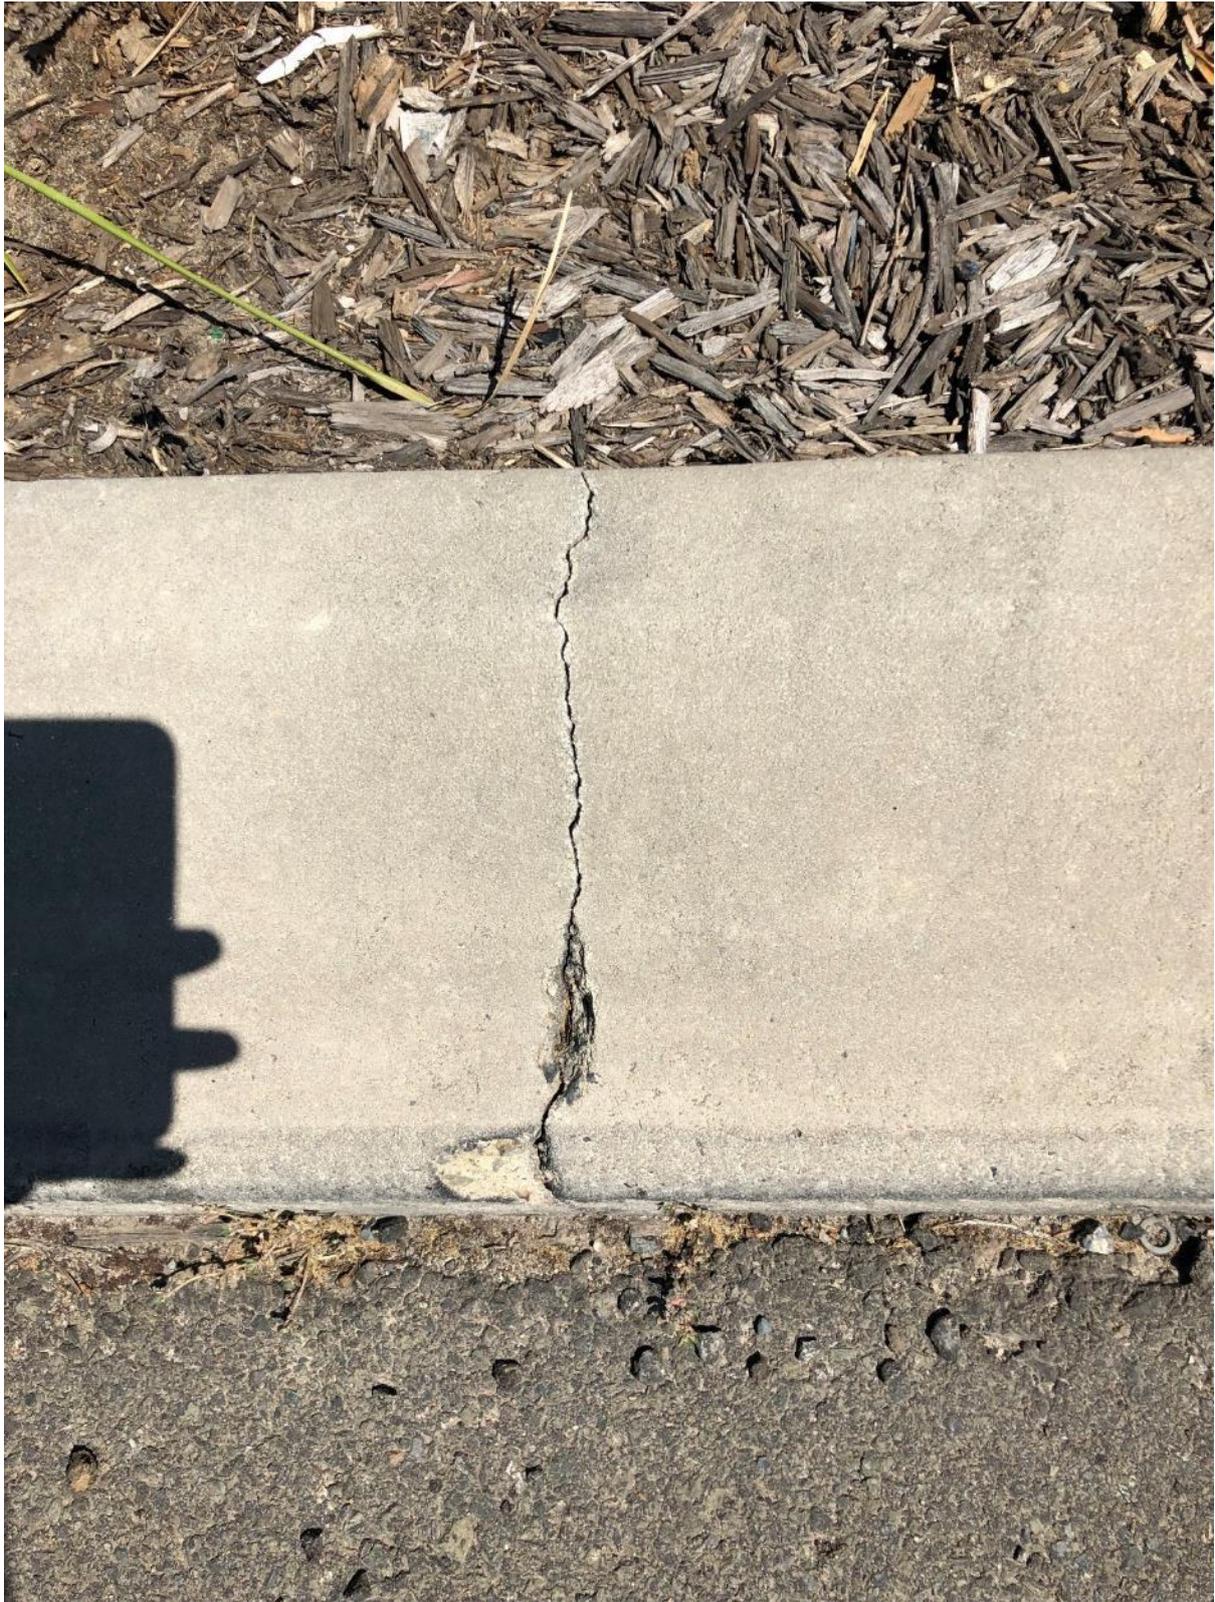
Figure 4: crack in median strip kerb.

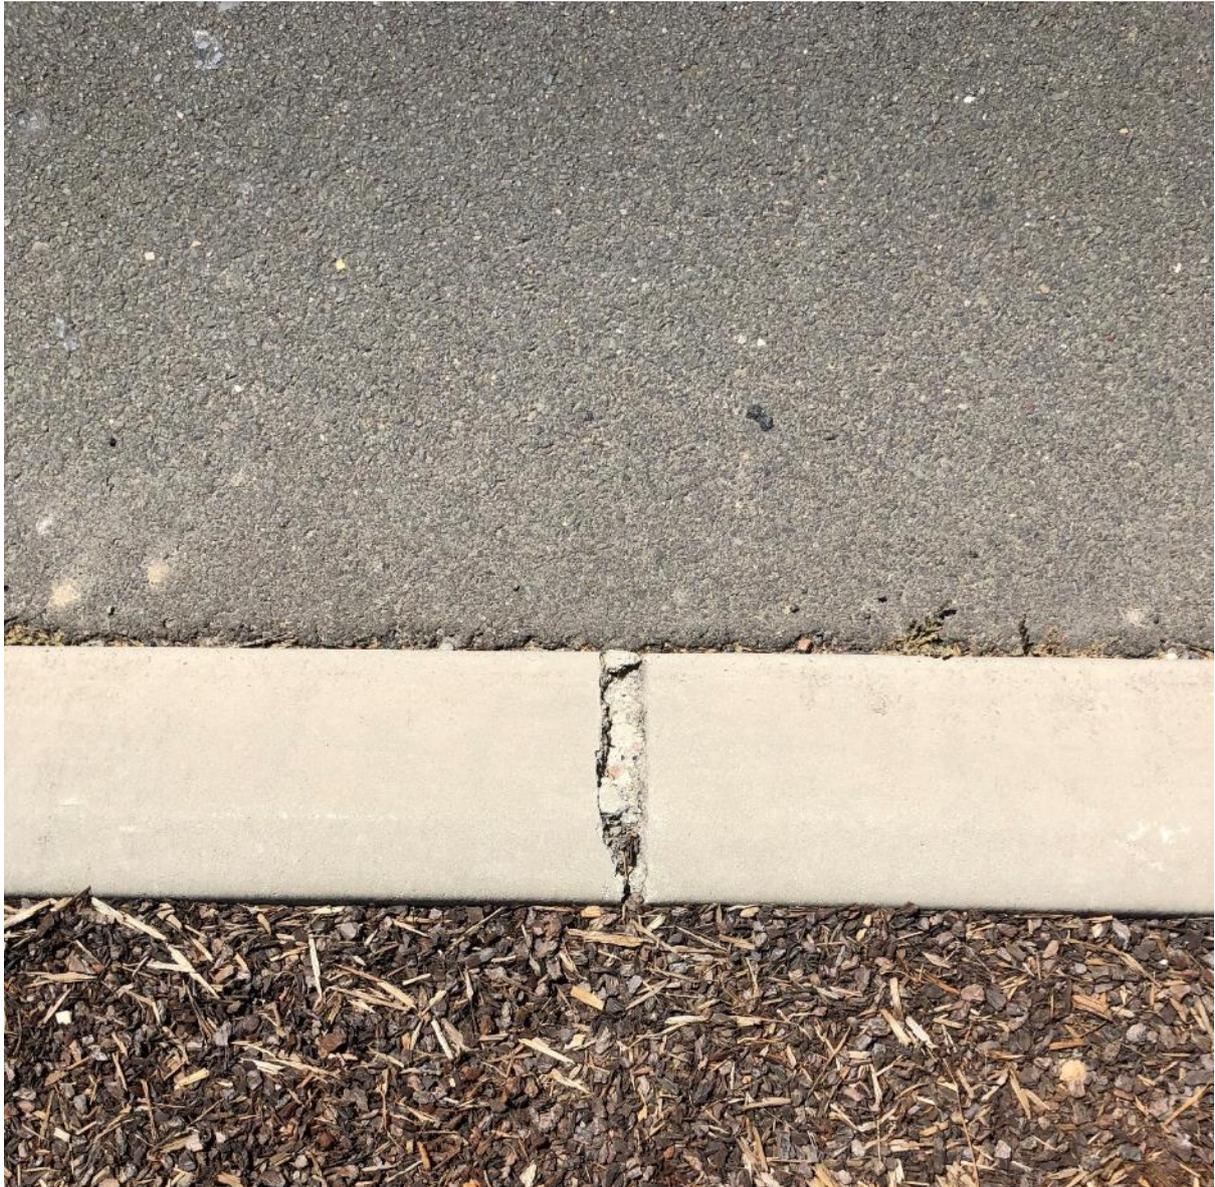
Figure 5: separation at construction joint interface.

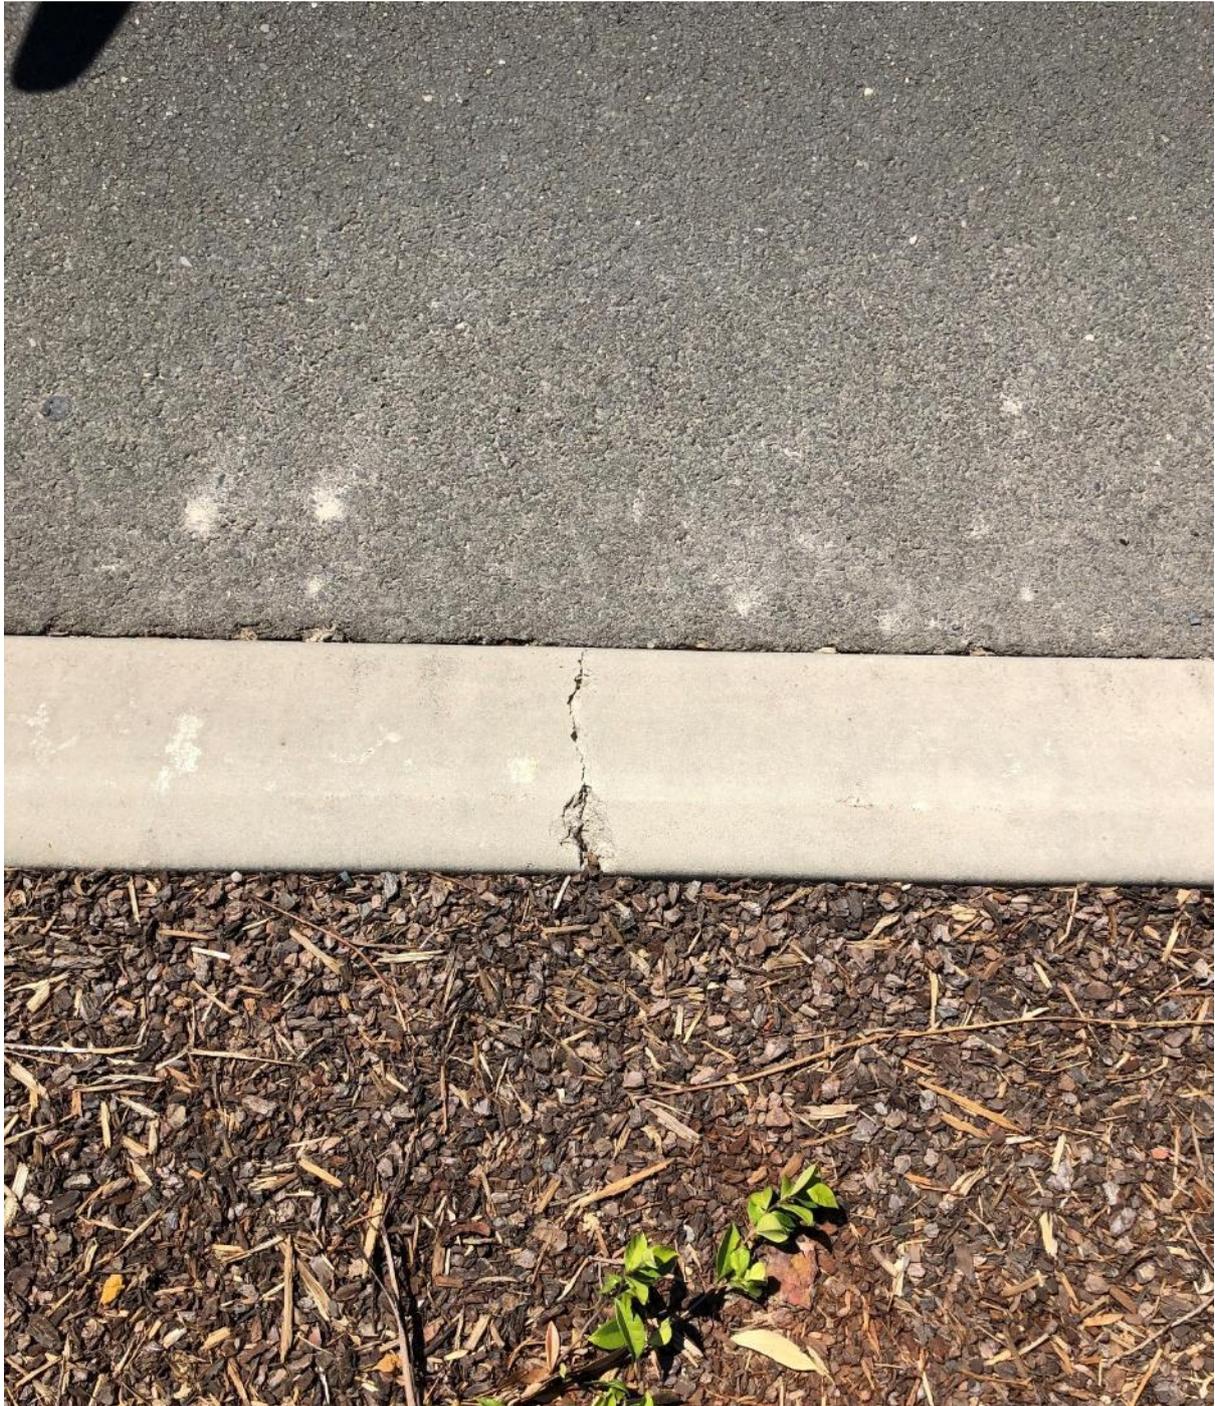
Figure 6: cracking to median strip kerb.

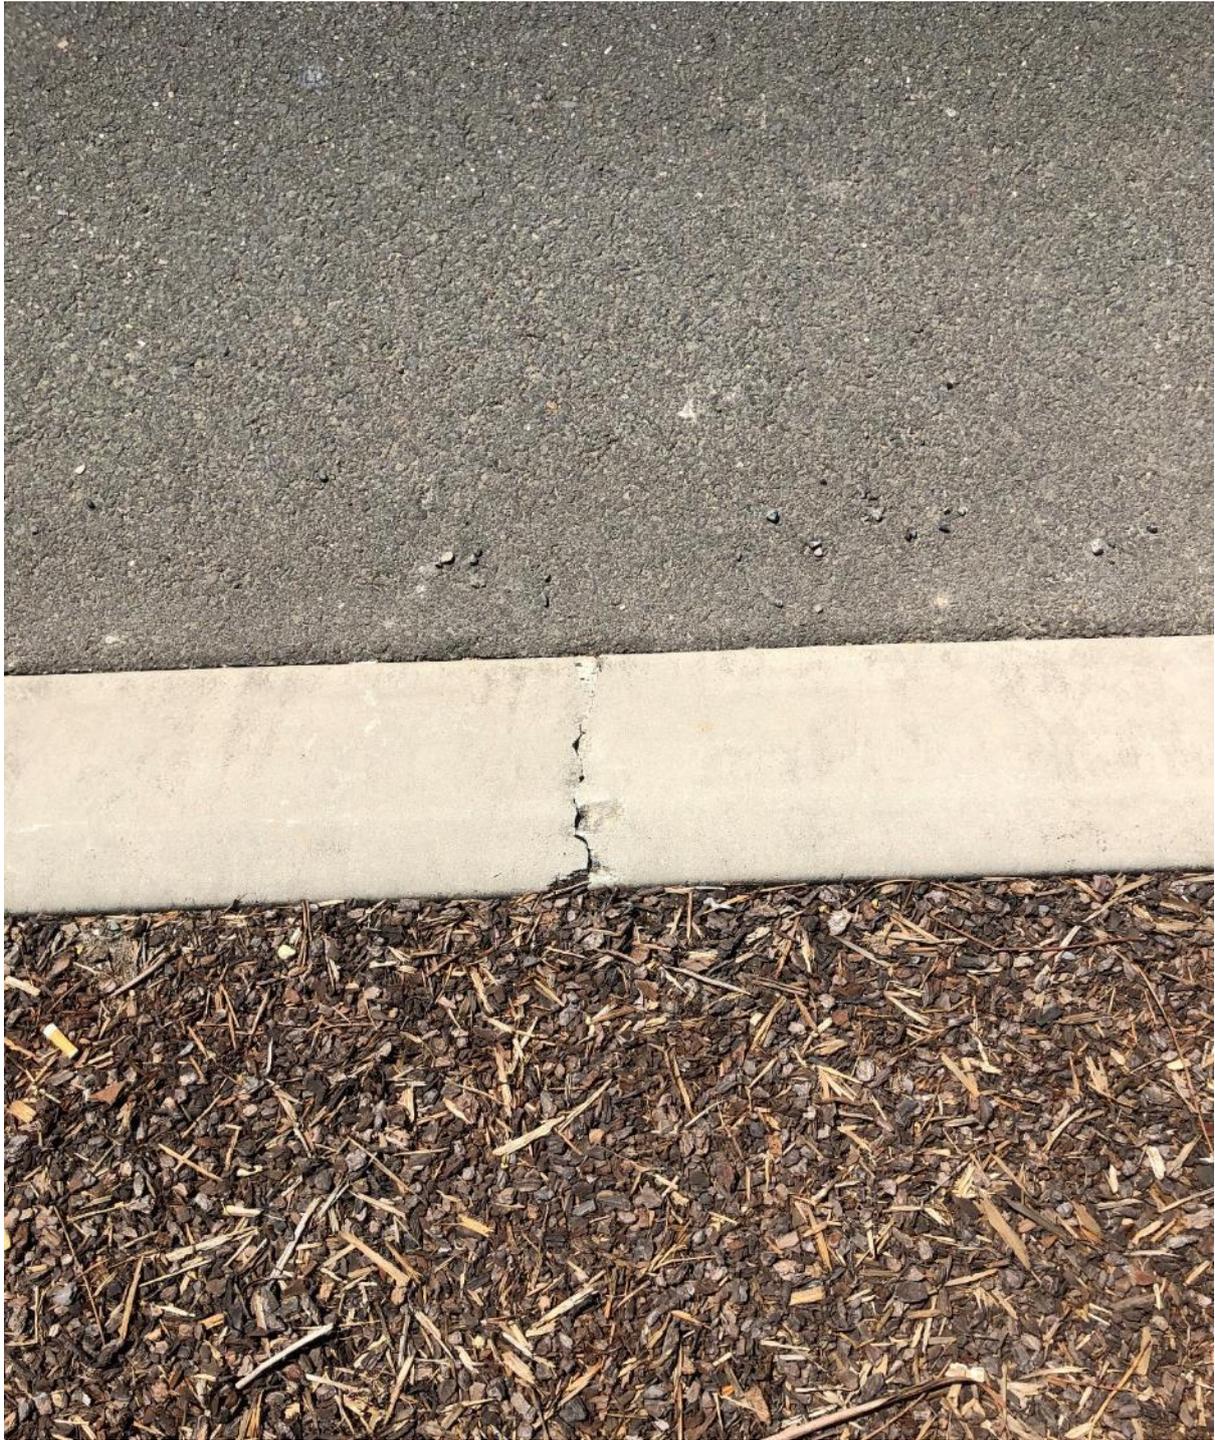
Figure 7: cracking to median strip kerb.

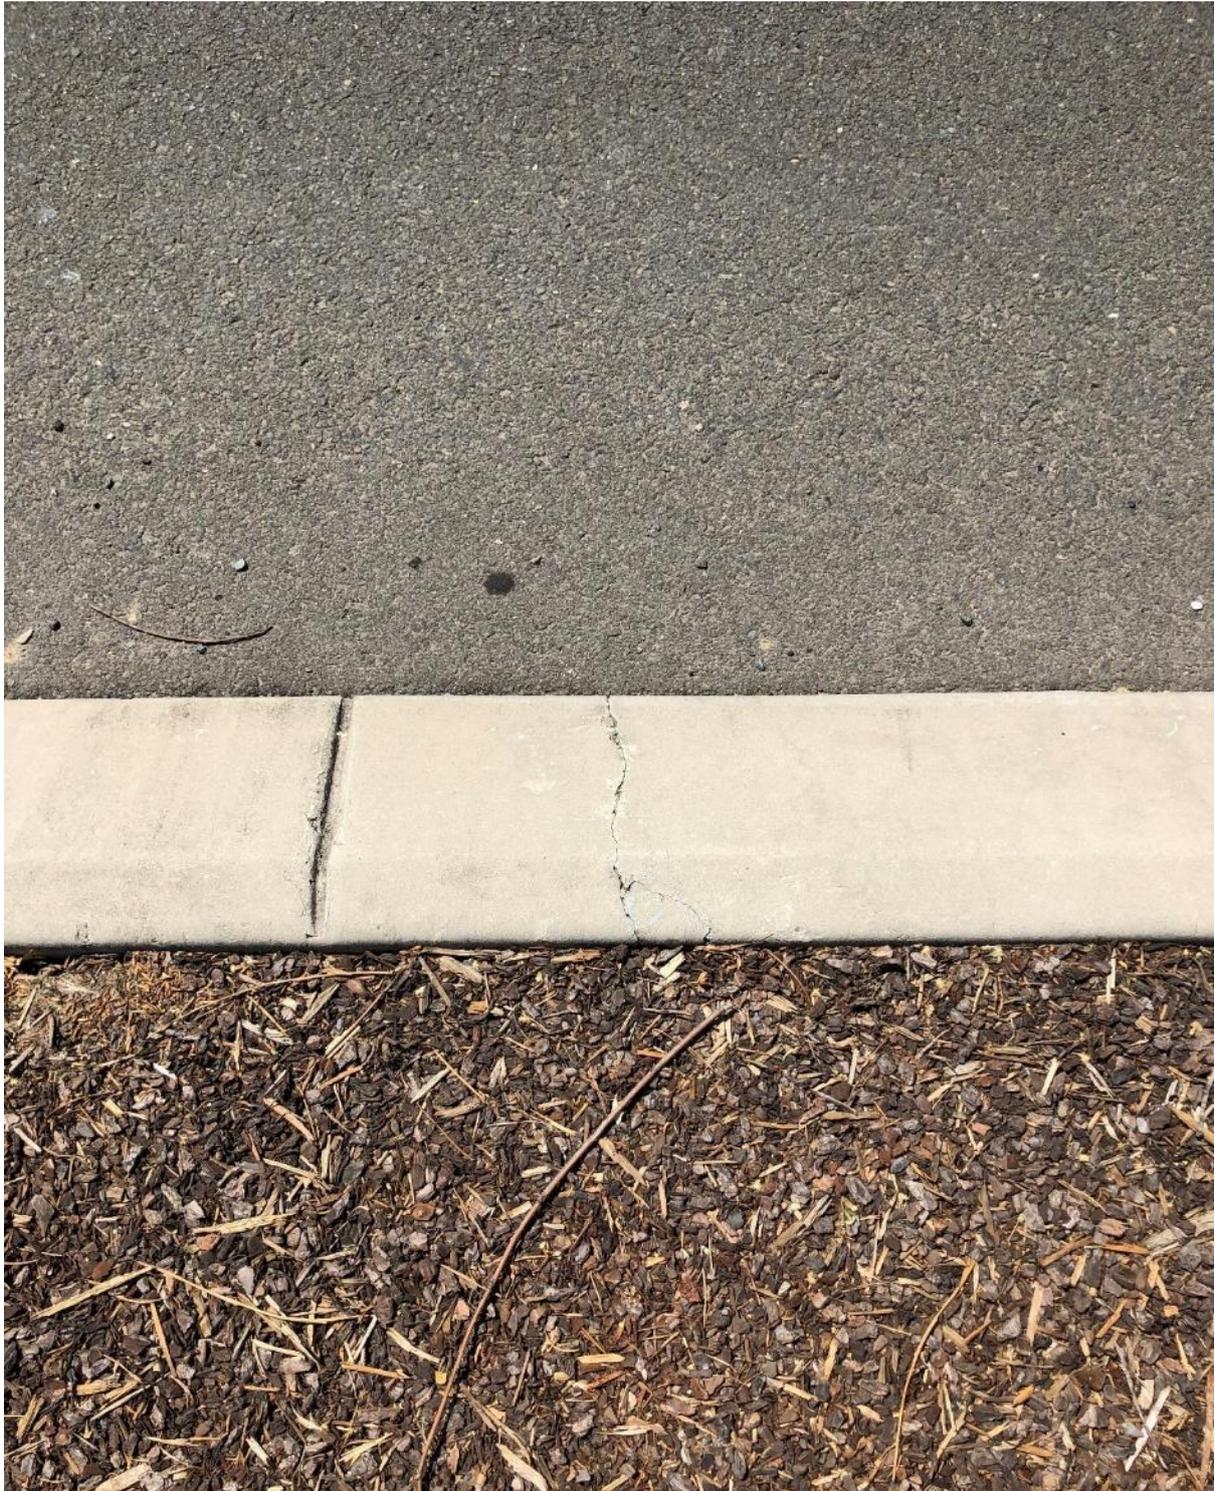
Figure 8: cracking to median strip kerb.

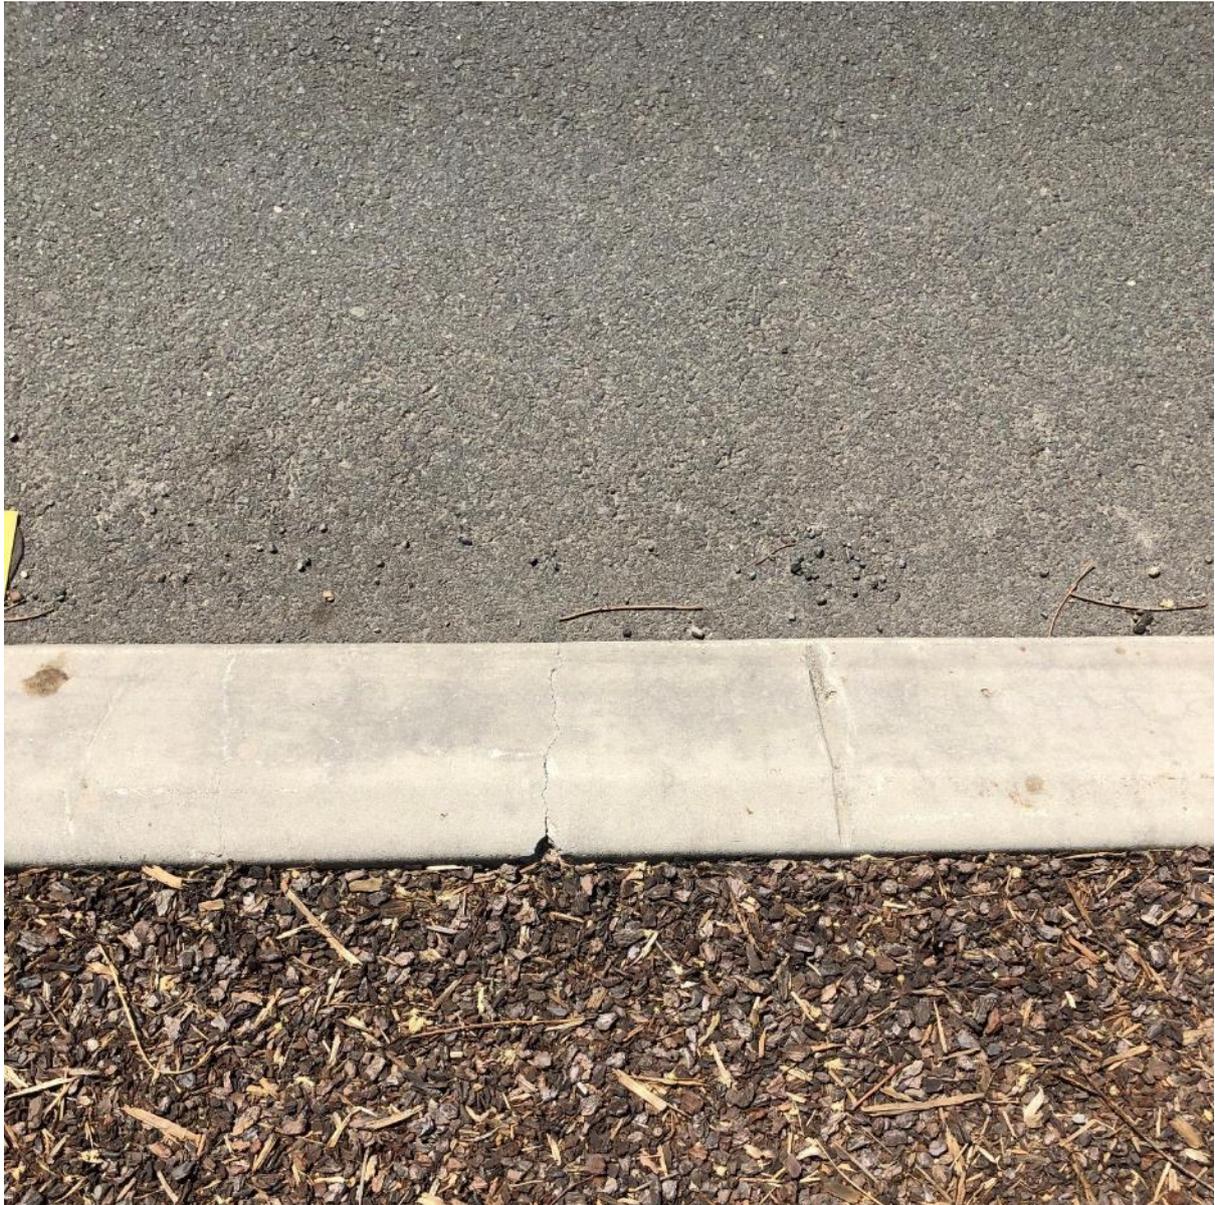
Figure 9: cracking to median strip kerb.

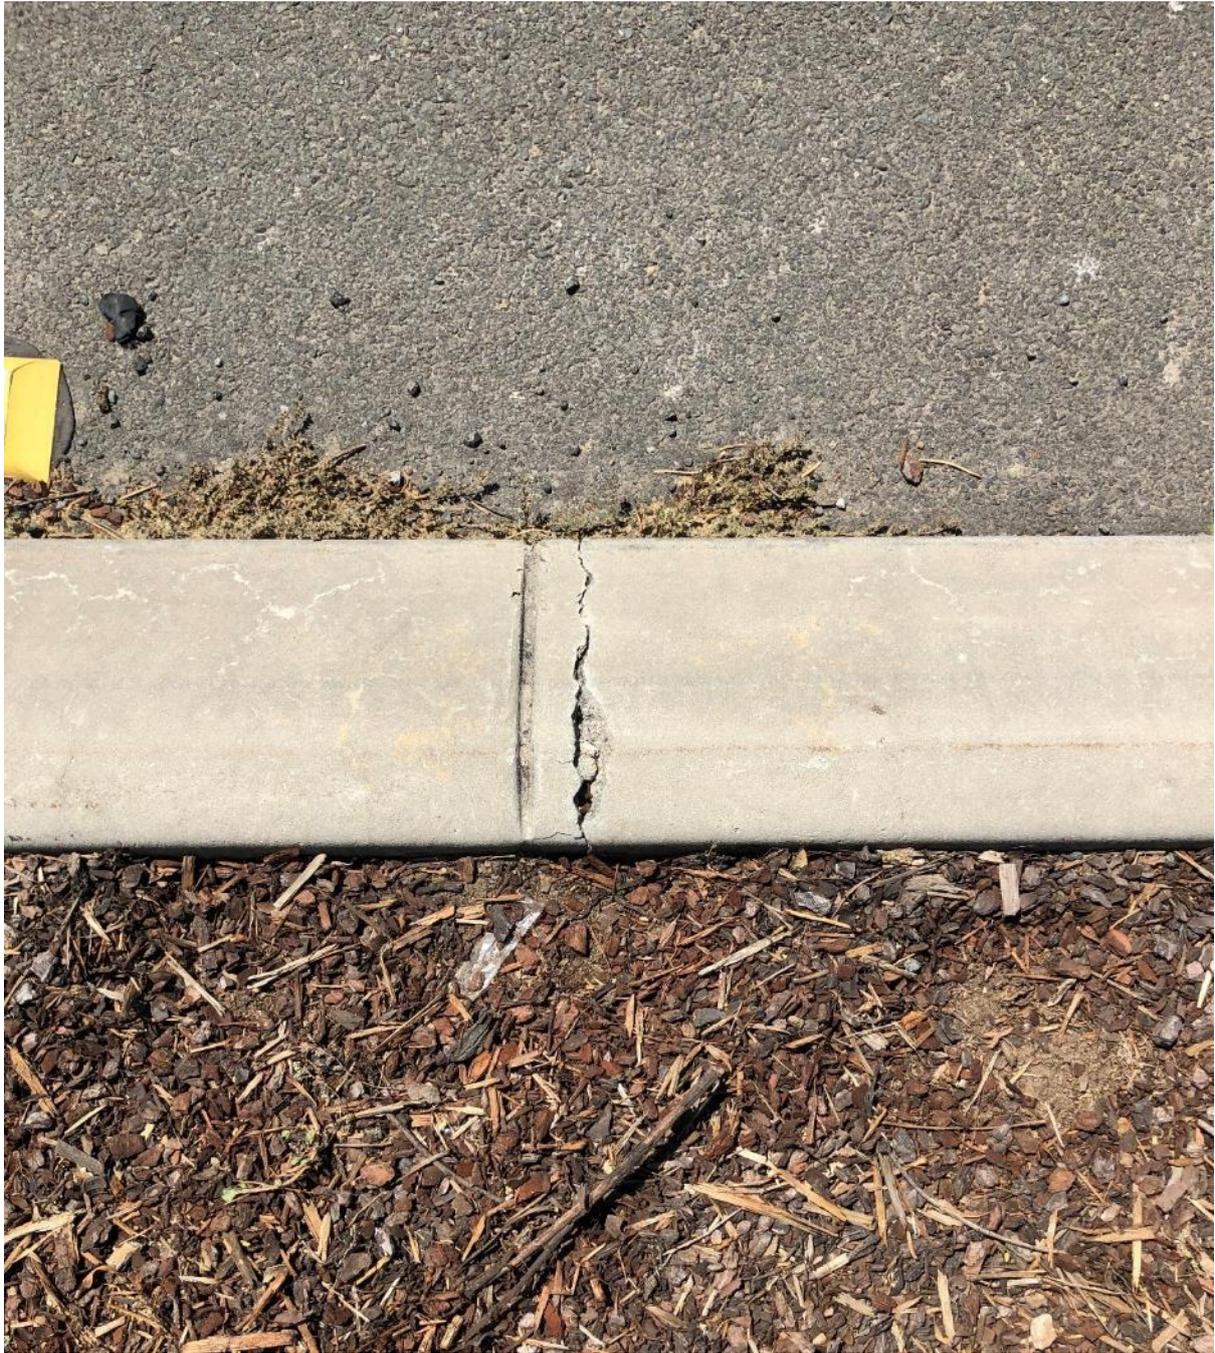
Figure 10: cracking to median strip, adjacent to construction joint.

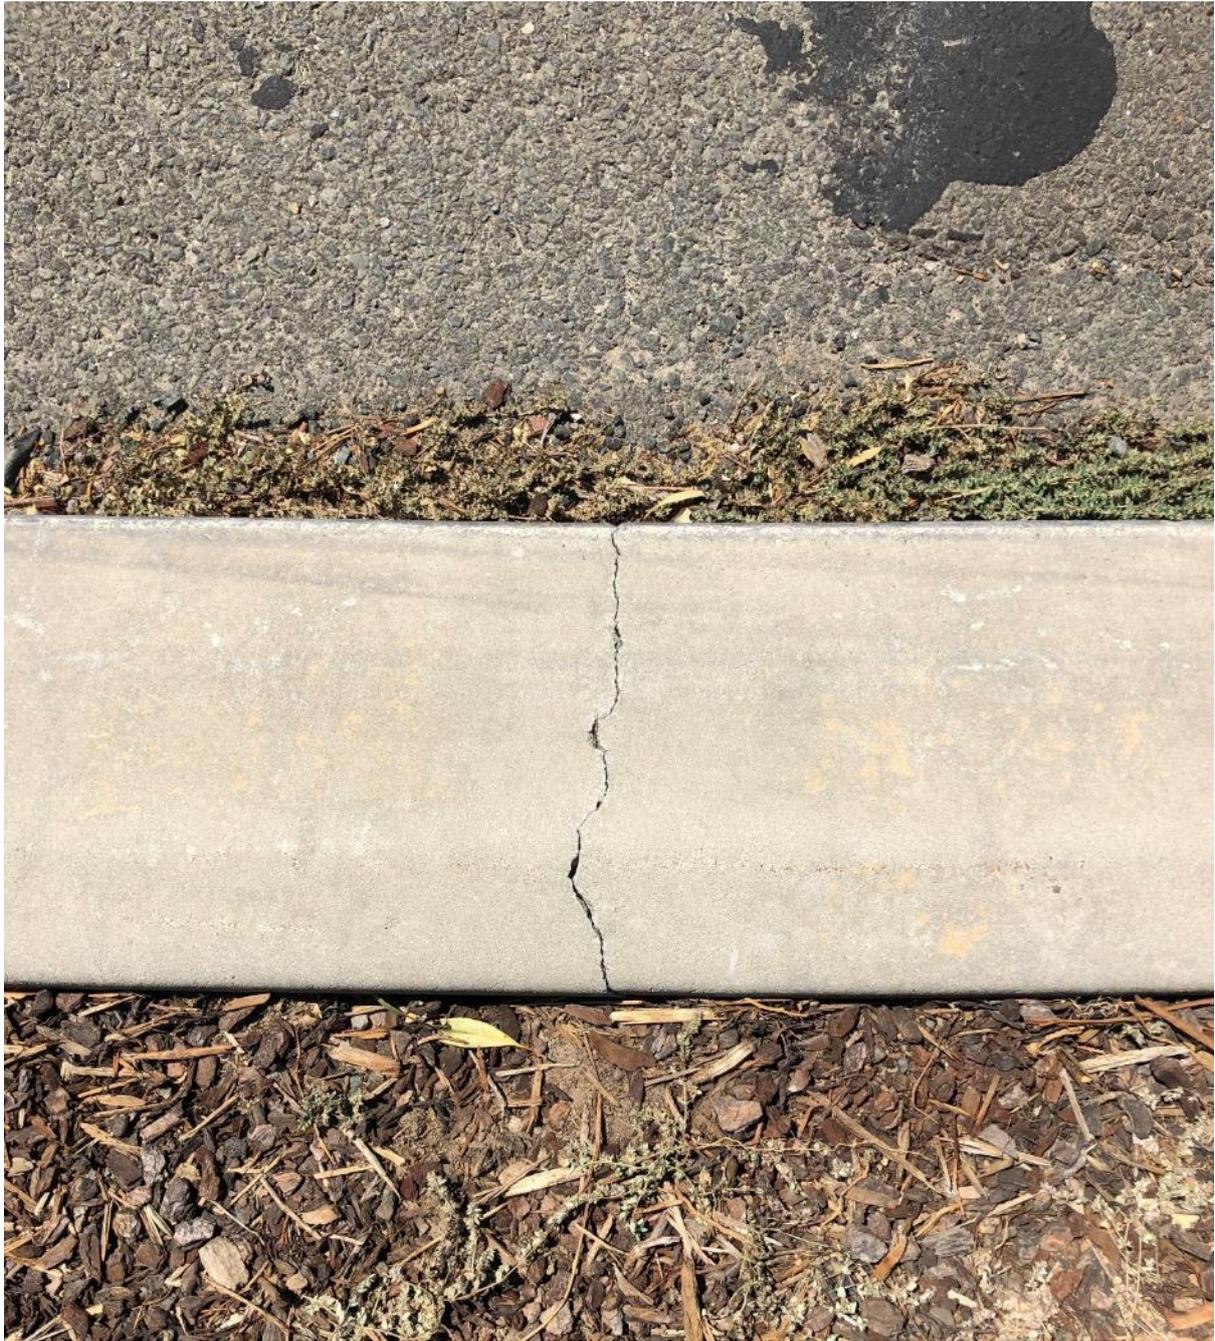
Figure 11: cracking to median strip kerb.

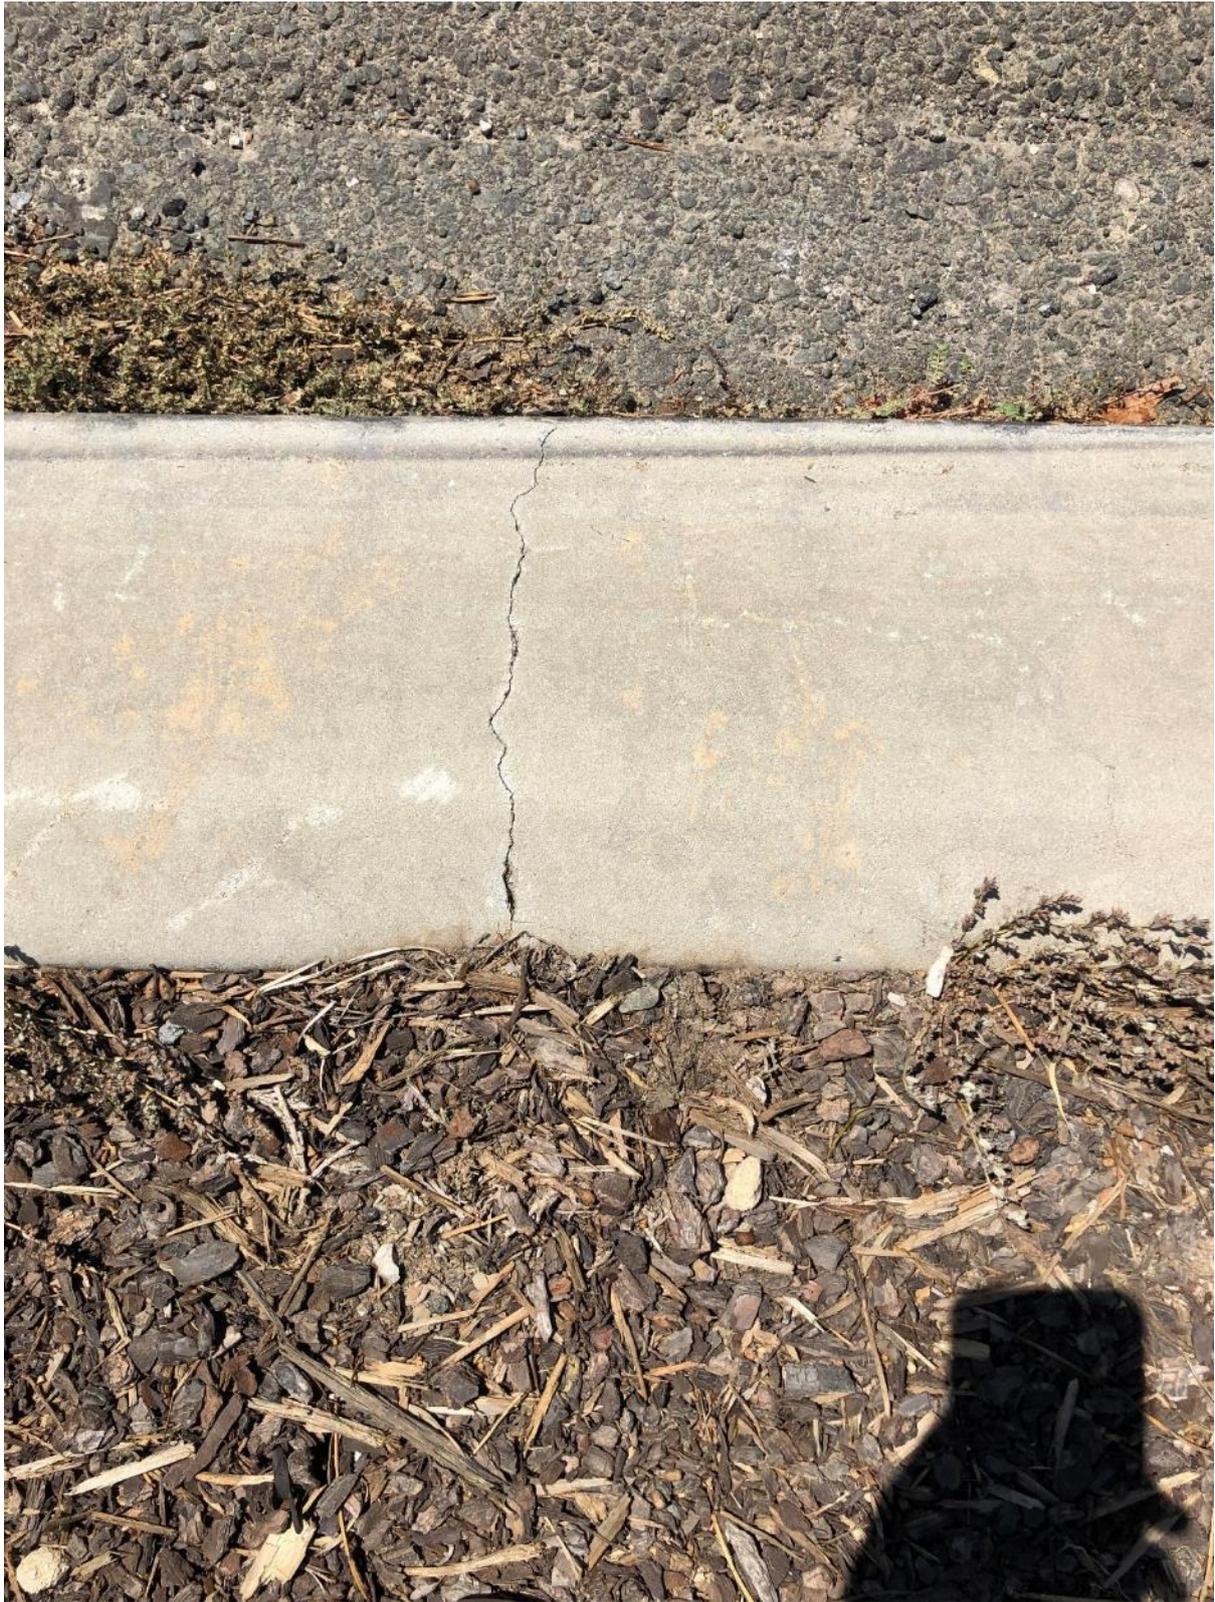
Figure 12: cracking to median strip kerb.

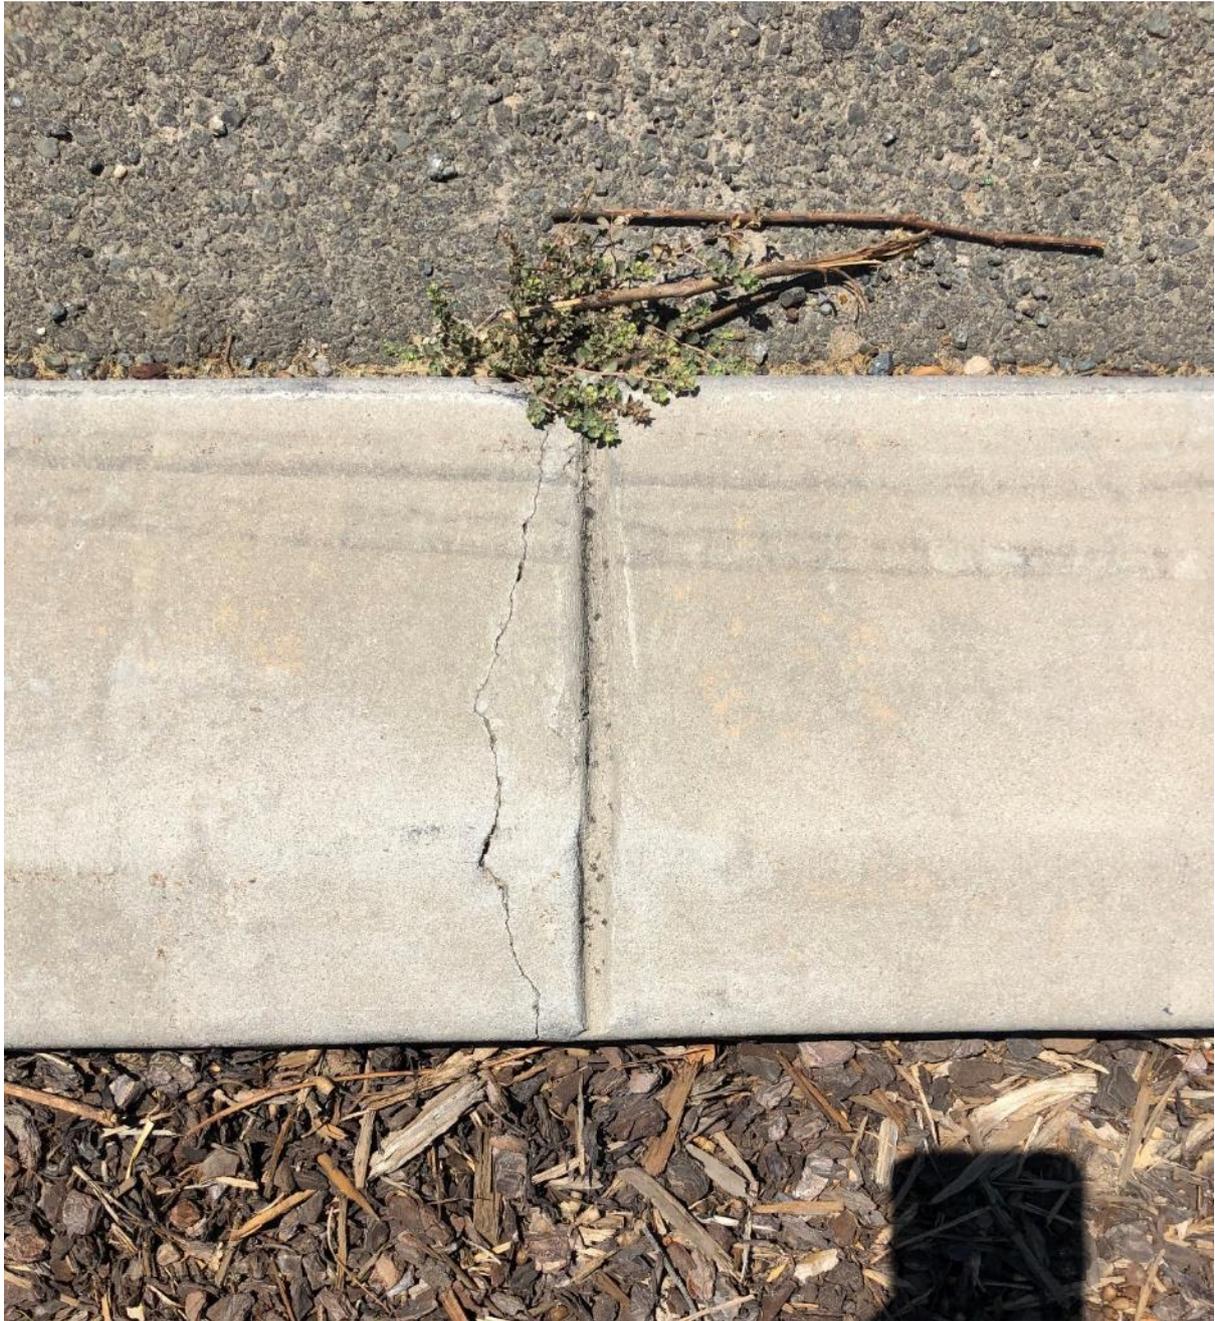
Figure 13: cracking to median strip kerb.

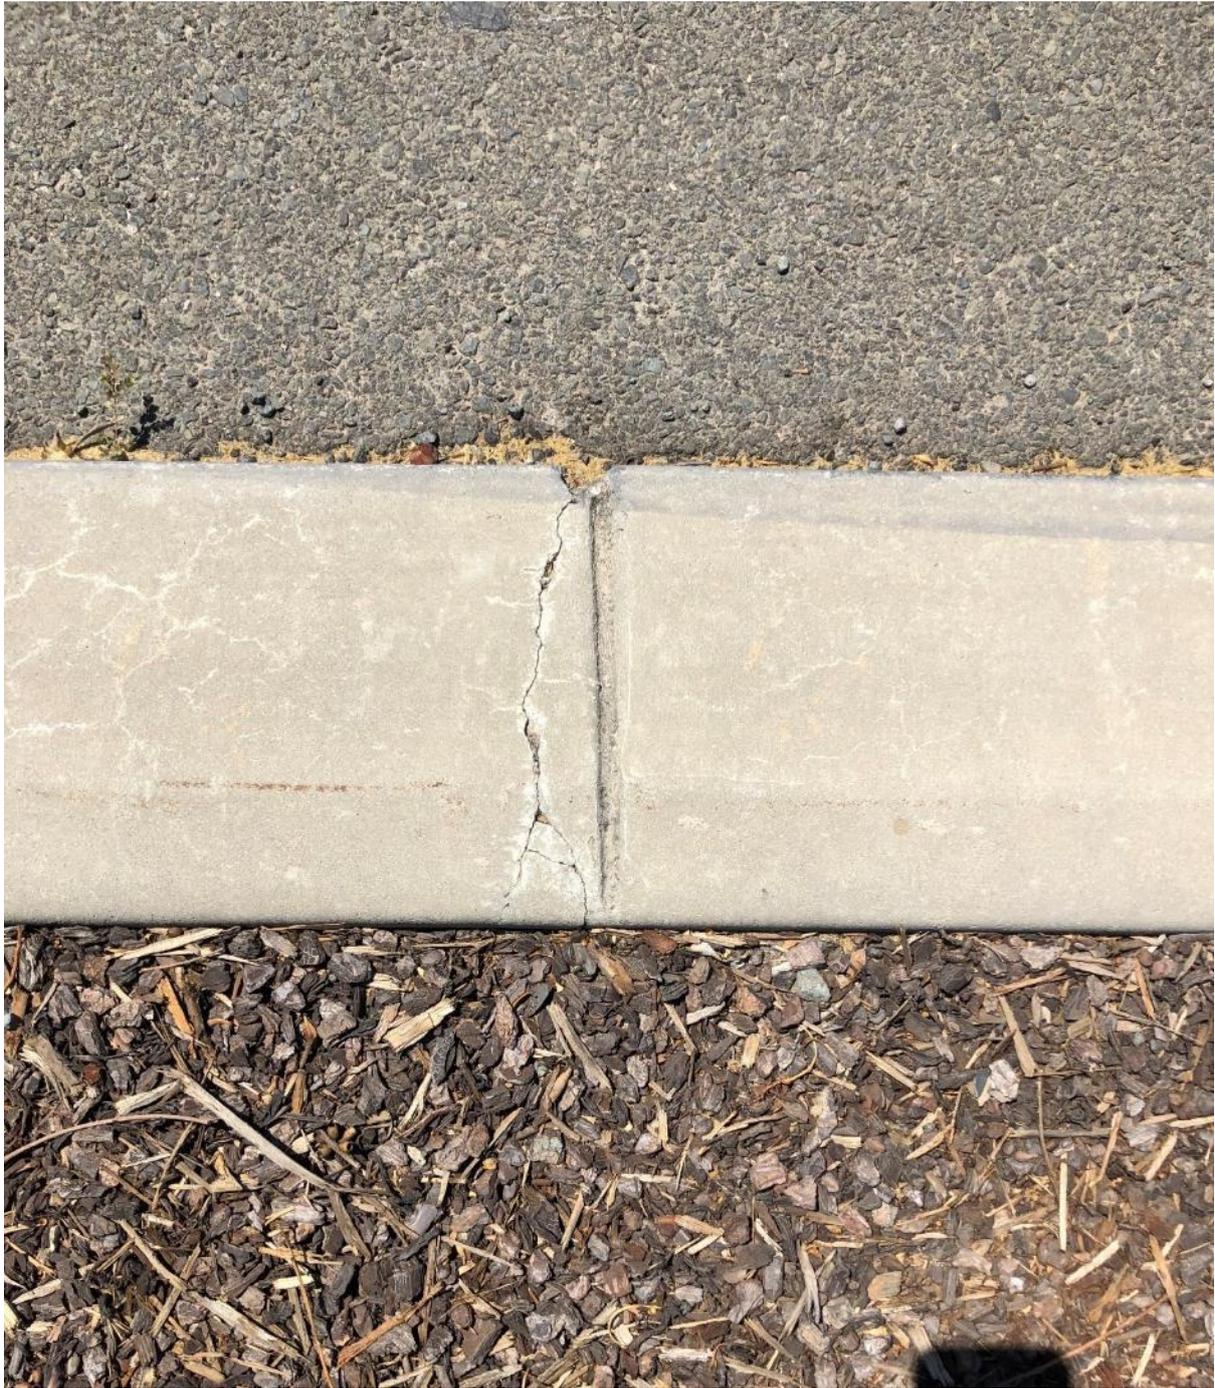
Figure 14: cracking to median strip kerb.
