J K Williams Contracting Pty Ltd

Dilapidation Report

Proposed Works - Jordan Springs Stage 2 Retirement Living

James Sae Siew
5th March 2019
Revision 1

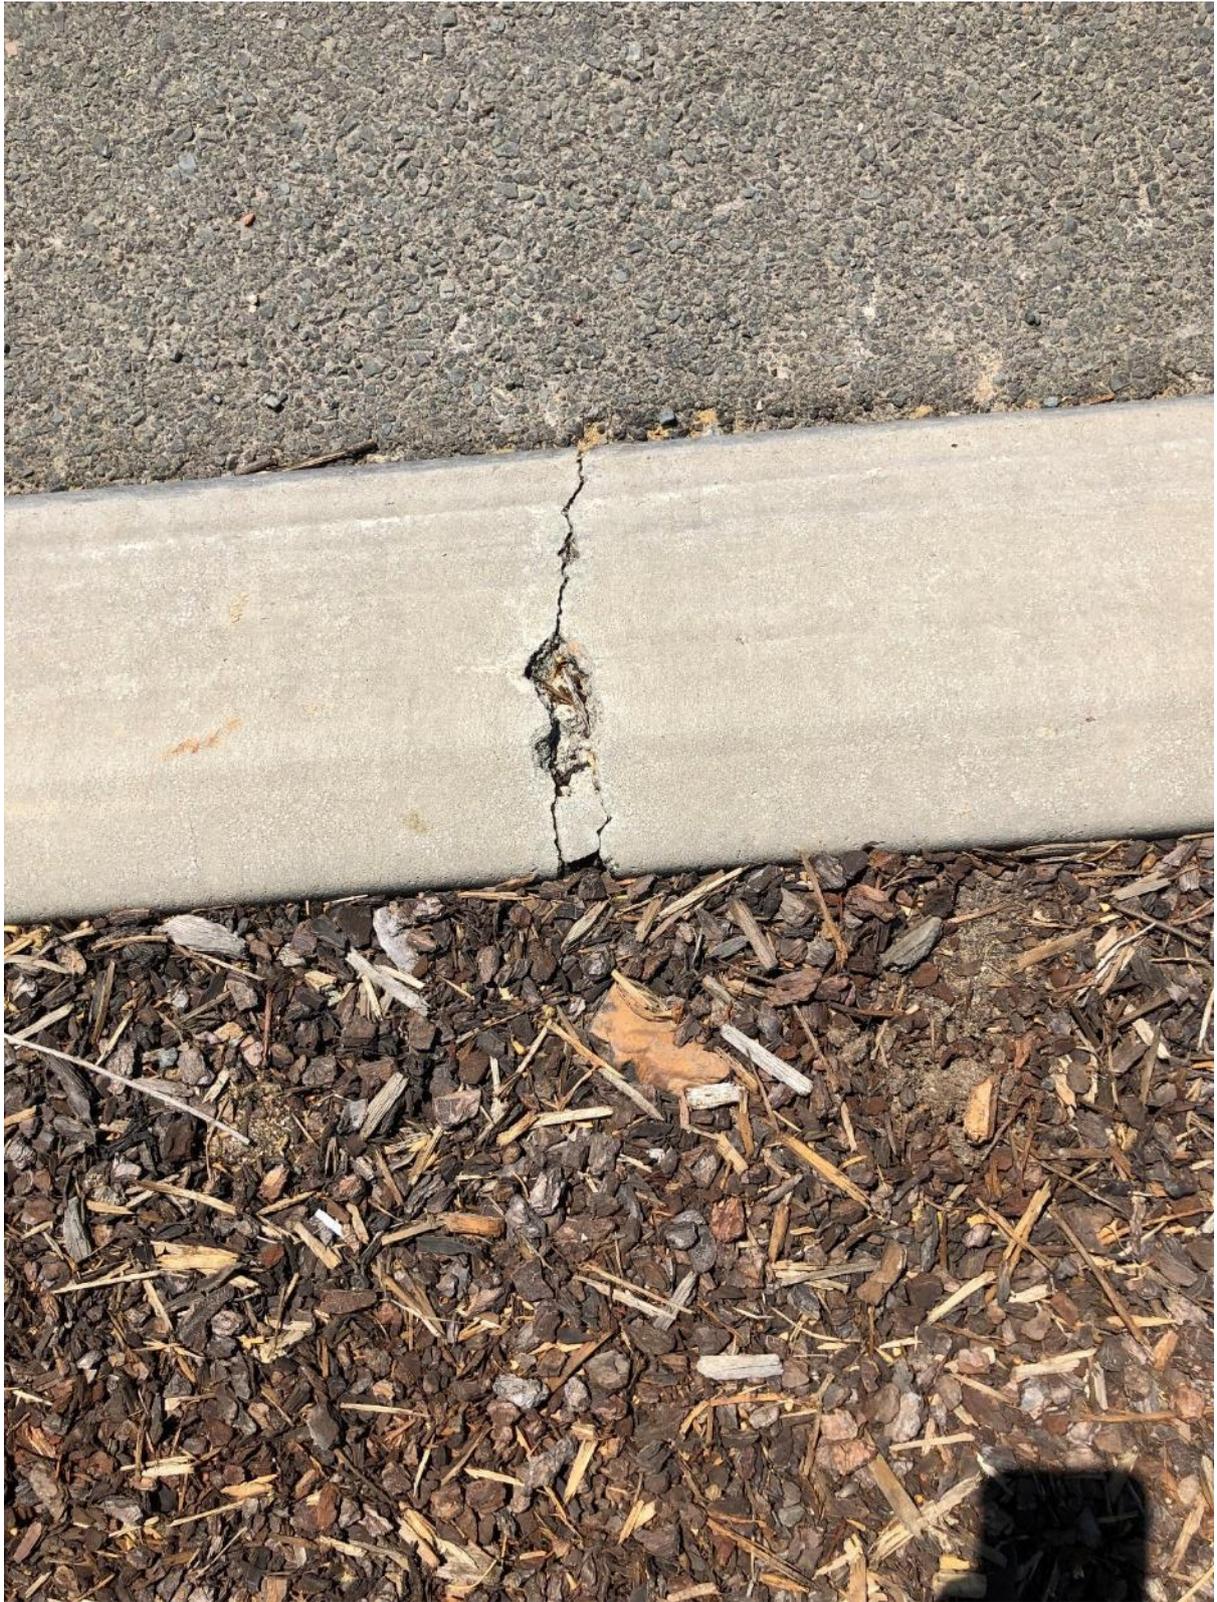
Figure 15: cracking to median strip kerb.

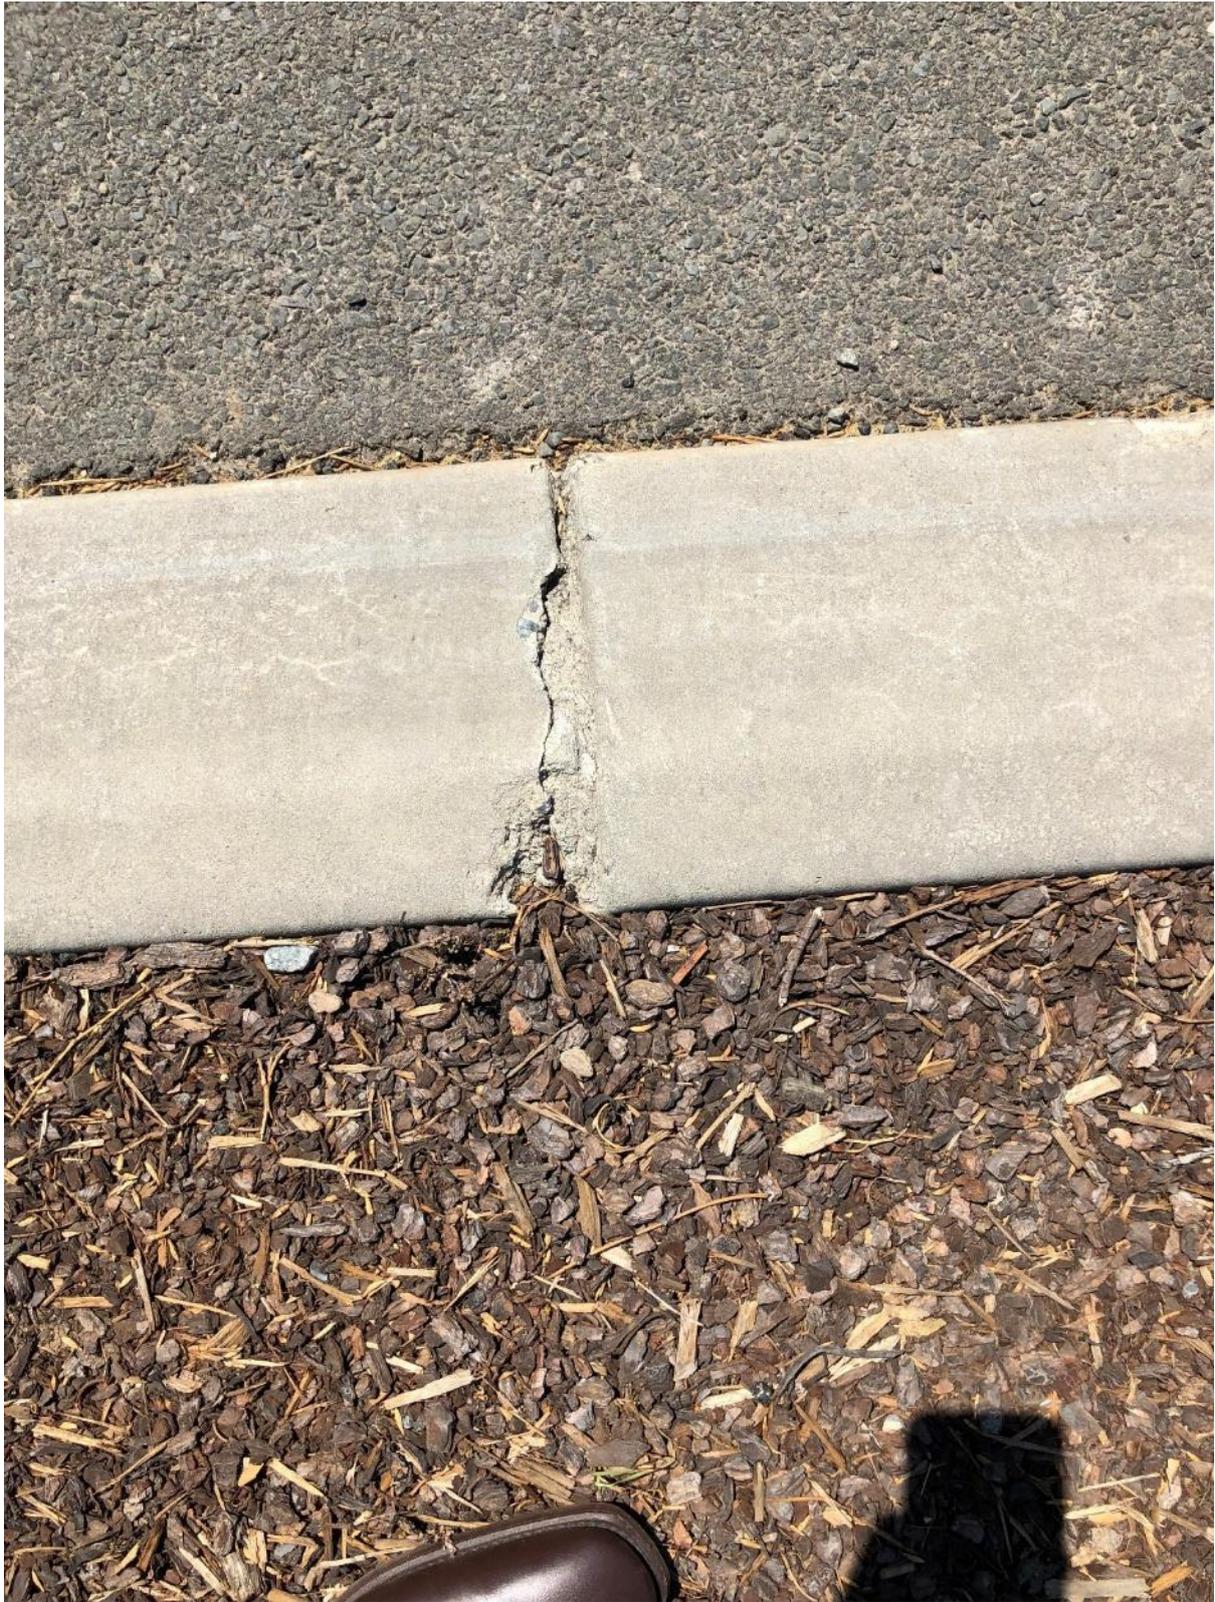
Figure 16: cracking on construction joint interface.

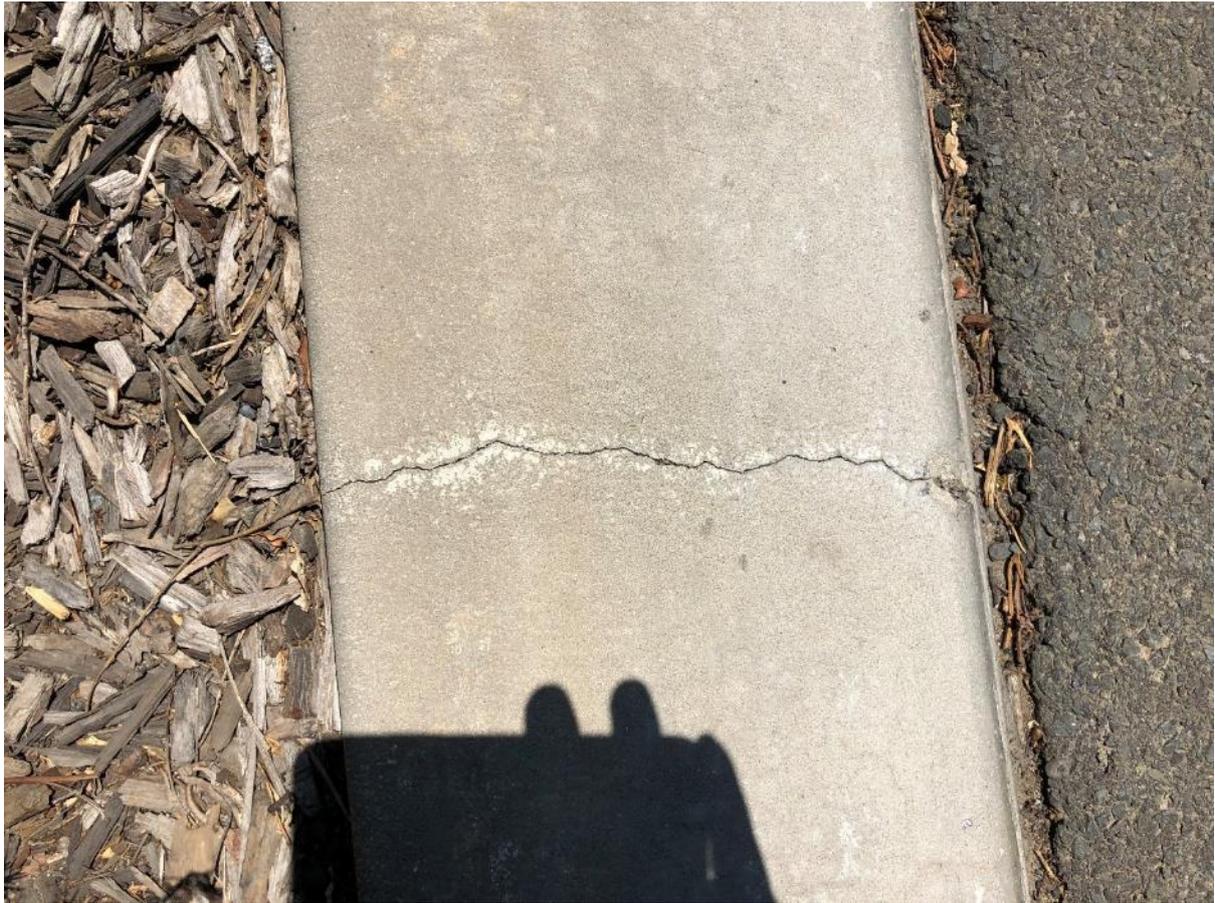
Figure 21: cracking to median strip kerb.

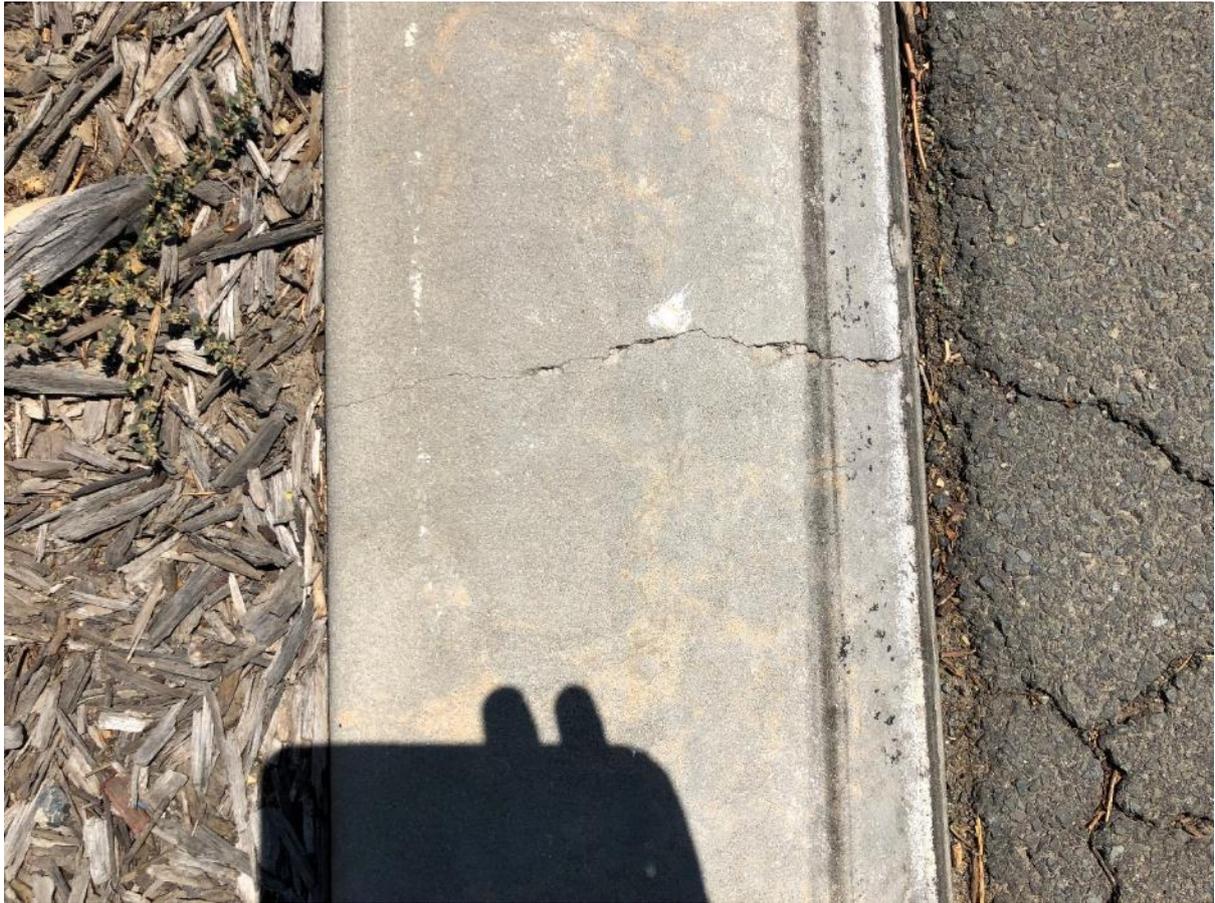
Figure 22: cracking to median strip kerb.

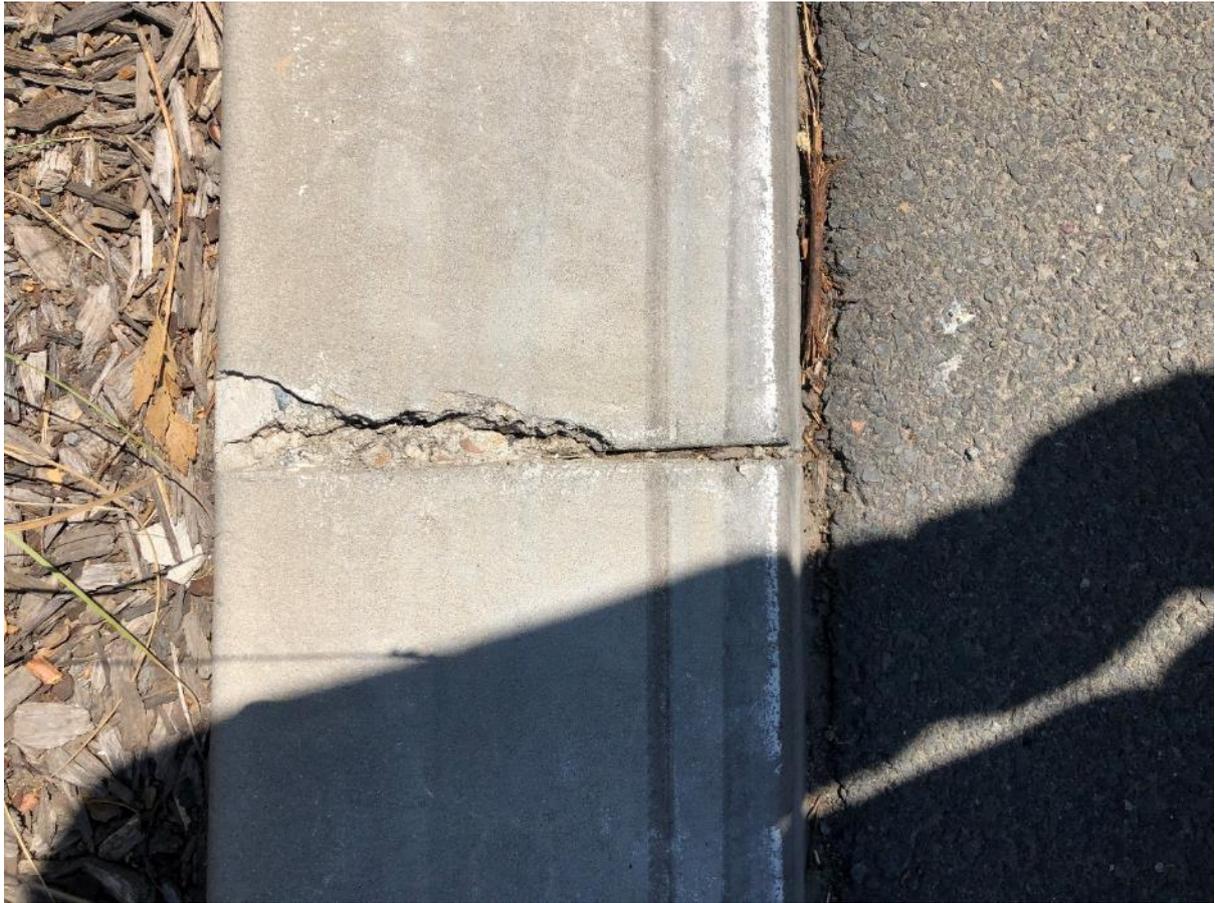
Figure 23: spalling at construction joint interface.

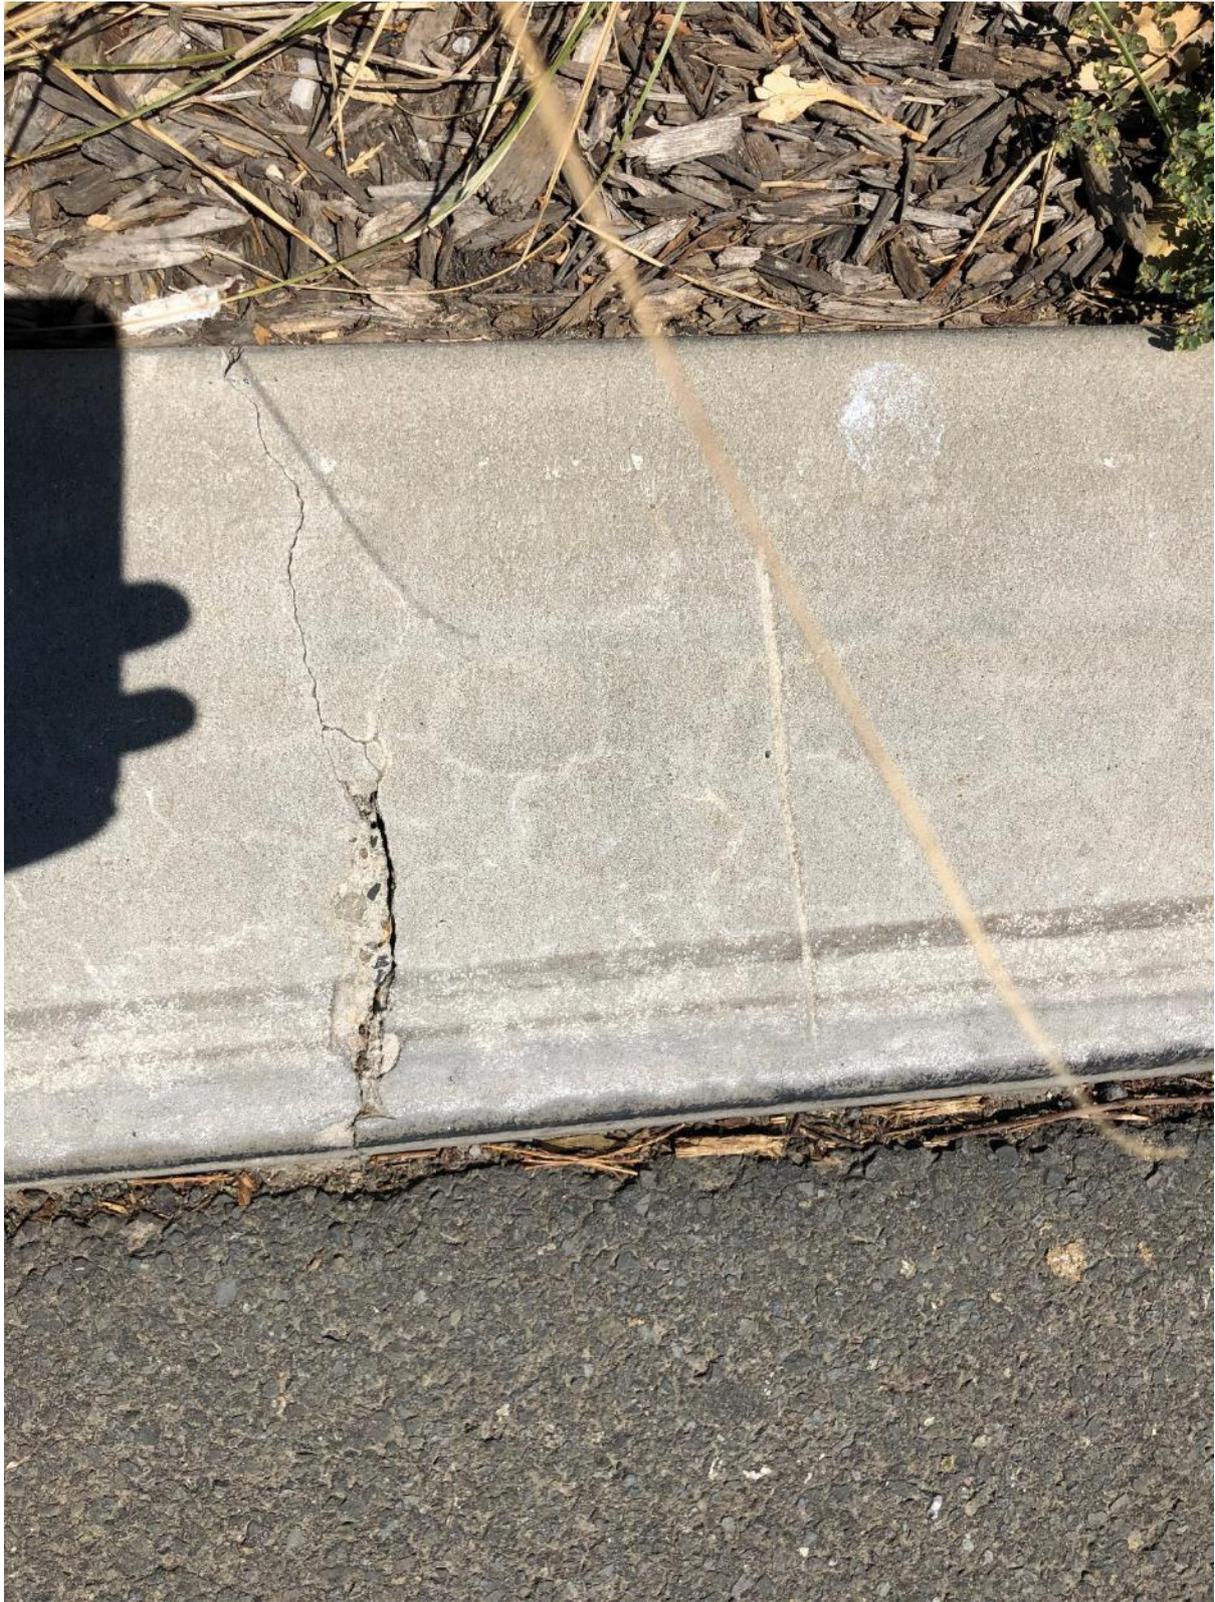
Figure 24: cracking to median strip kerb.

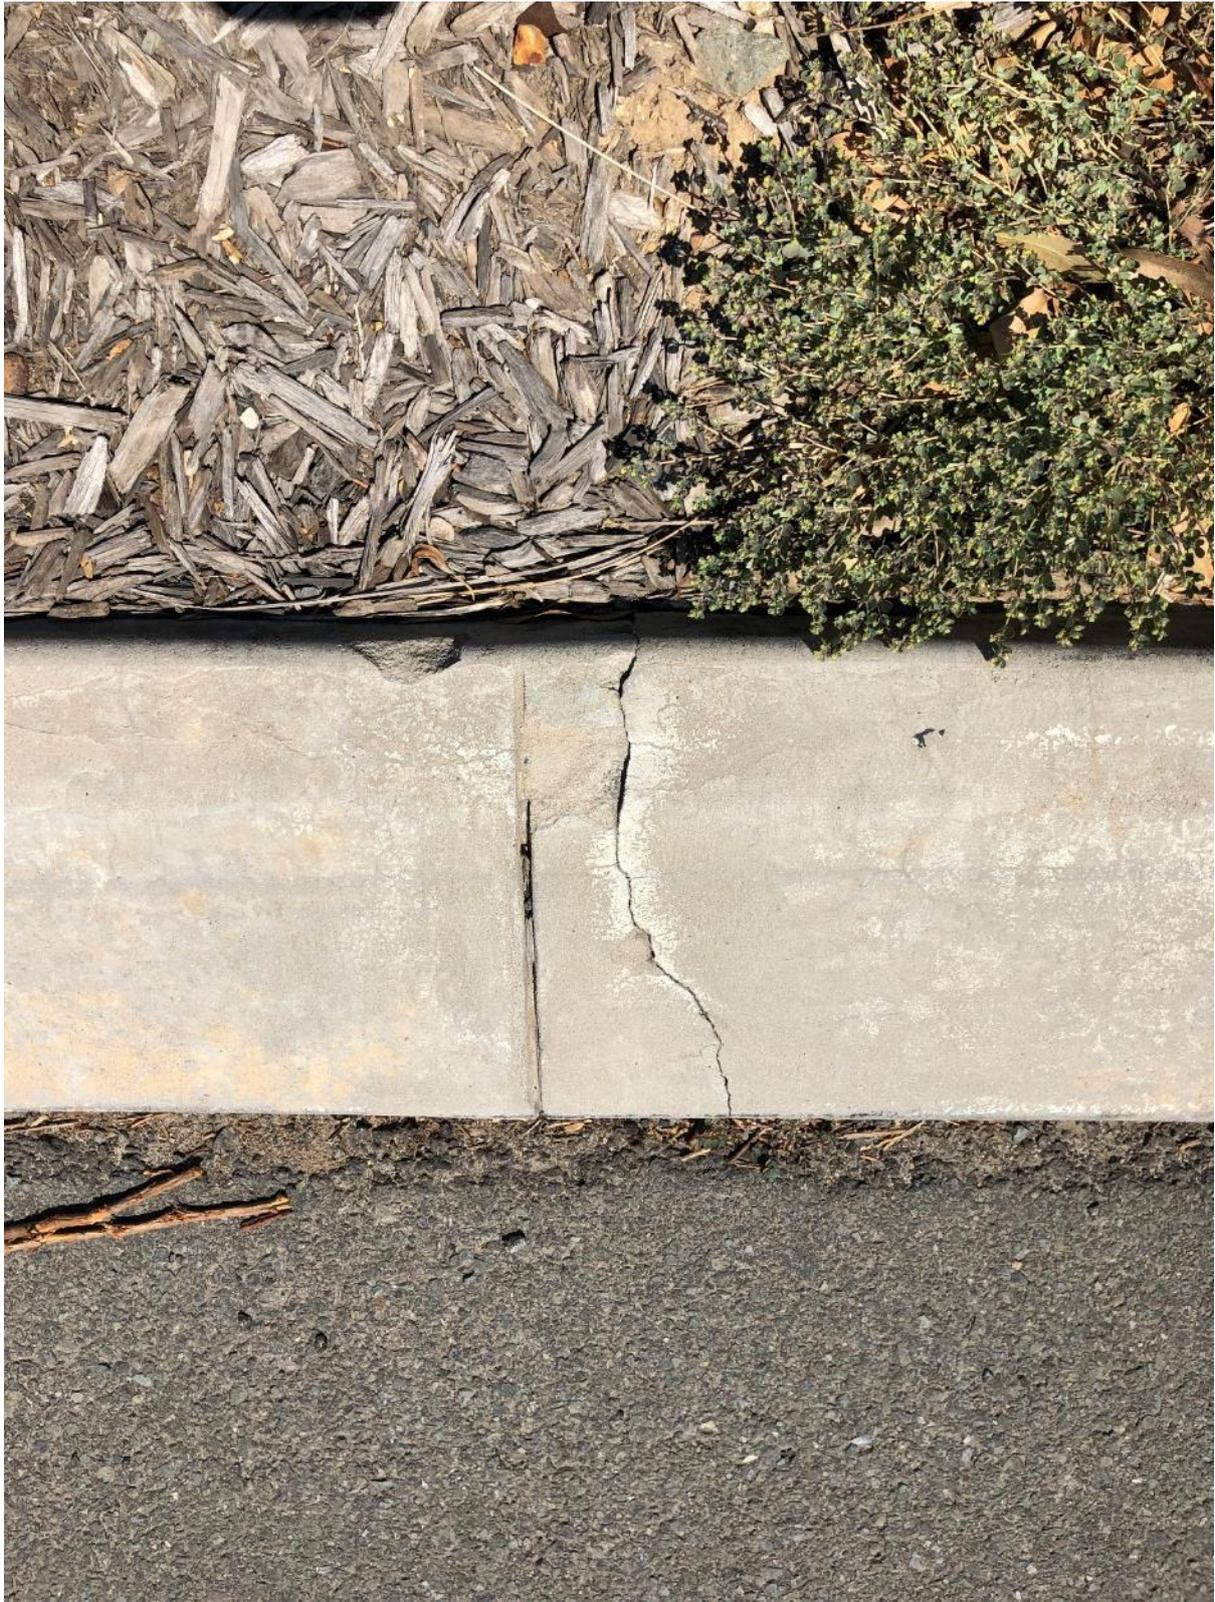
Figure 25: cracking to median strip kerb.

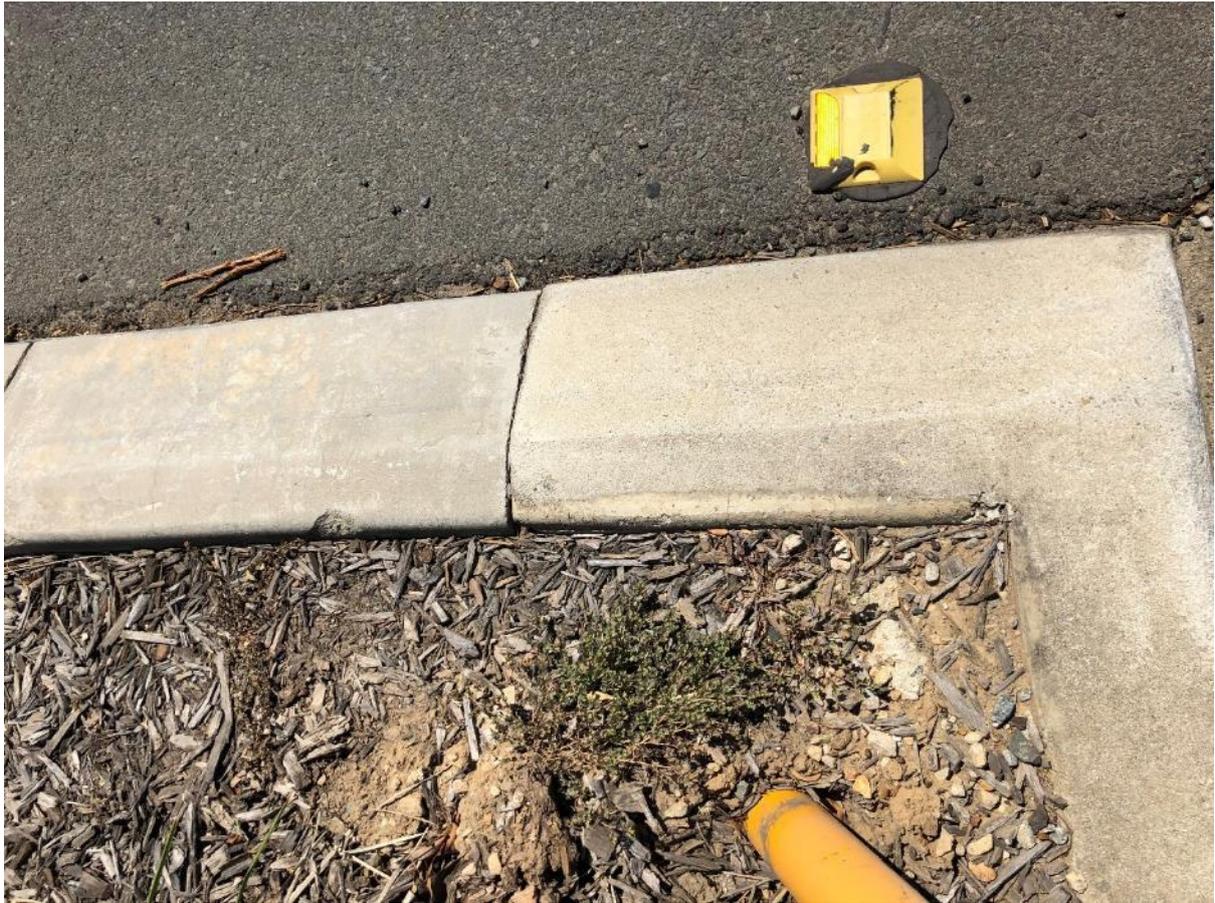
Figure 26: chips to top of median strip kerb.

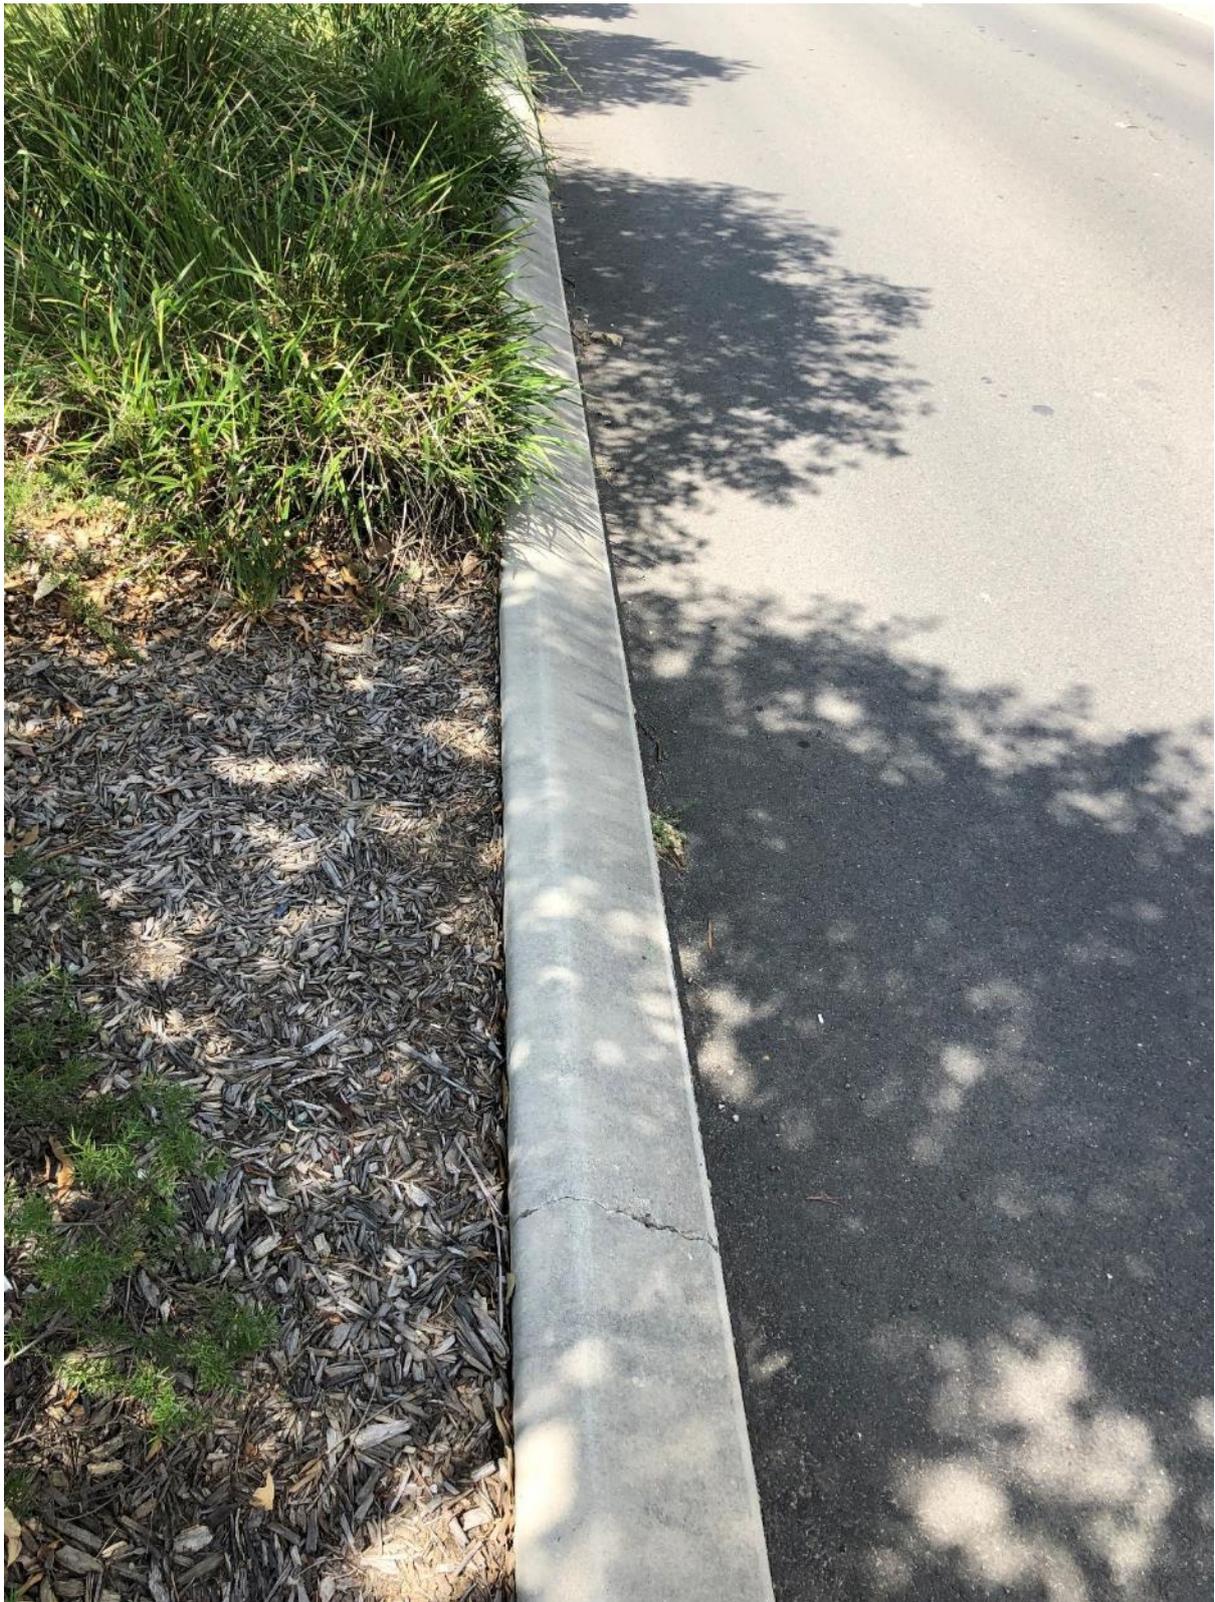
Figure 27: cracking to median strip kerb.

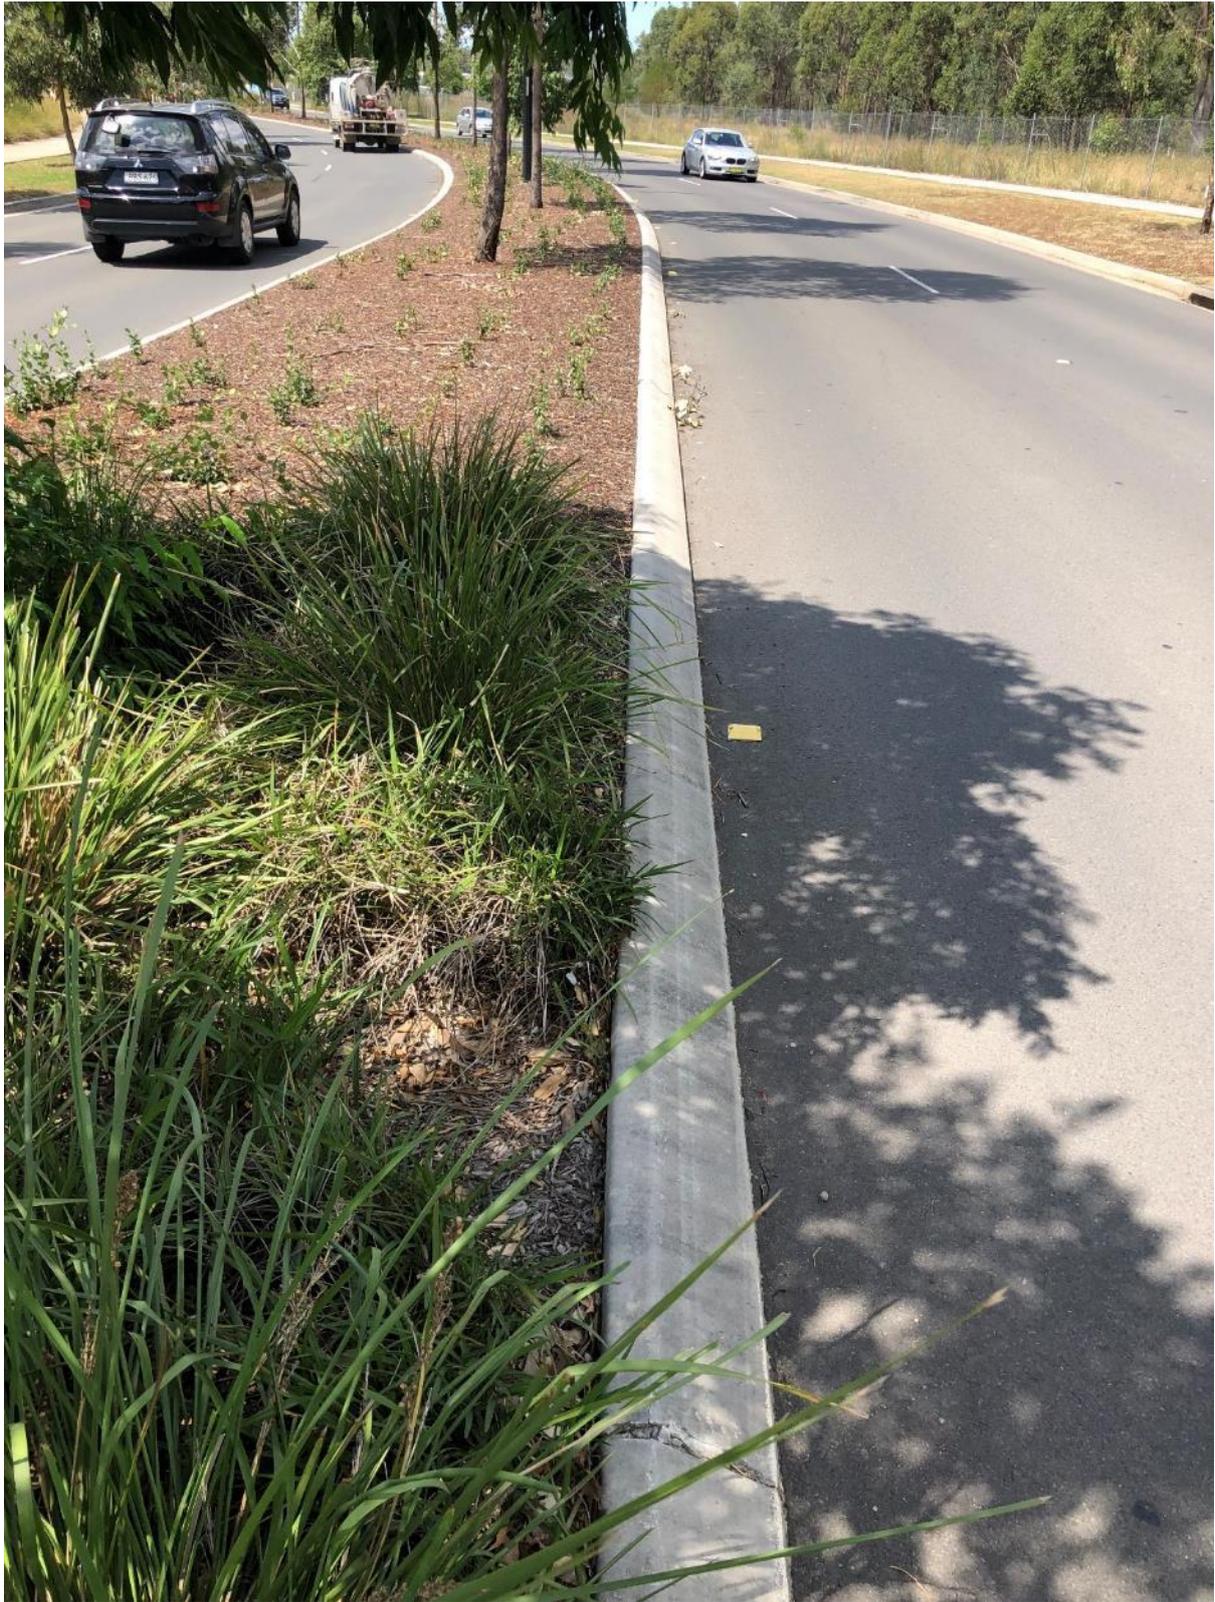
Figure 28: damage at joint interface of median strip kerb.

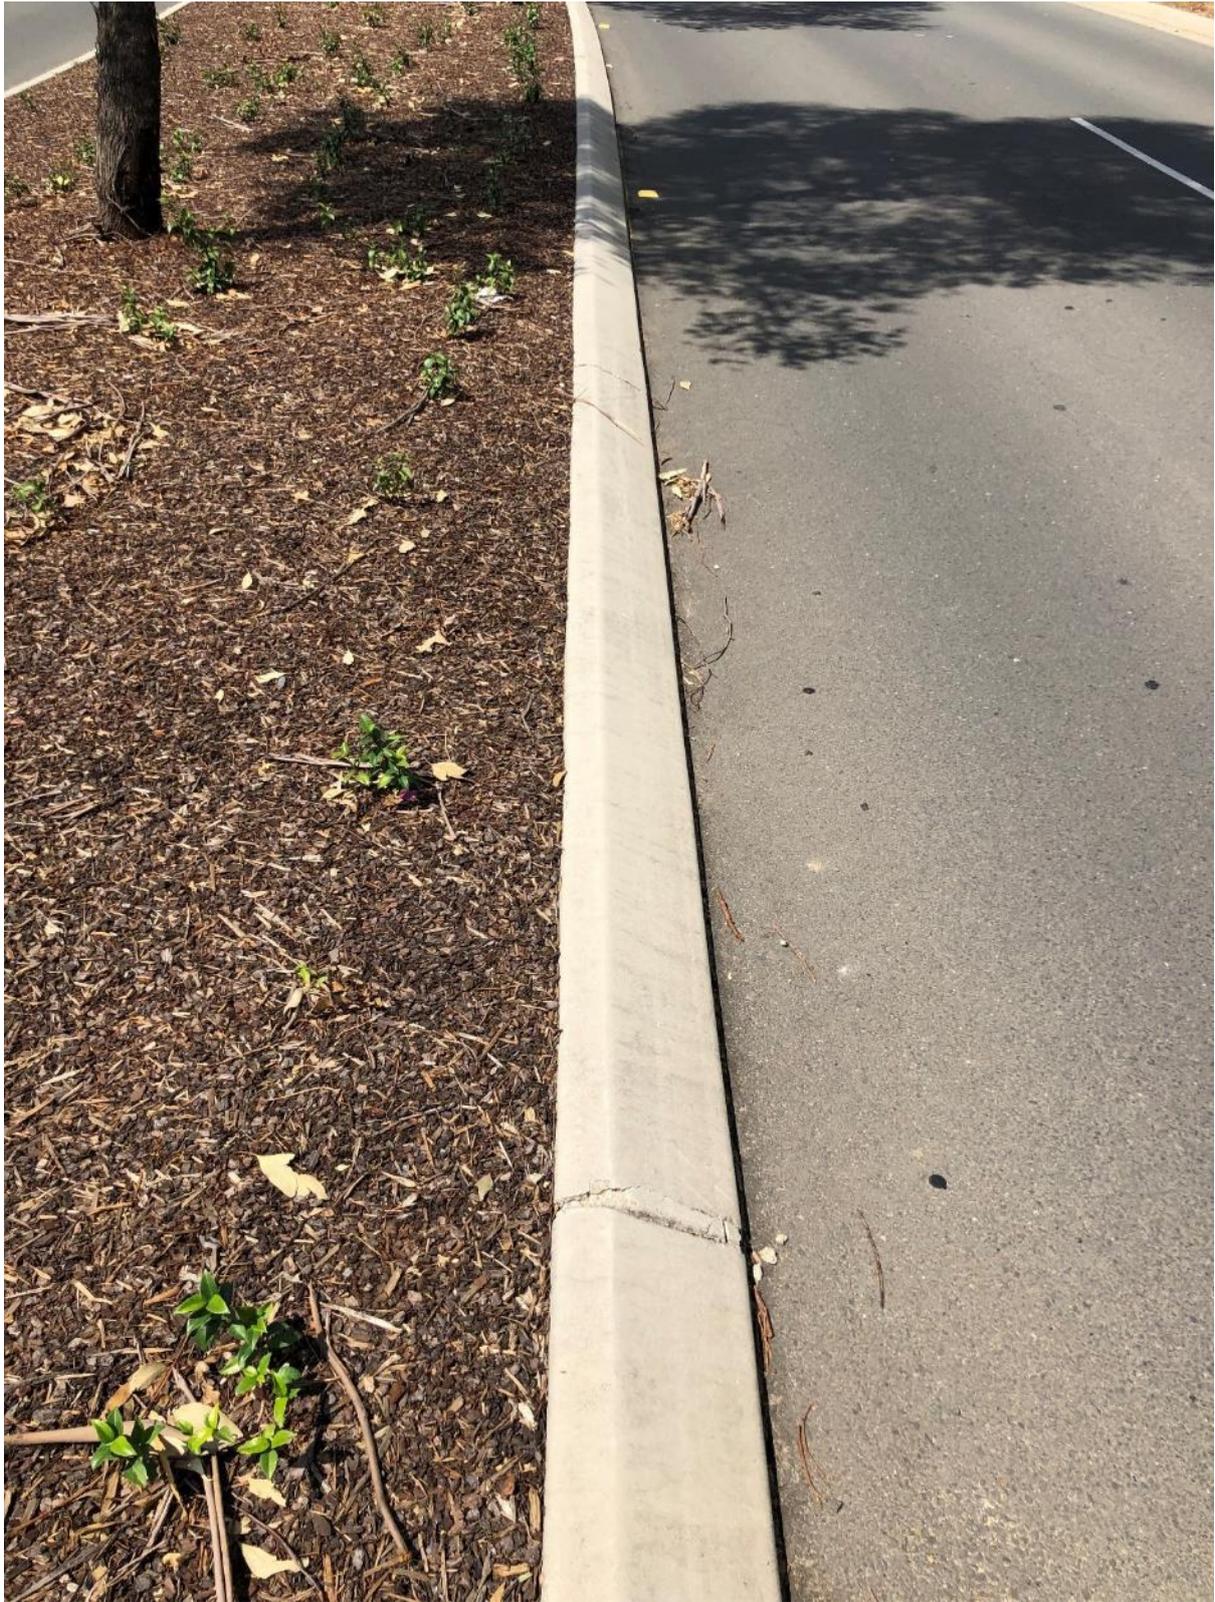
Figure 29: cracking on median strip kerb (adjacent to construction joint).

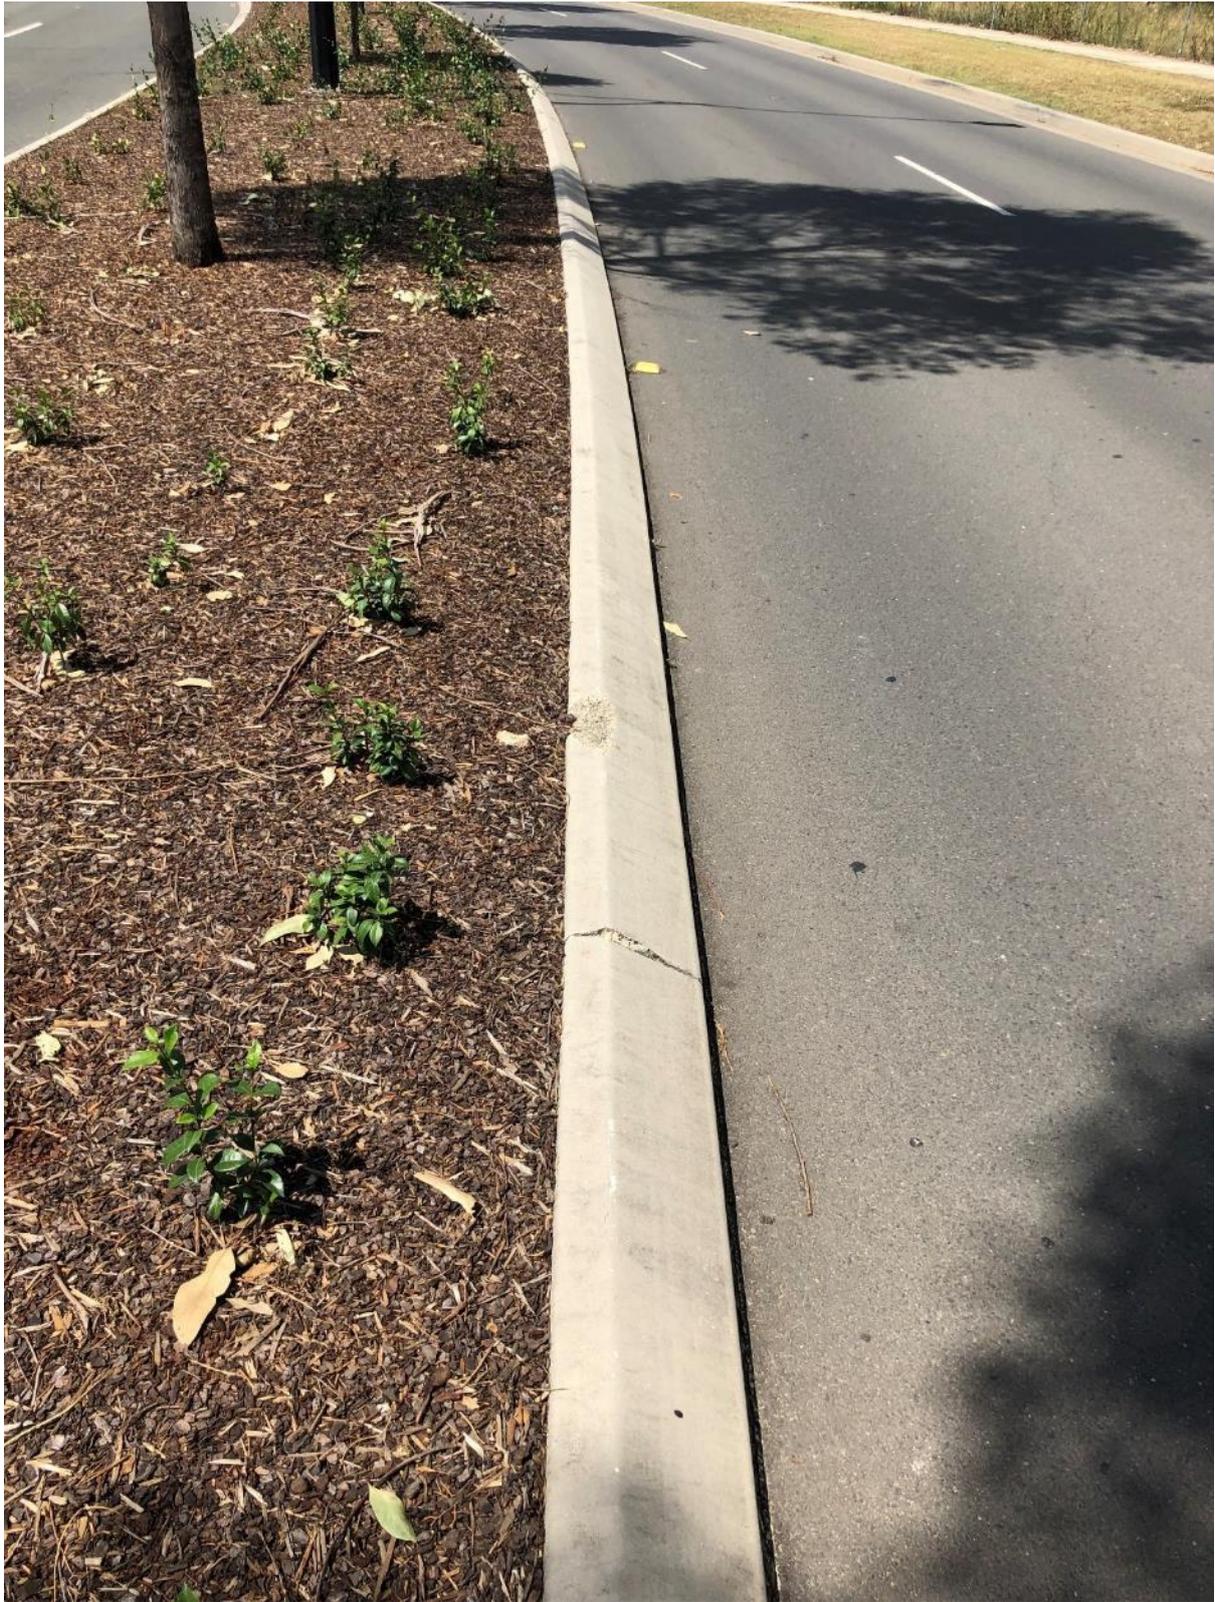
Figure 30: damage on construction joint interface.

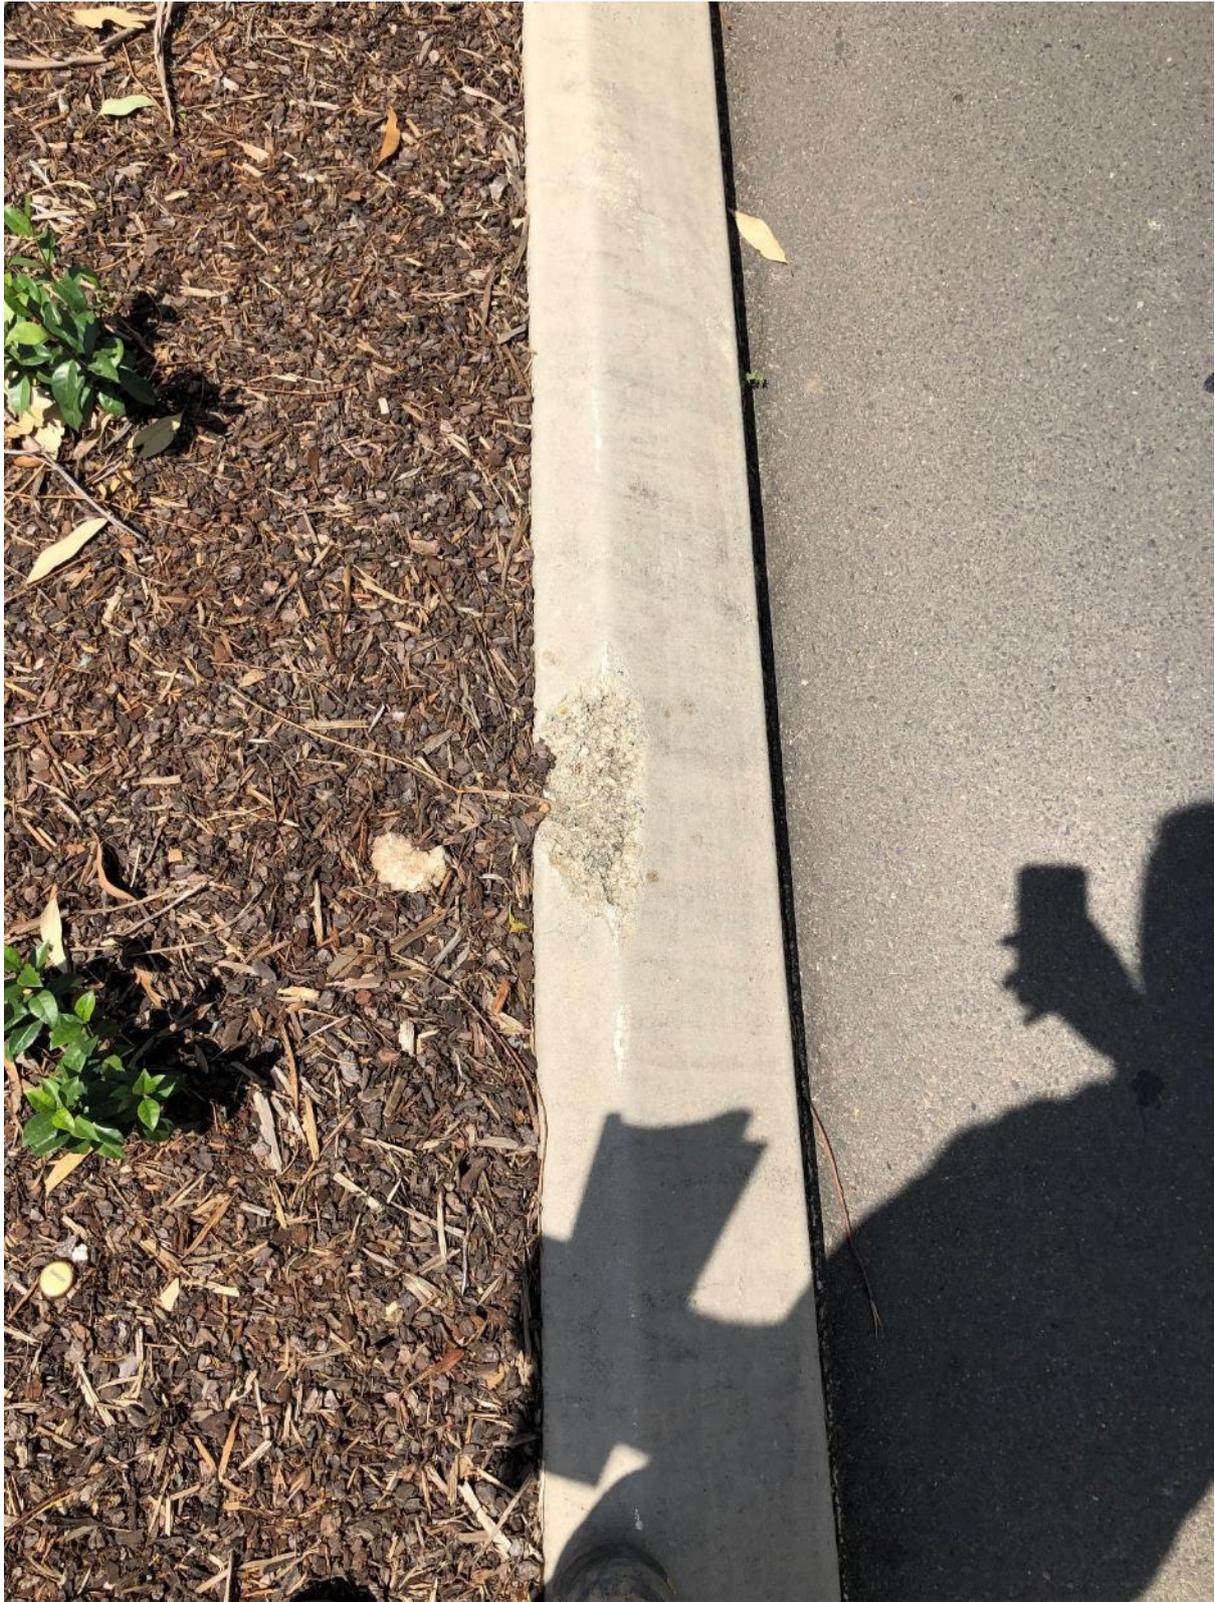
Figure 31: chip on top of median strip kerb.
