J K Williams Contracting Pty Ltd

Dilapidation Report

Proposed Works - Jordan Springs Stage 2 Retirement Living

James Sae Siew
5th March 2019
Revision 1

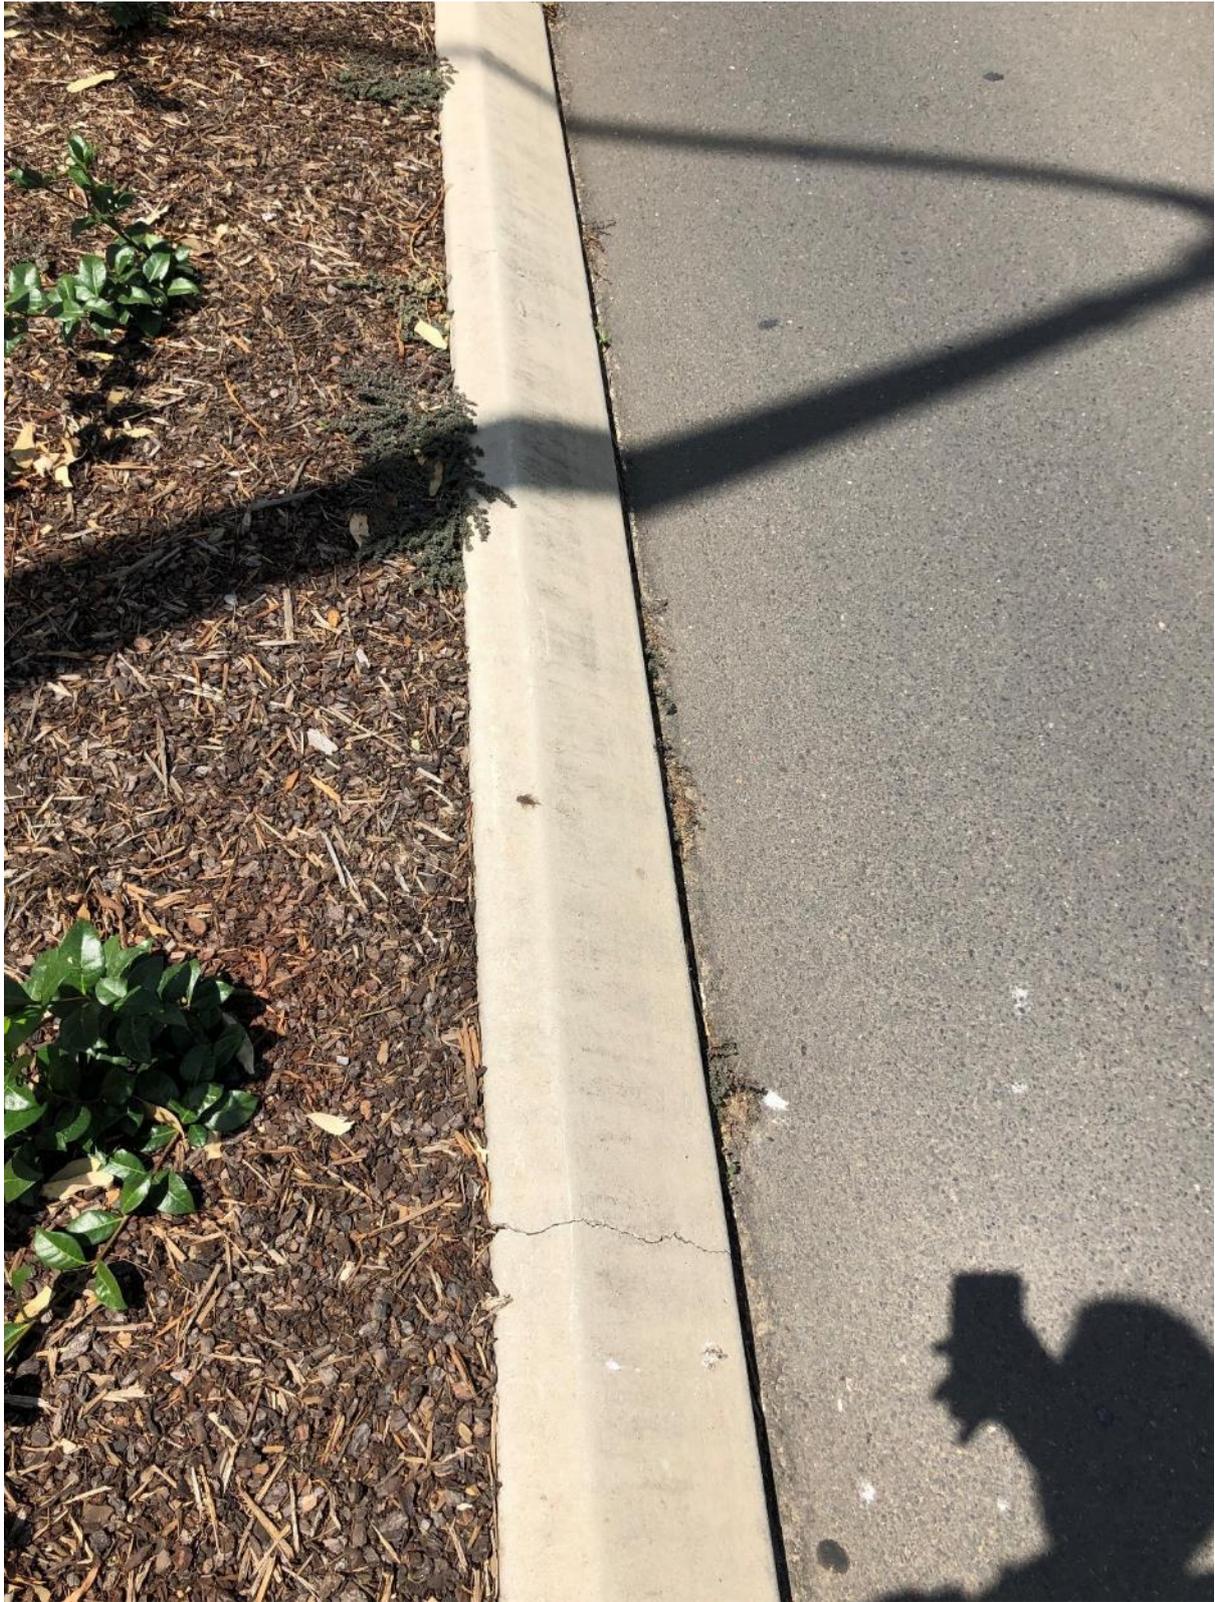
Figure 32: cracking to median strip kerb.

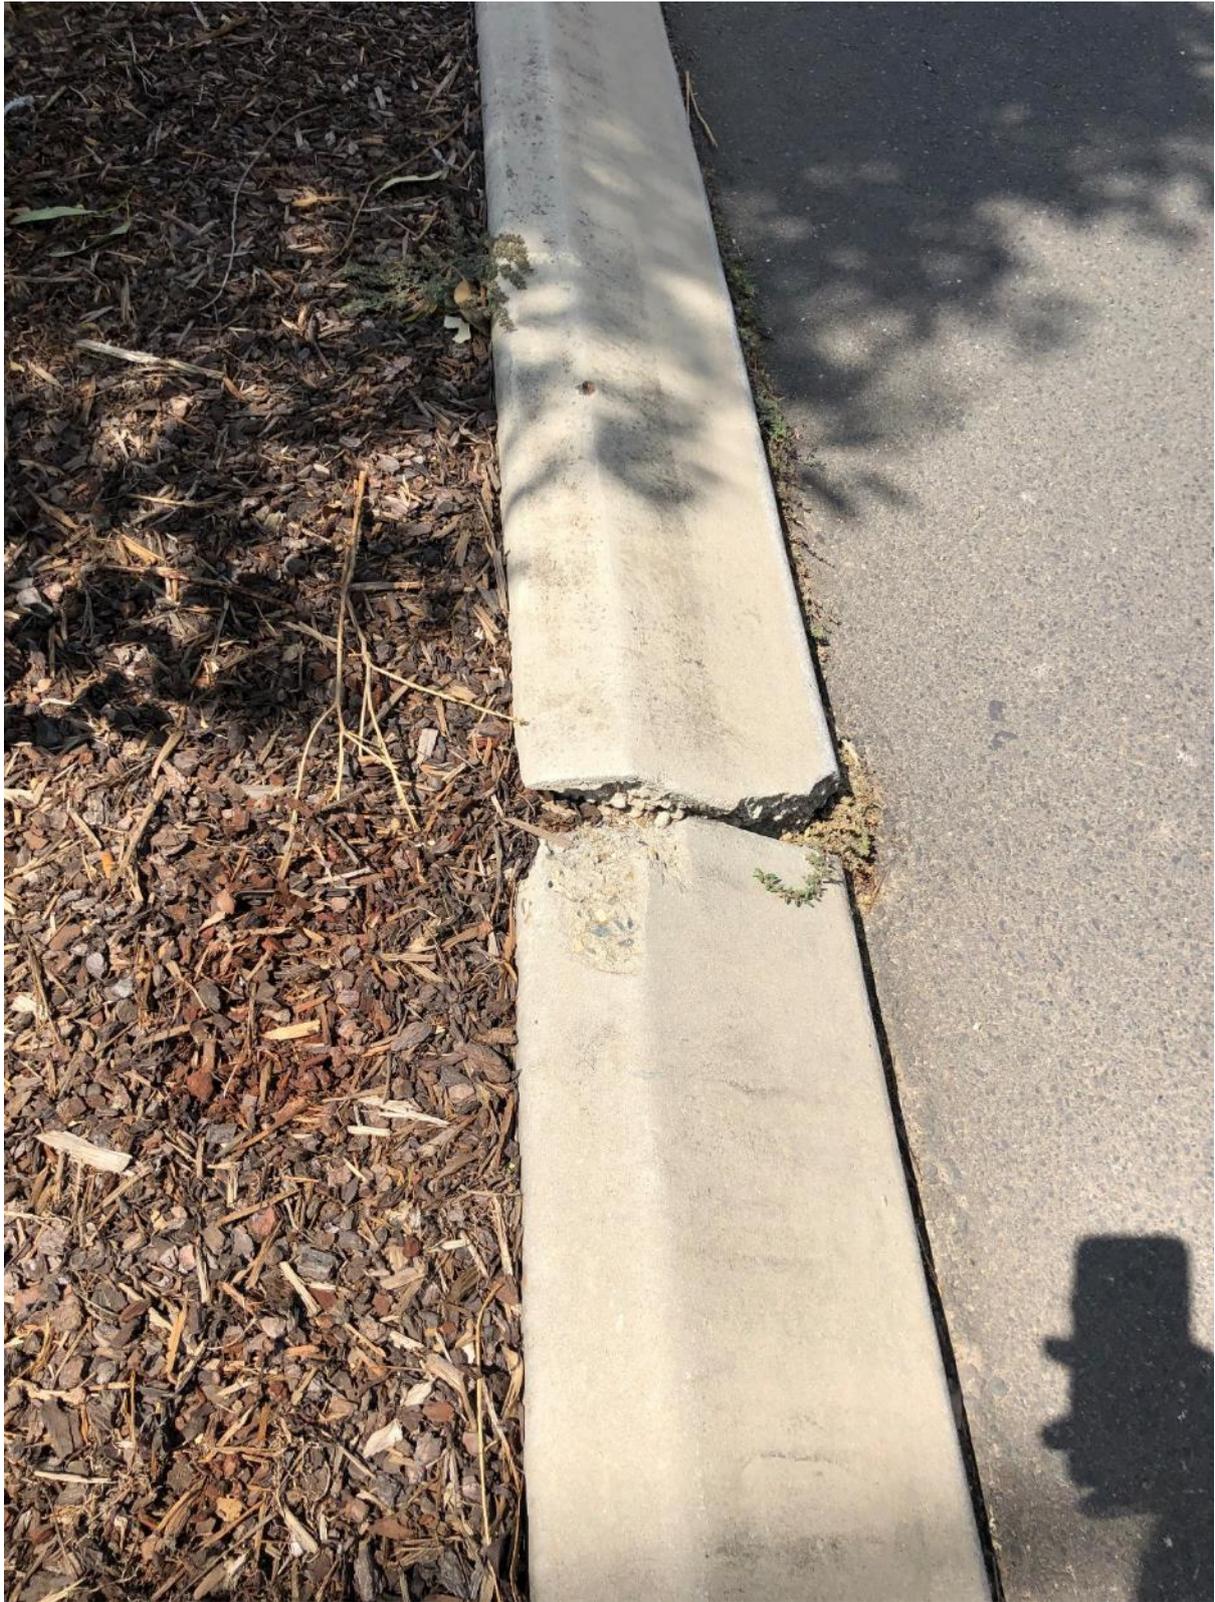
Figure 33: separation at construction joint interface.

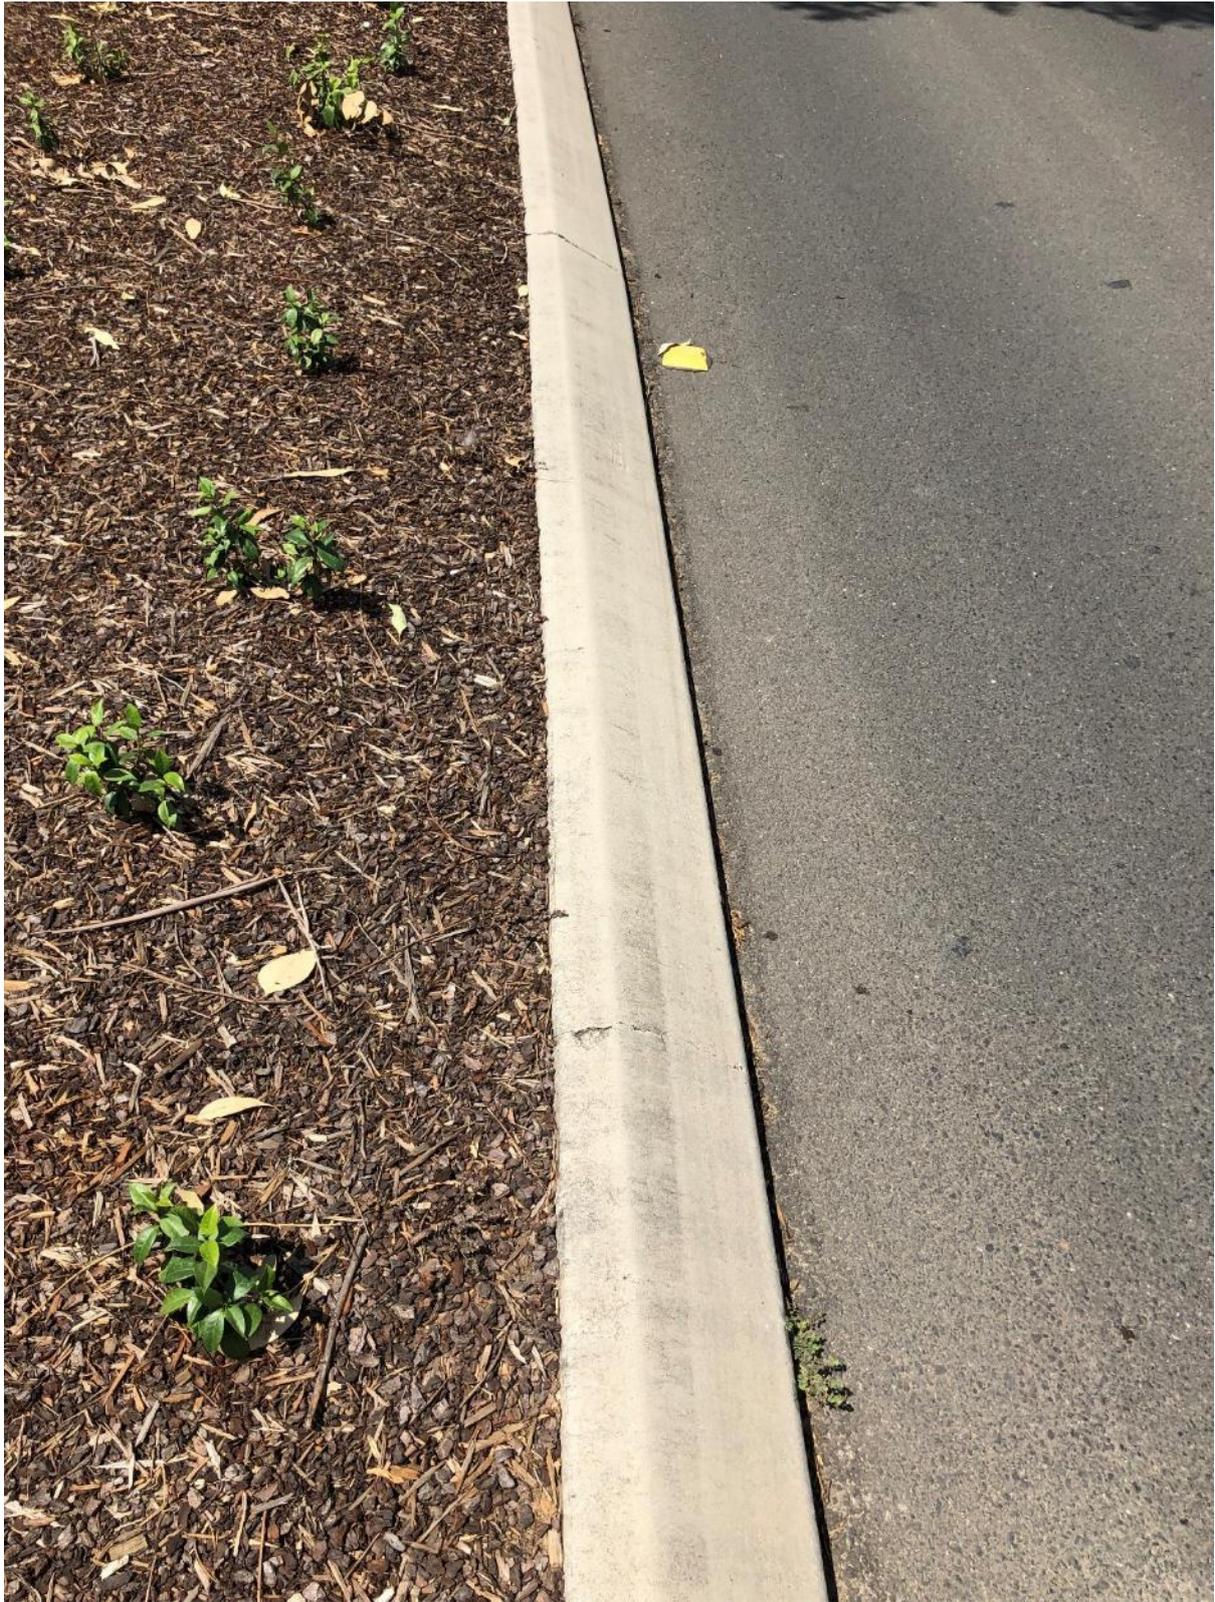
Figure 34: cracking to median strip kerb.

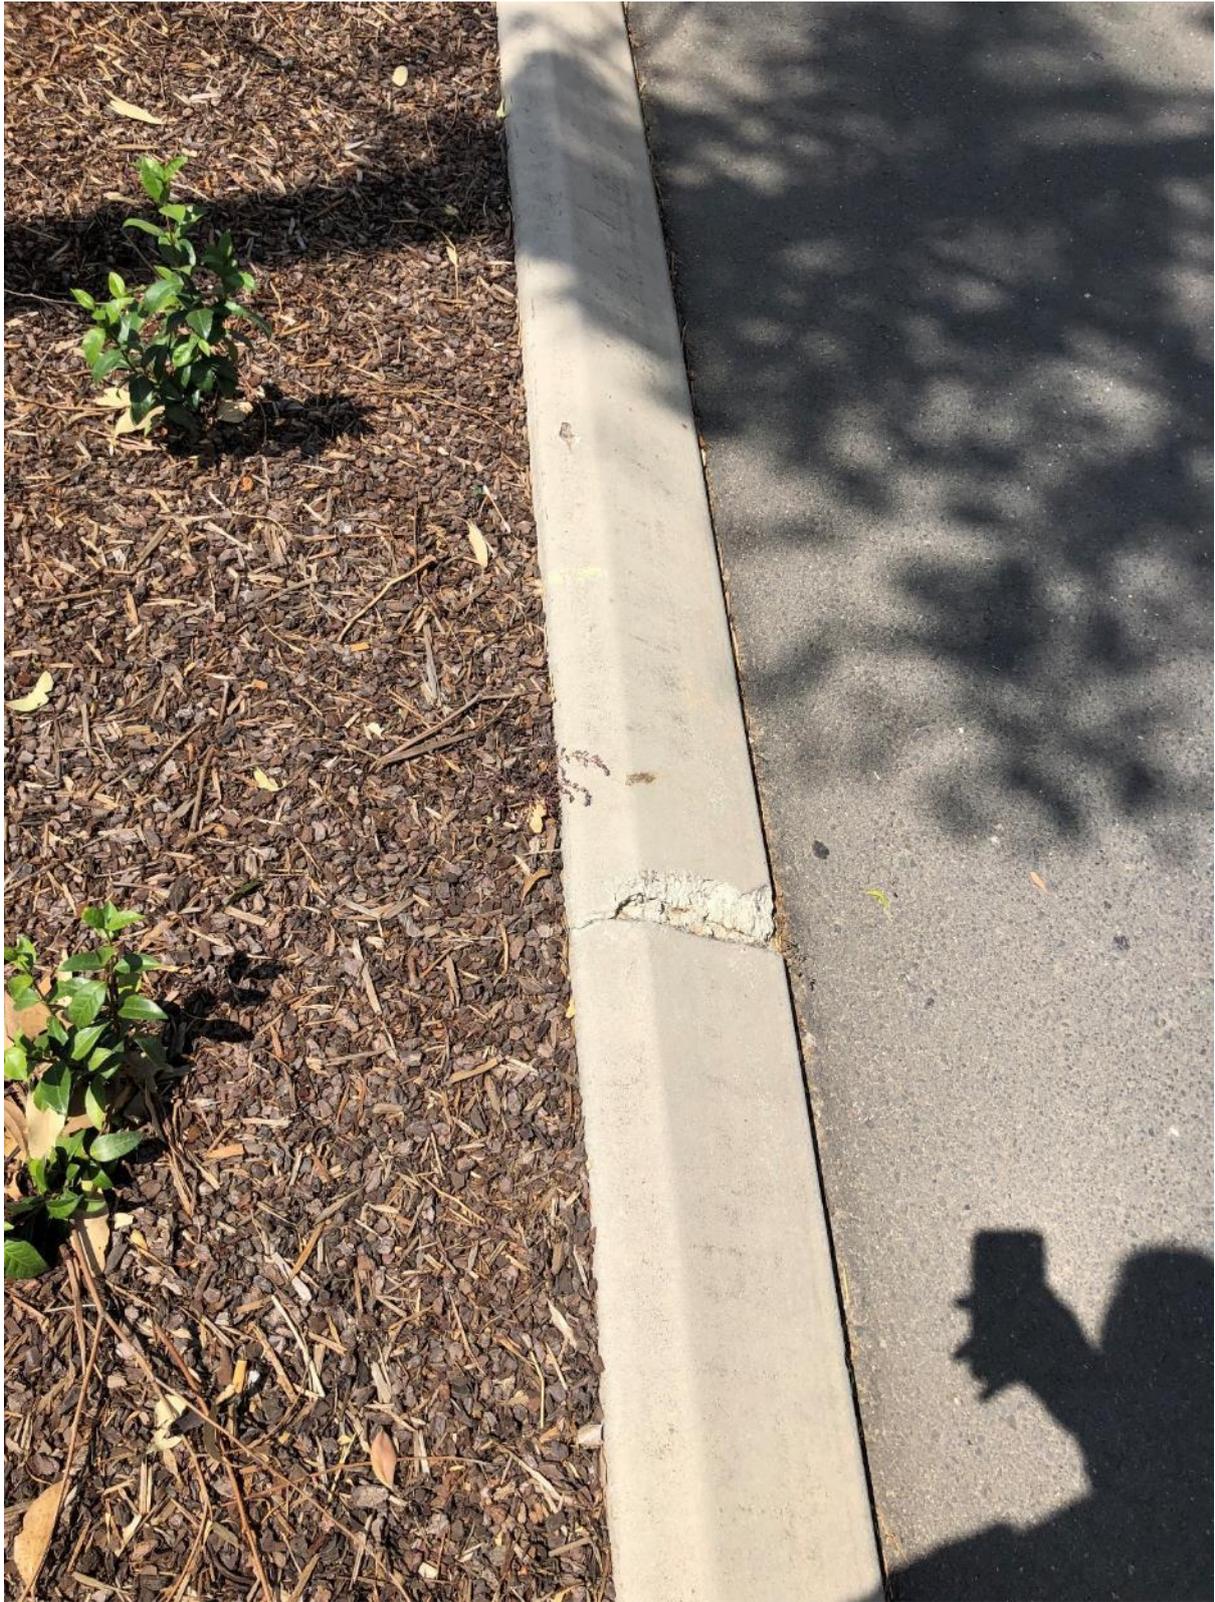
Figure 35: damage on construction joint interface.

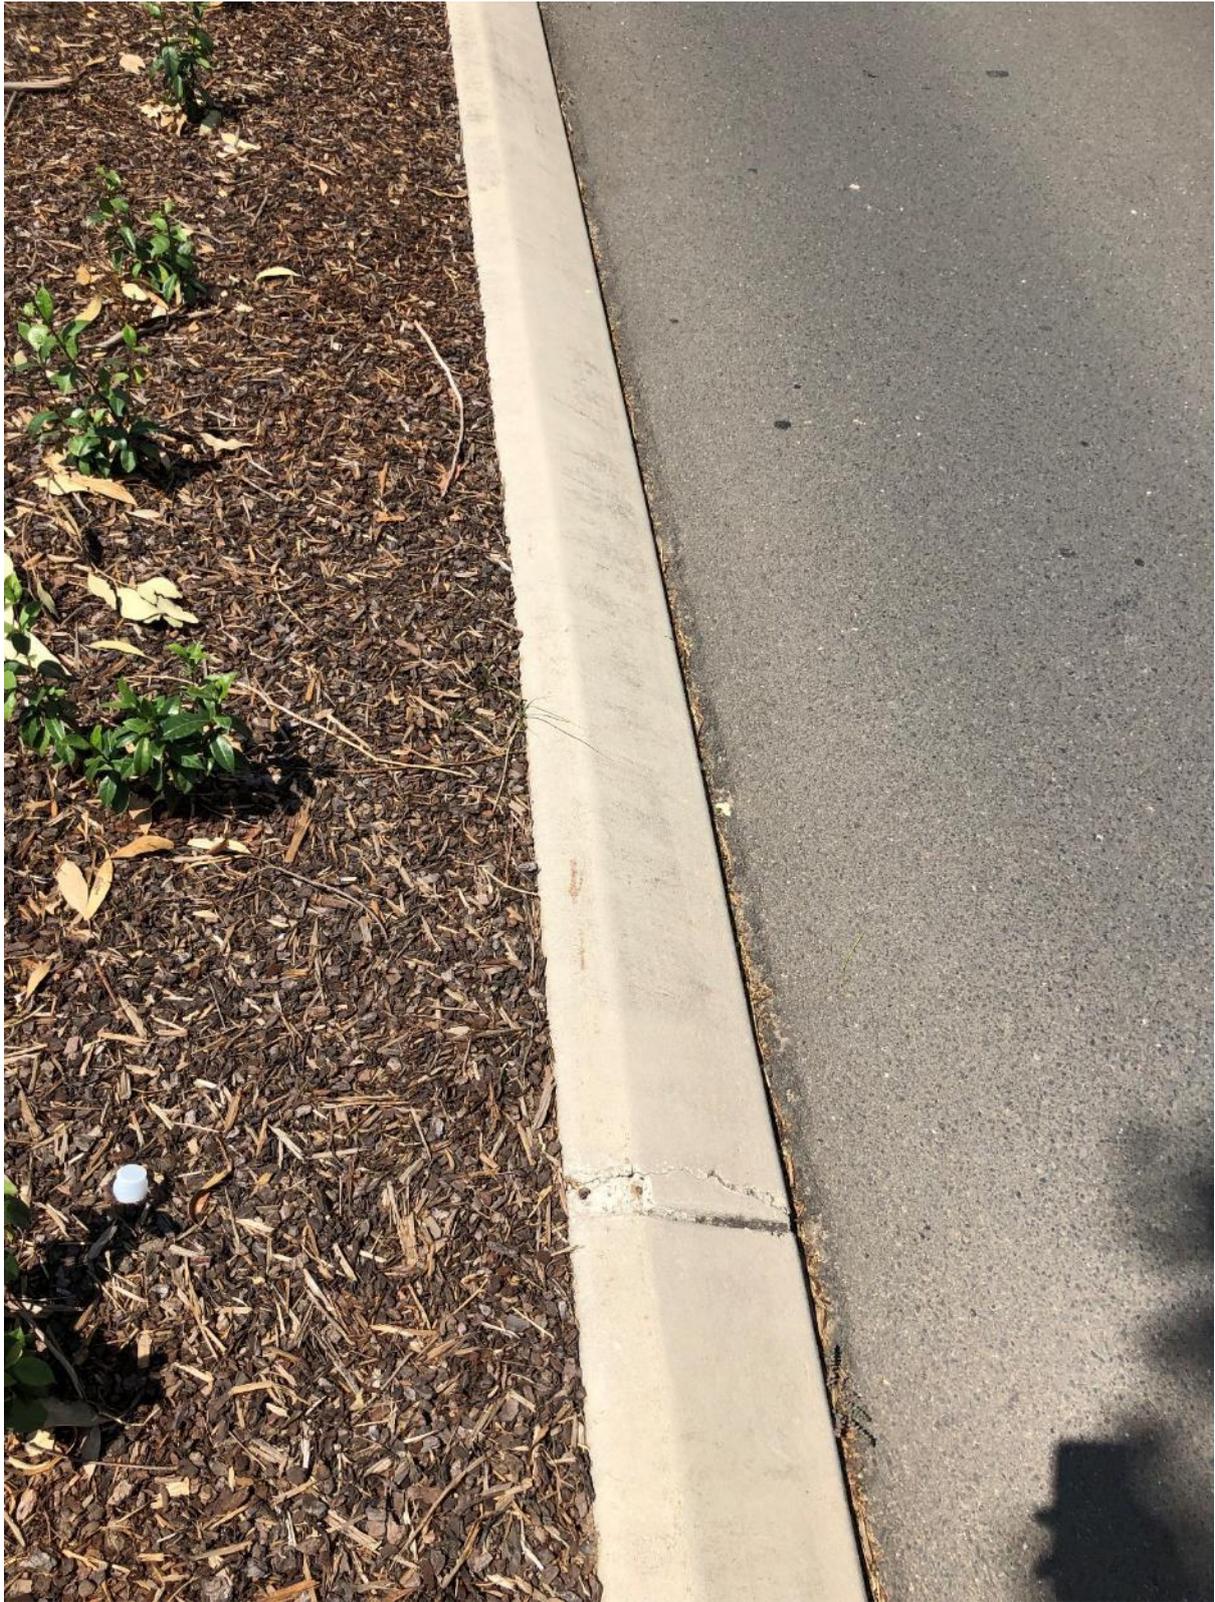
Figure 36: spalling on construction joint interface.

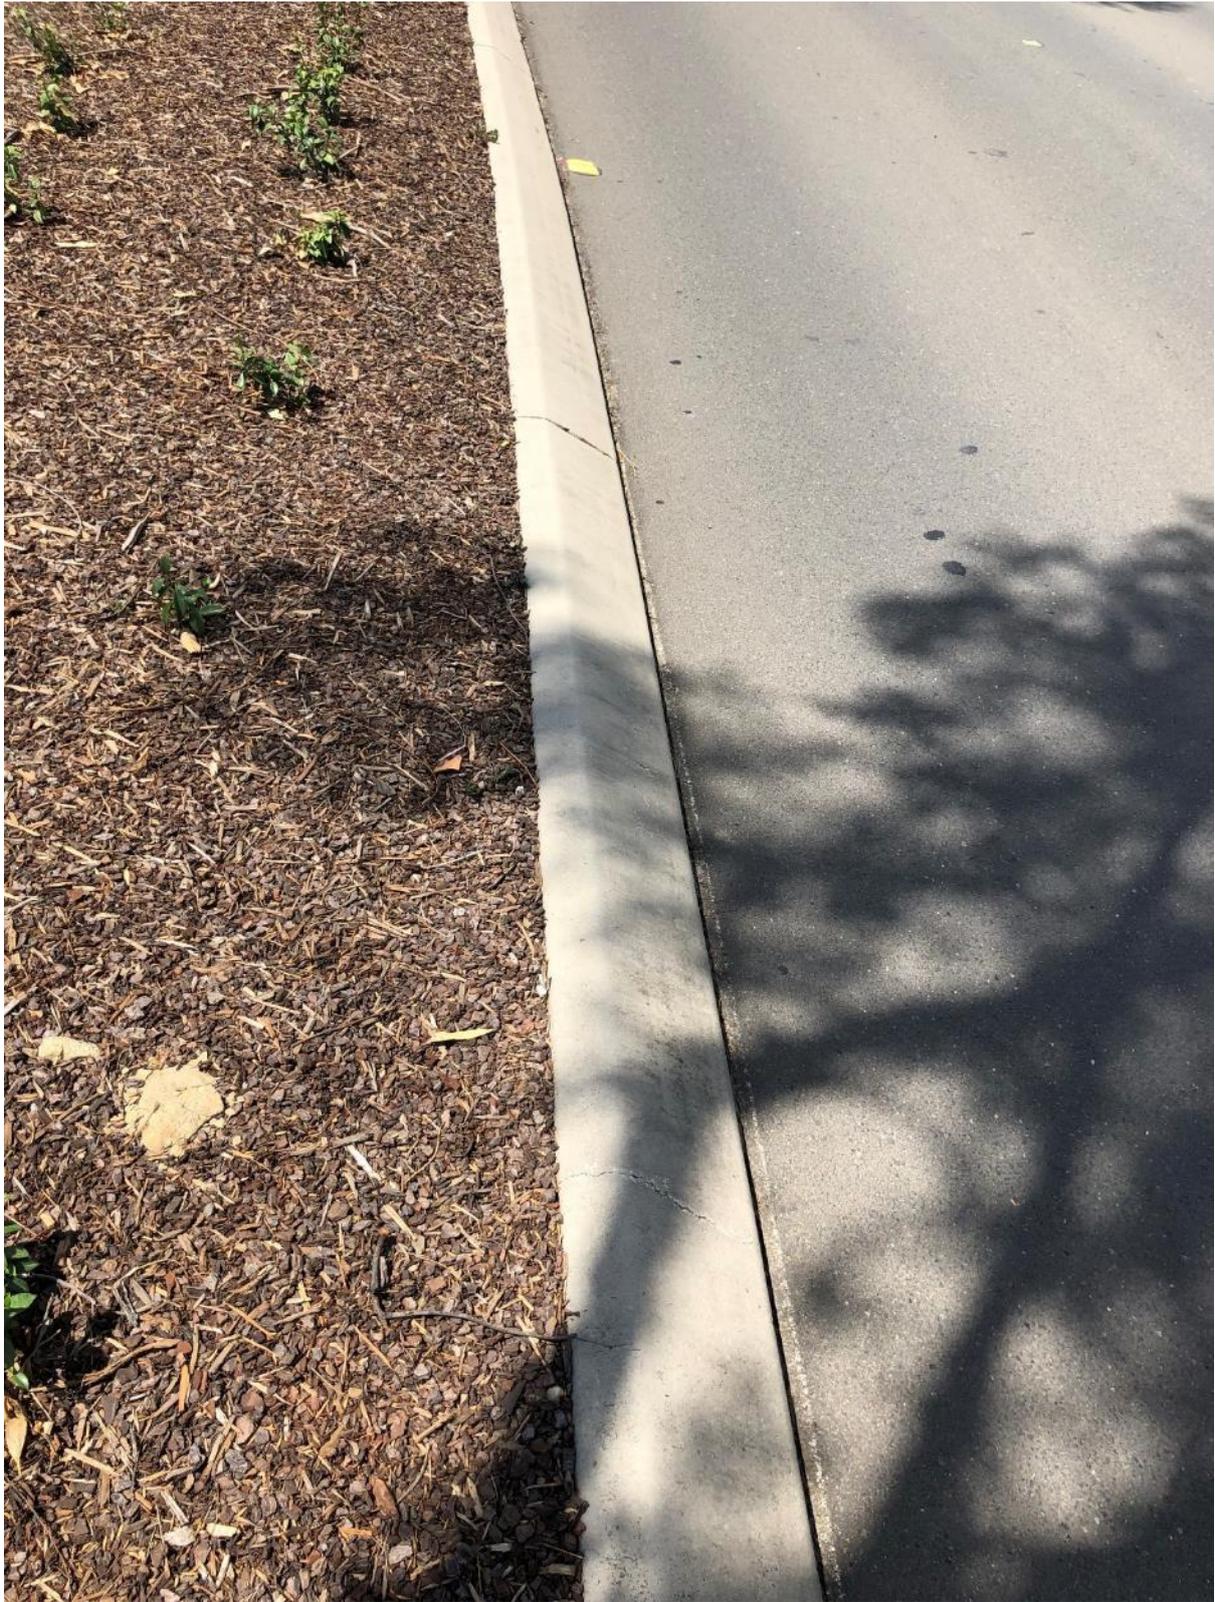
Figure 37: cracking to median strip kerb.

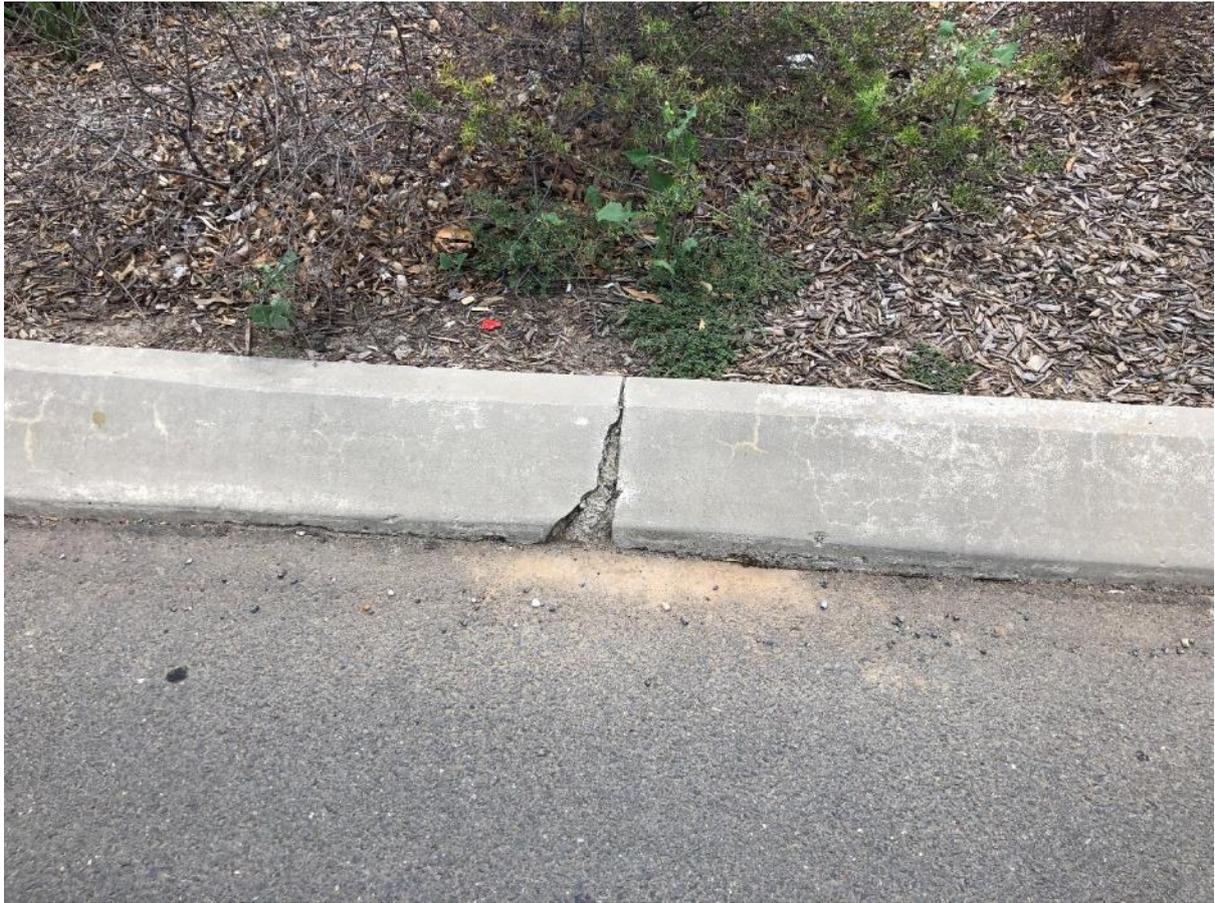
Figure 38: spalling to median strip kerb (construction joint interface).

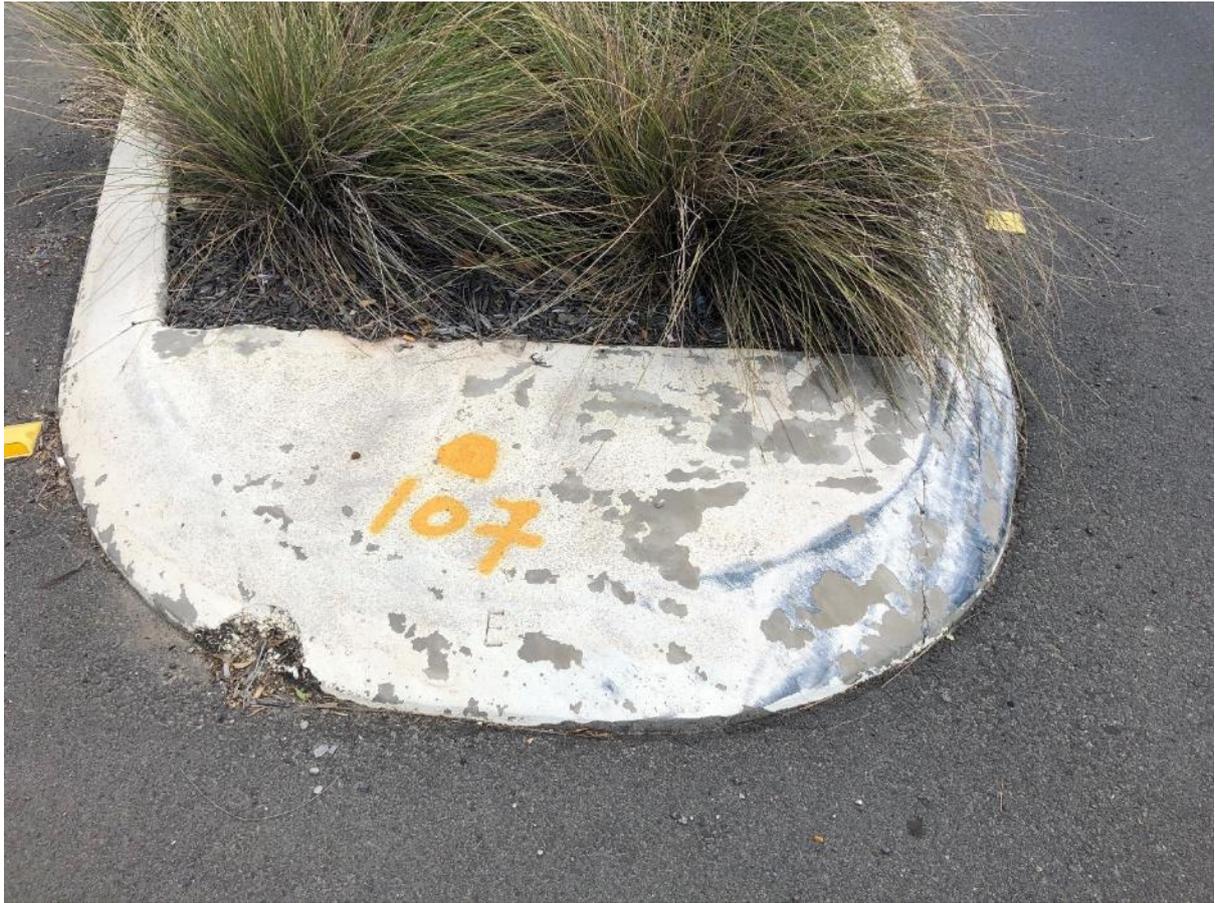
Figure 39: chip in median strip kerb (facing Lakeside Parade).

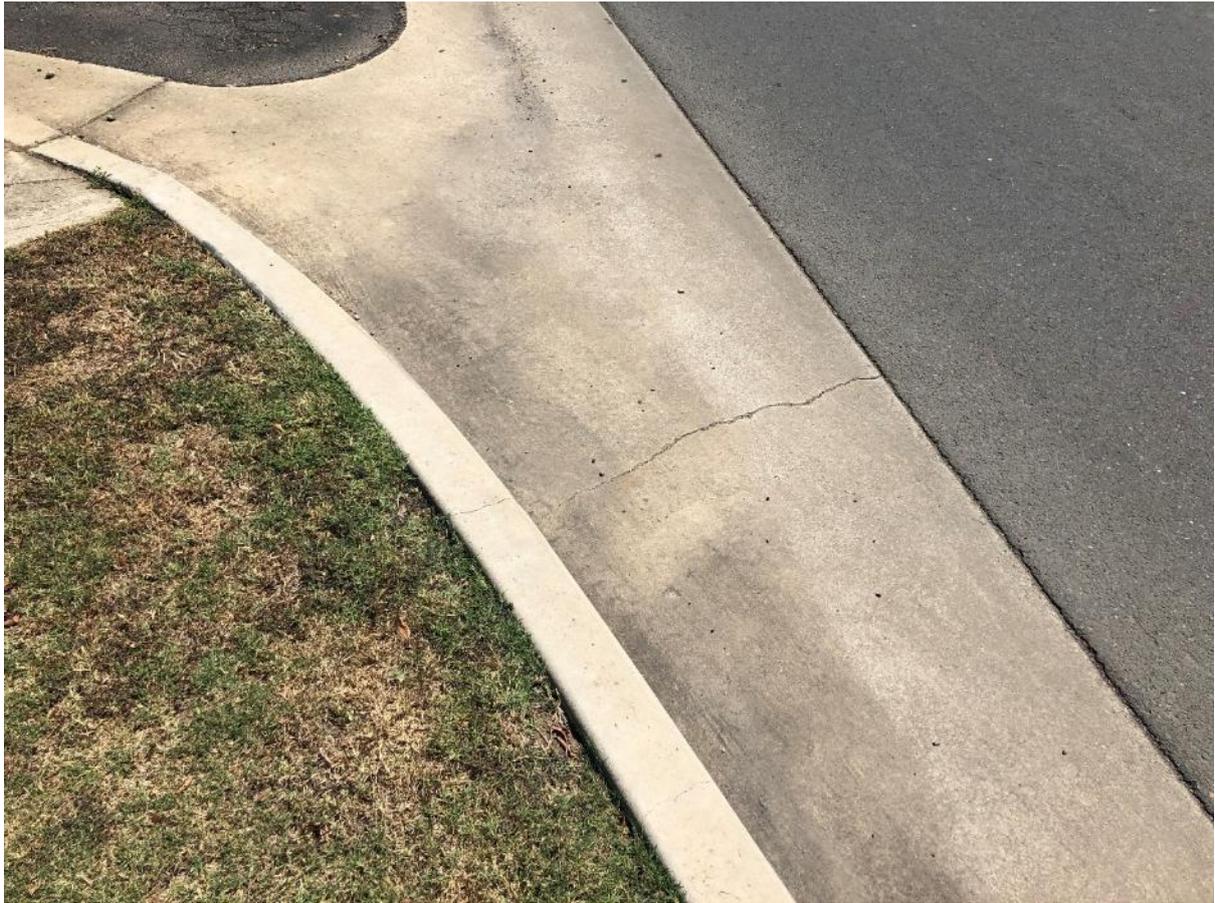
Figure 43: cracking to kerb and gutter.

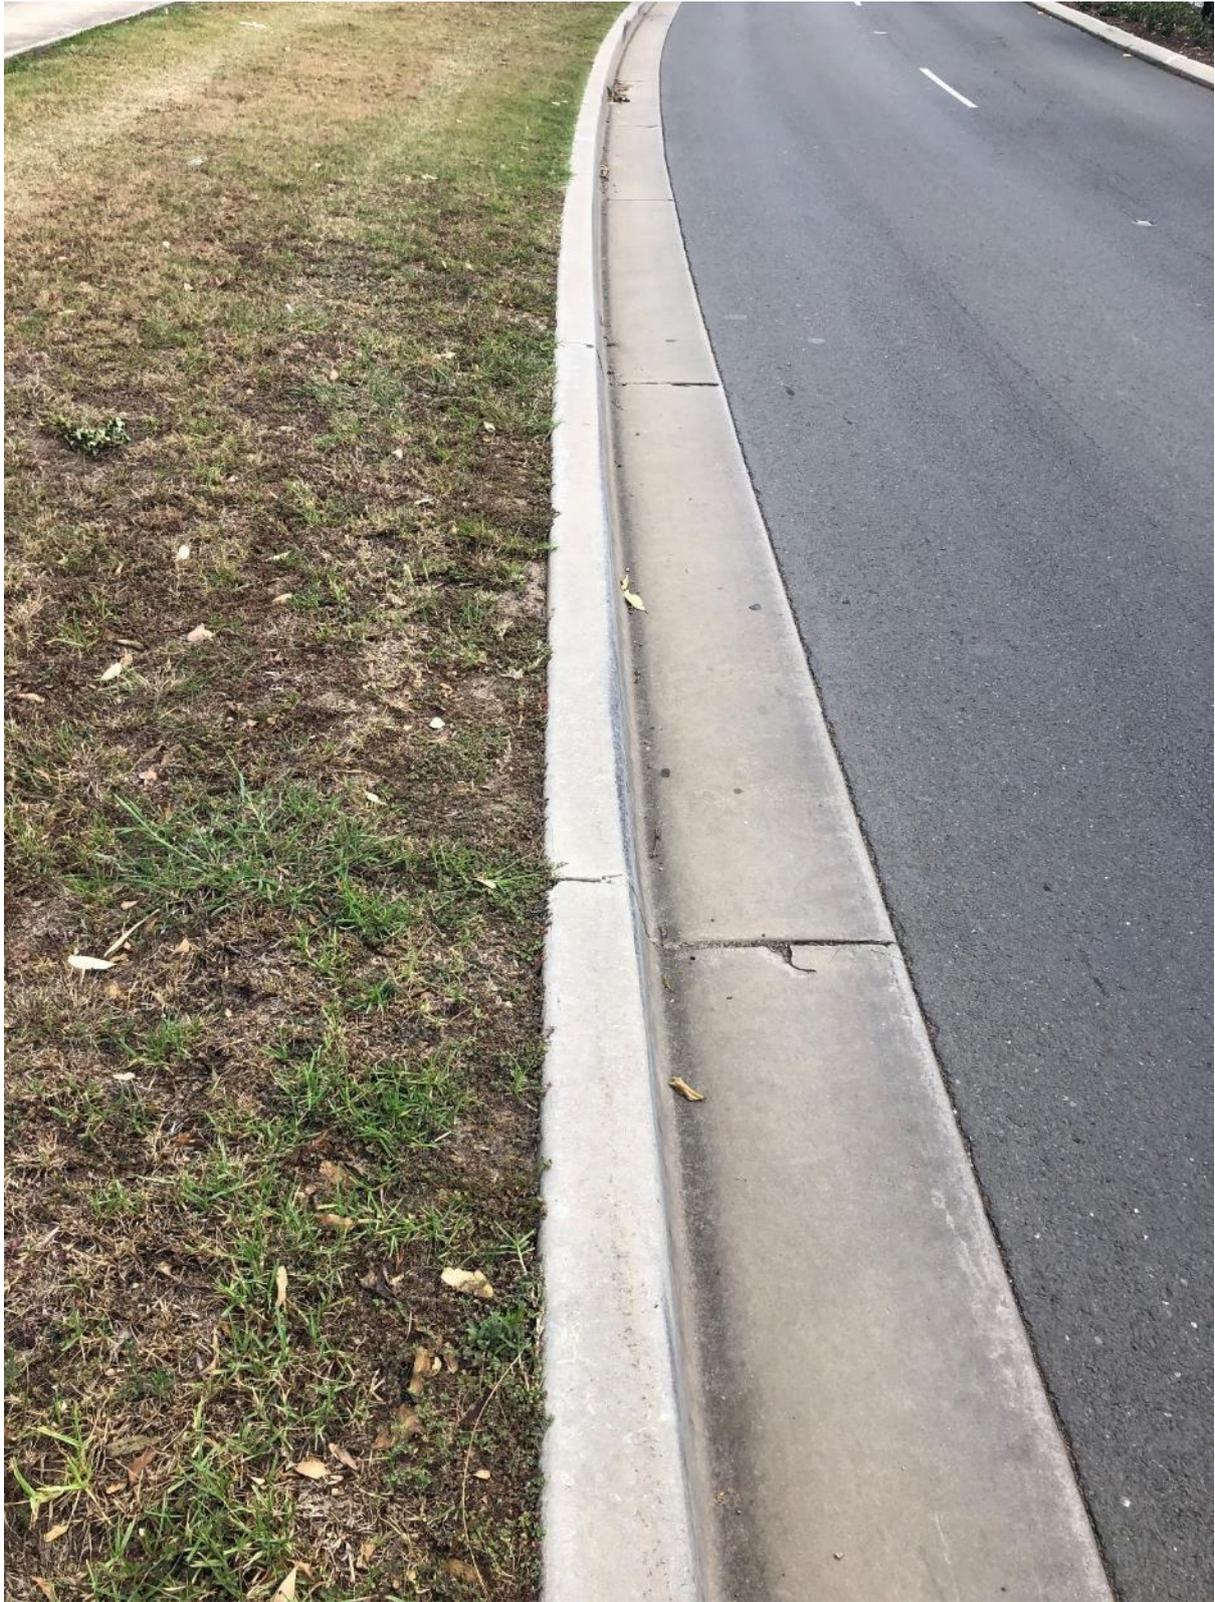
Figure 44: chip on construction joint interface on kerb and gutter.

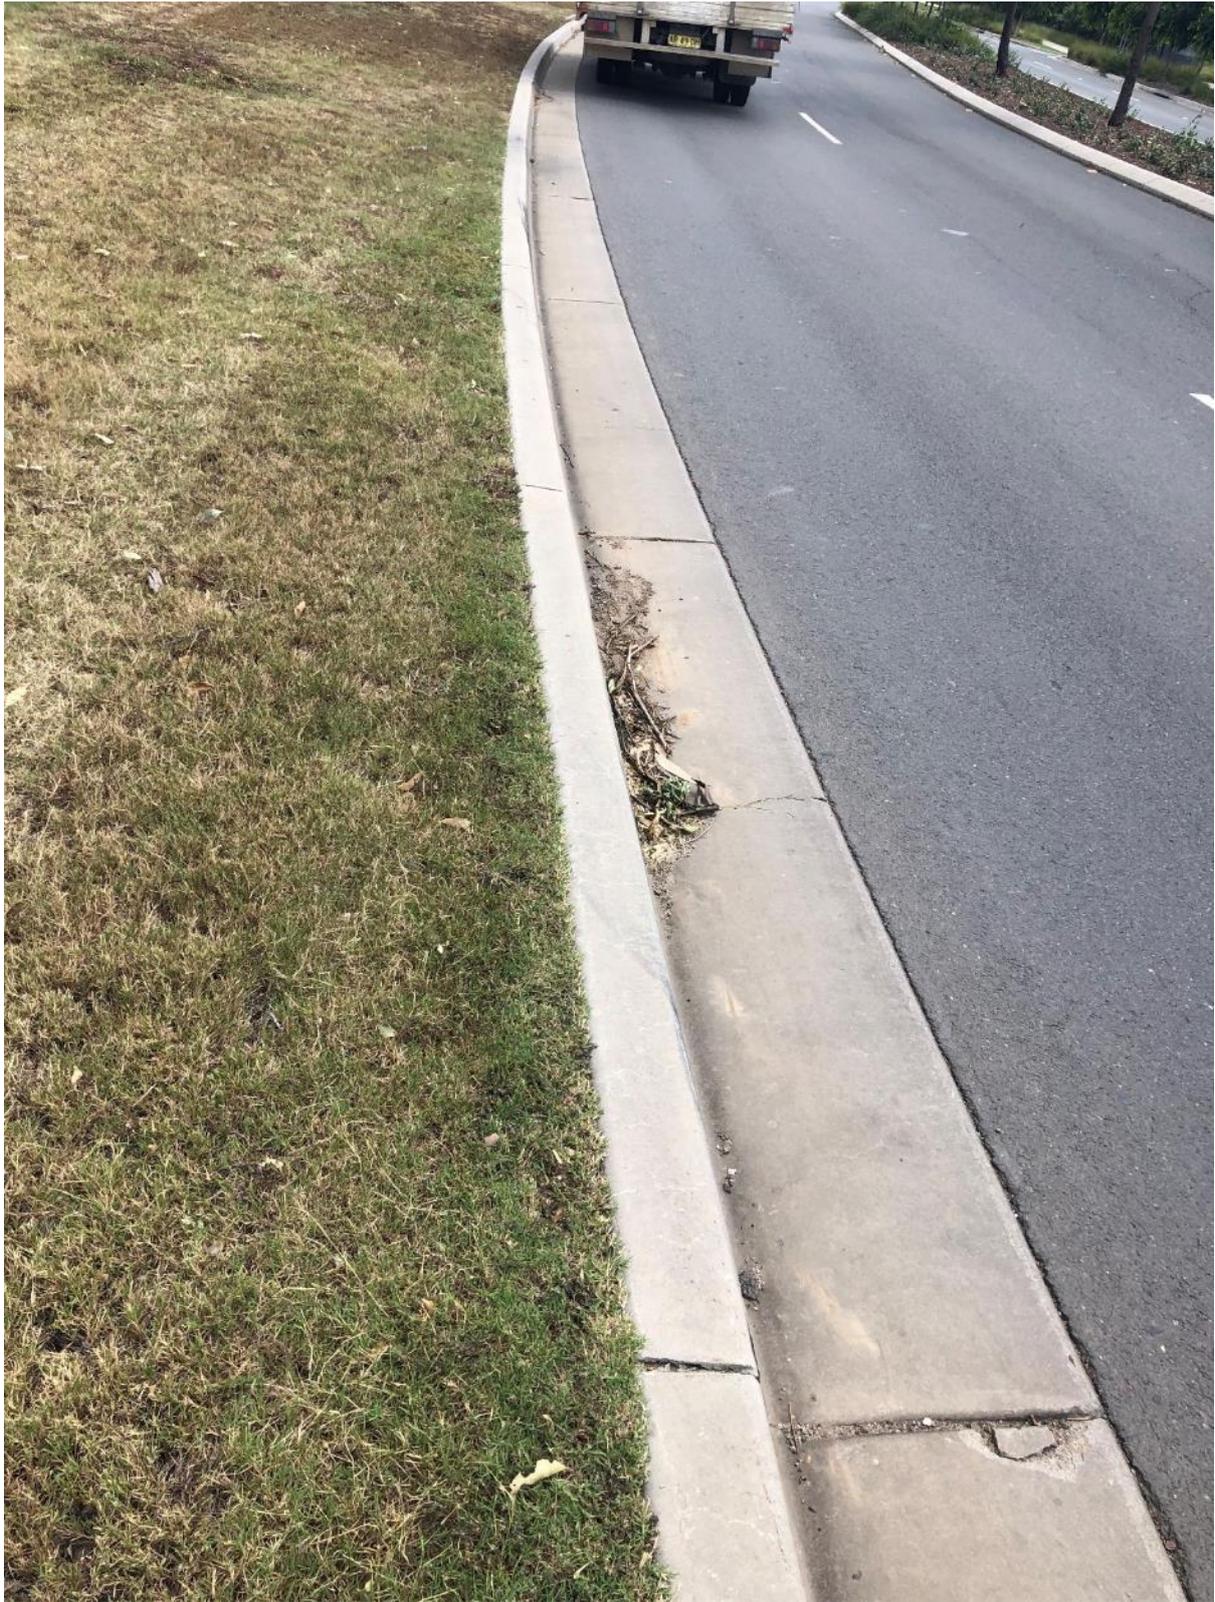
Figure 45: chip damage to kerb & gutter construction joint interface and cracking.

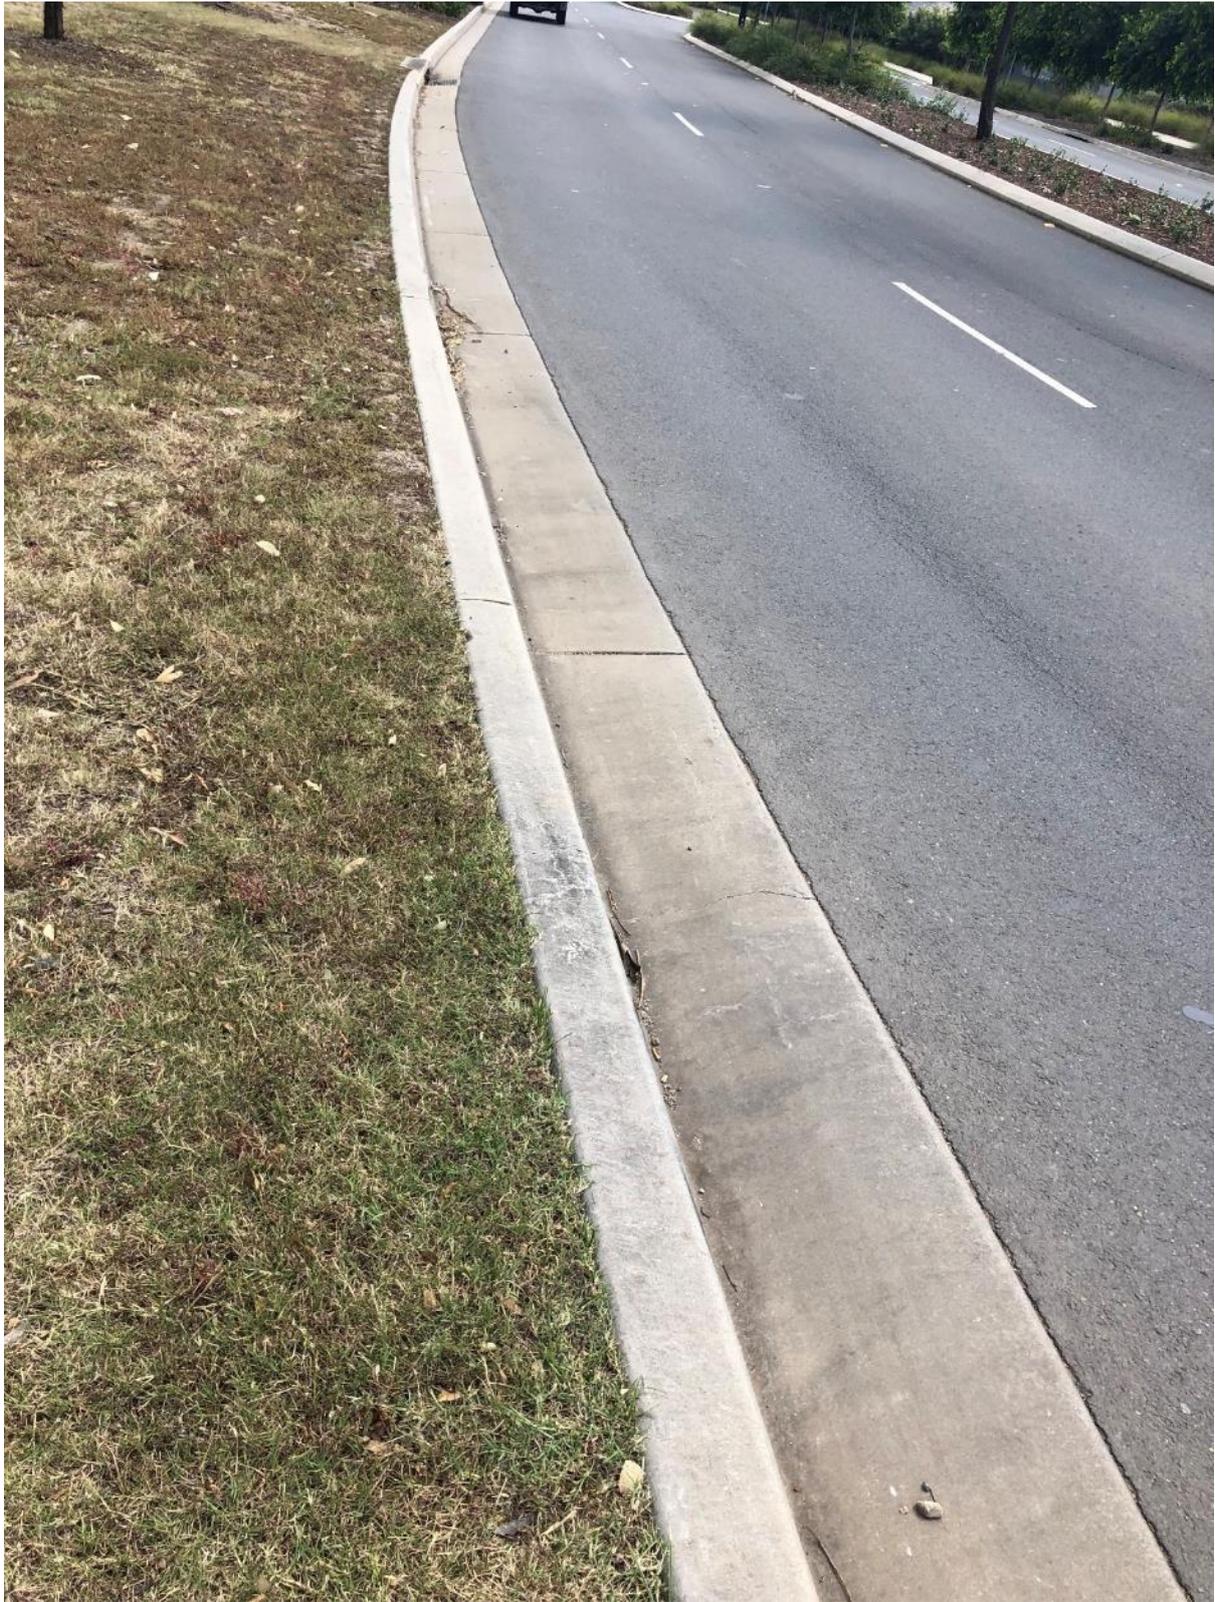
Figure 46: minor cracking to gutter.

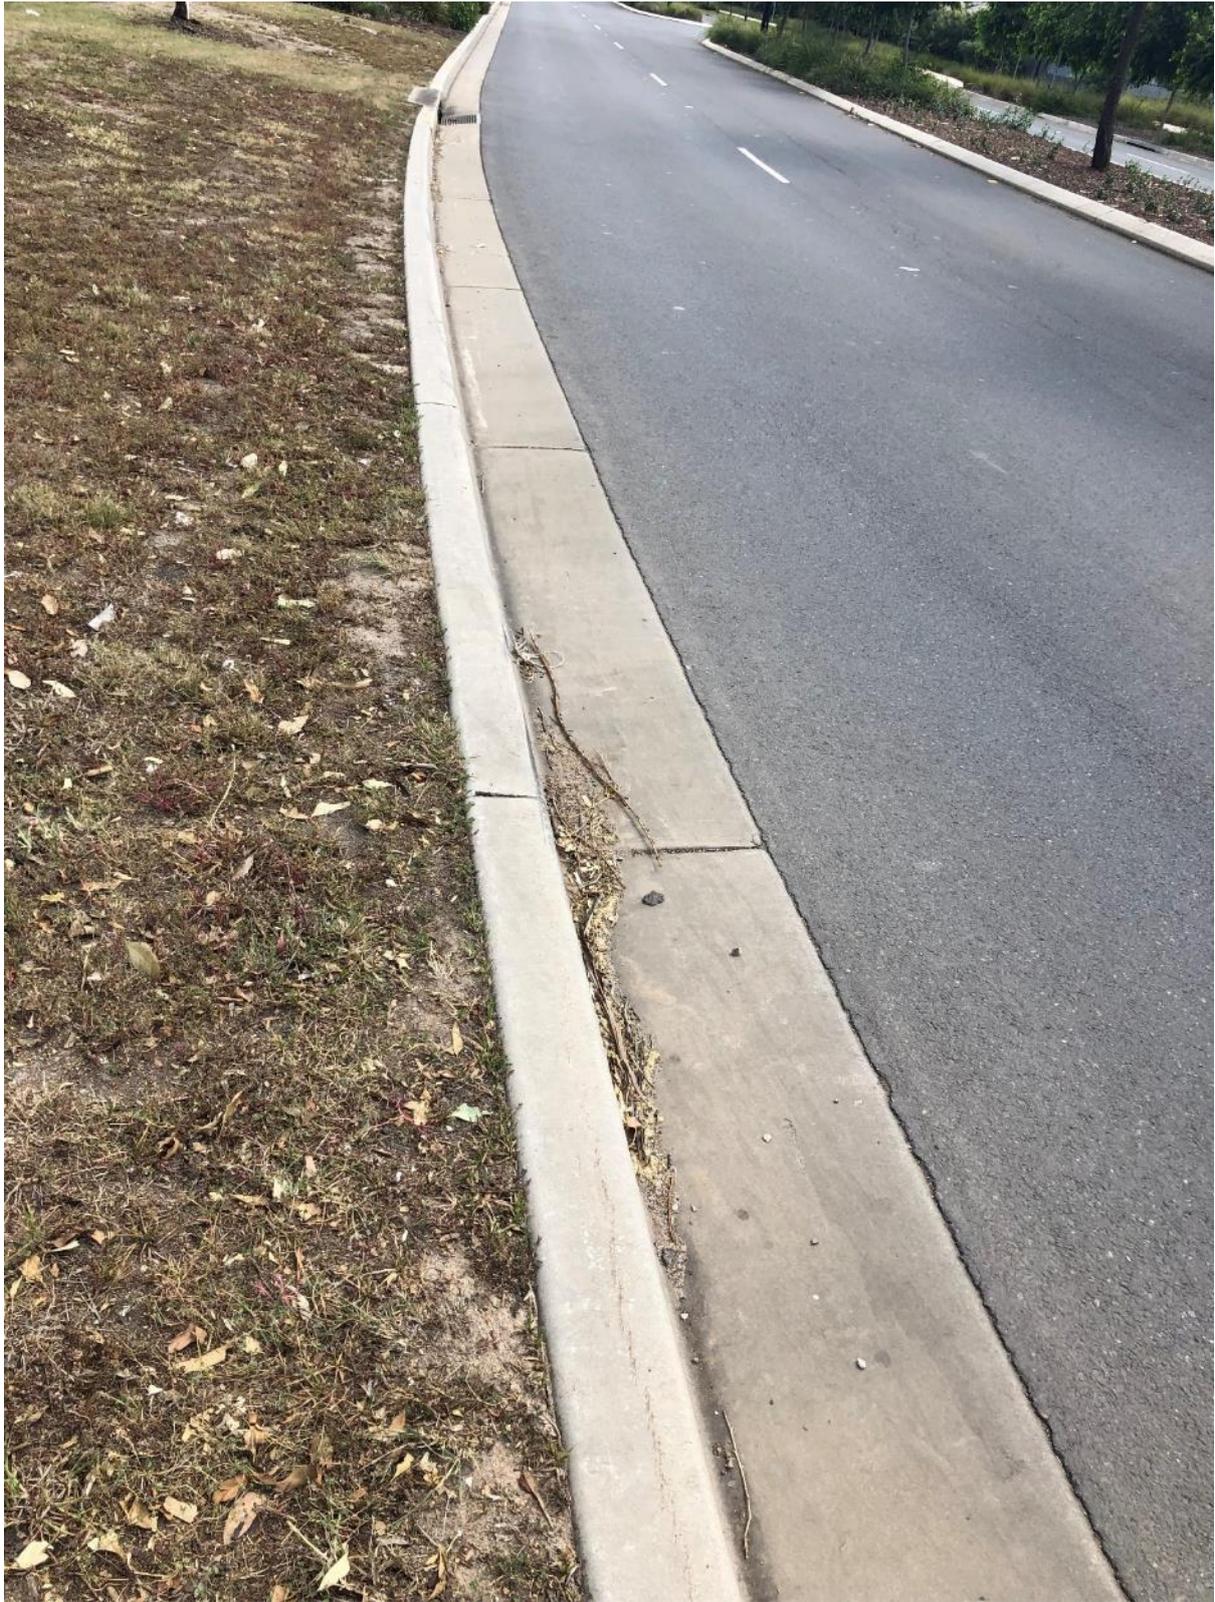
Figure 47: indentation to concrete gutter.
