J K Williams Contracting Pty Ltd

Dilapidation Report

Proposed Works - Jordan Springs Stage 2 Retirement Living

James Sae Siew
5th March 2019
Revision 1

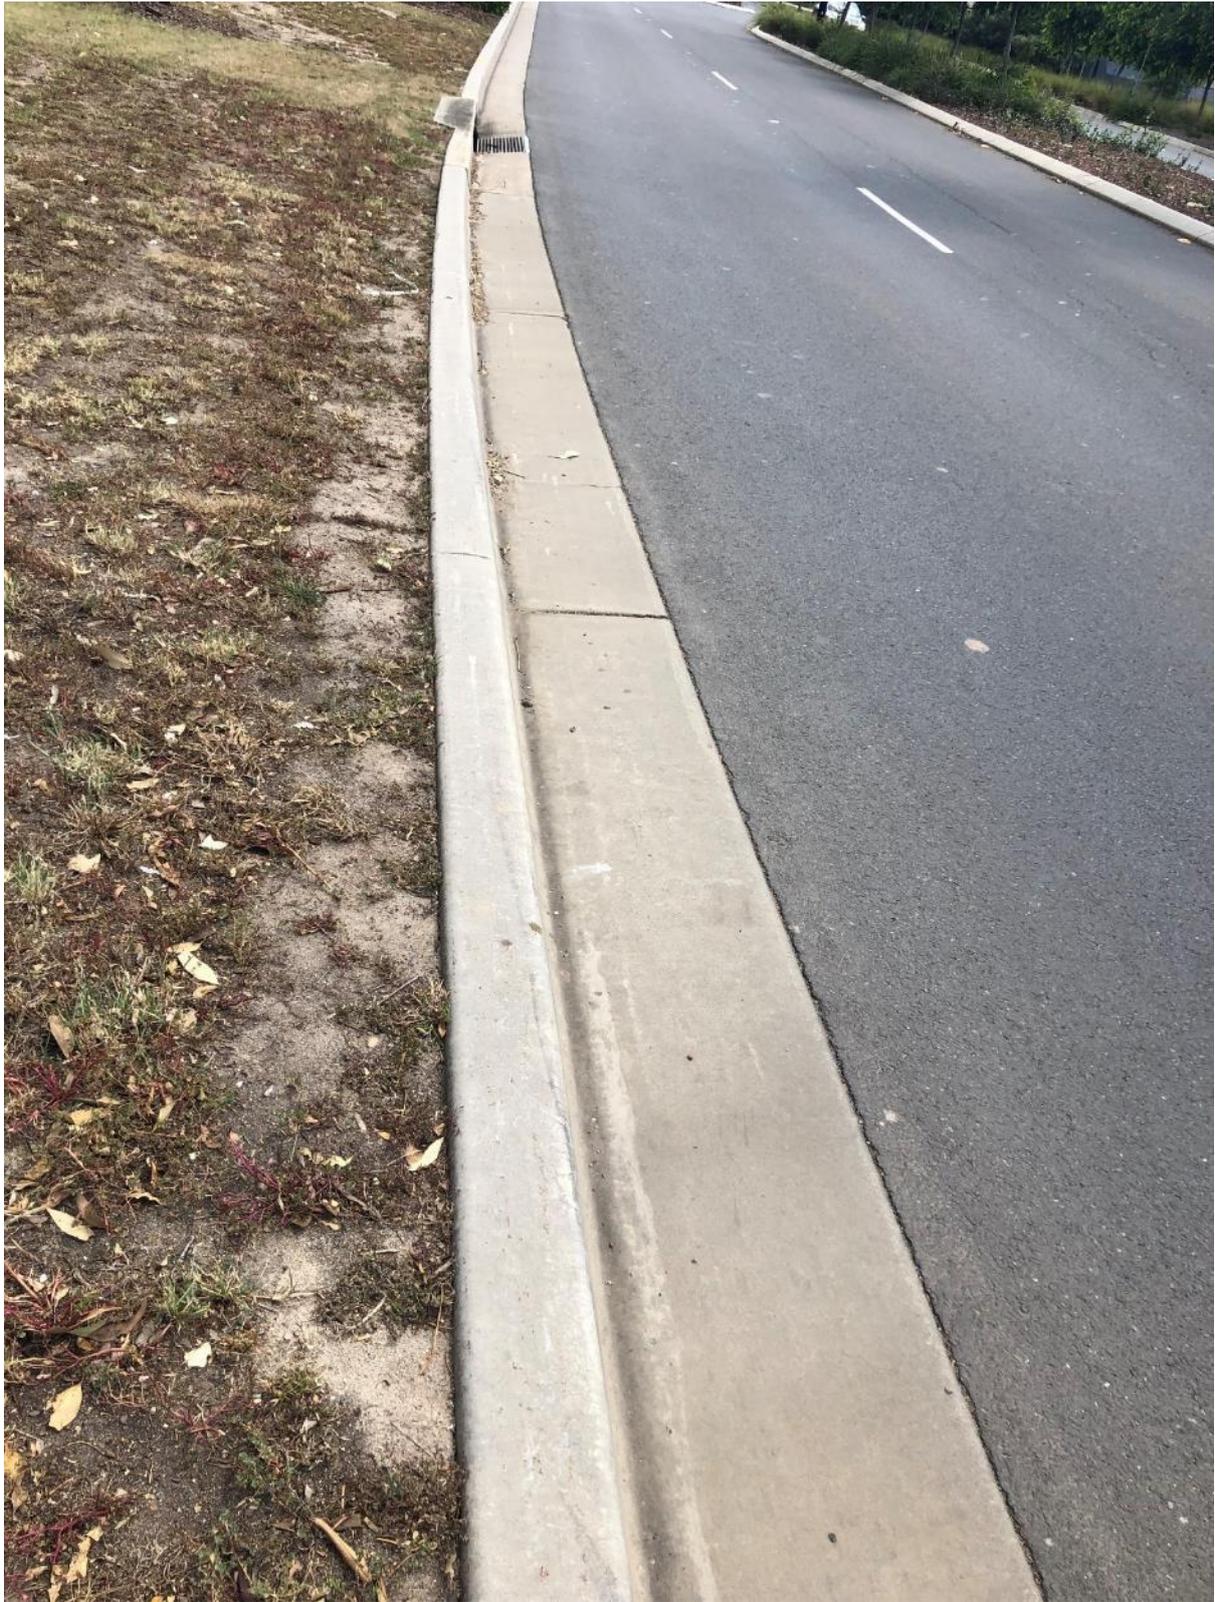
Figure 48: crack on concrete gutter.

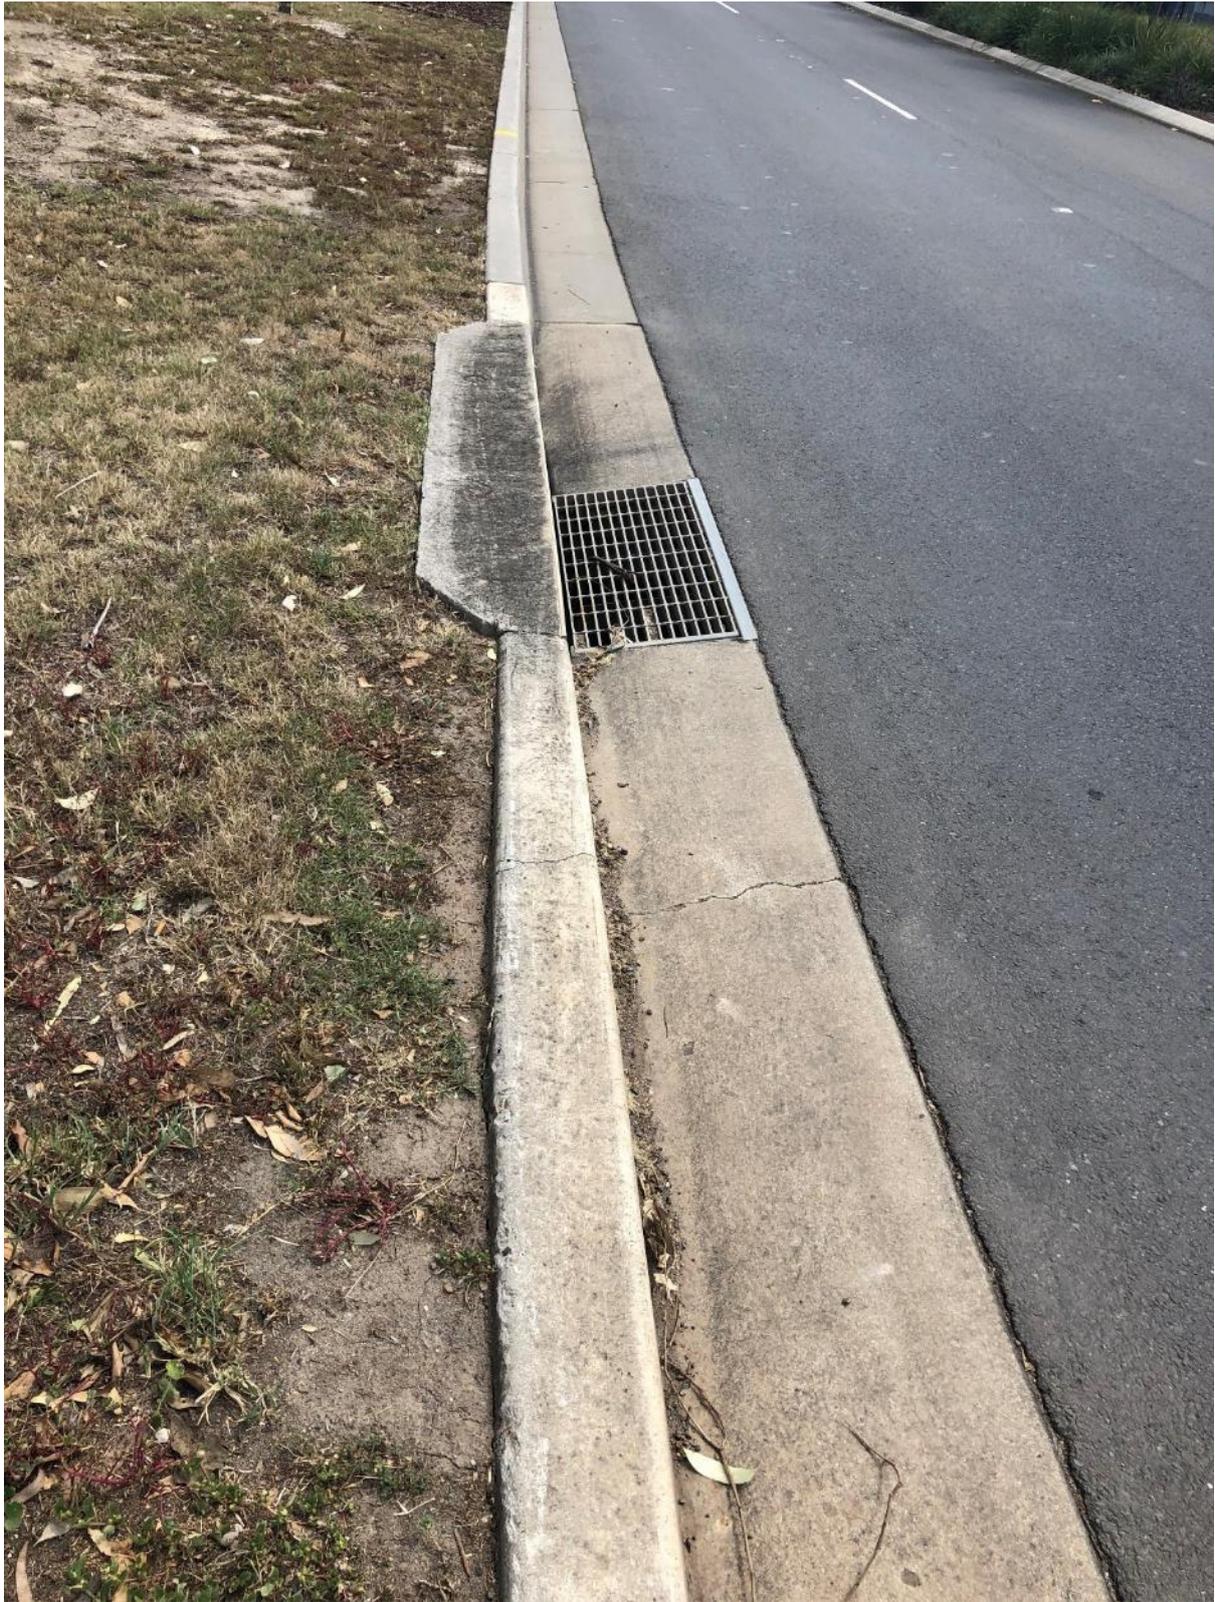
Figure 49: cracking on kerb and gutter, adjacent to SW pit.

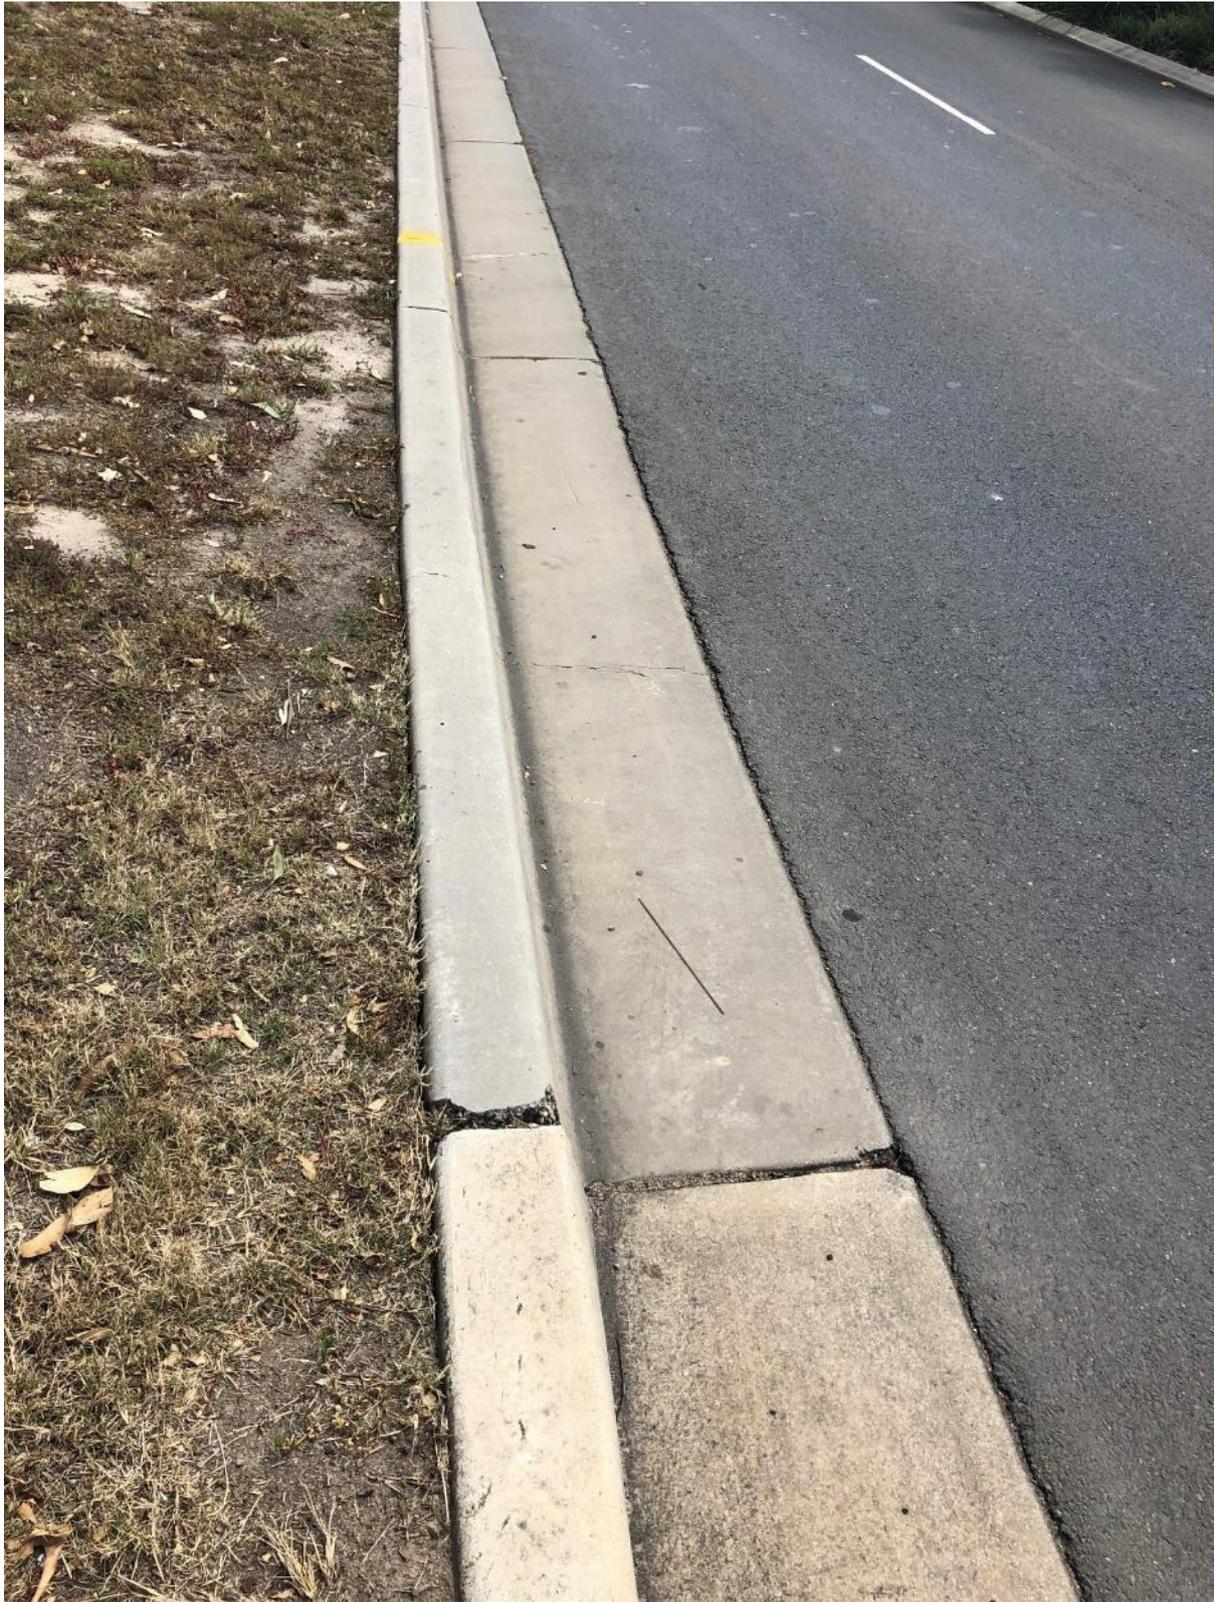
Figure 50: damage to expansion joint interface on kerb and gutter.

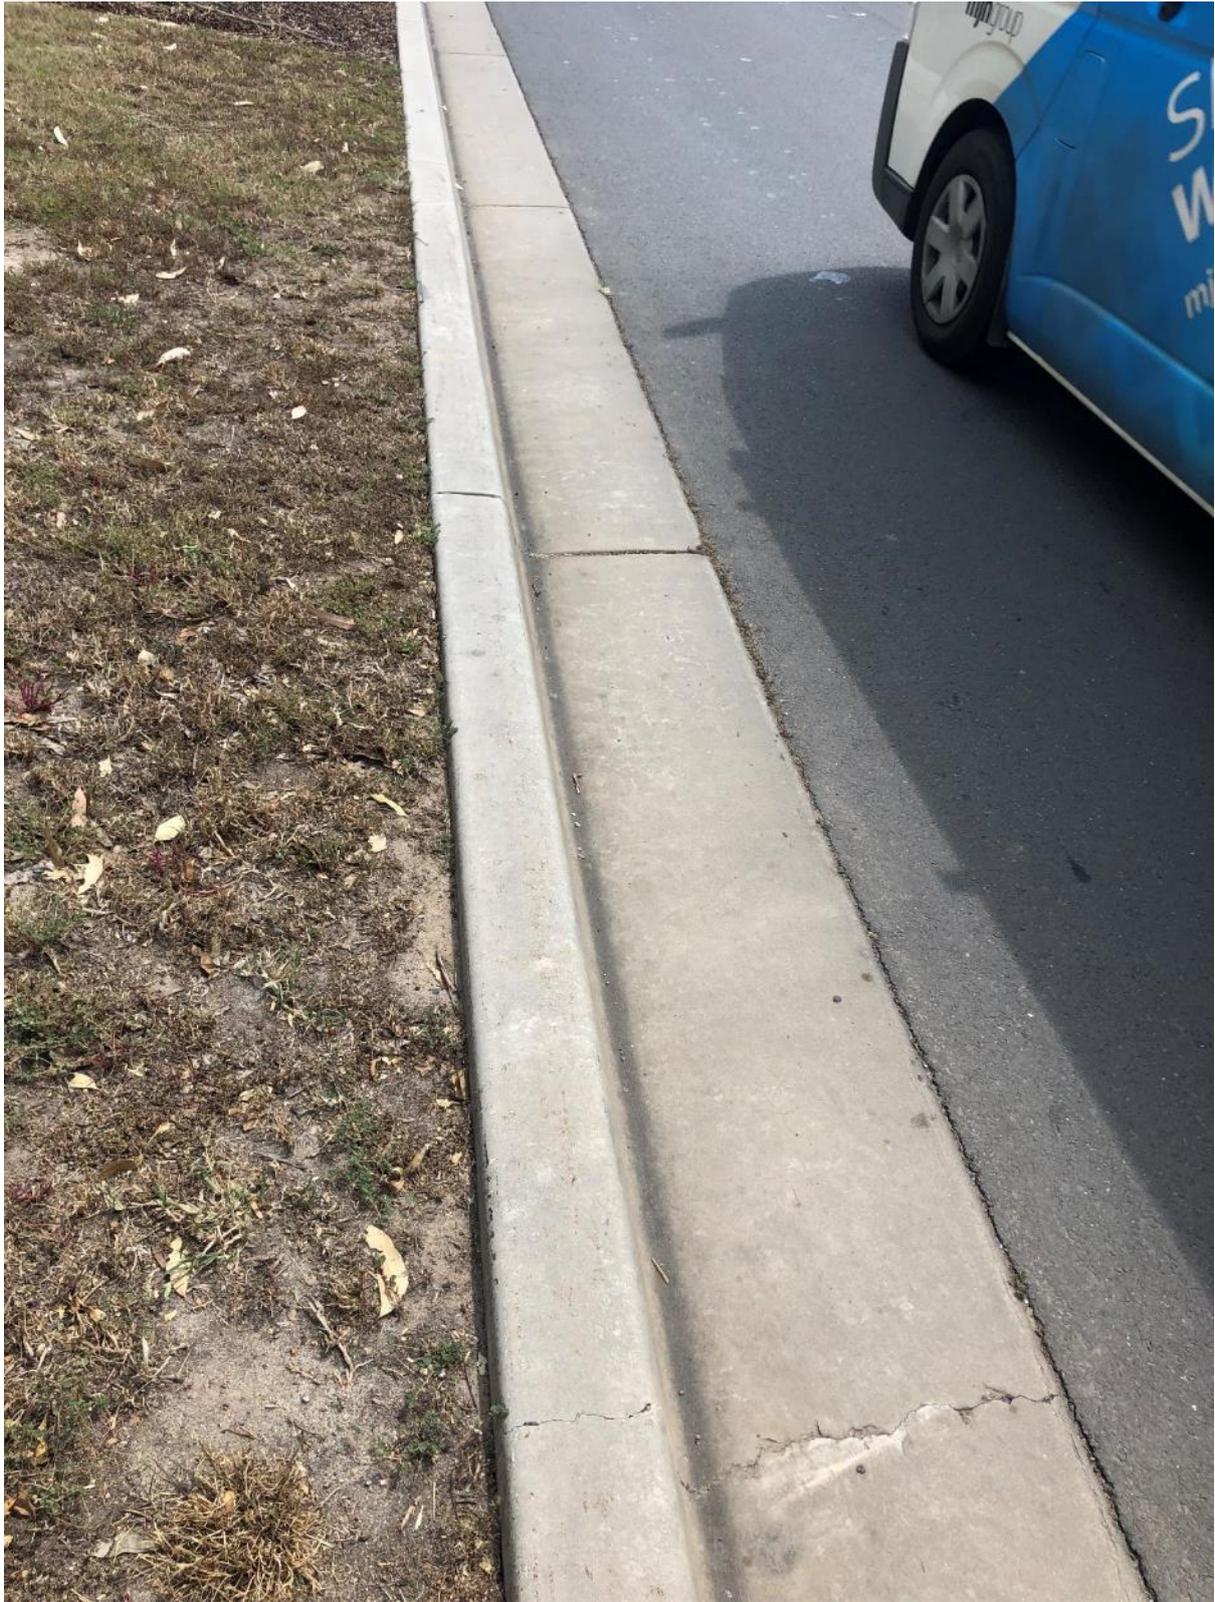
Figure 51: cracking to kerb and gutter.

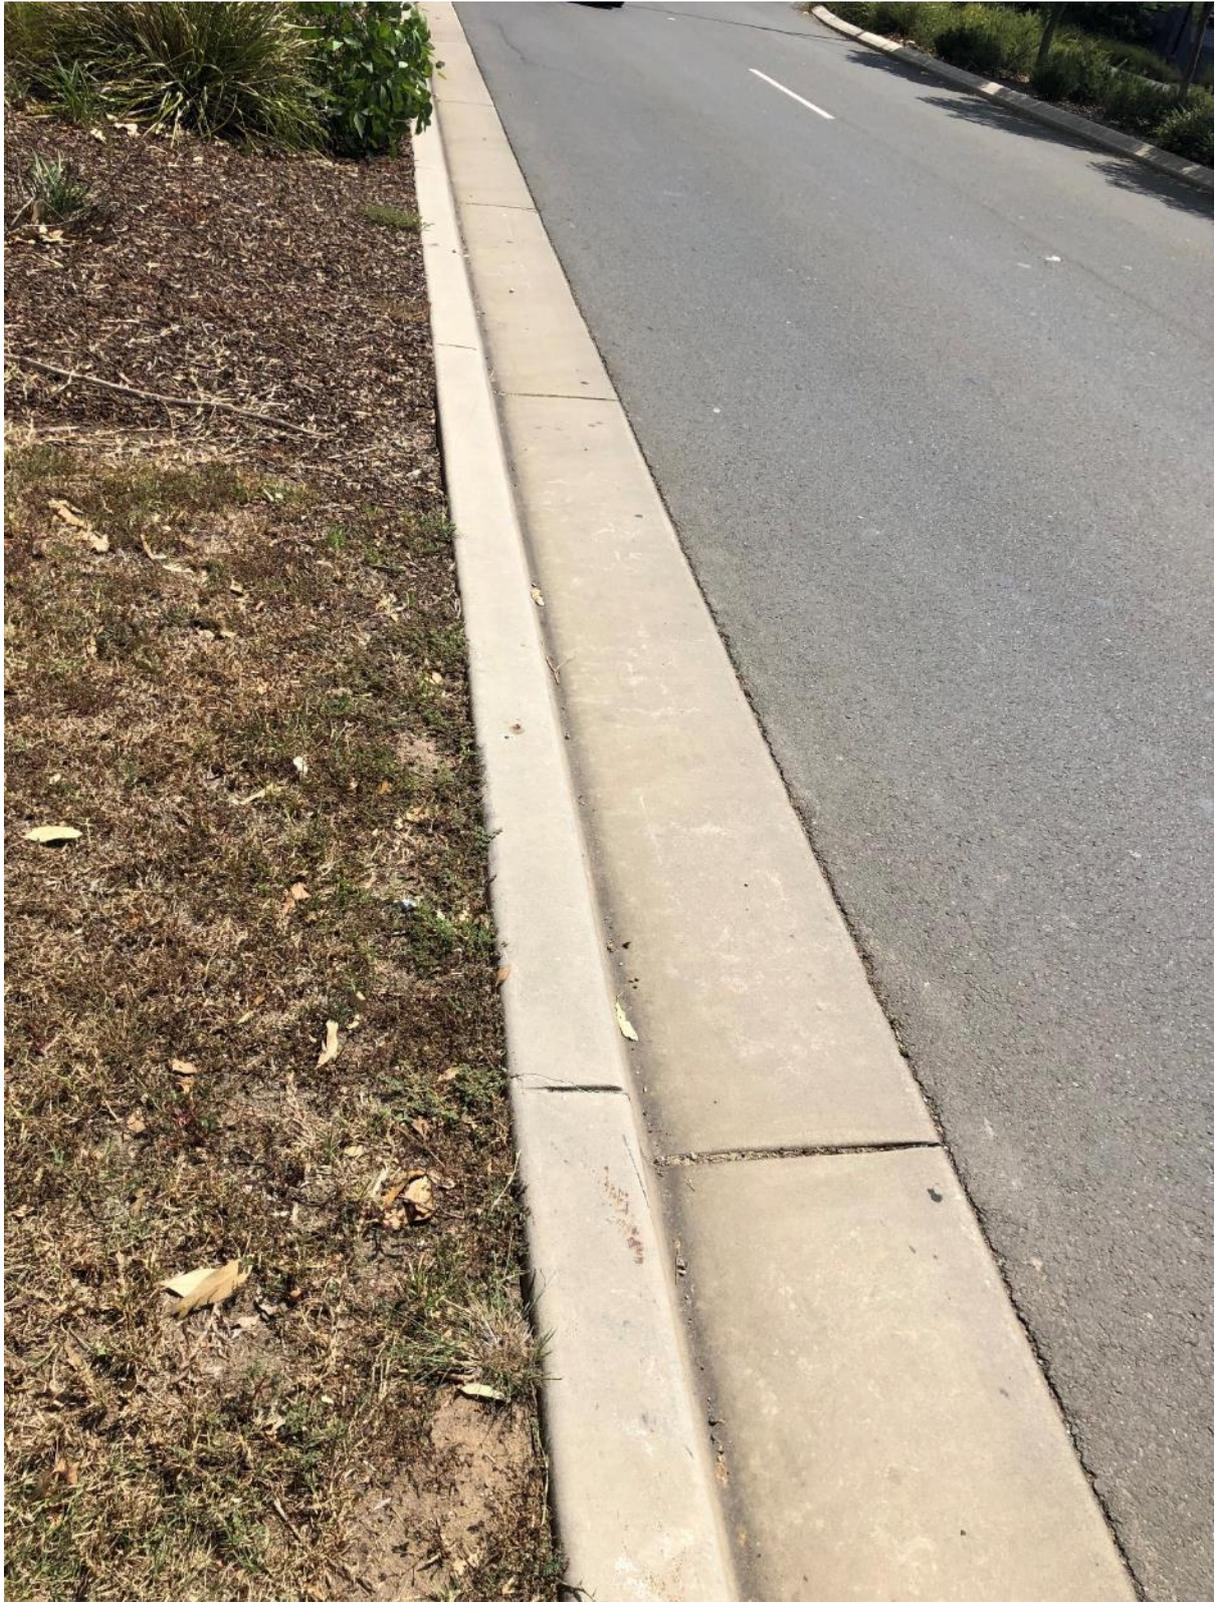
Figure 52: cracking to top of kerb.

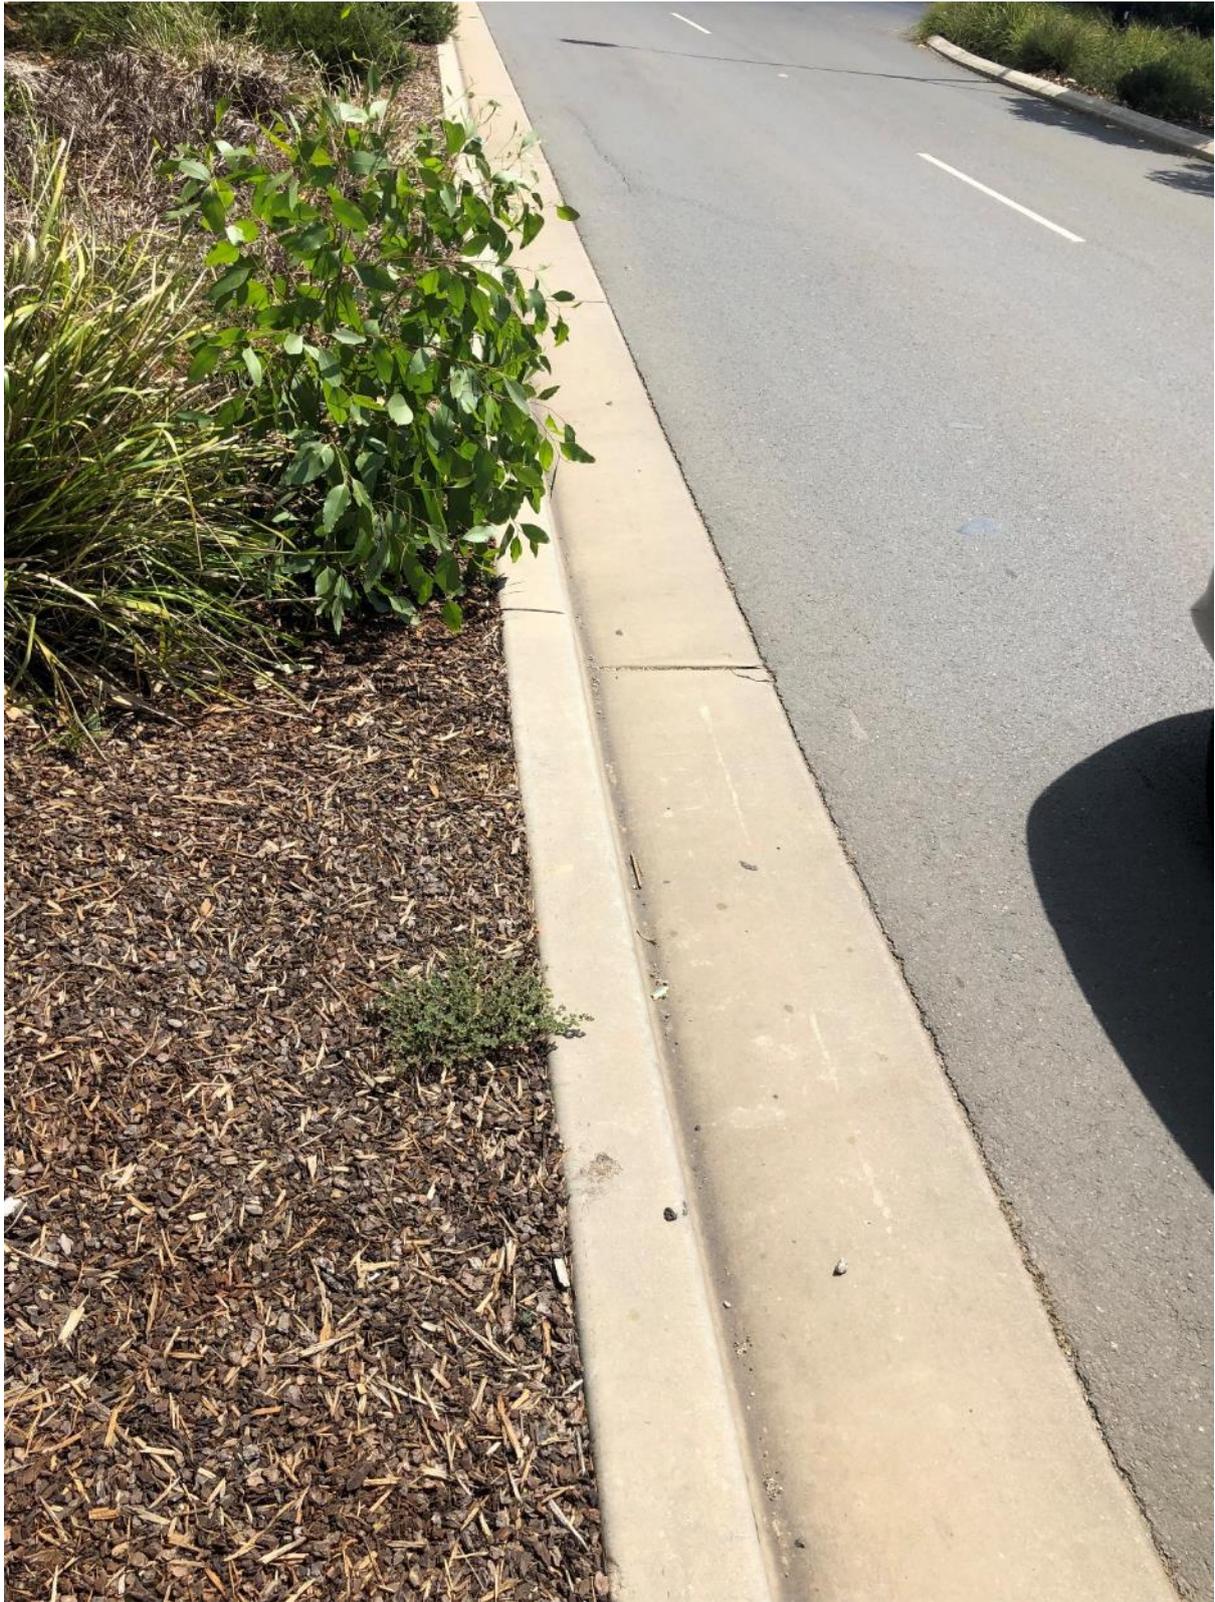
Figure 53: diagonal cracking at construction joint interface.

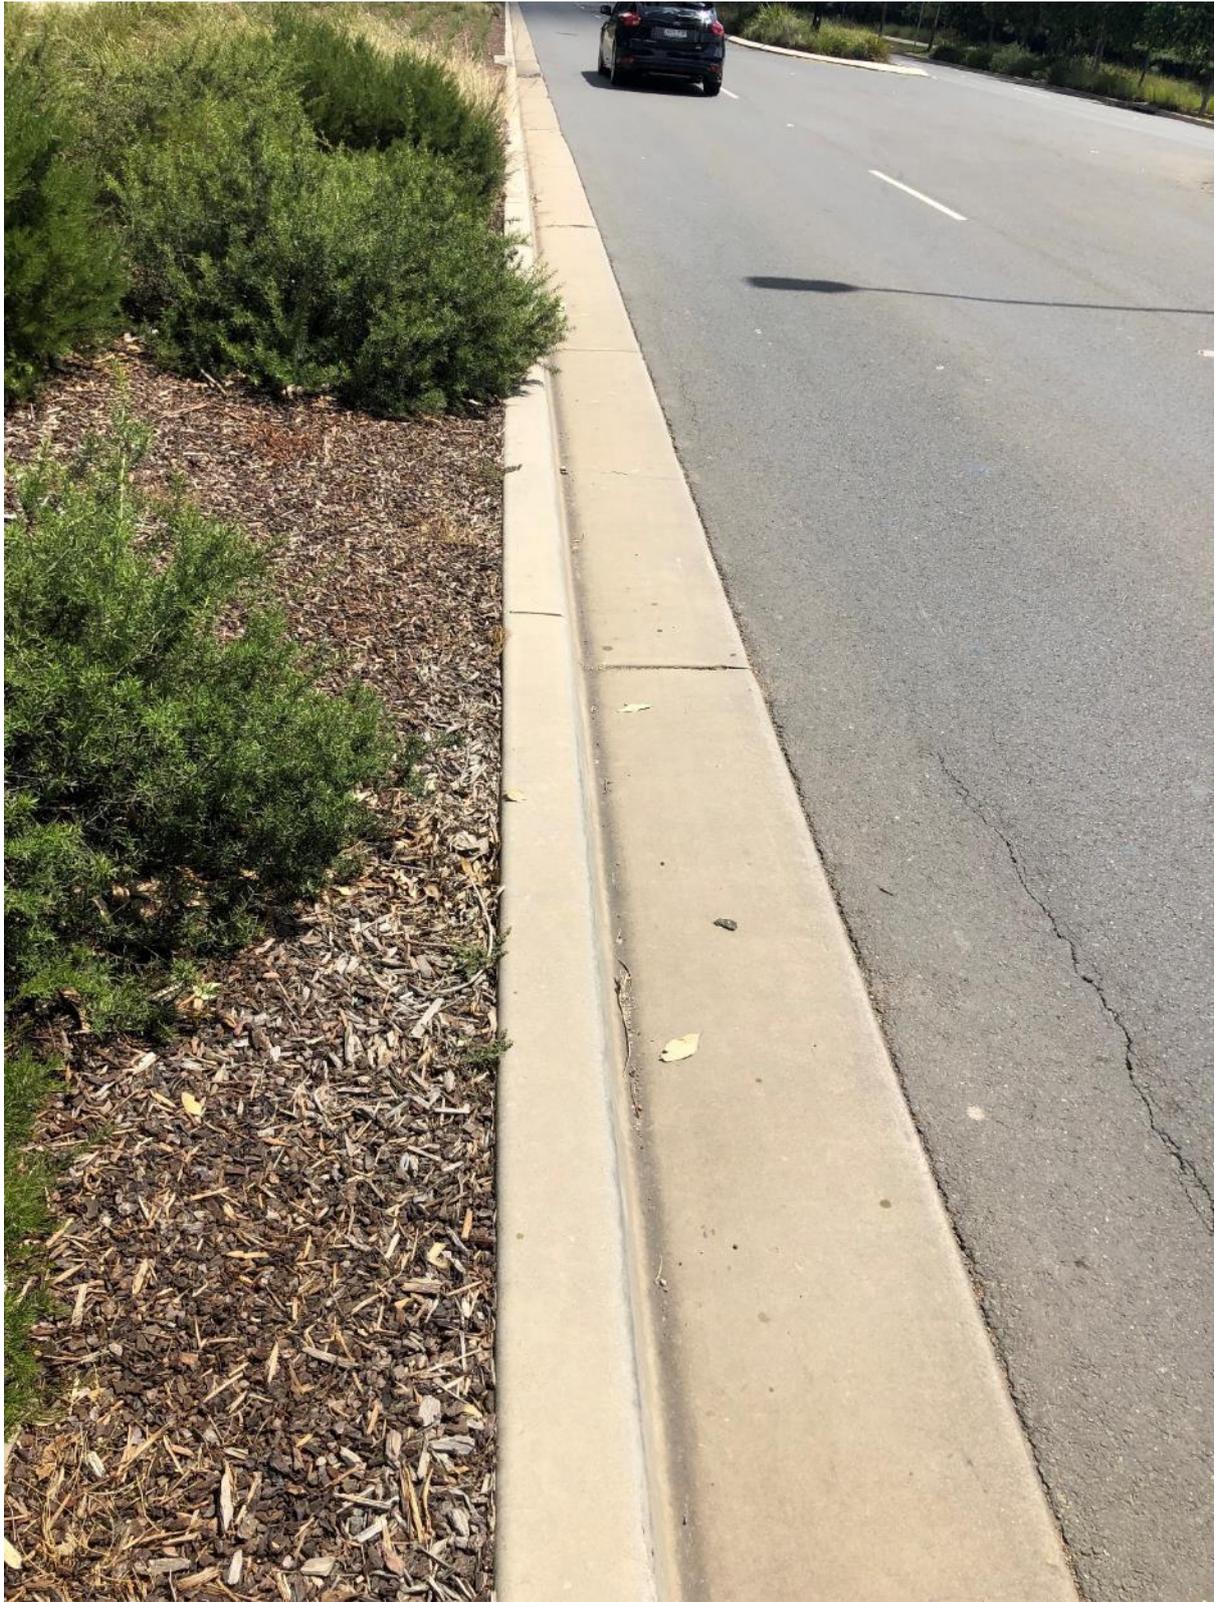
Figure 54: crack on asphalt, adjacent to gutter.

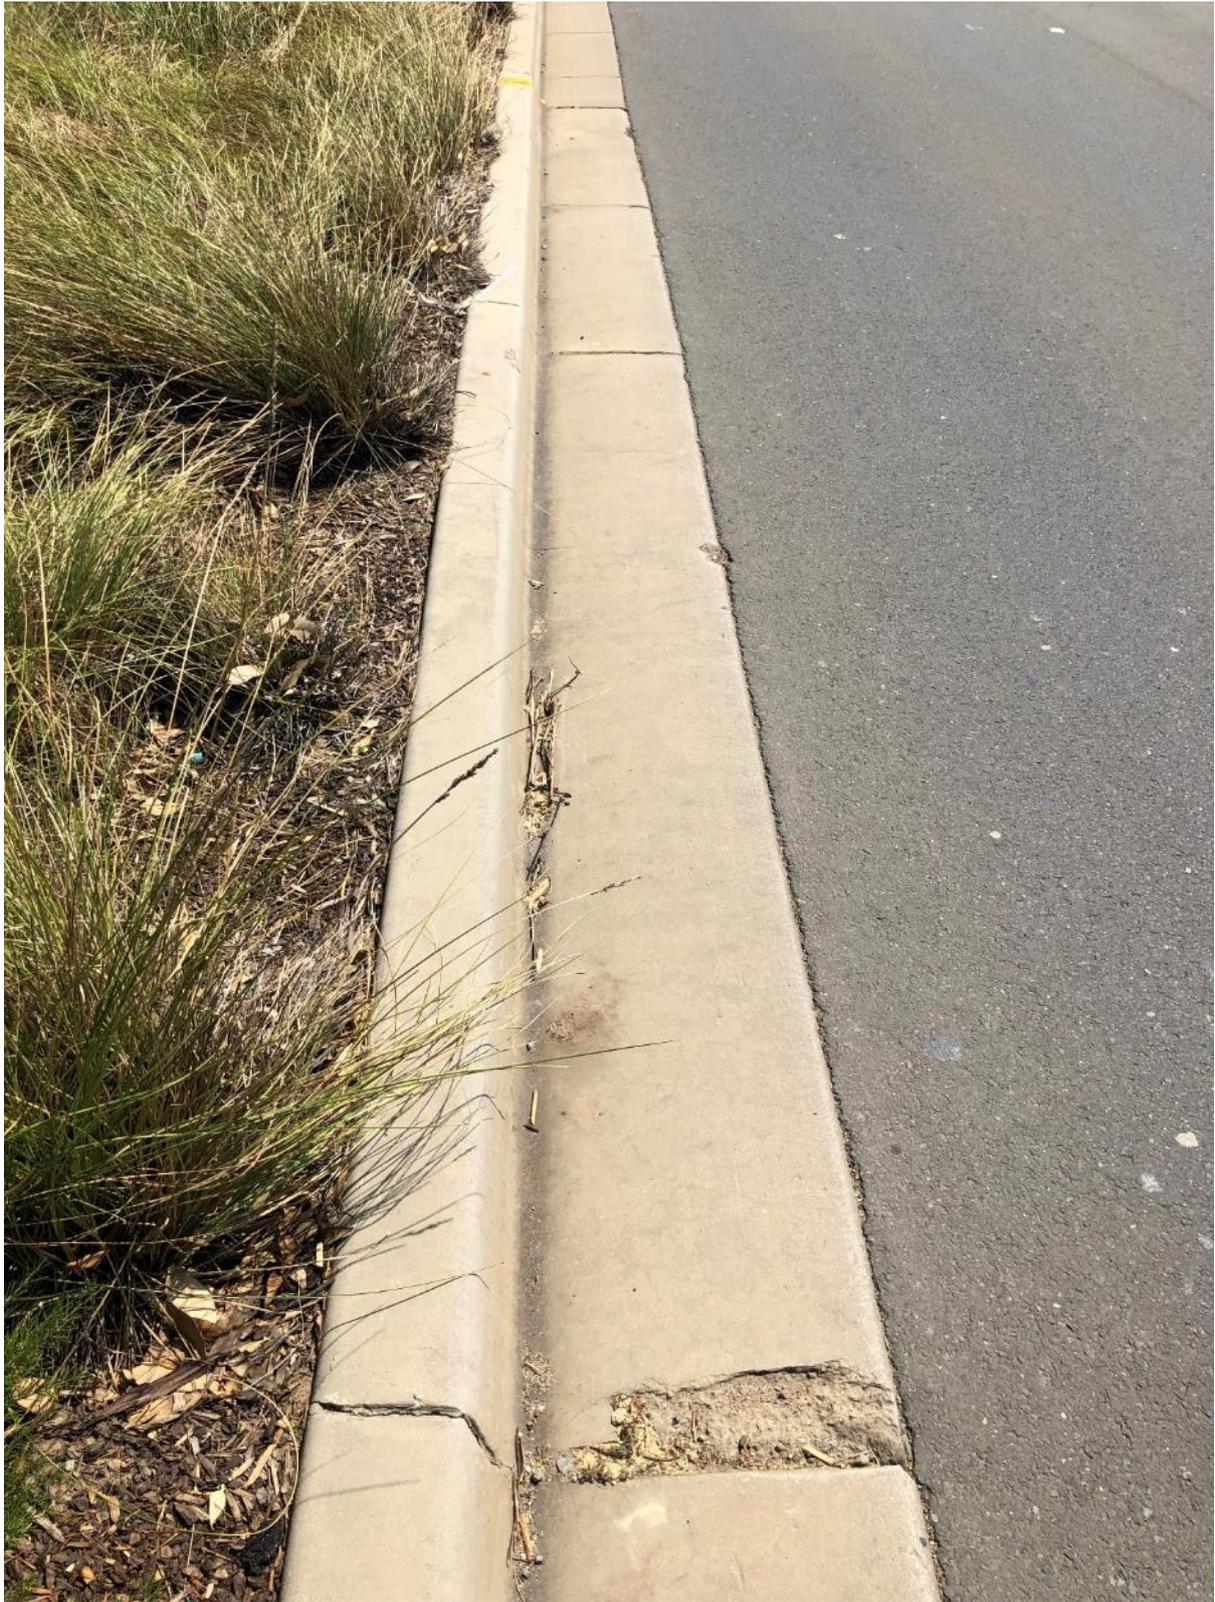
Figure 55: spalling to gutter, expansion joint interface.

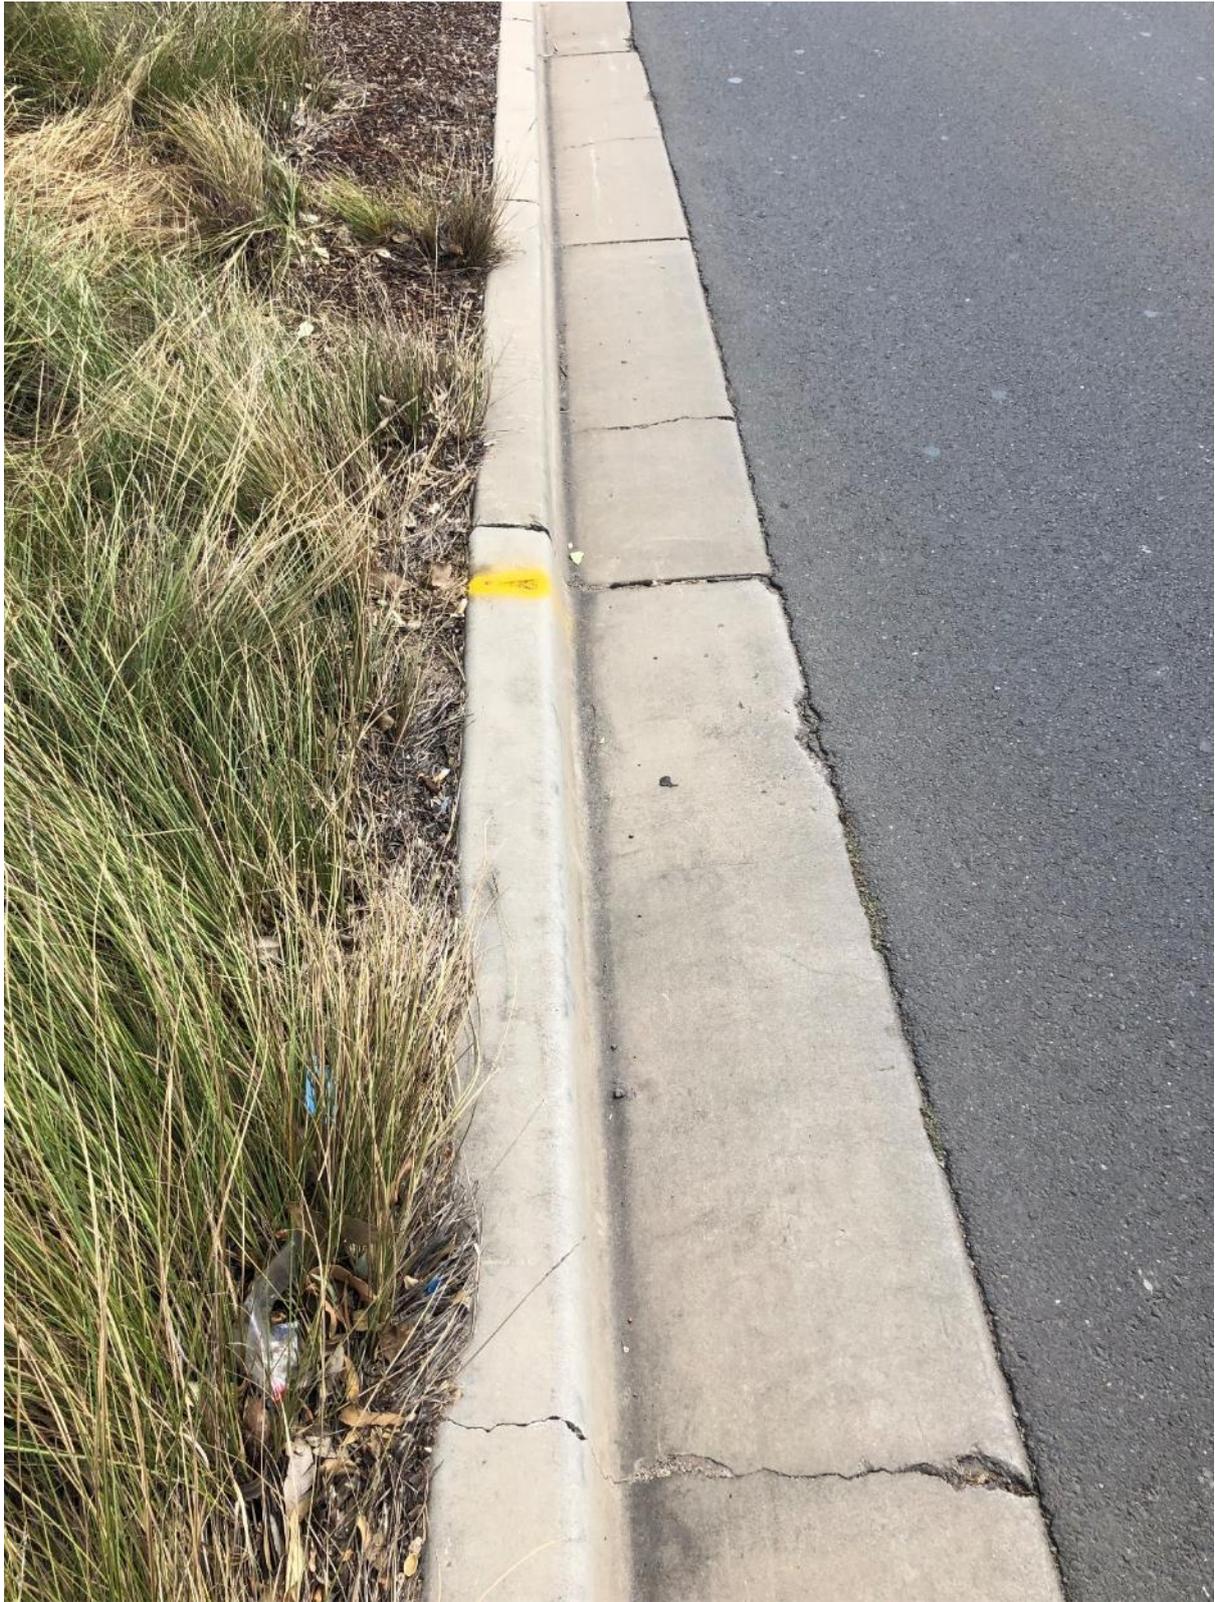
Figure 56: crack on kerb and gutter.

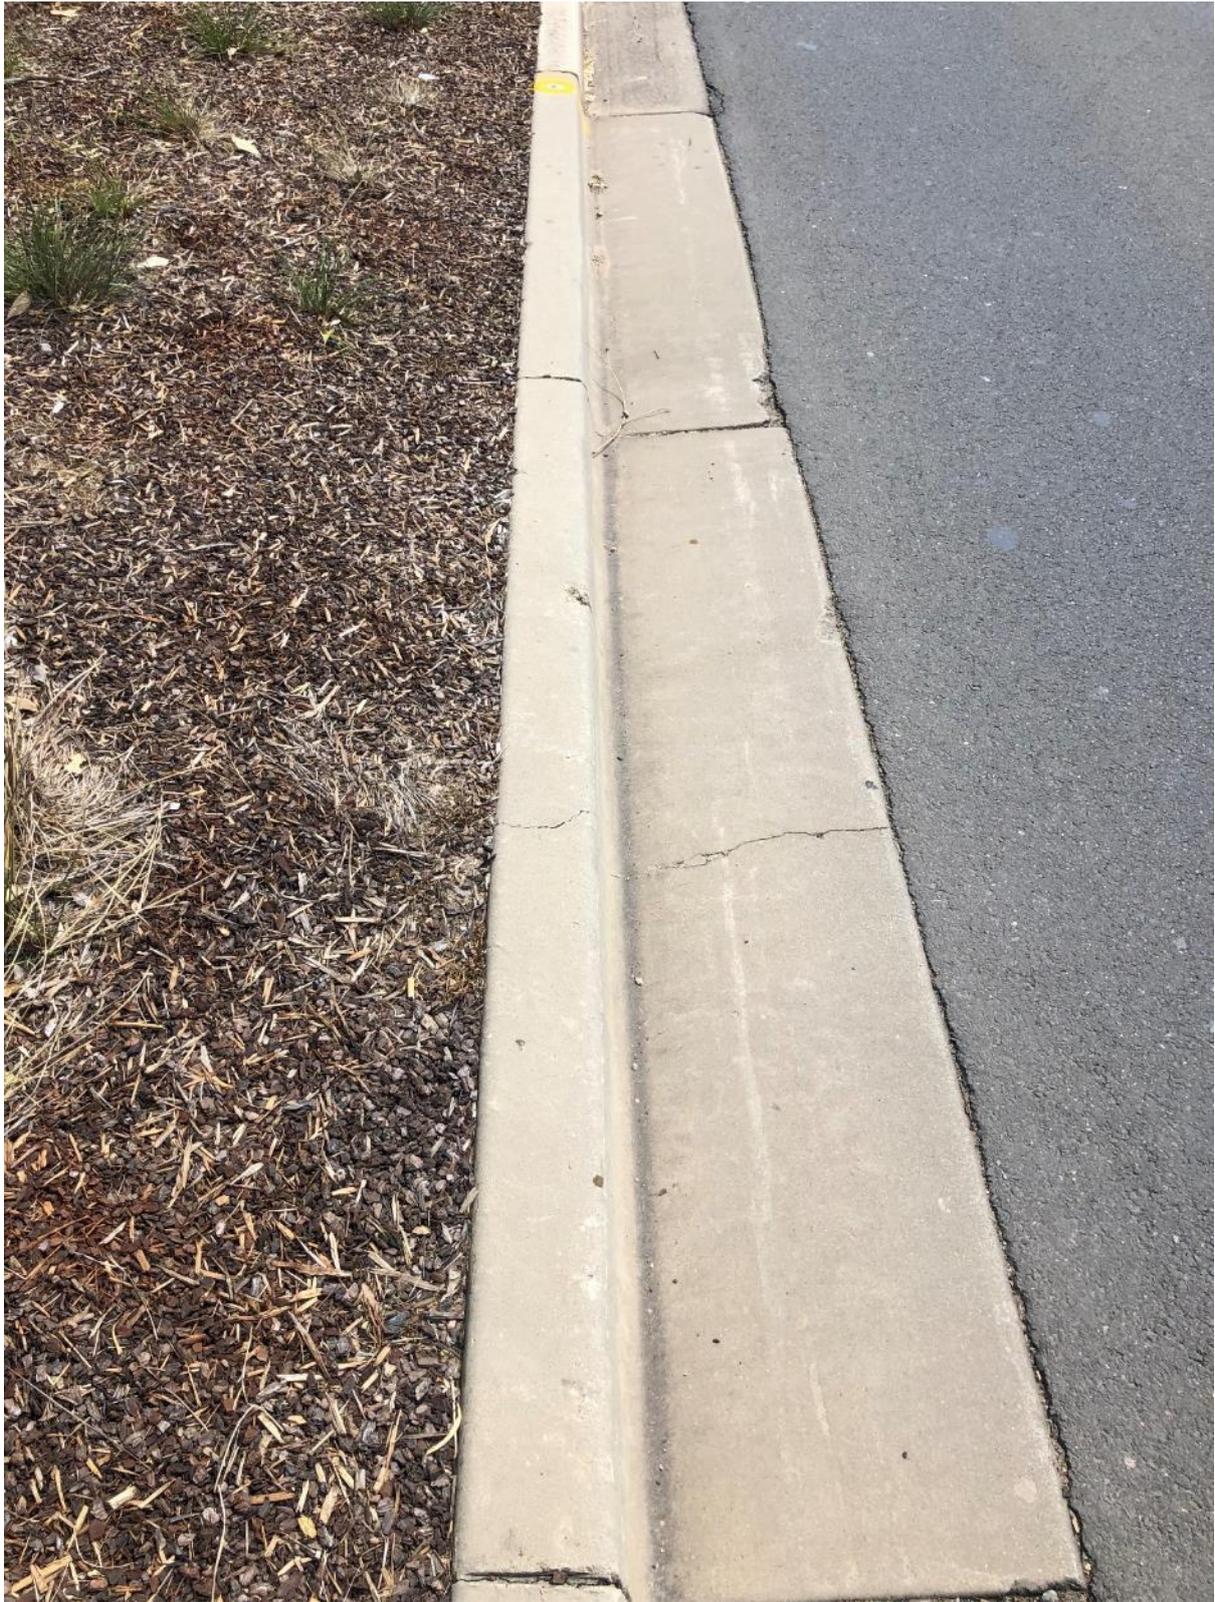
Figure 57: cracking on kerb and gutter as well as chips to gutter.

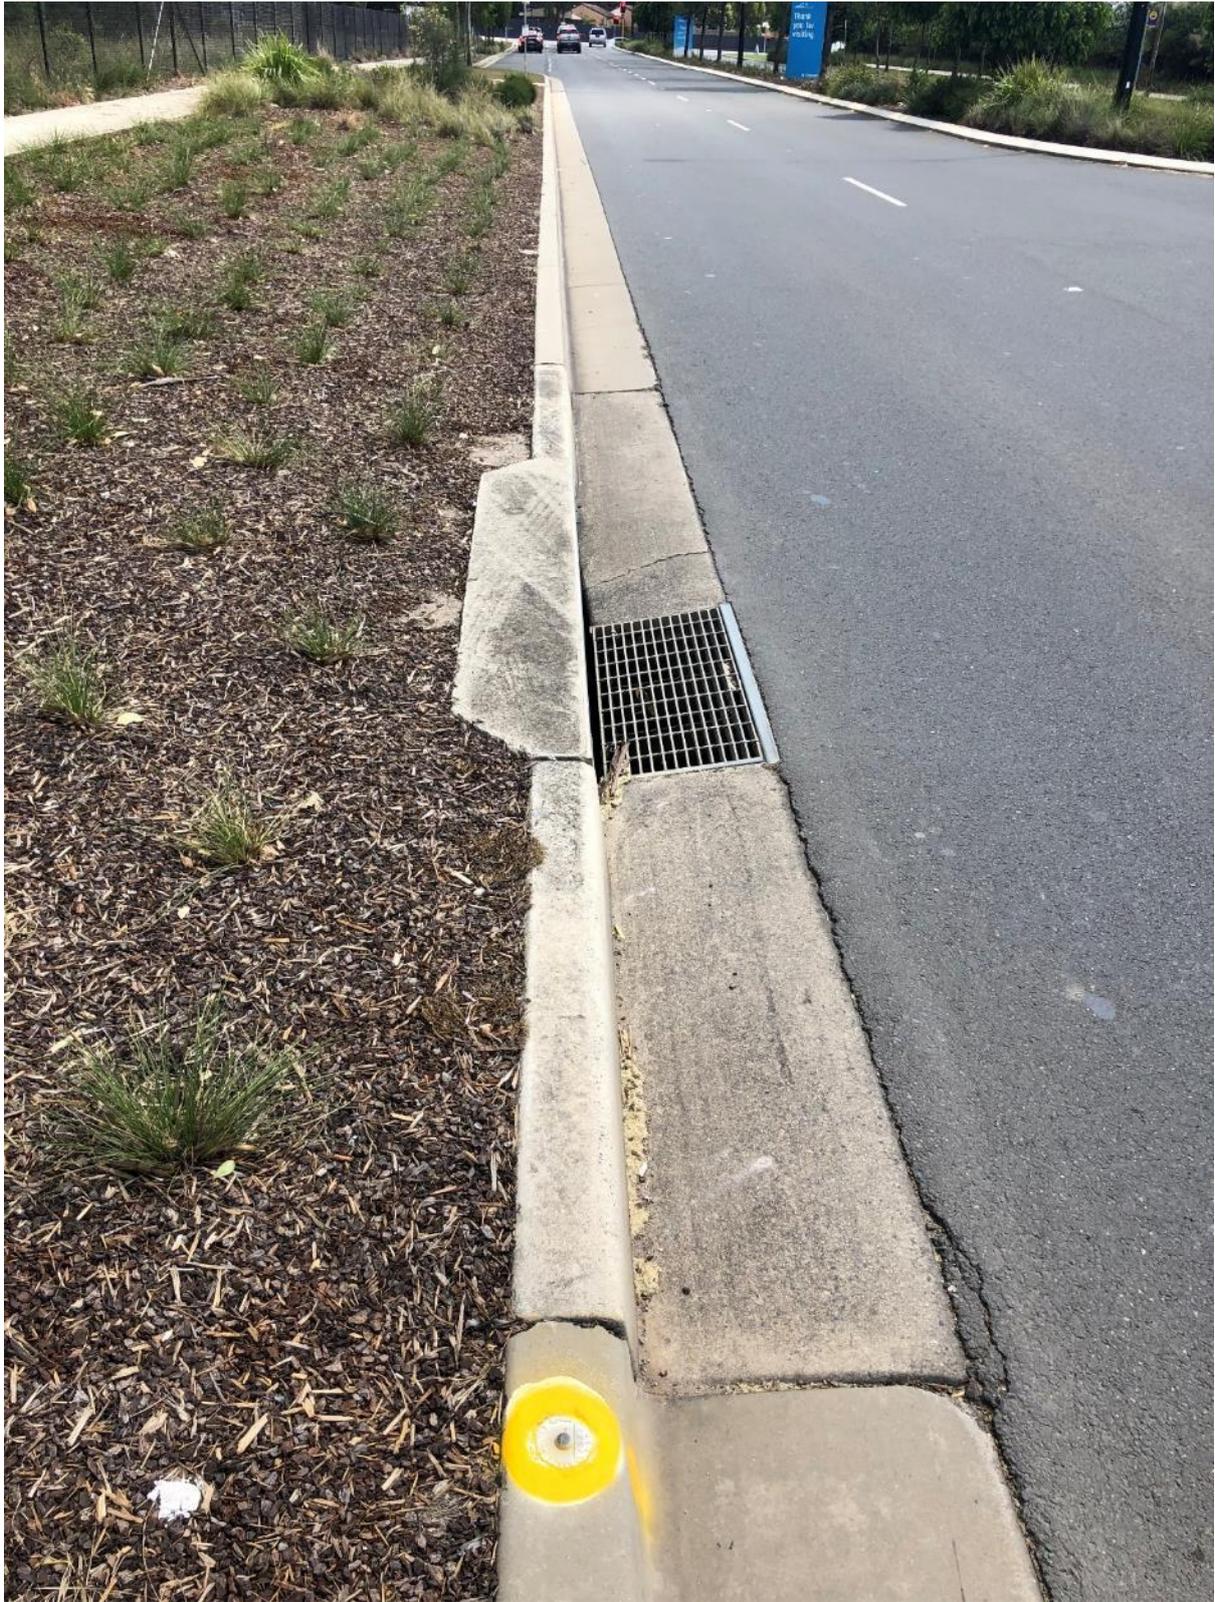
Figure 58: damage to asphalt (adjacent to expansion joint), cracking to gutter (adjacent to SW pit) and damage to top of gutter (expansion joint interface).
