J K Williams Contracting Pty Ltd

Dilapidation Report

Proposed Works - Jordan Springs Stage 2 Retirement Living

James Sae Siew
5th March 2019
Revision 1

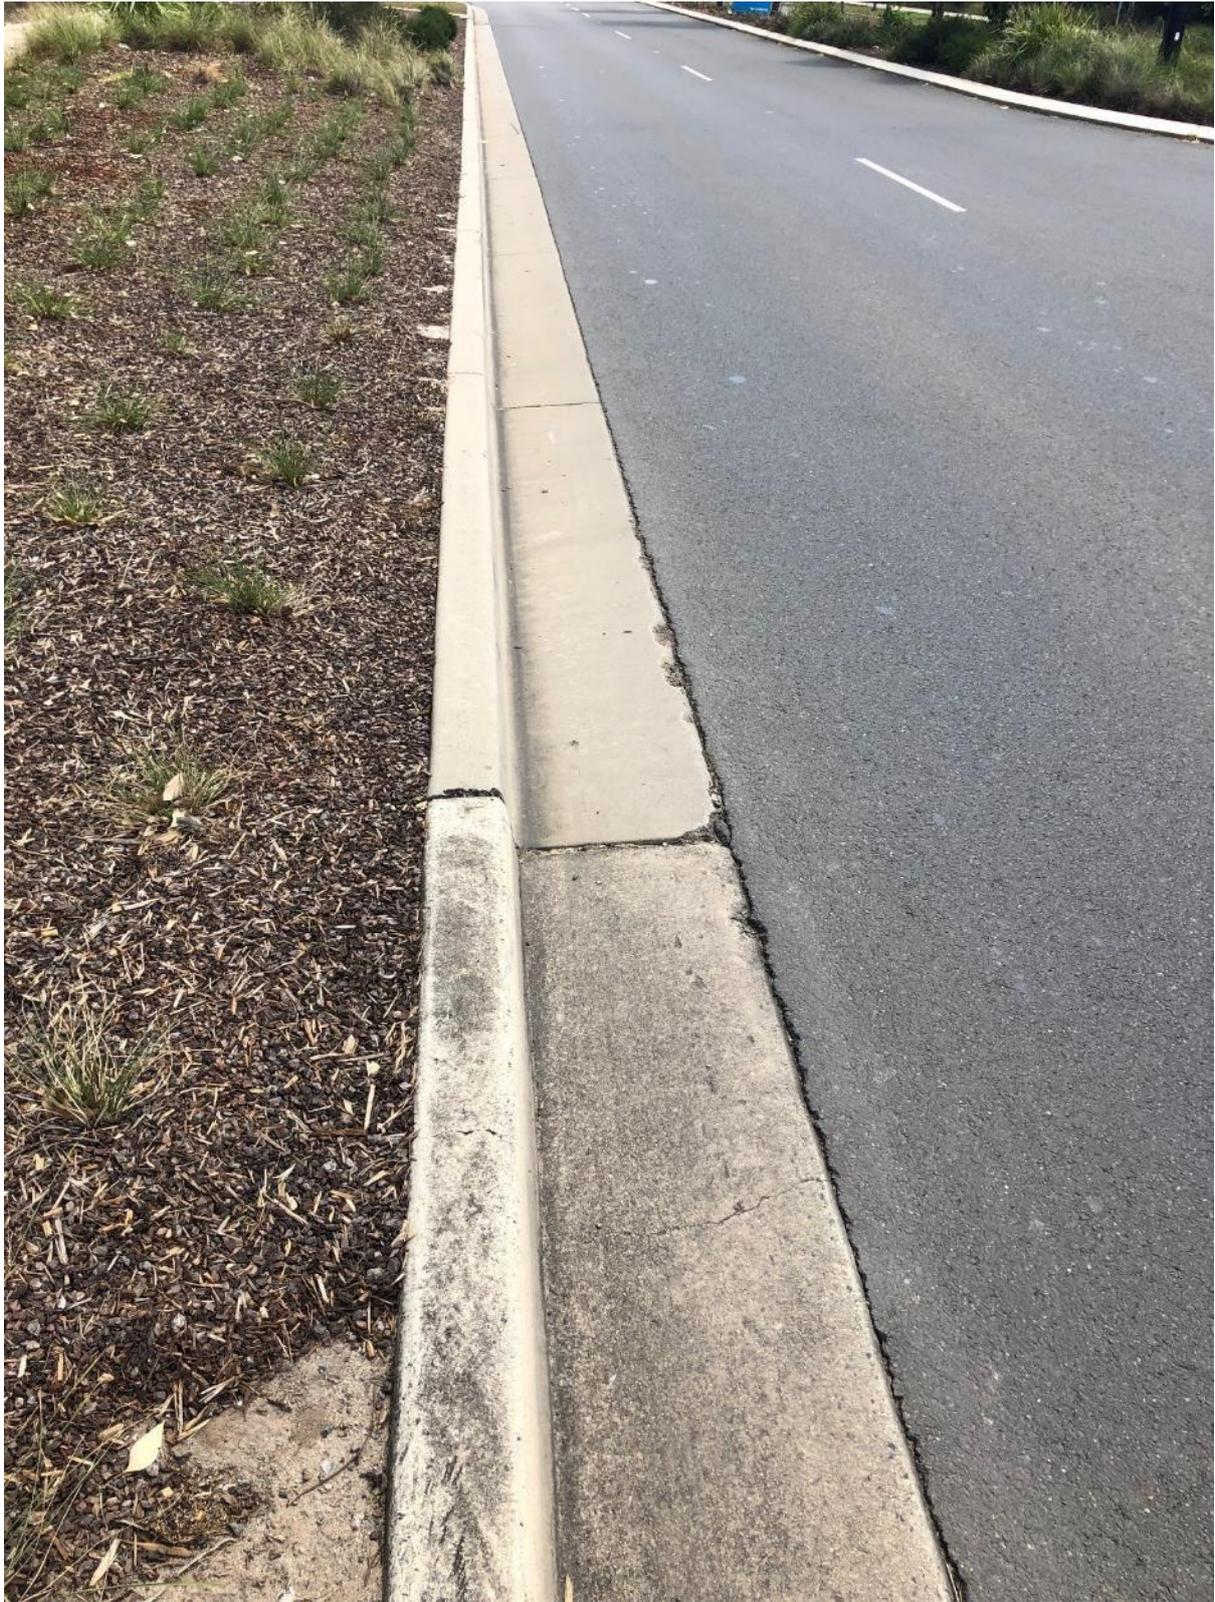
Figure 59: chip to gutter and cracking to kerb and gutter.

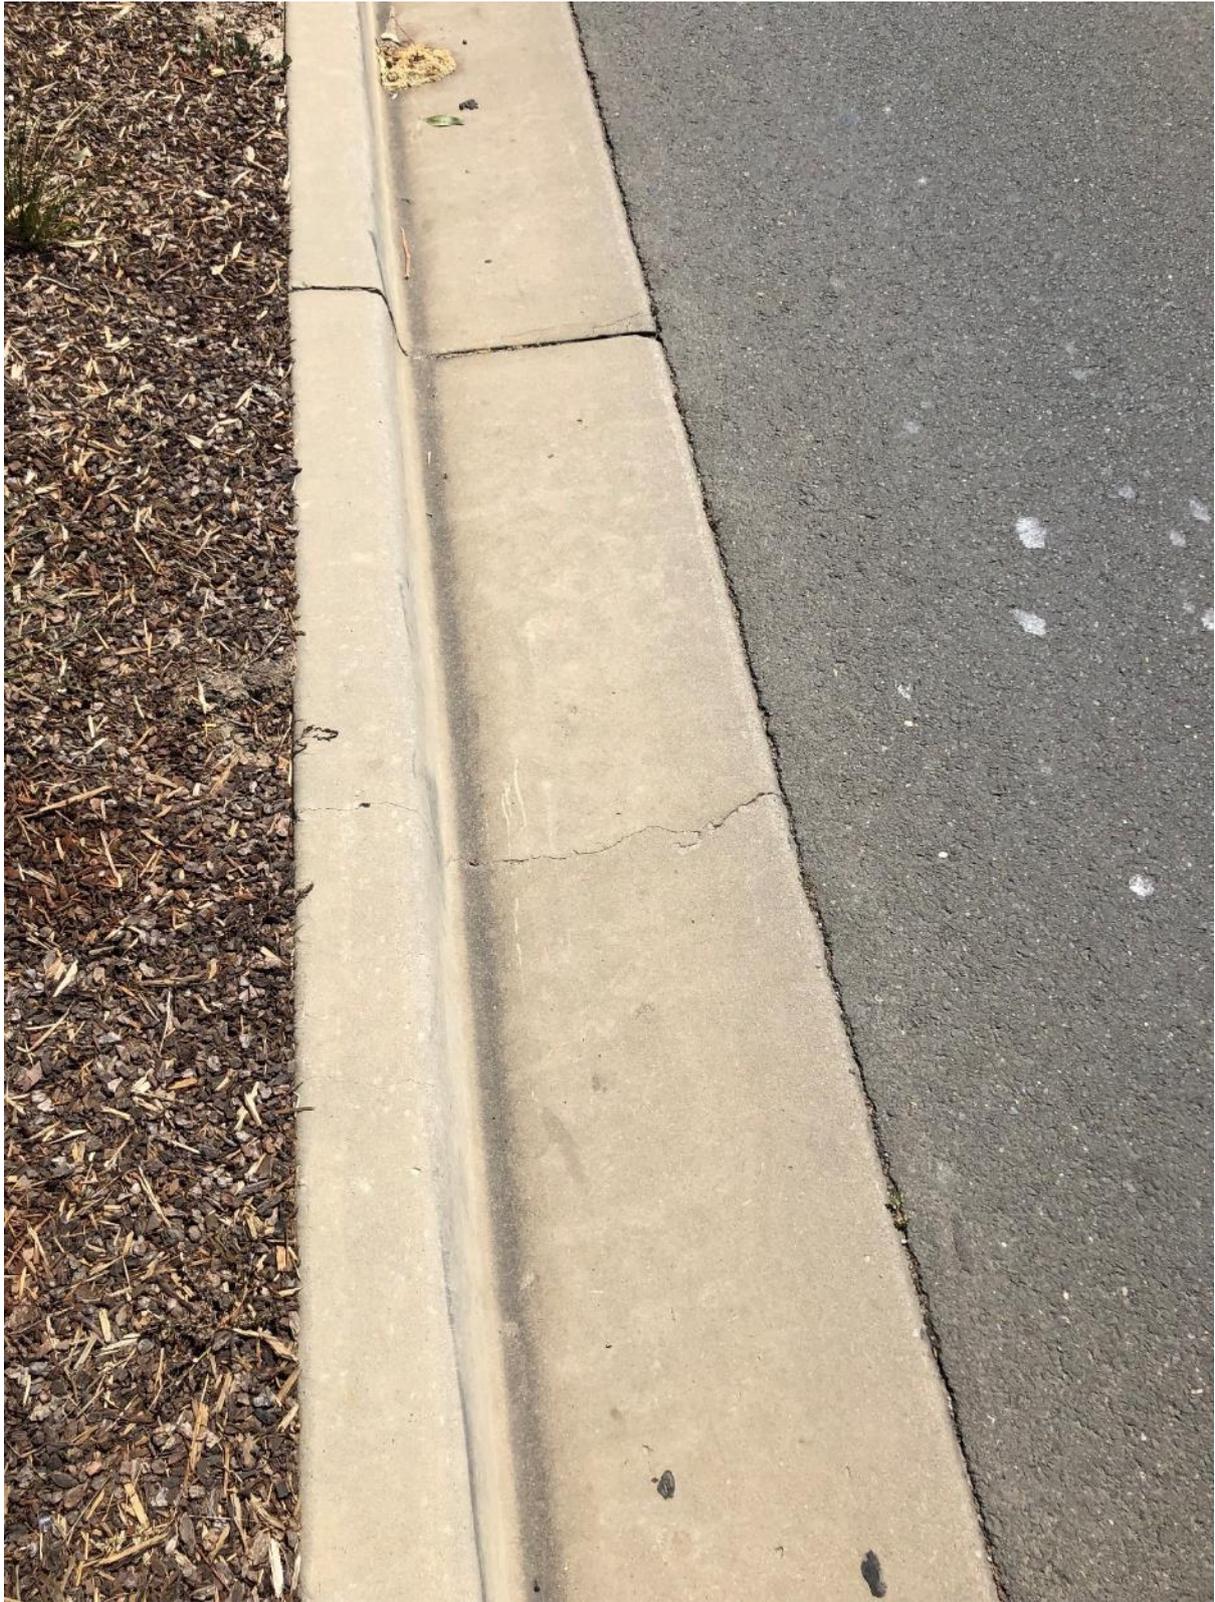
Figure 60: cracking to kerb and gutter.

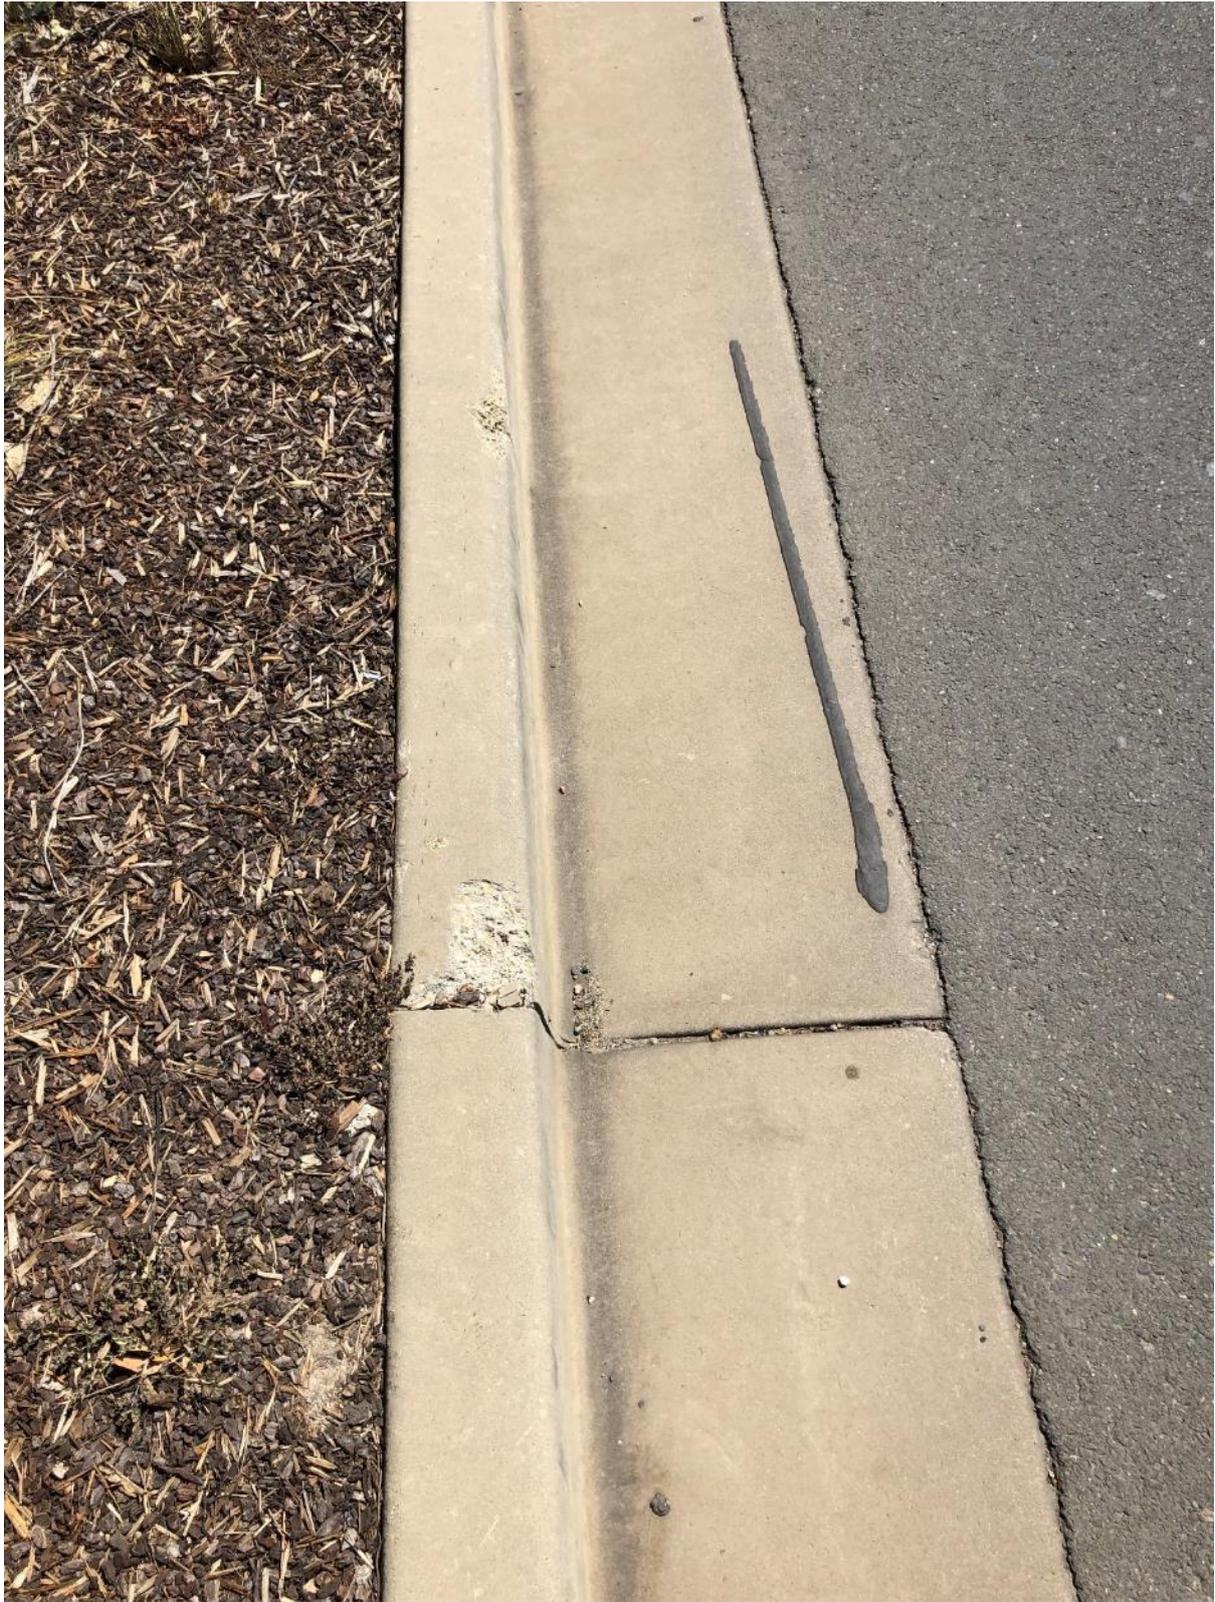
Figure 61: chip to top of kerb. Crack seal residue on gutter.

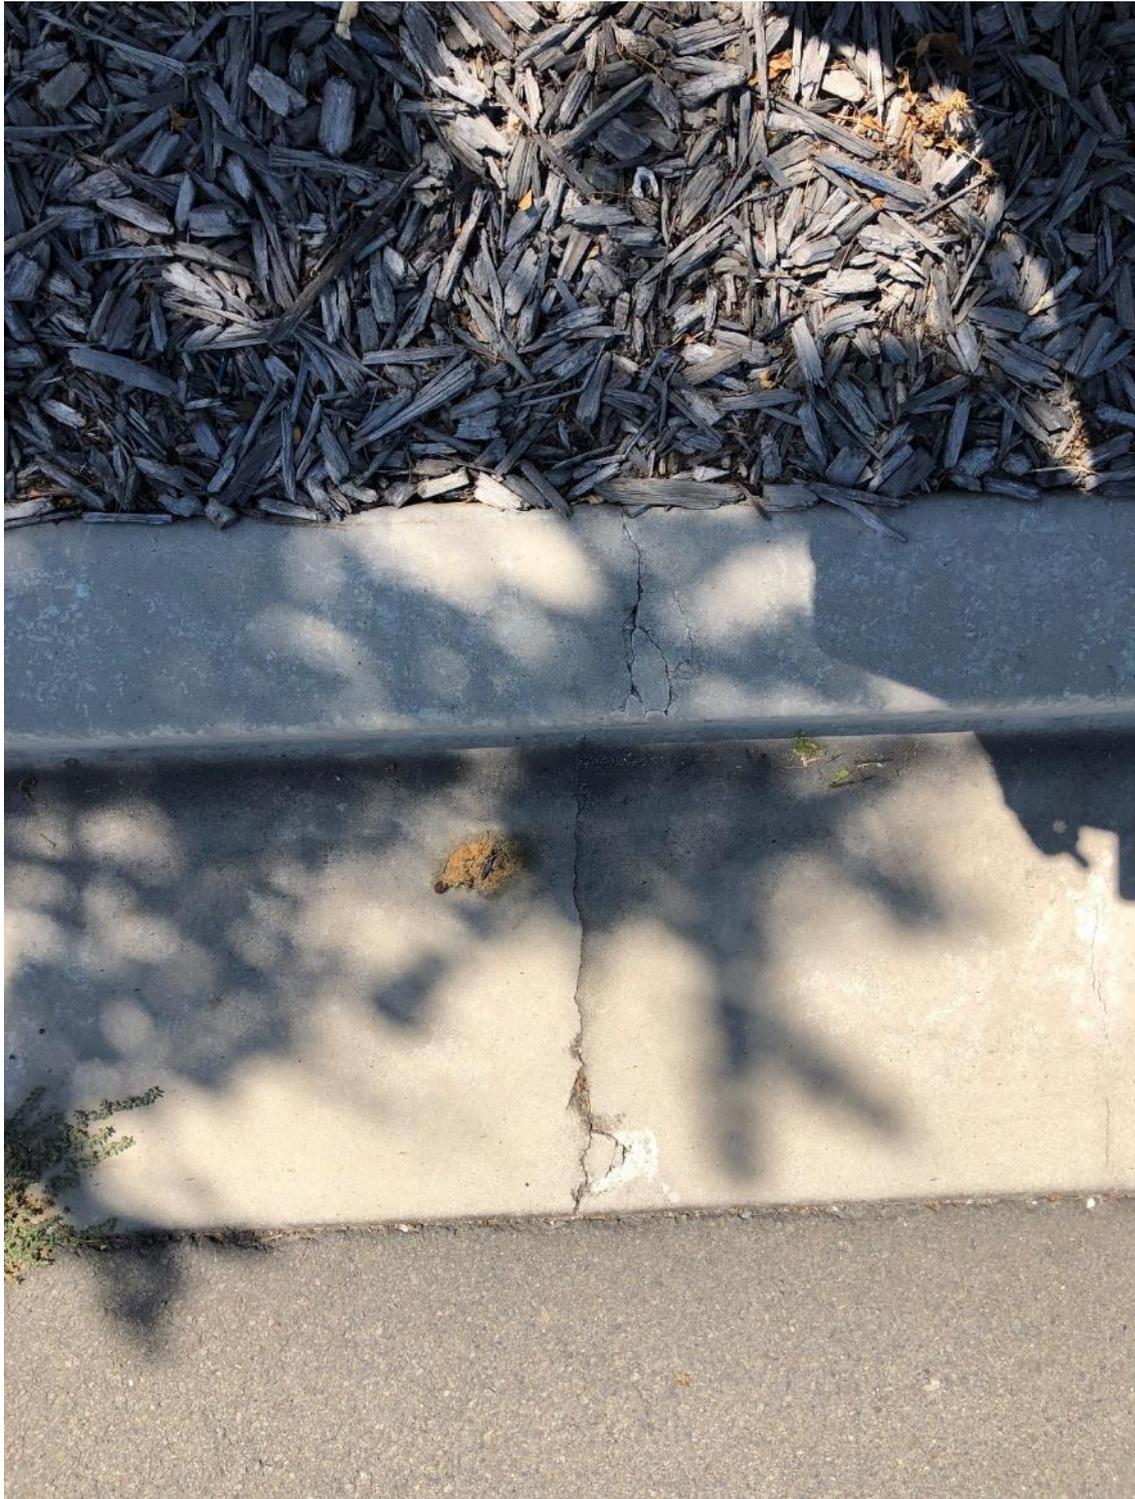
Figure 62: cracking to kerb and gutter.

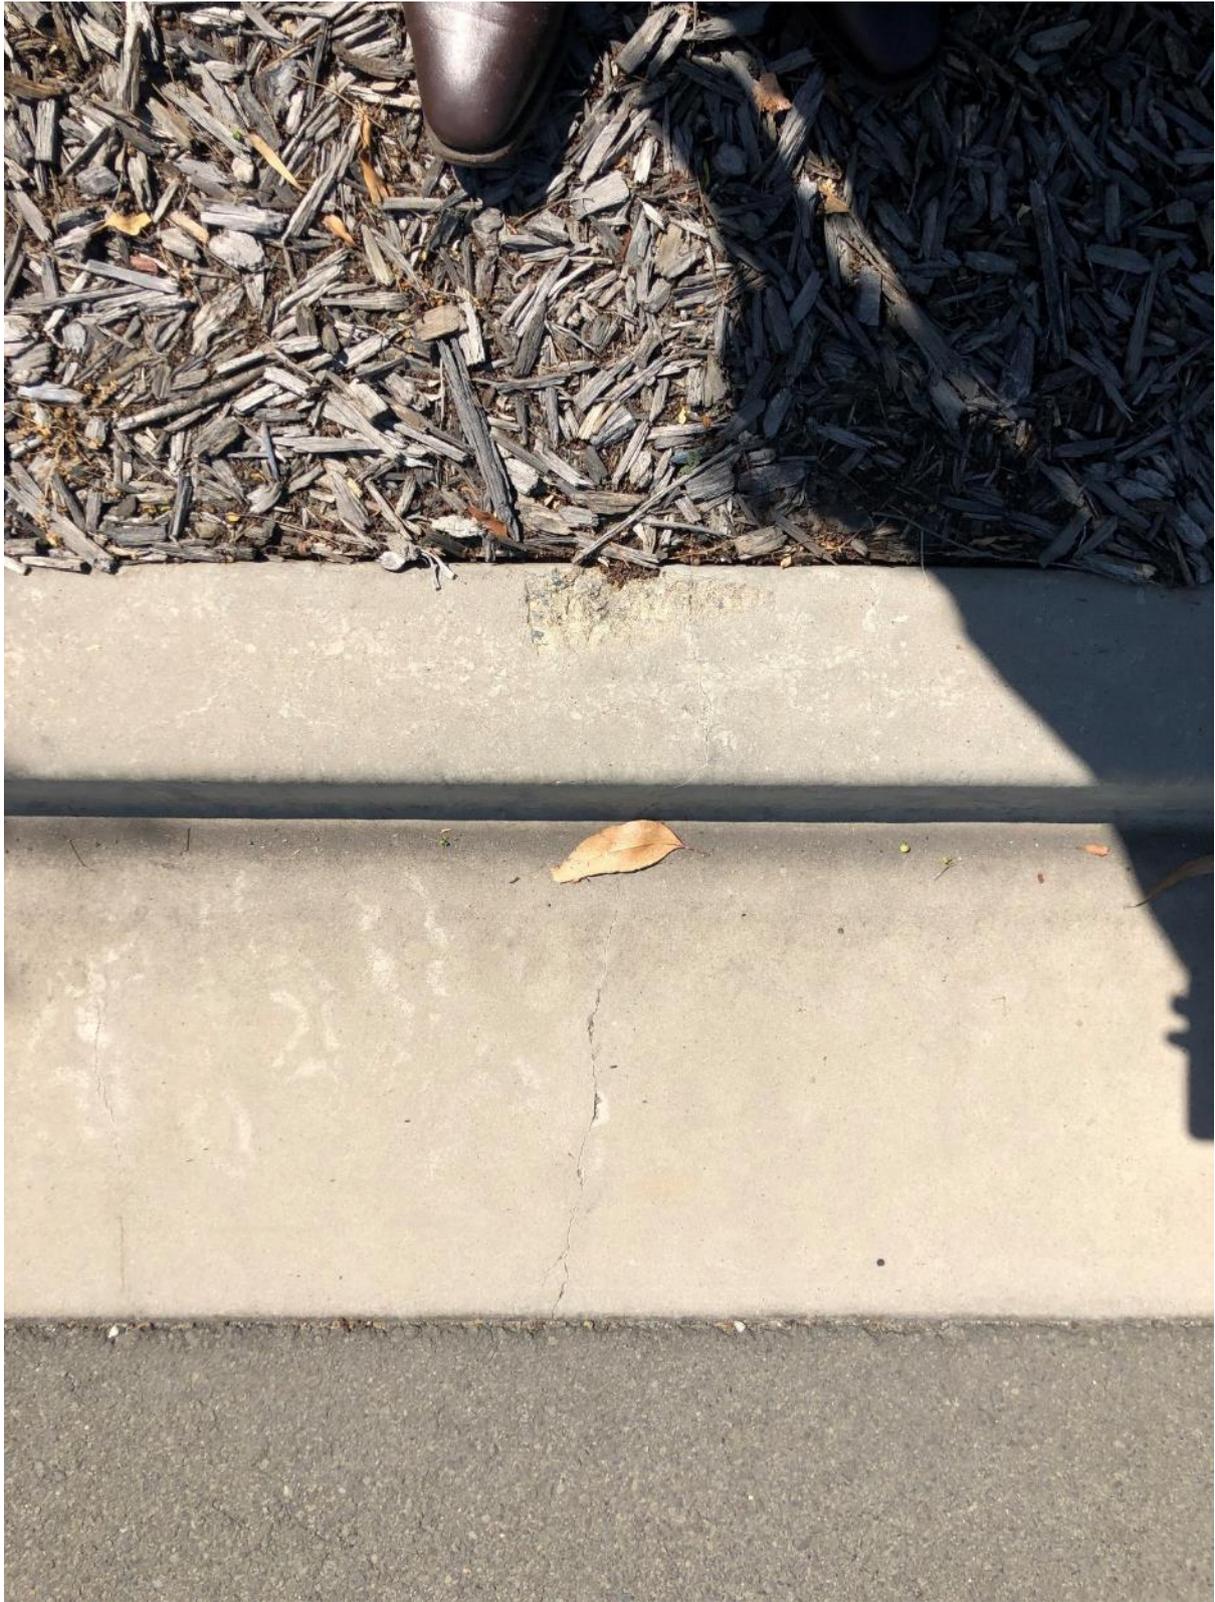
Figure 63: chip on top of kerb and minor cracking on gutter.

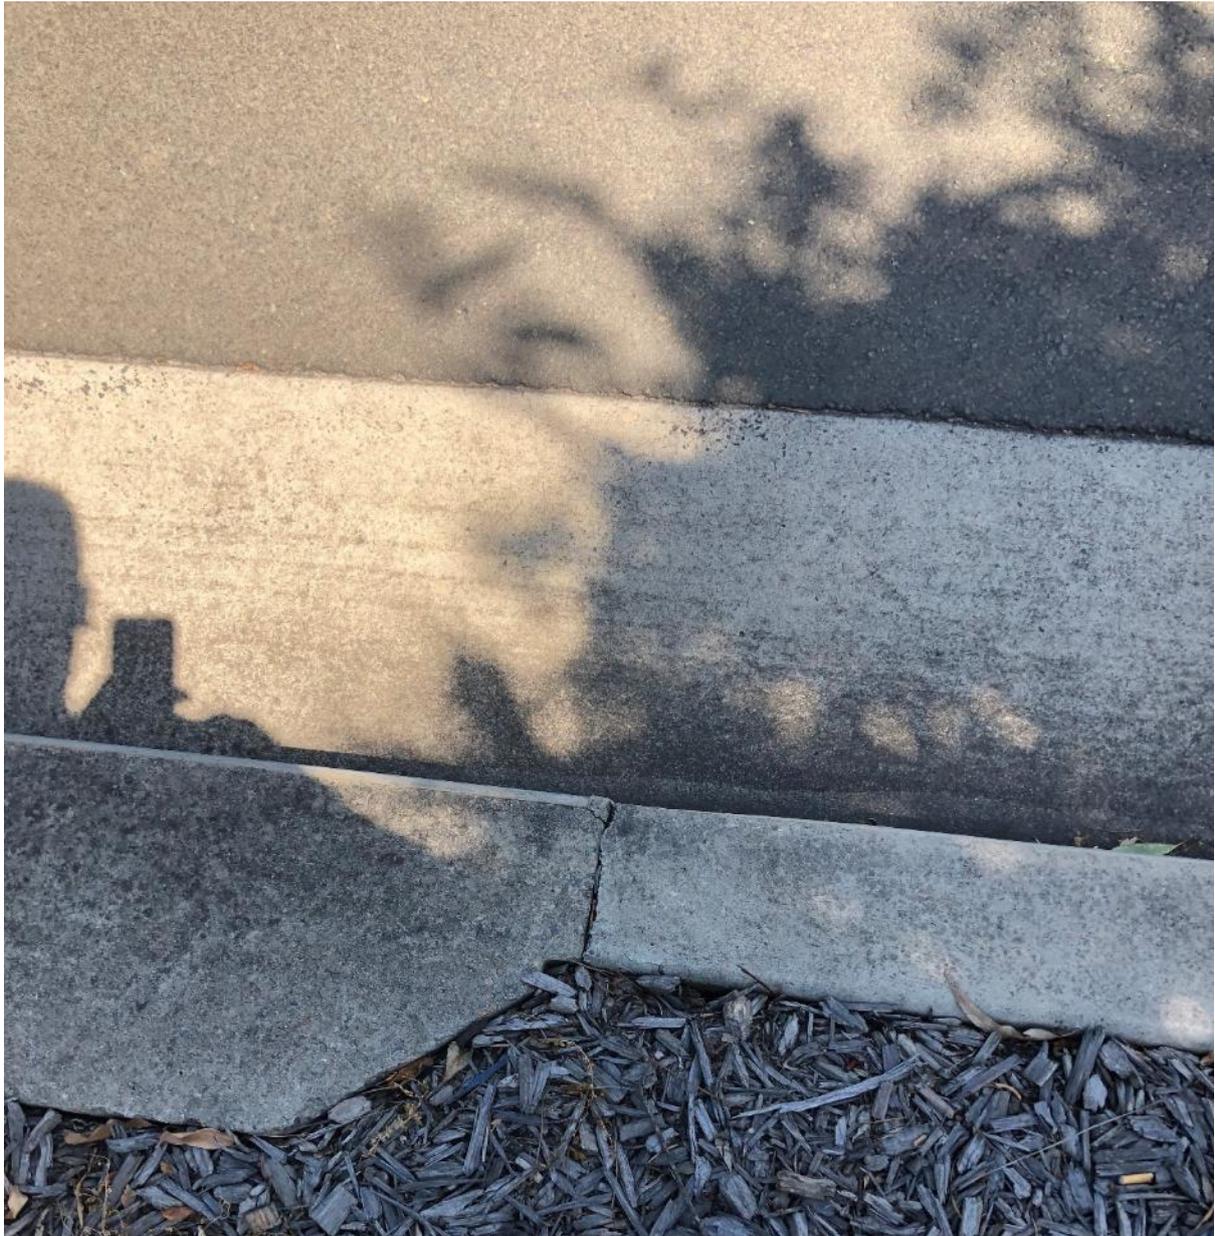
Figure 64: cracking at lintel and kerb joint (both sides of lintel).

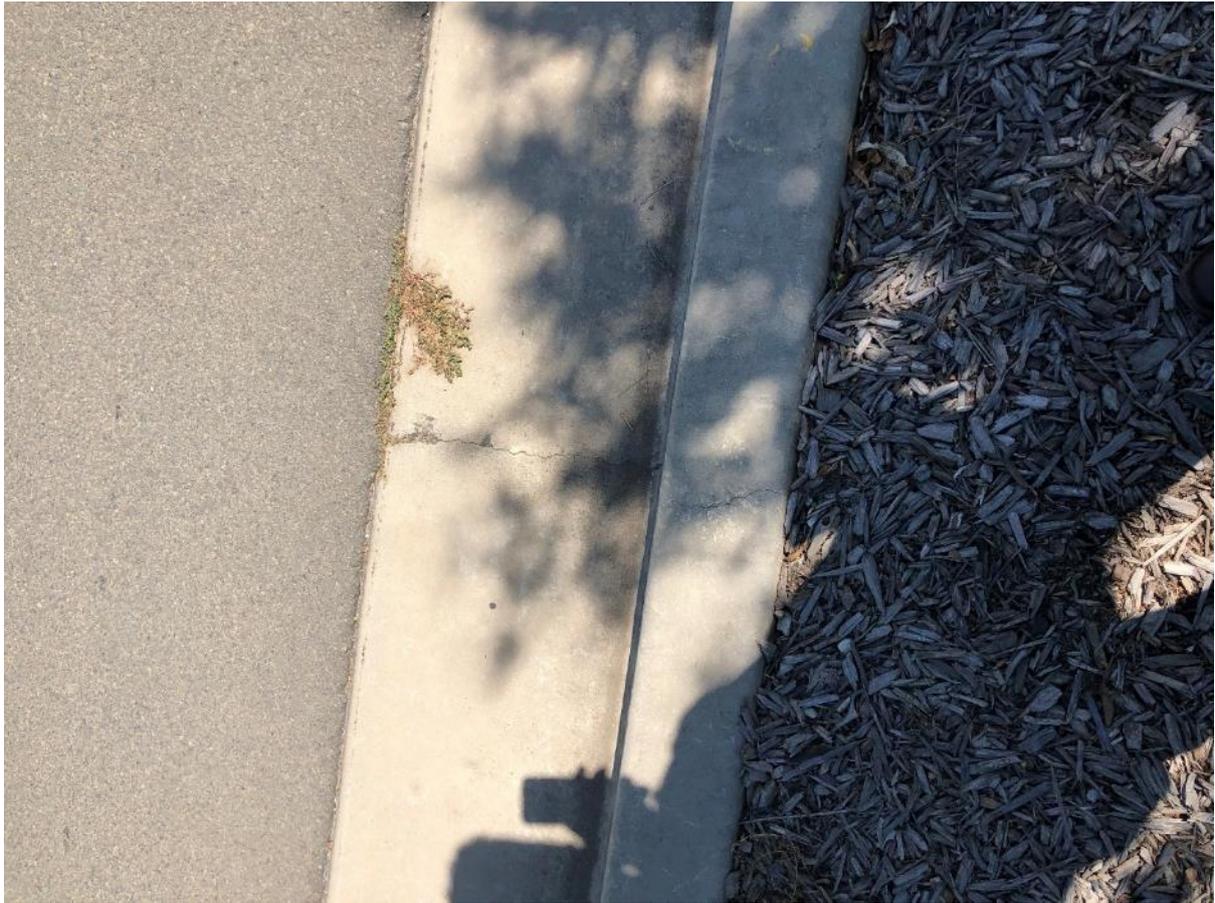
Figure 65: cracking on kerb and gutter.

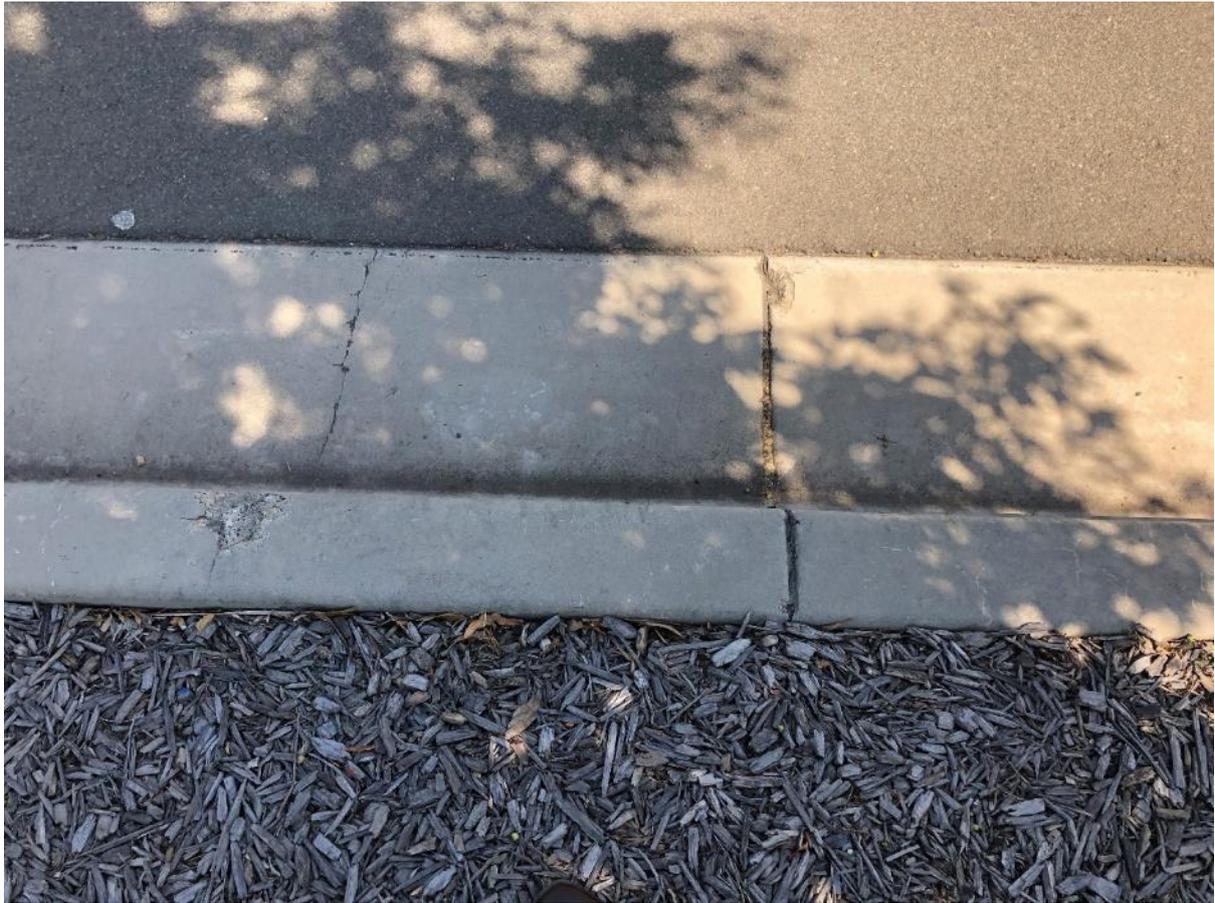
Figure 66: chip to top of kerb and cracking on gutter.

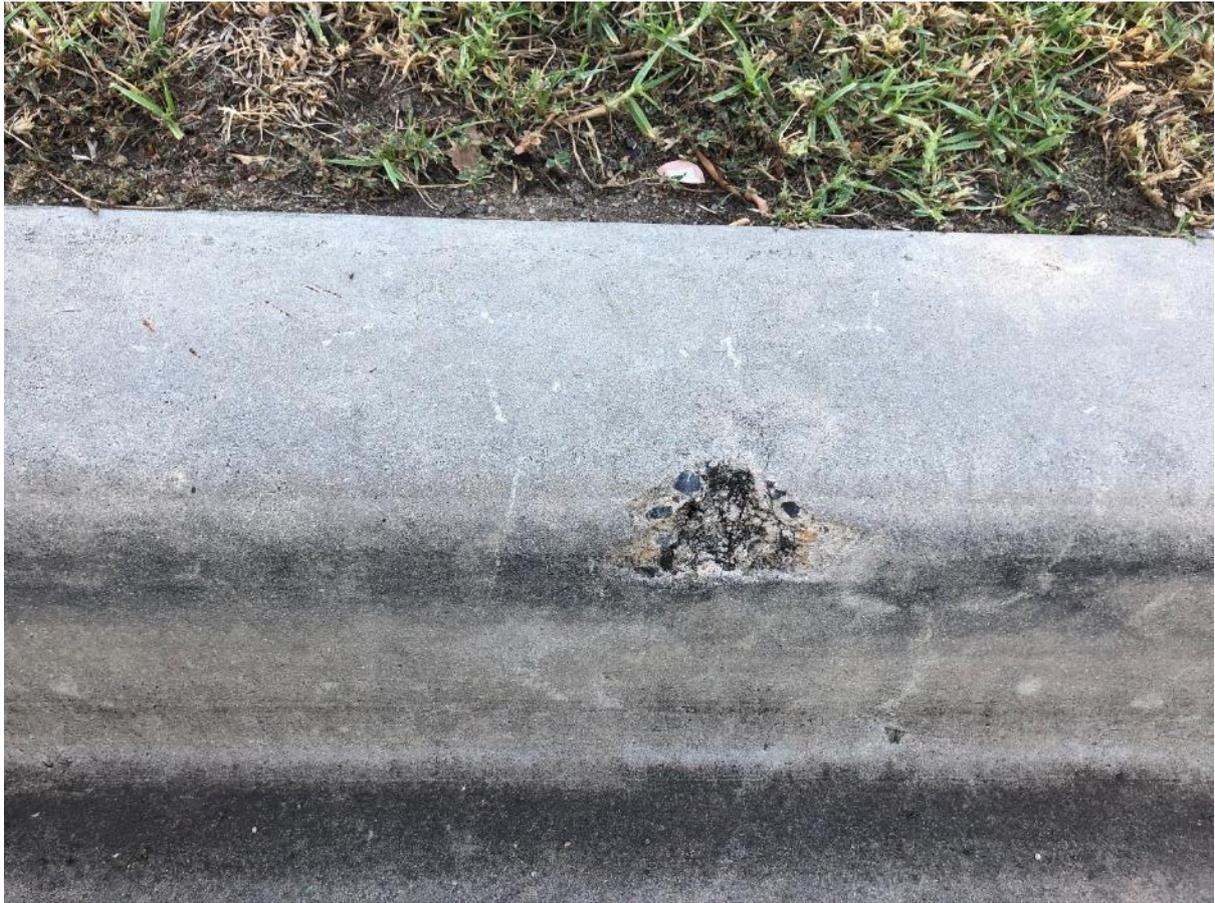
Figure 67: chip on top of kerb.

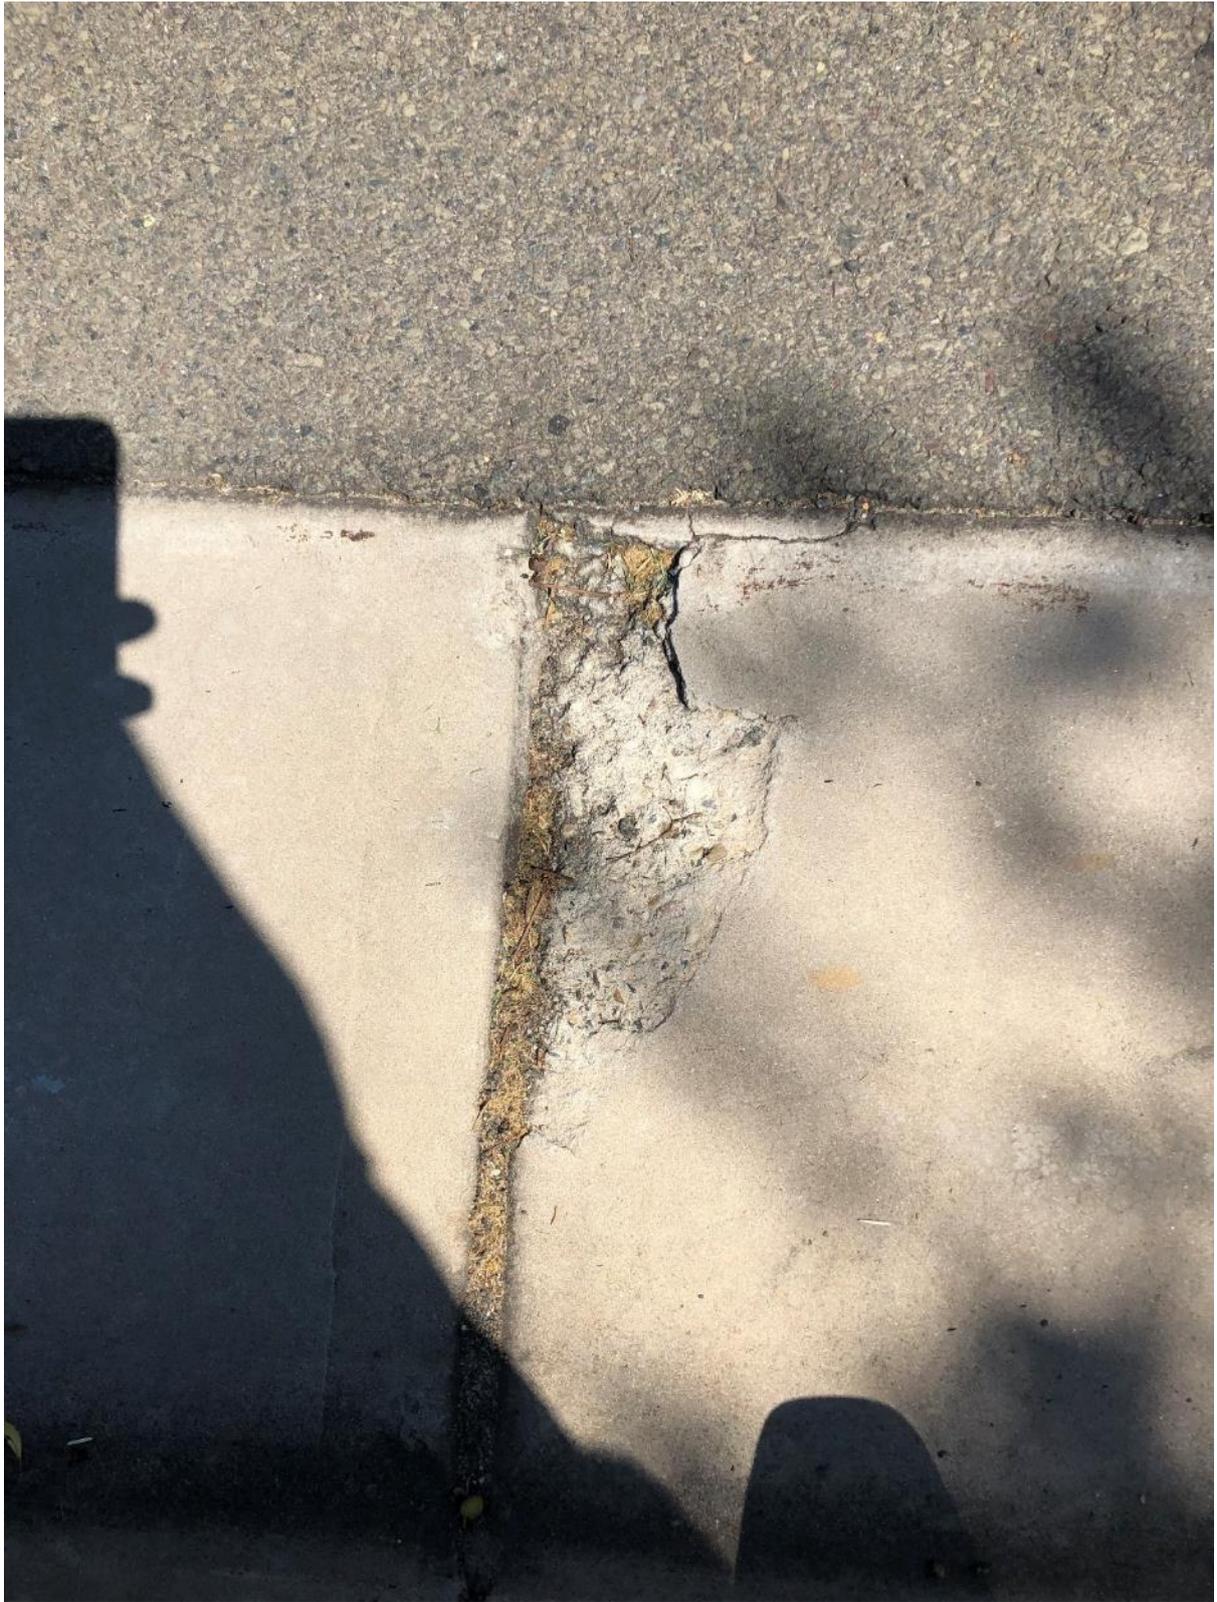
Figure 68: spalling to gutter construction joint interface.

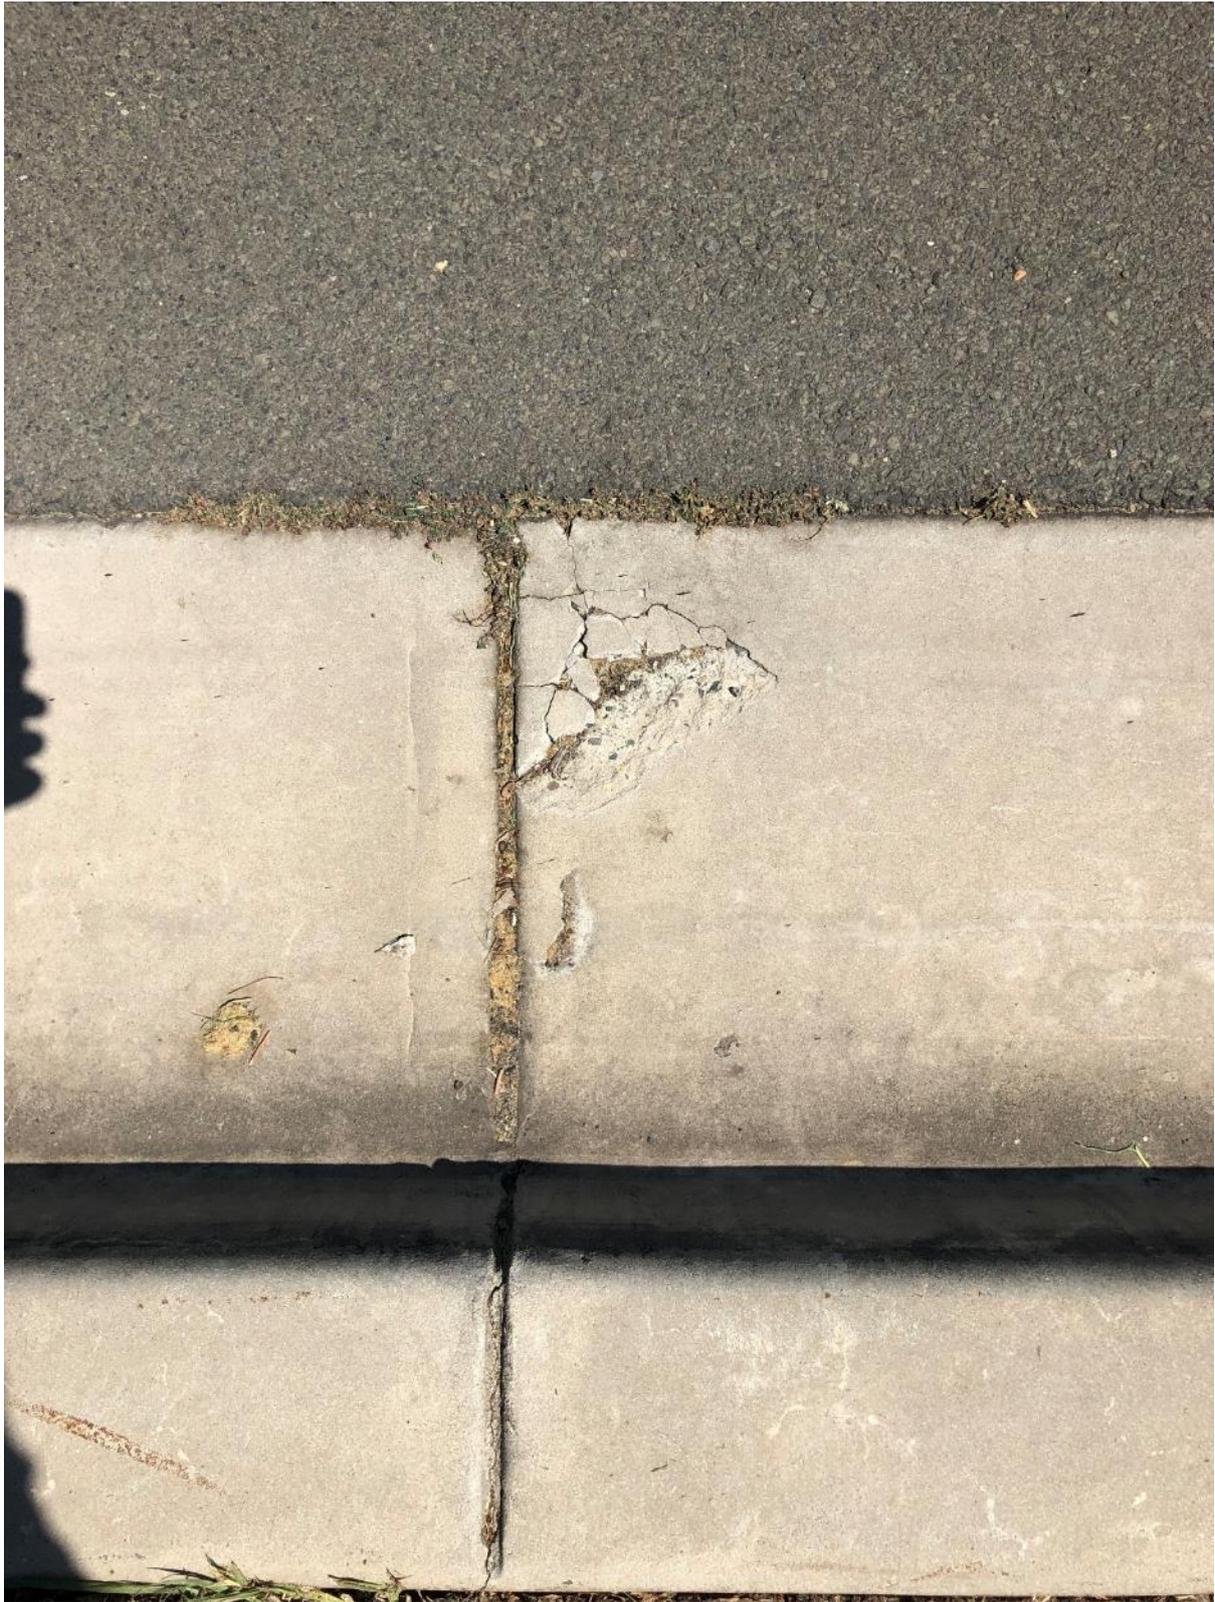
Figure 69: chip to gutter construction joint interface.

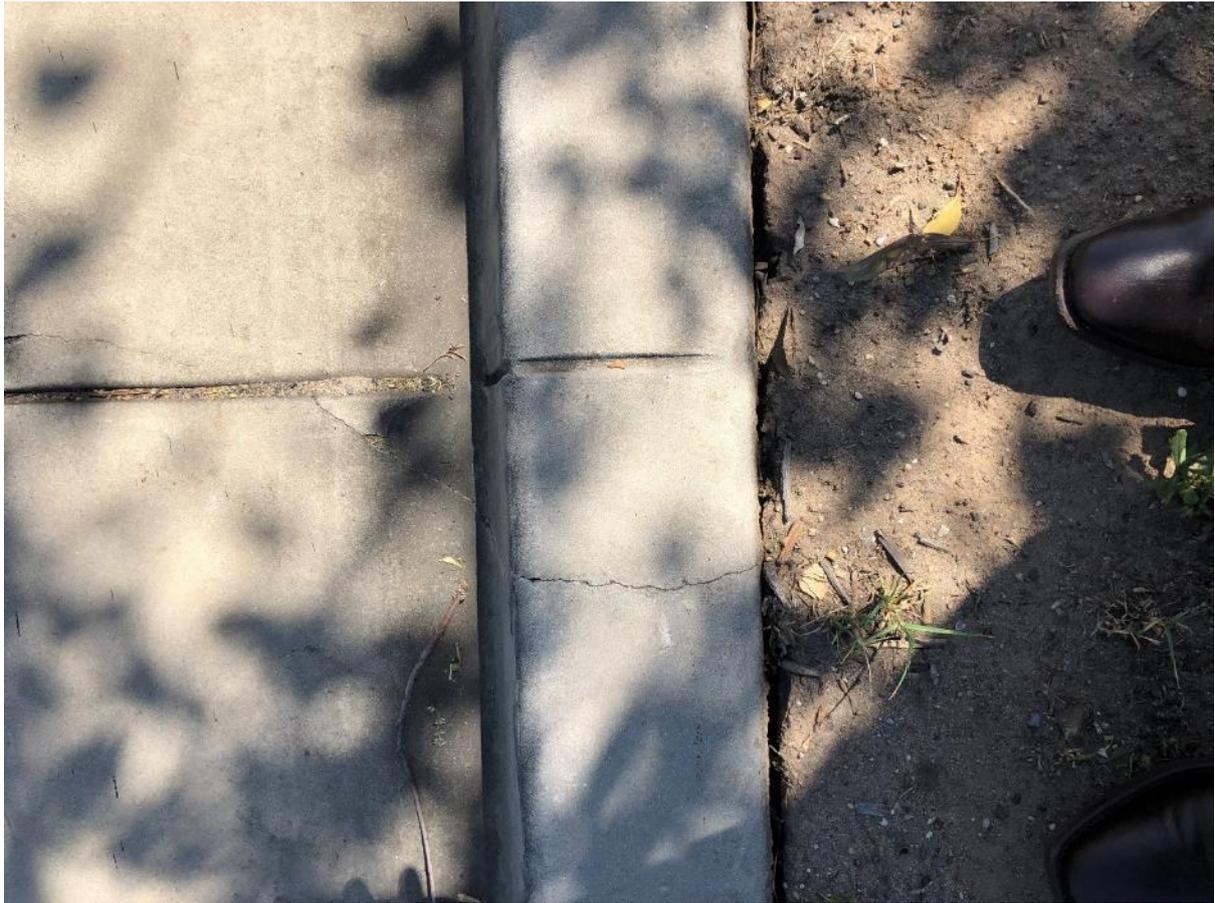
Figure 70: cracking to kerb and gutter.

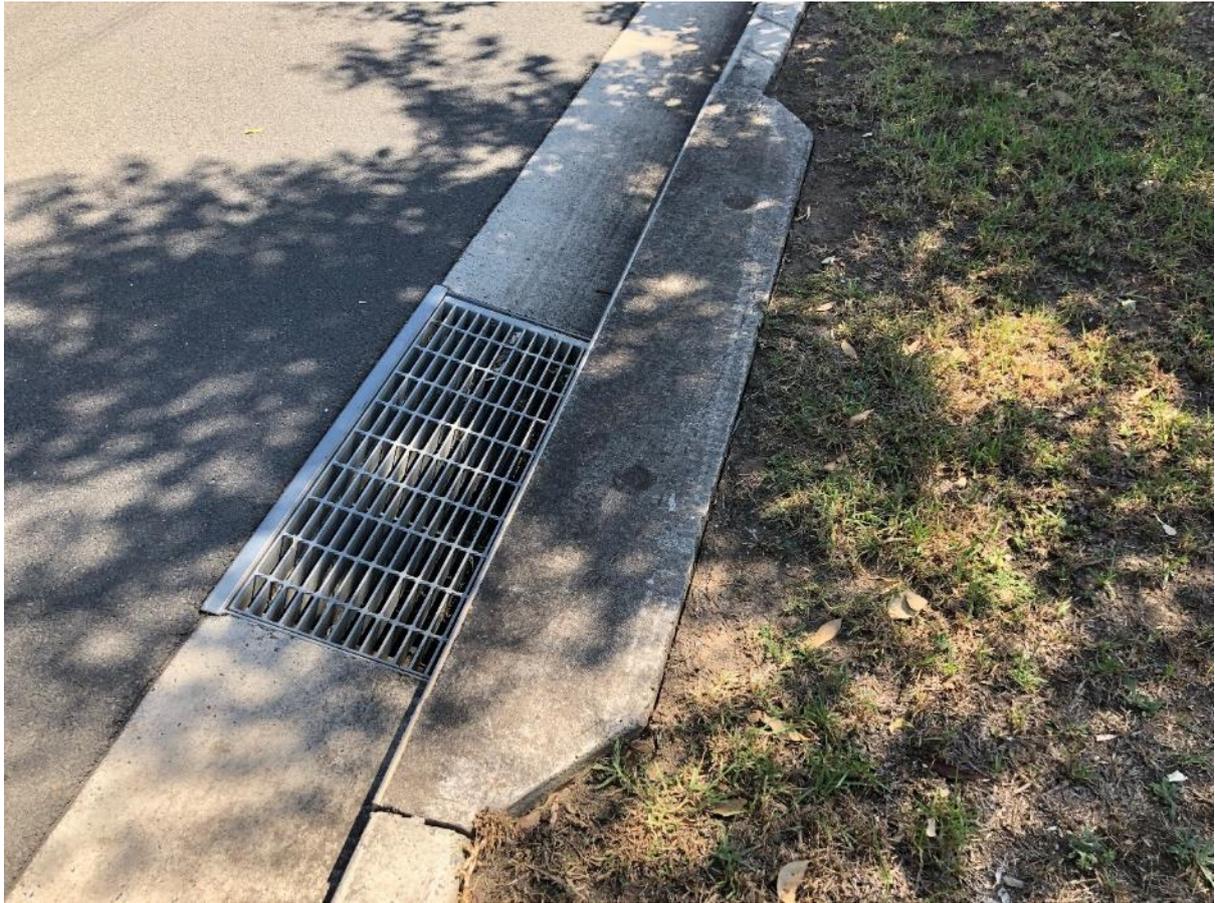
Figure 71: cracking to lintel and kerb joint (both sides).

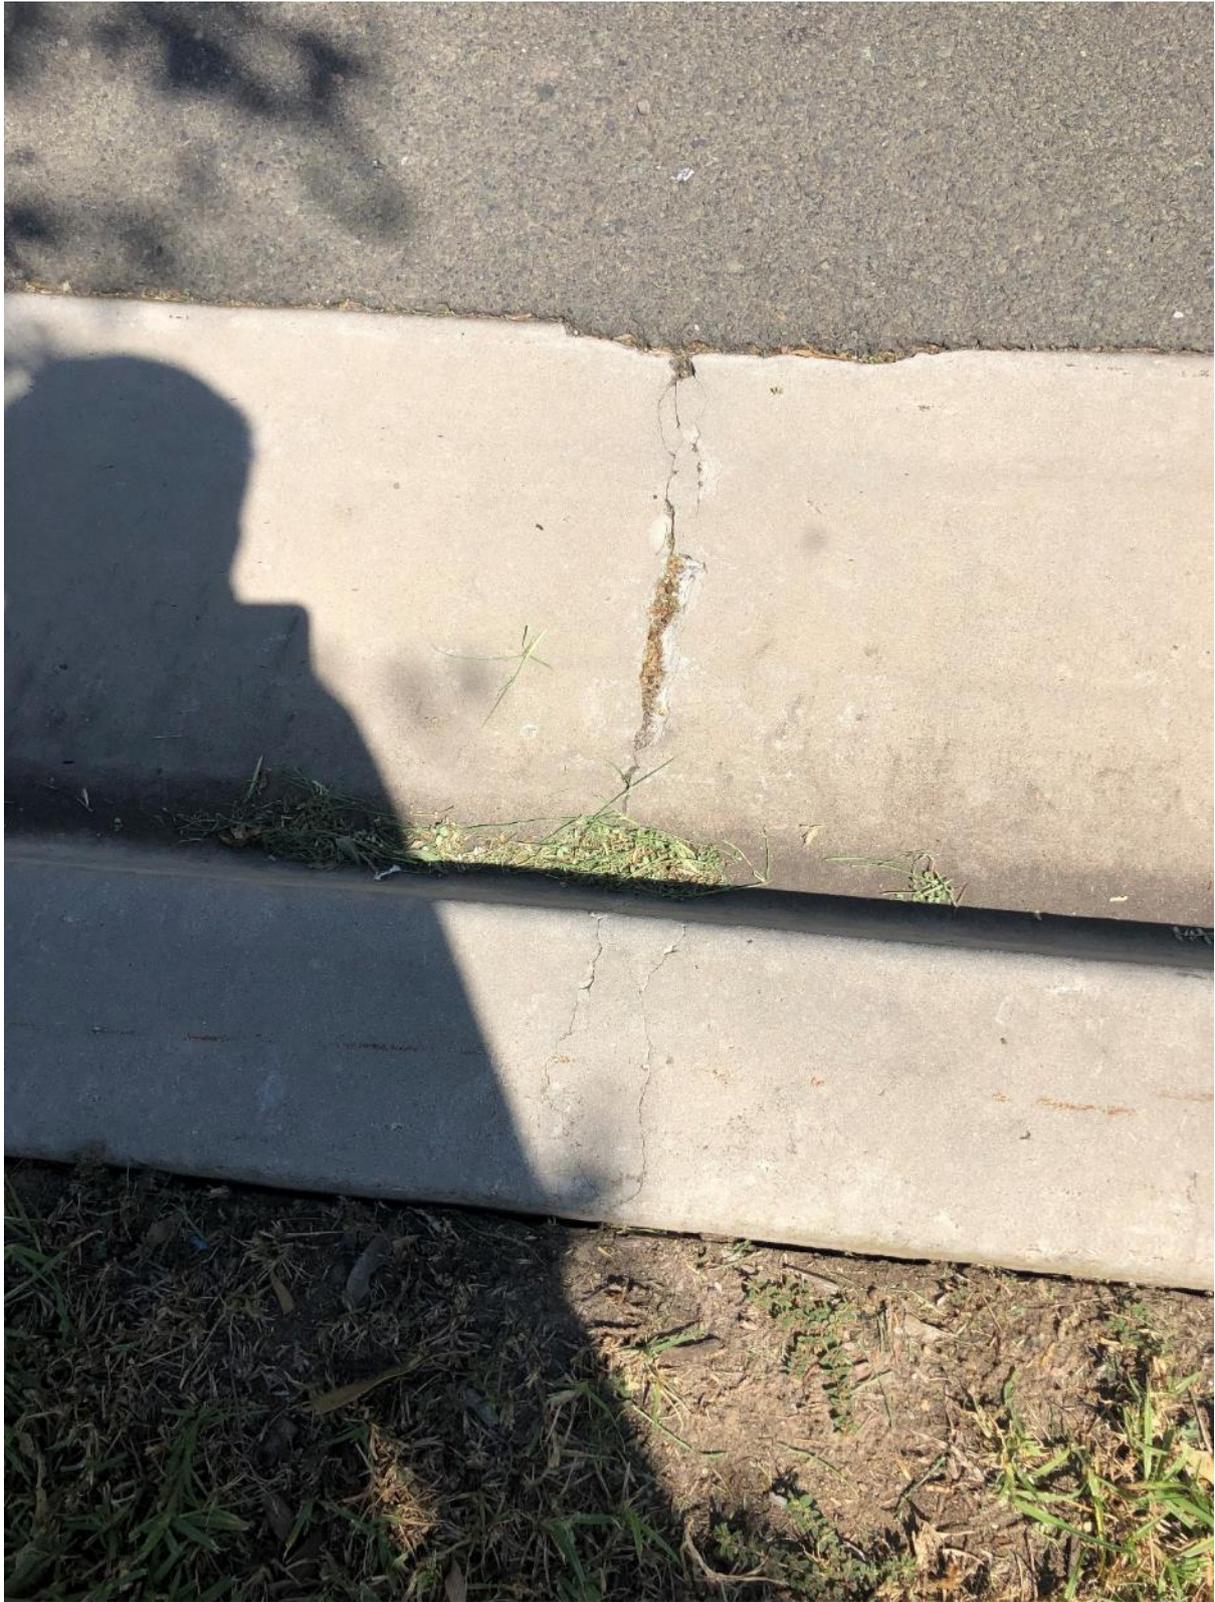
Figure 73: cracking to gutter and top of kerb.
