J K Williams Contracting Pty Ltd

Dilapidation Report

Proposed Works - Jordan Springs Stage 2 Retirement Living

James Sae Siew
5th March 2019
Revision 1

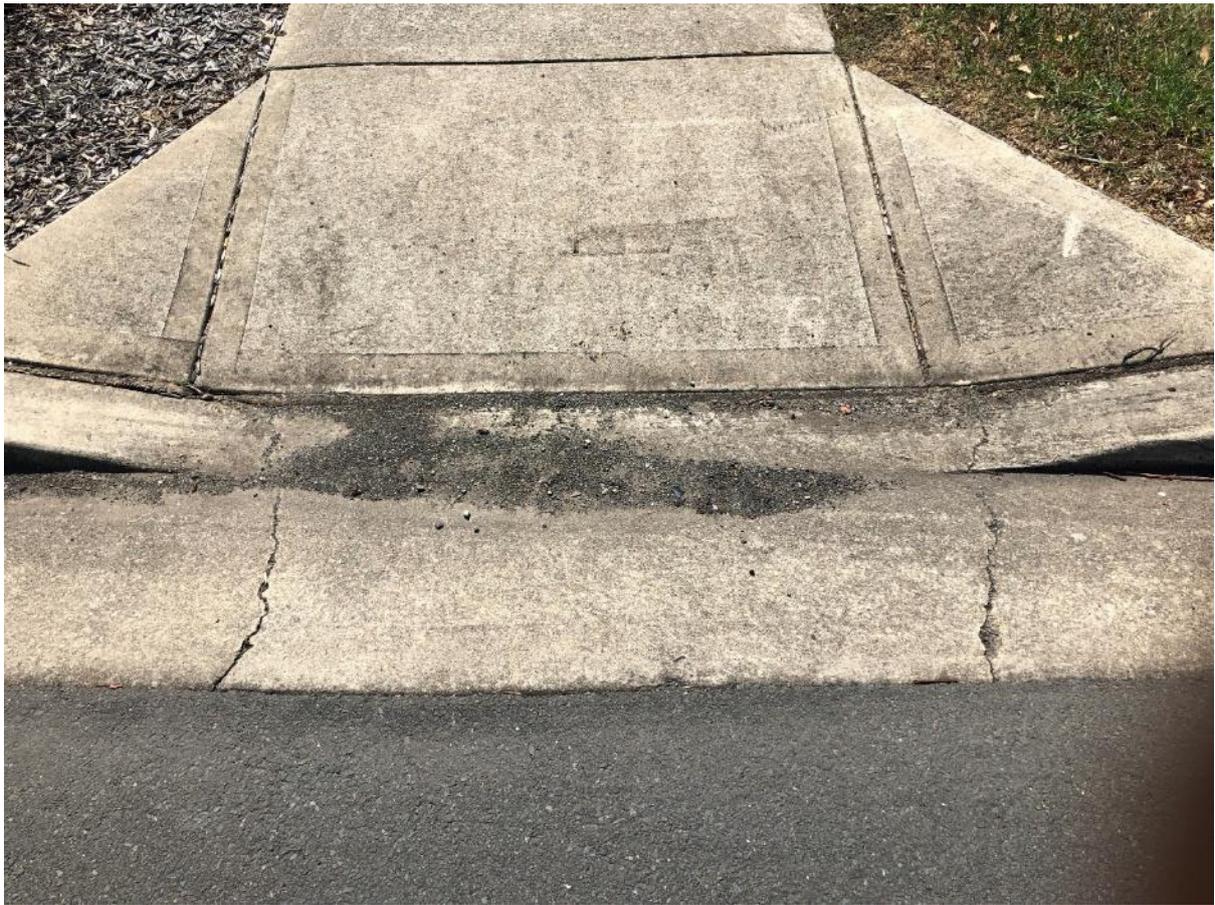
Figure 81: cracking to gutter, adjacent to flat portion of eastern pram ramp.

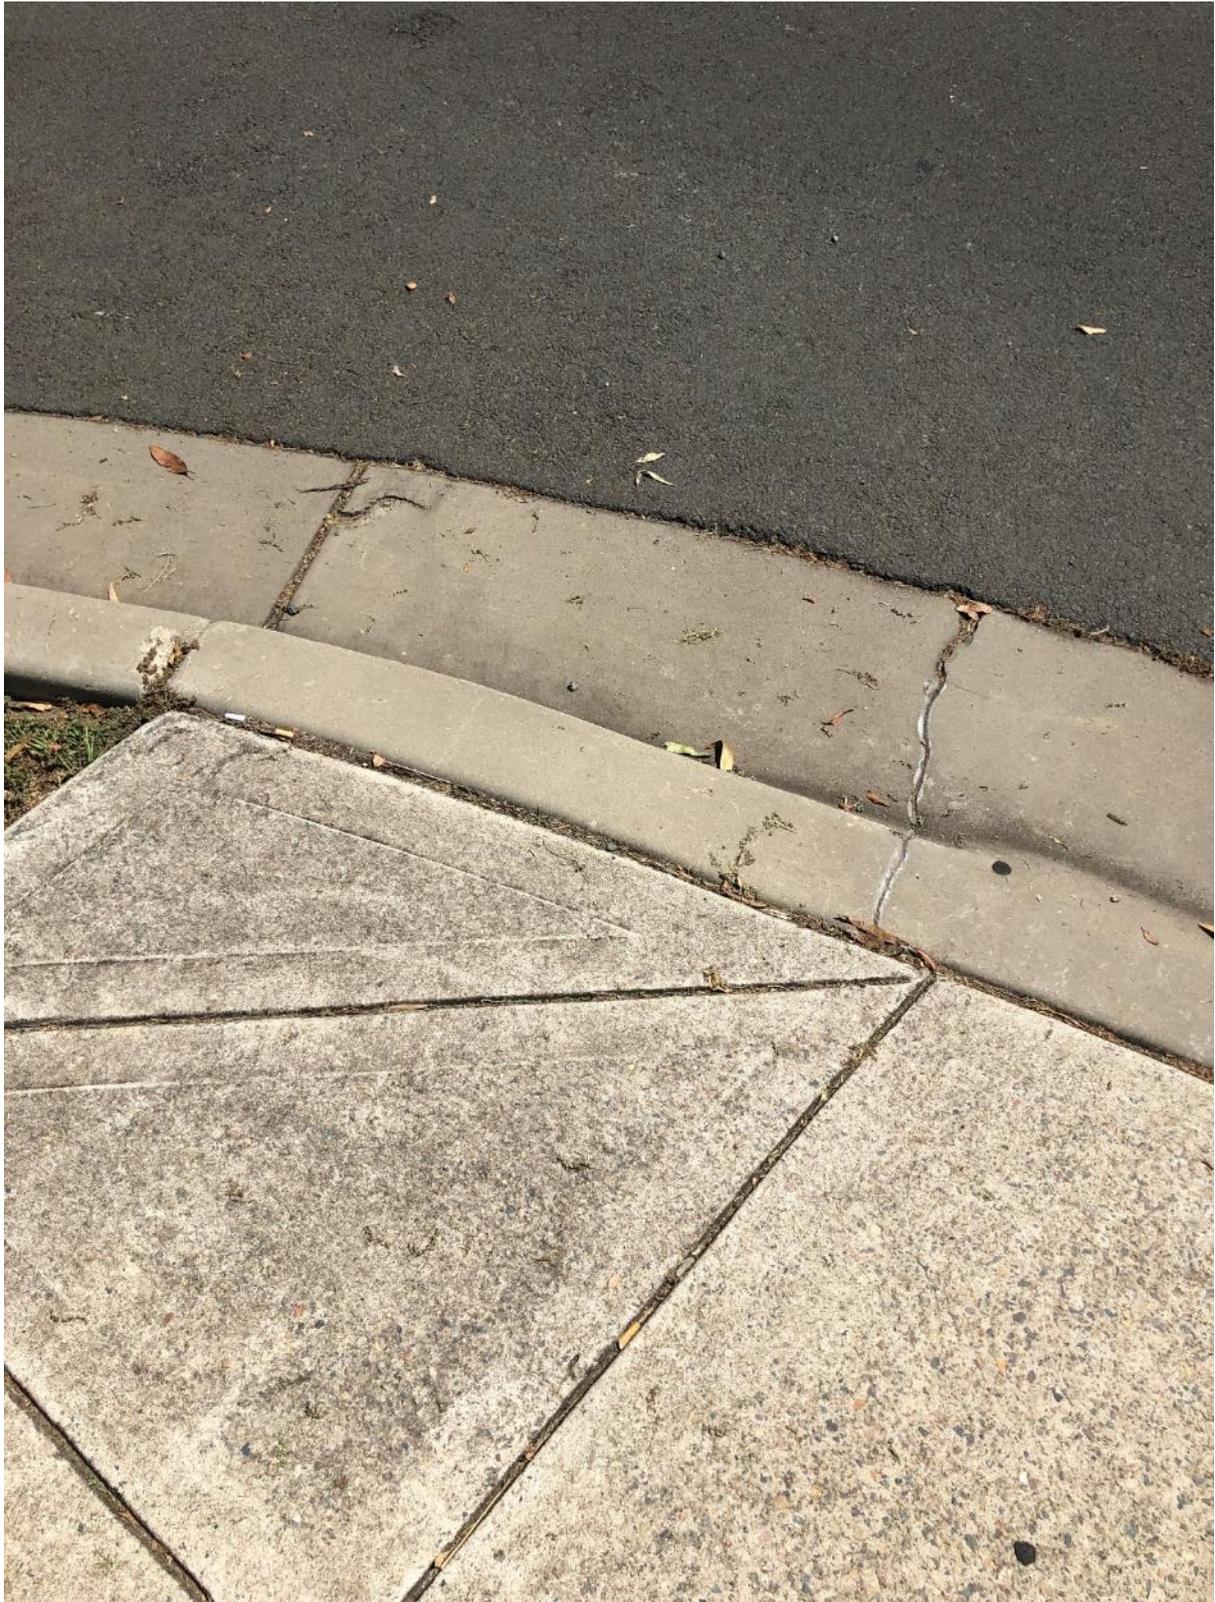
Figure 82: cracking to kerb and gutter, adjacent to right portion bottom of wing.

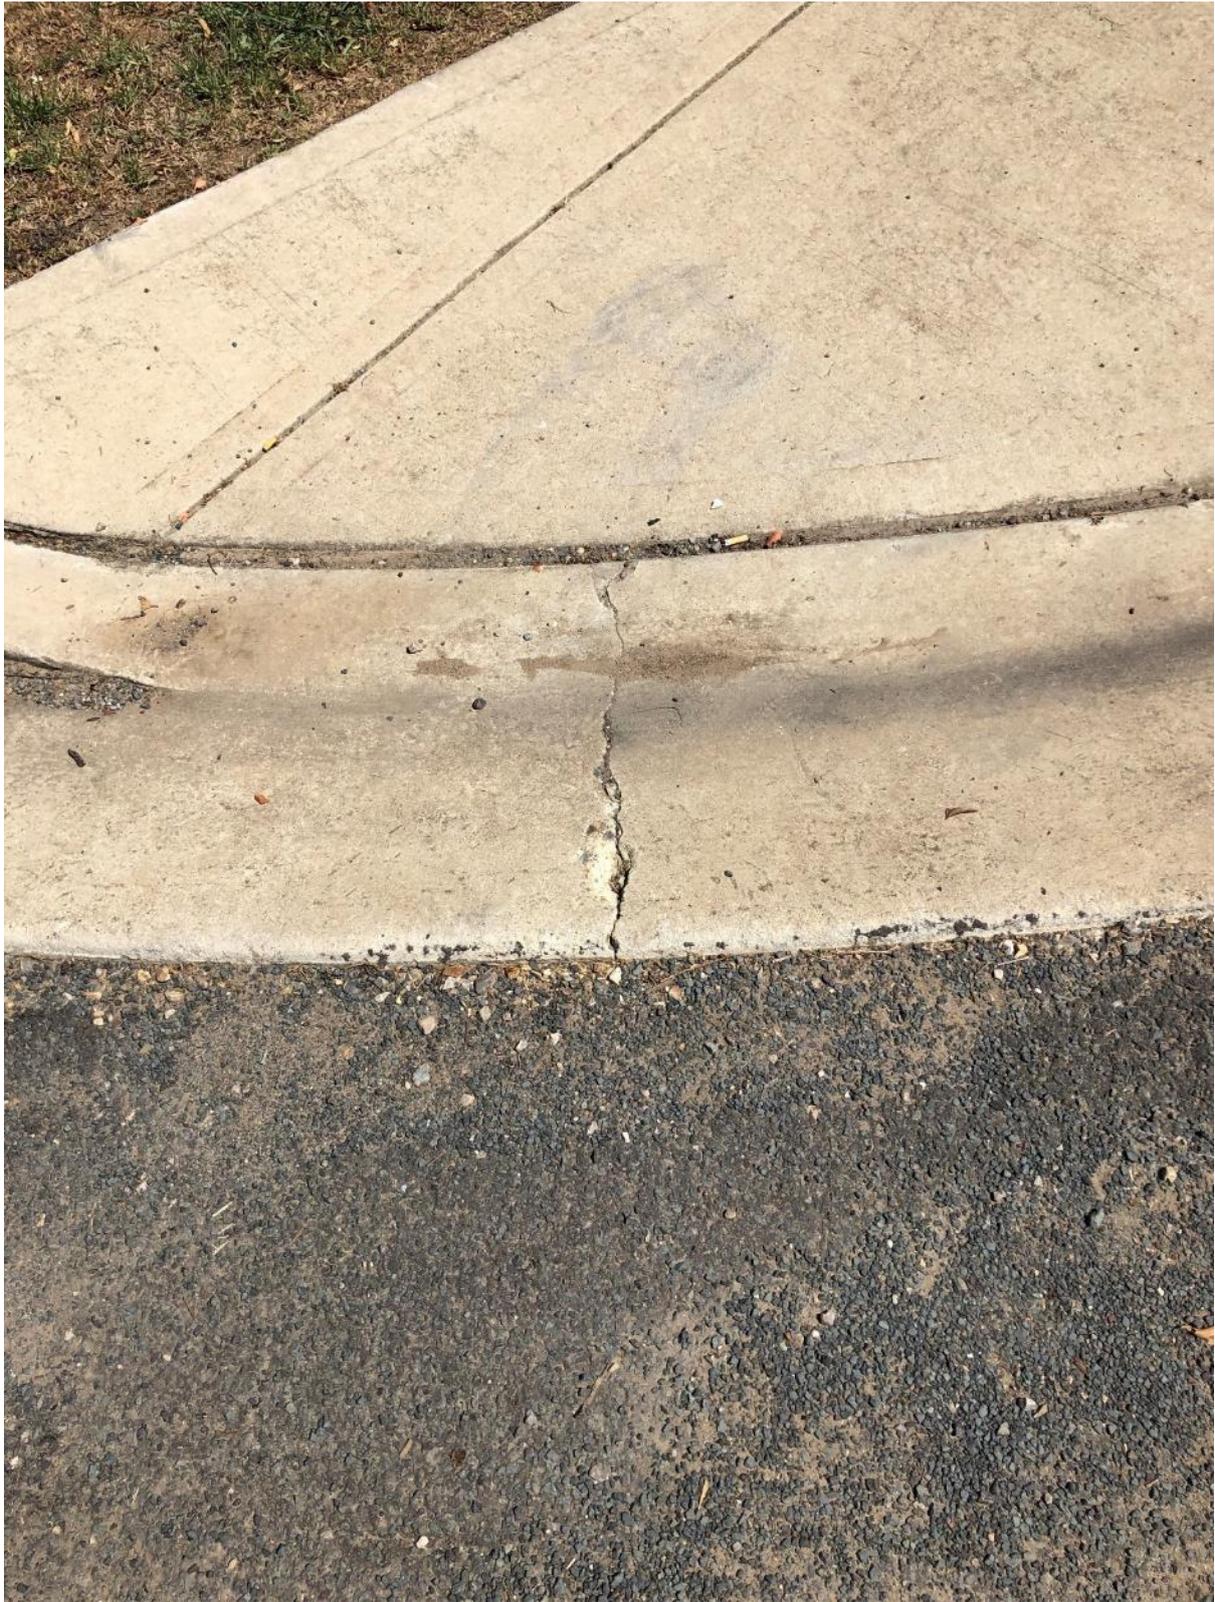
Figure 86: cracking to gutter, adjacent to pram ramp located right of proposed site entry.
