TREE INSPECTION REPORT.

**Location: 6 Edna Street Kingswood
NSW 2747**

TREEHAVEN ENVIRONSCAPES.
128 Showground Road Castle Hill. NSW 2154

For Designcorp
On. 28/10/2020

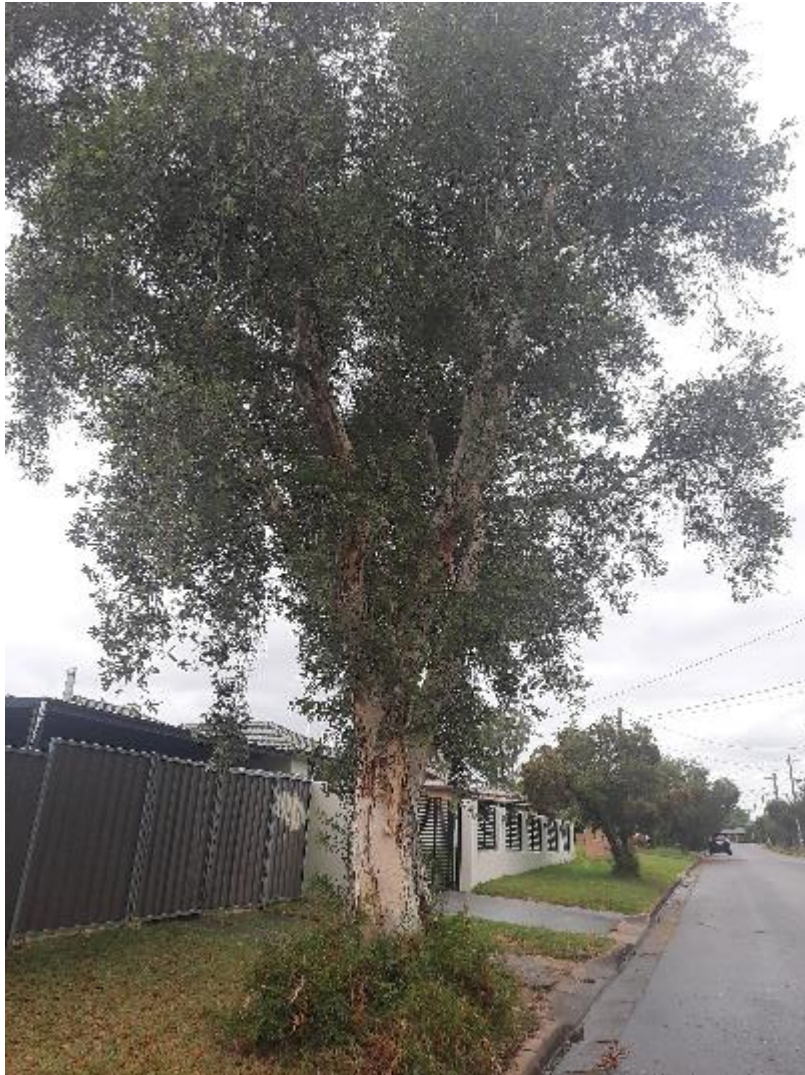
4.1 Tree **T1** is a *Melaleuca quinquinervia* or 'Broadleaved Paperbark' which is an endemic species common in rivers and estuaries in the Sydney region. It has been planted in the nature strip to the East of the Site (see Fig. 2).

The tree was in good health and vigour at the time of inspection with no significant pathogens. The tree has a major defect in the form of a 'V' shaped stem junction with included bark (Mattheck & Breloer 2005).

The tree will be directly affected by the development by the construction of a concrete footpath crossover which will engulf its main stem (See Appendix 2a and 2b).

- **T1** has a significant defect where the main stems adjoin in a 'V' shaped union with included bark in the junction. This is inherently a weak union (Mattheck & Breloer 2005).

Fig 2. Photo of tree T1 a *Melaleuca quinquervia*

- 6.1.** It is recommended that, for the development to proceed as planned, trees **T1**, **T3** and to **T6** be removed.
- 6.2** Trees **T2**, **T4 & T5** are Council's street trees to be retained and protected.

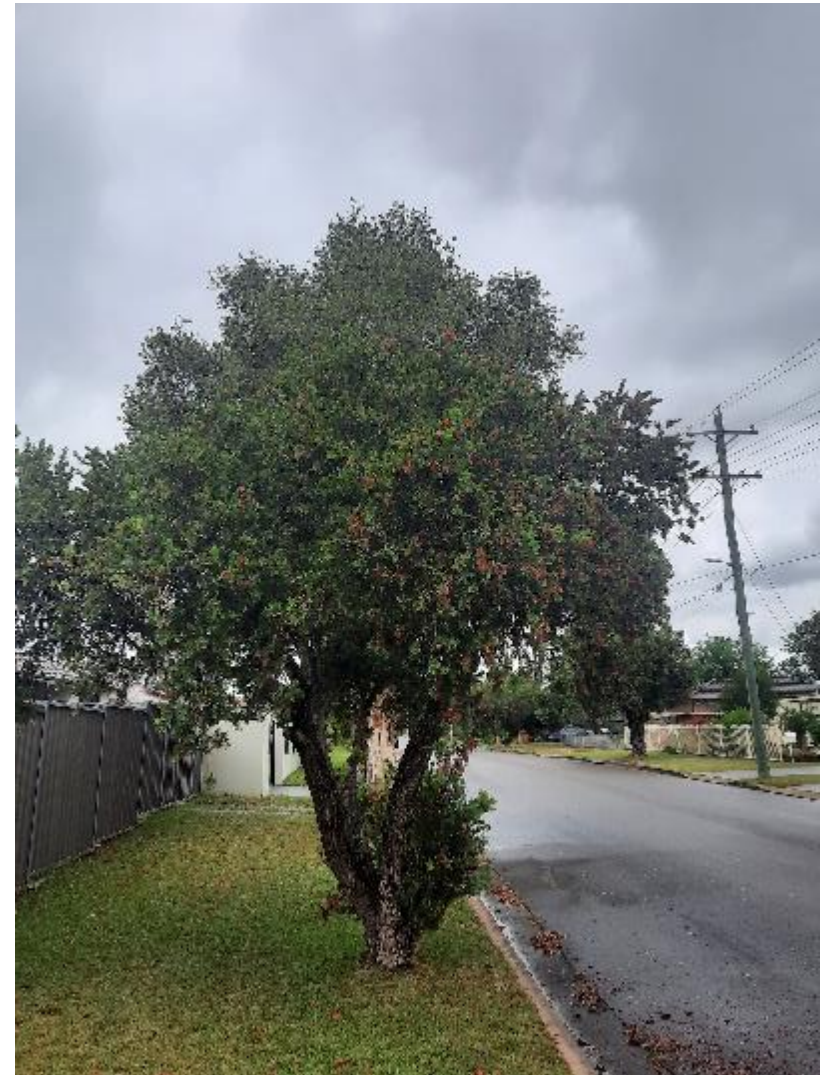
4.2 Trees **T2, T4 & T5** are all *Callistemon viminalis* or 'Weeping Bottlebrush' which is a small native tree species which have been planted on the nature strip to the North and East of the Site (See Figs. 3, 5 and 6). The trees are quite small and have pruned back regularly to accommodate overhead wires.

These specimens won't be directly affected by the development but will need to be protected during the construction period (See Appendix 2b and 2c).

Fig 3. Photo of tree T2 *Callistemon viminalis*

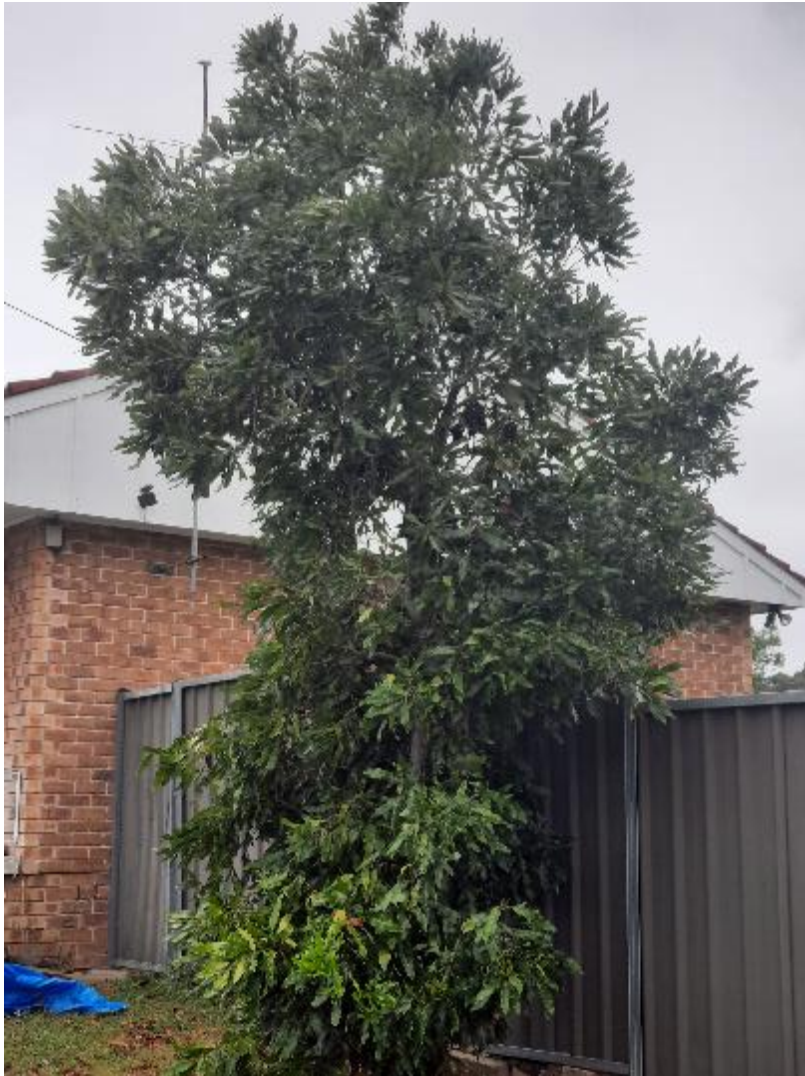
4.3 Tree **T3** is a *Stenocarpus sinuatus* or 'Queensland Firewheel Tree' which is a medium sized native tree which has been planted on the Site to the South East of the existing house (See Fig. 4). The tree is relatively small being just 4m in height with a narrow main stem and appears to be a young sapling. The specimen was in good health and condition at the time of my inspection.

The specimen is scheduled to be removed as it will be engulfed by the new building footprint (See Appendix 2b and 2c).

- **T3** is a small tree not yet significant in the streetscape.
 - **T6** is in poor condition and is proposed to be removed to allow for new plantings in the landscaping for the development

Fig. 4. Photo of tree T3 a *Stenocarpus sinuatus*.

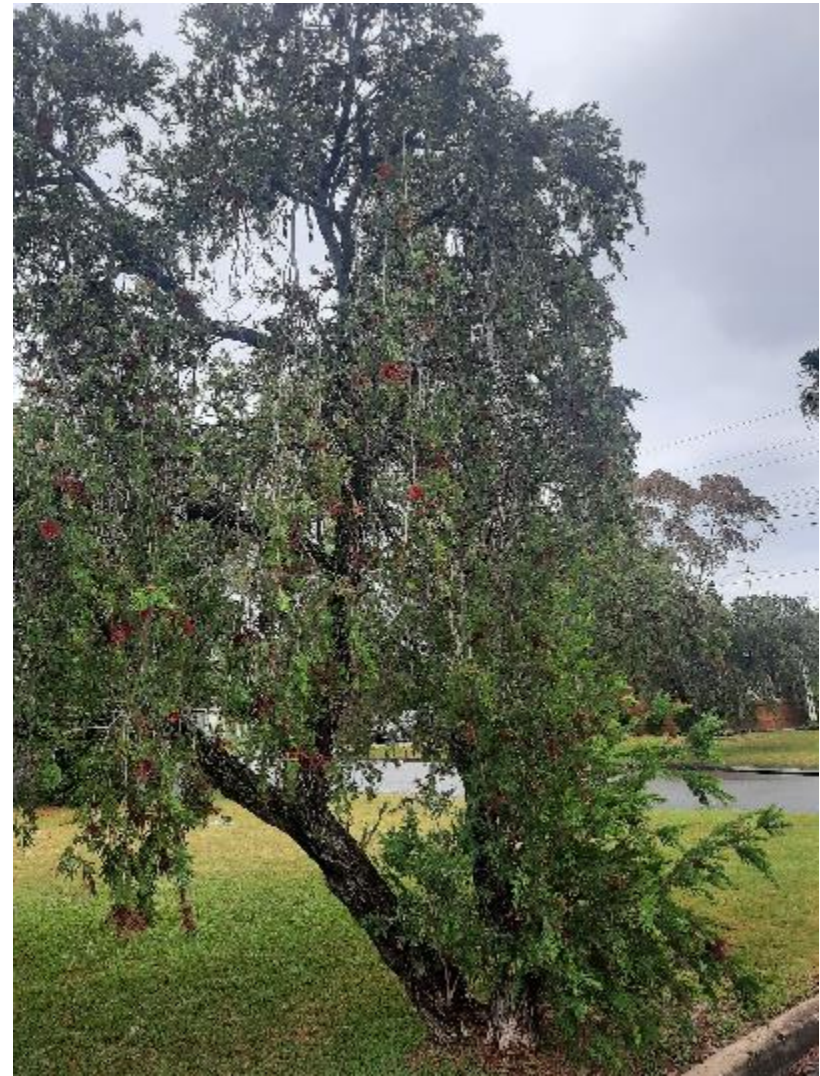
Fig. 5. Photo of Tree T4 a *Callistemon viminalis*

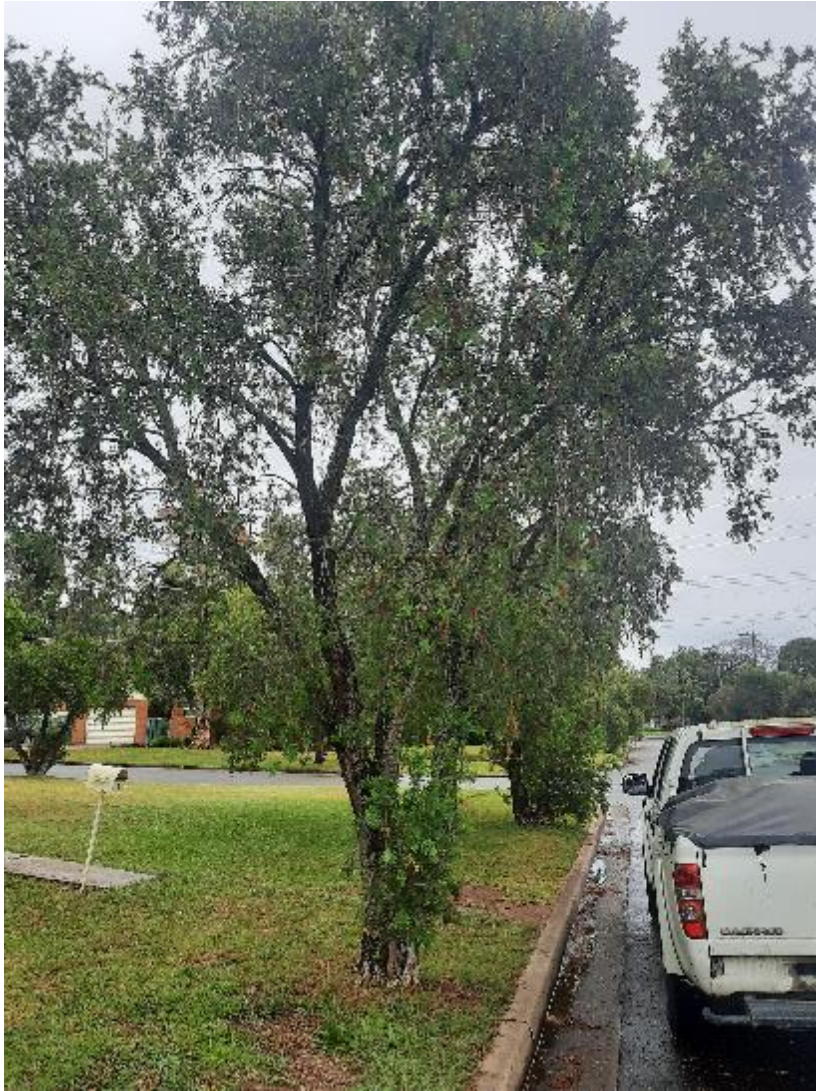
Fig. 6. Photo of tree T5 a *Callistemon viminalis*

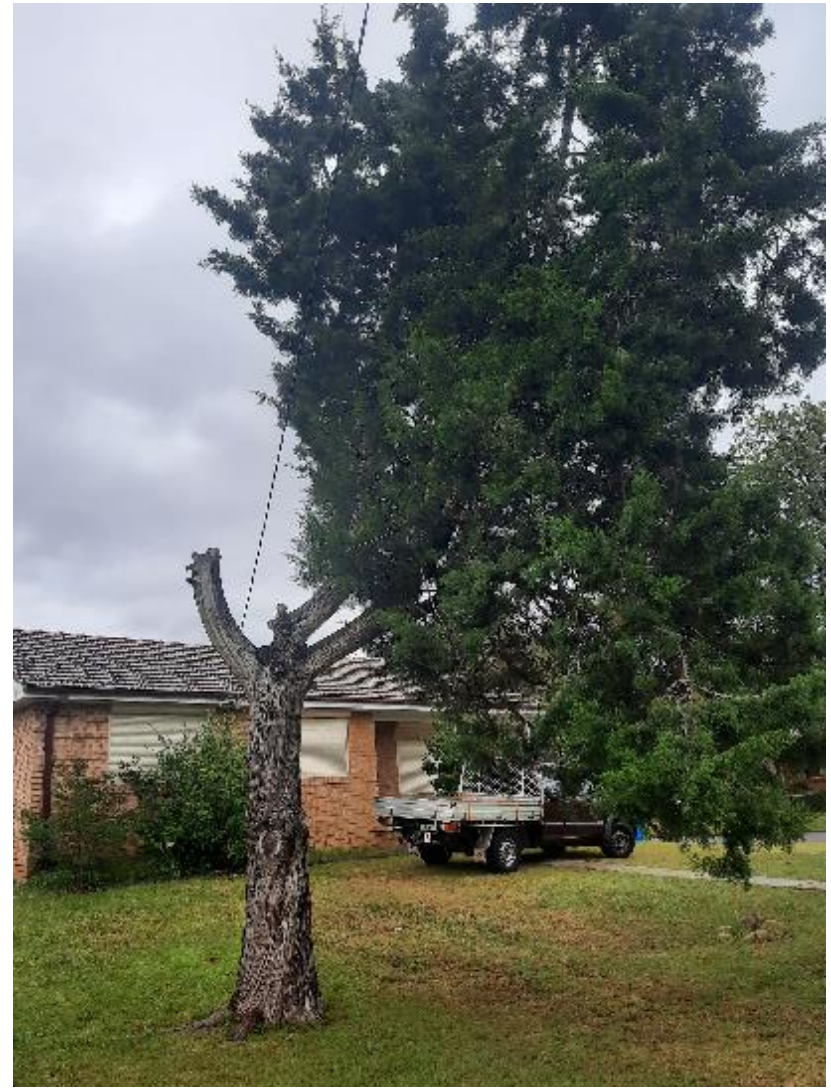
4.4 Tree **T6** is a *Cupressus macrocarpa* or Monterey Pine which is an exotic conifer from East coast USA. The tree was in poor condition at the time of my inspection with one dead stem which has been removed and the tree has subsequently formed a lopsided habit (See Fig. 7)

The specimen is scheduled to be removed in order to make room for new plantings in the new landscaping for the development (See Appendix 2b and 2c).

Fig.7. Photo of Tree T6 a *Cupressus macrocarpa*

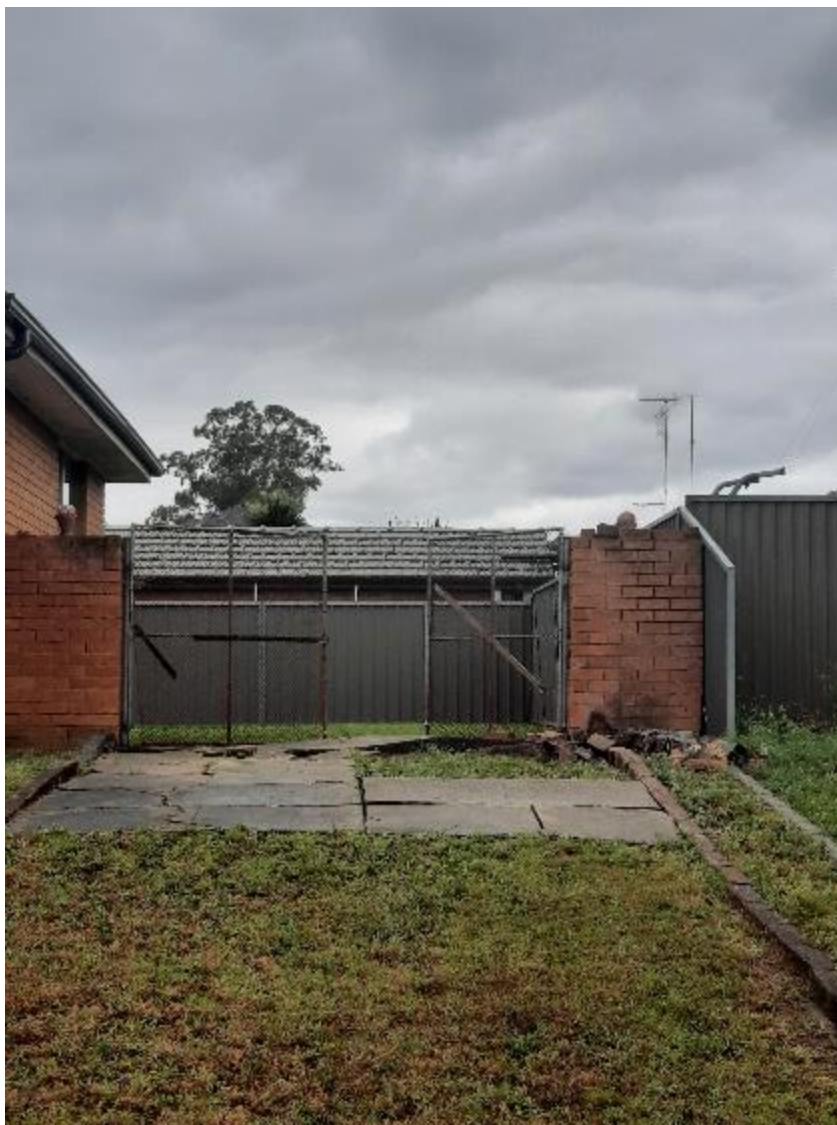
4.5 There are no trees on neighbouring property to the West of the site (See Fig. 8).

Fig. 8. Photo showing no trees in neighbouring property to the West of the Site.
