WSA assessment

Date: 8/02/2014	Asset owner's job ref.:	Asset Owner: jk williams	Operator : m crocker	Section number: 2	Pipe Asset Id: 37/2 to 37/3
Time of inspection: 07:35:32	Cleaning: cleaned	Standard: WSA 05-2008 2.2	LRP Ins	Conduit Unit Length	Method of Inspection Television Camera

Town: Suburb: jordan springs Street: road 5 Asset Location	Catchment: Asset Owner: jk williams Precipitation.: Flow control No measures	US MH: 37/2 Survey Dir: downstream DS MH: 37/3 Inspect Lenght : 6.62 m
---	---	---

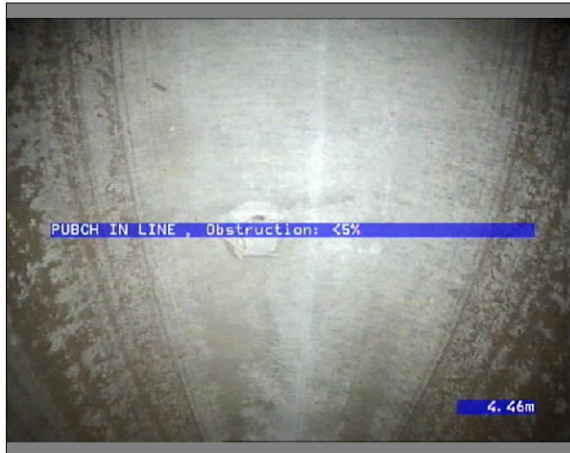
Photo: 23_1_2_08022014_111853_A.JPG
4.46m, PUBCH IN LINE , Obstruction: <5%

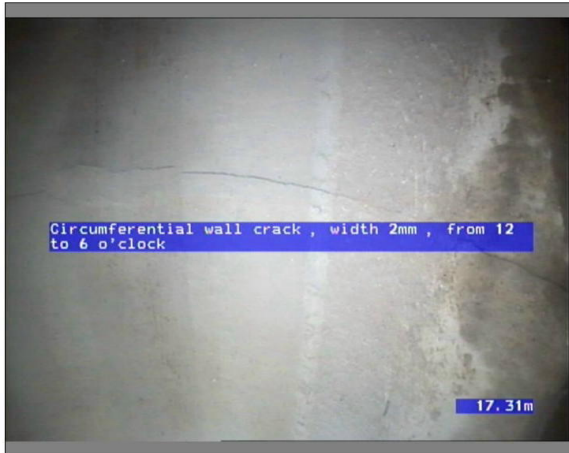
STR no def	STR peak	STR mean	STR total	STR grade	SER no def	SER peak	SER mean	SER total	SER grade
4	63	3.21	63	5	0	0	0	0	1

Photo: 35_1_2_08022014_125944_A.JPG
 17.31m, Circumferential wall crack , width 2mm , from 12 to 6 o'clock

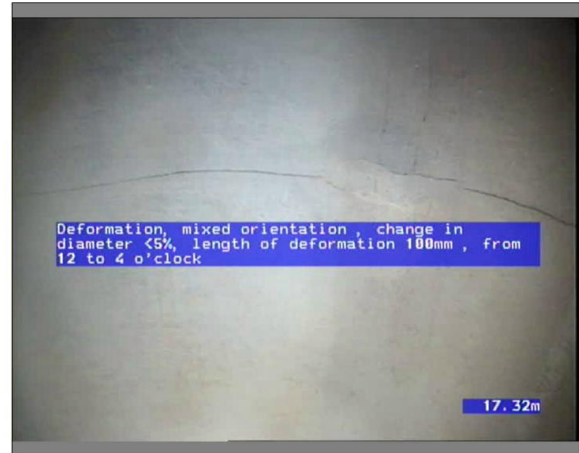
Photo: 35_1_3_08022014_130008_A.JPG
 17.31m, Deformation, mixed orientation , change in diameter <5%, length of deformation 100mm , from 12 to 4 o'clock

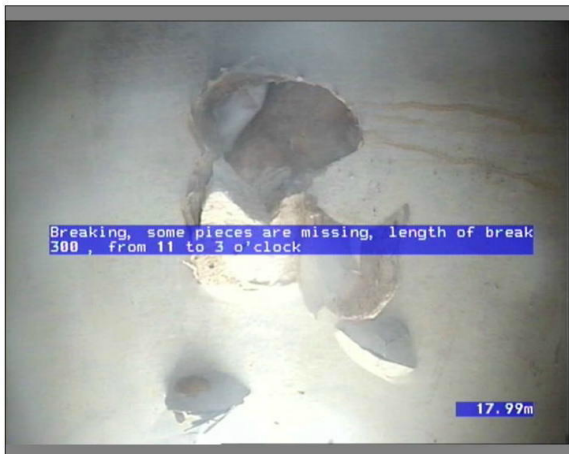
Photo: 35_1_4_08022014_130025_A.JPG
 17.99m, Breaking, some pieces are missing, length of break 300 , from 11 to 3 o'clock

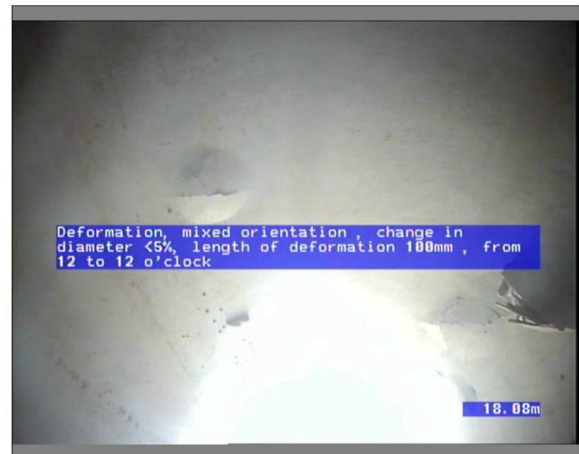
Photo: 35_1_5_08022014_130043_A.JPG
 18.08m, Deformation, mixed orientation , change in diameter <5%, length of deformation 100mm , from 12 to 12 o'clock
