Tree Report
Glenmore Park Town Centre
Glenmore Parkway Glenmore Park
For Village Fair Glenmore Park Pty Ltd
May 2010

Tree Report

Glenmore Park Town Centre

Glenmore Parkway Glenmore Park

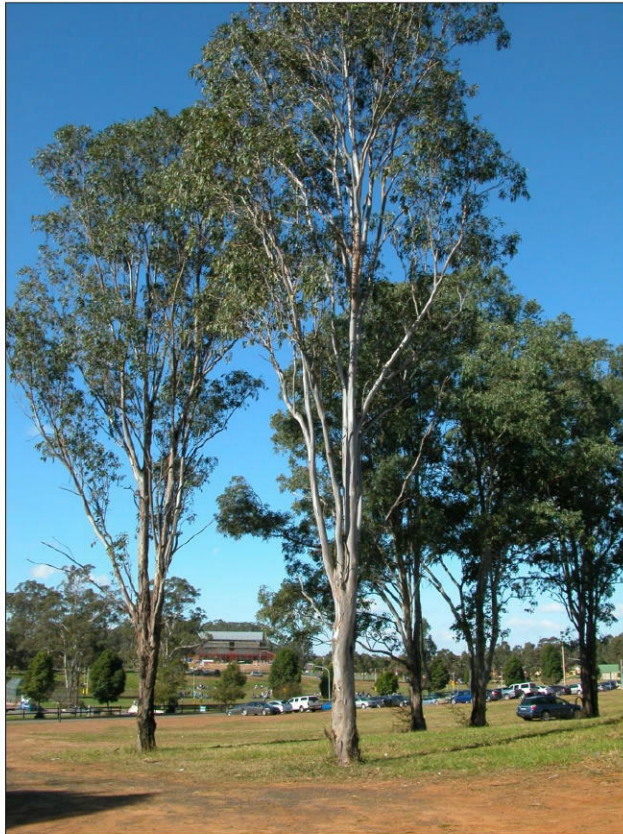
Tree no	Species	Approx trunk dbh mm	Approx height m	Approx crown spread m	Health	Condition	SULE	Comment	Effect of proposed development
1	<i>Eucalyptus tereticornis</i> (Forest Red Gum)	400	15	8	Fair	Fair	2D	Sparse crown Codominant crown Trunk wound	Removal
2	<i>Eucalyptus tereticornis</i> (Forest Red Gum)	400	15	10	Fair	Fair	2D	Sparse crown Codominant crown Branch dieback in lower crown Trunk wound Soil compaction in root zone	Removal
3	<i>Eucalyptus tereticornis</i> (Forest Red Gum)	400 250	12	10	Good	Fair	2D	Codominant crown Soil levels raised	Removal
4	<i>Eucalyptus tereticornis</i> (Forest Red Gum)	400 250 x 2	15	12	Good	Fair	2D	Codominant crown x 3 stems	Removal
5	<i>Eucalyptus tereticornis</i> (Forest Red Gum)	300 x 2	15	8	Good	Fair	2D	Codominant crown with weak junction at base	Removal
6	<i>Eucalyptus tereticornis</i> (Forest Red Gum)	400	16	12	Good	Fair	2D	Codominant crown with weak junction at 5m height	Removal

Plate 1: Trees 1 and 2 viewed from the west

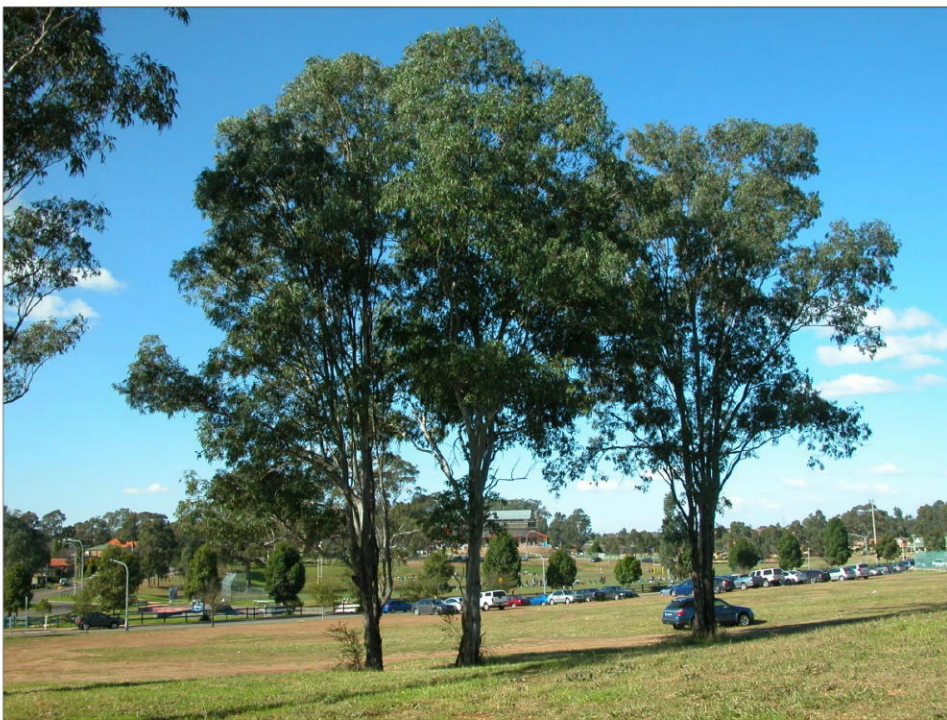
Plate 2: Trees 3, 4, 5 and 6 viewed from the west

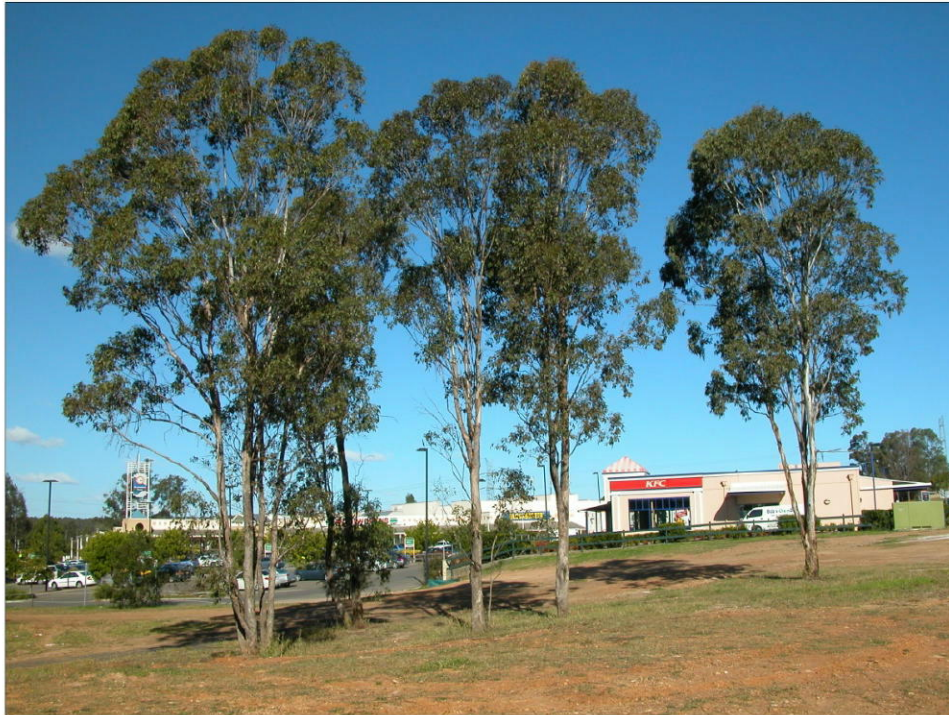
7	<i>Eucalyptus tereticornis</i> (Forest Red Gum)	400	12	8	Good	Fair	3D	Codominant crown with weak junction at 1m height	Removal
8	<i>Eucalyptus moluccana</i> (Grey Box)	300	12	6	Good	Fair	3D	Trunk wound with decay Codominant crown with weak junction at 4m height	Removal
9	<i>Eucalyptus moluccana</i> (Grey Box)	250	12	6	Fair	Fair	2D	Sparse crown Weak junction at 5m height	Removal

Tree no	Species	Approx trunk dbh mm	Approx height m	Approx crown spread m	Health	Condition	SULE	Comment	Effect of proposed development
10	<i>Eucalyptus moluccana</i> (Grey Box)	250 150	12	8	Fair	Fair	3D	Trunk wound near base	Removal
11	<i>Eucalyptus moluccana</i> (Grey Box)	300 250 x 2 bf	12	8	Fair	Fair	2A	Sparse crown Codominant crown	Removal
12	<i>Eucalyptus moluccana</i> (Grey Box)	400 300 bf	12	8	Good	Fair	3D	Weak junction near base	Removal
13	<i>Eucalyptus moluccana</i> (Grey Box)	250	10	6	Fair	Fair	2D	Codominant crown with weak junction at 3m height	Removal
14	<i>Eucalyptus moluccana</i> (Grey Box)	300 250	12	12	Good	Fair	2D	Weak junction at 1m height	Removal
15	<i>Eucalyptus tereticornis</i> (Forest Red Gum)	200	10	5	Good	Poor	3D	Suppressed	Removal

Plate 3: Trees 7, 8, 9, 10 and 11
(right to left) viewed from the
north

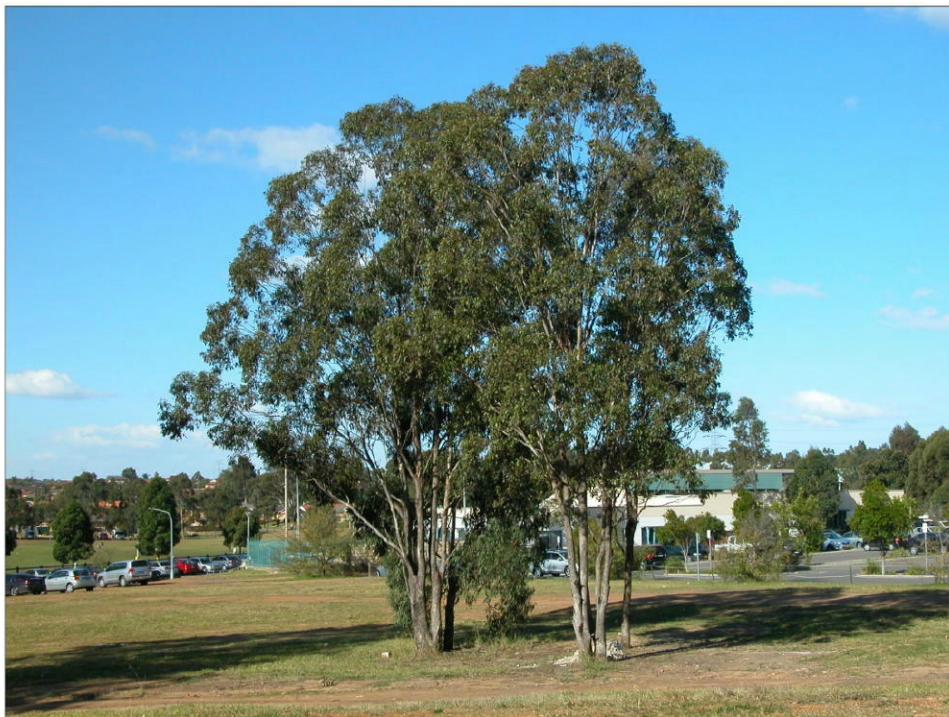
Plate 4: Trees 12, 13, 14 and 15
viewed from the west
