Asbestos Remedial Management Plan

Penrith City Council

**11a Canopus Close
ERSKINE PARK NSW 2759**

Report Number: 11538.01.ARCP

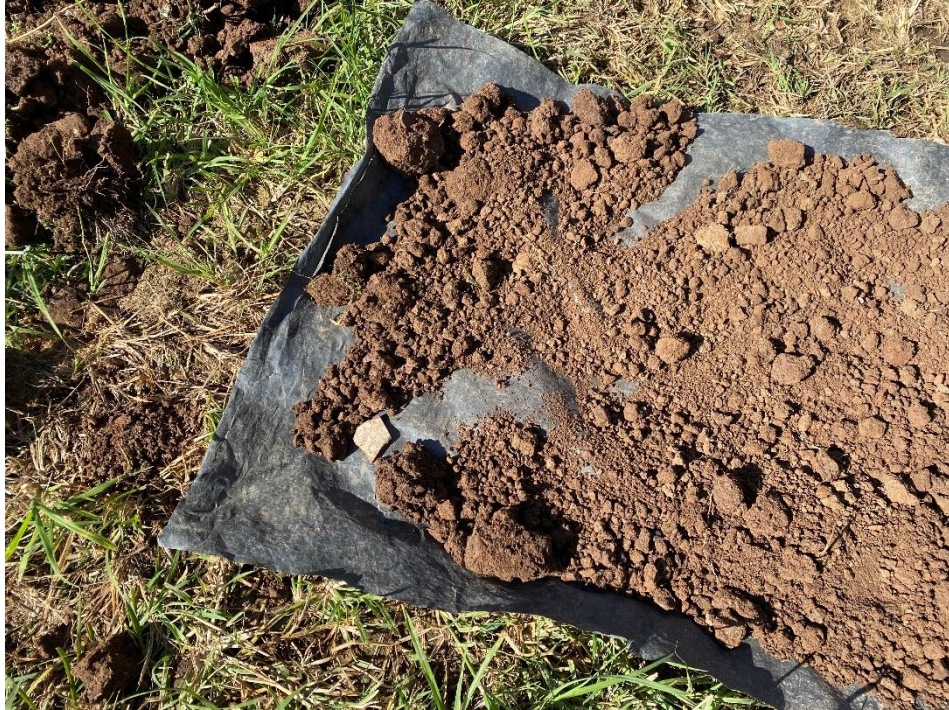
Photograph 1

| Description of Material | Specific Location | Sample ID | Friable or Non-Friable | Condition | Risk Rating | Control Measures |
|---|--|---|---|---|---|---|
| Fill material containing asbestos cement debris | Within test pit TP04 at a depth of 0.3m. | 11538/ST2/TP04/AS02 | Non-Friable (bonded) | Fragments in sound condition | Low | Refer to Section 8 |

View of the Asbestos Cement Sheetting identified within test pit TP04.

- Excavate fill material and load into trucks with appropriate coverings.
- All fill material removed from the excavation is to be treated as asbestos waste.
- Excavate until there is no more signs of asbestos contamination.
- All trucks used to load the asbestos contaminated material into are to park as close as practicable to the material being removed and within the asbestos exclusion zone.
- When a truck is ready to leave site the wheels and sub-frame (i.e. tow bar of any trailers) are to be washed with a fine water spray to ensure no spilled material leaves the asbestos exclusion zone. The truck should also ensure that its load is fully covered before moving off.
- All asbestos waste must be disposed of appropriately at a waste facility that is licensed to accept asbestos waste.

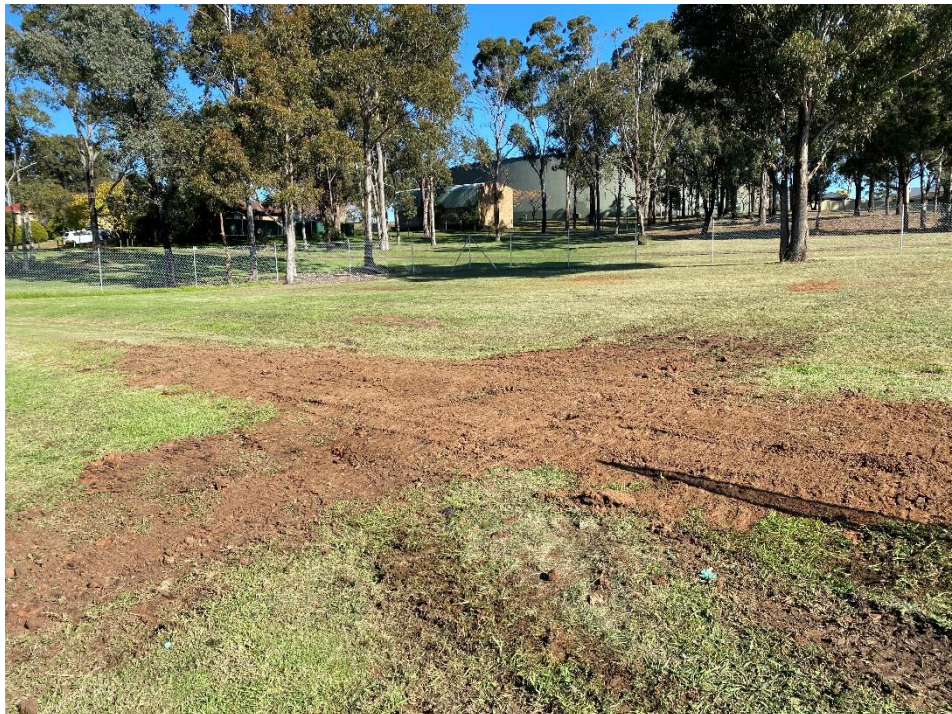
Photograph 2

1. Area surrounding TP04 within the fill material and bounded by the following:
 - To the north by location TP04/DN (1.0m from TP04);
 - To the east by location TP04/DE (1.0m from TP04);
 - To the south by location TP04/DS (1.0m from TP04); and
 - To the west by location TP04/DW (1.0m from TP04).

View of the delineated area surrounding test pit TP04.
