# PRELIMINARY TREE INSPECTION REPORT.

**On:** Tree Specimens

**Location:** 110-112 Mt Vernon Rd Mount  
Vernon. NSW 2178

For Superior Home Solutions  
On. 30/11/2017

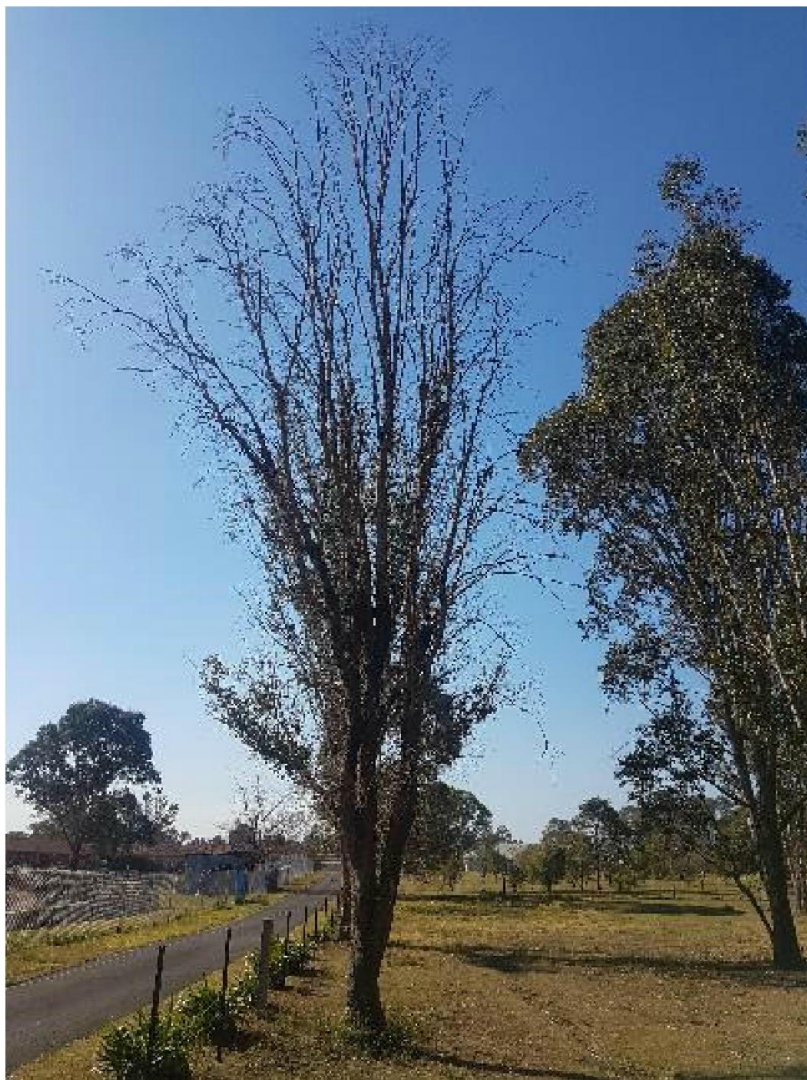
T3 Dead Tree See Fig. 4	8m	N/A	N/A	Tree is dead and not subject to the TPO	A4	N/A	N/A
T4 <i>Eucalyptus molucanna</i> Common name 'Grey box' Age class. 40 years See Fig. 5.	16m	23cm 31cm at the base	N 2m E 2m S 2m W 1m	An endemic tree common to the Western Sydney region and a member of Cumberland Plains Forest community. The tree is growing in the front of the property to the South West of the Site. At the time of inspection the specimen was in poor condition. There were no significant pathogens nor signs of mechanical damage. The tree has mainly epicormic growth in its canopy and appears to be recovering from some dieback assumed to be from the Psyllid outbreak in Western Sydney.	C1	2.76m	2m

Fig 4. Photo of T3 a dead tree

6.1. It is recommended that trees **T3, T4, T5, T9, T10, T11, T12, T13, T14, T24, T26, T27, T28, T30, T32, T33, T34, T35, T36, T37, T38 T39 & T43** be removed and replaced with suitable endemic species elsewhere on the Site.

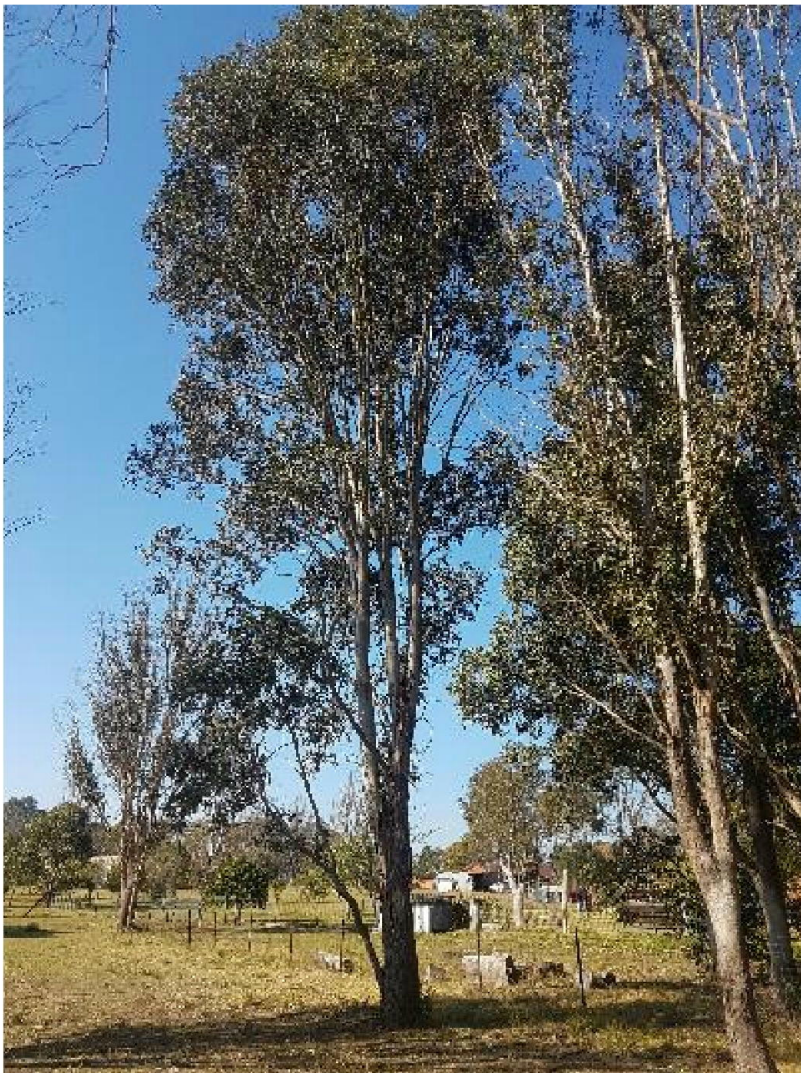
Fig 6. Photo of T5 a *Eucalyptus amplifolia*

T5 <i>Eucalyptus amplifolia</i> Common name 'Cabbage Tree Gum' Age class. 30 years See Fig. 6.	16m	38cm 54cm at the base	N 2m E 5m S 5m W 4m	An endemic tree common to the Western Sydney region and a member of Cumberland Plains Forest community. The tree is growing in the front of the property to the South West of the Site. At the time of inspection the specimen was in good condition. There were no significant pathogens nor signs of mechanical damage.	C1	4.56m	2.55m
T6 <i>Eucalyptus molucana</i> Common name 'Grey box' Age class. 40 years See Fig. 7.	16m	1 x 31cm 1 x 44cm 69cm at the base	N 4m E 4m S 4m W 4m	An endemic tree common to the Western Sydney region and a member of Cumberland Plains Forest community. The tree is growing centrally on the property in the Southern portion of the Site. At the time of inspection the specimen was in poor condition. There were no significant pathogens nor signs of mechanical damage. The tree has mainly epicormic growth in its canopy and appears to be recovering from some dieback assumed to be from the Psyllid outbreak in Western Sydney.	C1	6.45m	2.83m

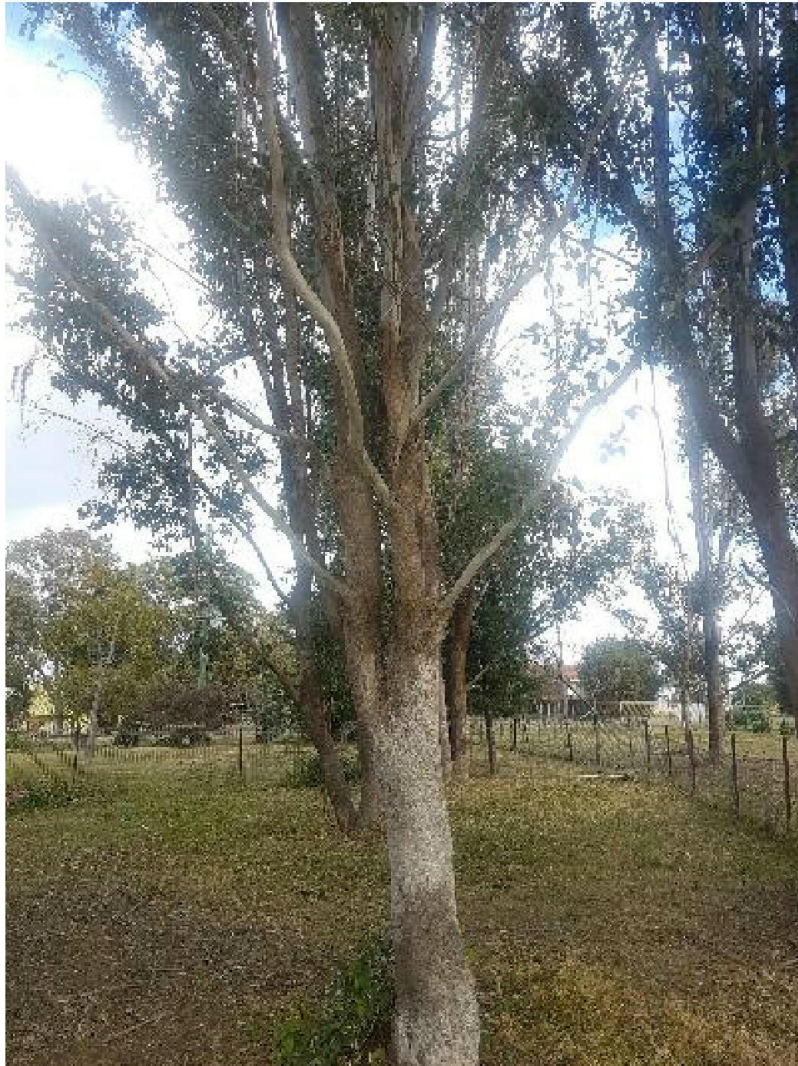
Fig 12. Photo of T11 a *Eucalyptus molucana*

T11 <i>Eucalyptus molucanna</i> Common name 'Grey box' Age class. 40 years See Fig. 12.	12m	30cm 39cm at the base	N 1m E 0m S 3m W 3m	An endemic tree common to the Western Sydney region and a member of Cumberland Plains Forest community. The tree is growing centrally on the property in the Southern portion of the Site. At the time of inspection the specimen was in poor condition. There were no significant pathogens nor signs of mechanical damage. The tree has mainly epicormic growth in its canopy and appears to be recovering from some dieback assumed to be from the Psyllid outbreak in Western Sydney.	C1	3.6m	2.23m
T12A <i>Eucalyptus molucanna</i> Common name 'Grey box' Age class. 40 years See Fig. 13.	10m	1 x 22cm 1 x 26cm 39cm at the base	N 0m E 1m S 2m W 2m	An endemic tree common to the Western Sydney region and a member of Cumberland Plains Forest community. The tree is growing centrally on the property. At the time of inspection the specimen was in poor condition. There was 20% dead wood in the crown and no significant pathogens nor signs of mechanical damage. The tree	C1	4.08m	2.23m

has mainly epicormic growth in its canopy and appears to be recovering from some dieback assumed to be from the Psyllid outbreak in Western Sydney.			
T12B <i>Eucalyptus molucanna</i> Common name 'Grey box' Age class. 40 years See Fig. 14.	12m	25cm 27cm at the base	N 2m E 1m S 0m W 0m	An endemic tree common to the Western Sydney region and a member of Cumberland Plains Forest community. The tree is growing centrally on the property in the Southern portion of the Site. At the time of inspection the specimen was in poor condition. There were no significant pathogens nor signs of mechanical damage. The tree has mainly epicormic growth in its canopy and appears to be recovering from some dieback and appears to be recovering from some dieback assumed to be from the Psyllid outbreak in Western Sydney. The tree has a bias in its crown to the North East.	C1	3m	2.88m
T13 <i>Eucalyptus molucanna</i> Common name 'Grey box' Age class. 40 years See Fig. 15.	14m	1 x 26cm 1 x 28cm 57cm at the base	N 2m E 3m S 4m W 4m	An endemic tree common to the Western Sydney region and a member of Cumberland Plains Forest community. The tree is growing centrally on the property. At the time of inspection the specimen was in poor condition with 20% deadwood in the crown. There were no significant pathogens nor signs of mechanical damage. The tree has mainly epicormic growth in its canopy and appears to be recovering from some dieback assumed to be from the Psyllid outbreak in Western Sydney.	C1	4.59m	2.61m

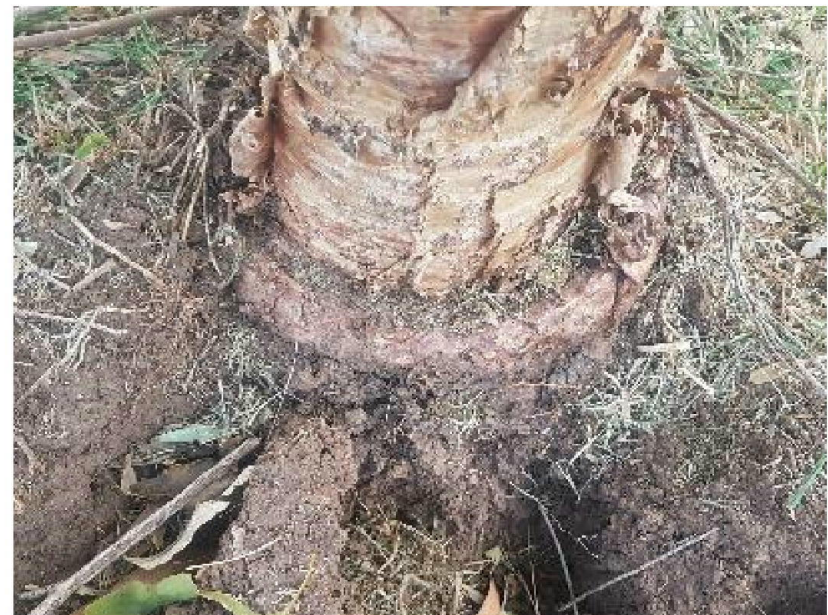
Fig 21. Photo of T18 with girdled Roots.

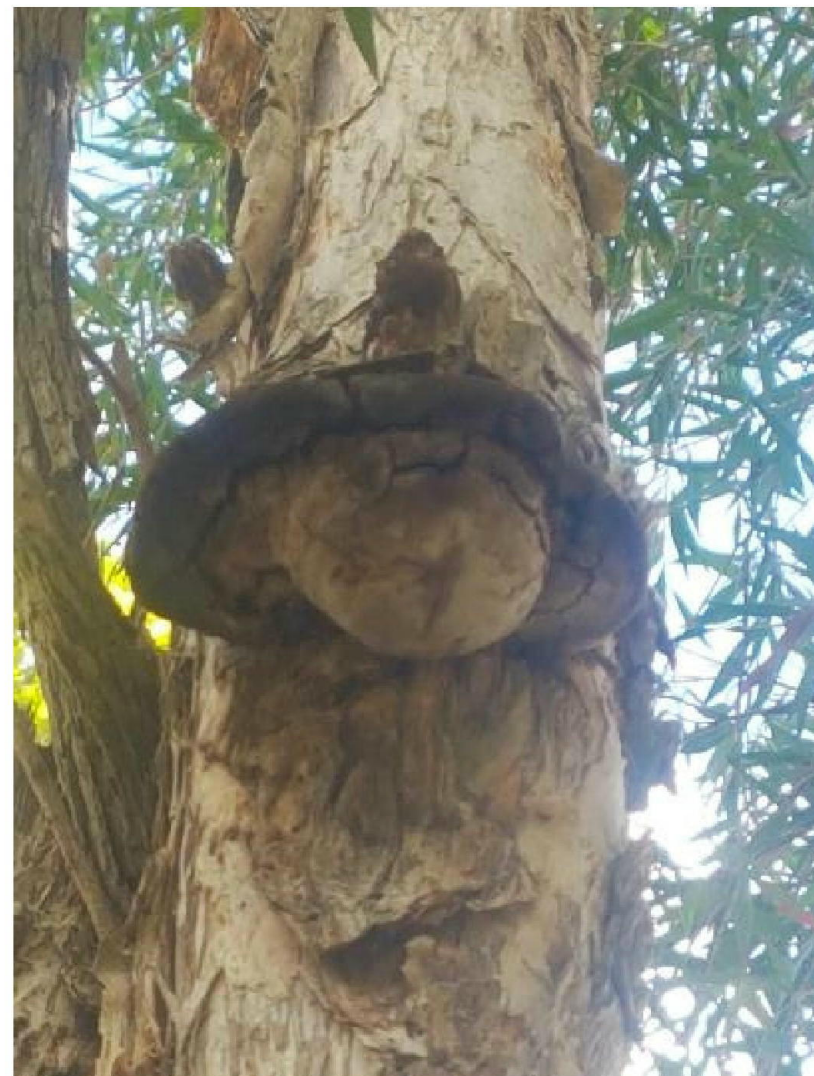
Age class. 10 years See Figs. 20 & 21.							
T19 <i>Melaleuca quinquineria</i> Common name 'Broadleaved Paperbark' Age class. 10 years See Fig. 22 & 23.	8m	2 x 12cm 2 x 14cm 25cm at the base	N 3m E 3m S 3m W 2m	A native tree common to estuarine areas of the NSW coast. The tree is growing centrally on the property in the Southern portion of the Site. At the time of inspection the specimen was in poor condition. There was two large <i>Ganoderma</i> bracket fungus on the main stem and the tree has 4 co dominant stems meeting in 'V' shaped stem junctions.	A5	3.13m	2.38m
T20 <i>Lophostemon confertus</i> Common name 'Brushbox" Age class. 20 years See Fig. 24.	9m	1 x 10cm 1 x 19cm 37cm at the base	N 3m E 3m S 3m W 3m	A native tree endemic to Northern NSW and Queensland. The tree has been planted in the center in the southern portion of the Site. At the time of inspection the specimen was in good condition with no significant pathogens or defects. The tree has co dominant stems meeting in a 'V' shape at 1.1m from the ground.	A1	2.58m	2.18m

Fig 23. Photo of T19 showing *Ganoderma* bracket on main stem.

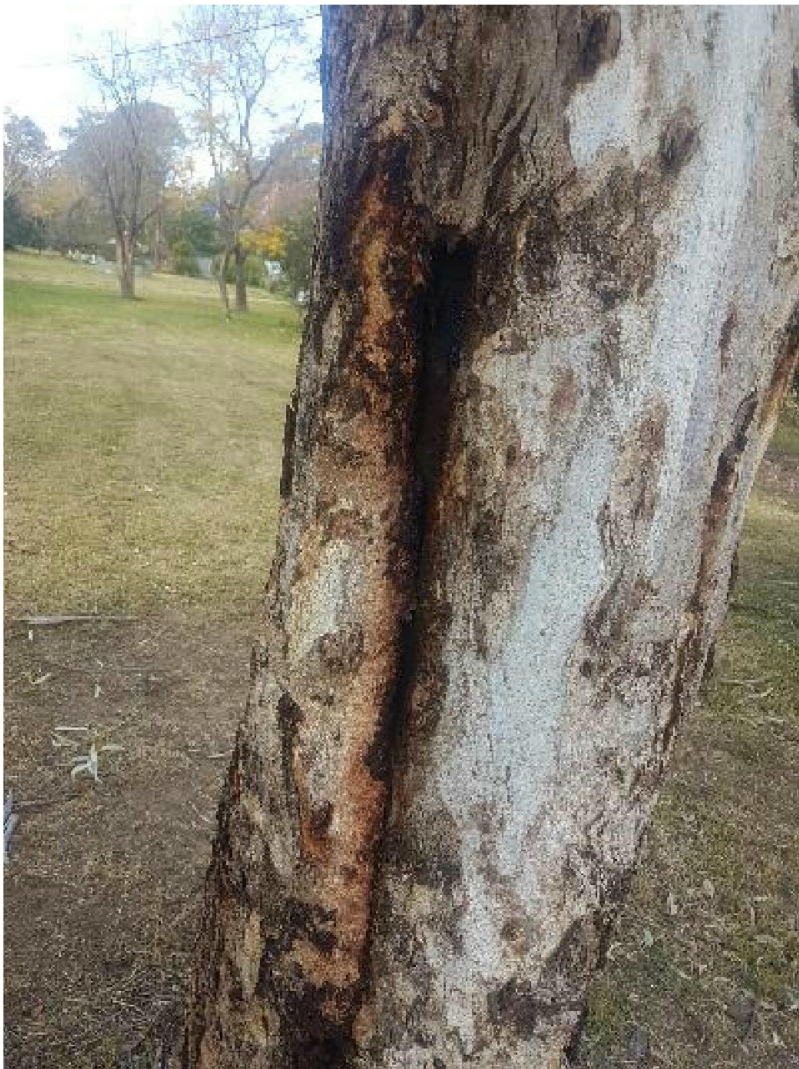
Fig 26. Photo of T21 showing large scar at base growing over

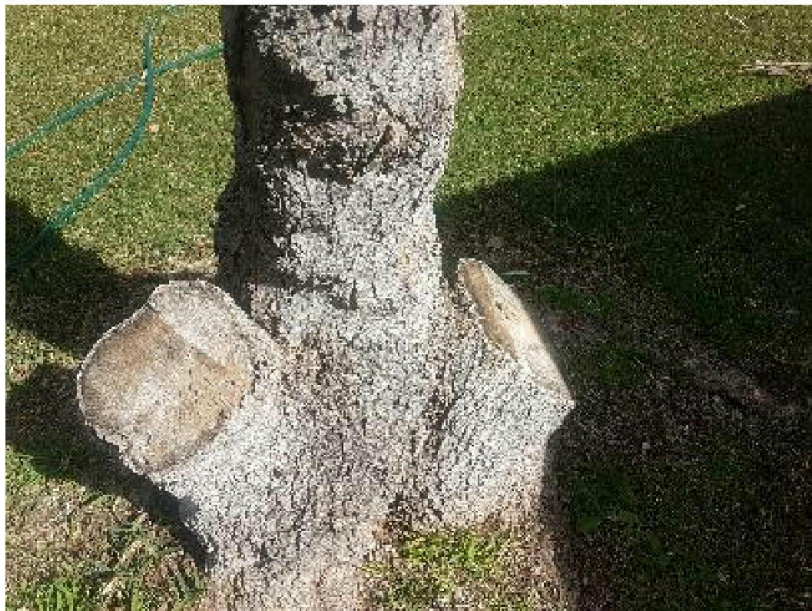
'Chinese tallowwood' Age class. 30 years See Fig. 32				damage. The species is widely recognised to have 'Weedy' properties.			
T28 <i>Acer negundo</i> Common name 'Box elder' Age class. 30 years See Fig. 33 & 34.	5m	1 x 5cm 1 x 8cm 1 x 10cm 43cm at the base	N 2m E 1m S 2m W 1m	An exotic tree endemic to North America. The tree is growing in the Southern portion of the Site. At the time of inspection the specimen was in poor health condition with two stems removed and one main stem remaining.	A2	2m Min TPZ	1.5m Min SRZ
T29 <i>Brachychiton populneus</i> Common name 'Kurrajong' Age class. 40 years See Fig. 35.	6m	18cm 27cm at the base	N 2m E 1m S 1m W 1m	A native tree belonging to Inland areas of NSW Queensland and Victoria. The tree is growing in the Southeast corner of the Site. At the time of inspection the specimen was in poor health and condition with foliage restricted to the top of the tree. there are co dominant stems with included bark in the main stem.	A3	2m Min TPZ	2.3m

Fig 34. Base of T28 showing old stubs from removed stems.

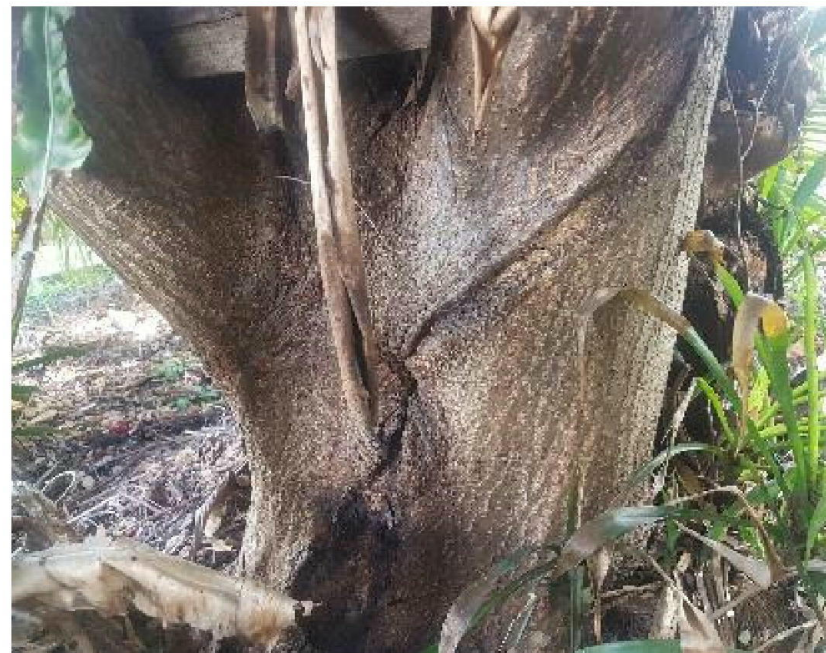
Fig 39. Photo of T32 Showing scar at base.

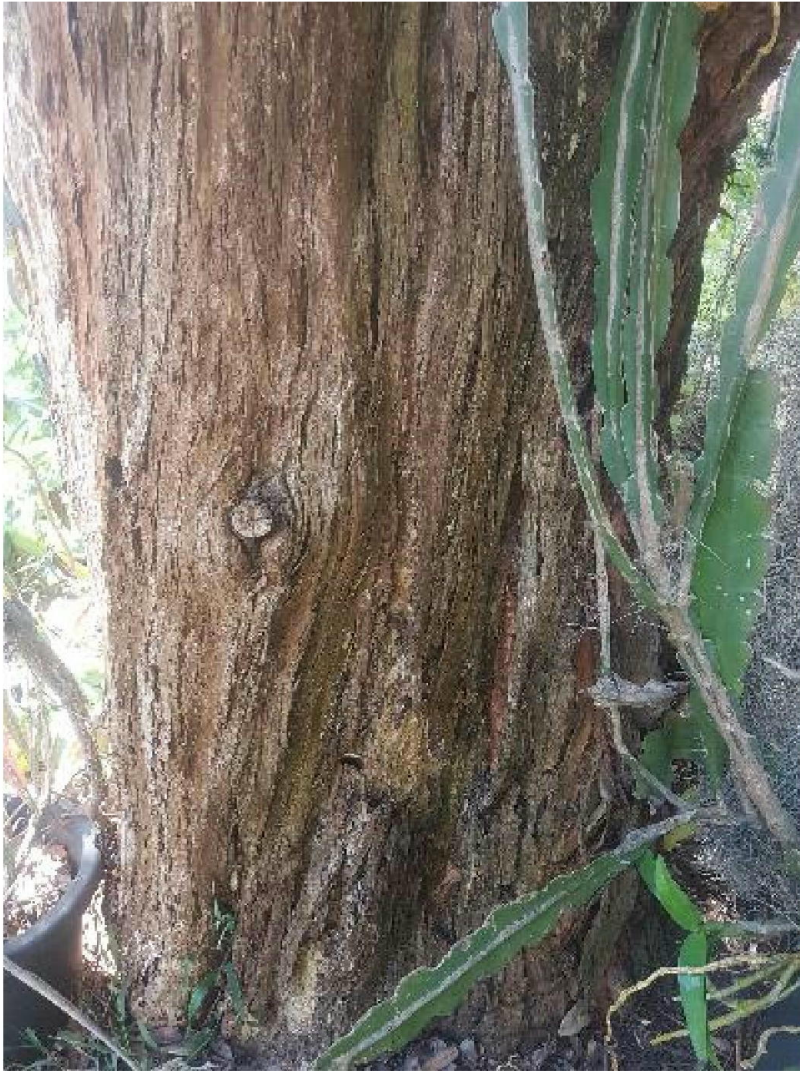
Fig 42. Included bark and rot at base of T34.
