Lenore Drive, Erskine Park Hot Spot Assessment December, 2019

Complete Petro-Chemical Consulting
Services Pty Ltd

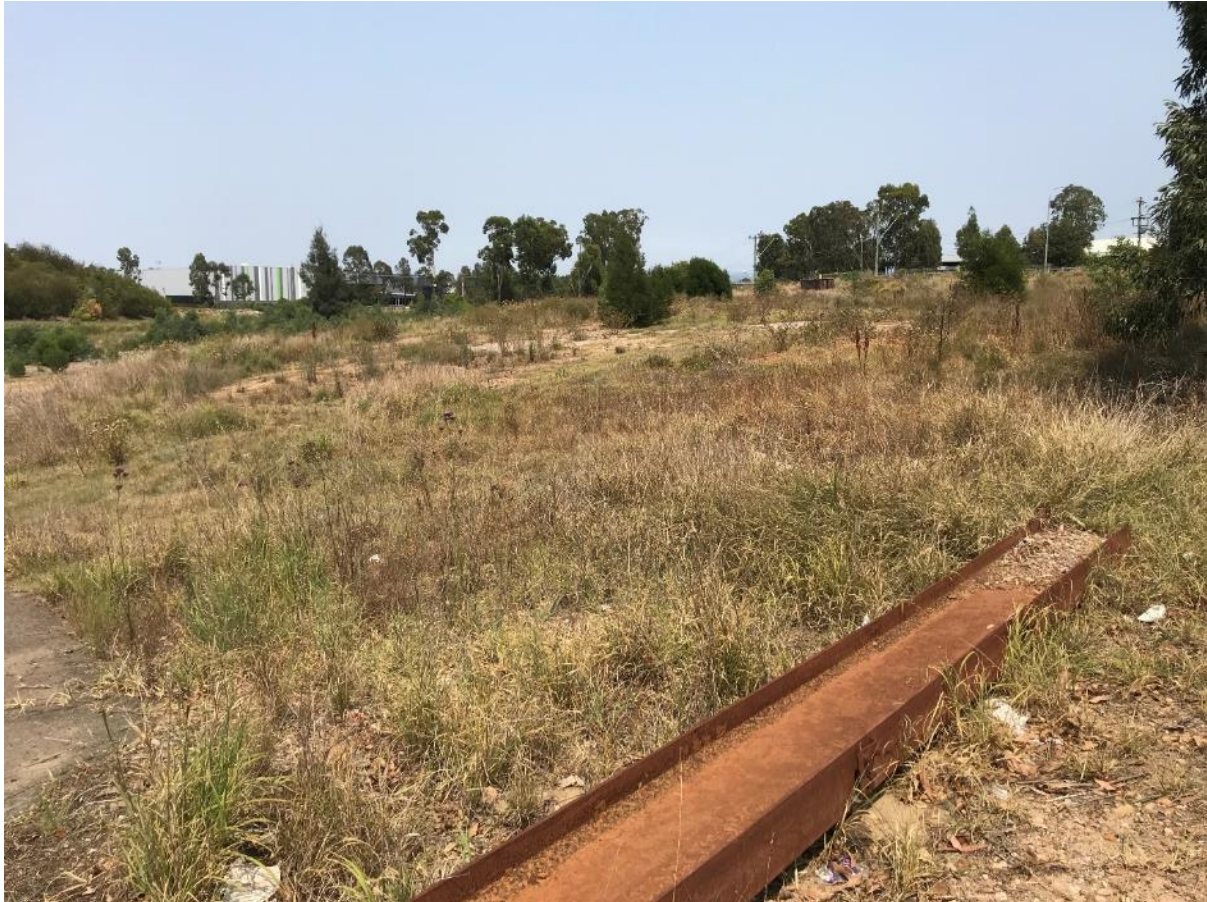
BH10A and 10 B

The area previously sampled and identified as BH10A and BH10B on Site Sample Location Plan Number 11839-002 (see Appendix 1) has since been completely overgrown by natural vegetation including the emergence of scotch thistles, an accepted indication of fertile soils. As expected, the small spill of diesel fuel, when the earthmoving machine was being refuelled, has bio-degraded and been digested into the soils and no longer poses a risk. Although Diesel spills are to be avoided wherever possible, the amount spilled in this case was minimal and as natural attenuation has occurred it is not expected to cause any ongoing concern.

There are no recommendations for this event. As the development progresses it is anticipated that soil will be moved, repositioned, compacted and eventually concreted over. There are no sources of contamination remaining which would affect human health.

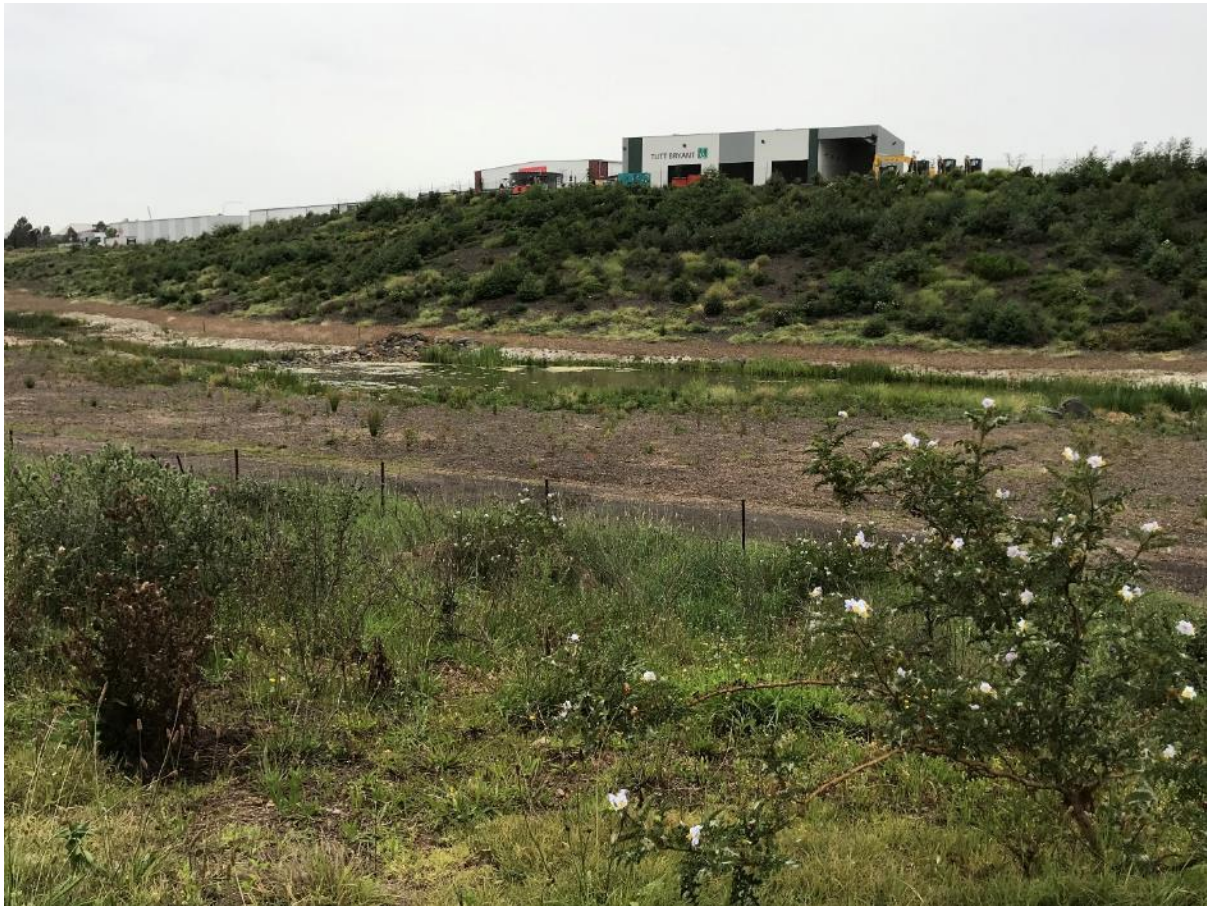
Area identified as BH10A

Kikuyu grass and thistle varieties indicate no detrimental effects from the diesel refuelling spillage. No further treatment is considered necessary.

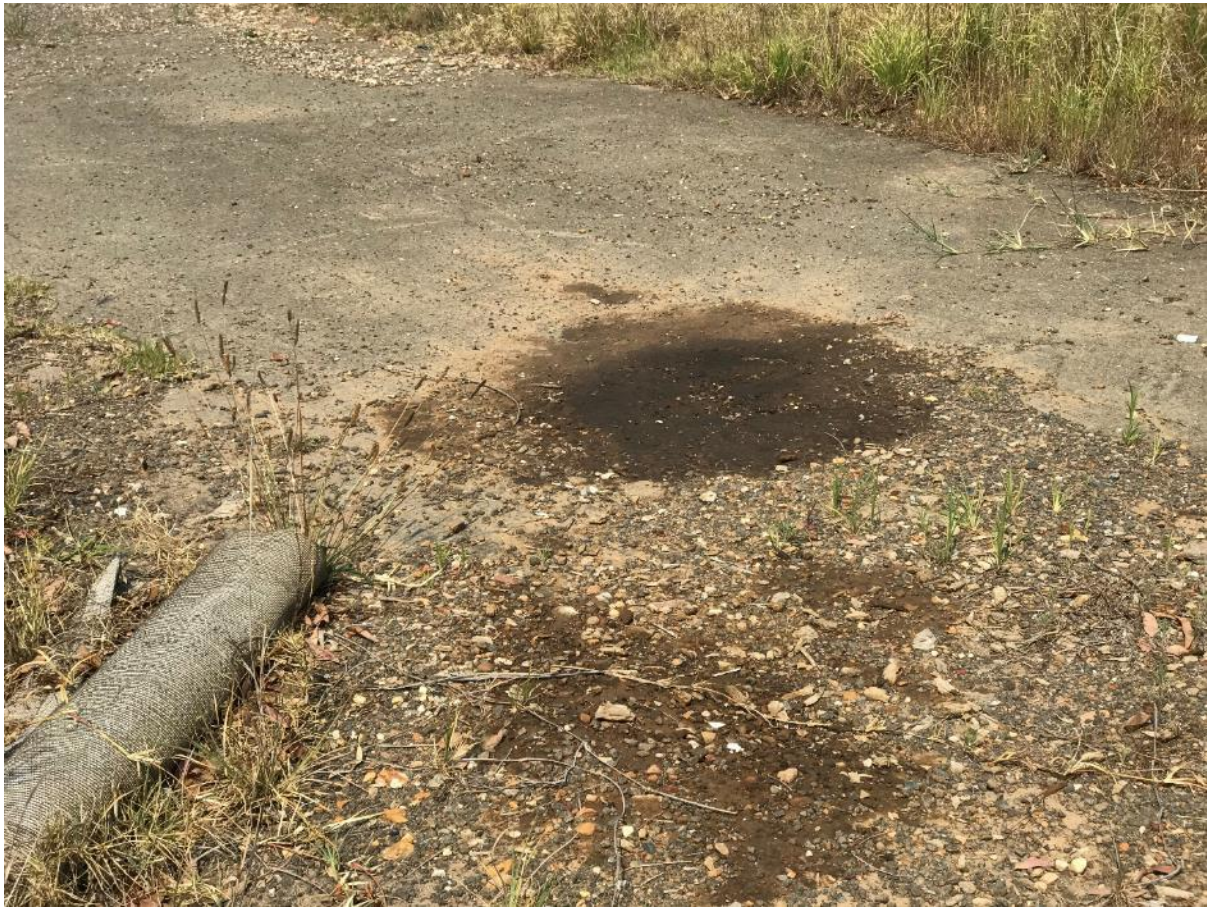
The earthmoving equipment was parked in this position, adjacent to the entrance to the property and obviously had some issues with spillage or oil leaks from the motor or the hydraulic system.

When the proposed development is approved, all future earthmoving equipment will be subject to strict mechanical checks prior to being engaged. Machinery left on site will be positioned over spill trays and environmental absorption pads.

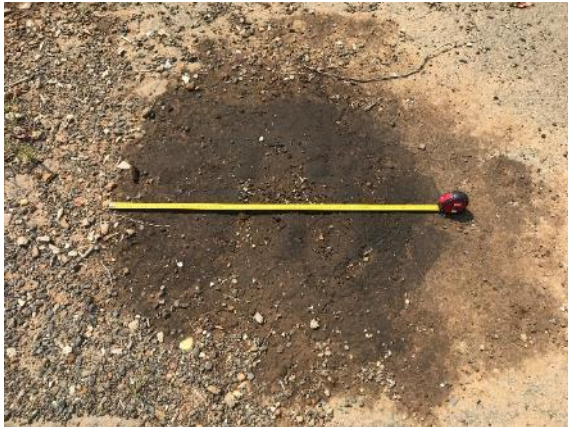
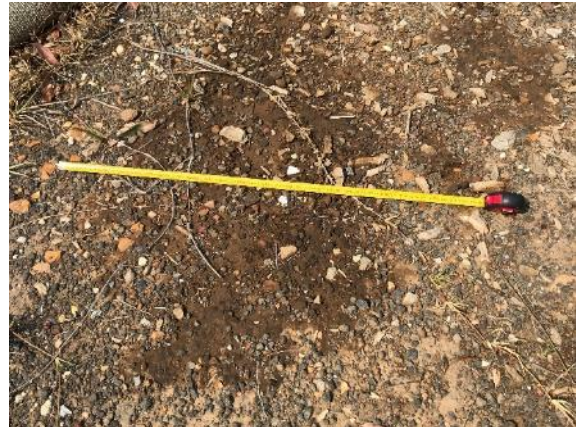
The two contamination hot spots consist of areas measuring approximately 700 mm in diameter. One spill/leak is situated on the tarmac and the other is off the edge of the tar on a gravel/dirt area.

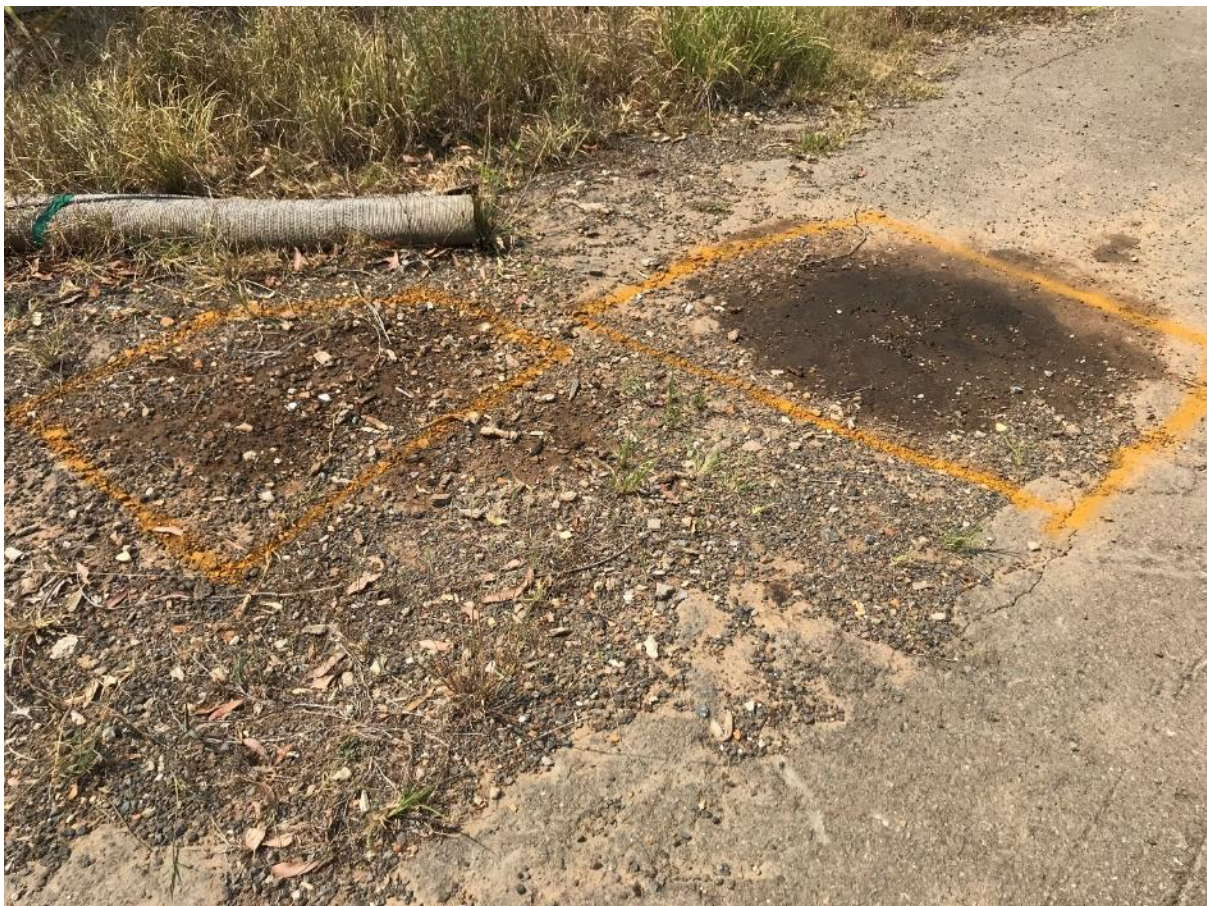
The two hot spots areas have been delineated by a yellow line marked on the ground.

Area one is situated on a tar base and has not penetrated beyond the tarmac. Onsite remediation will be almost immediate.

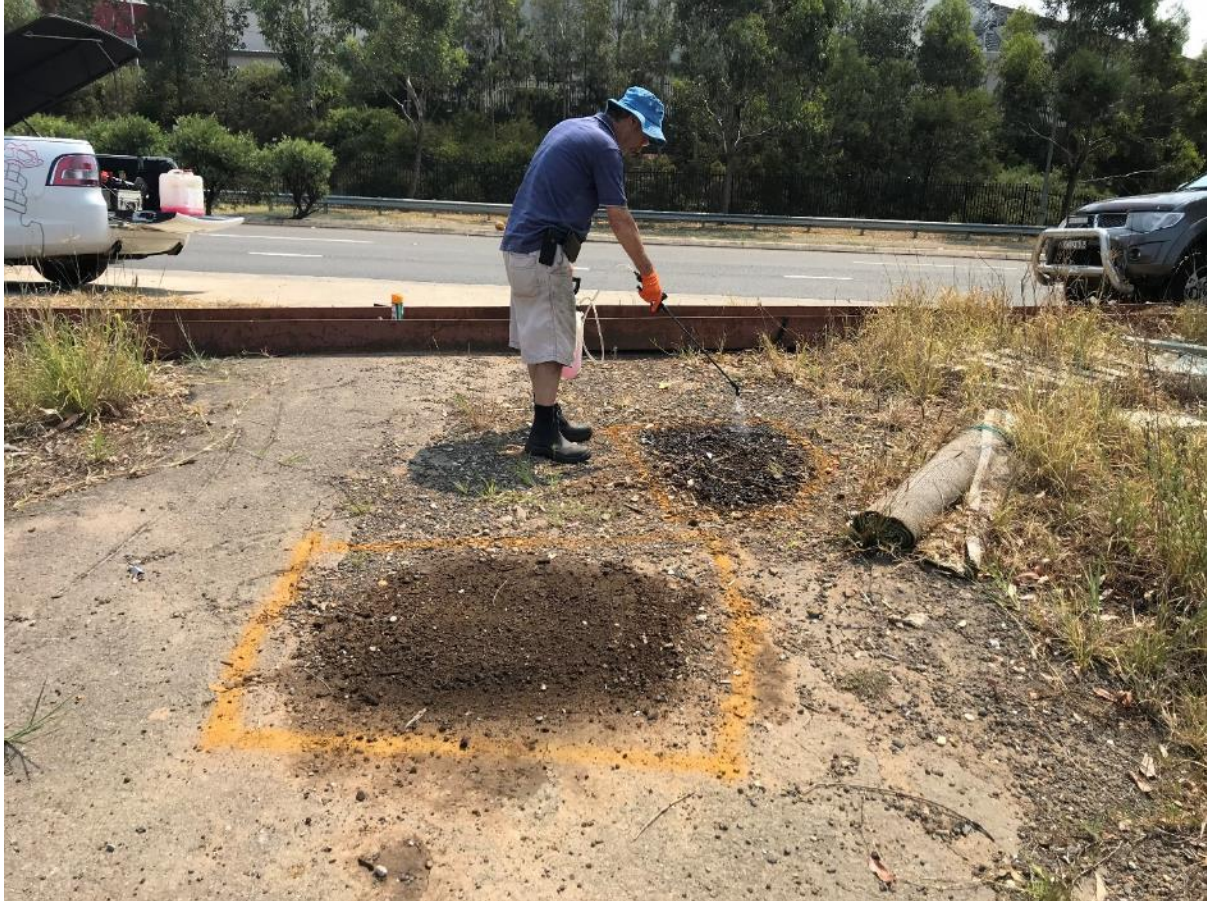
Area Two was on a gravel and soil area and possible deeper contamination may have occurred, the lighter colouring indicating some absorption into the soil may have taken place.

Area One was disturbed with the 5 tyne pitchfork to a depth of 10 mm, to refusal on the tarmac. The area was then liberally broadcast with a quantity of crumbled “Dynamic Lifter” a product high in nitrogen content and recognised as a fast breakdown into bacteria producing hydrocarbon digestive.

The area was disturbed by the pitchfork method to a depth of 100 mm and was then liberally broadcast with Dynamic Lifter.

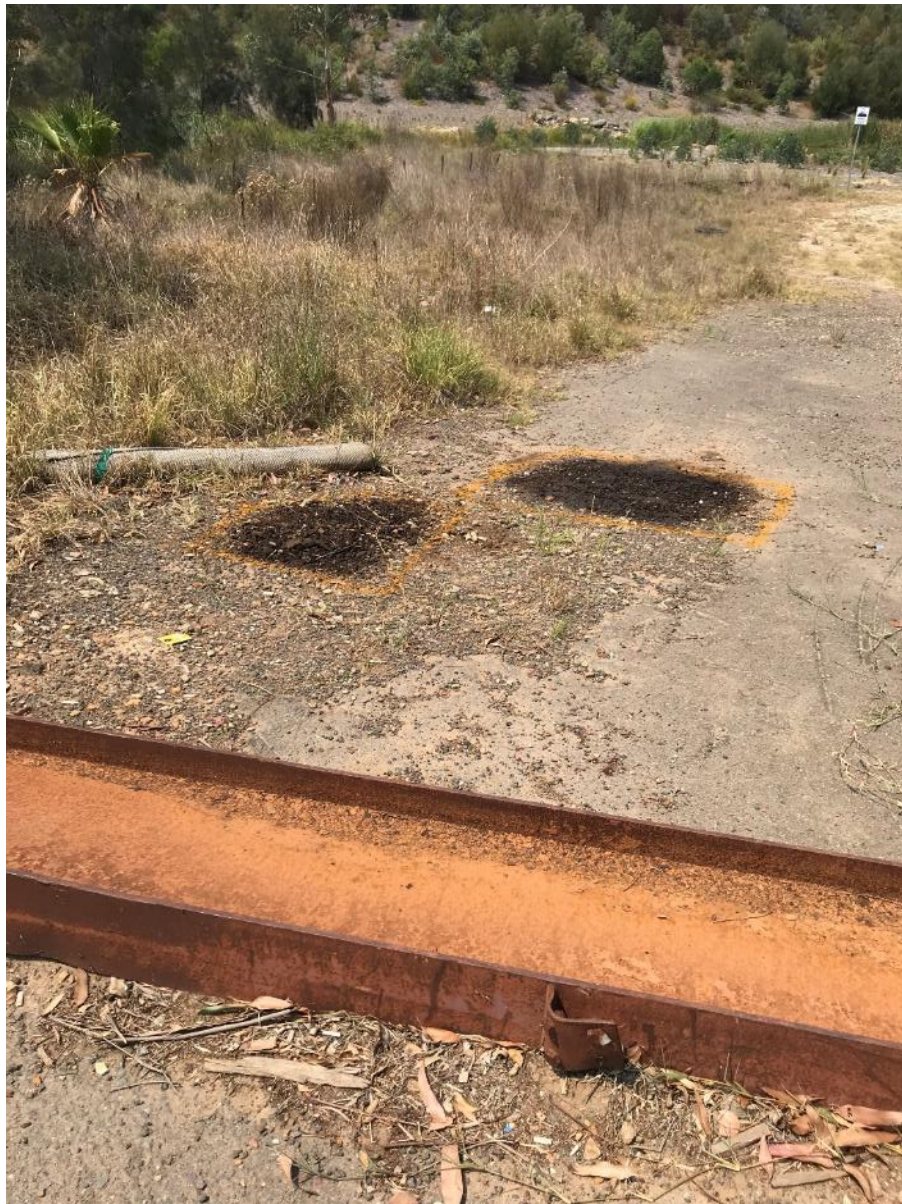
The positioning of the two remaining hotspots are easily identifiable on approach to the entrance to the site off Lenore Drive, by the yellow marker paint, however, for accuracy the hotspots are 6200 mm west and 2500 mm south of intersection of the site boundaries to Lenore Drive.
