R 16/112

Report **Tree Impact Assessment Report**
38,40 Orth St & 1,3,5 Hargrave St
Kingswood, NSW 2747

20-05-2016

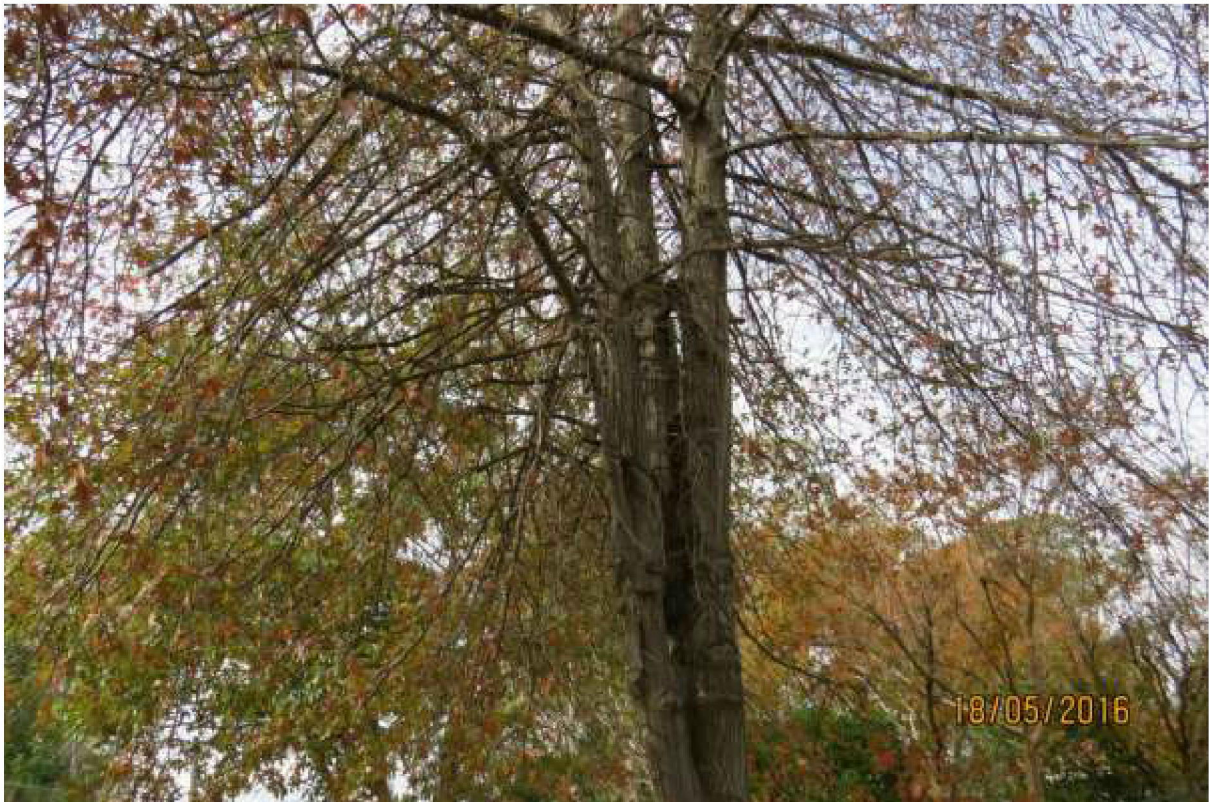
Photo 11 Tree 12 has a union of two trunks growing together

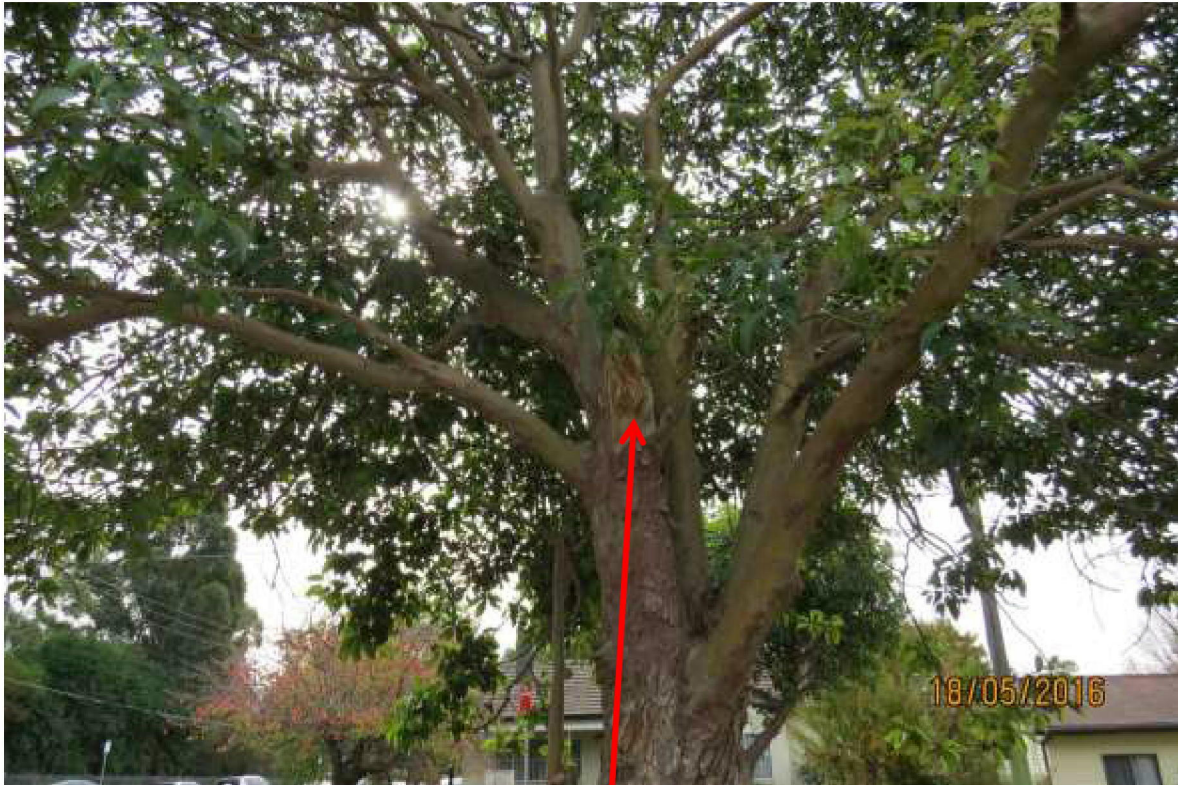
Photo 12 Tree 17 has a had a recent branch failure/tear out

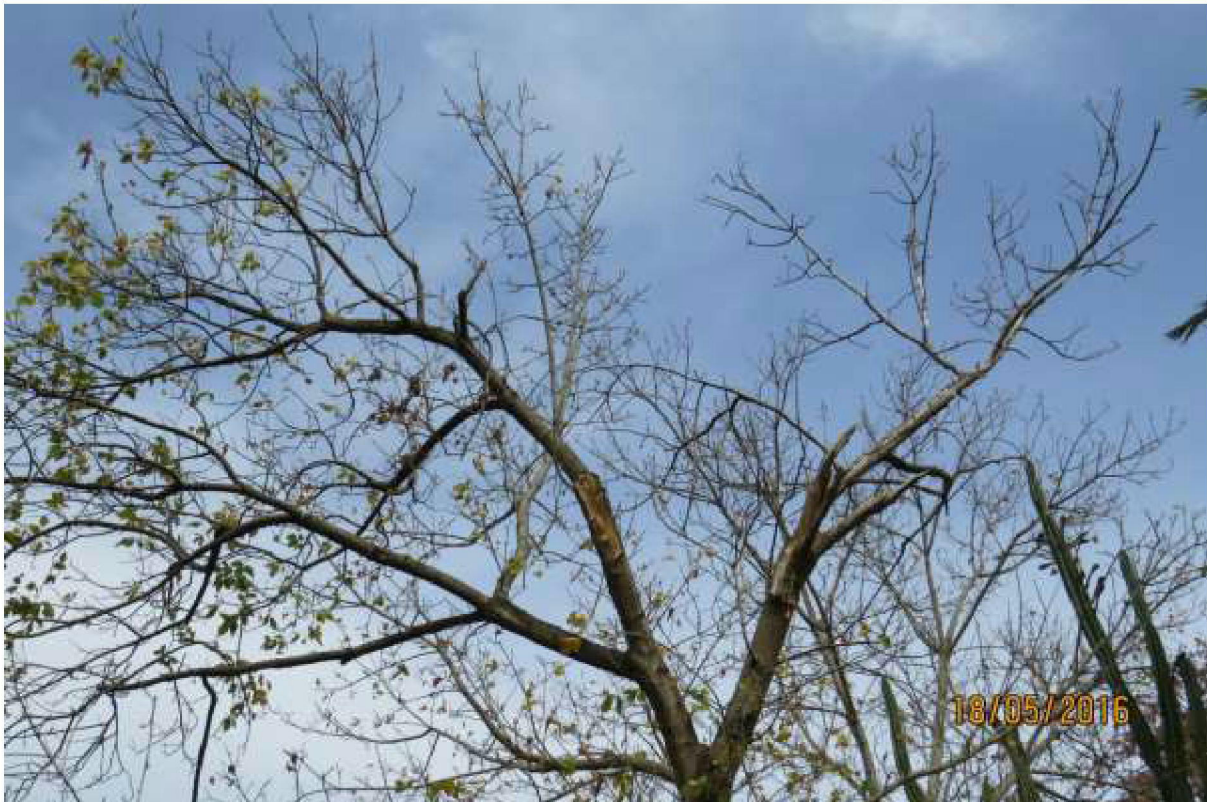
Photo 15 Tree 19 top is dead and has had some branches fail
