# Geotechnical Site Classification

## 880 Londonderry Road Londonderry NSW 2753

**Project:** 7001-18

**Date:** 31/10/2018

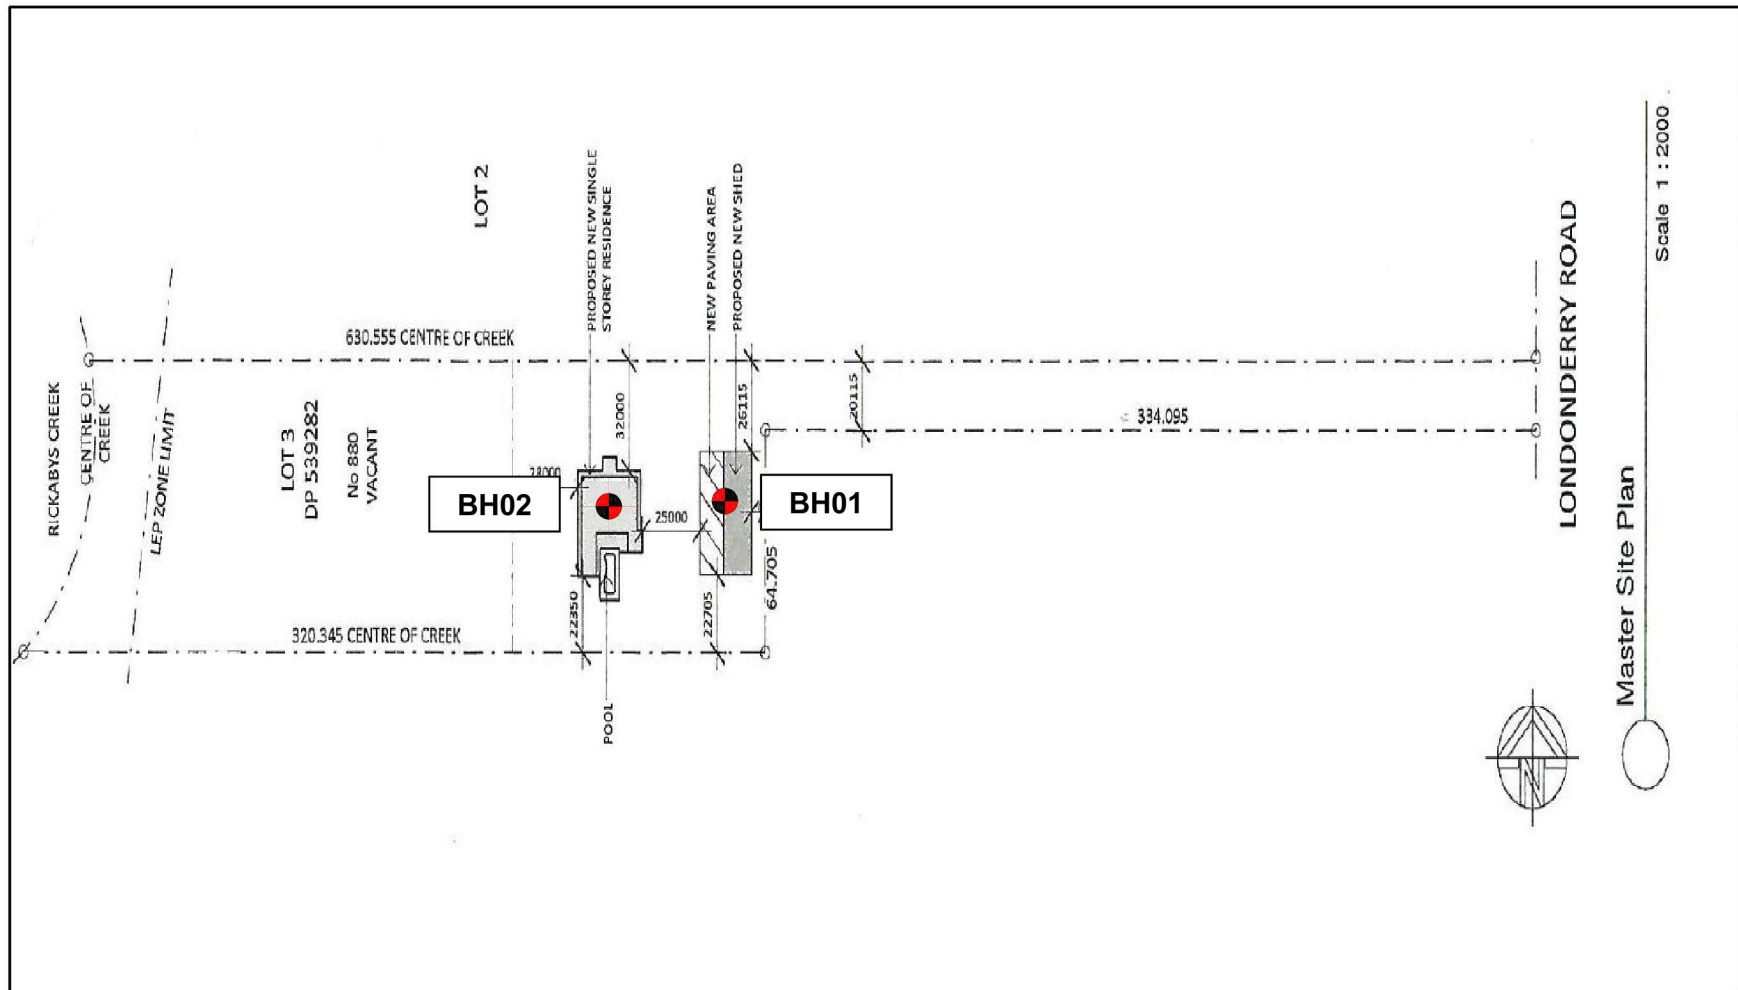
## Borehole and DCP Test locations

Note: Boreholes not to scale. Borehole/test location approximate.  
DCP undertaken in all borehole locations.
