28.02.2018

ARBORICULTURAL IMPACT REPORT

Site Address: 1-23 Lenore Drive, Erskine Park 2759

Prepared by Karen Marshall

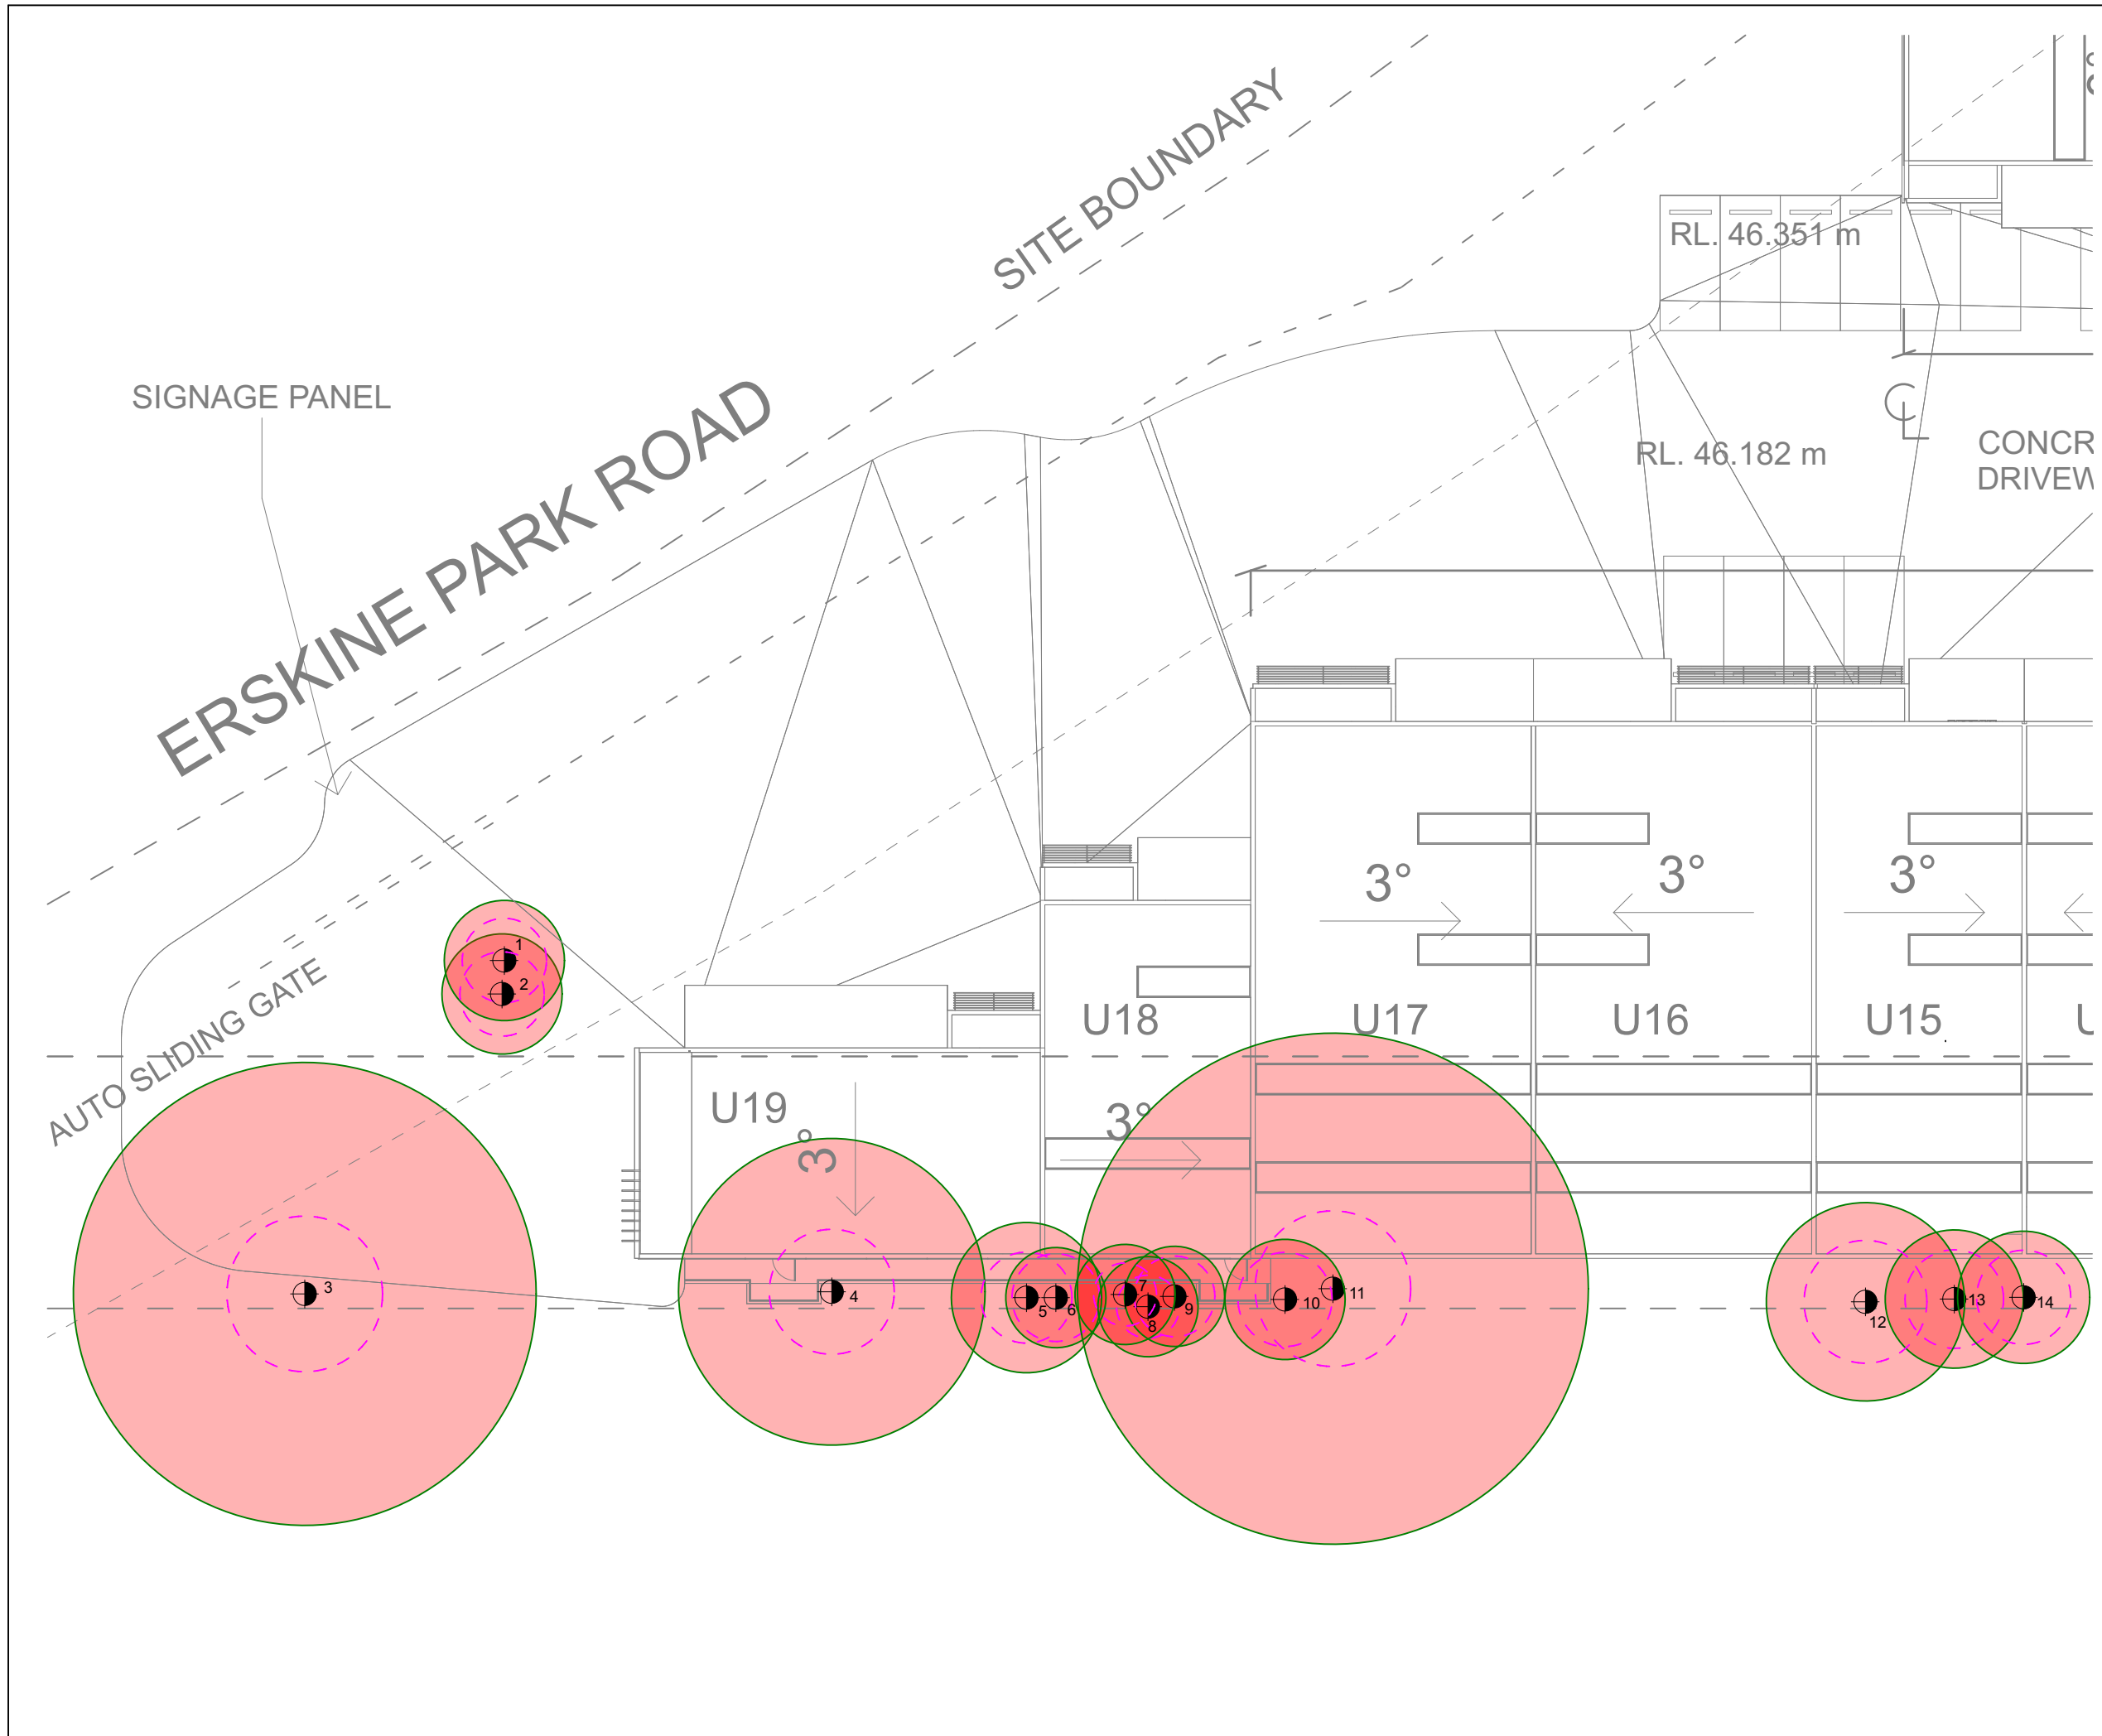
PLAN TITLE
 APPENDIX D
 TREE IMPACT PLAN

All 14 x trees assessed as part of this report are proposed to be removed as part of the proposed development. For detailed observations and calculations regarding each tree, impact of the proposed development and recommendations, please refer to Appendix C – Tree Impact and Assessment Table.

The proposed development represents major incursions into the TPZ areas for all 12 x *Eucalyptus moluccana* and also incurs into the SRZ for these trees. Given the current fair to poor health and condition of the trees, it is highly likely that any further disturbance would increase stress and contribute to a further decline in health and condition.

All 14 x trees assessed as part of this report are recommended to be removed and replaced.

The habitat box attached to tree number 4 will be required to be carefully removed by an appropriately qualified professional and re-attached at a similar height to a semi-mature tree within the adjoining property. Note that permission from the property owner will be required.

Replacement tree planting proposed within the embankment areas to the north east and north west property boundaries should include a minimum of 14 x *Eucalyptus moluccana* (Grey Box).
