ASBESTOS MANAGEMENT PLAN

**Masters Home Improvement
Development Site
Forrester Road, ST MARYS NSW 2760**

REPORT NUMBER: 7407.01.AMMP

DATE: 14th May 2013

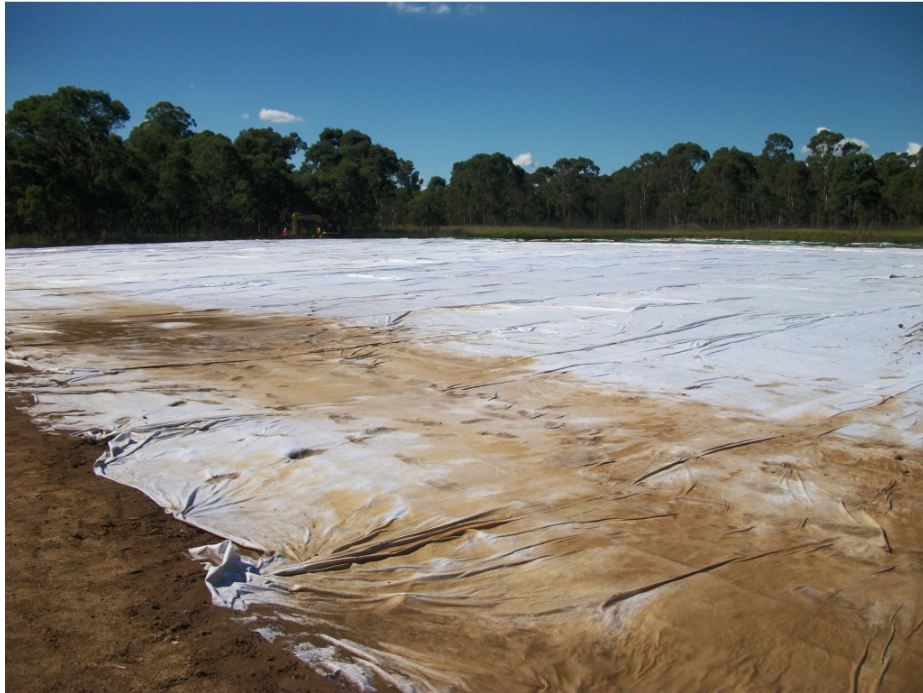
Photograph 1

No visually identifiable asbestos containing materials were identified at the Time of Inspection within the Area Inspected and based on the results of the inspection it is considered that the encapsulation of asbestos contaminated soils was carried out to a satisfactory industry standard.

The geo-fabric material covering the northern section of the site.

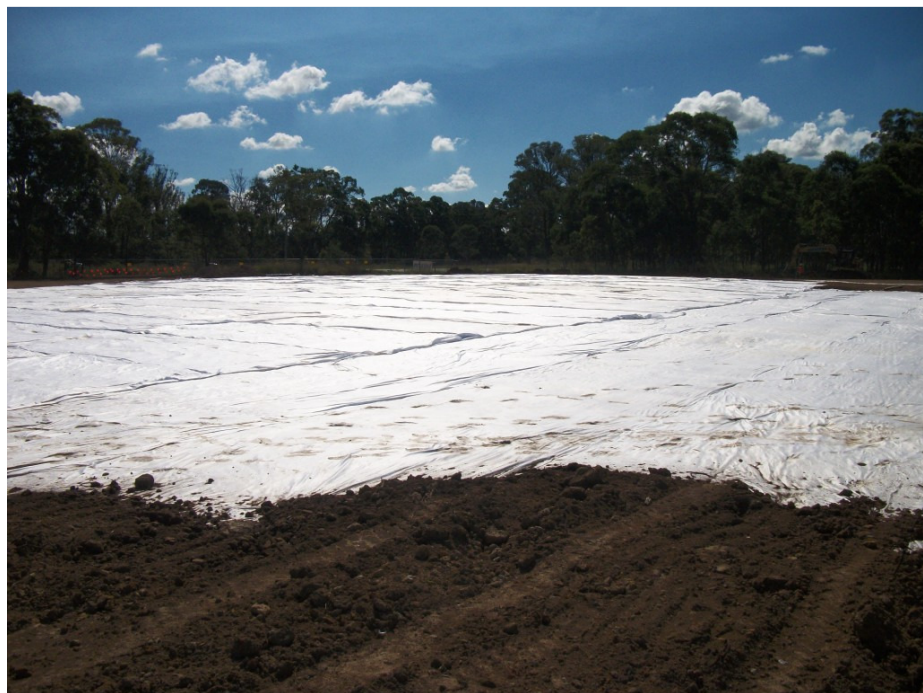
Photograph 2

Close up of geo-fabric layer along with the commencement of validated fill being placed above the indicator layer as part of the encapsulation process.
