ARBORICULTURAL IMPACT REPORT

Site Address: 1-23 Lenore Drive, Erskine Park 2759

Prepared by Karen Marshall

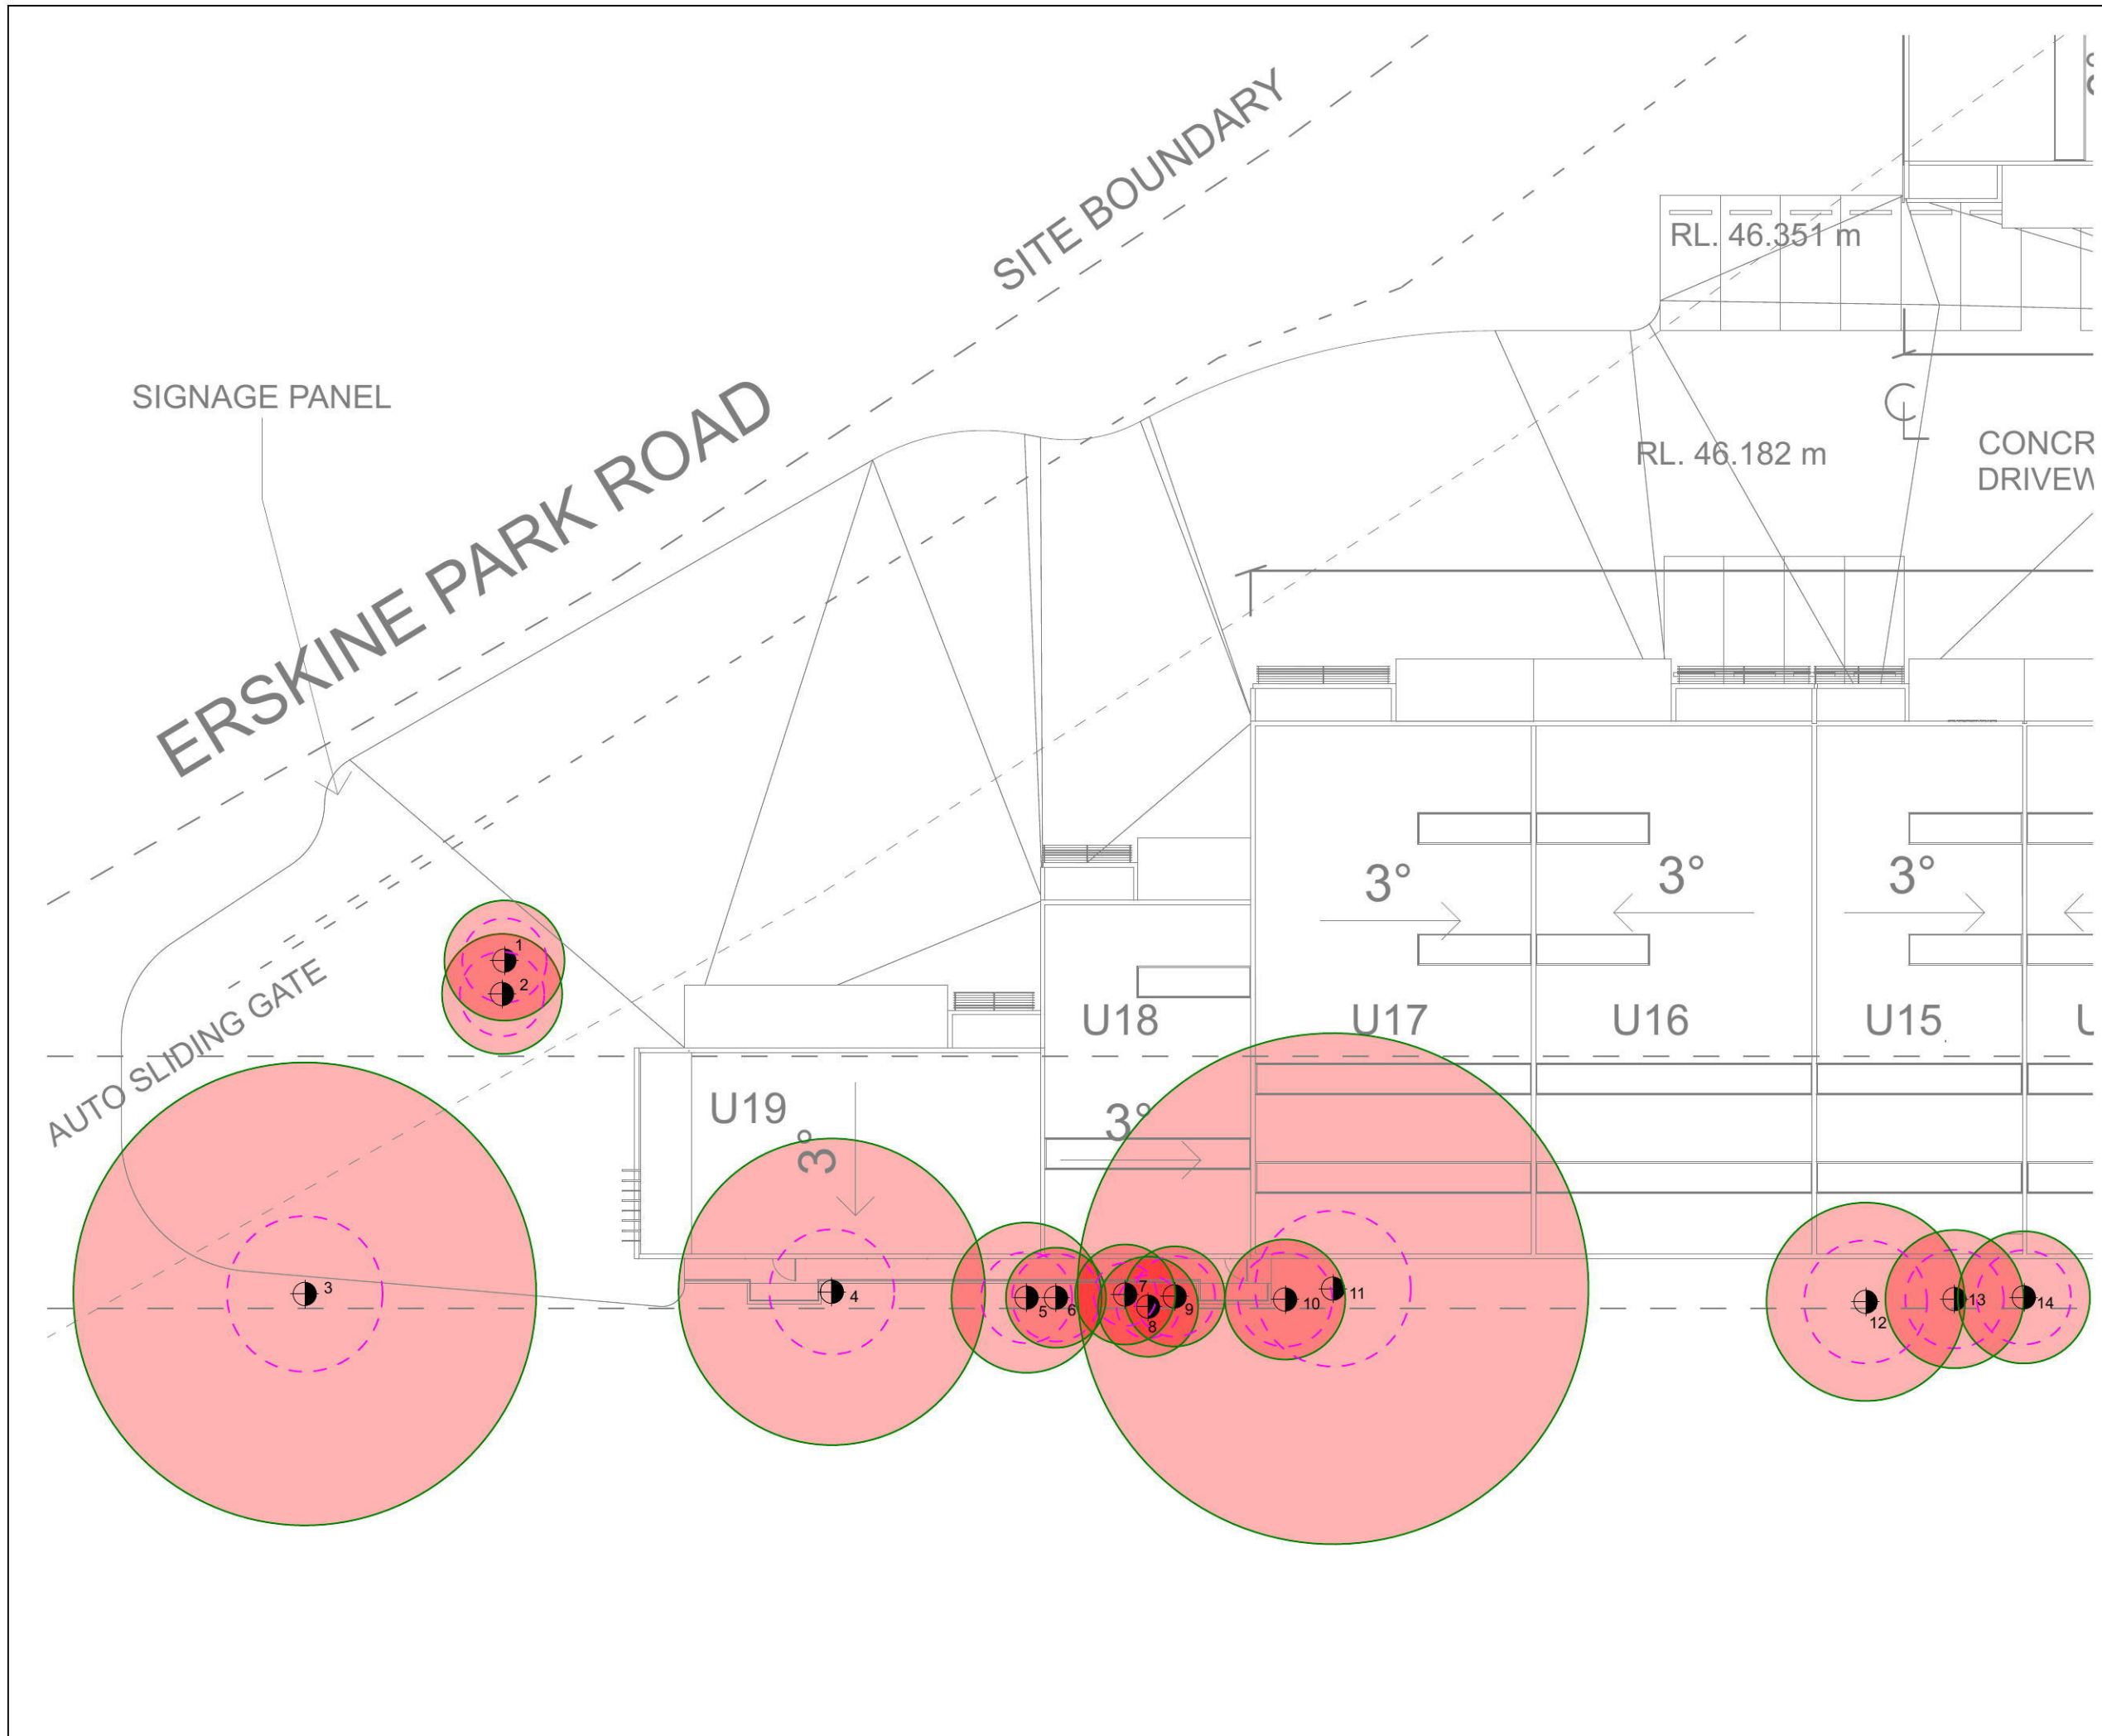
APPENDIX D
 TREE IMPACT PLAN

All 14 x trees assessed as part of this report are proposed to be removed as part of the proposed development. For detailed observations and calculations regarding each tree, impact of the proposed development and recommendations, please refer to Appendix C – Tree Impact and Assessment Table.

The proposed development represents major incursions into the TPZ areas for all 12 x *Eucalyptus moluccana* and also incurs into the SRZ for these trees. Given the current fair to poor health and condition of the trees, it is highly likely that any further disturbance would increase stress and contribute to a further decline in health and condition.

All 14 x trees assessed as part of this report are recommended to be removed and replaced.
