Hazardous Materials Survey Report

230 Aldington Road, Kemps Creek NSW

Report E23529.E10_Rev0
19 September 2017

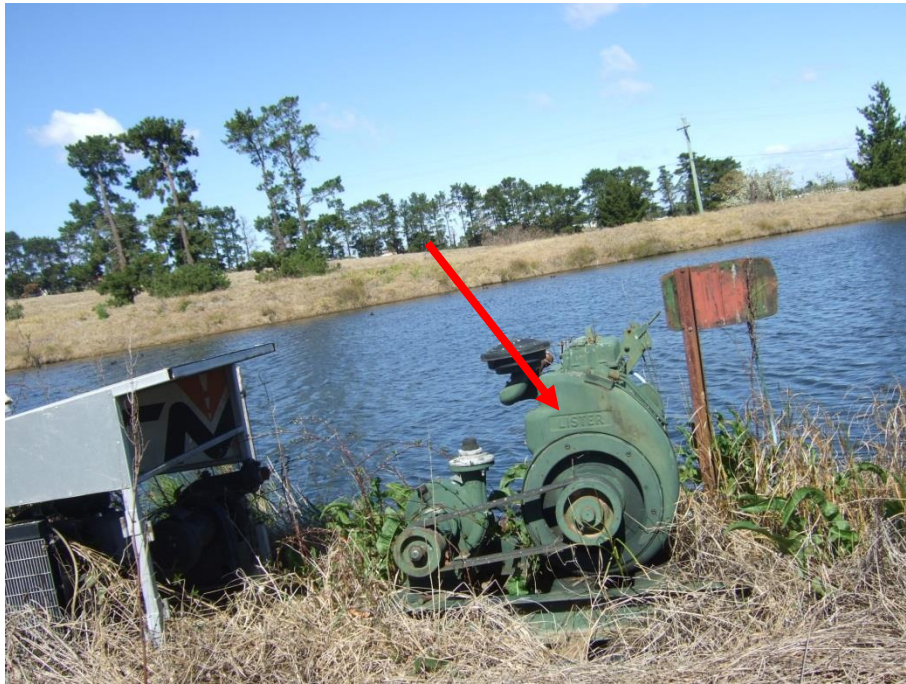
Location	Material Type	Sample / Photograph Reference	Quantity	Condition	Accessibility	Risk Priority Rating	Recommendations	Timing
Asbestos								
Pump shed, external, Lister water pump, engine exhaust manifold flange and engine head flanges	Gaskets (may contain asbestos)	Not sampled (mechanical hazard) Photograph 1	ND	Good	Maintenance only	Priority 3 - Negligible Risk under Present Conditions	Remove prior to demolition works. Confirm asbestos status prior to demolition.	September 2022
Residential building, external, southern elevation, debris to grounds	Fibre cement sheeting	ASB03	NA	NA	NA	No asbestos materials detected	NA	NA
Residential building, external, eaves	Fibre cement sheeting	Similar to ASB03	NA	NA	NA	No asbestos materials detected	NA	NA
Office/Flat, external, eaves	Fibre cement sheeting	ASB02	NA	NA	NA	No asbestos materials detected	NA	NA
Large shed, external, western retaining wall, concrete filled pipes	Fibre cement pipes	ASB01	NA	NA	NA	No asbestos materials detected	NA	NA

The red arrow points to the Lister water pump that may contain asbestos gaskets.

Asbestos materials should be removed prior to the commencement of any renovation or demolition works that may cause their disturbance. The removal of these materials is to be done in accordance with the requirements of the SafeWork NSW approved code of practice "How to Safely Remove Asbestos" and requires a minimum Class B licenced asbestos removal contractor.
