Supplementary Arboricultural Impact Assessment Report

Village 5 Playground, Jordan Springs,
NSW

14 September 2015

ANNEXURE 1 - TREE LOCATION PLAN

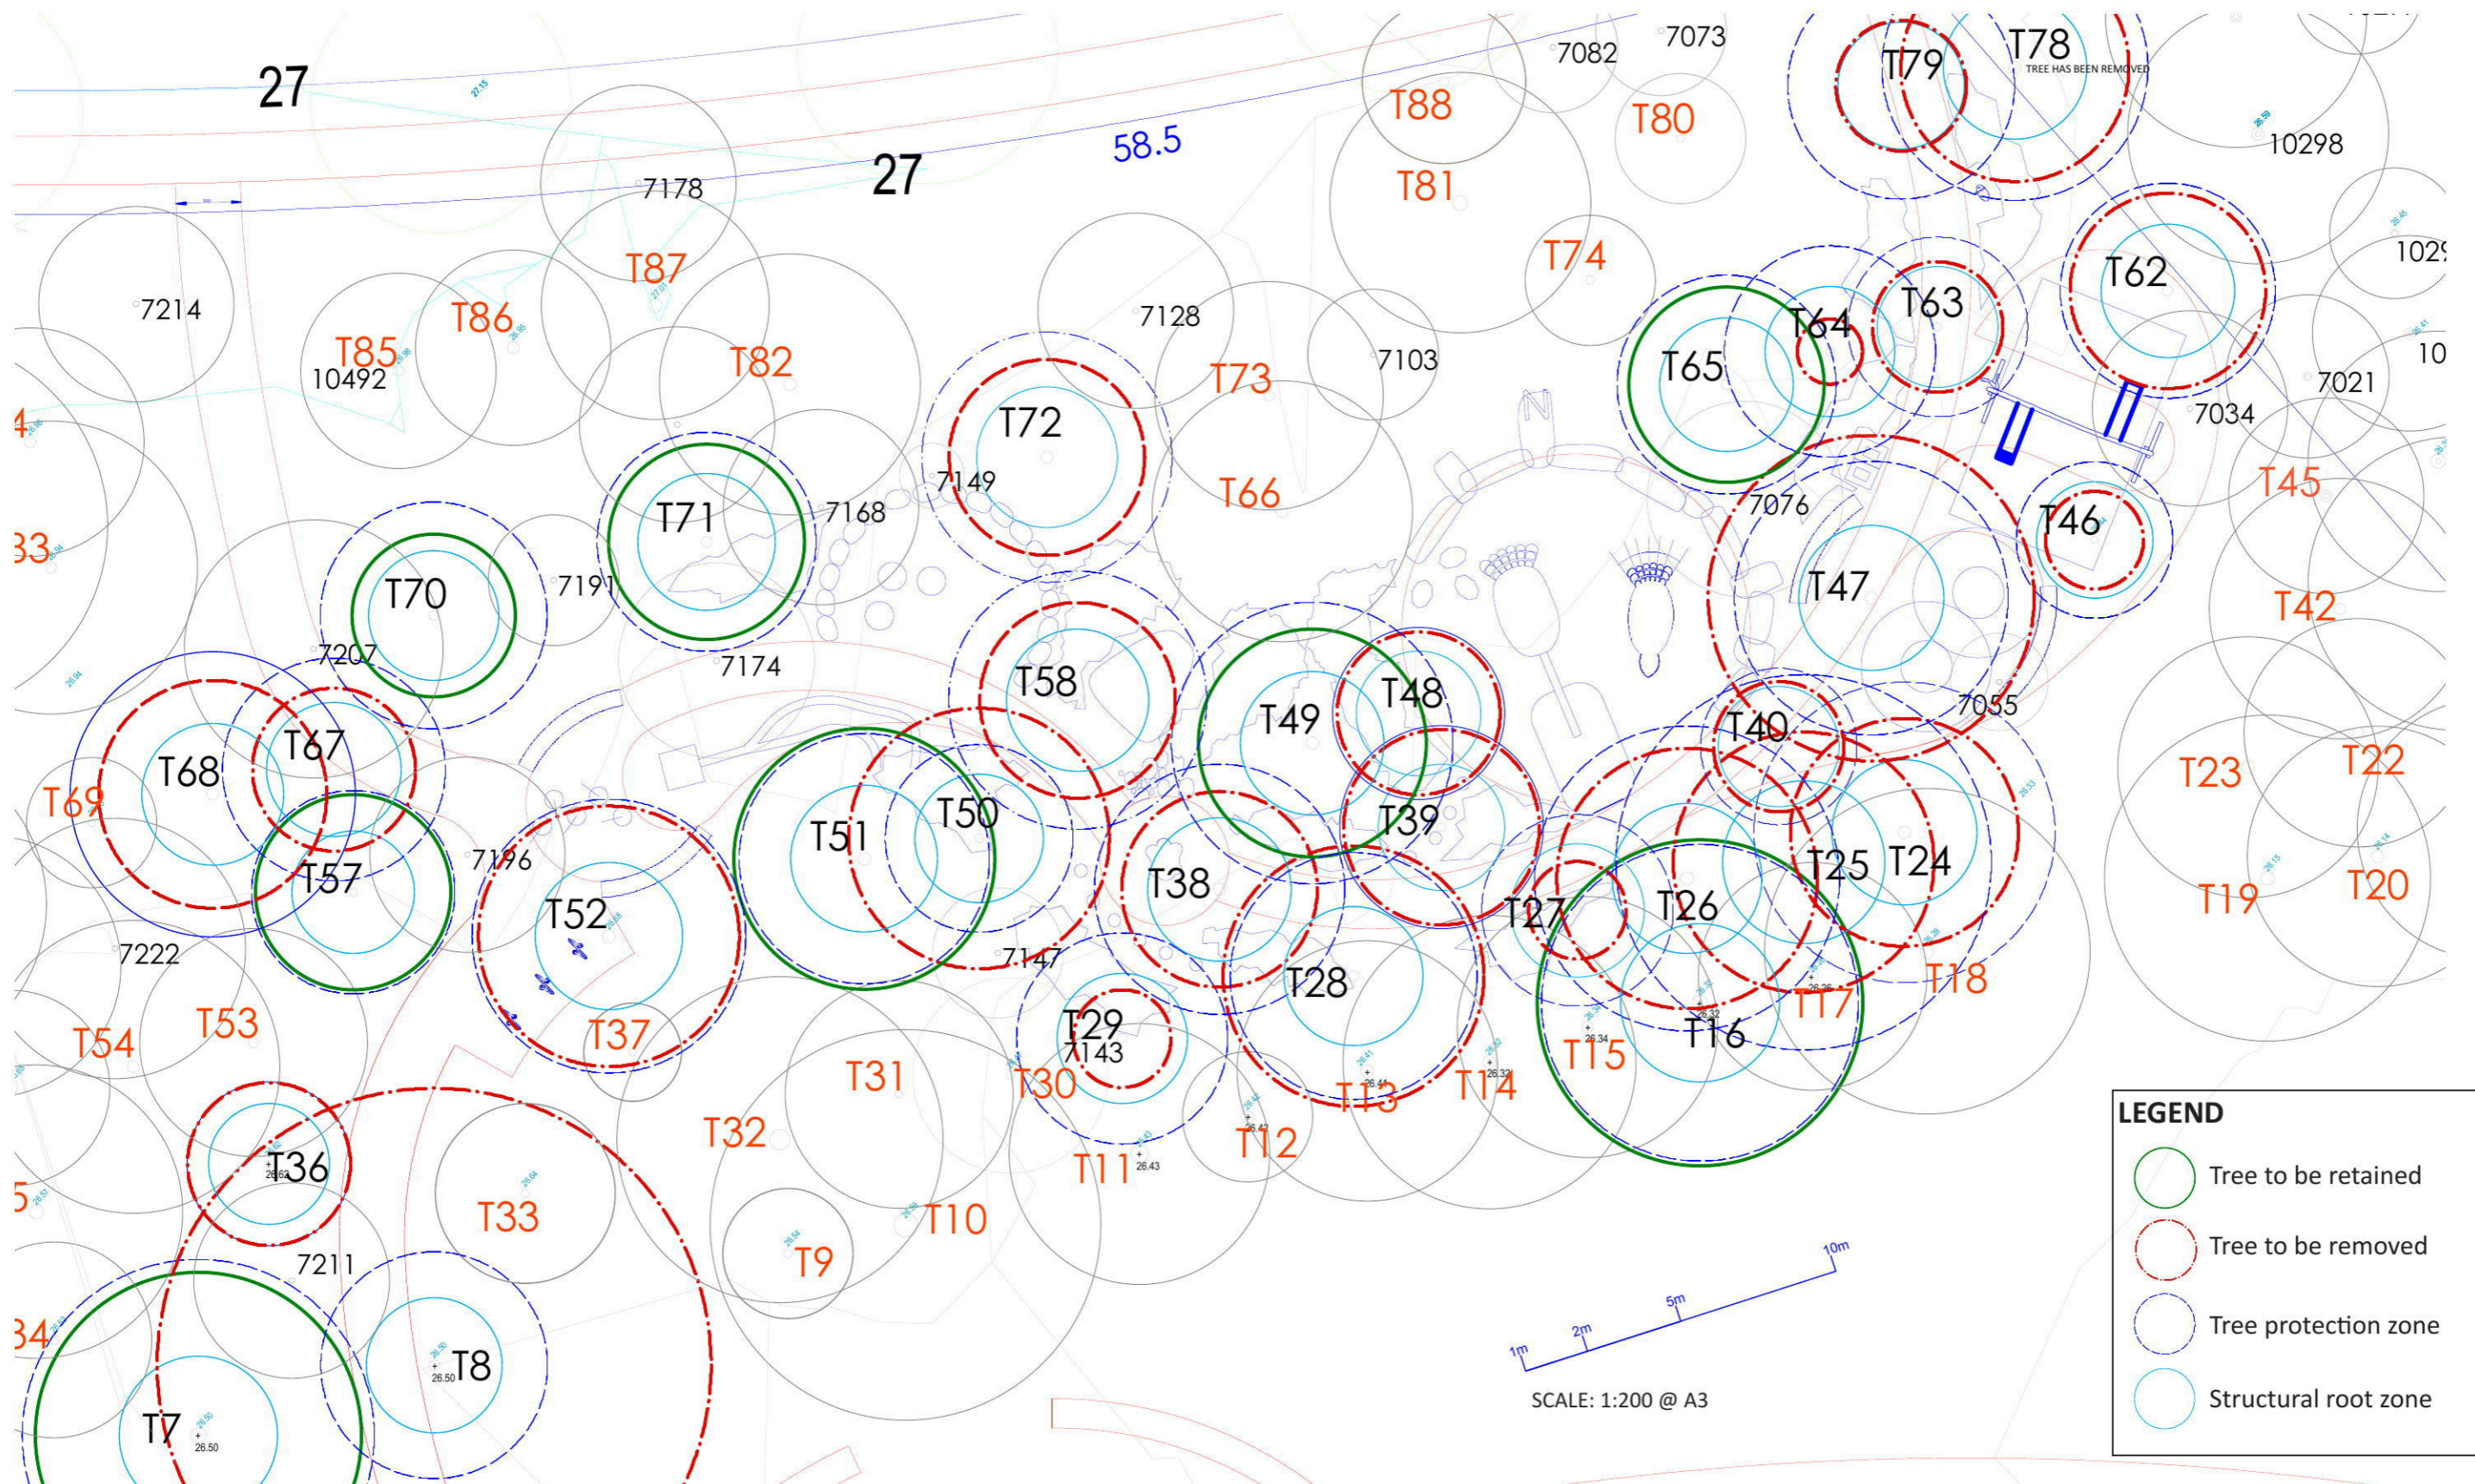
DRAWING TITLE:
TREE LOCATION PLAN 1

The trees are shown on the Tree Location Plan attached as Annexure 1. The tree landscape significance (as calculated in the Arborist Report) of the trees are shown on the same plan. The plan is based on plans provided by Clouston Associates listed in section 1. It has been assumed that the plans accurately show the location of the trees, tree protection zones, structural root zones and amendments to the proposed playground design.

Tree 7 - A less than 1% incursion to the tree protection zone (previously none) due to a change in the route of the concrete path to the west of the playground. This is considered to be a minor encroachment under AS 4970 - 2009. The Arborist Report states that the tree is in good health and good condition, has medium landscape significance, medium amenity value and high ecological value. Based on this information the tree should be retained.

Tree 8 - A 47.6% incursion to the tree protection zone (previously 39.1%) and 35% incursion to the structural root zone by the concrete path because of the change in location. Although the Arborist Report states that the tree is in fair health it is unlikely to survive this significant level of incursion and will need to be removed.

Tree 24 - A 10.6% incursion to the tree protection zone (previously 36.3%) from the rubber softfall around the trampolines. Despite the moderate level of incursion the Arborist Report records that the tree is fair to average health and has bottle butt. The tree should be removed.

Tree 26 - The proposed changes slightly reduce the incursion to the tree protection zone of this tree from 28.3% to 24.9% due to excavation for both rubber and mulch softfall. This is still a high impact and the tree may not survive. The proposed works also encroach into the structural rootzone by 10%. The Arborist Report records that the tree is in poor to fair health only with visible structural defects. The tree will need to be removed.

Tree 28 - An increase in the incursion to the tree protection zone from 20.1% previously to 25.9% and an 18.3% incursion to the structural root zone of the tree caused by excavation for the rubber softfall path. This is a high level of incursion and the tree may not survive. The tree may be destabilised and will need to be removed.

Tree 38 - The tree now lays within the footprint of the circular area of concrete paving under the frog (100% incursion to both the tree protection zone and structural root zone, previously 38.6%). This tree will need to be removed.

Tree 52 - A 100% incursion to the tree protection zone of the tree (previously 16.3%). The stem of the tree is within the concrete footpath to the west of the playground. The Arborist Report states that the tree is in average to good health but poor condition with significant structural defects visible. The tree has low landscape significance and low visual amenity. The tree will need to be removed.

As a consequence of the amendments to the proposed design eight trees should be retained, and 17 trees will need to be removed. In addition, seven trees should be removed irrespective of changes to the design. These trees are identified in Tables 1 and 2 below.
