ARBORICULTURAL DEVELOPMENT IMPACT ASSESSMENT REPORT

1 Edna Street, Kingswood NSW

REVISION C

5 July 2018

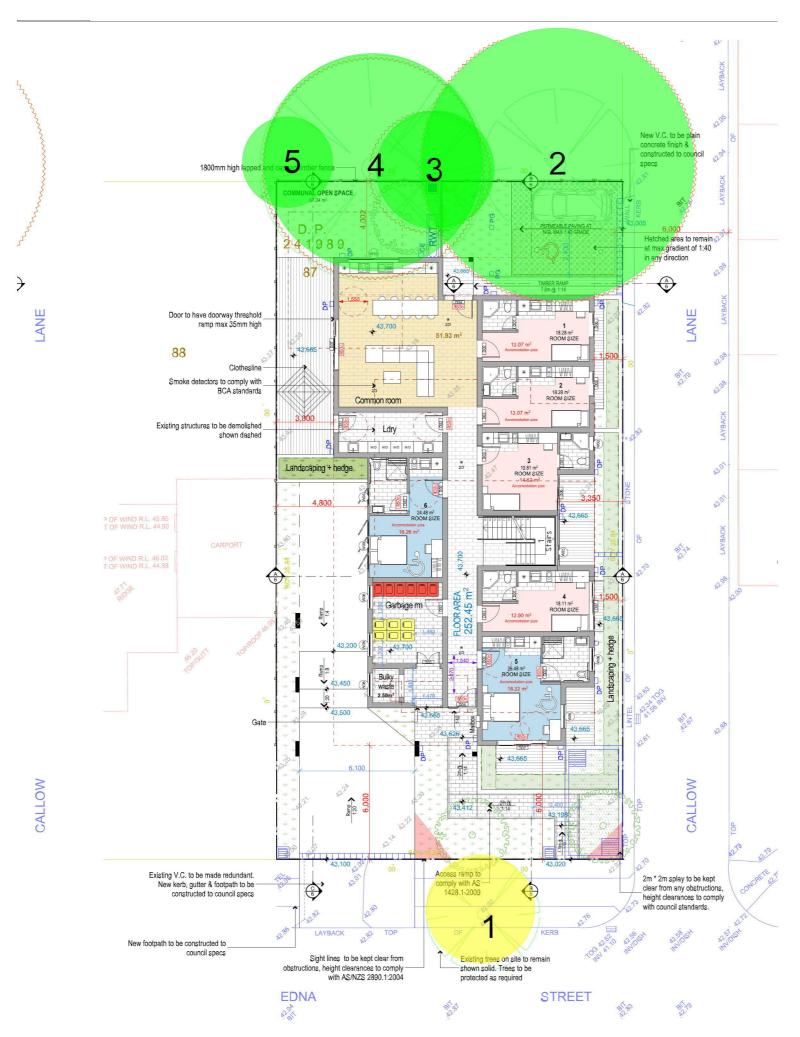
Plan: Tree Location Plan

Trees are as identified in the attached inspection forms in Appendix A and shown in Tree location Plan A01 in Appendix B.

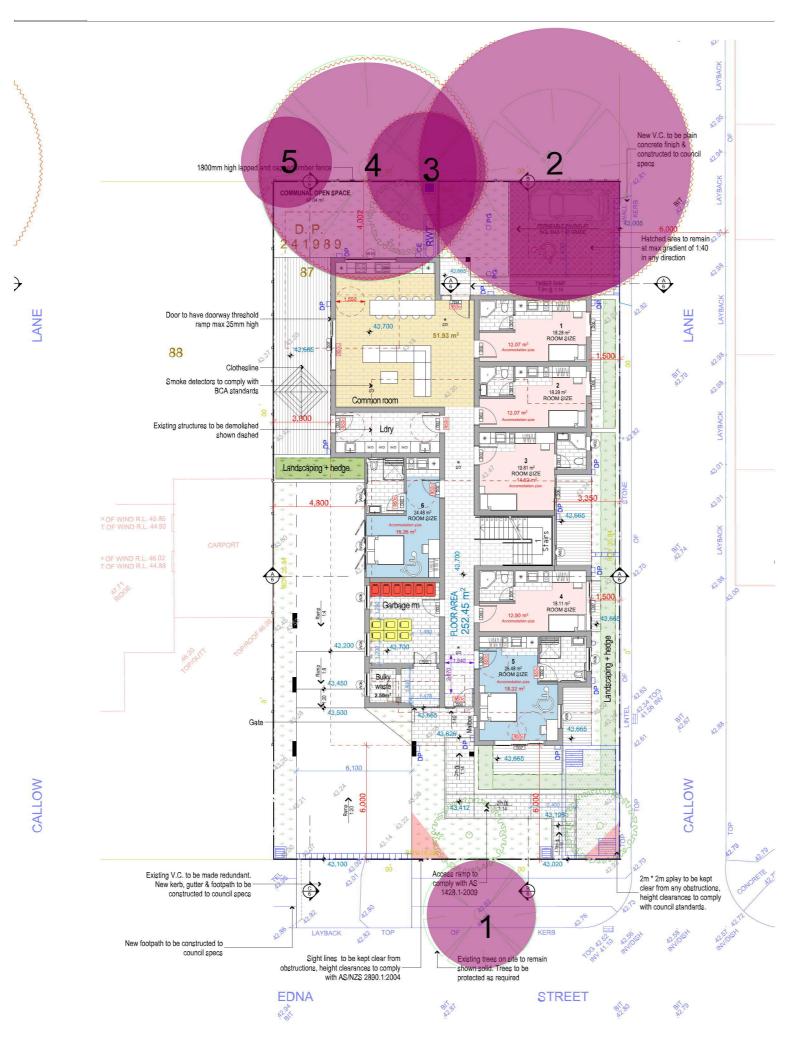
Plan: Tree Protection Zone Plan

Tree no.	Species	TPZ Radius (m)	Encroachment (%)
1.	Callistemon viminalis	2.88	50
2.	Alectryon coriaceus	7.2	21
3.	Callistemon viminalis	3.12	0
4.	Melaleuca stypheloides	5.76	13
5.	Alectryon coriaceus	2.4	0
