22nd November 2013

DL2591_PJ00317

Re: Review of Land Use Suitability and Remedial Requirements for the Escarpment Area of PLDC.

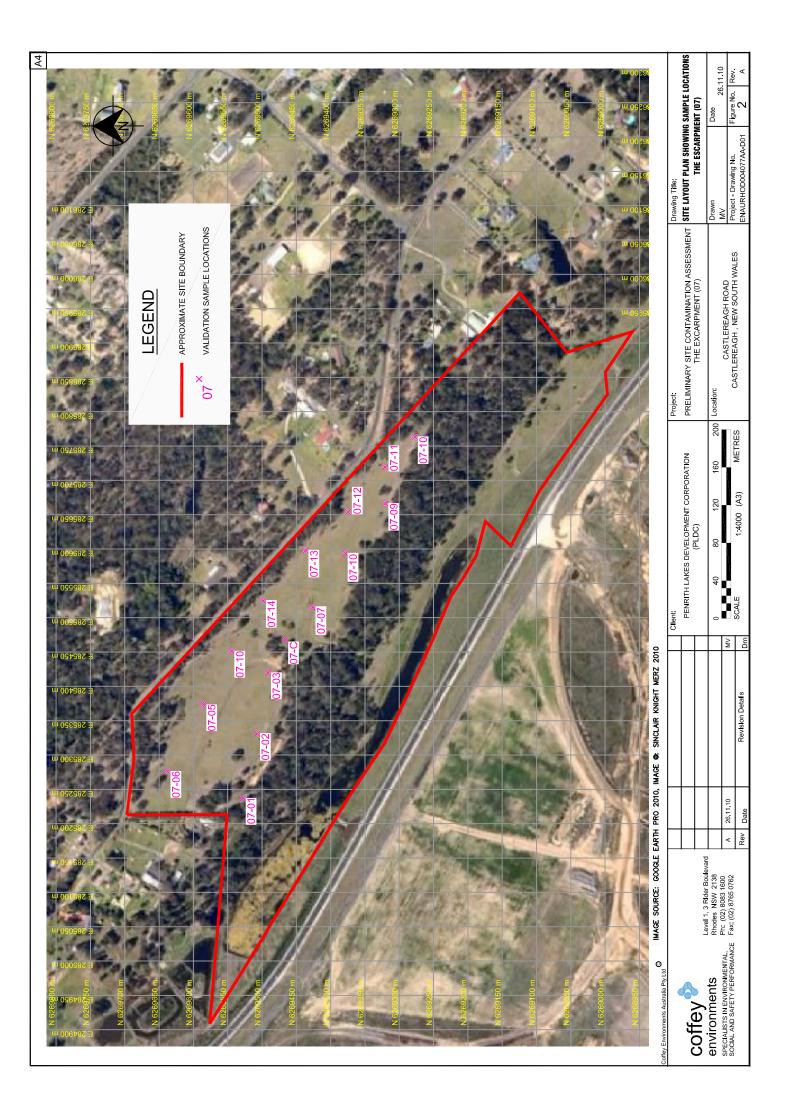
Figure 1

The Escarpment comprises approximately 24 hectares of land bound by Castlereagh Road to the southwest and Church Lane to the northeast. No structures are present, with the exception of the concrete and cobble remains of a derelict house in the centre of the site. The north-eastern portion of the site is primarily open grass covered land, with mature trees (Eucalypts and Casuarina) present along the southern boundary. A narrow lake extends approximately 700m along the Castlereagh Road boundary ranging between approximately 20m to 60m width.

Results from the laboratory analysis of twenty one (21) soil samples by Coffey in 2011 indicated that all contaminants of potential concern in the soil across the site were less than the soil investigation levels with the exception of sample 7-B (0.0m) for lead 2,500mg/kg and sample 7-C which contained asbestos cement within surface soils (i.e. upper 200mm of the soil) in the immediate vicinity of the derelict dwelling.

The Escarpment Layout

Based the findings of the Coffey investigation it is recommended that some delineation of the extent of the identified contaminants be undertaken. It is likely that remediation will be required in this isolated area, which will require excavation and disposal of the contaminated material. DLA will carry out these works under instruction from PLDC, which will then be validated in accordance with NSW EPA Guidelines for Consultants Reporting on Contaminated Sites, 1997 and the requirements of the NSW EPA Guidelines for the NSW Site Auditor Scheme, second edition 2006.
