BASIC TREE ASSESSMENT

Site Address:
31-32 Park Avenue,
Kingswood

Site Inspection Date:
06th October 2020

Job No:
5626

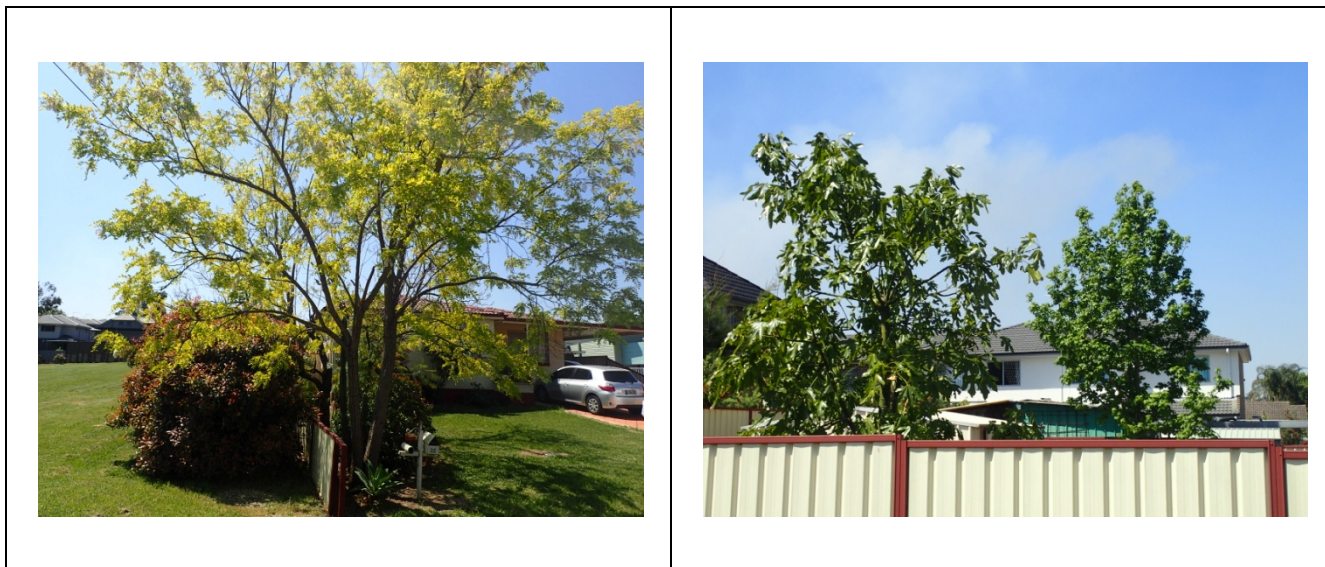
Plate 1 – Front Setback

Plate 2 – Rear Setback
