Report on
Land Capability Assessment

Fernhill Estate
Western Precinct
Fairlight Road, Mulgoa

Prepared for
Cubelic Holdings Pty Ltd

Project 71706.03
July 2014

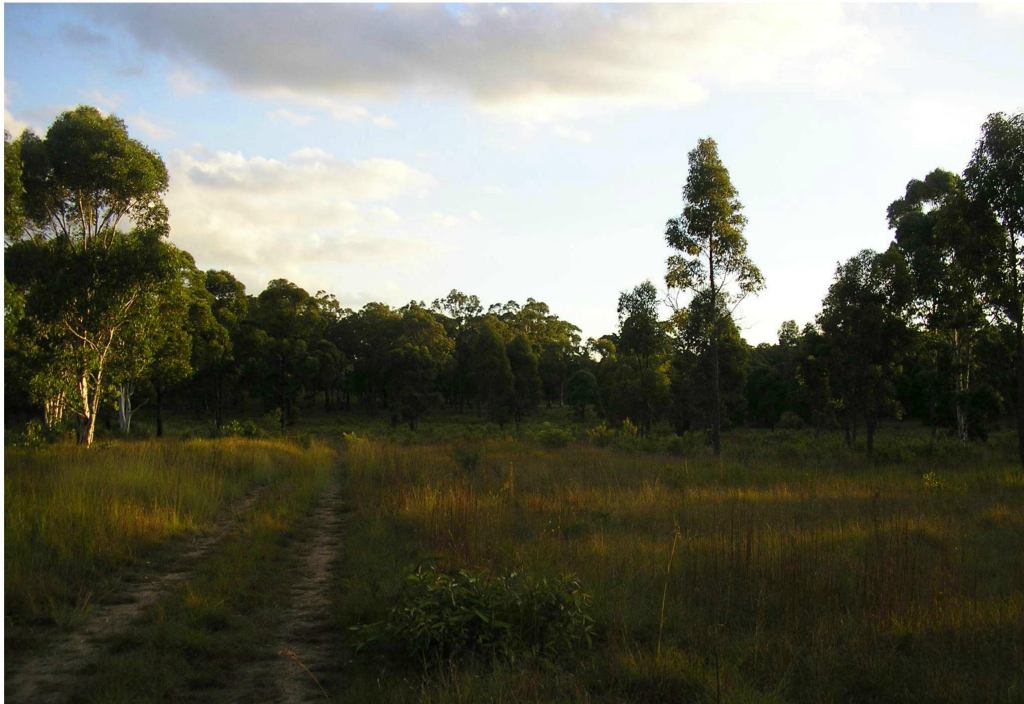
Photo 1 – View looking south along existing unsealed track within central part of proposed development area

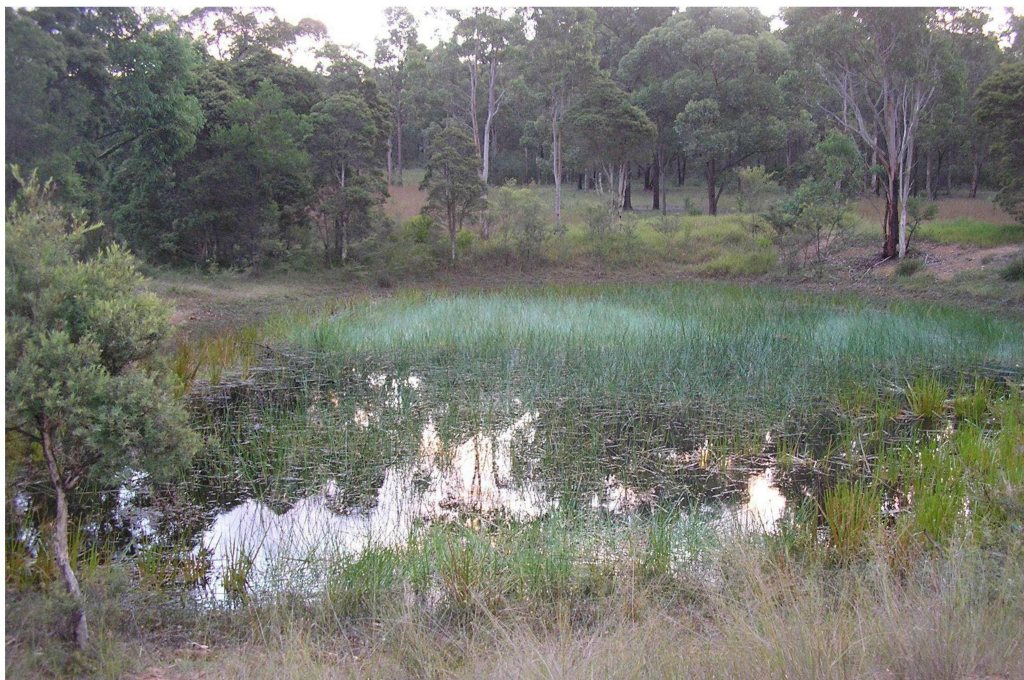
Photo 2 – View looking north-west across Dam 9 at central western part of proposed development area

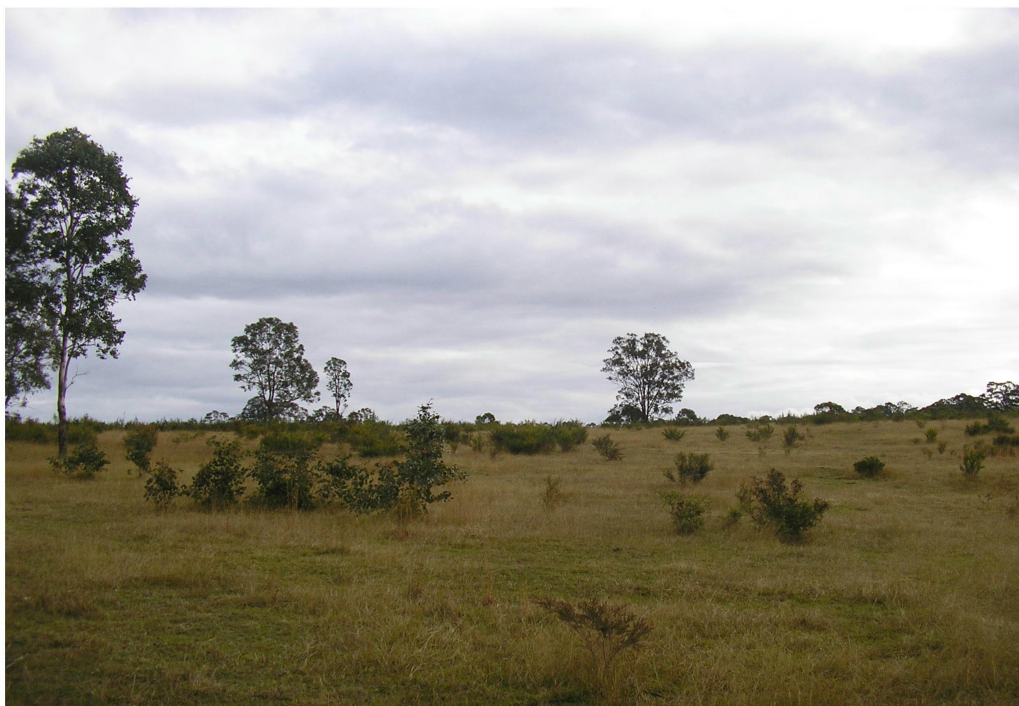
Photo 3 – View looking south-west across central eastern part of proposed development area near to Dam 10

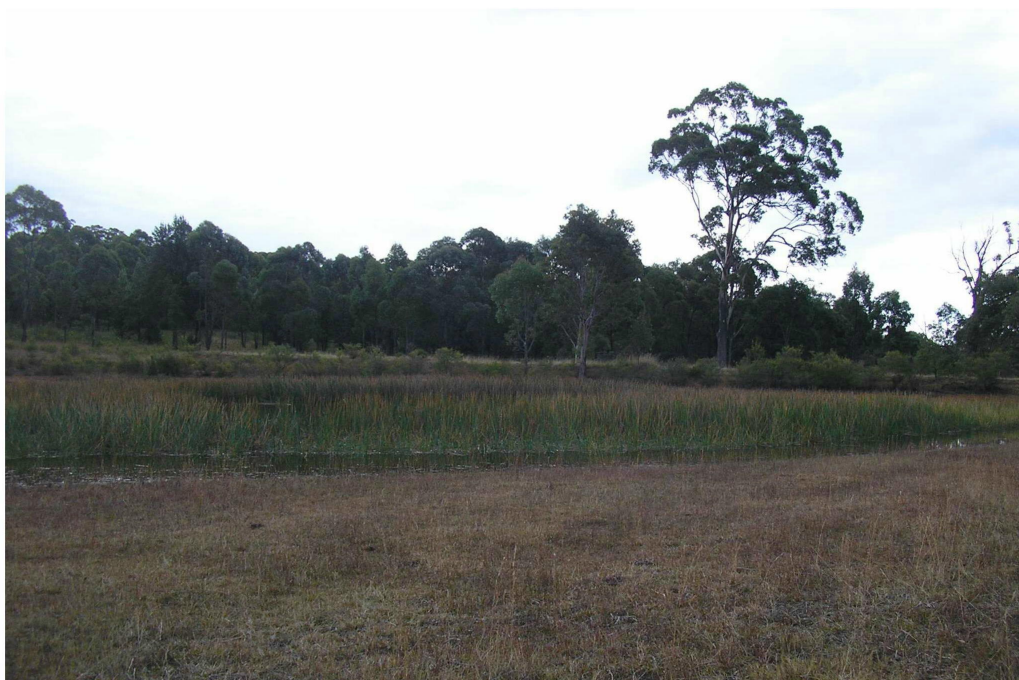
Photo 4 – View looking north-west across existing Dam 11 to tree line near to western site boundary

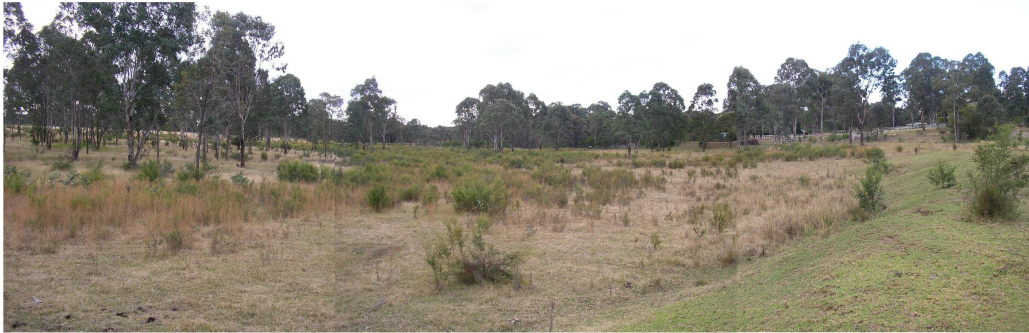
Photo 5 – Panoramic view looking north from Dam 12 across south-eastern part of proposed development area

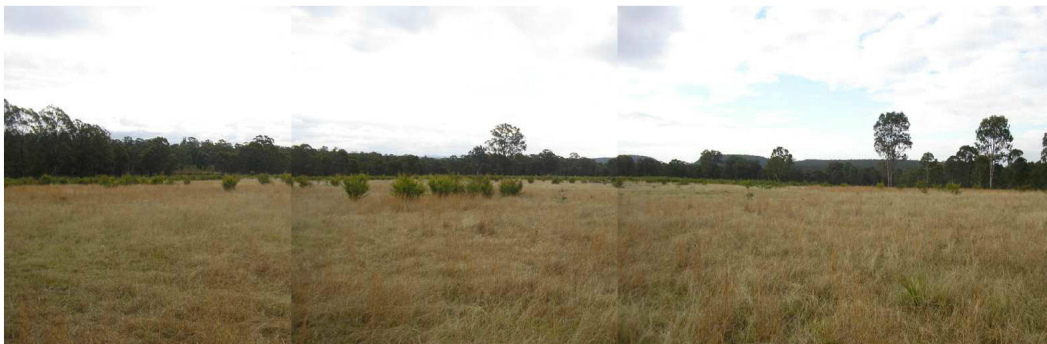
Photo 6 – Panoramic view looking north across the central southern part of the proposed development area

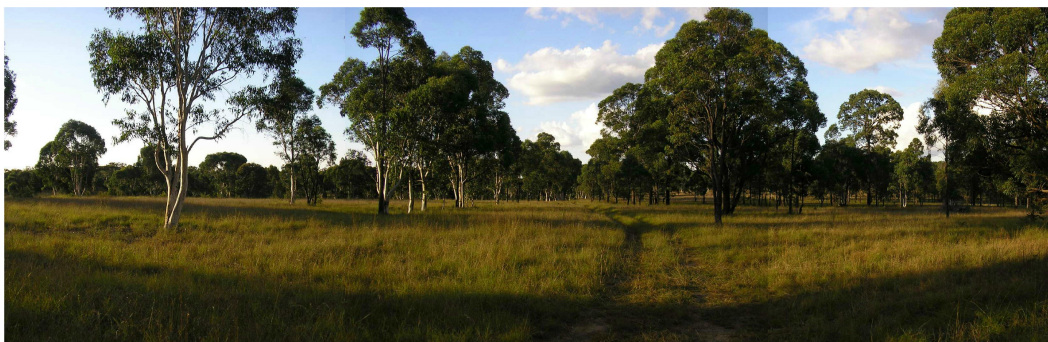
Photo 7 – Panoramic view looking south along existing unsealed track in central northern part of proposed development area

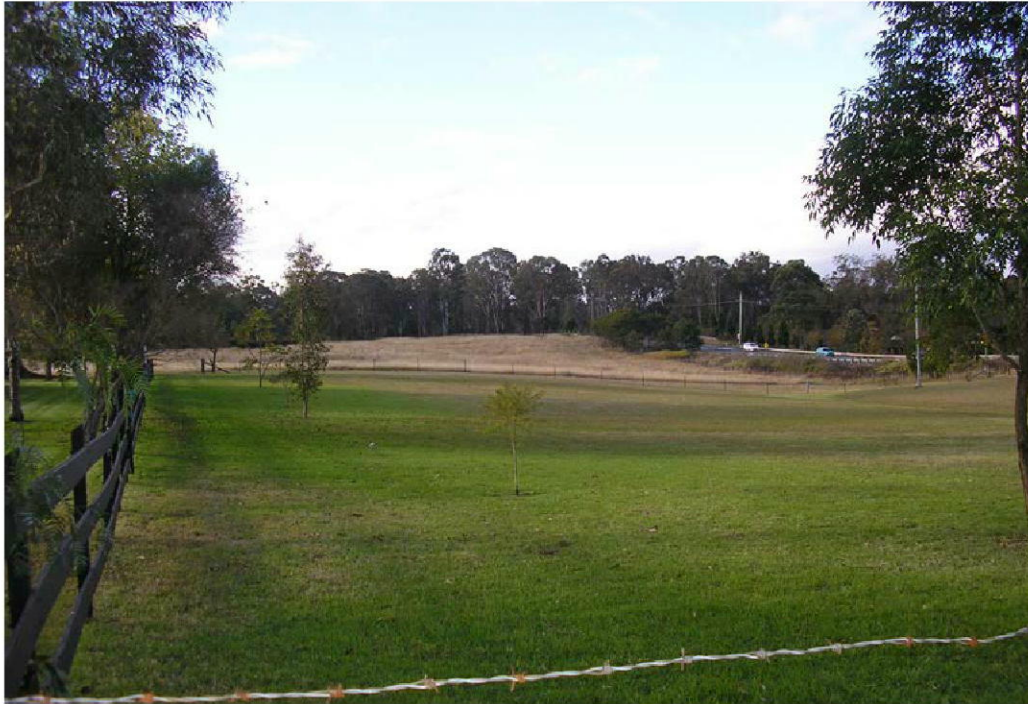
Photo 1 – View looking north across eastern part of Lot 1 between existing dwelling and Mulgoa Road

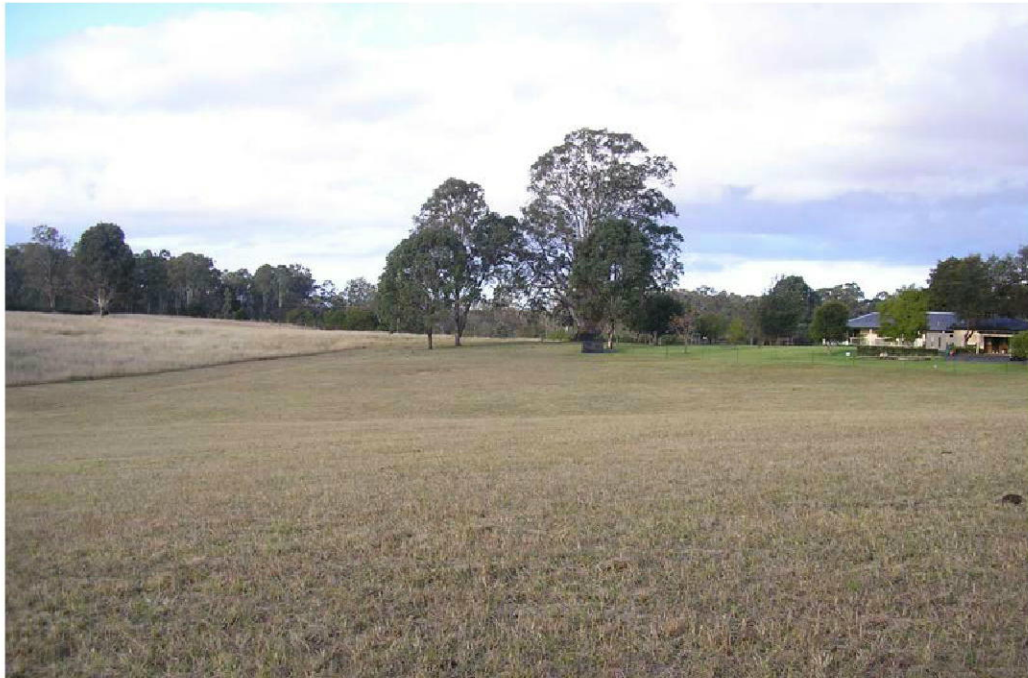
Photo 2 – View looking east across central eastern part of Lot 1 between Dam 1 and existing dwelling

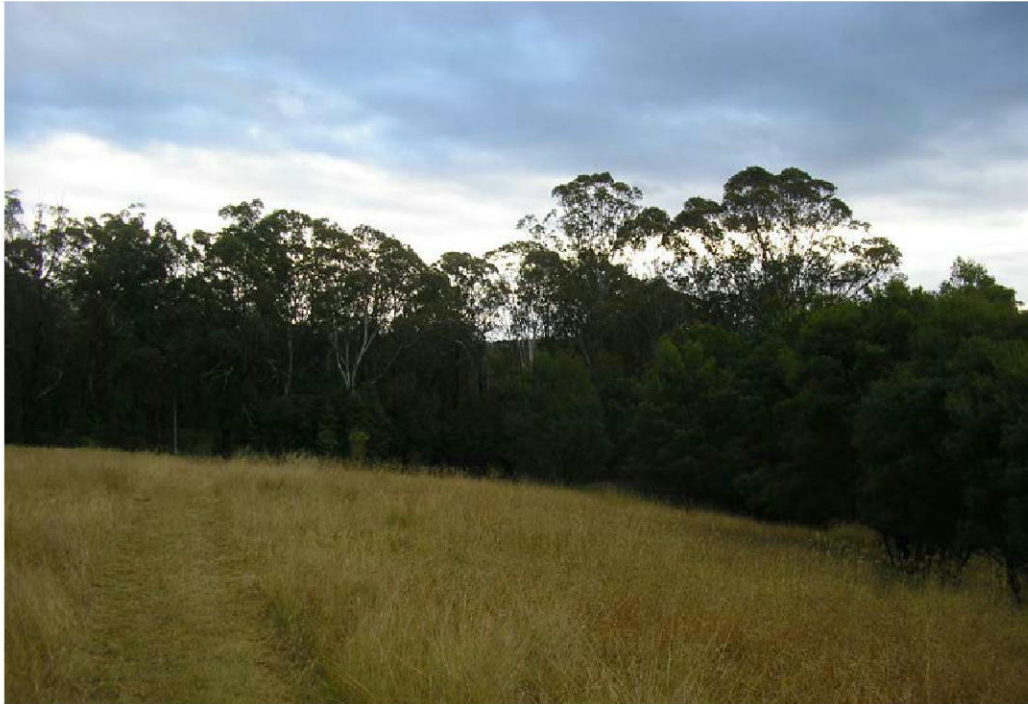
Photo 3 – View looking west across western part of Lot 1 west of Dam 1 towards tree line along western site boundary

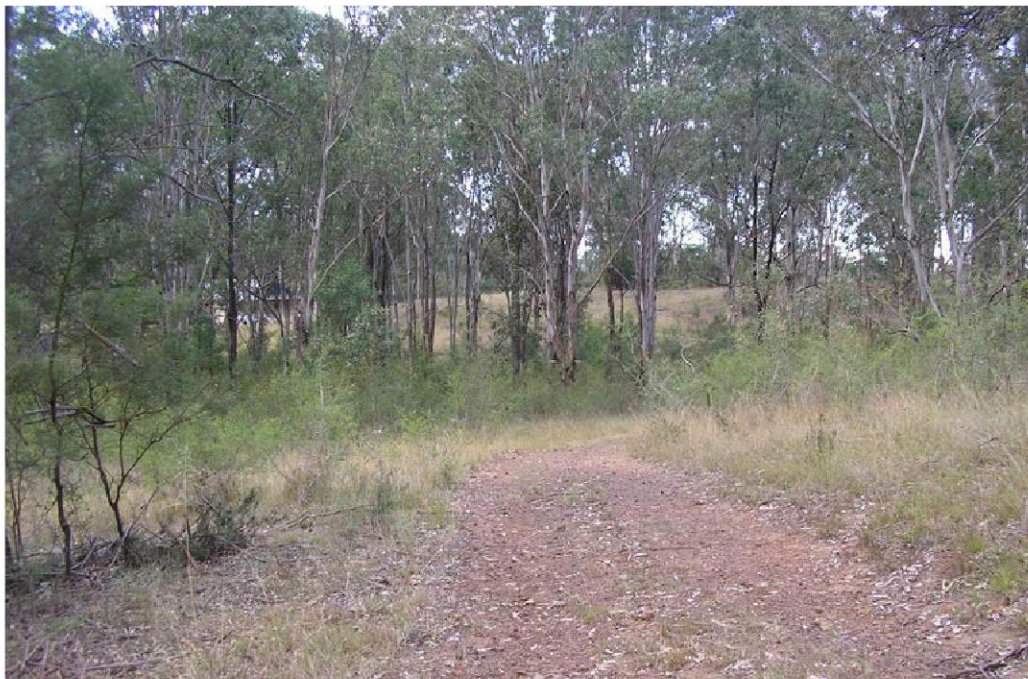
Photo 4 – View looking along existing unsealed track traversing partly cleared bushland near northern site boundary

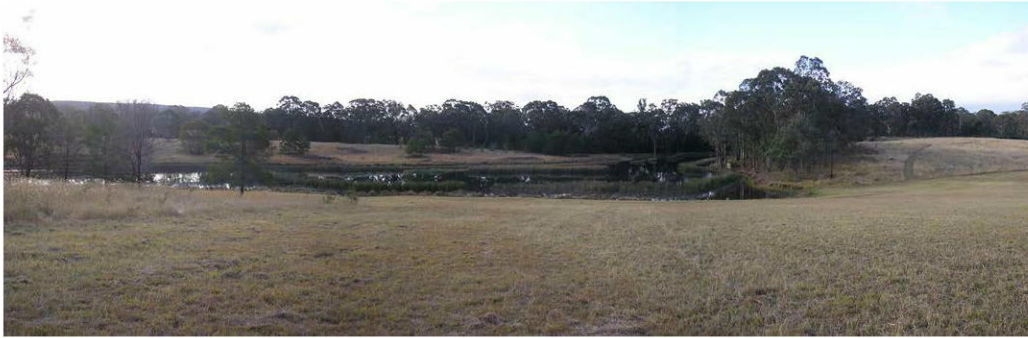
Photo 5 – Panoramic view looking north across Dam 1 through central part of Lot 1

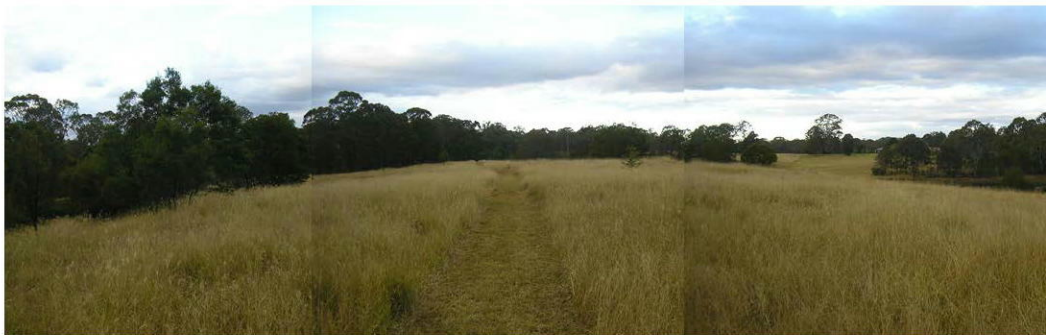
Photo 6 – Panoramic view looking north-east across western part of Lot 1

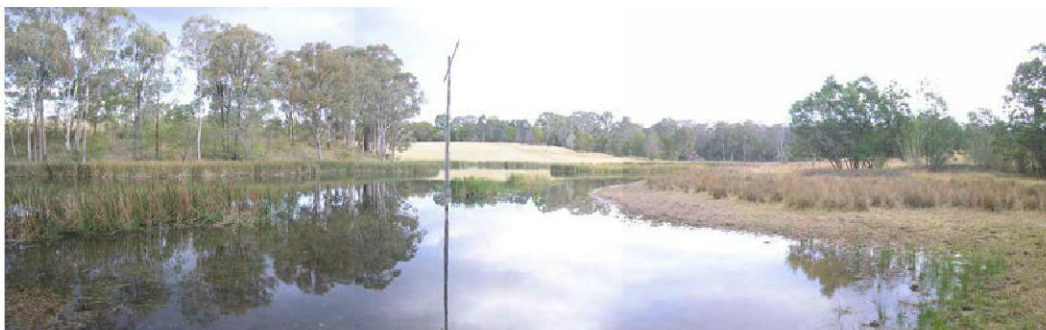
Photo 7 – Panoramic view looking south across Dam 1 through central part of Lot 1
