**RE: PROPOSED NEPEAN GARDENS - WALLACIA GOLF COURSE, PARK ROAD, WALLACIA, NSW.**

## 1.0 Overview

This letter provides a summary of groundwater level monitoring undertaken using wells previously installed to the west of the proposed development area by Martens and Associates Pty Ltd (MA). The groundwater conditions at the proposed development area are assumed to be similar to the area covered by the well locations. The letter should be read in conjunction with MA's preliminary geotechnical, groundwater and salinity assessment report for the site (Ref: P1706171JR01V02, October 2019) and MA's previous interim groundwater summary (ref: P1706171JC03V01, 14 January 2019).

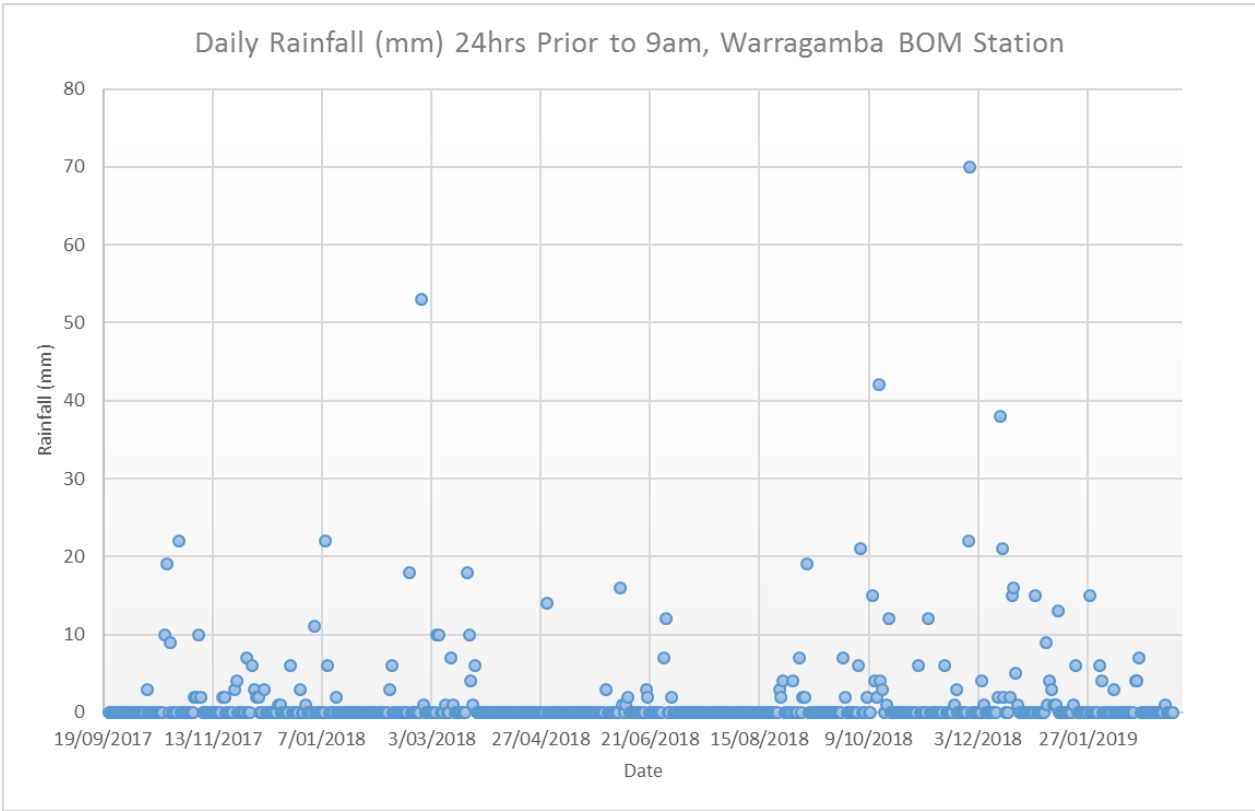
**Figure 1:** Rainfall over groundwater monitoring period (22 September 2017 to February 2019).

Rainfall data over the groundwater monitoring period is provided in Figure 1. Throughout the monitoring period there were 49 days with rain of equal to or greater than 5 mm, 31 days with rain of equal to or greater than 10 mm and 4 days with rain of equal to or greater than 25 mm. Maximum daily rainfall was 70 mm.

A cumulative monthly residual rain mass analysis was completed to assess recent rainfall trends during and leading up to the groundwater monitoring period. The analysis was based on observed rainfall data from Badgerys Creek AWS BOM Station (data from 1995 to present) and long term average rainfall from Badgerys Creek McMasters F.Stn BOM Station (data from 1936 - 1996 ). The analysis indicated generally below average rainfall from March 2017 onwards. Groundwater level trends are often influenced by cumulative

residual rain mass trends, which indicates groundwater levels in the region are likely to have been generally declining over the monitoring period.

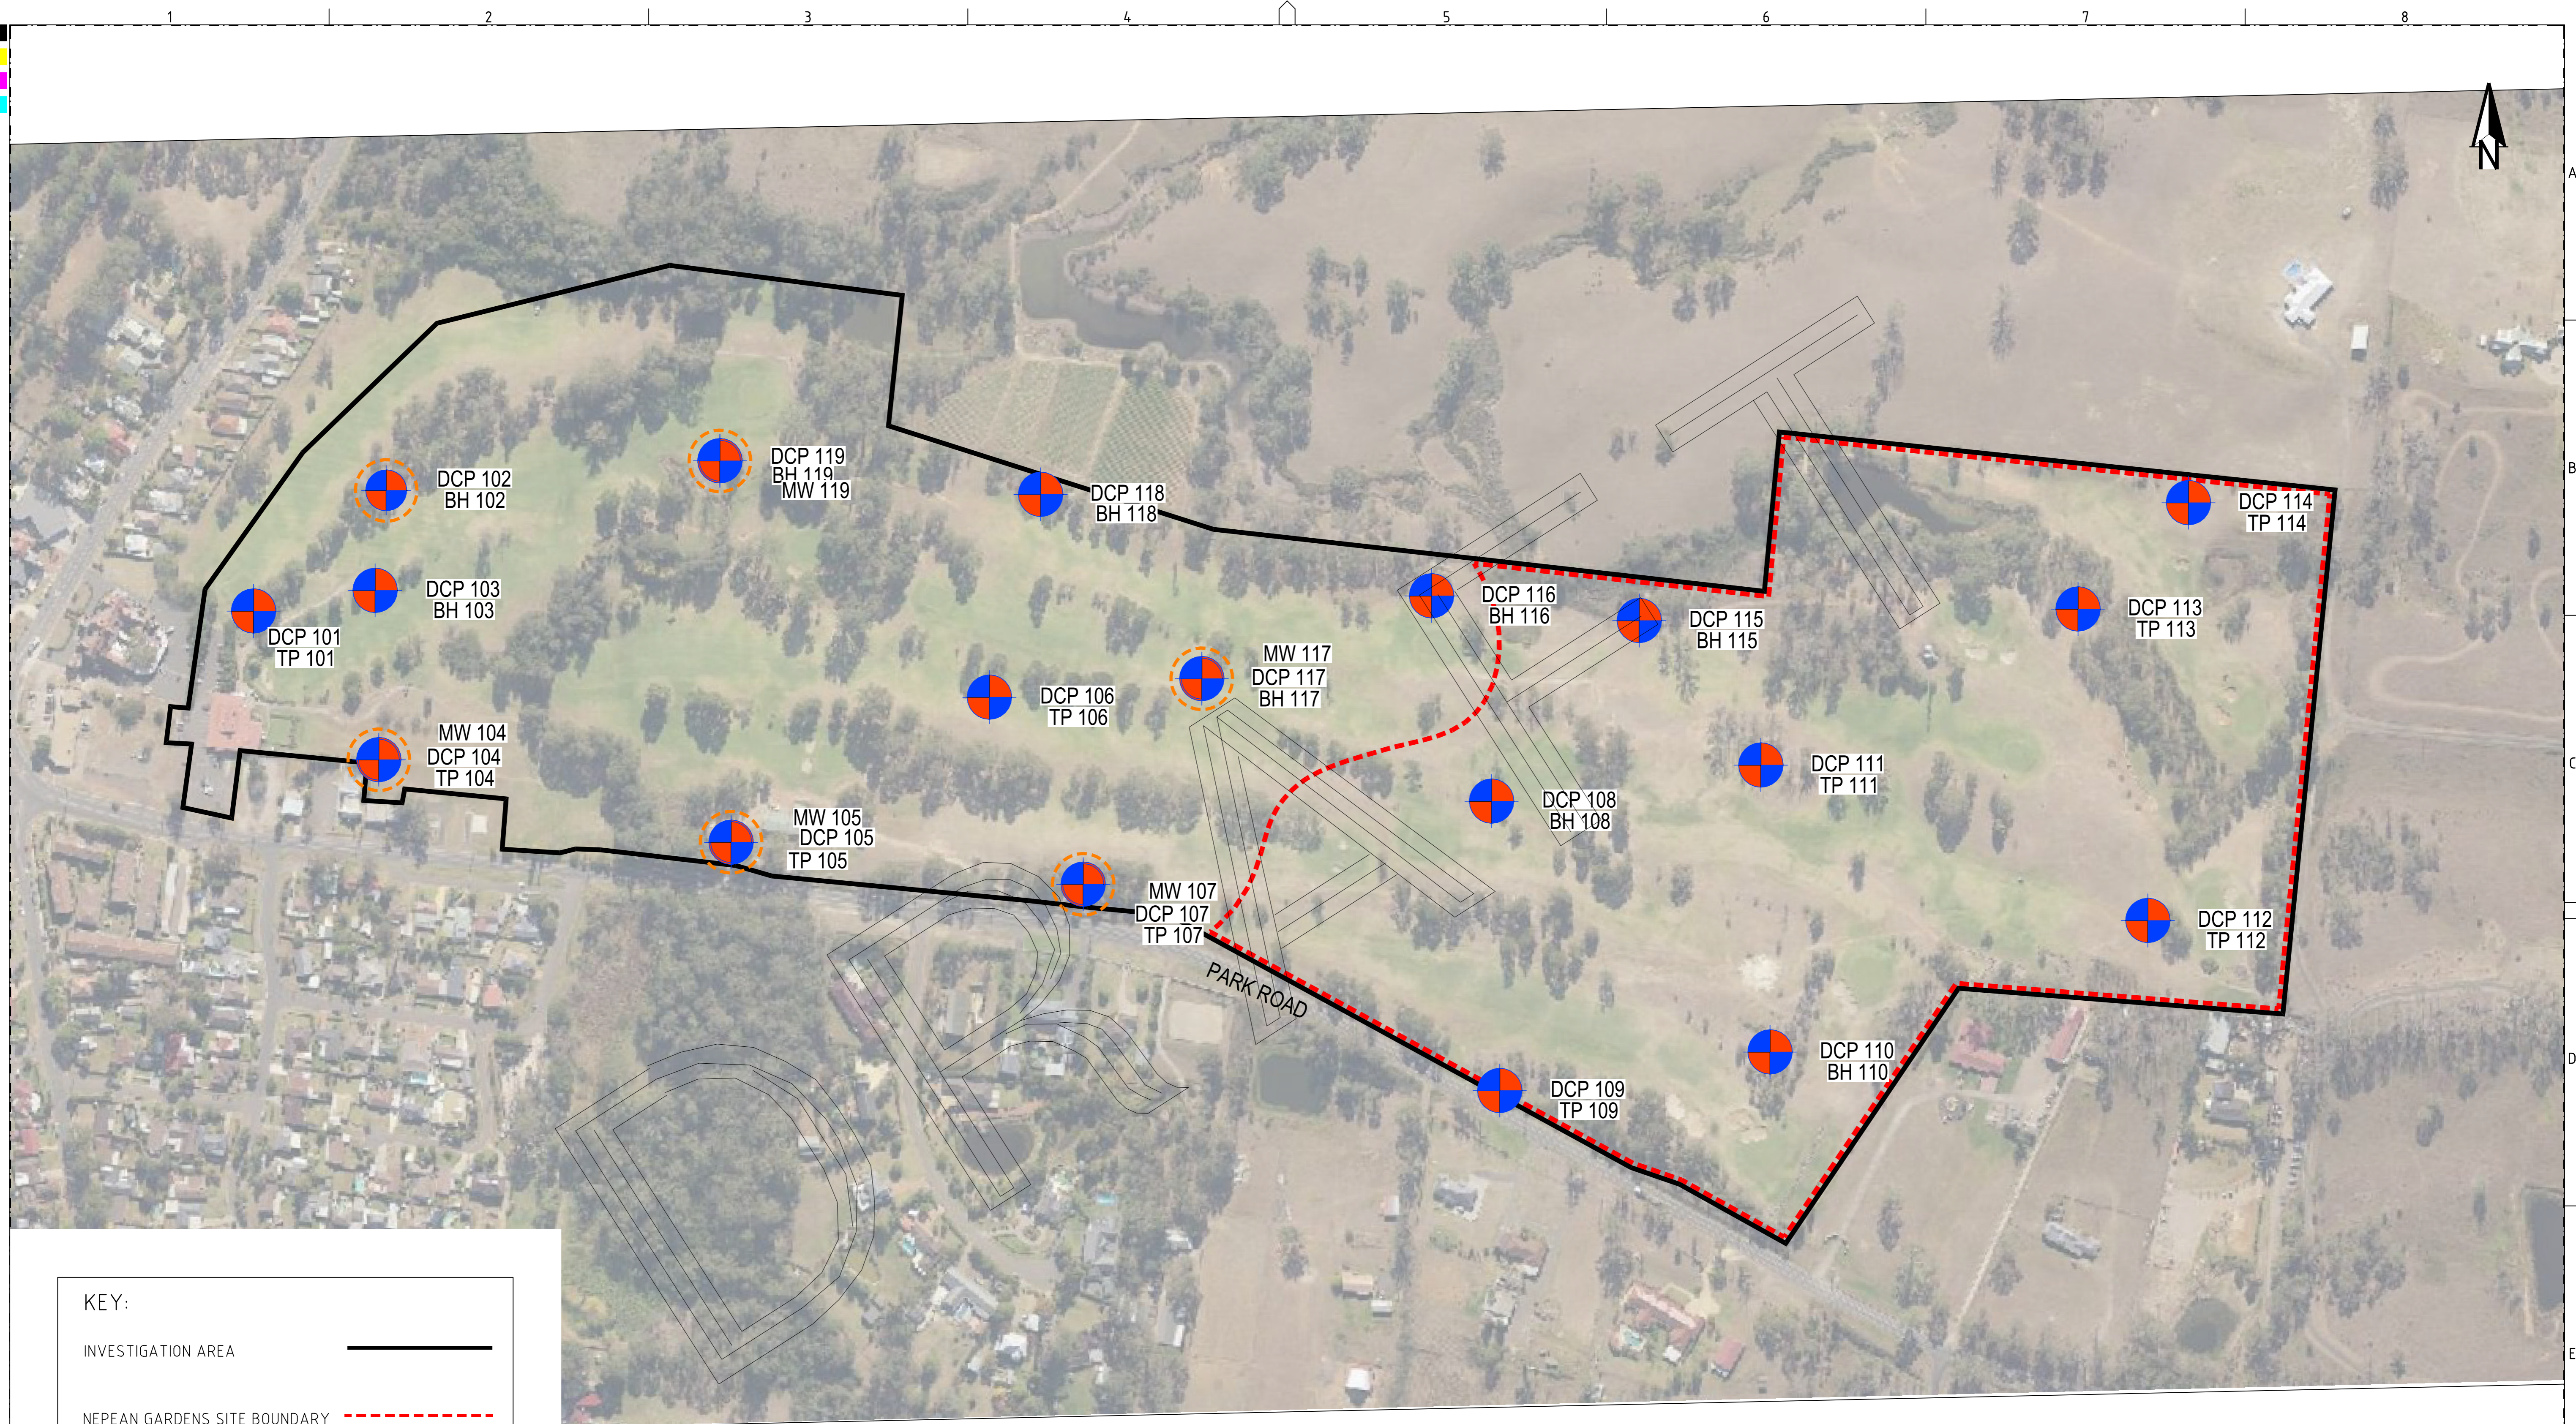
**Attachment A – Borehole/Groundwater Monitoring Well Locations**

On 22 September 2017, Boreholes (BHs) BH102, BH104, BH105, BH107, BH117 and BH119 were drilled to the west of the site and completed as groundwater monitoring wells (MW102, MW104, MW105, MW107, MW117 and MW119 respectively). The BHs were drilled for geotechnical and hydrogeological characterisation purposes. Refer to Attachment A for BH/MW locations, Attachment B for borehole and groundwater monitoring well logs and Table 1 for a summary of monitoring well details.
