Jacfin Pty Ltd

Geomorphological Assessment: Proposed Subdivision - 2B Adlington Road, Kemps Creek, NSW

P1907485JR01V02
October 2019

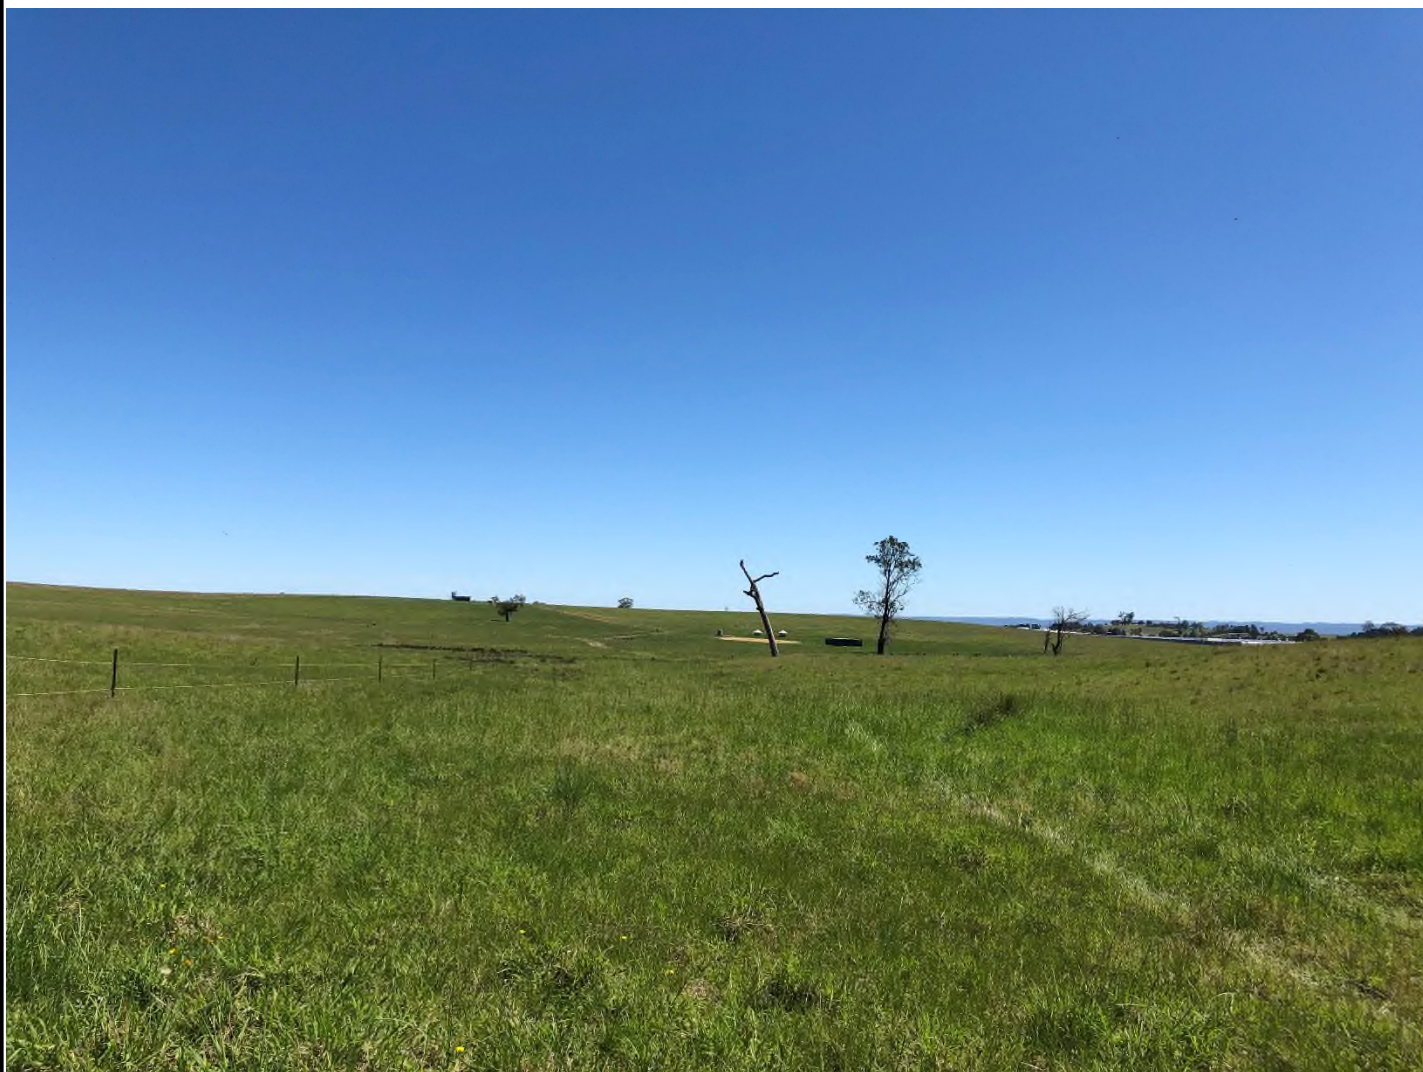
Martens & Associates Pty Ltd ABN 85 070 240 890		Environment Water Wastewater Geotechnical Civil Management	
Drawn:	MGD	Photograph of Drainage Depression A – Looking downslope and south-west towards proposed boundary of Lot 12	PHOTO 1
Approved:	DMM		
Date:	23.10.19		Job No: P1907485
Scale:	nts

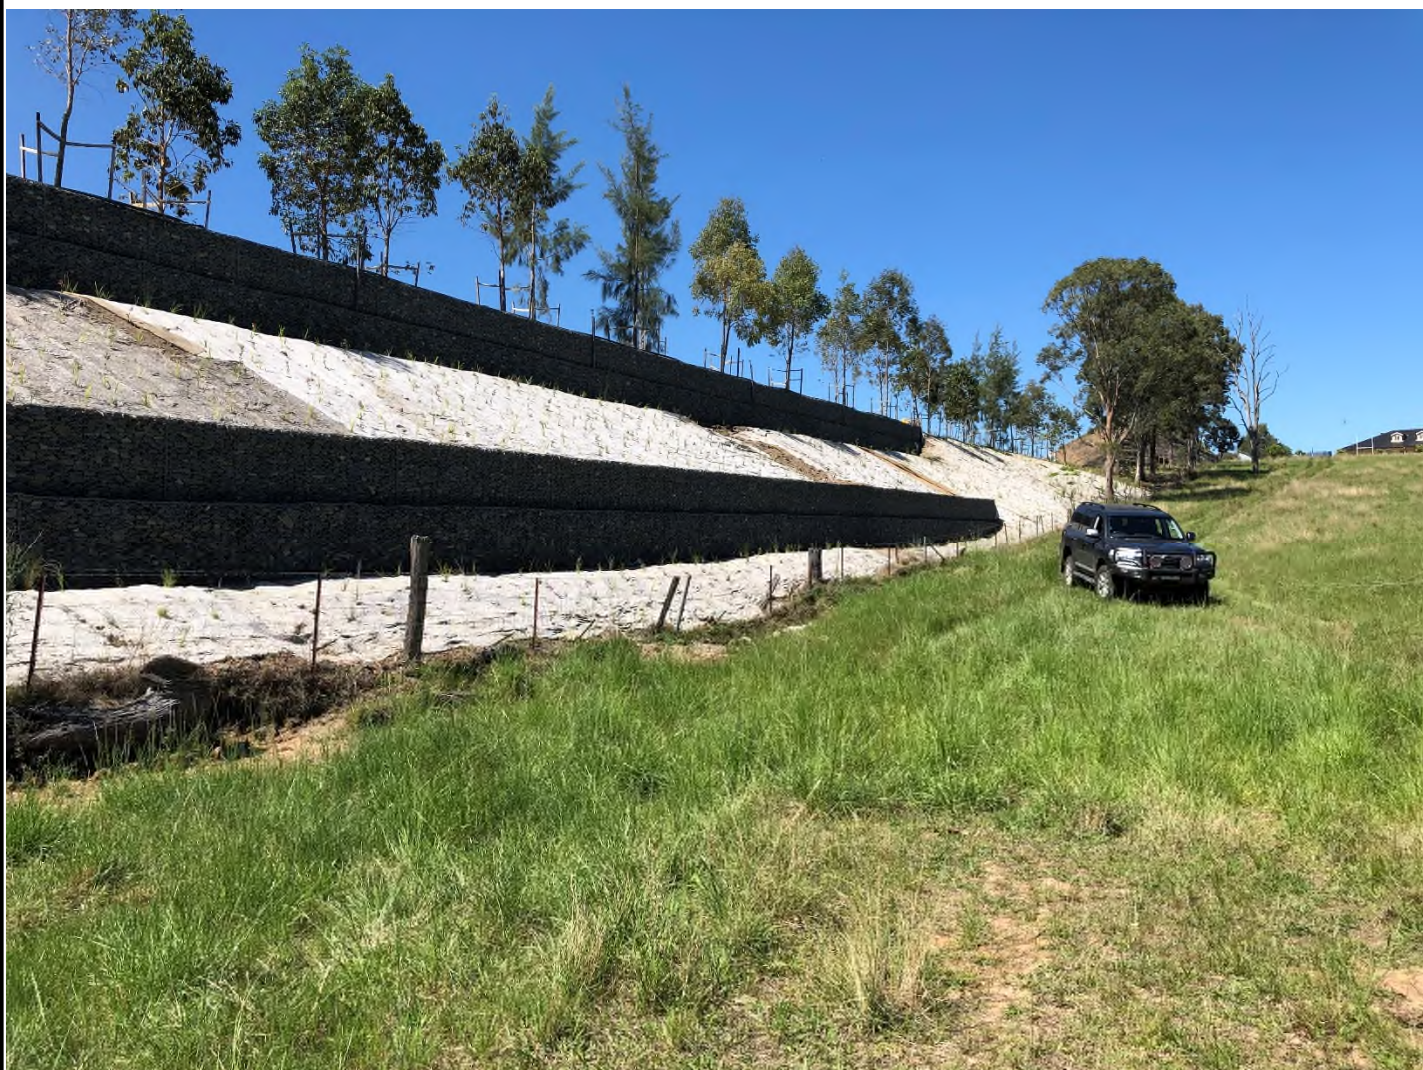
Martens & Associates Pty Ltd ABN 85 070 240 890		Environment Water Wastewater Geotechnical Civil Management	
Drawn:	MGD	Photograph of Drainage Depression A – Looking upslope and north-east towards boundary with Lot 103 DP 1214912 (6 Johnston Crescent, Horsley Park, NSW)	PHOTO 2
Approved:	DMM		
Date:	23.10.19		Job No: P1907485
Scale:	nts

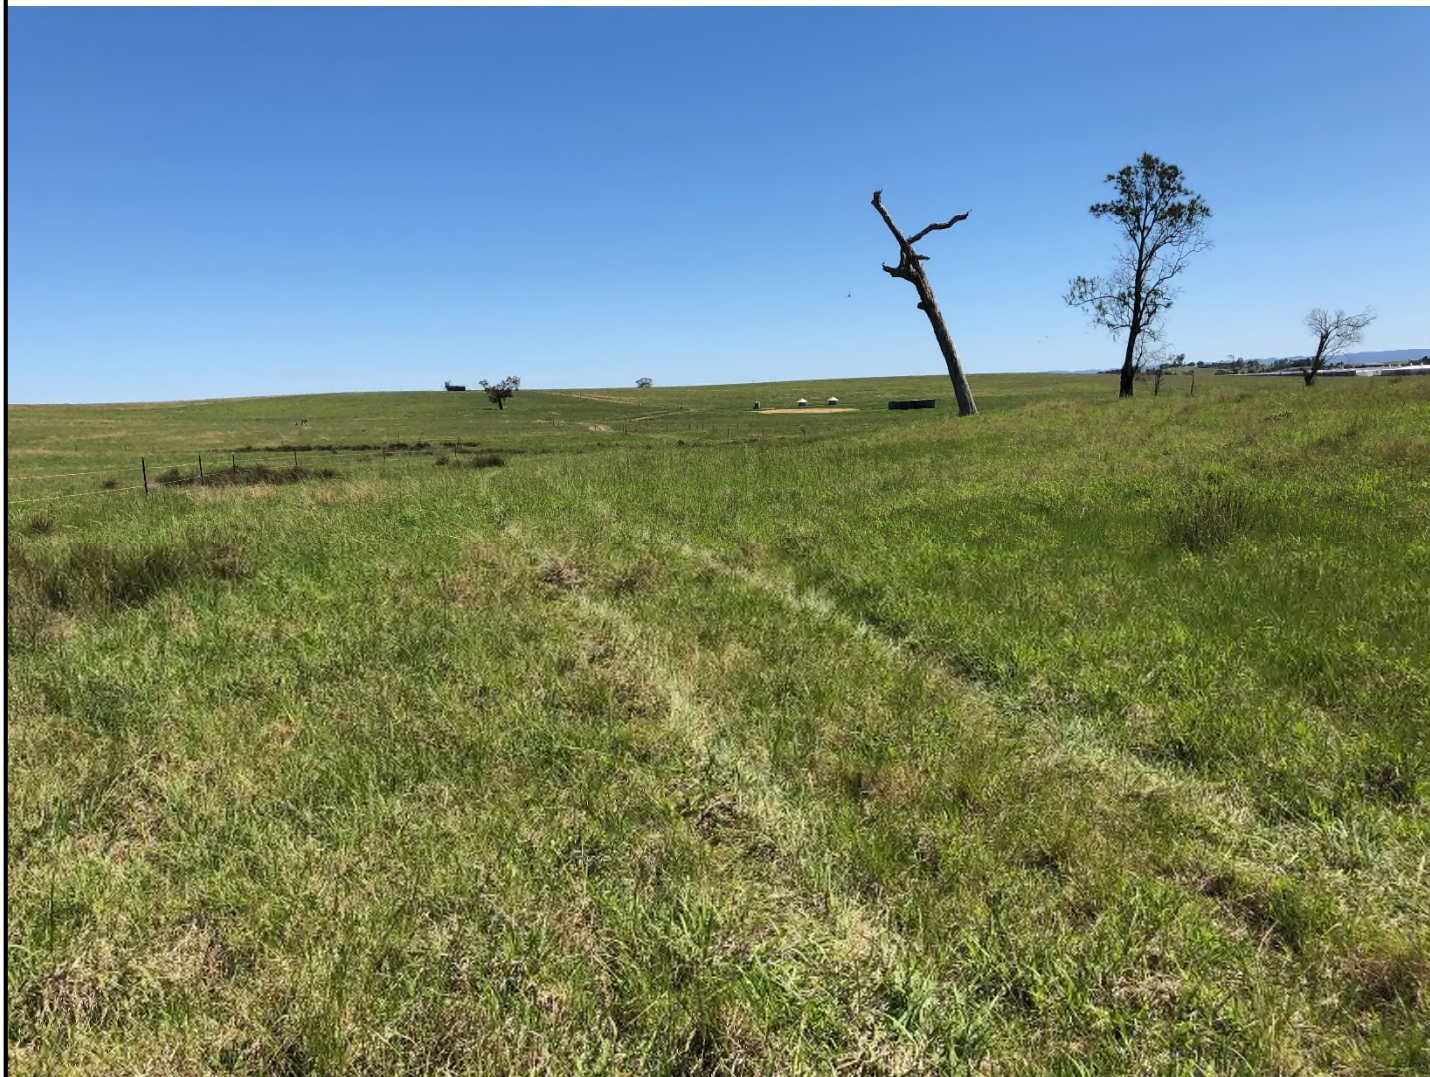
Martens & Associates Pty Ltd ABN 85 070 240 890		Environment Water Wastewater Geotechnical Civil Management	
Drawn:	MGD	Photograph of Drainage Depression A – Looking downslope and south-west in the vicinity of the proposed boundary of Lots 12 and 17	PHOTO 3
Approved:	DMM		
Date:	23.10.19		Job No: P1907485
Scale:	nts

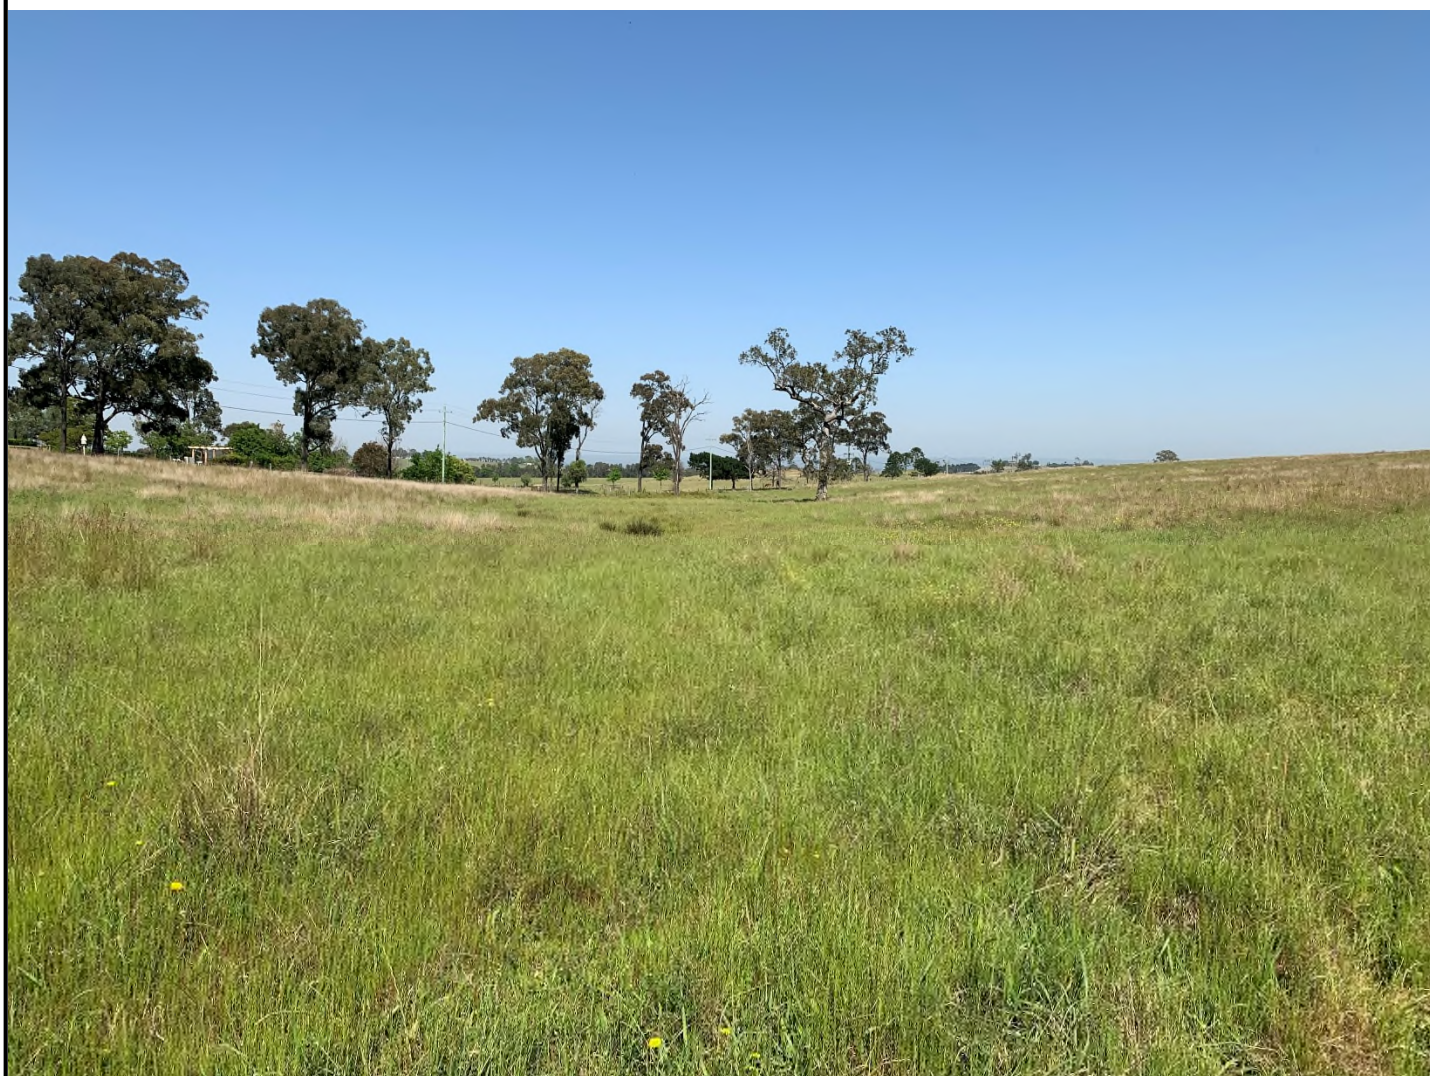
Martens & Associates Pty Ltd ABN 85 070 240 890		Environment Water Wastewater Geotechnical Civil Management	
Drawn:	MGD	Photograph of Drainage Depression B – Looking downslope and south in the vicinity of the proposed access road between Lots 13 and 14	PHOTO 7
Approved:	DMM		
Date:	24.10.19		Job No: P1907485
Scale:	nts

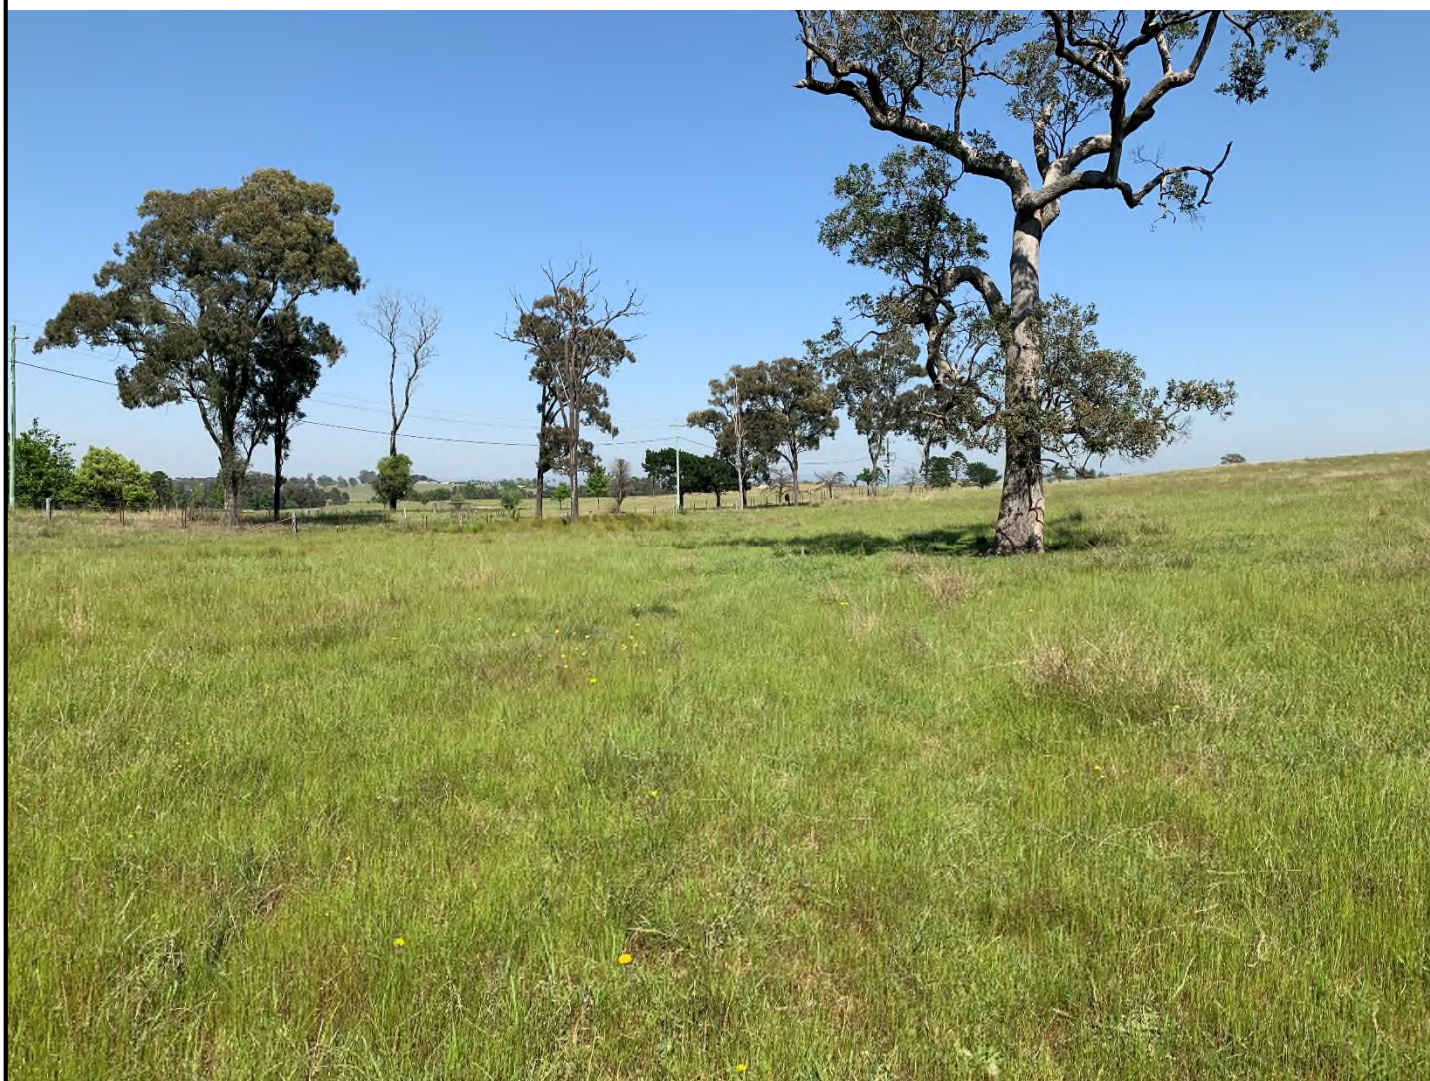
Martens & Associates Pty Ltd ABN 85 070 240 890		Environment Water Wastewater Geotechnical Civil Management	
Drawn:	MGD	Photograph of Drainage Depression B – Looking downslope and south-west approximately 30 m upslope of the site boundary	PHOTO 8
Approved:	DMM		
Date:	24.10.19		Job No: P1907485
Scale:	nts

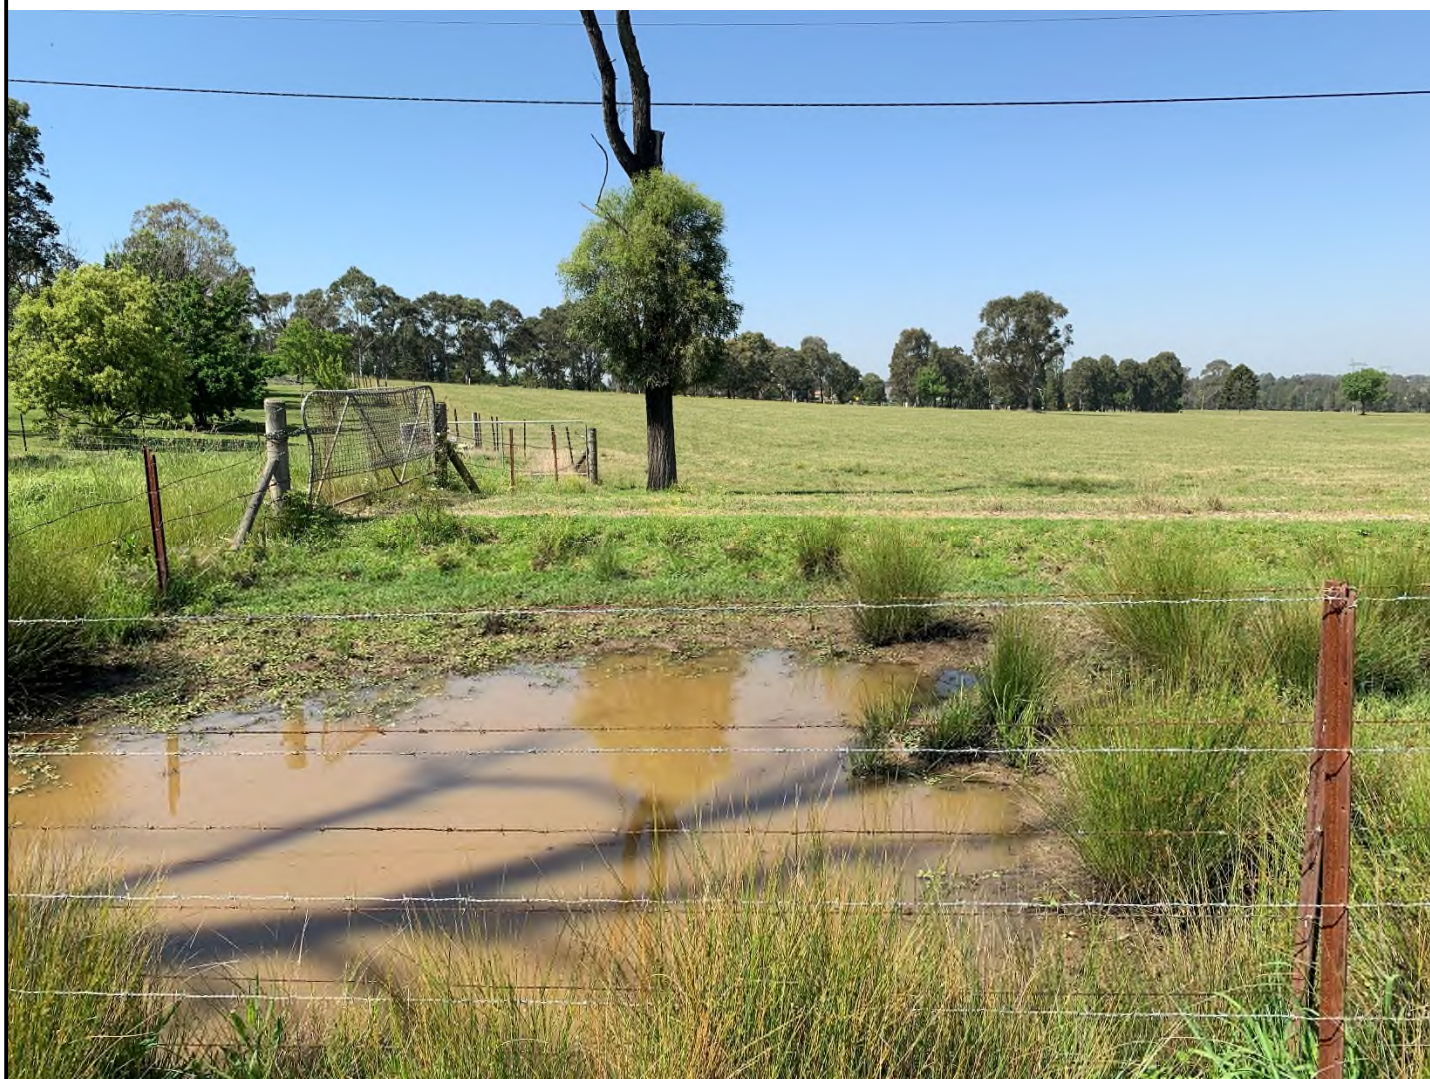
Martens & Associates Pty Ltd ABN 85 070 240 890		Environment Water Wastewater Geotechnical Civil Management	
Drawn:	MGD	Photograph of Drainage Depression B – Looking downslope in the vicinity of the site boundary showing standing water ponded behind access (due to poorly sited drainage pipes)	PHOTO 9
Approved:	DMM		
Date:	24.10.19		Job No: P1907485
Scale:	nts

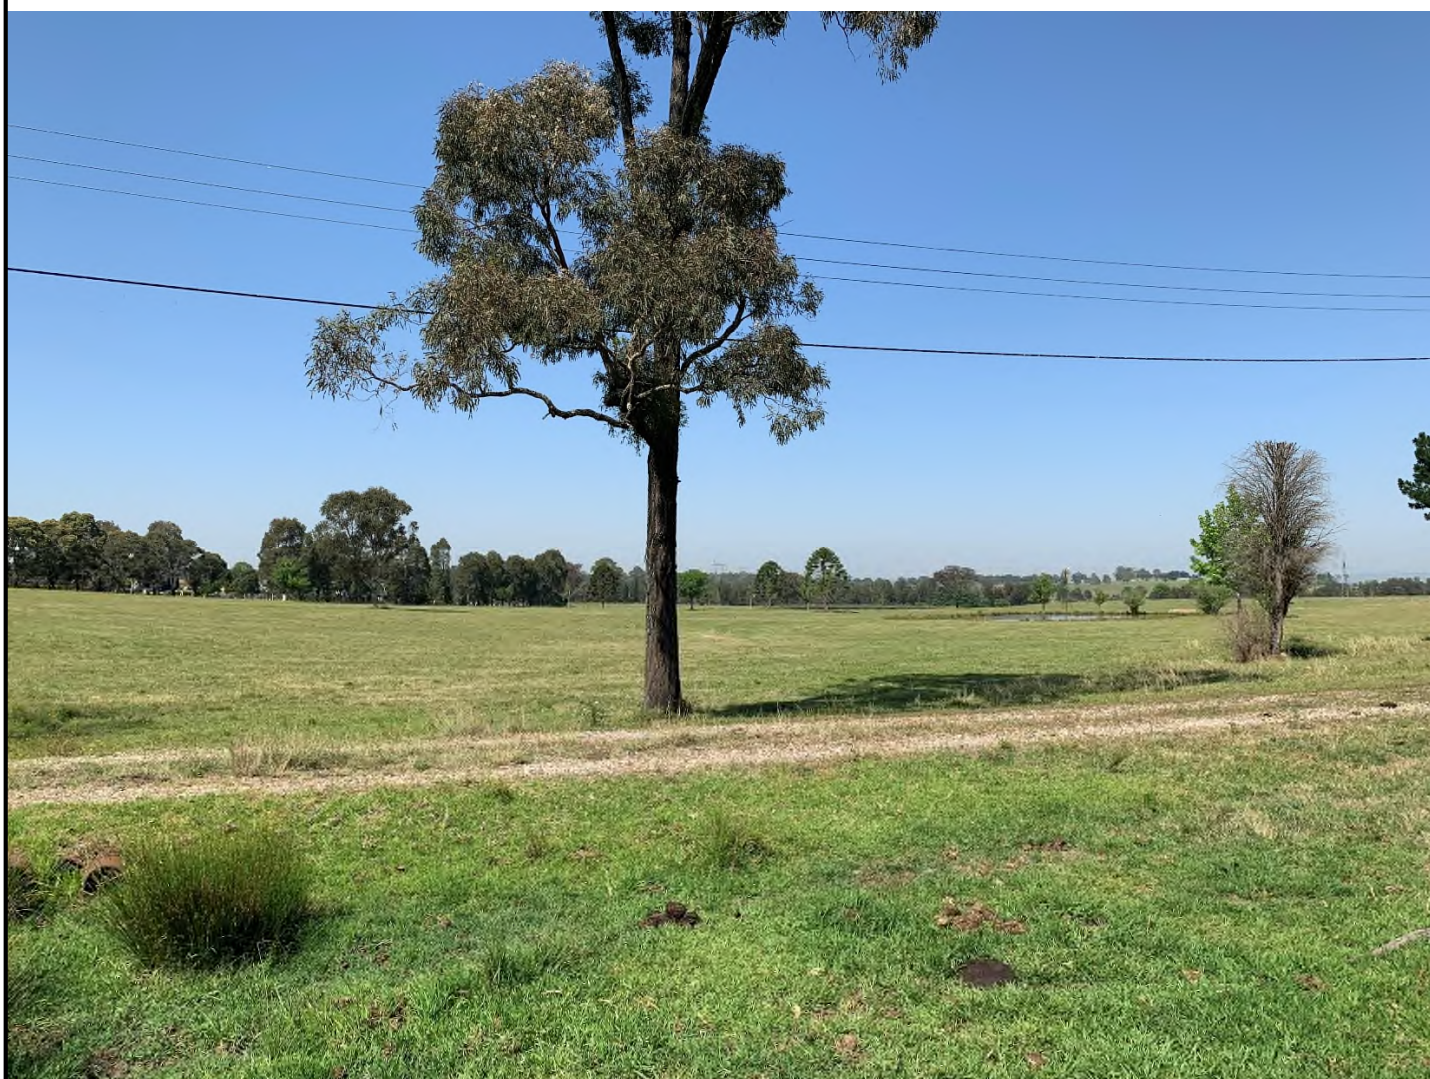
Martens & Associates Pty Ltd ABN 85 070 240 890		Environment Water Wastewater Geotechnical Civil Management	
Drawn:	MGD	Photograph of Drainage Depression B – Looking downslope from the site boundary showing no characteristics of a watercourse	PHOTO 10
Approved:	DMM		
Date:	24.10.19		
Scale:	nts		Job No: P1907485
