30 March 2017

# Oakdale West Estate, Contamination Appraisal

SITE PLAN Site Condition Report Horsley Park, New South Wales

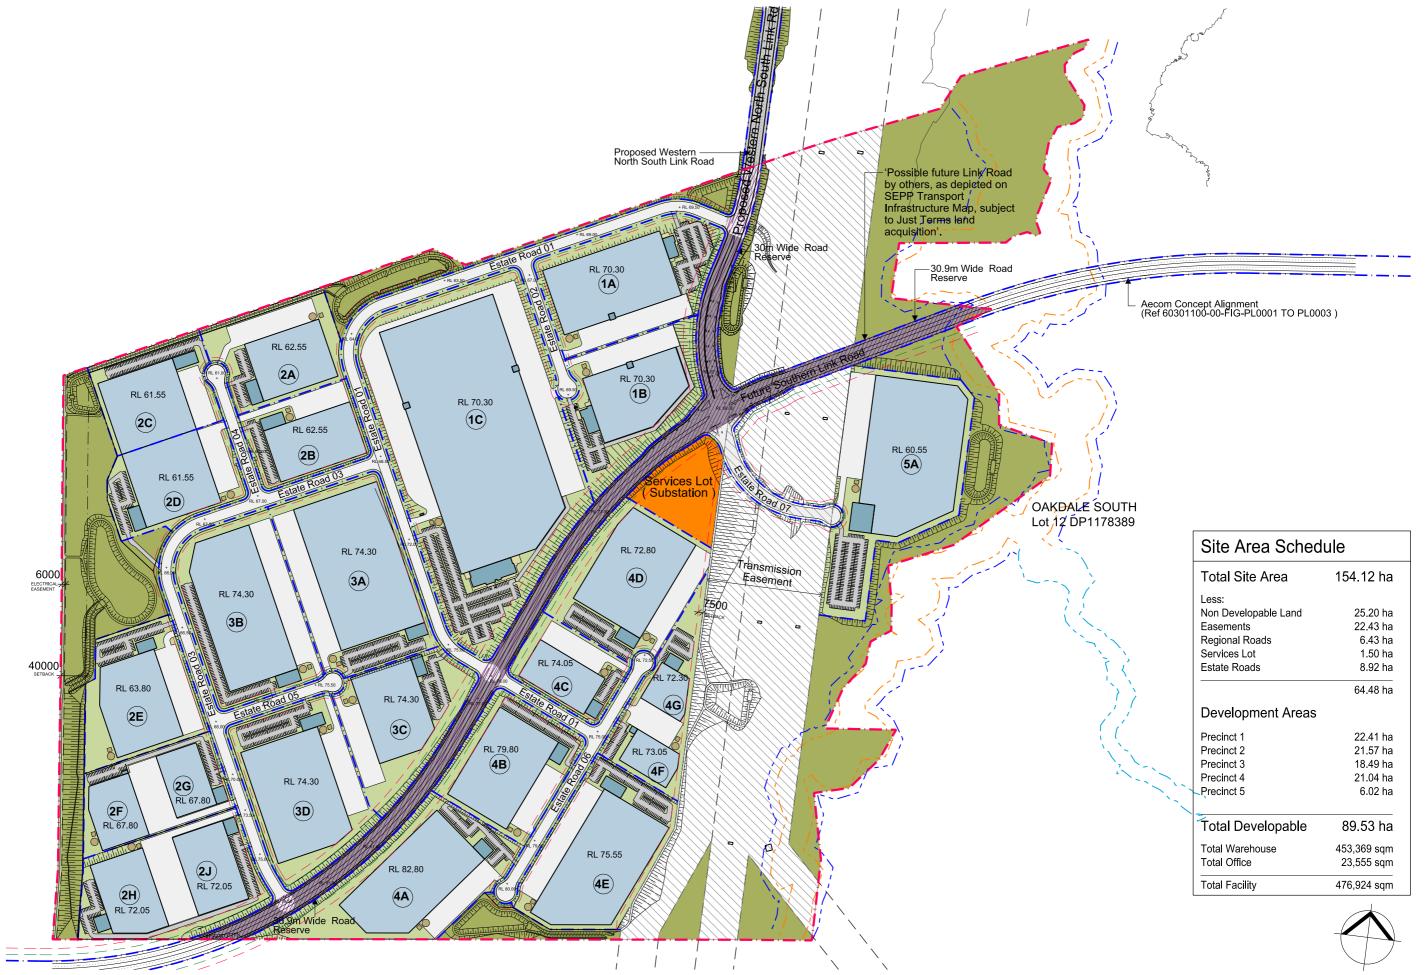
FIGURE 1

Review of satellite imagery for July 2013 / 2014 / 2015 (refer to Figure 1) indicates no observable changes in Site conditions.
